## Presentation on the Existing Condition of the Public Works Building

City Council Study Session  
May 5, 2026

AB 6920

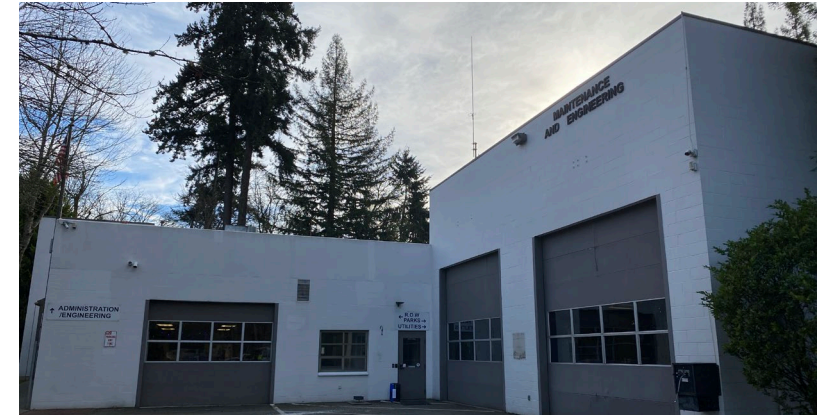
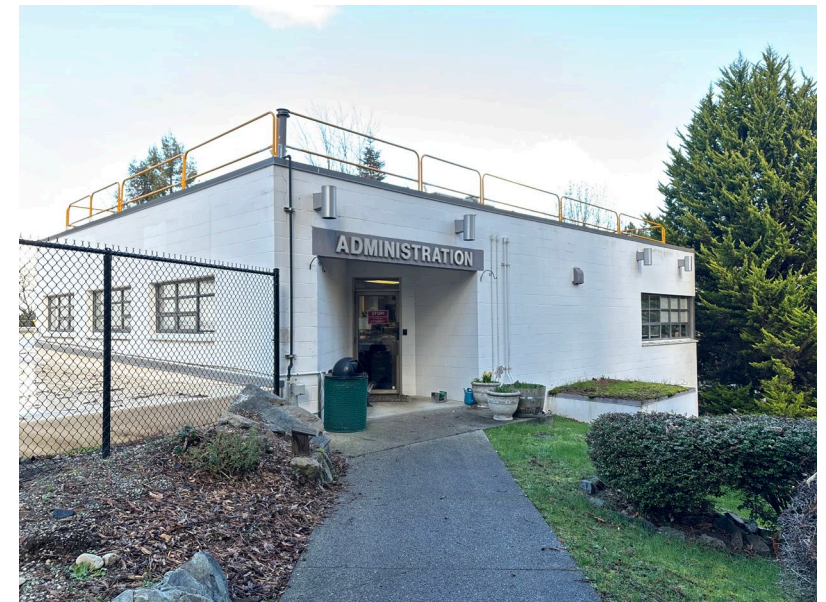
## Existing conditions

- The existing Public Works Building was **constructed in 1980**.
- The building is Construction Type V-1 hour (non-combustible).
- The building is **not equipped with an automatic sprinkler system**.
- The building is a two-story structure with a total building area of 15,347 square feet (SF).
- The original occupancy classification of the building is B-2 (business) and H-2, H-3, H-4 (hazard).
