**SUMMARY REPORT OF A
LIMITED FORENSIC EVALUATION**

**MICANOPY TOWN HALL
MICANOPY, ALACHUA COUNTY, FLORIDA**

GSE PROJECT NO. 17318

Subject: Summary Report of a Limited Forensic Evaluation
Micanopy Town Hall
Micanopy, Alachua County, Florida
GSE Project No. 17318

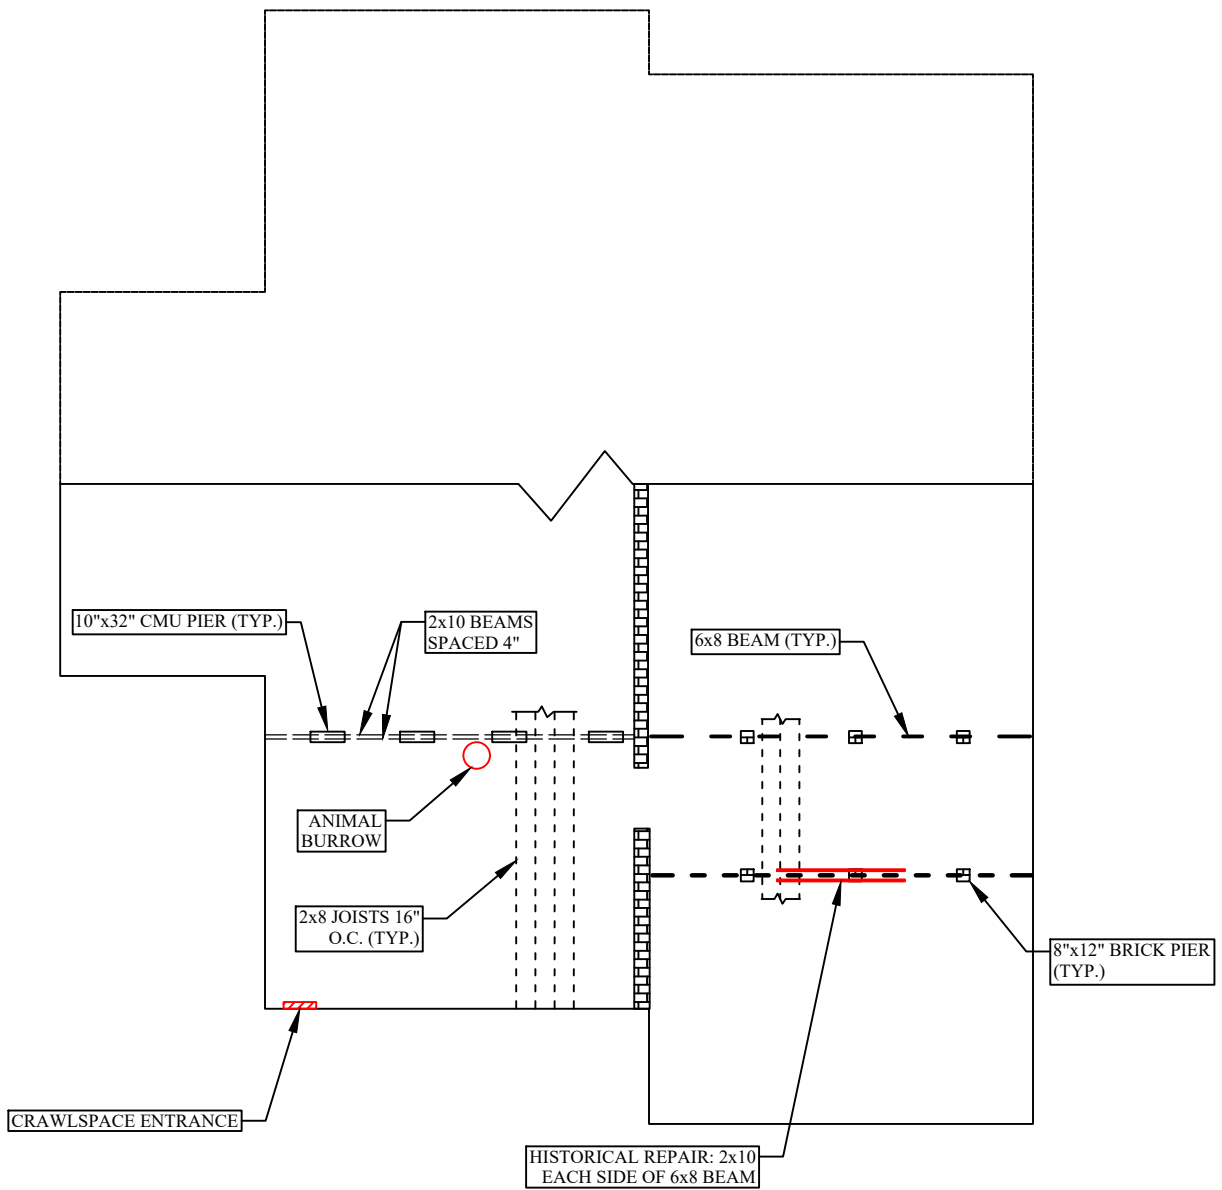
FIGURE
 5

CRAWLSPACE OBSERVATION LOCATIONS

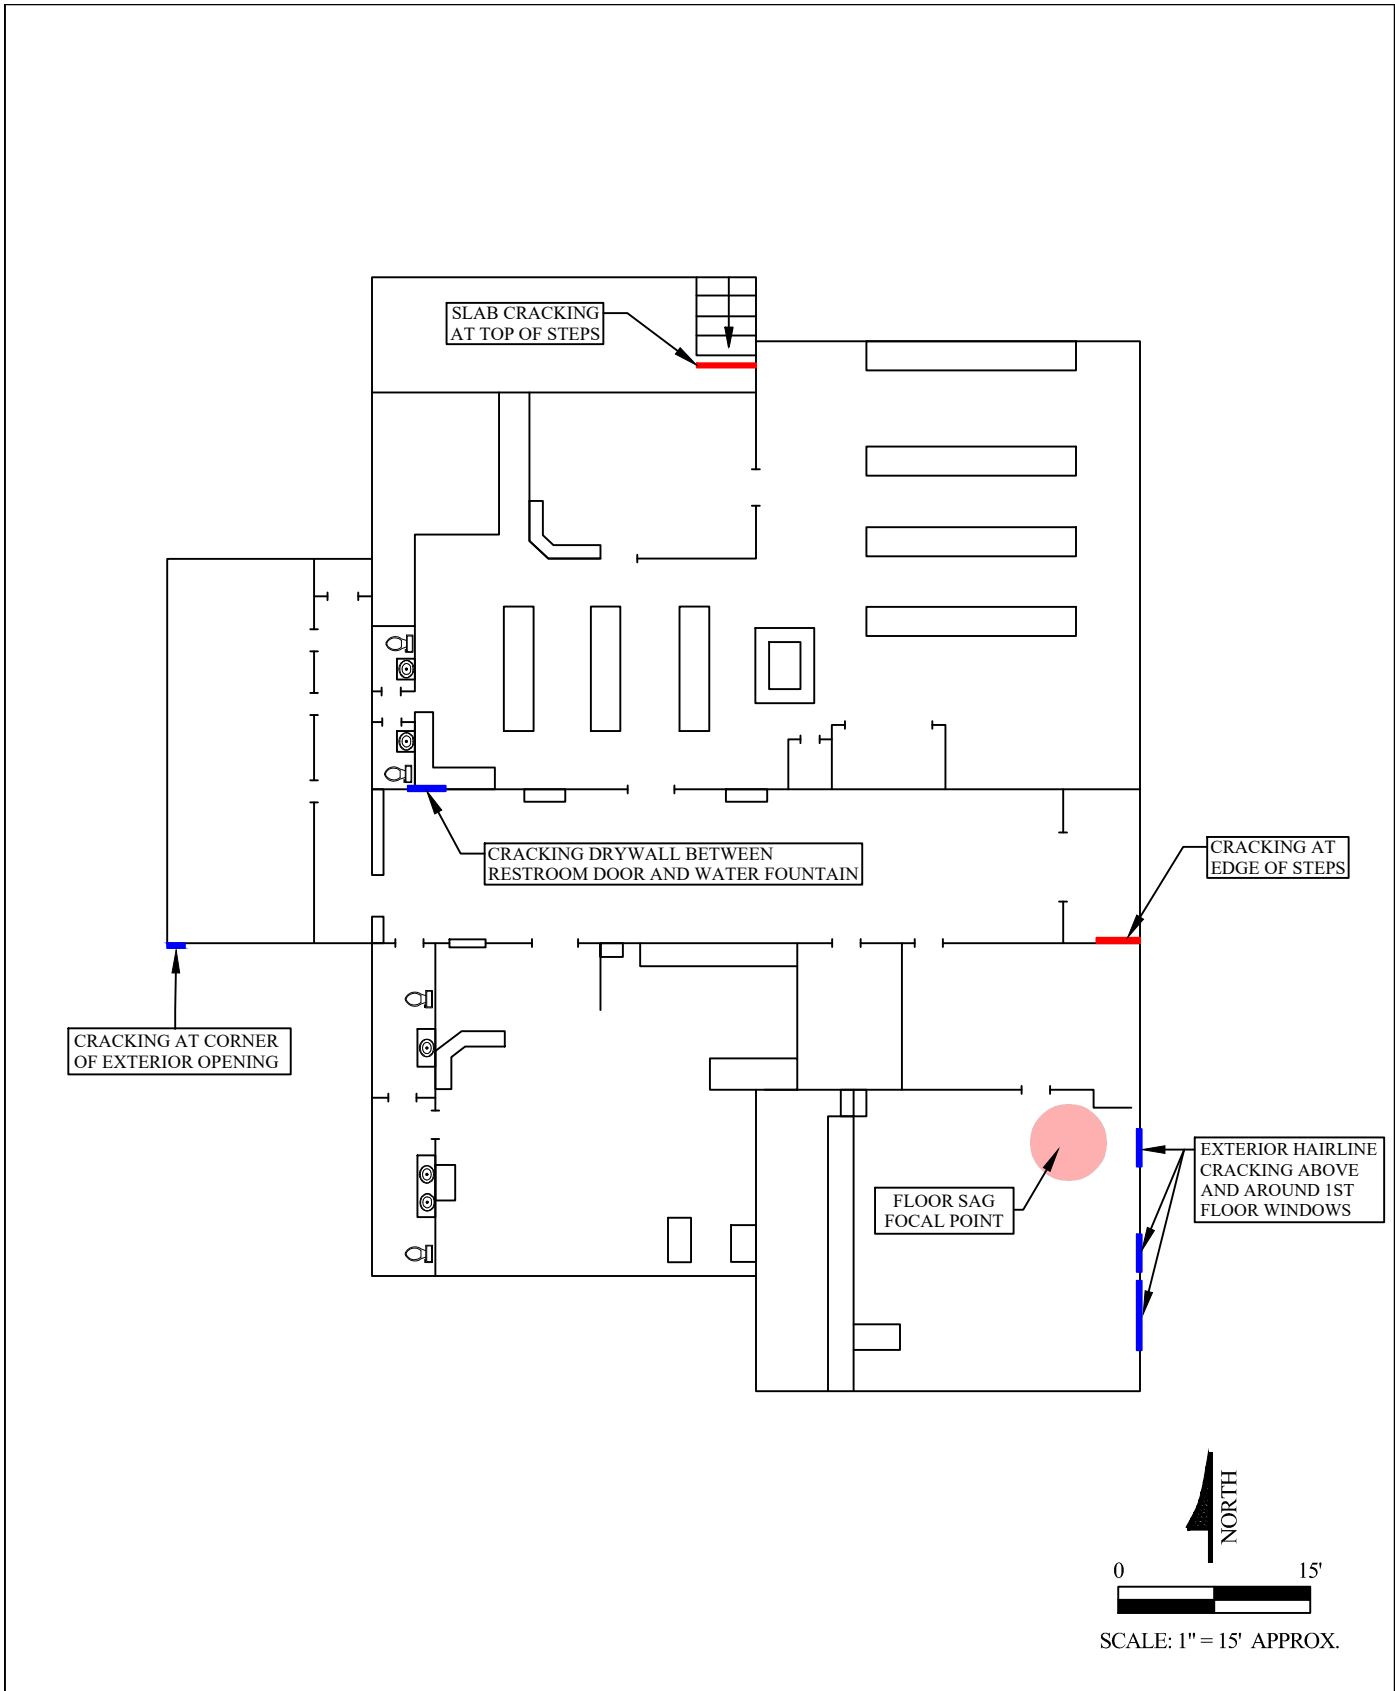
<p>MICANOPY TOWN HALL MICANOPY, ALACHUA COUNTY, FLORIDA GSE PROJECT NO. 17318A</p>	FIRST FLOOR AND EXTERIOR OBSERVATION LOCATIONS	
	<p>DESIGNED BY : AJD CHECKED BY : JCN DRAWN BY : IMH</p>

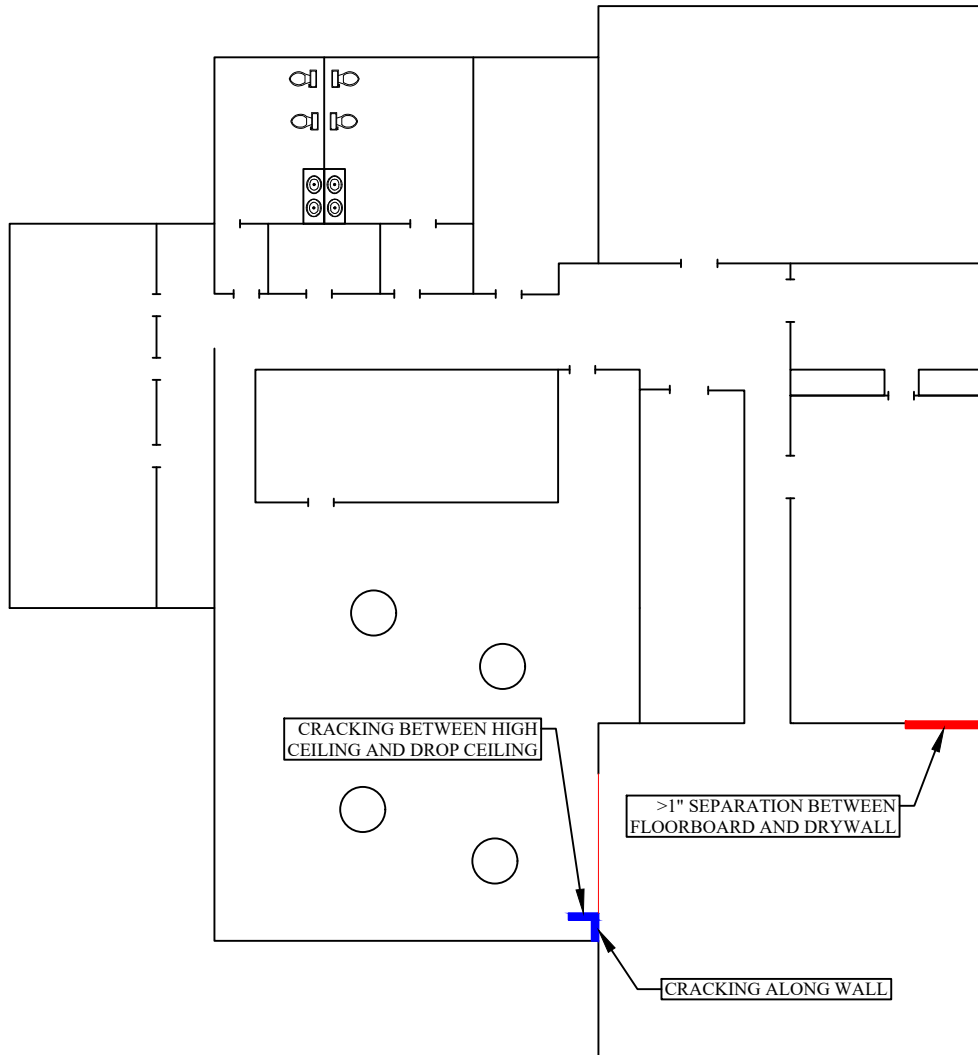
<p>MICANOPY TOWN HALL MICANOPY, ALACHUA COUNTY, FLORIDA GSE PROJECT NO. 17318A</p>	<p>SECOND FLOOR OBSERVATION LOCATIONS</p>		<p>FIGURE 7</p>
	<p>DESIGNED BY : AJD CHECKED BY : JCN DRAWN BY : IMH</p>
