# MILES CITY, MT SPLASH PAD

**Preliminary  
Engineering  
Review**

**PRELIMINARY ENGINEERING REVIEW**  
**SPLASH PAD**  
**MILES CITY, MONTANA**  
July 2025  
WR25-04-106

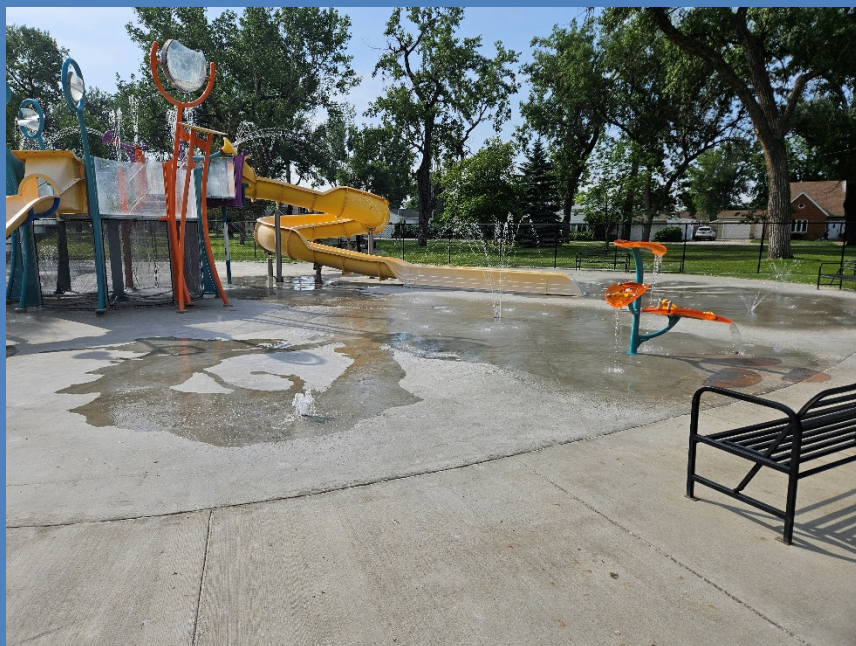
- A large play feature is roughly centered on the splash pad. The structure features an elevated play tower with two slides, dump features and numerous aerial and ground sprays. While onsite it was observed that the same dump bucket from the 2024 meeting was stuck upside down. The operators found a hex key, loosened a set screw, rotated the spray bar, tightened the set screw and the dump bucket began working properly the rest of the time we were onsite. It was also noticed that the slide structures have excessive oxidation staining and the slide flanges are cracked and leaking at numerous joints.

Figure 2: Joint leak below slide.

- The waterslides should be put on a minimum annual maintenance schedule. The waterslides are oxidized, the slide joints are cracked and leaking water, and it was stated that kids have informed the staff of rough joints when sliding down the surface. If an operations and maintenance manual isn't on record for the
