# BELLM BRIDGE MINTURN TEMPORARY SCOUR PROTECTION DESIGN MEMO

DATE: July 13, 2023

RE: Bellm Bridge Design Minturn, CO  
Taylor St Over Eagle River  
Temporary Scour Protection Design  
SEH No. MINTU\_173117

The goal of this memorandum is to describe the temporary scour protection design for the Taylor Street Bridge over Eagle River (Bellm Bridge) in Minturn Colorado.

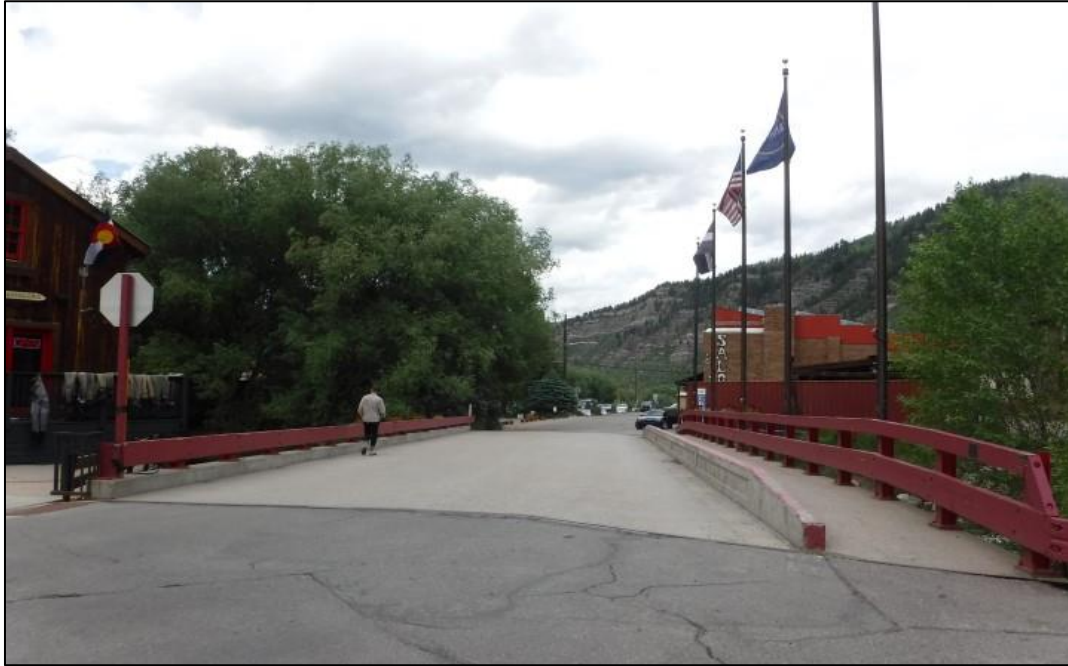
Roadway looking north.

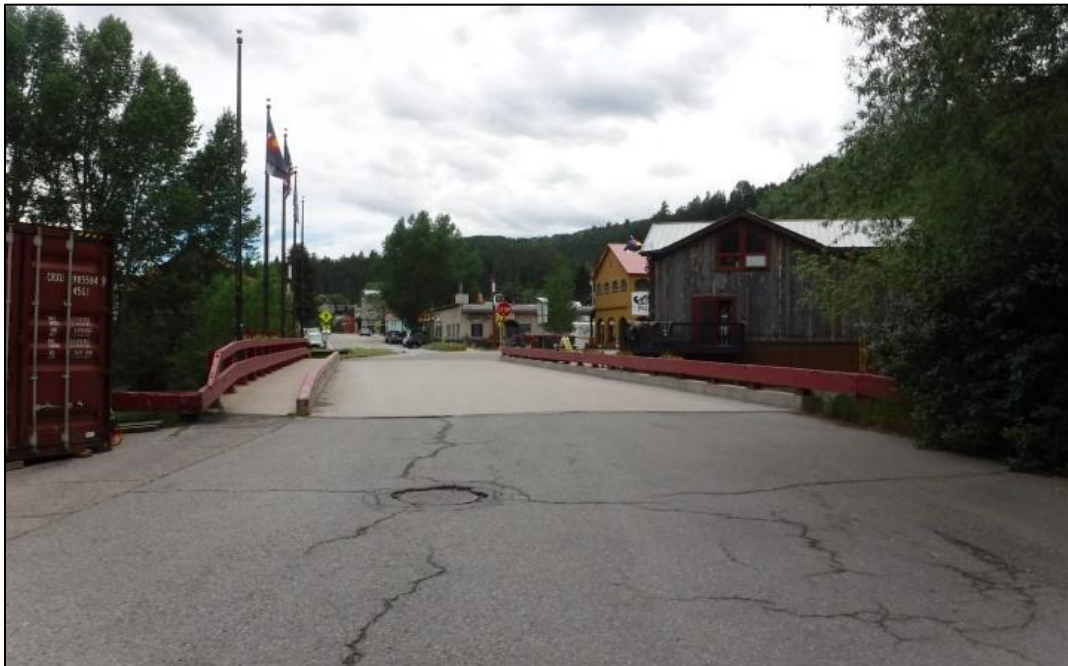
Roadway looking south.

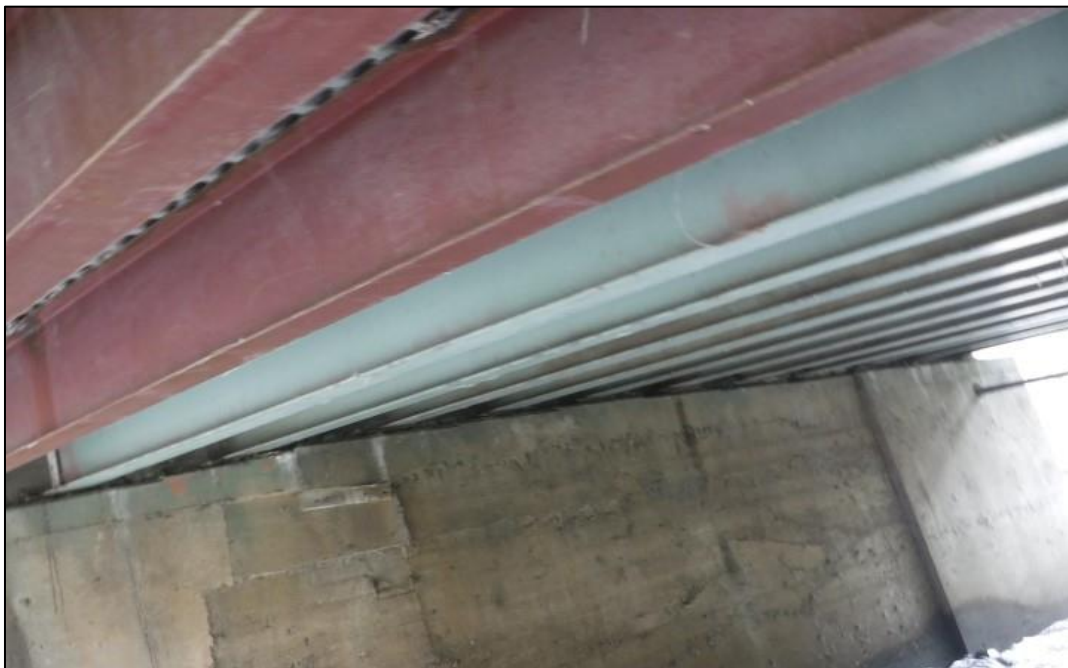
Superstructure looking north.

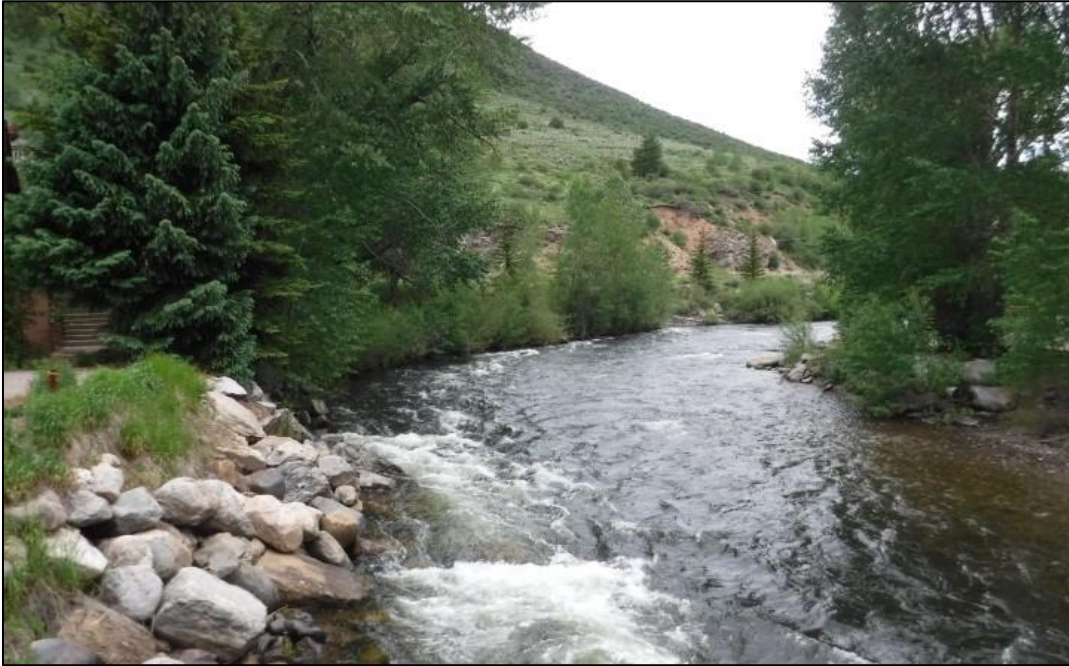
Channel looking east upstream.

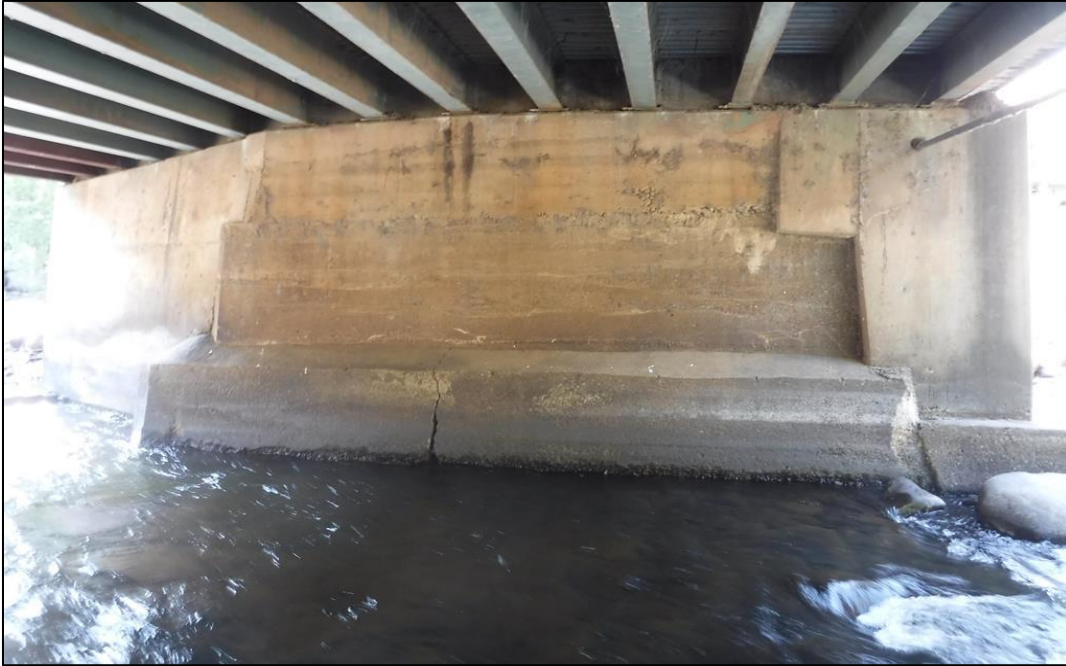
General view of Pier 3.

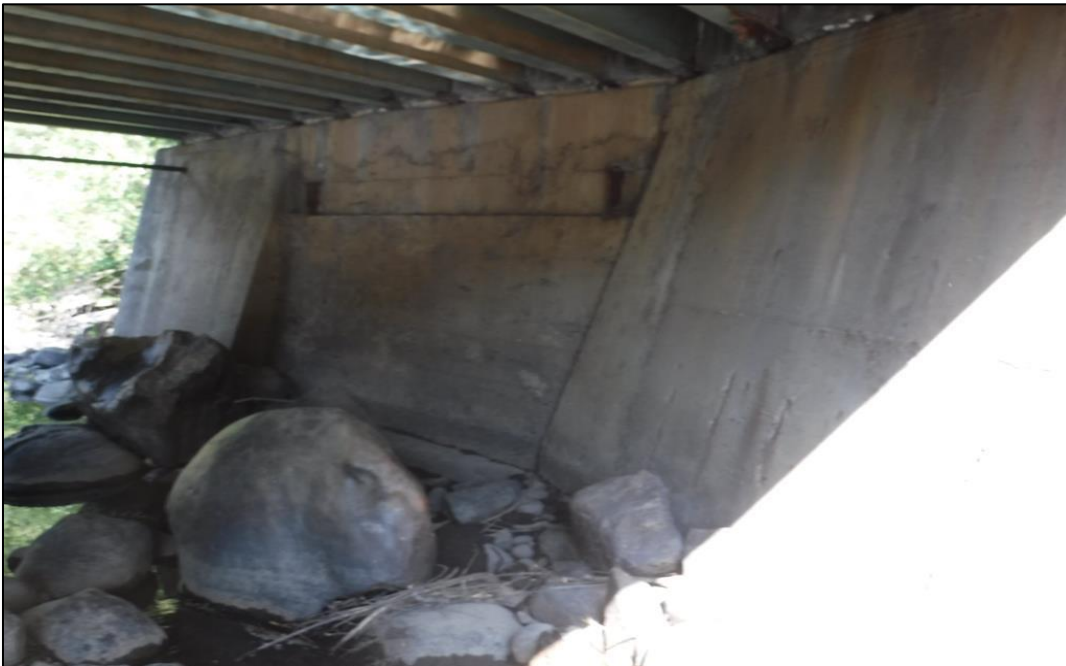
General view of Abutment 5.

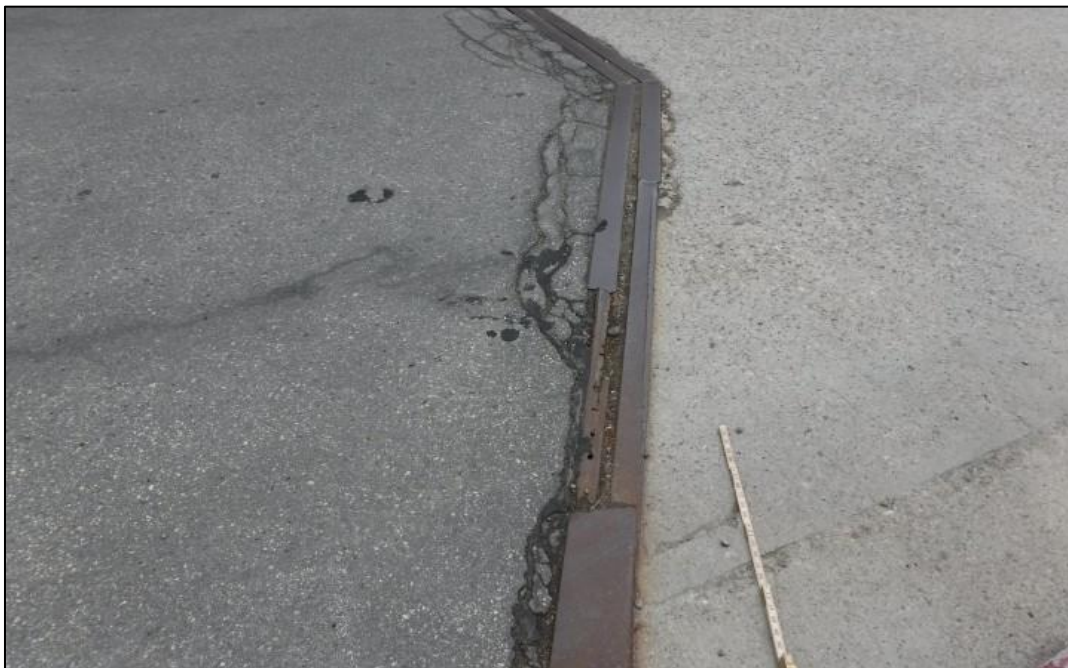
General view of south expansion joint.

Replace expansion devices at both ends of deck.

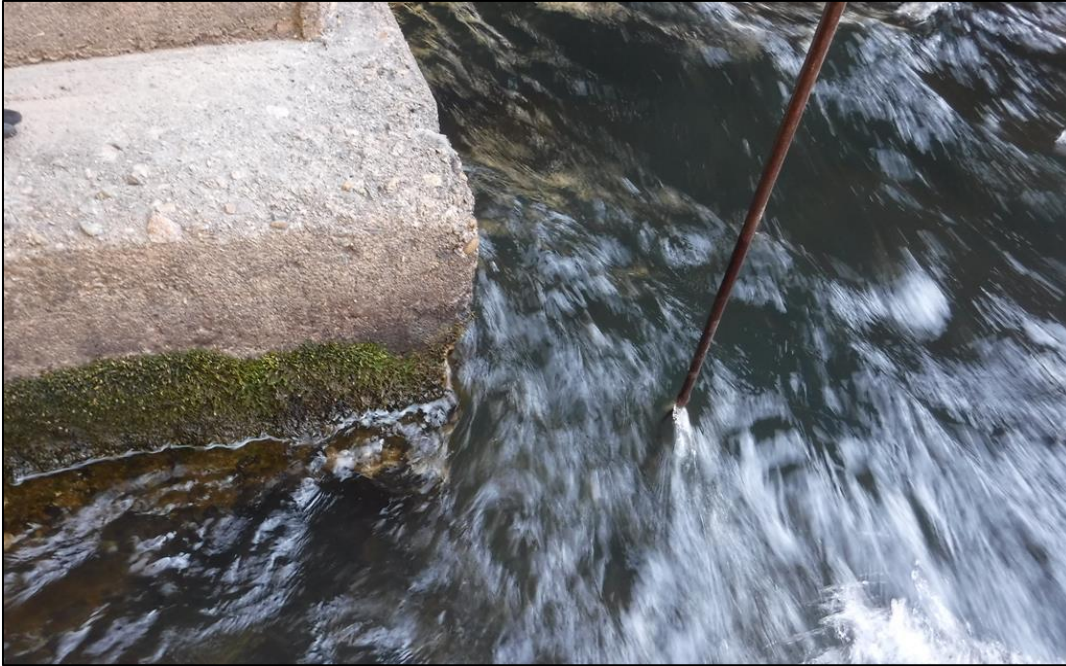
P4 scour hole at SW corner upstream side.

We recommend that scour countermeasures be installed at the piers and the north abutment footing within 90 days and be installed in accordance with an engineered design. Structure should be monitored after high-flow or flood events until countermeasures are installed. The Essential Repair for this structure has been given a **YELLOW** Priority.

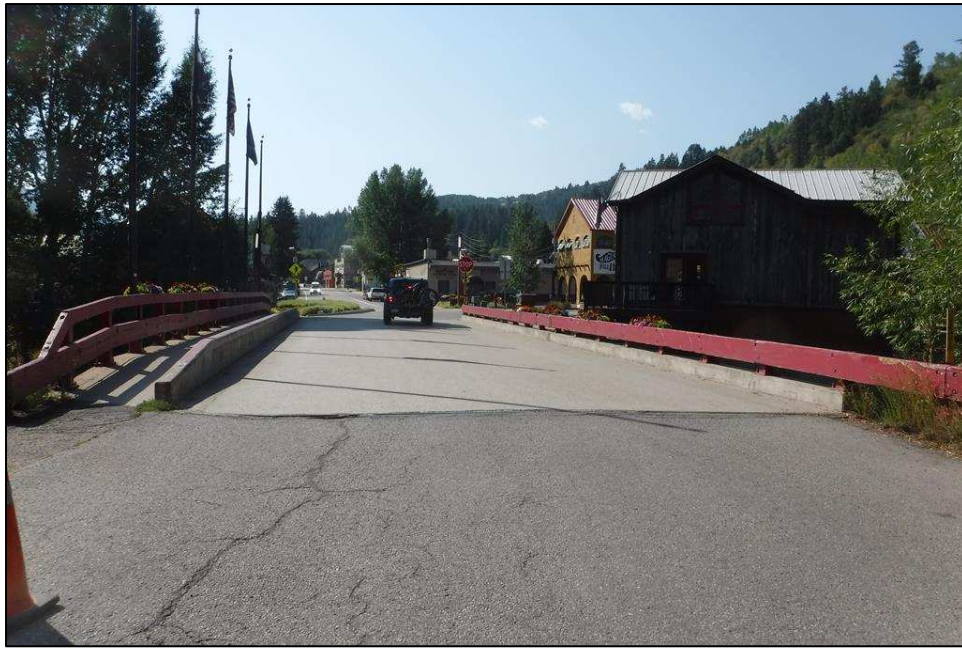
**Roadway looking south.**

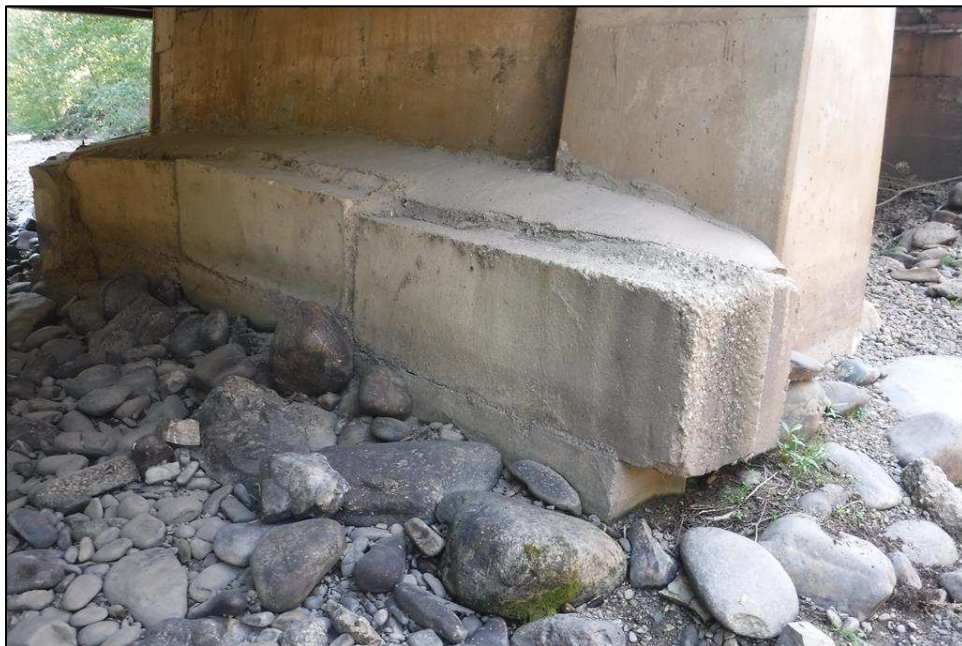
During the follow-up inspection of this bridge on 9/7/2022, our inspector noted that all pier footings are exposed. The south pier (P2) north concrete collar/concrete blocks at the footing are undermined up to 10 inches back. The south pier (P3) footing is undermined up to 20 inches back on the upstream end. The south pier (P4) footing is undermined up to 24 inches back on the upstream end. The north abutment (A5) footing is also exposed and is undermined up to 13 inches back at mid-span. See the attached photos.

**Pier 2 exposed footer.**

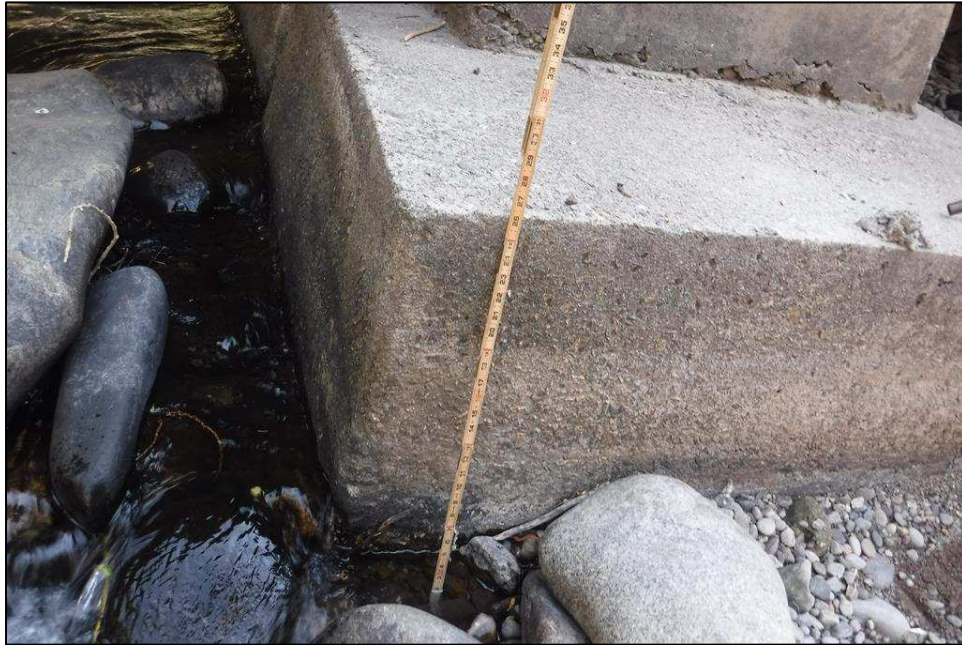
**P3 exposed footing at downstream end.**

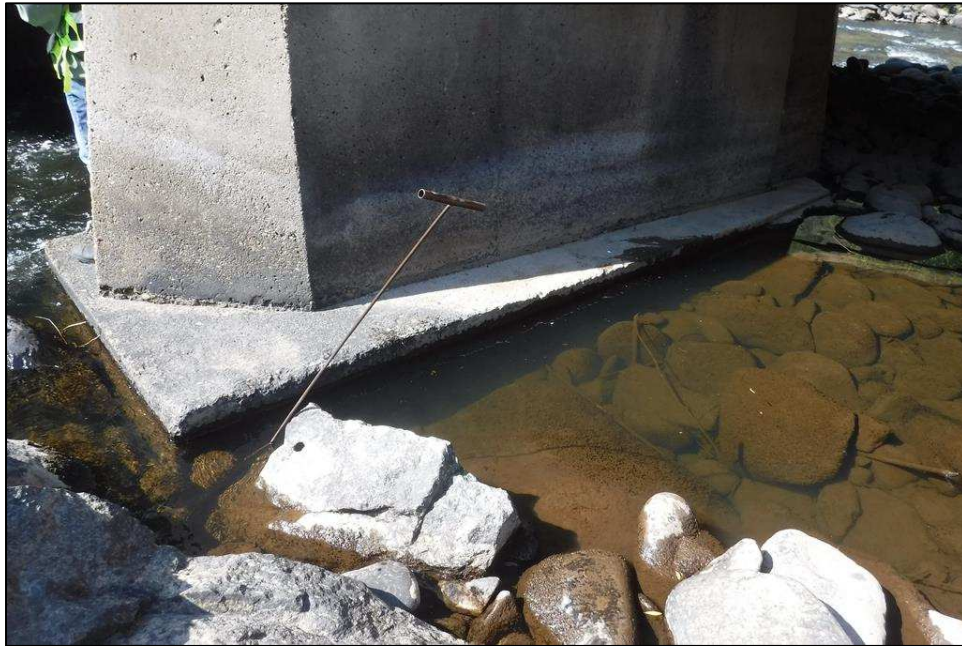
**P4 north side exposed footing.**

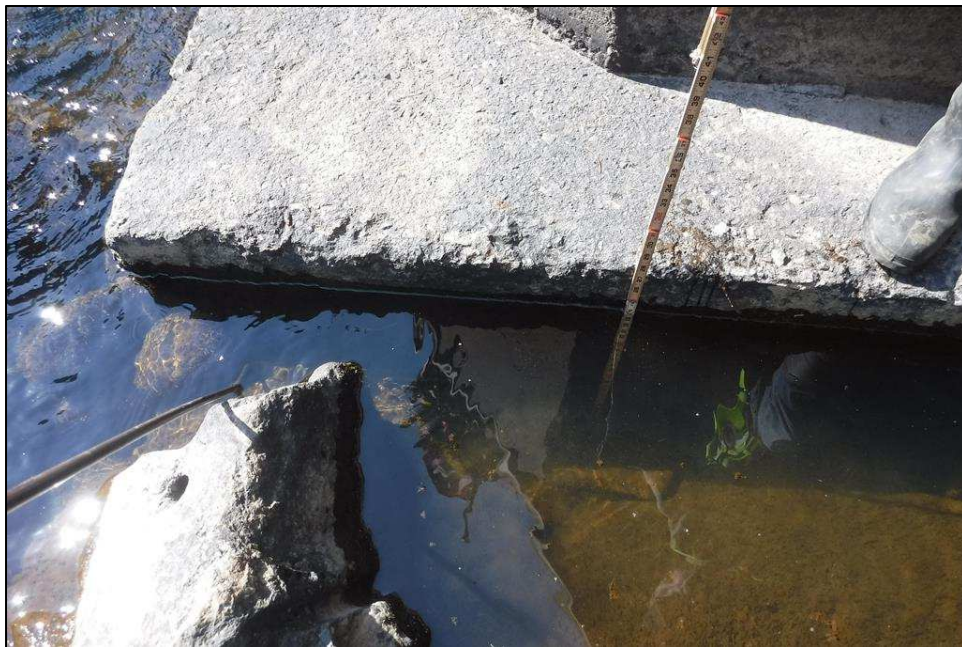
**P4 northwest corner exposed footing.**

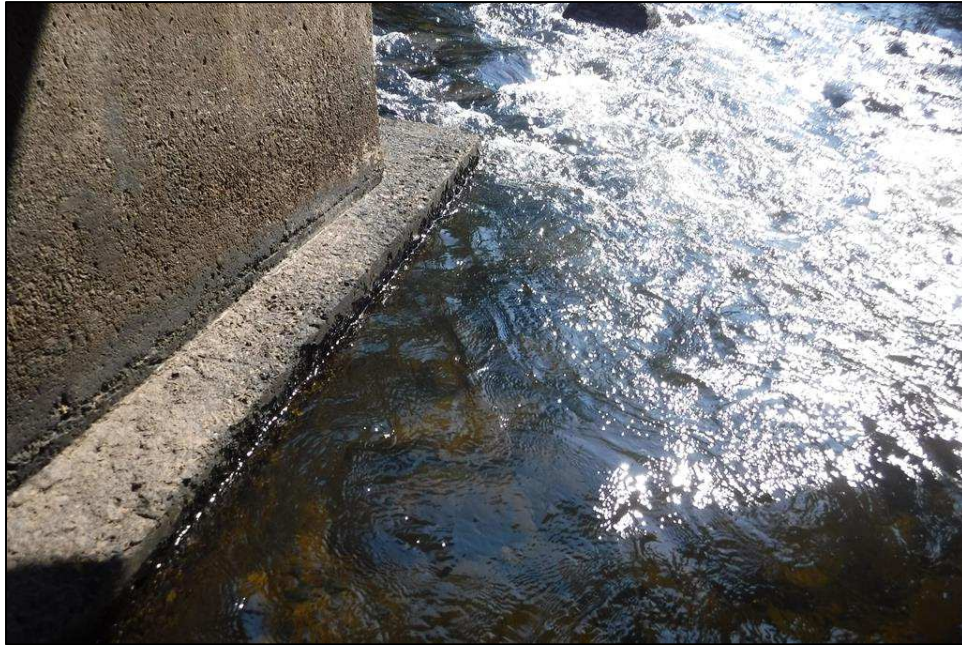
**P4 south side exposed footing.**

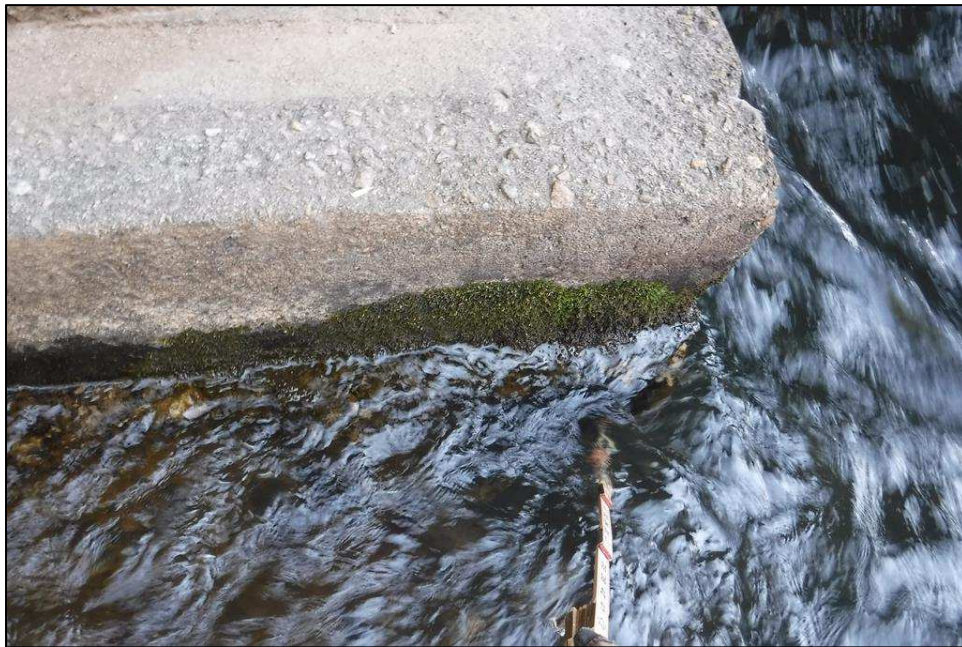
**P4 southwest corner undermining at upstream end.**
