**SUMMARY**

478 Eagle St , Minturn, CO 81645

David Ford  
05/24/2024

Chris Jobson  
True Perspective Home Consultants  
970-209-2041  
[chris@trueperspectivehc.com](mailto:chris@trueperspectivehc.com)

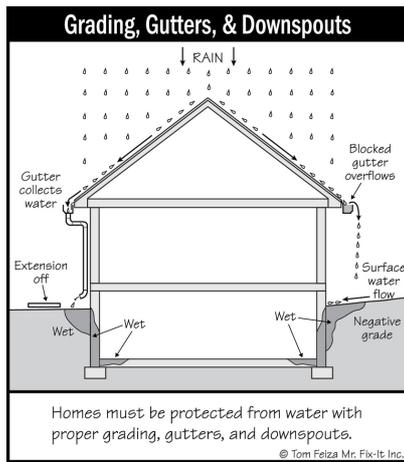
The grading was sloped toward the building condition promotes water accumulation near the building, which could result in deterioration of the foundation and water penetration under the structure. We recommend re-grading areas near the building as needed to ensure the unobstructed flow of the surface water away from the foundation.

Recommendation  
Contact a qualified grading contractor.

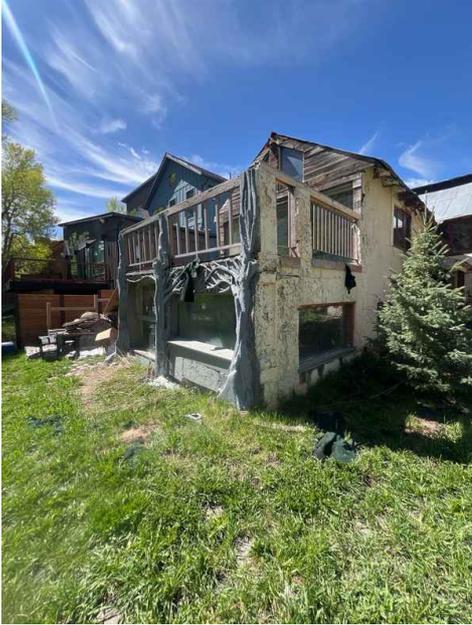
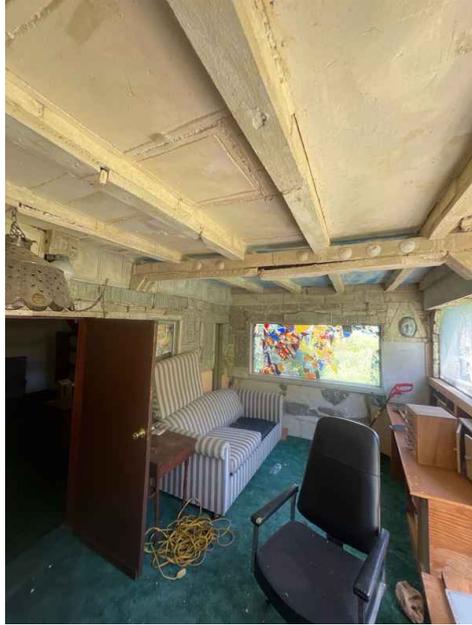
## 4.1.4 Structural

**DECAYED LOGS**

Decayed log(s) were noted. We suggest a further review with repairs made to restore the structural integrity.

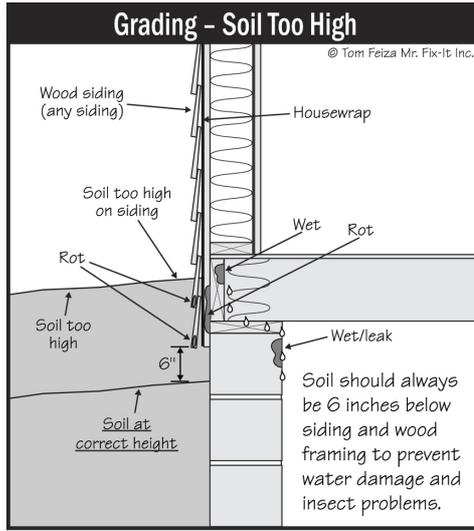
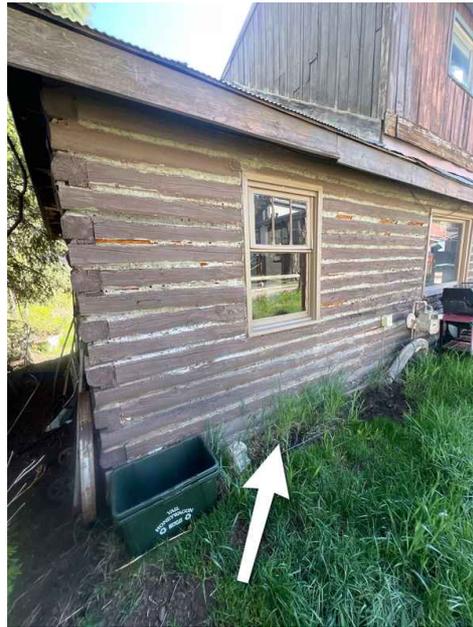
4.3.3 Wood siding  
**DETERIORATED SIDING**

The wood siding was observed to have deteriorated. We recommend repair or replacement to prevent moisture intrusion, restore aesthetics and extend the service life of the siding.

Contact a qualified siding specialist.

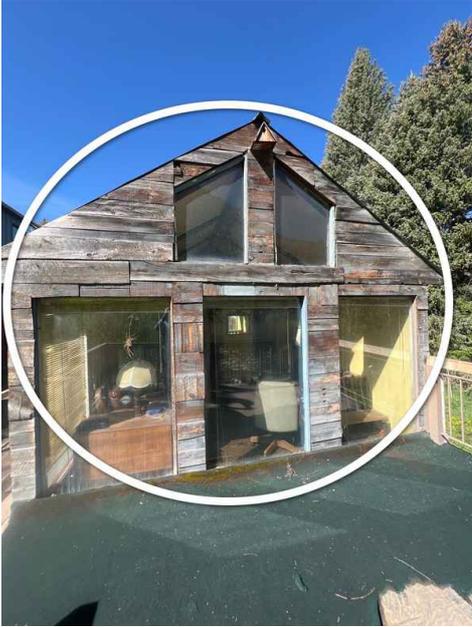
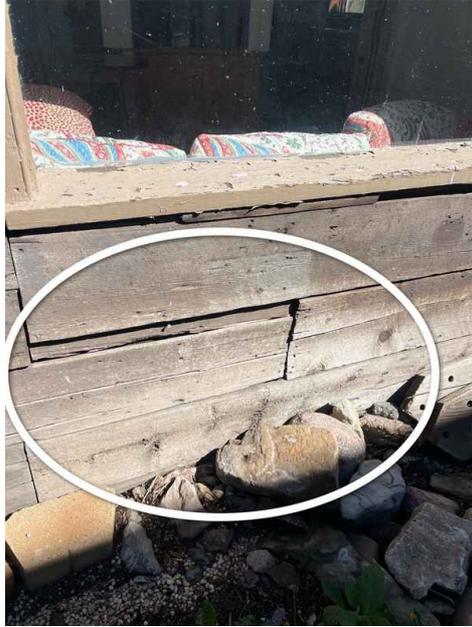
4.3.4 Wood siding  
**EXPOSED FRAMING**

Exposed and unfinished wood framing was noted. We suggest further review with flashing or finishing to prevent water intrusion and premature deterioration of the wood.

Contact a qualified siding specialist.

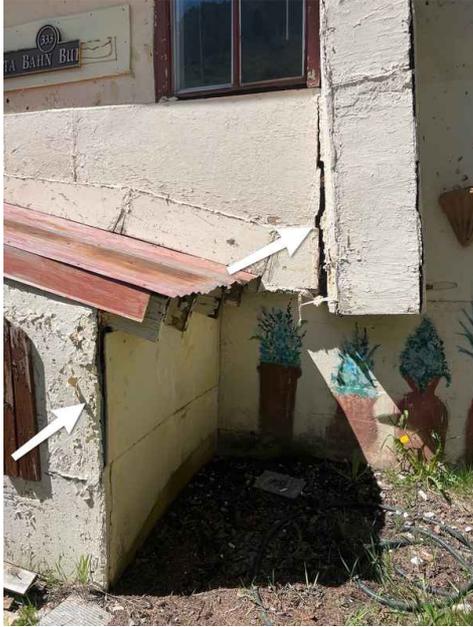
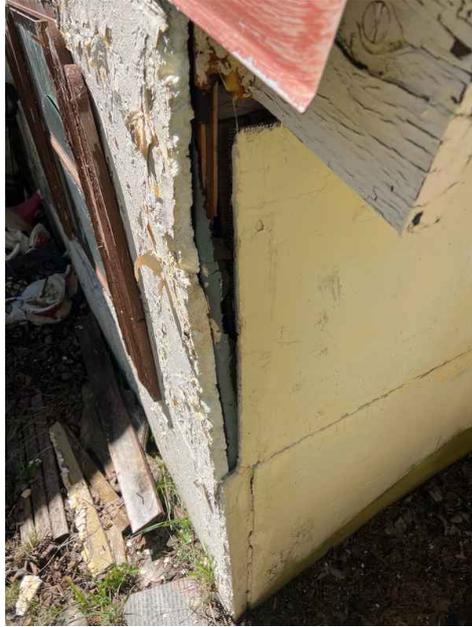
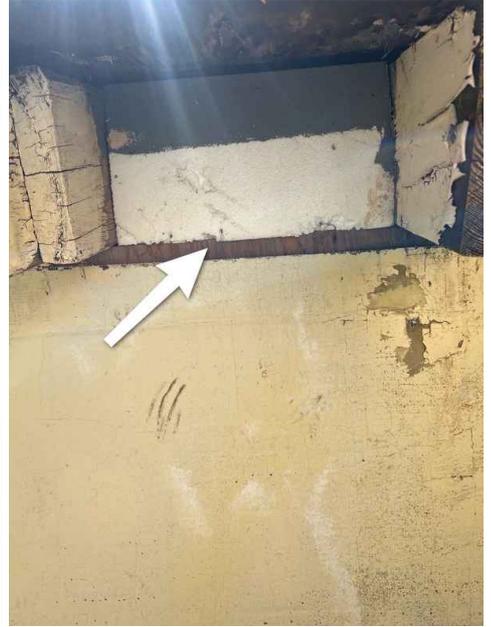
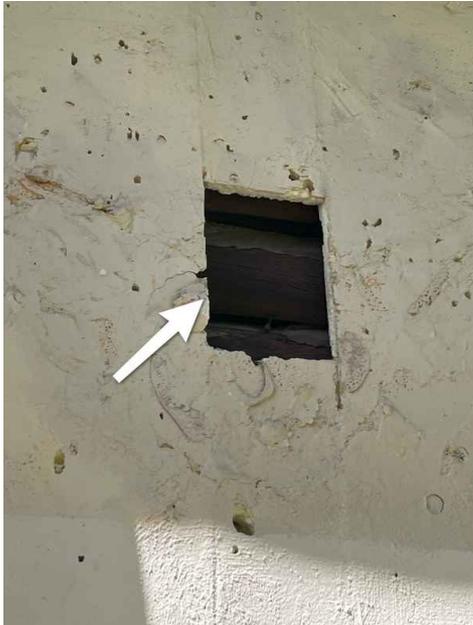
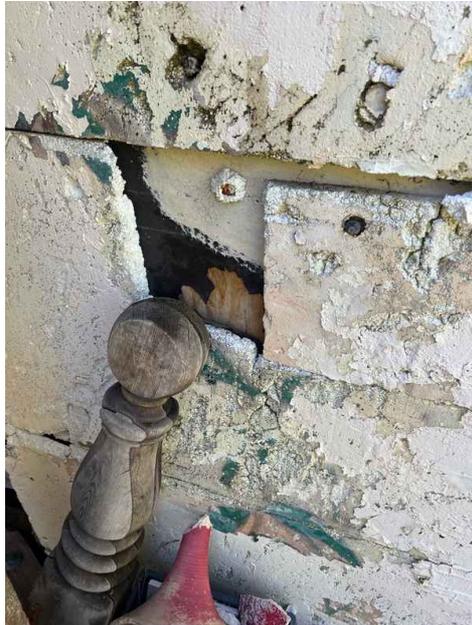
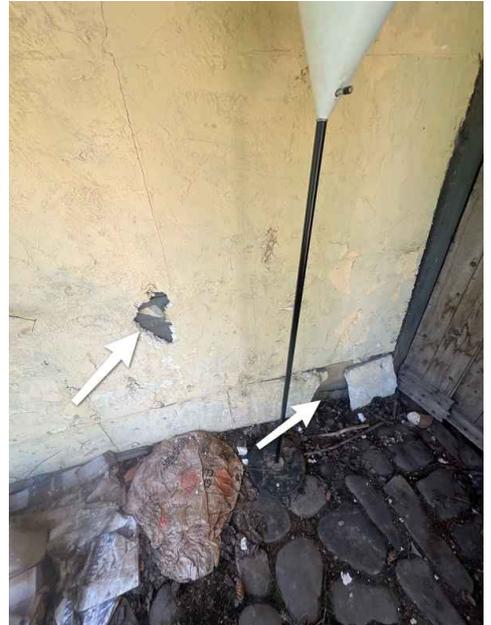
### 4.3.5 Wood siding

## MISSING SIDING

Missing siding was noted. We suggest installing to prevent moisture and pest intrusion.

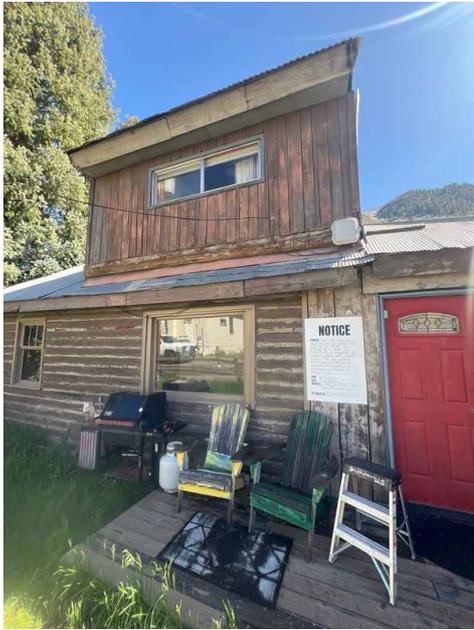
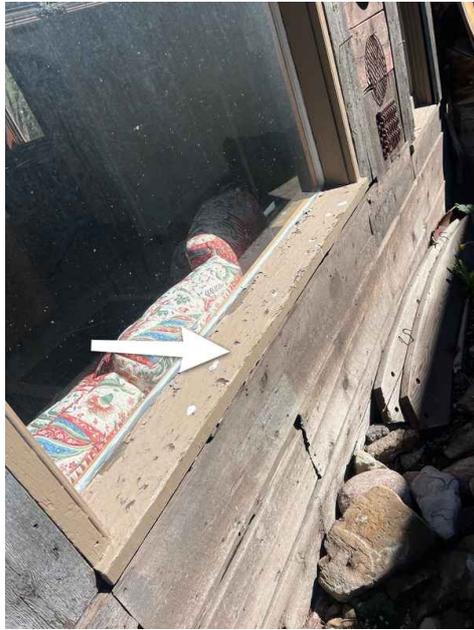
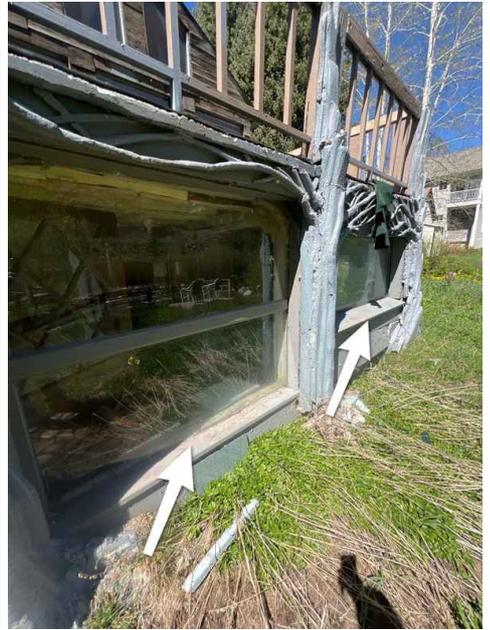
4.7.2 Trim

**DETERIORATED TRIM**

Deterioration of the exterior trim was observed. We recommend that any deteriorated trim be repaired or replaced as required.

Contact a qualified siding specialist.

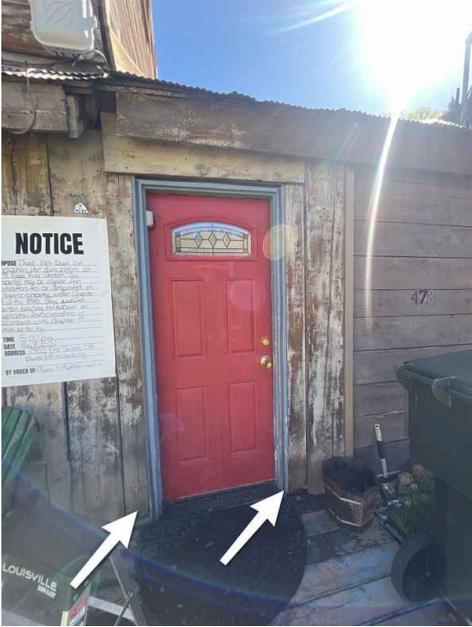
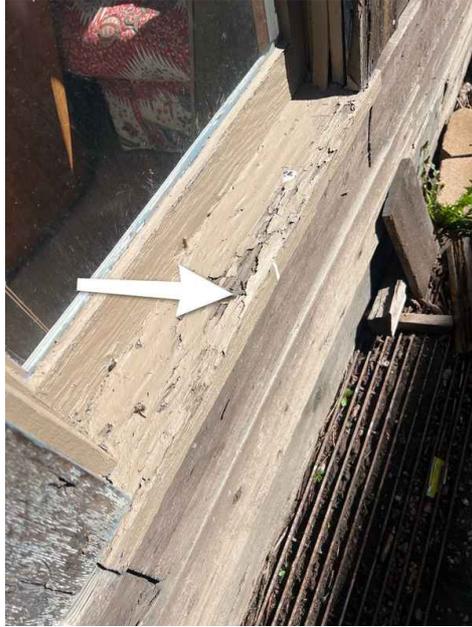
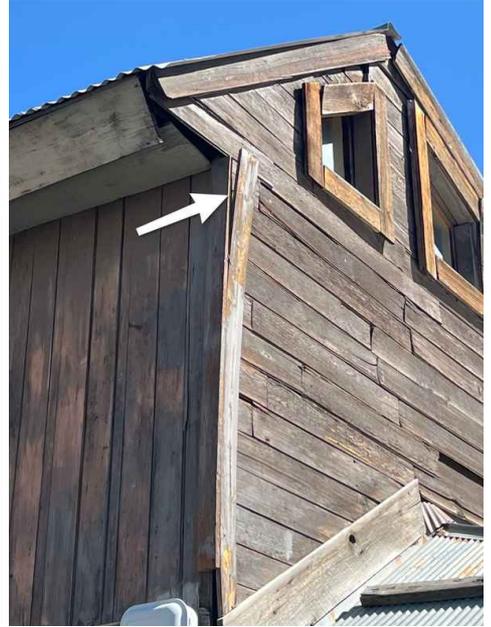
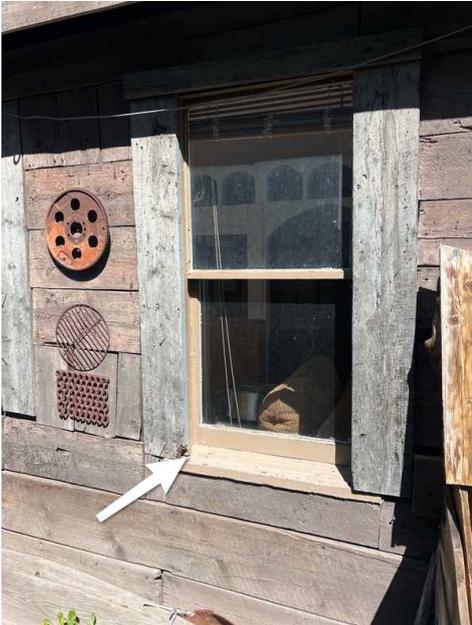
## 4.7.3 Trim

**MISSING TRIM**

Missing trim was noted, this will eventually allow moisture and pest intrusion. We recommend that the trim be repaired or replaced as required.

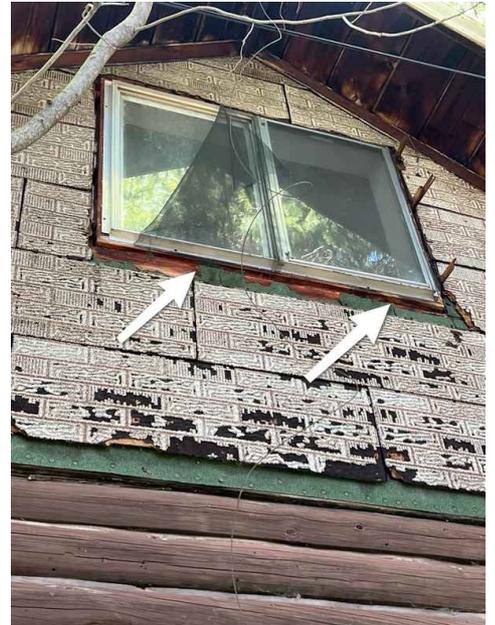
## 4.8.1 Flashing

**FLASHING MISSING**

Wall flashings are missing. Wall flashing is suggested to guard against water intrusion. We recommend monitoring and installing as deemed necessary.

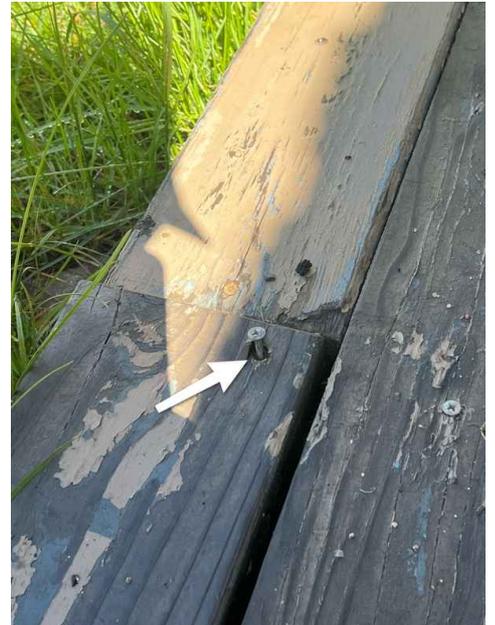
## 6.6.1 Deck surface

**WEATHERED**

The deck(s) surfaces were weathered and in need of general maintenance. We suggest refinishing to restore UV and moisture protection as well as to restore aesthetics

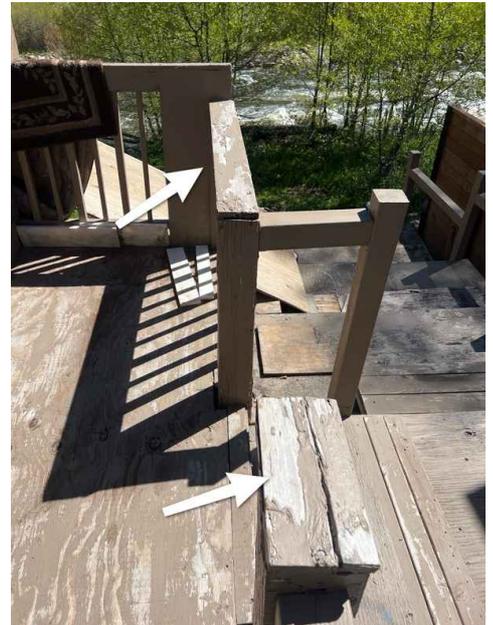
6.7.2 Guard rails

**BALUSTER SPACING GREATER THAN 4"**

The baluster spacing on the deck railing is too wide based on modern safety standards. Railings should not have openings larger than 4" to prevent small children's heads from fitting through them. Although this installation may have been acceptable at the construction time, upgrading for safety should be considered.

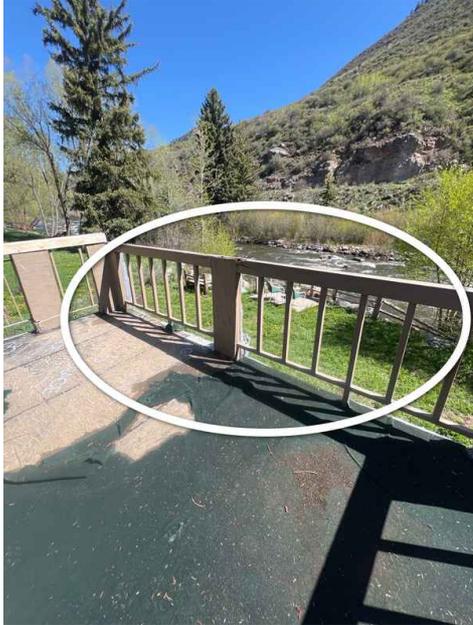
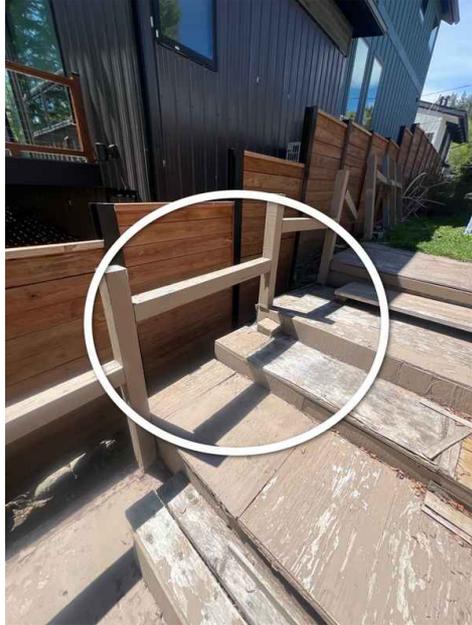
6.7.3 Guard rails

**LOOSE GUARD RAIL**

The deck guardrail assemblies were loose and should be secured to prevent possible safety concerns.

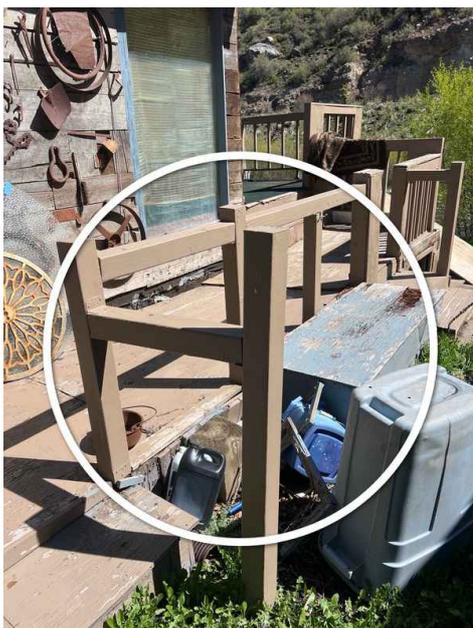
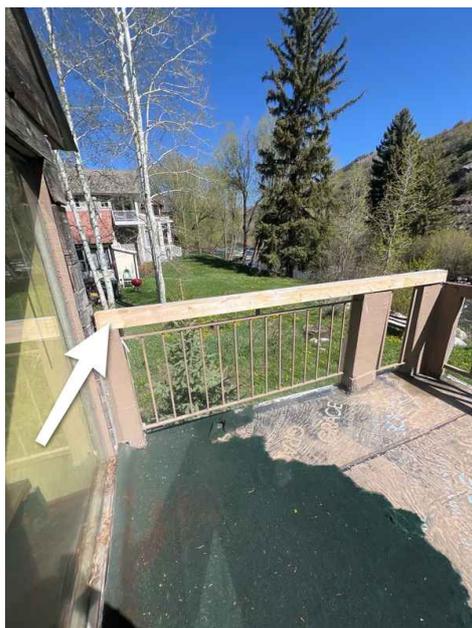
6.7.4 Guard rails  
**DETERIORATED**

The deck guardrail assemblies exhibited deterioration. Photographs are examples only. We suggest a review of the complete rail system by a qualified contractor and repairs made as needed.

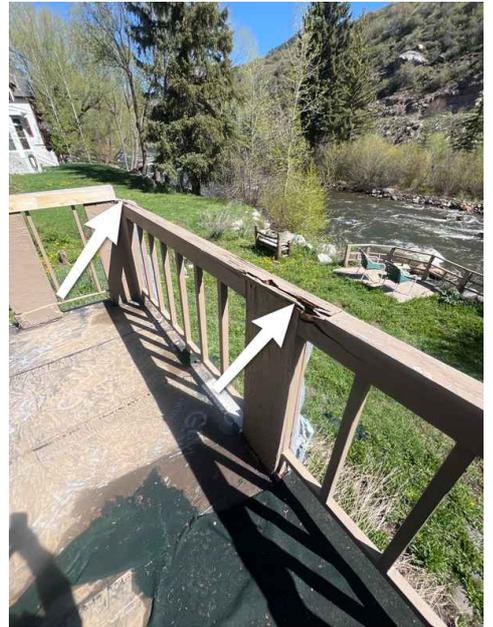
6.7.5 Guard rails  
**DAMAGED RAILINGS**

Damaged railings were noted. We suggest repair for safe deck usage.

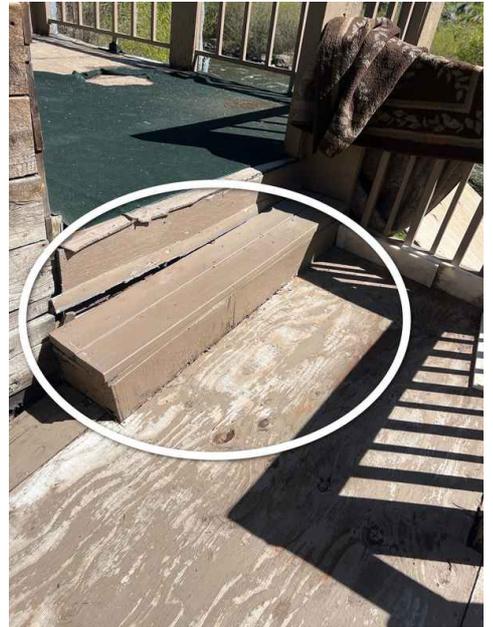
## 6.9.1 Handrails

**NO HANDRAIL**

The handrail is missing. While the home may have complied with the building code when it was built, upgrading for safety should be considered.

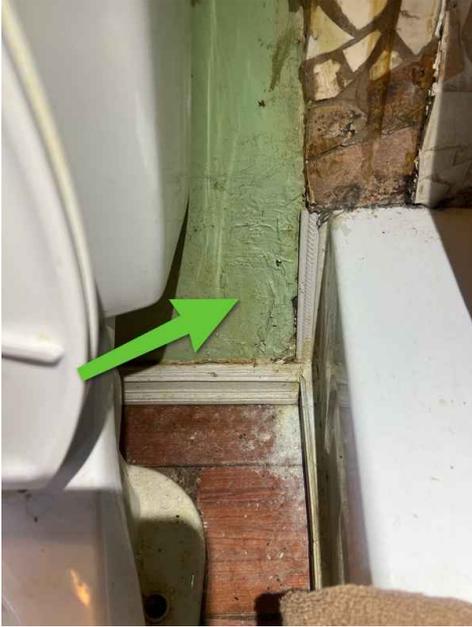
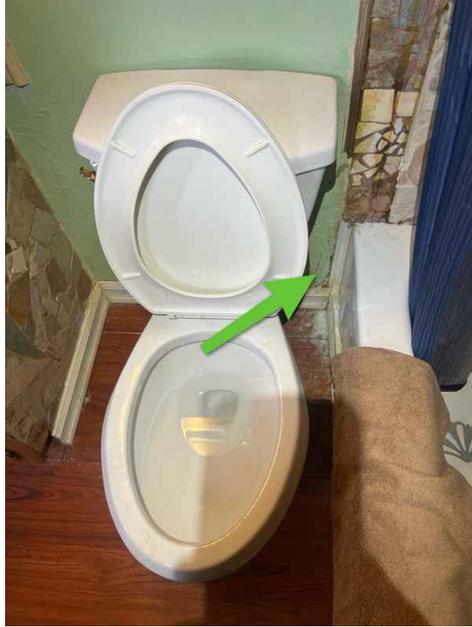
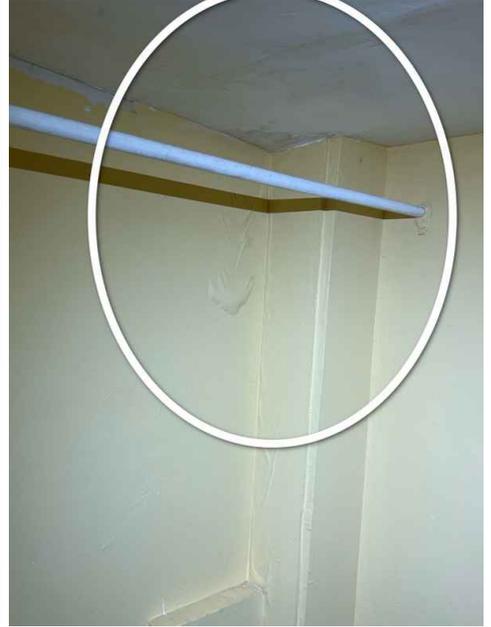
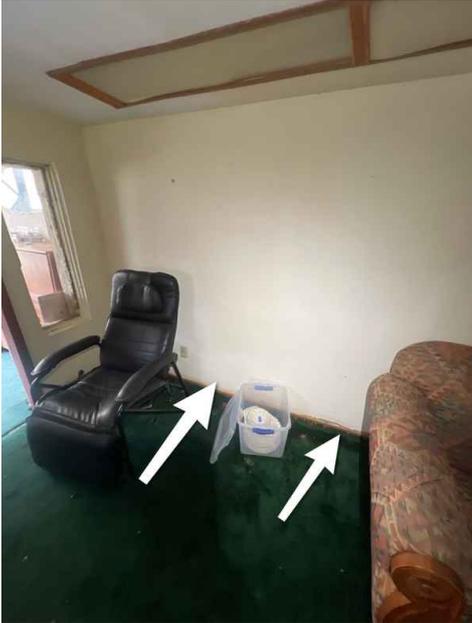
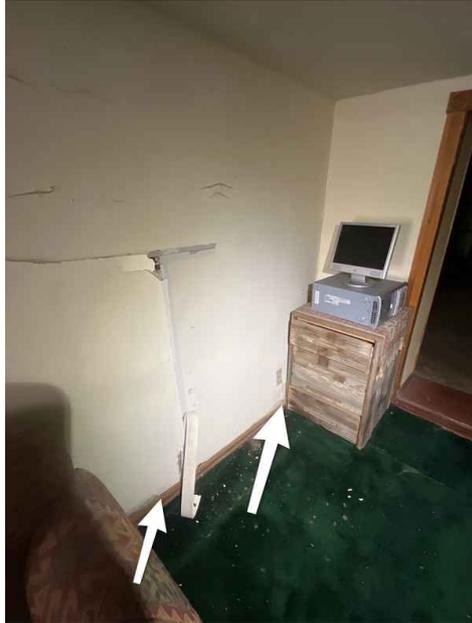
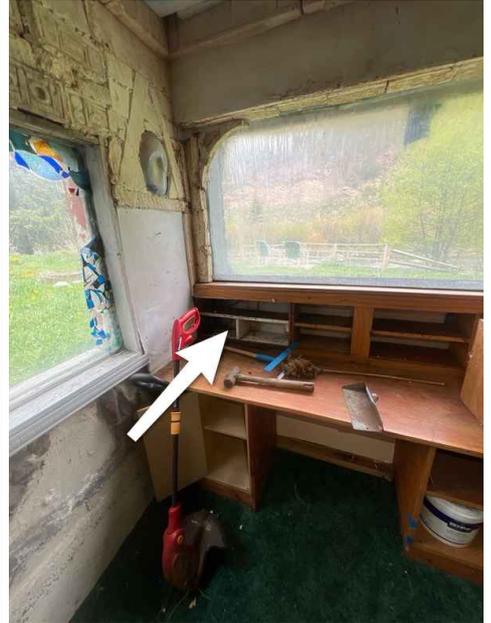
**EVIDENCE OF MOISTURE - DRY**

SEVERAL

Stains or drip marks on the walls visible at the time of the inspection appeared to be the result of moisture intrusion. The source of moisture may have been corrected. We suggest asking the owners for more information about this condition. If no information is available, we recommend a further examination by a qualified contractor to better understand the situation.

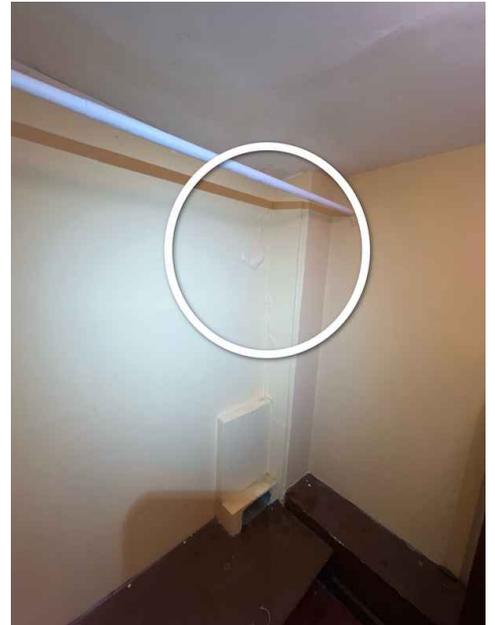
10.4.2 Walls

**ACTIVE LEAK PRESENT**

Active leaking was noted, and the wall was wet at the time of inspection. We suggest further investigation of the moisture source, correction with proper drying techniques to prevent microbial growth.

Contact a qualified professional.

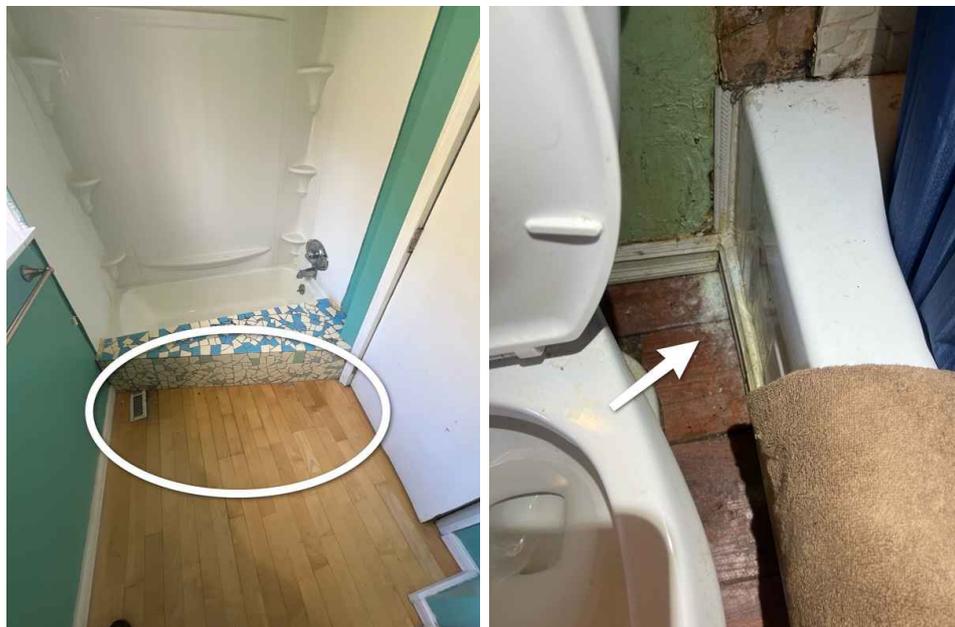
10.7.1 Floors

**WATER DAMAGED WOOD FLOOR**

Bowing and cupping was noted on the wood floor. This is possible evidence of a water intrusion event and we suggest asking the seller for more information. We recommend that all floor damage be repaired.

Contact a qualified flooring contractor

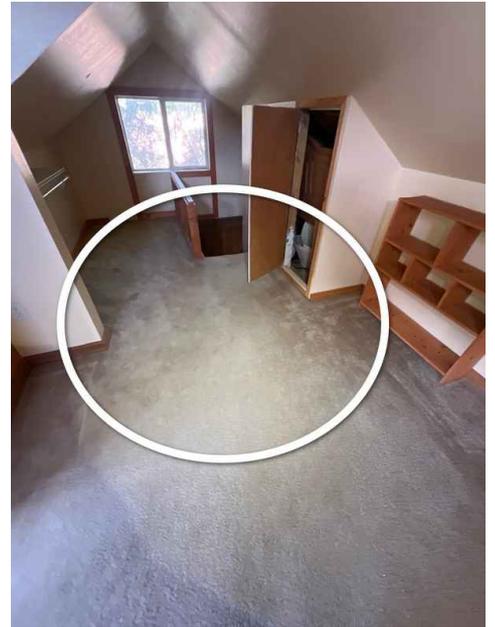
10.7.2 Floors

**SQUEAKY OR LOOSE FLOOR**

The floor was observed to be squeaky or loose. Squeaky or loose flooring may indicate non-visible structural or attachment issues. We recommend further review for a better understanding of replacement costs/repairs and present condition.

Contact your builder.

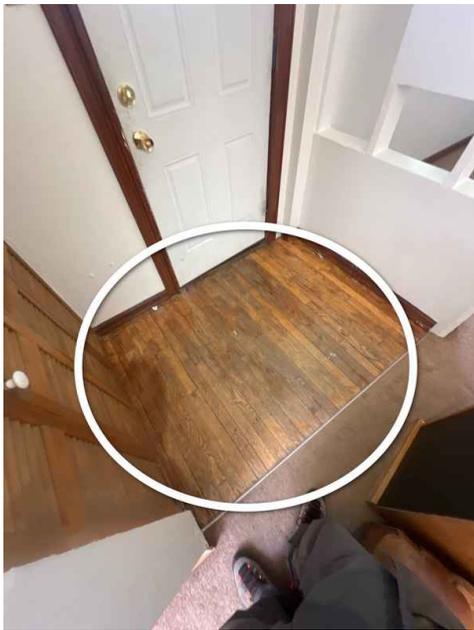
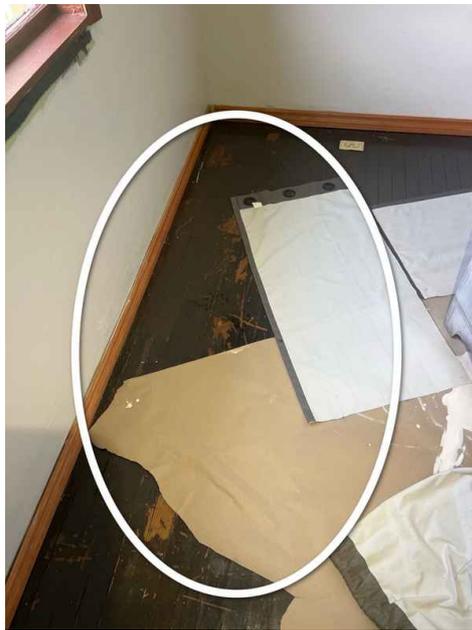
10.7.3 Floors

**HEAVY USE**

MAIN APARTMENT

Wear and tear in the flooring was evident throughout the building. We have made no attempt to list all the cosmetic flaws and recommend that these deficiencies be addressed by routine maintenance.

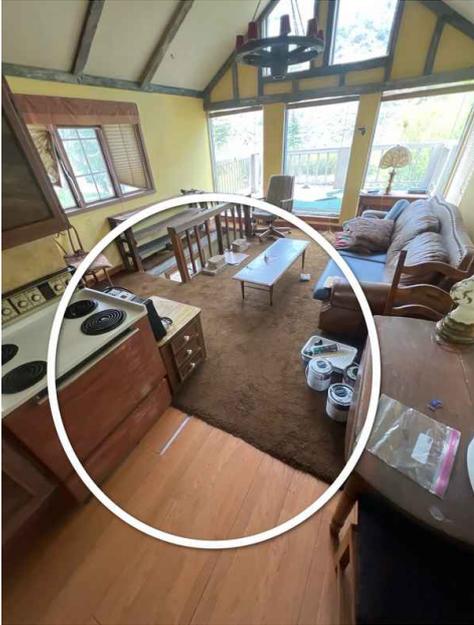
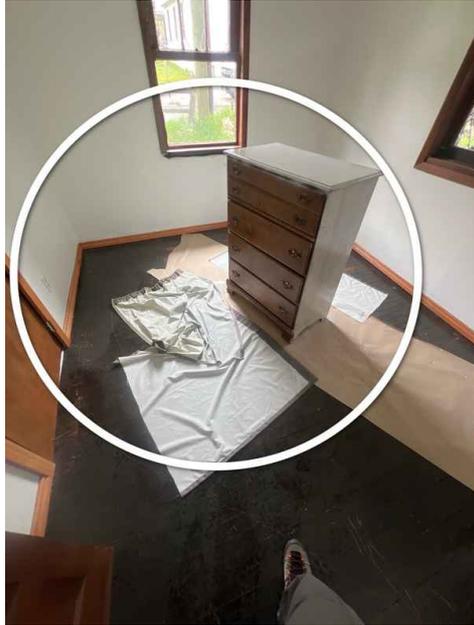
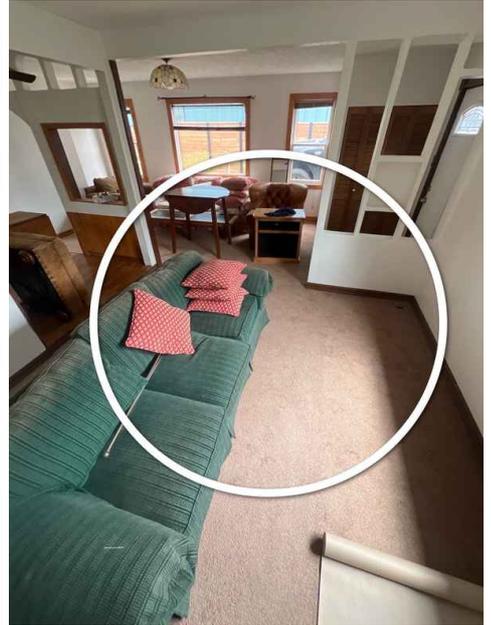
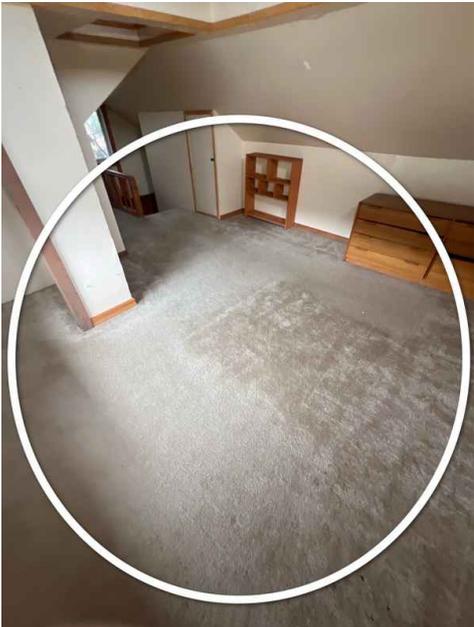
Several areas of the floors in the home were not level with either low or high spots noted. This is most likely caused by settlement or old building practices and materials.

Contact a qualified professional.

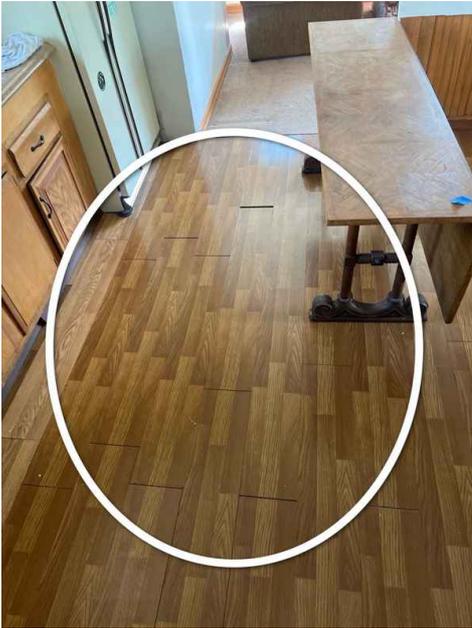
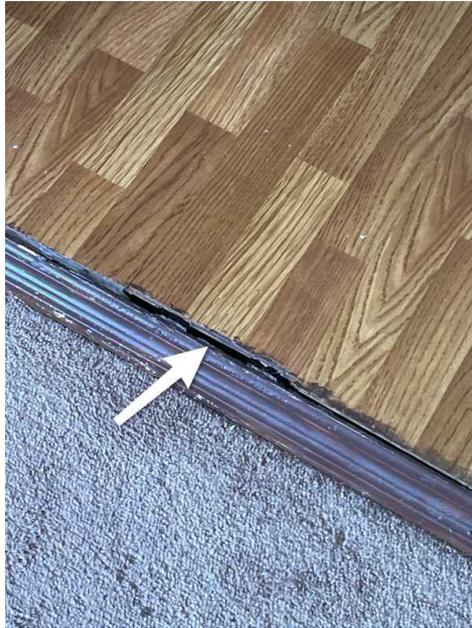
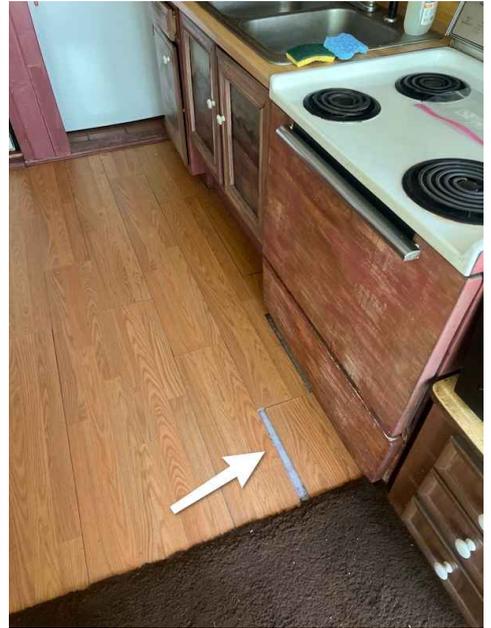
10.7.6 Floors

**GAPS IN THE FLOOR**

SEVERAL

Several areas of flooring have wide gaps from poor installation. We suggest repairs.

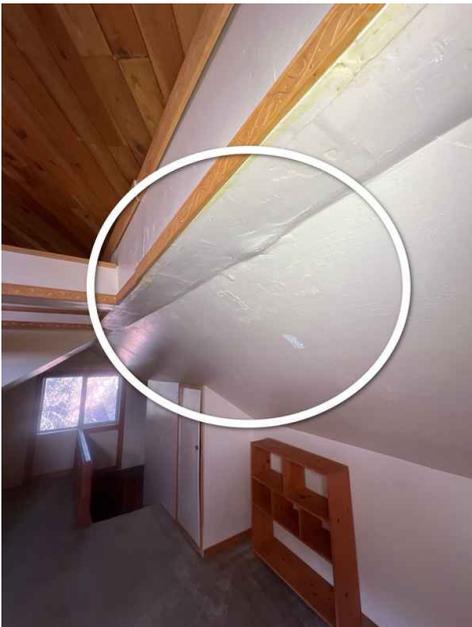
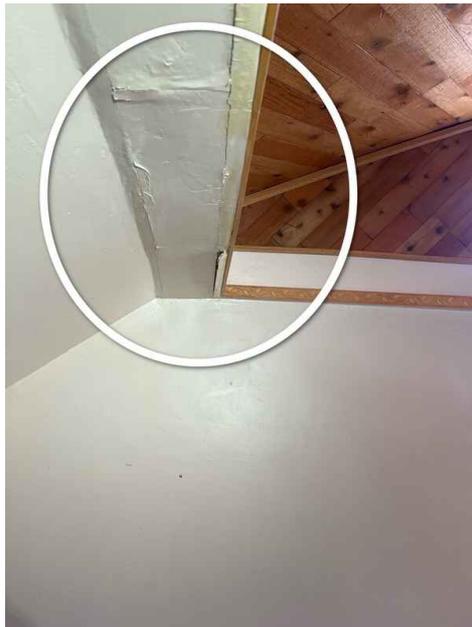
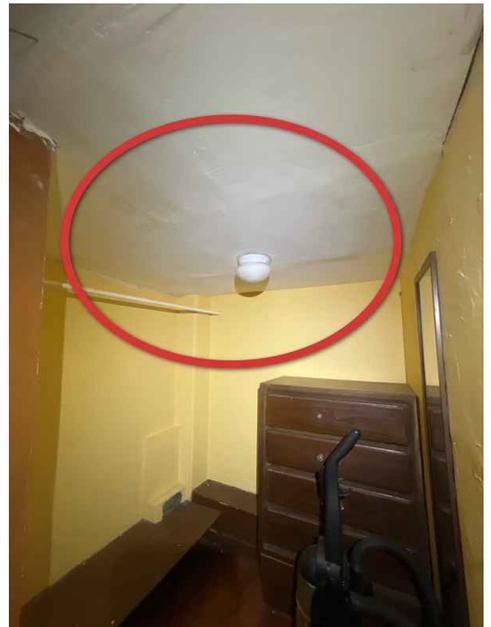
10.8.1 Ceilings

**STAIN(S) ON CEILINGS/WALLS- DRY**

SEVERAL

Water stains were observed indicating a past or present leak. The area was dry at the time of inspection. Monitoring the stained area(s) is recommended if repairs have been made. We recommend further review to understand repair costs and present conditions better.

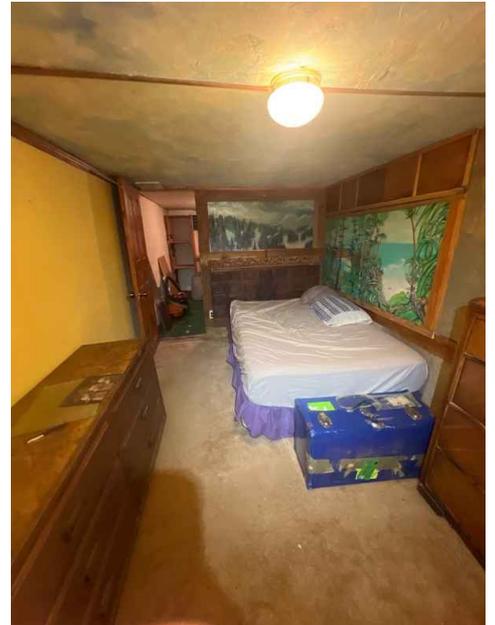
## 10.13.1 Egress

**ROOMS SHOULD NOT BE USED AS SLEEPING AREA-NO EGRESS**

Contact a qualified professional.

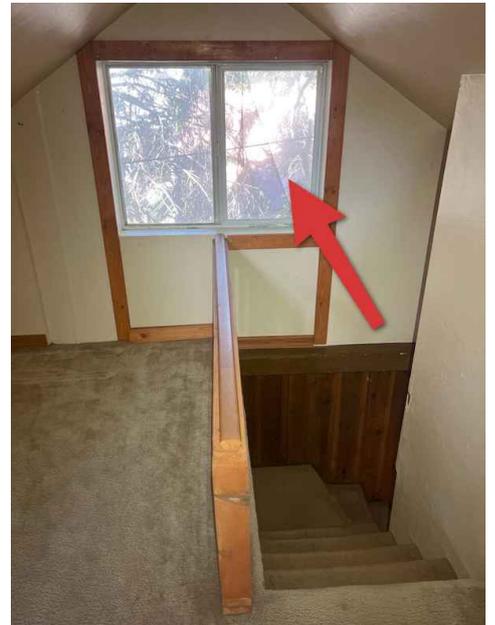
## 10.13.2 Egress

**OPERABLE WINDOW OVER STAIRS**

## UPPER BEDROOM

The bedroom egress window is located above the stairwell and is not readily accessible.

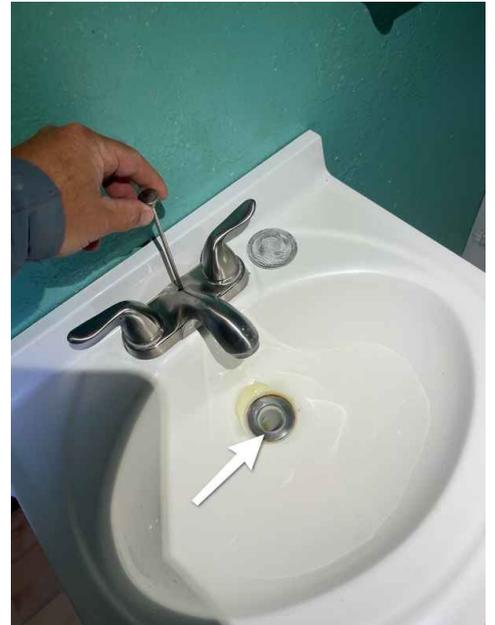
## 12.2.1 Sink drains

**DRAIN STOPS MISSING OR INOPERABLE**

The drain stops were inoperable or missing. We recommend that all inoperable drain stops should be repaired or replaced to restore function.

Contact a qualified plumbing contractor.

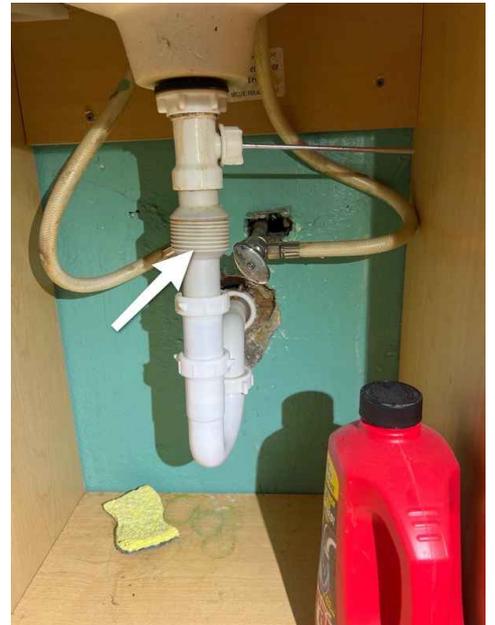
## 12.2.2 Sink drains

**FLEXIBLE DRAIN PIPE**

Corrugated or flexible drain lines are present. Drain pipes should have smooth walls to promote proper drainage and prevent clogs. These types of drains are prone to clog, and should only be installed vertically if used at all. We suggest further review with repairs made as deemed necessary.

Contact a qualified plumbing contractor.

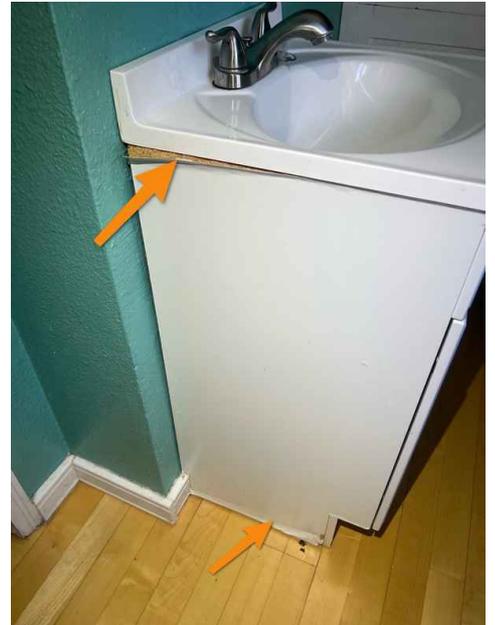
12.3.1 Cabinets

**CABINETS DAMAGED**

Cabinets are damaged in one or more areas. Recommend a qualified cabinets contractor evaluate and repair.

Contact a qualified cabinet contractor.

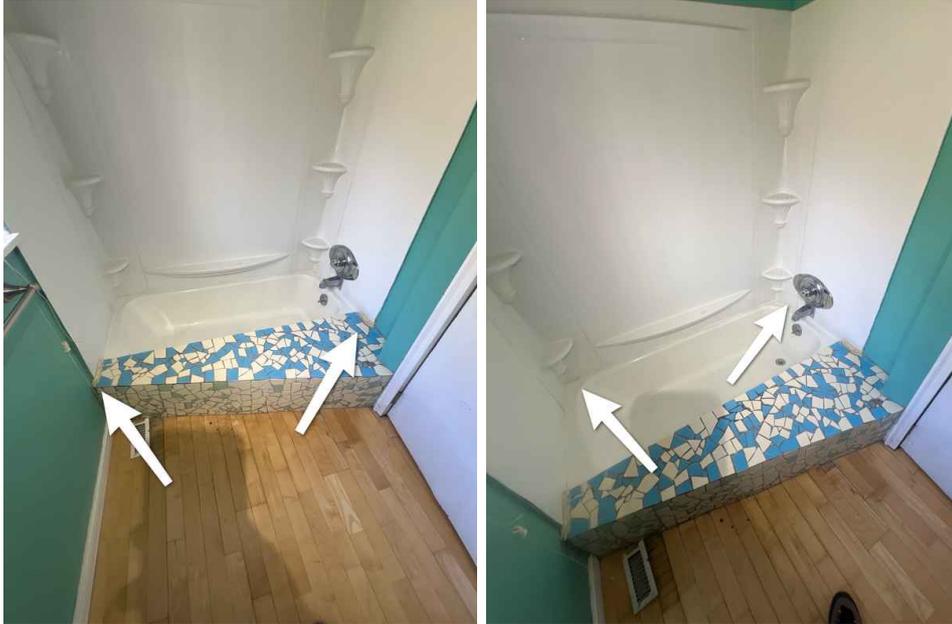
Joint caulking at the shower/tub wall area in the bathroom(s) was deteriorated in one or more places. We recommend that the deteriorated caulking be repaired to reduce water penetration and possible damage to the surrounding areas.

Contact a qualified tile contractor

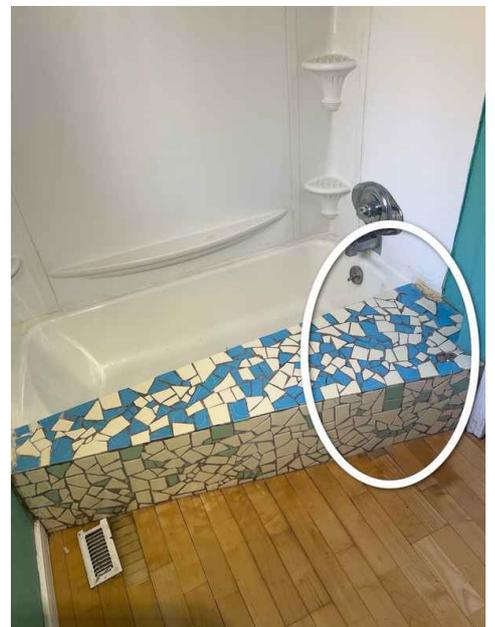
## 12.5.2 Tile

**CRACKED TILES**

Cracked tiles were observed in the bath(s) shower/tub wall area. We recommend that all cracked tiles be repaired or replaced to reduce water penetration and possible damage to the surrounding areas.

Contact a qualified tile contractor

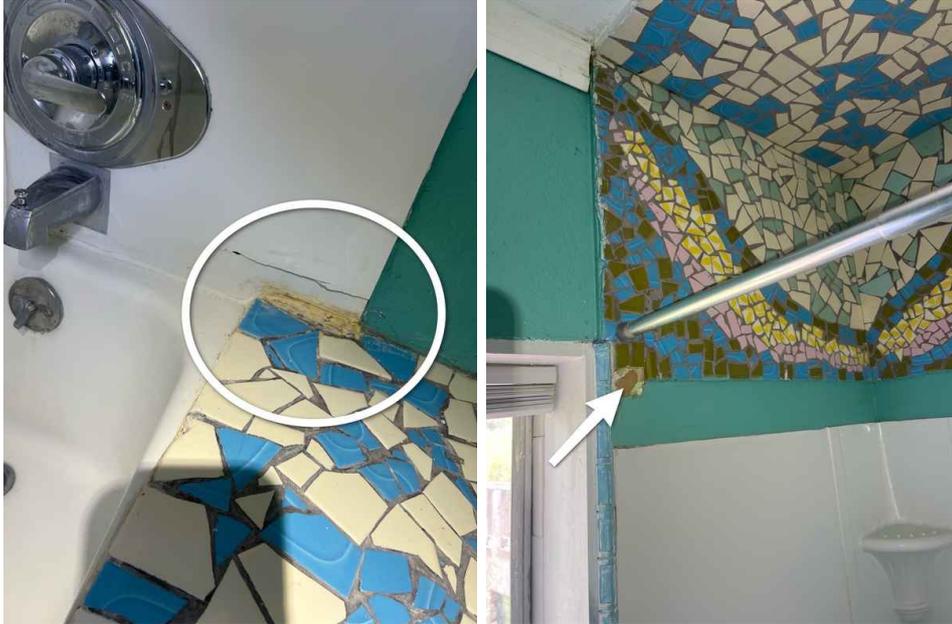
## 12.5.3 Tile

**LOOSE OR DAMAGED TILES**

Loose or damaged tiles were observed in the bath(s) shower/tub area. We recommend that all loose and damaged tiles be repaired or replaced to reduce water penetration, health concerns and possible damage to the surrounding areas.

Contact a qualified tile contractor

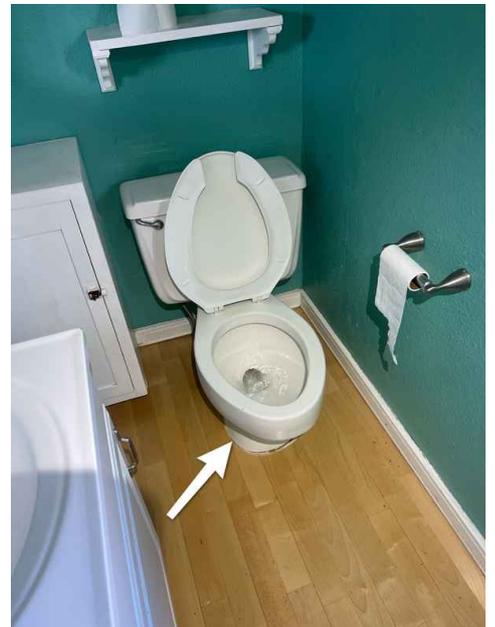
## 12.12.1 Toilets

**LOOSE TOILET**

The bath toilet was not securely attached to the soil pipe flange at the floor surface. We recommend that the toilet(s) be secured or repaired for health and safety considerations.

Contact a qualified plumbing contractor.

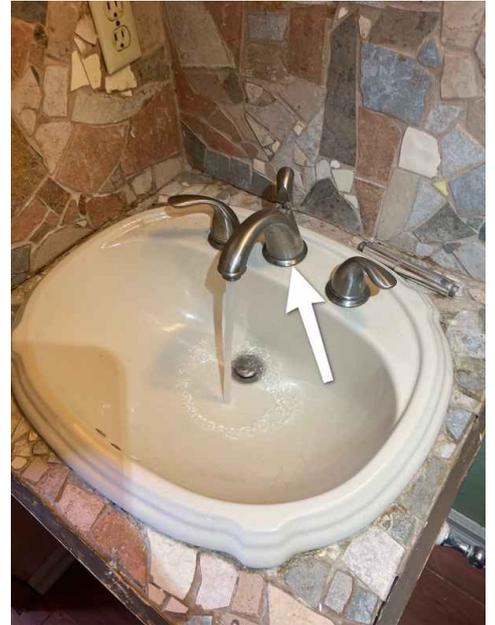
**LOOSE FAUCET**

The faucet (s) was found to be loose. We recommend that the faucet(s) be secured to the sink basin or countertop as required.

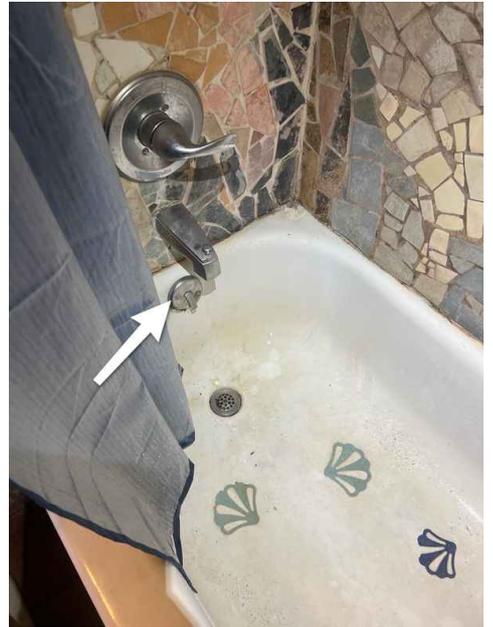
The drain stop was missing or defective in the bathtub(s). We recommend that all missing, damaged or non-functioning drain stops be repaired or replaced.

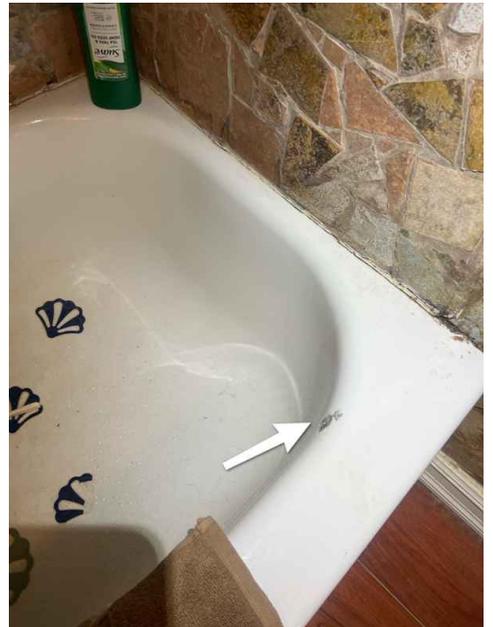
13.10.1 Bathtub

**DAMAGED TUB**

Damage was noted to the bathtub.

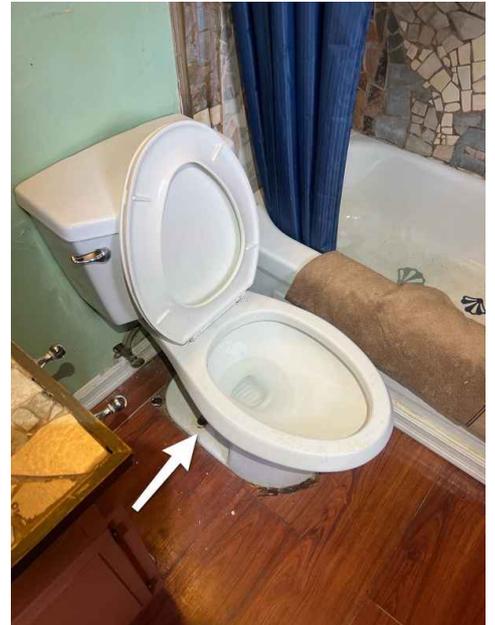
## 13.12.1 Toilets

**LOOSE TOILET**

The bath toilet was not securely attached to the soil pipe flange at the floor surface. We recommend that the toilet(s) be secured or repaired for health and safety considerations.

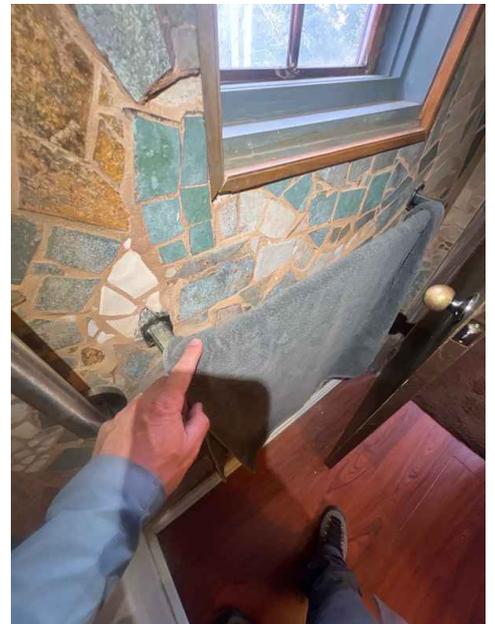
**LOOSE TOWEL BAR**

A loose towel bar was noted.

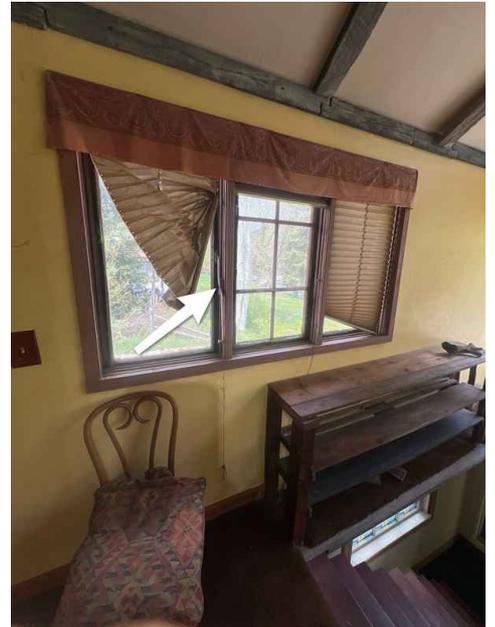
14.5.1 Window condition

**MISSING OR DAMAGED HARDWARE**

The hardware at the windows was observed to be missing or broken. We recommend repair or replacement.

Contact a qualified window repair/installation contractor.

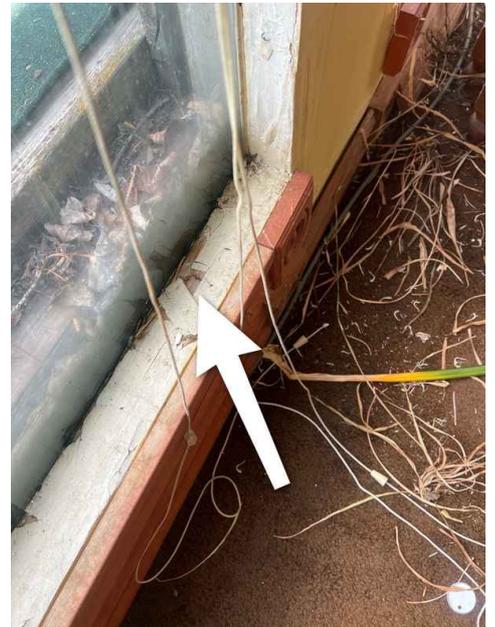
14.5.2 Window condition

**DETERIORATED FINISH**

Deteriorated finish was noted on the windows. We suggest repair to restore proper aesthetics.

Contact a qualified professional.
