**SUMMARY**

478 Eagle St , Minturn, CO 81645

David Ford  
05/24/2024

Chris Jobson  
True Perspective Home Consultants  
970-209-2041  
[chris@trueperspectivehc.com](mailto:chris@trueperspectivehc.com)

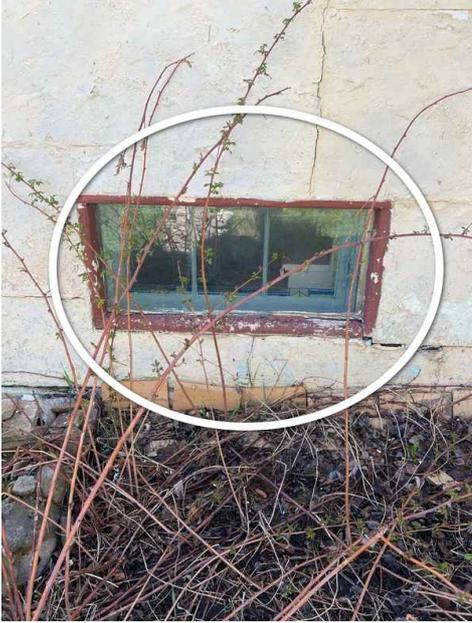
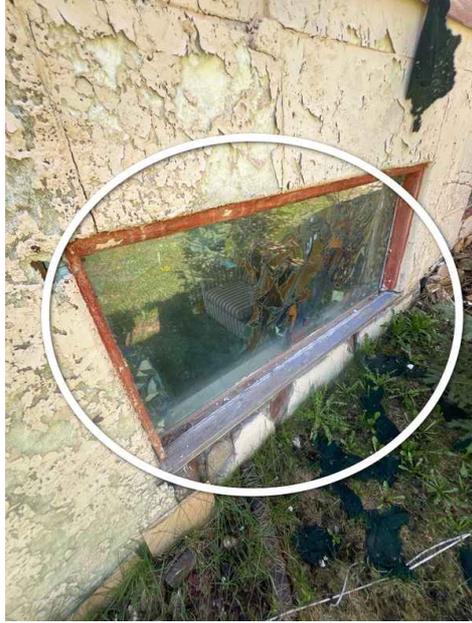
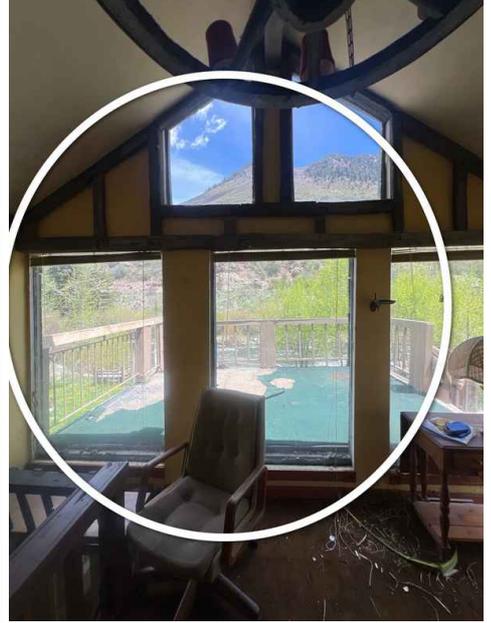
14.5.3 Window condition

**DETERIORATED WINDOWS**

Wood windows have deteriorated.

We suggest further review to better understand repair or replacement costs.

Contact a qualified professional.

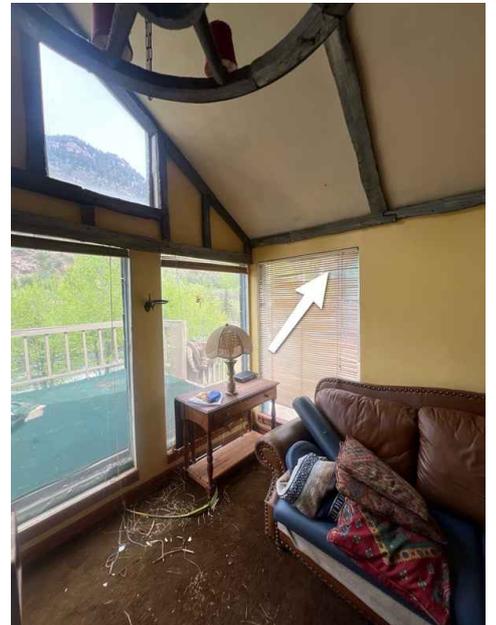
**FAILED WINDOW SEAL- SEVERAL**

Several windows and/or sliding glass doors presented symptoms of a breach seal or film failure between the two pieces of glass. This often takes the form of striations, molting, fogging, discoloration, or condensation between the panes of an insulated glass unit. These failures are not always apparent at the inspection time due to lighting conditions, dirt builds up, and/or attached sunscreens. We recommend evaluation of all the windows by an appropriate person with replacement as necessary.

Contact a qualified window repair/installation contractor.

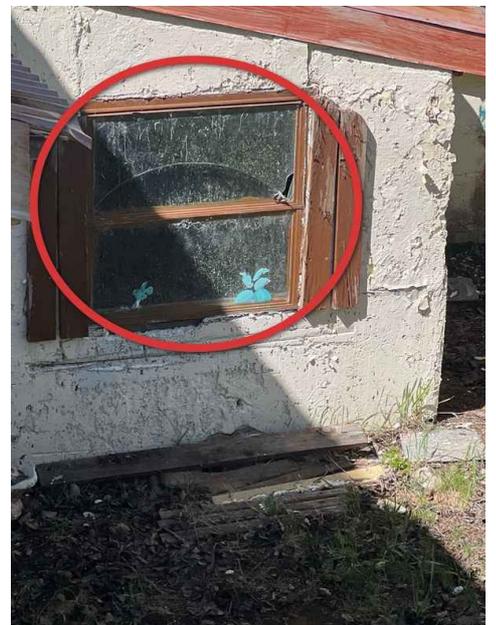
## 14.8.2 Windows - Glass

**CRACKED OR BROKEN GLASS**

Cracked or broken glass was observed. We recommend an immediate replacement for all cracked or broken windows. This is a safety concern and should be addressed.

Contact a qualified window repair/installation contractor.

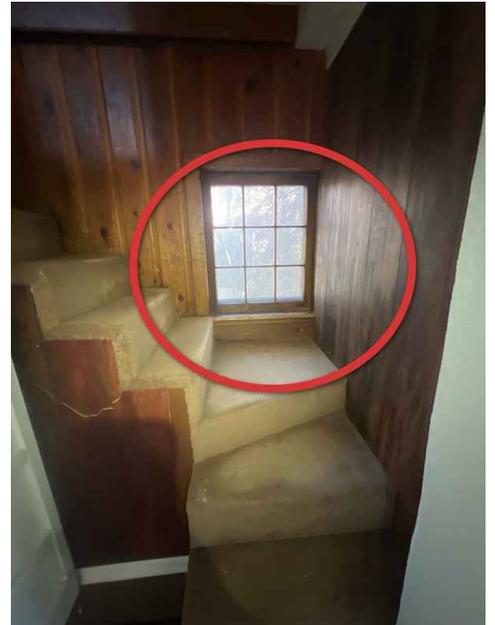
## 14.8.3 Windows - Glass

**MISSING TEMPERED GLASS**

Tempered glass was not found or could not be verified in currently recommended locations. This building may have been built before this feature was required. Upgrading is not required in a pre-1960's building but should be considered for glass in the more vulnerable locations.

Contact a qualified window repair/installation contractor.

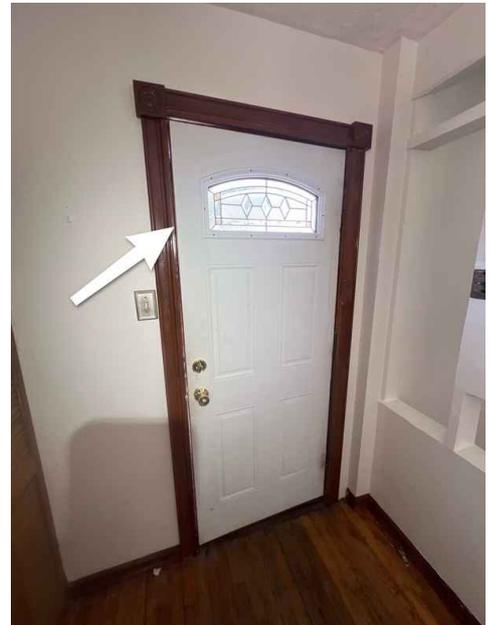
## 15.1.1 Exterior doors

**DOOR RUBBED**

The exterior door(s) rubbed on a portion of the frame or floor area. We recommend repair as necessary to restore the door(s) to proper function.

Contact a qualified carpenter.

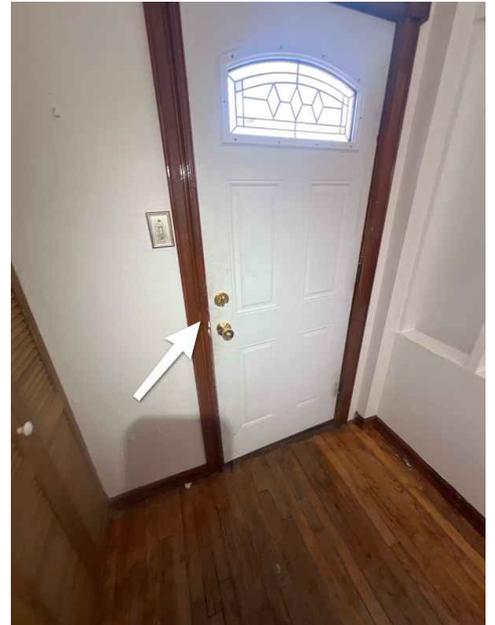
15.1.2 Exterior doors

**BAD LATCH**

The exterior door(s) did not latch properly. We recommend repair to return the door to proper operation.

Recommendation  
Contact a handyman or DIY project

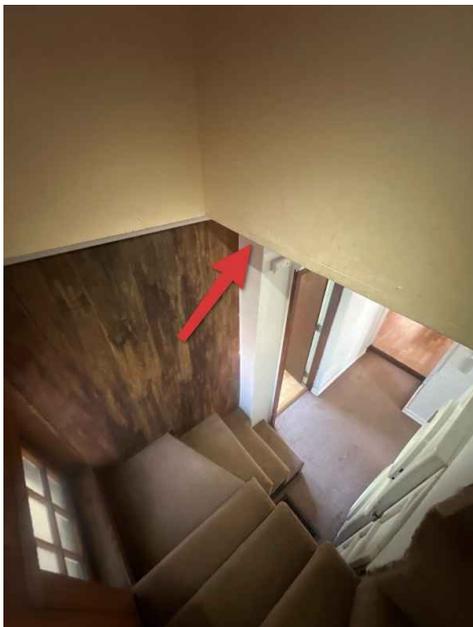
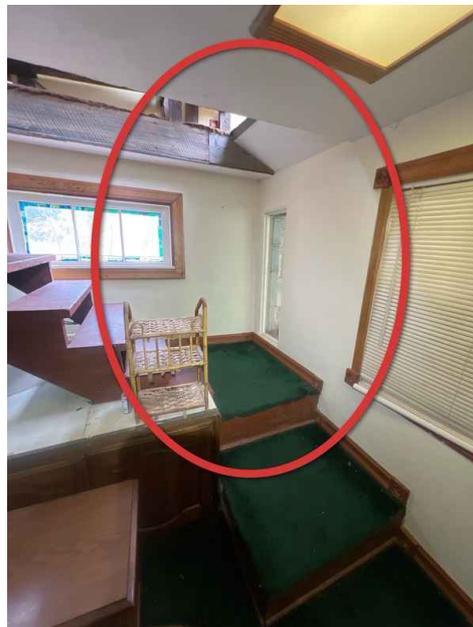
16.1.1 Stairways

**HEAD ROOM**

Inadequate headroom, less than 6'-8"

This staircase did not comply with generally-accepted modern standards for headroom which require that staircases have a minimum vertical clearance of 6 feet 8 inches, measured from the sloped plane represented by the nose of the stair treads.

Recommendation  
Contact your builder.

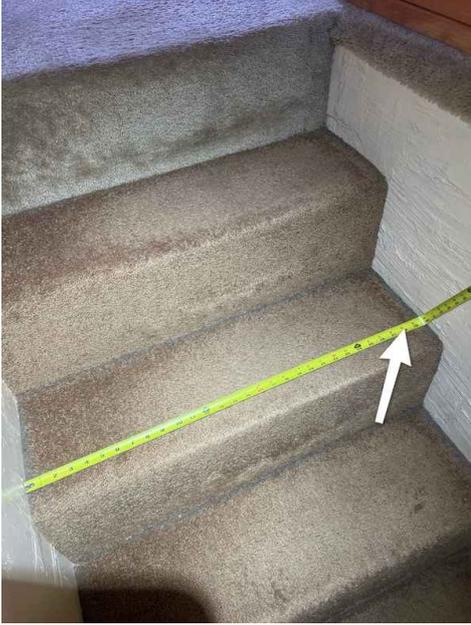
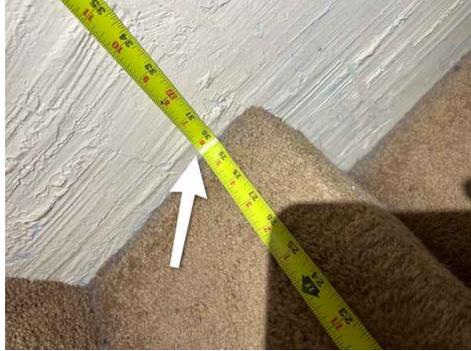
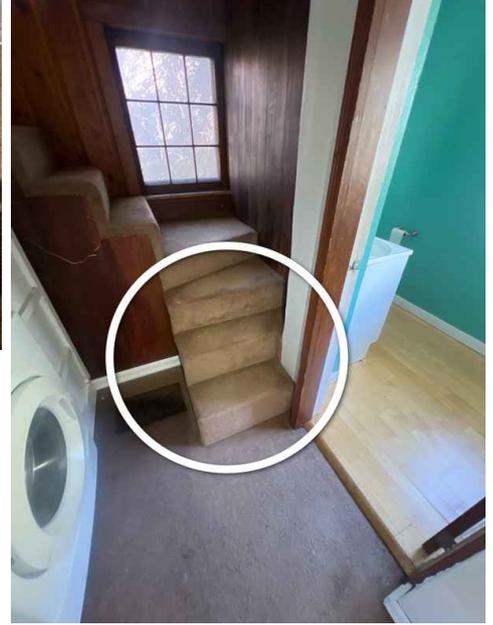
## 16.1.2 Stairways

### TOO NARROW

This staircase did not have a minimum clear width of 31 inches, measured at and just below the handrail. This condition is not uncommon in older homes built to standards that were accepted practice at the time of original construction.

Recommendation  
Contact a qualified professional.

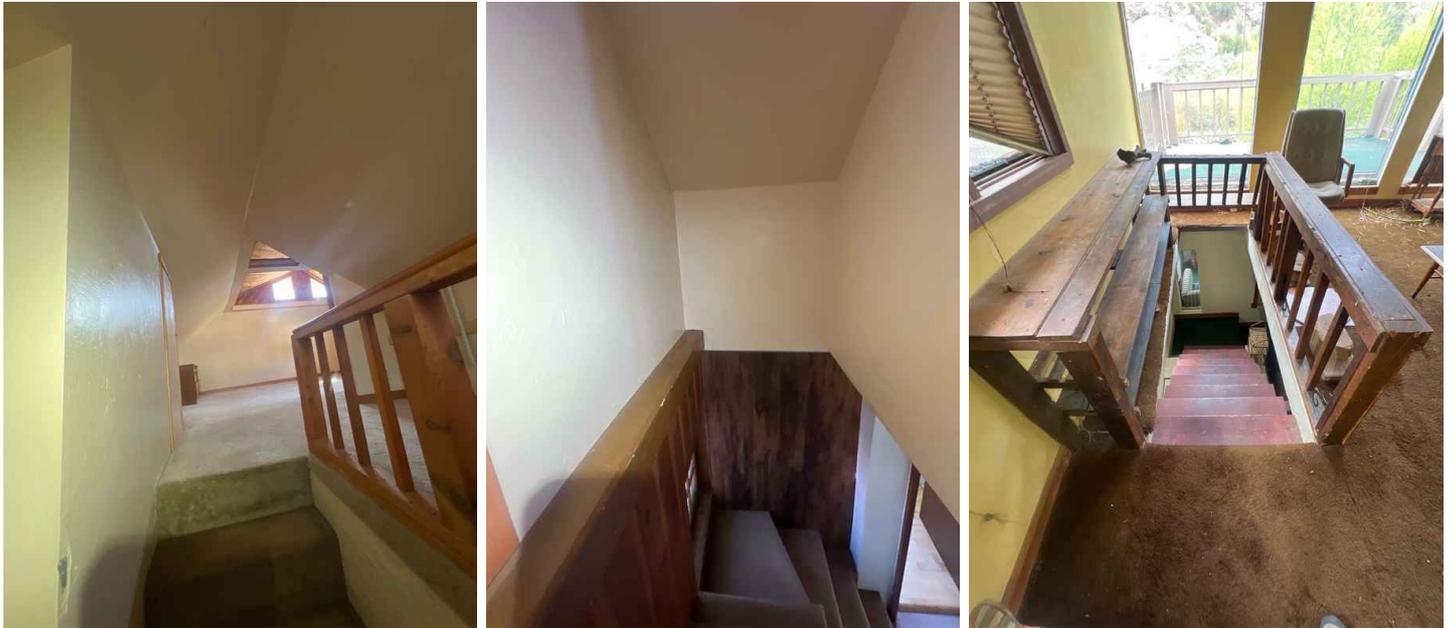
## 16.2.1 Staircase illumination

**NO STAIRCASE LIGHT**

No lighting was provided to illuminate this staircase. Modern safety standards require that all staircases with 6 risers or more, such as this one, have lights installed that illuminate the stairs, including landings and treads. The lights illuminating the stairs must be controlled by switches installed at and operable from both the top and bottom of the staircase. For safety reasons, the Inspector recommends that lighting and switches be installed by a qualified electrical contractor.

Contact a qualified electrical contractor.

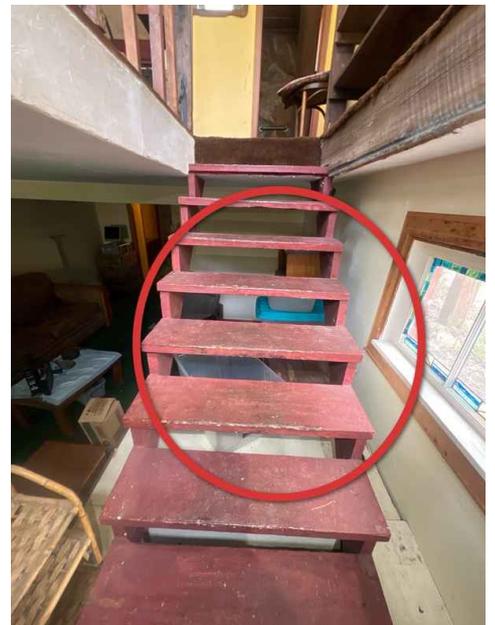
## 16.3.1 Stair Risers

**OPEN RISERS GREATER THAN 4"**

This condition is not uncommon in older homes built to standards that may have been the generally-accepted practice at the time of original construction, but which differ from generally-accepted current standards.

Contact your builder.

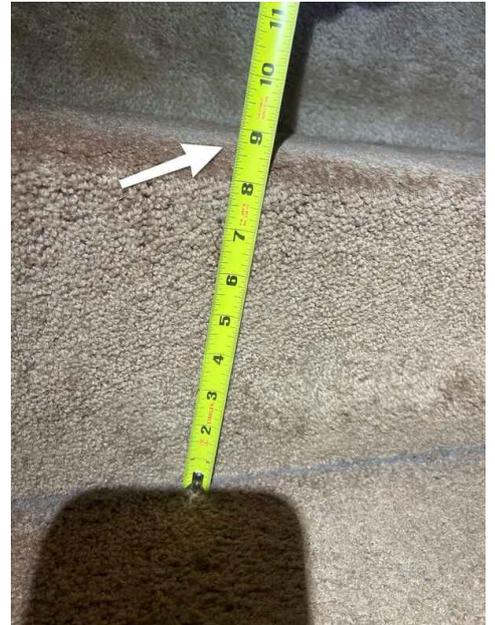
## 16.3.2 Stair Risers

**RISERS TOO TALL- OLDER HOME**

Risers at this staircase exceeded 7 3/4 inches (19.6cm) in height. Although this condition is now considered a potential trip/fall hazard, it is not uncommon in older homes such as this one, built during a time period during which safety standards were different from generally-accepted current safety standards. Current standards mandate a minimum height of 4 inches minimum and maximum height of 7 3/4 inches.

Contact your builder.

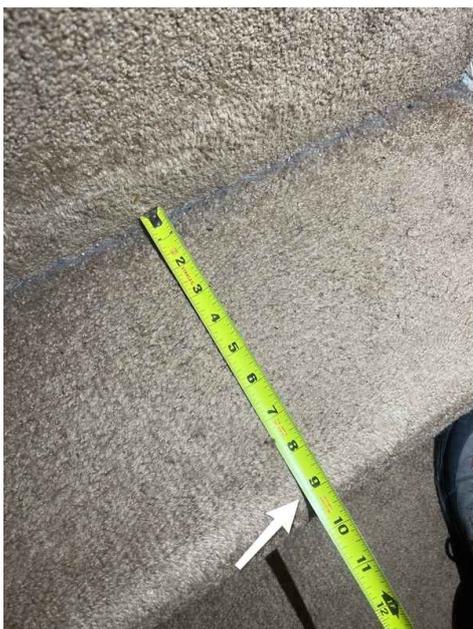
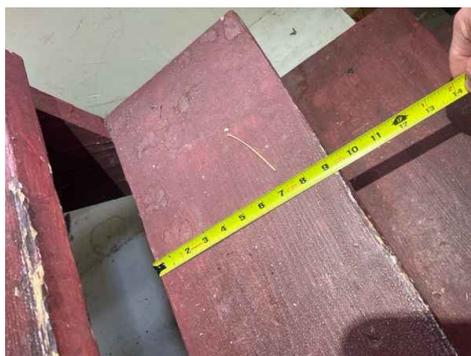
## 16.4.1 Stair Treads

**TREADS TOO NARROW**

Treads at this staircase were less than 10 inches in depth measured from riser to nosing. This condition is a potential trip/fall hazard. A 10-inch minimum and 10 3/8-inch maximum are the generally-accepted current standard tread depths.

Contact your builder.

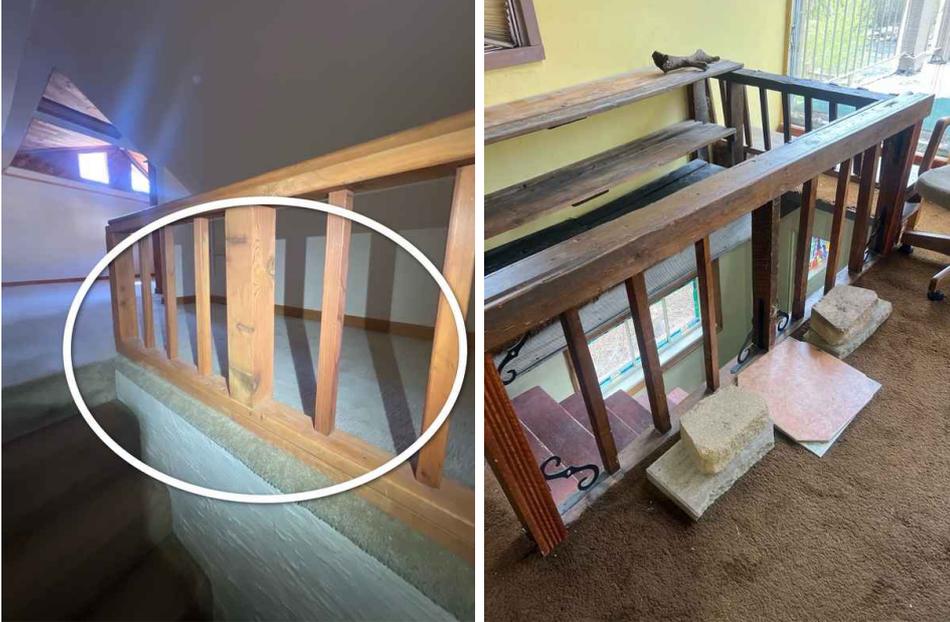
## 16.5.1 Railings

**BALLUSTER SPACING**

Contact a qualified professional.

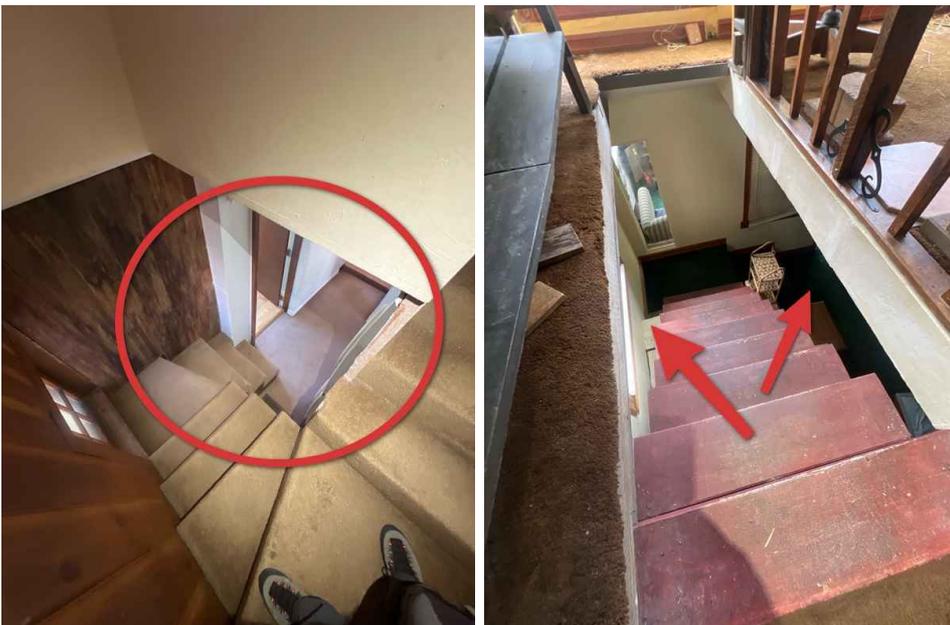
## 16.5.2 Railings

**NO GUARD RAIL**

Contact a qualified professional.

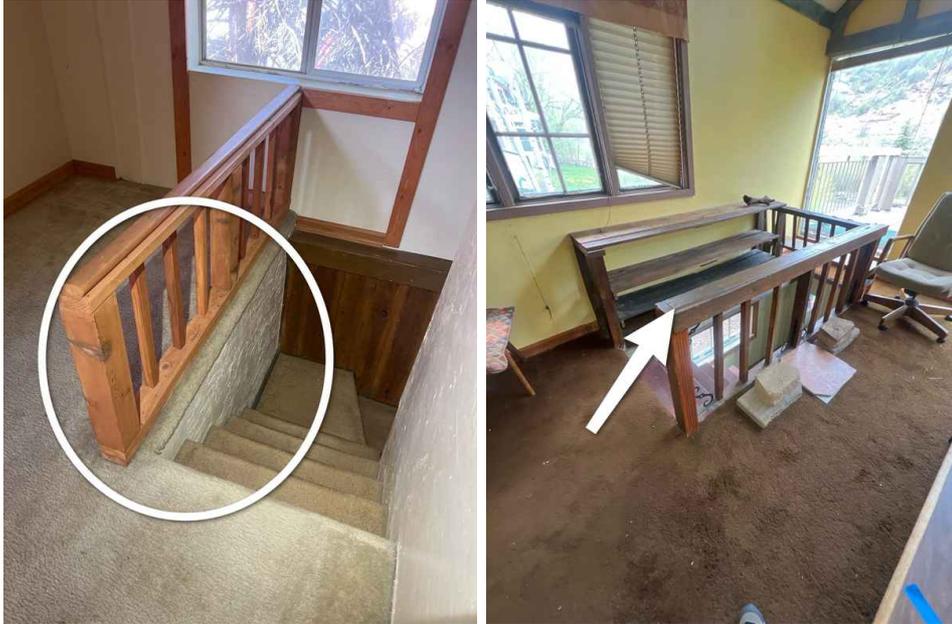
## 16.5.3 Railings

**GUARD RAIL HEIGHT TO LOW**

Contact a qualified professional.

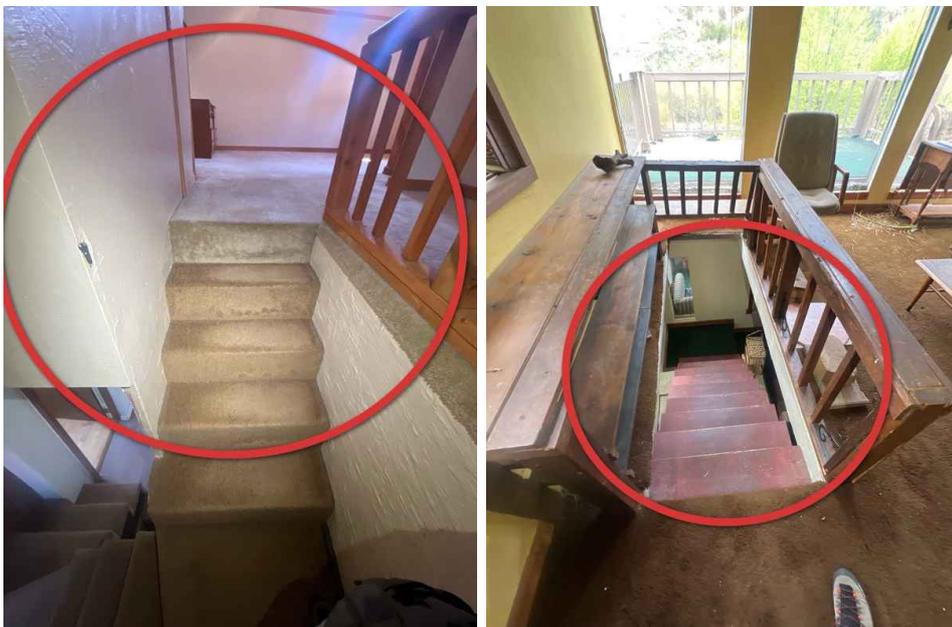
## 16.6.1 Handrails

**NO HANDRAIL**

The handrail is missing. While the home may have complied with the building code at the time it was built, upgrading for safety should be considered.

Contact a qualified carpenter.

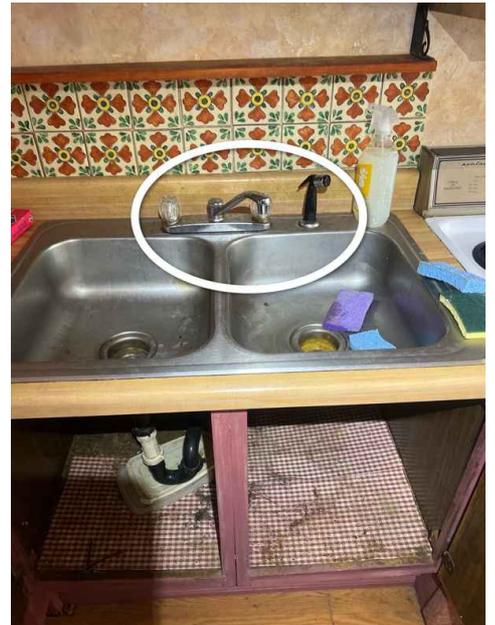
## 17.1.1 Faucet and sink

**HOT AND COLD WATER REVERSED**

The hot and cold controls on the faucet were reversed. We recommend that the hot water be plumbed to the left faucet and the cold water be plumbed to the right faucet for safety reasons.

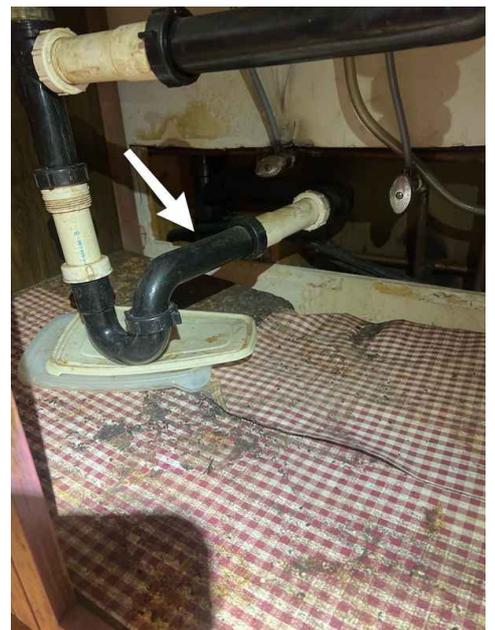
## 17.2.1 Sink Drain

**INSUFFICIENT PITCH OF DRAIN PIPE**

The drain line for the kitchen sink lacks adequate pitch from the trap to the wall. This configuration can promote clogging. We recommend adjustments be made to give the line a constant downhill slope of at least 1/4" per foot.

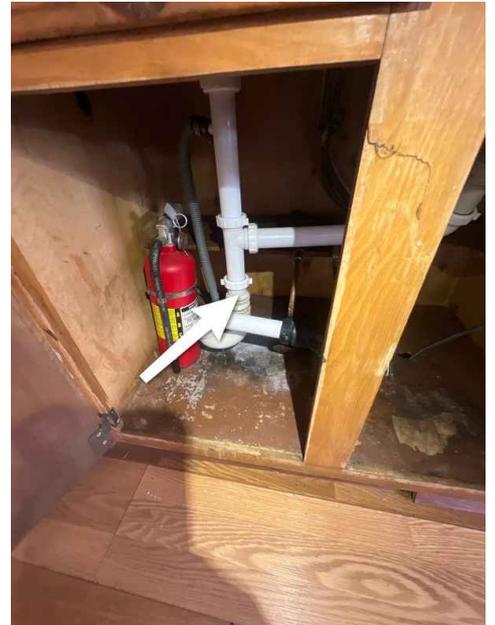
## 17.2.2 Sink Drain

**LEAKING DRAIN**

The drain trap or drain of the kitchen sink appeared to be leaking. We recommend repair of the drain trap or drain.

Contact a qualified plumbing contractor.

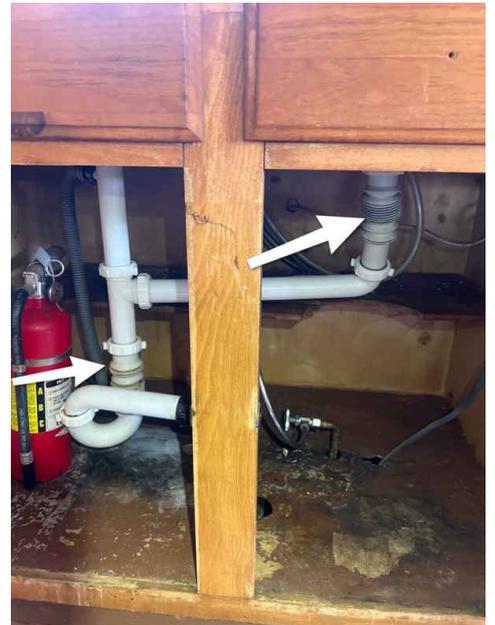
## 17.2.3 Sink Drain

**FLEXIBLE DRAIN PIPE**

A flexible drain pipe was noted under the kitchen sink, this is not recommended and suggests a nonprofessional installation. These types of pipes can become easily clogged by collecting dirt and grime in the accordion corrugations that impede flow. We recommend further review by a qualified plumbing contractor.

Contact a qualified plumbing contractor.

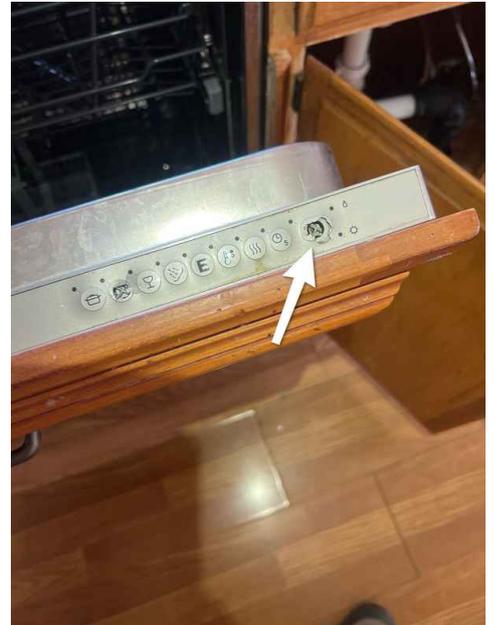
17.4.1 Dishwasher

**DAMAGED CONTROLS**

The dishwasher controls were damaged. We recommend that the controls be repaired or replaced.

Recommendation  
Contact a qualified professional.

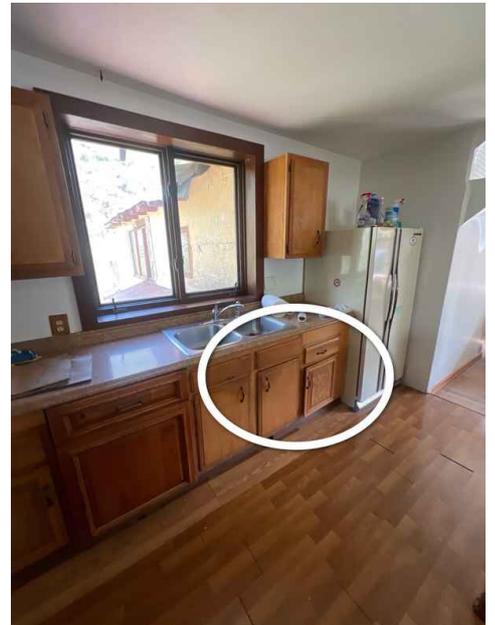
17.7.1 Cabinets

**ADJUST CABINET DOORS**

The cabinet doors were noted to need adjustment. We recommend all cabinet doors be adjusted for proper aesthetics and operation.

Recommendation  
Contact a handyman or DIY project

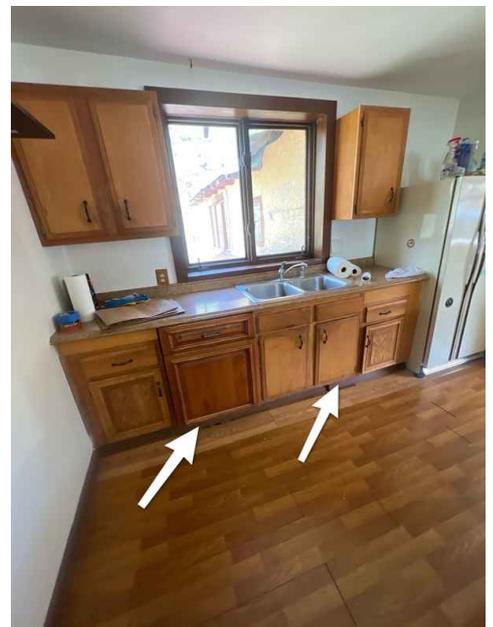
**LOOSE TOE KICK**

The base cabinets in the kitchen had loose sections of toe kick trim.

Recommendation  
Contact a qualified cabinet contractor.

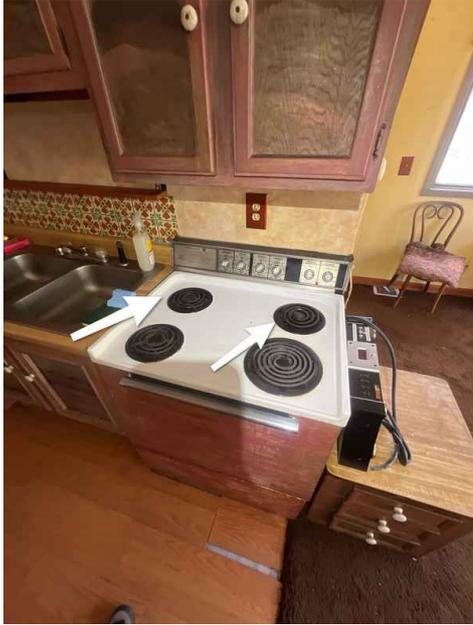
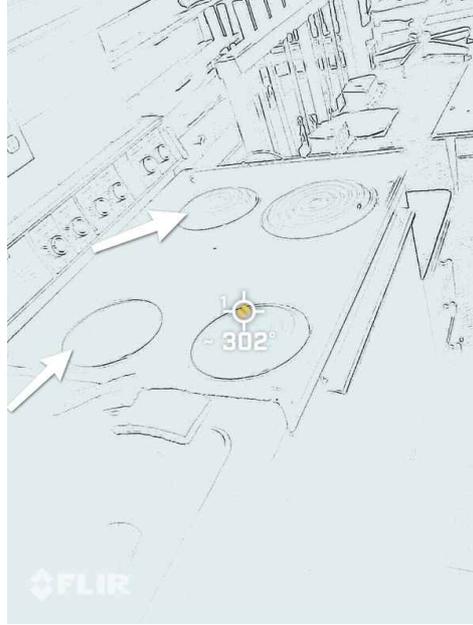
## 17.10.1 Range / Cook top/ oven

**BURNER FAILED TO OPERATE**

One or more heating elements did not heat up when turned on. We recommend qualified professional evaluation & repair.

Contact a qualified appliance repair professional.

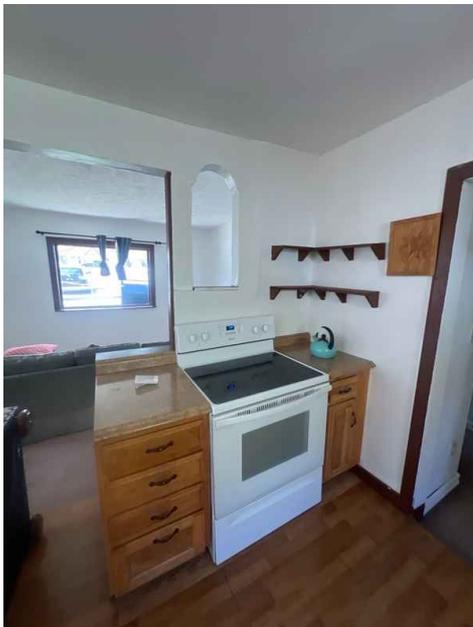
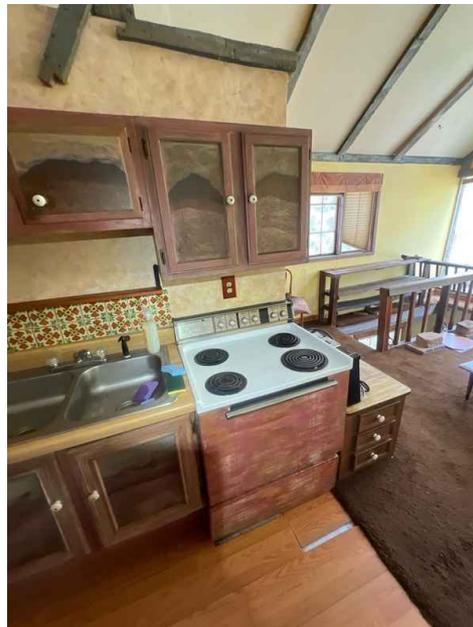
## 17.11.1 Ventilation

**EXHAUST SYSTEM MISSING**

No exhaust system is present to prevent moisture and grease and carbon monoxide in the kitchen area. We recommend further review with installation as deemed necessary.

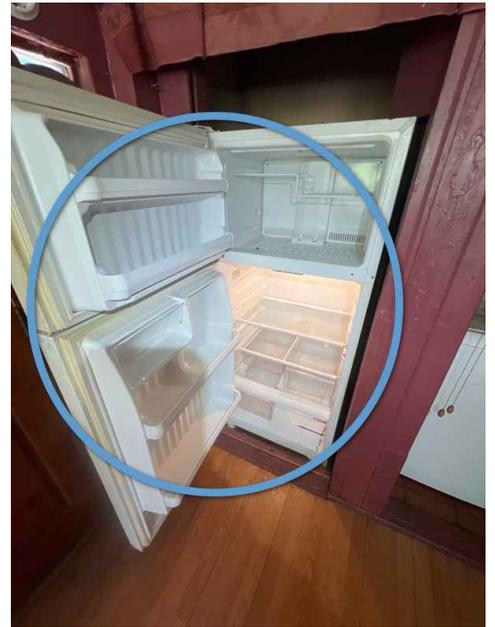
## 17.13.1 Refrigerator

**INTERIOR IN POOR CONDITION**

The interior of the refrigerator was found to be in poor condition. We recommend further review for a better understanding of replacement/repair costs and present condition.

Contact a qualified appliance repair professional.

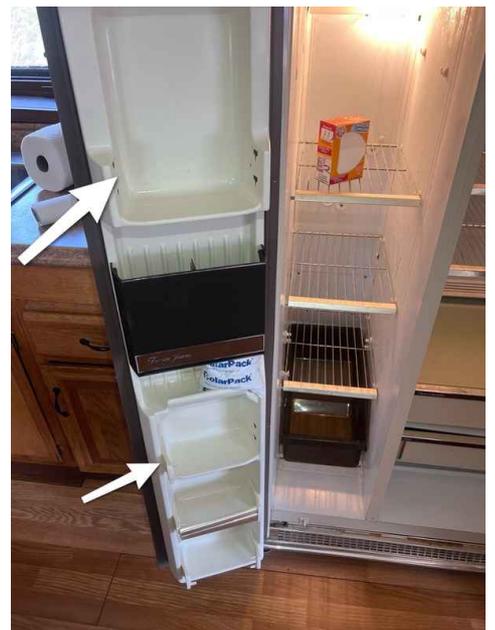
## 17.13.2 Refrigerator

**DAMAGED OR MISSING SHELVES**

The shelving in the refrigerator or freezer was damaged or missing.

Contact a qualified appliance repair professional.

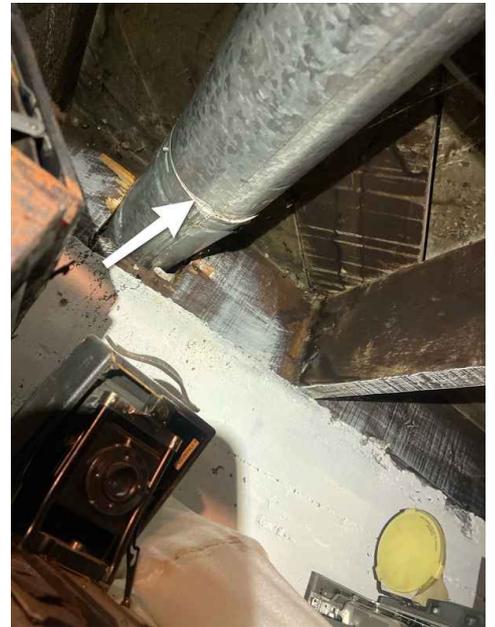
**CORROSION**

Corrosion visible on the exhaust flue indicated that the flue system may have a problem with condensation. The boiler should be serviced by a qualified HVAC technician or plumbing contractor.

Contact a qualified HVAC professional.

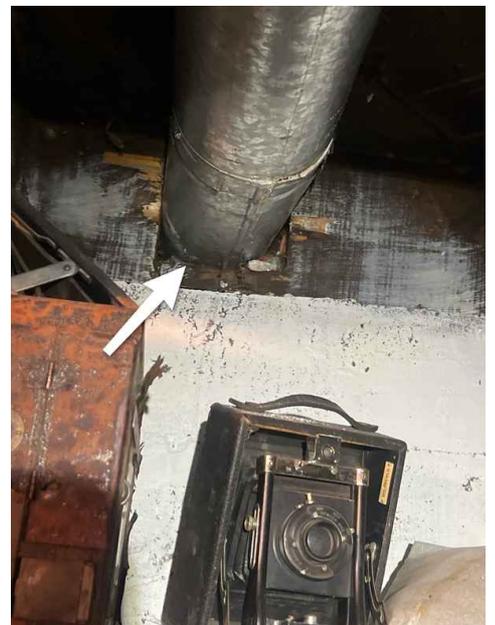
## 19.8.2 Exhaust flue

**TO CLOSE TO COMBUSTIBLES**

The combustion exhaust flue had improper clearance from combustible materials. The minimum clearance is 1 inch. This condition is a potential fire hazard and should be corrected by a qualified contractor.

Contact a qualified HVAC professional.

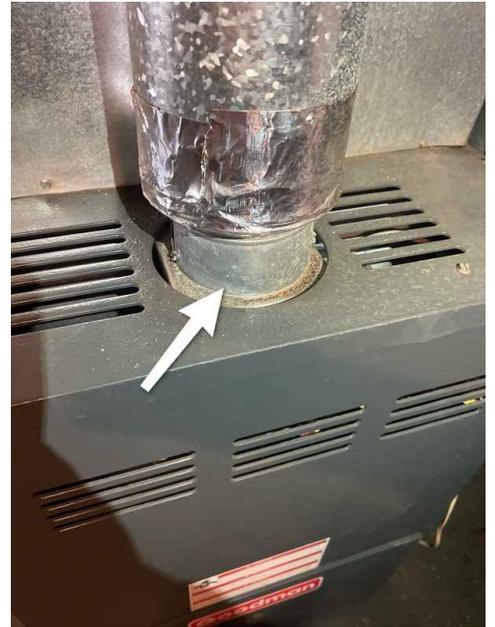
## 19.8.3 Exhaust flue

**CORROSION BASE OF VENT**

Corrosion visible at the base of the combustion exhaust vent of the furnace indicated the presence of excessive amounts of moisture, typically related to condensation formed by improper furnace exhaust vent conditions. This condition may result in premature failure of furnace components. The Inspector recommends that the furnace be serviced by a qualified HVAC contractor.

Contact a qualified heating and cooling contractor

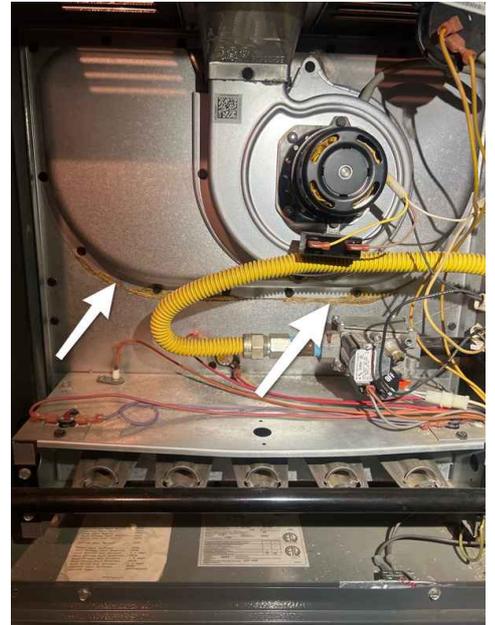
## 19.11.2 Furnace interior

**CORROSION**

Corrosion was noted on the interior of the heating system. We suggest further reviewing the heating system with repairs made as deemed necessary by a qualified heating contractor.

Contact a qualified professional.

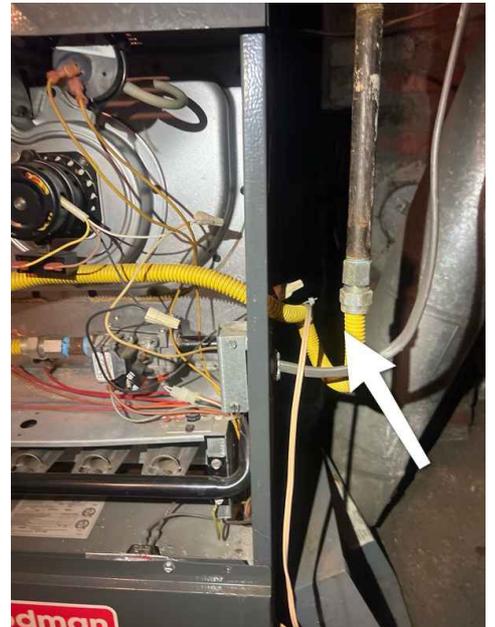
## 19.12.1 Fuel pipe

**NO DRIP LEG / SEDIMENT TRAP**

No sediment trap or drip leg was installed at this heating unit. Sediment traps and drip legs are installed to keep particulates and moisture out of the gas valve. Particulates or moisture in the gas valve can interfere with burner operation. The Inspector recommends the installation of a sediment trap/drip leg by a qualified plumbing contractor.

Contact a qualified HVAC professional.

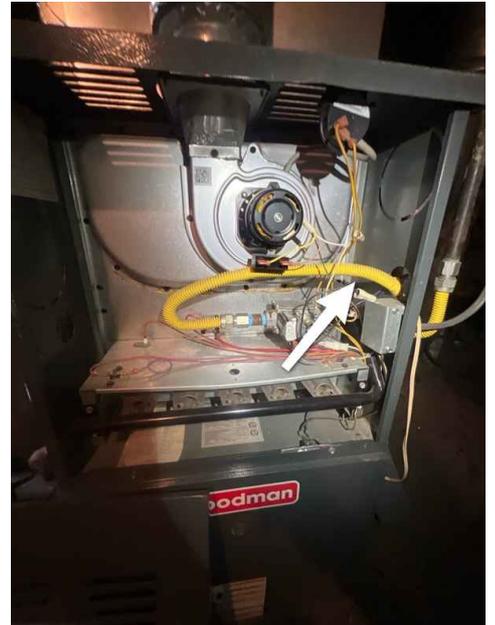
## 19.12.2 Fuel pipe

**FLEXIBLE TUBING THROUGH CABINET**

Contact a qualified heating and cooling contractor

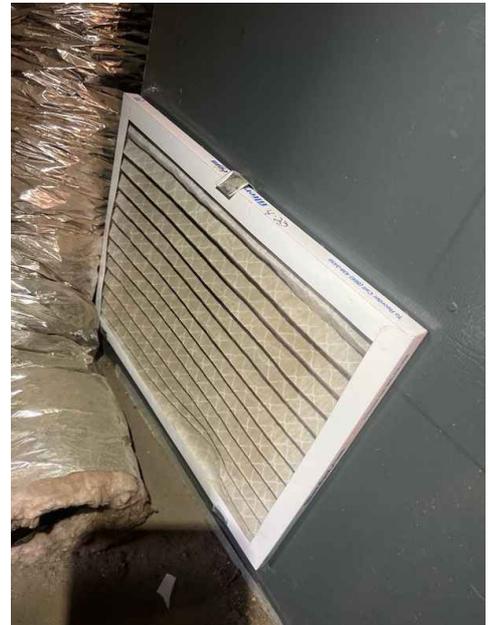
## 19.16.2 Air filter

**RETURN AIR DUCT DISCONNECTED**

We suggest repairs for proper function.

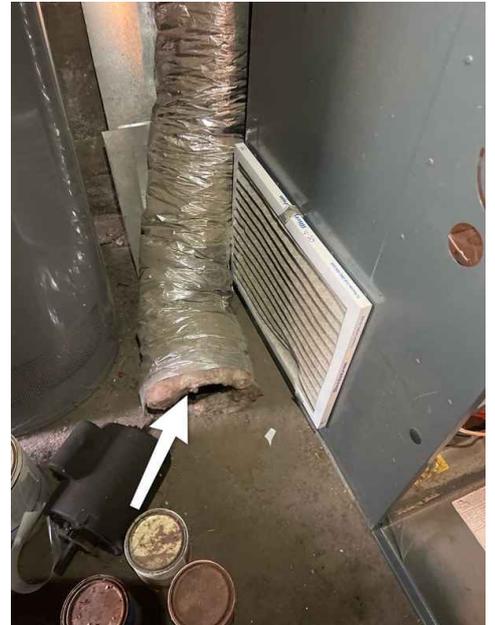
## 19.18.1 Distribution Systems

**DUCTS NOT SEALED**

Air supply ducts were not properly sealed. Recommend a qualified HVAC contractor to seal supply and return ducts for maximum efficiency.

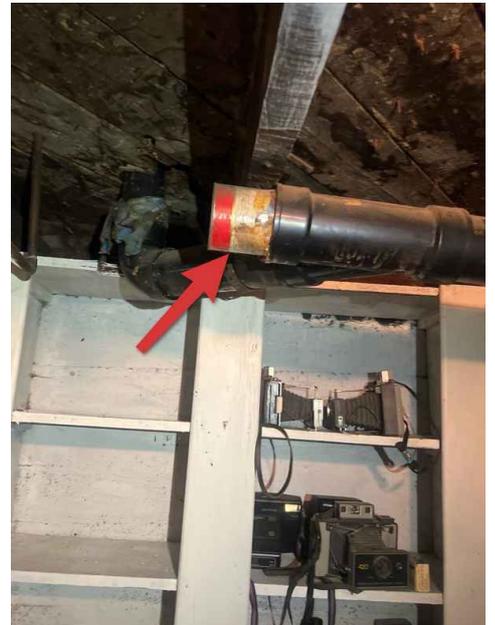
## 20.16.1 Fuel Storage &amp; Distribution Systems

**IMPROPER SUPPORT OF GAS LINES**

The gas piping needs support at six-foot to eight-foot intervals if suspended above a surface. Piping was observed without this support. Attention to the proper support of the piping is required to ensure the integrity of the piping system. We recommend that the proper supports and/or strapping be provided.

Contact a qualified plumbing contractor.

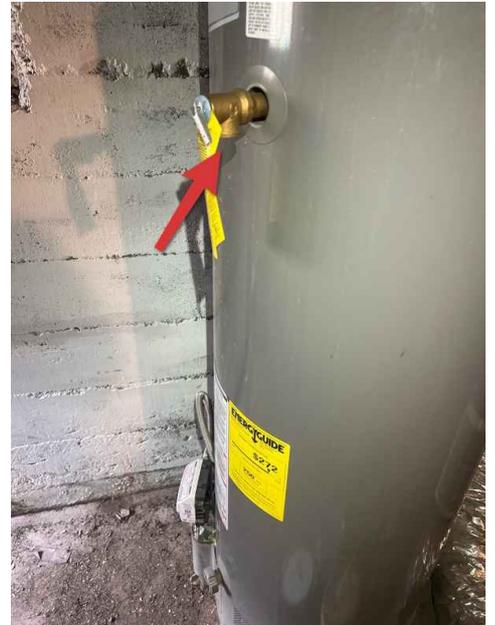
## 21.21.1 Expansion tank

**IMPROVE- CONSIDER ADDING EXPANSION TANK**

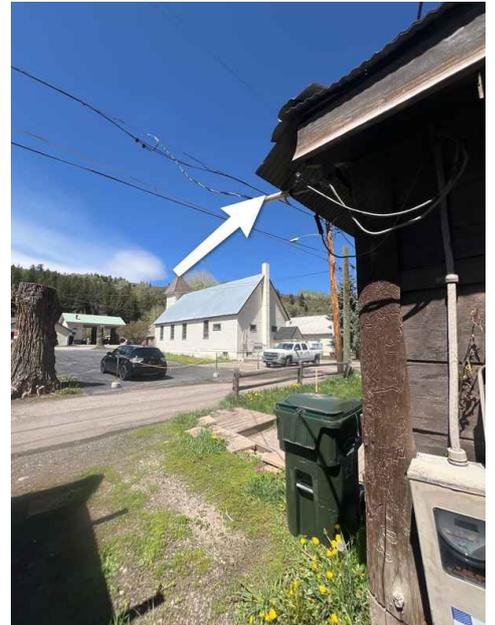
## 22.9.3 Main service -Condition

**LESS THAN 12' OVER DRIVEWAY**

The overhead clearance of service entrance conductors across the driveway was estimated to be less than the minimum (12 feet) required. This creates a potentially hazardous condition and we recommend repair.

Contact a qualified electrical contractor.

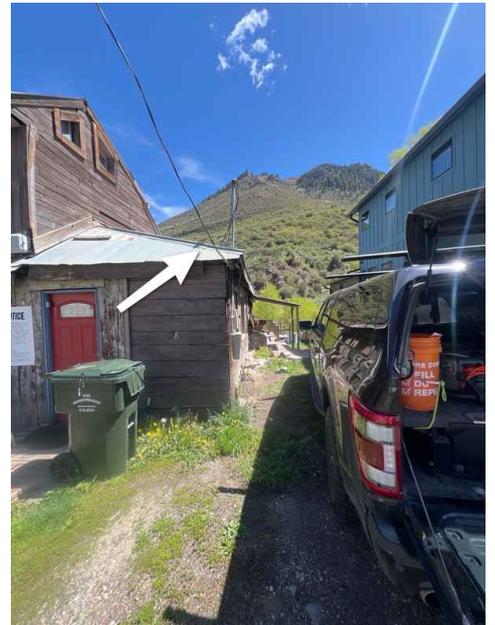
## 22.9.4 Main service -Condition

**LOOSE METER CABINET**

The electrical meter cabinet was loosely mounted. It should be securely fastened to the mounting surface by a qualified electrical contractor.

Contact a qualified electrical contractor.

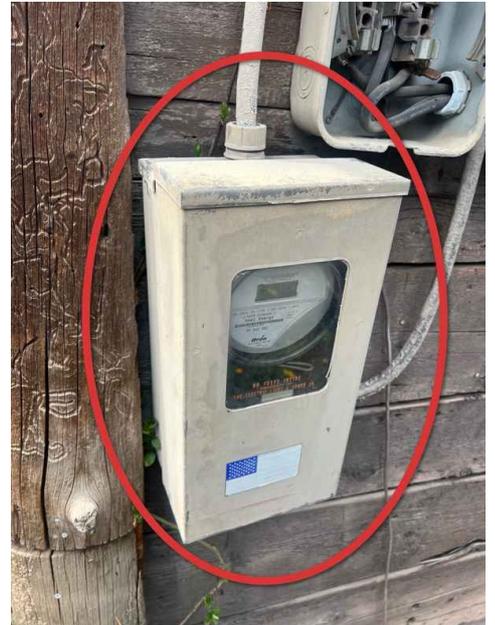
## 22.10.1 Disconnect -condition

**NO MAIN POWER SHUT OFF (MORE THAN 6)**

The electrical service equipment did not include a main shutoff, and more than six disconnects were used to completely shut off power to the building. A main shutoff may be required by local standards. We recommend further review for a better understanding of replacement costs/repairs and present condition.

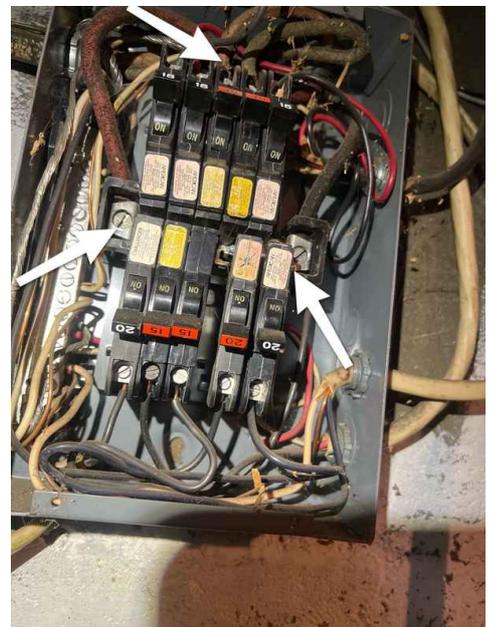
## 22.19.1 Main &amp; Subpanels- Conditions

**DEAD FRONT MISSING**

The protective "dead front" cover, which would help to prevent hazardous shocks if it were in place, was missing from the service panel. Replacing the cover plate is recommended.

Contact a qualified professional.

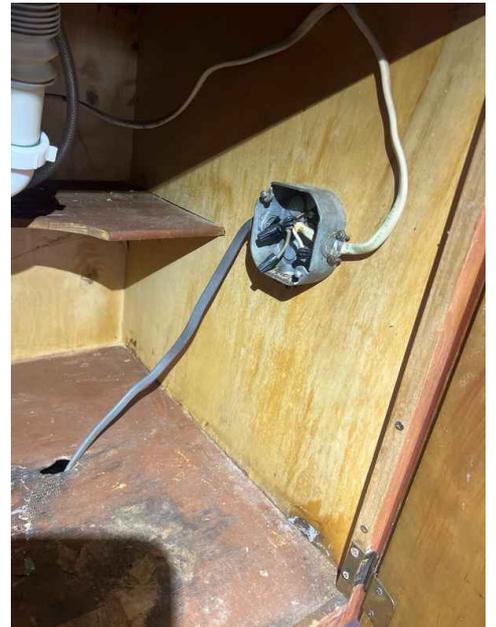
22.21.2 Wiring General

**EXPOSED WIRING**

Exposed wiring was observed. We recommend that any electrical wiring which is exposed to damage and human contact be enclosed or otherwise protected according to current applicable standards for safety.

Contact a qualified electrical contractor.

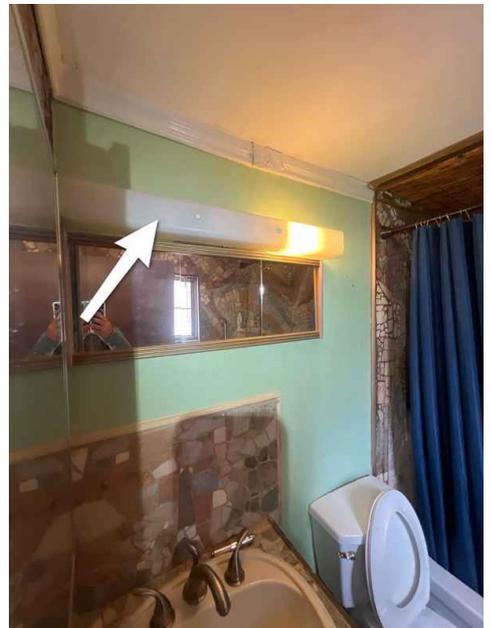
22.23.2 Lights

**DAMAGED OR IMPROPERLY INSTALLED**

The light fixture was damaged or improperly installed. All damaged or improperly installed fixtures should be repaired or replaced to proper operation by an electrician.

Contact a qualified electrical contractor.

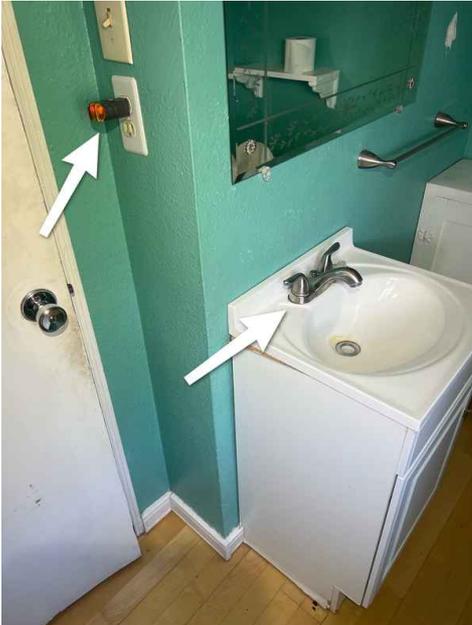
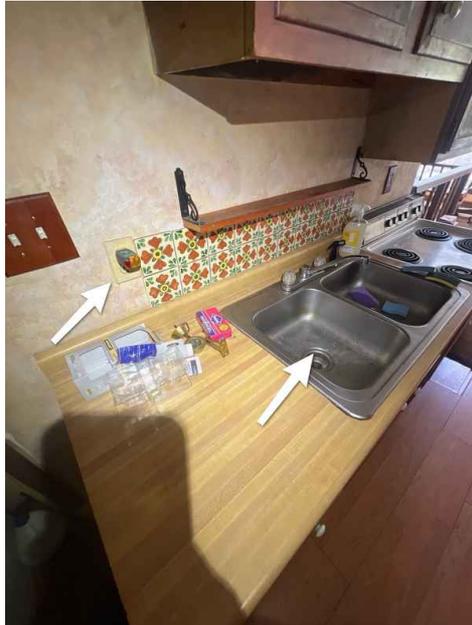
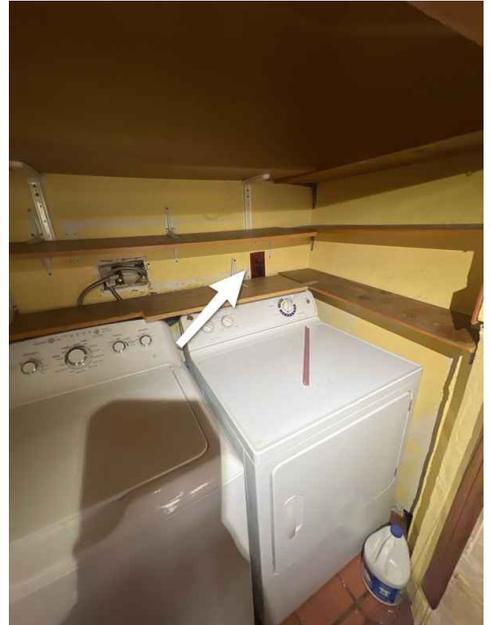
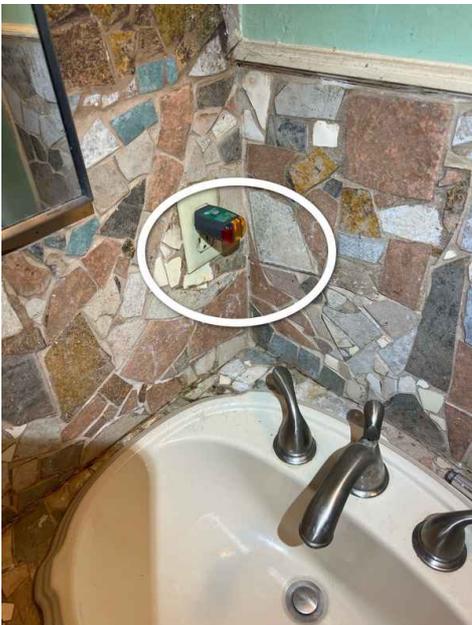
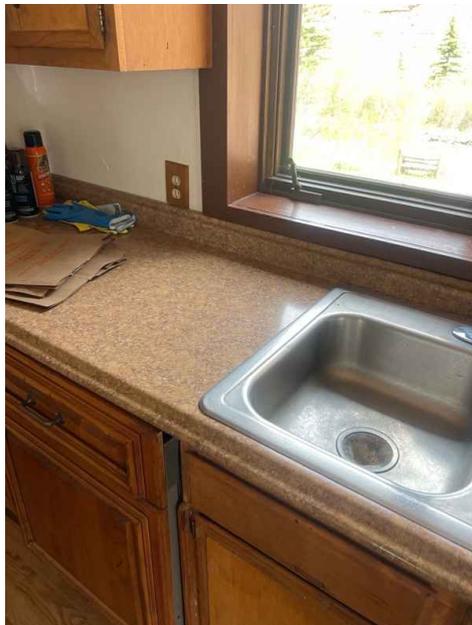
## 22.27.1 Arc Fault protection -AFCI

**ARC FAULT PROTECTION -UPGRADE SUGGESTED**

Contact a qualified electrical contractor.

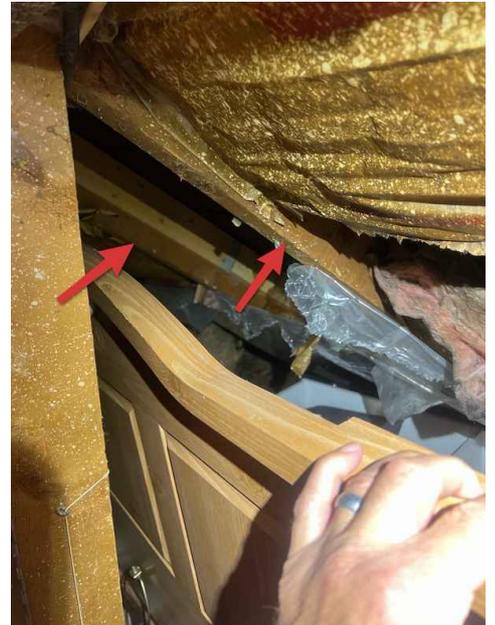
## 23.6.1 Rafters

**RAFTER SAG**

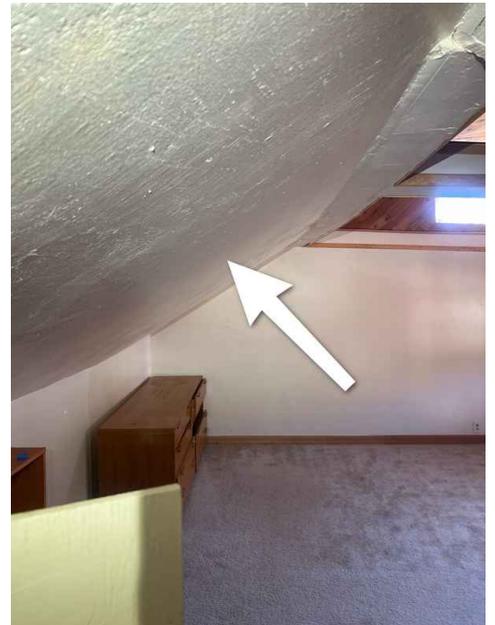
## 23.6.2 Rafters

**SPLICED RAFTERS**

Repairs have been made to the rafters in the attic. The inspector recommends evaluation by a structural engineer. Any correction should be made by a qualified contractor.

Contact your builder.

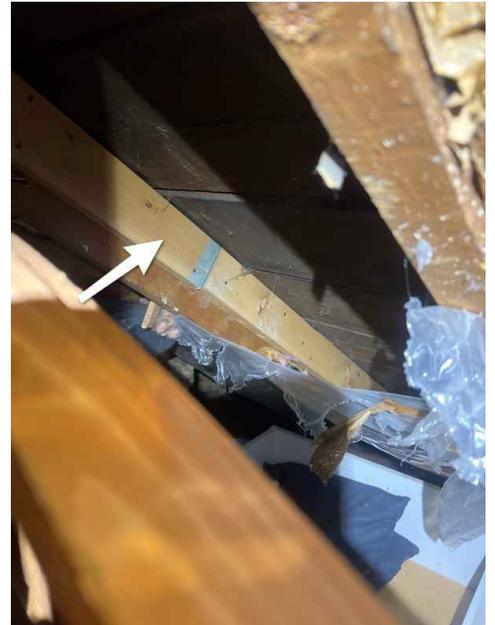
## 23.6.3 Rafters

**UNDERSIZED RAFTERS**
