**SUMMARY**

478 Eagle St , Minturn, CO 81645

David Ford  
05/24/2024

Chris Jobson  
True Perspective Home Consultants  
970-209-2041  
[chris@trueperspectivehc.com](mailto:chris@trueperspectivehc.com)

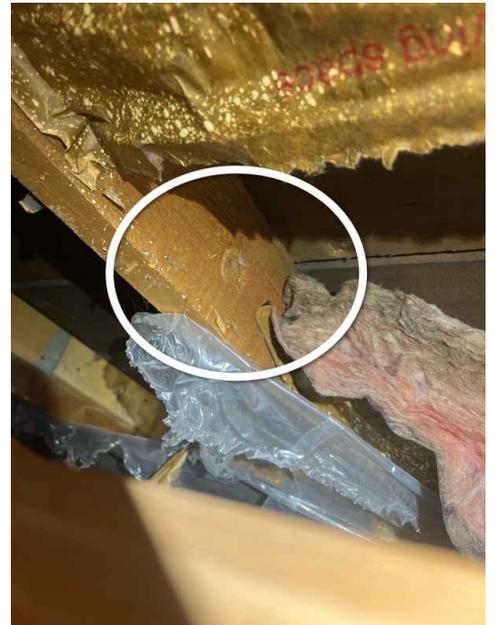
## 23.11.2 Attic Insulation Conditions

**MISSING INSULATION**

The attic was missing insulation over areas of significant size. This condition can increase heating and cooling costs, allow condensation that leads to microbial growth and reduce comfort levels. It may contribute to ice damming of the roof during the winter. The Inspector recommends that insulation be properly distributed to cover all portions of the attic located above the home living space.

Contact a qualified insulation contractor.

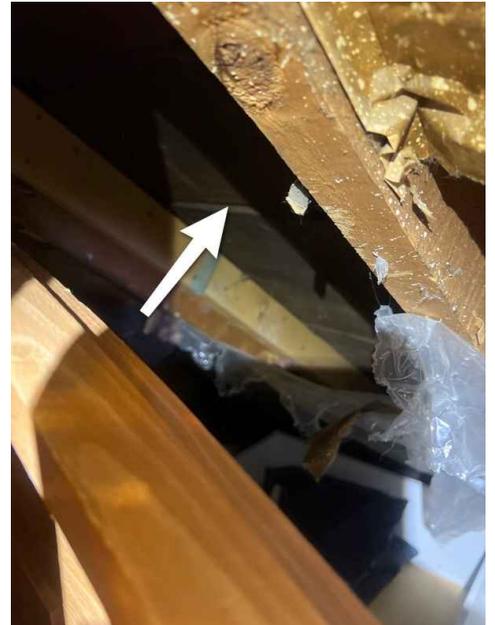
## 24.4.1 Foundation walls

**WOOD FOUNDATION WALLS**

Portions of the home appear to have a wood foundation. While this can be an acceptable means of construction these types of foundations do not typically last as long as concrete foundation walls and need careful monitoring of water issues. We suggest a full review of the foundation walls by a qualified contractor, waterproofing consultant, and/ or professional engineer.

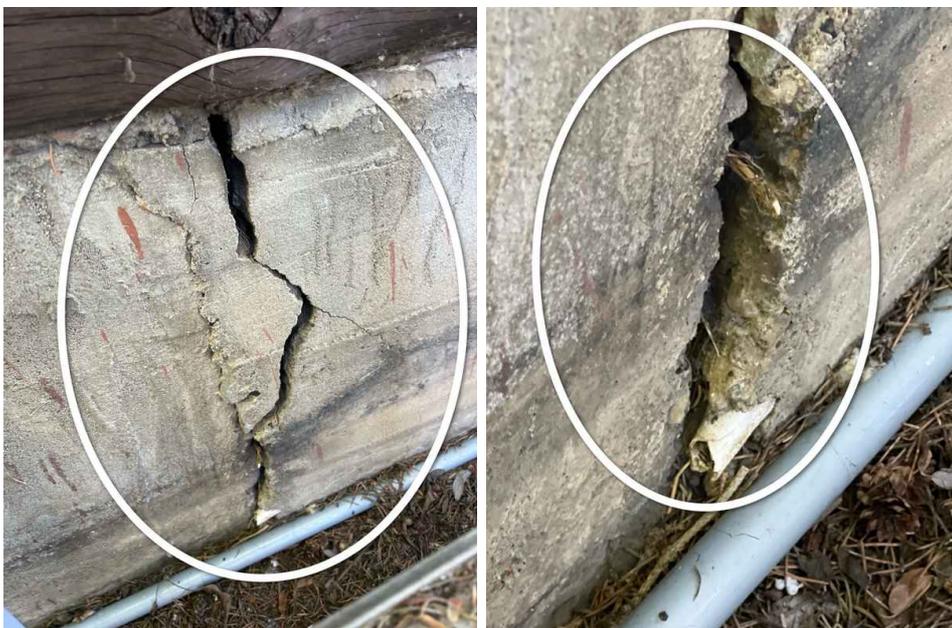
## 24.4.2 Foundation walls

**CRACKING**

A large crack was observed in the perimeter structure foundation wall. We recommend further review for a better understanding of repair costs and present conditions.

Contact a qualified professional engineer

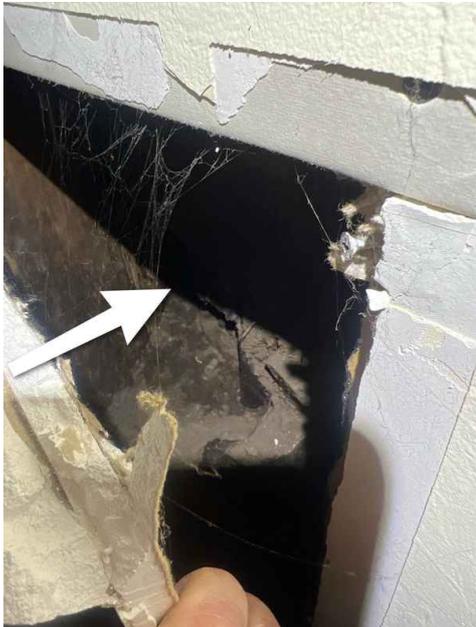
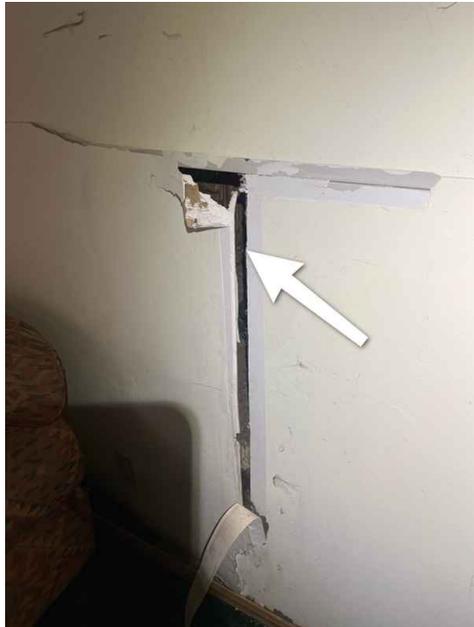
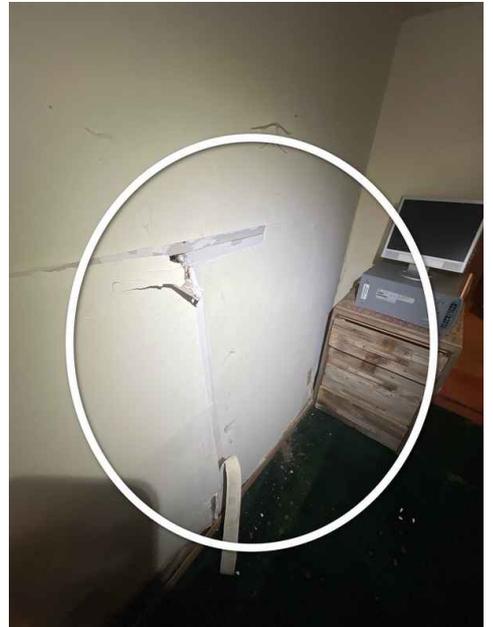
24.4.4 Foundation walls

**DETERIORATED WALLS**

The wood foundation walls are significantly bowing in towards the home. Damaged foundation plywood, moisture and soil intrusion, and drywall damage are visible. We suggest a further review by a qualified professional or structural engineer to evaluate this condition.

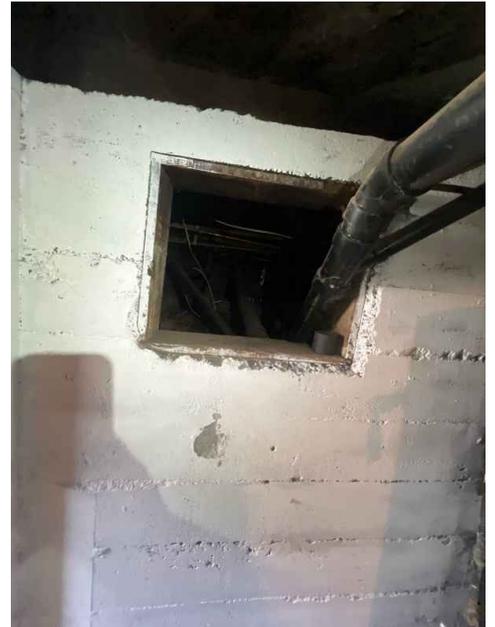
There was limited access to the crawl space at the time of the inspection due to obstructions, inspector safety, or stored items. Therefore the crawl space was only inspected from the entry or limited accessible areas with a flashlight. As a result of this condition, there may be hidden defects that were not detected at the time of the inspection.

Contact a qualified professional.

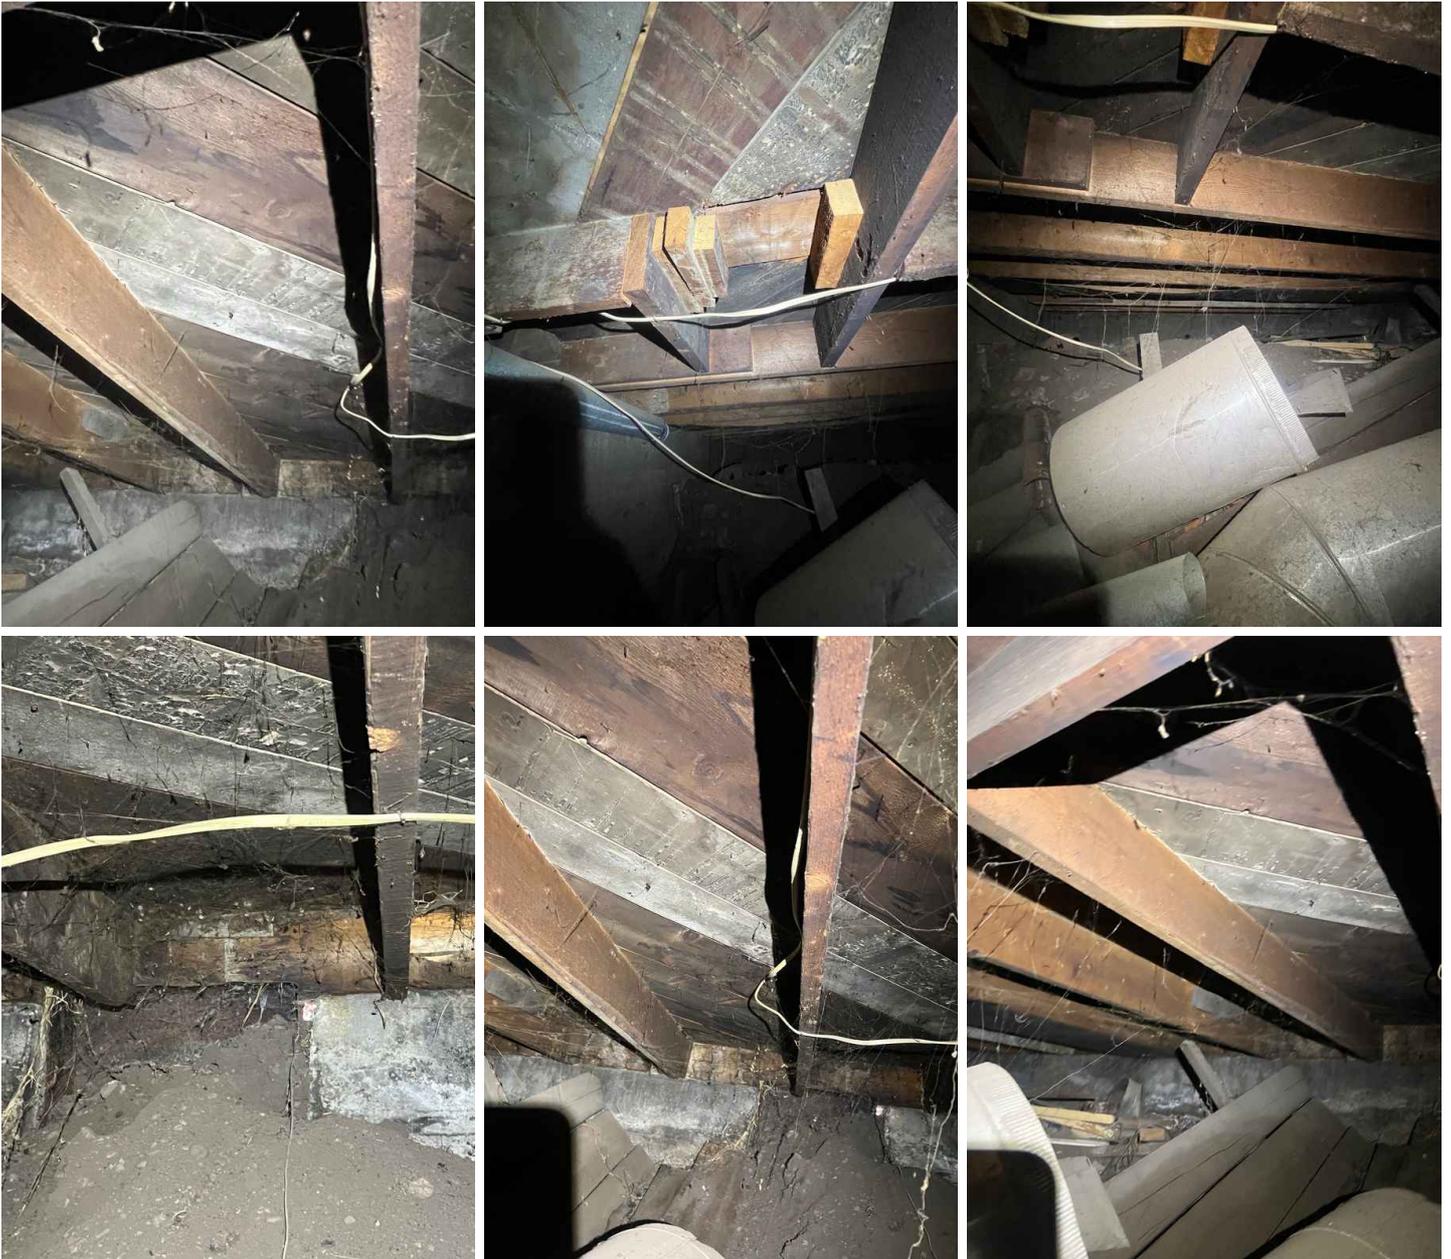
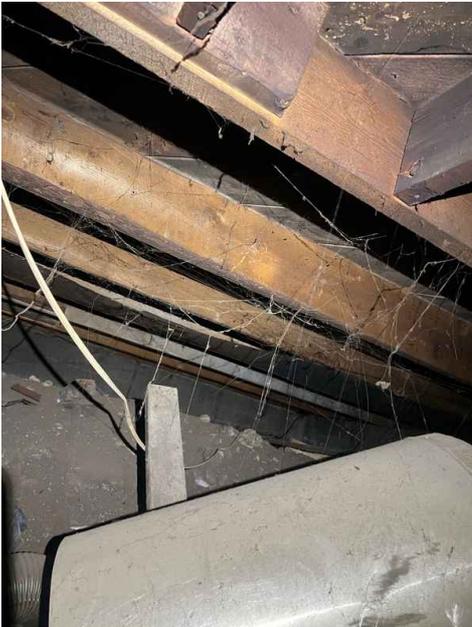
**OLD HOME - MULTIPLE CONDITIONS EXIST**[← Further Review](#)

Undersized framing members, over-spanned joists, improper splices, lack of proper bearing (missing hardware), cut/modified framing, temporary repairs, and other hidden conditions are likely present. All of these conditions could lead to future settling and structural movement. No attempt was made to list or photograph all conditions. Photographs are examples only.

We suggest a full review of the framing and foundation support to better understand current conditions, need for repairs, and cost associated.

Contact a qualified professional engineer

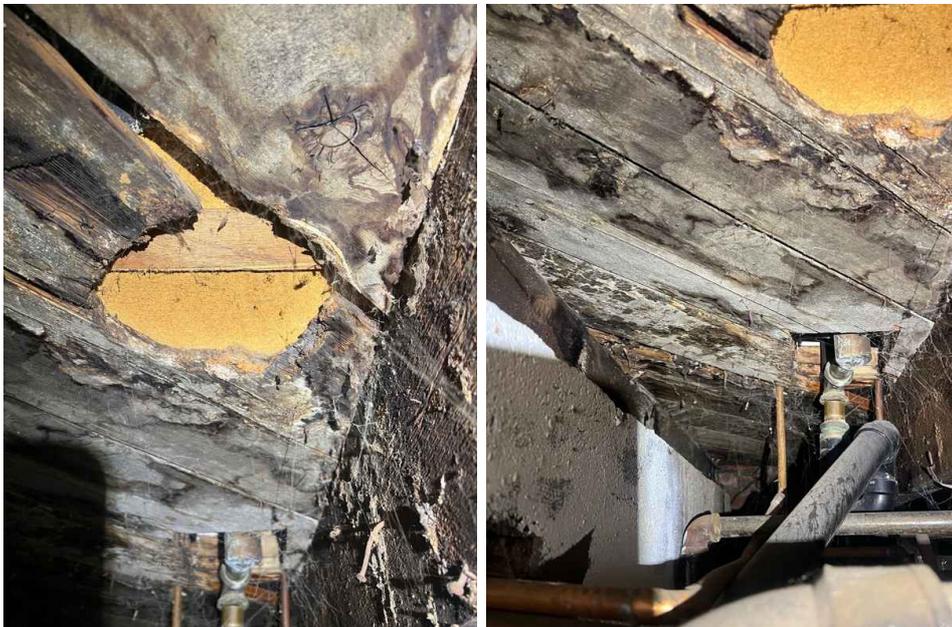
## 25.10.2 Moisture and leaks

**EVIDENCE OF MOISTURE FLOOR FRAMING-DRY**

Contact a qualified professional.

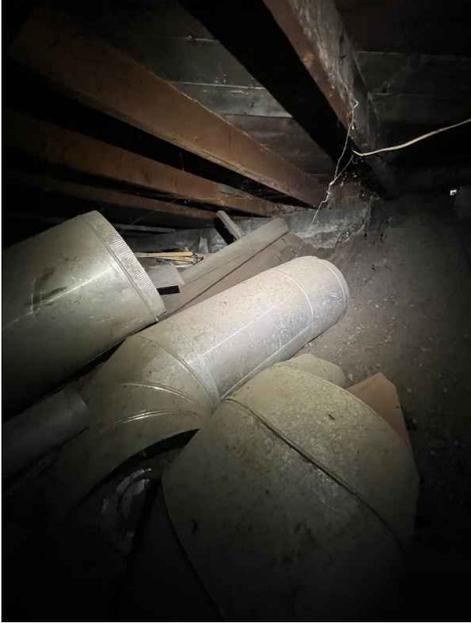
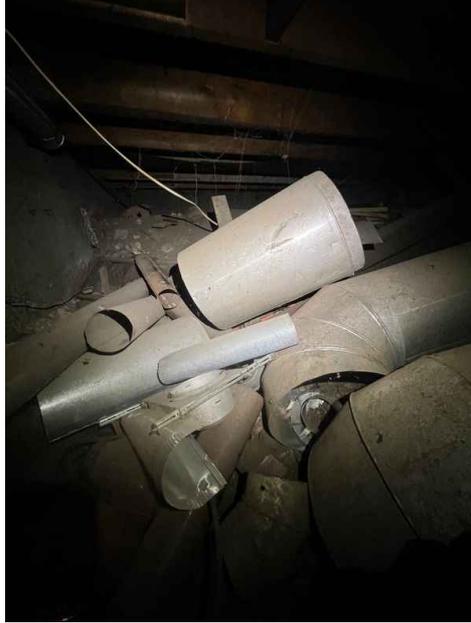
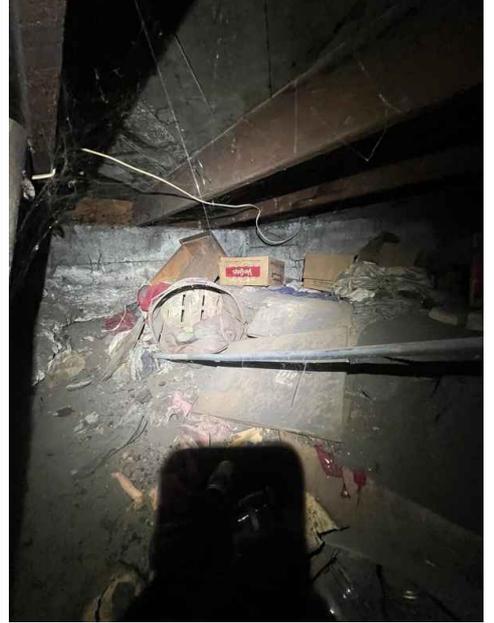
## 25.13.1 Crawlspace conditions

**DEBRIS**

Contact a qualified professional.
