July 30, 2024

Re: Estates of Lake Creek-Storm Sewer CCTV Videos  
Infrastructure Acceptance  
City of Montgomery

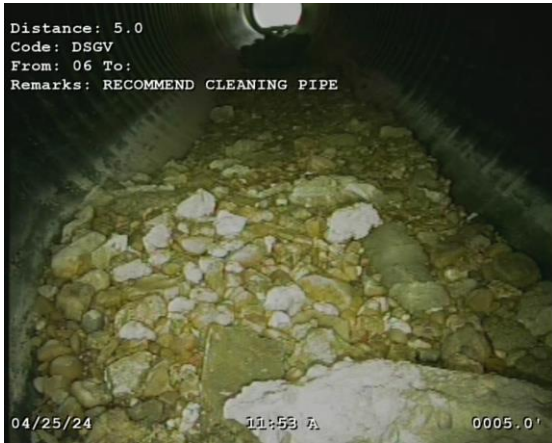
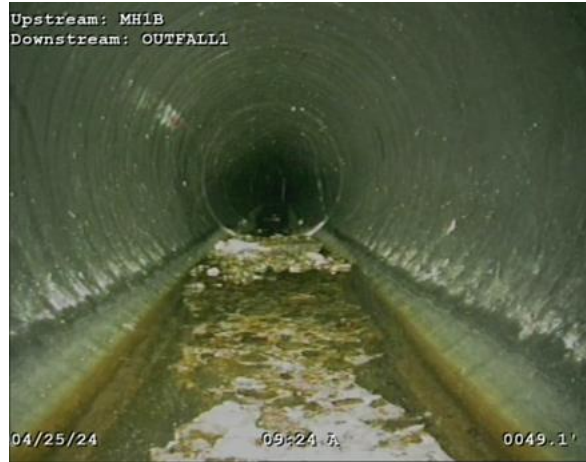
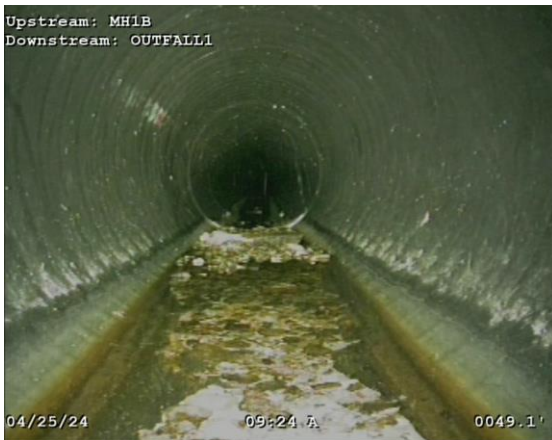
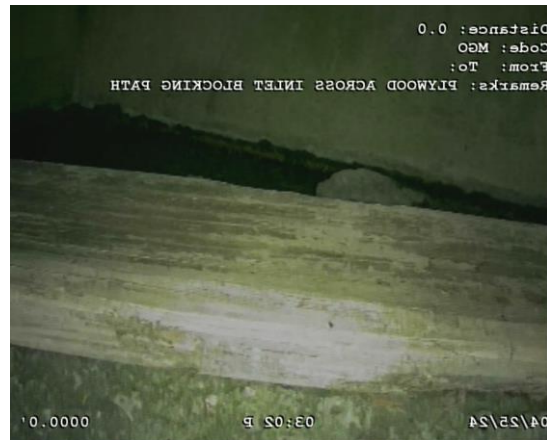
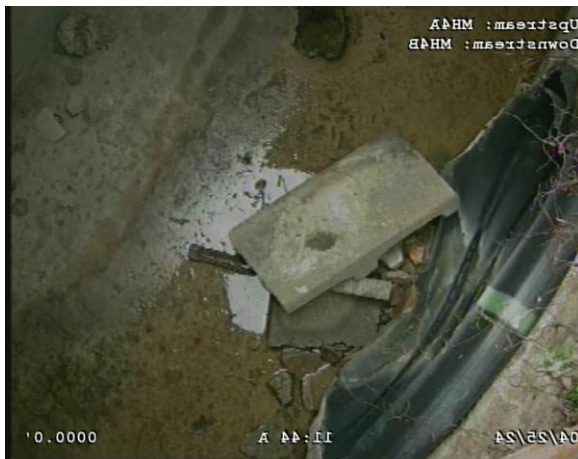
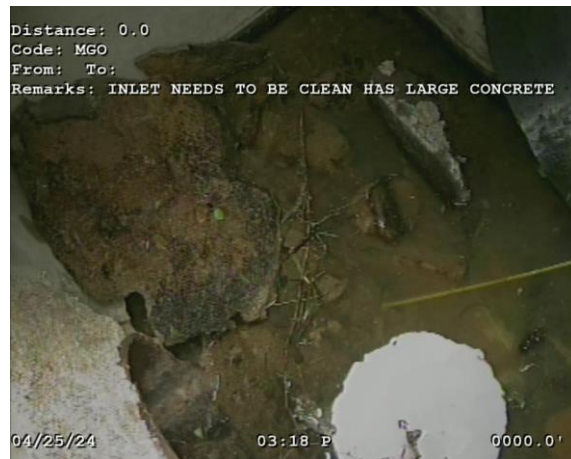
Other Identified Issues:

Based on our review of the CCTV videos provided by Estates of Lake Creek HOA of the interior of the storm sewer system, we have determined the condition of the system is not acceptable under City requirements. Figures 1-3 following this letter, are examples of problem areas identified during the inspection.

- Replace all HDPE storm piping with Reinforced Concrete Pipe.
- Heavy clean all piping with deposits of debris causing a restriction of flow.
- Removal of all large obstructions located within pipes or manholes.
- Replacement of all piping with holes or moderate to significant cracking.
