Inspection report for the property at
401 Virginia Street New Meadows, Idaho 83654

This report is prepared exclusively for **Julie Good (Mayor)**
Inspected On: **11-14-2025**

McCall Home Inspections
208-866-1578

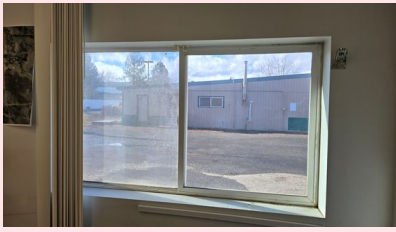
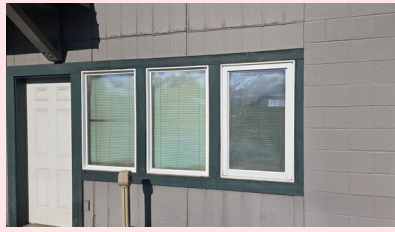
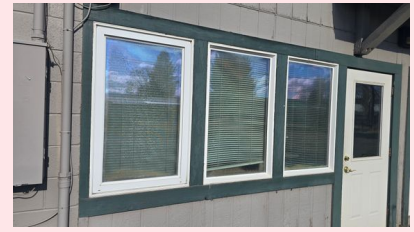
South and west windows have failed vacuum seals. Cracked glass also noted at one of the rear windows. This presents as visual irregularities between the double pane glass which cannot be cleaned without glazing replacement. I list as a major concern due to the cost of replacing multiple windows. Hire a glass replacement company to further evaluate and replace windows with lost seals.

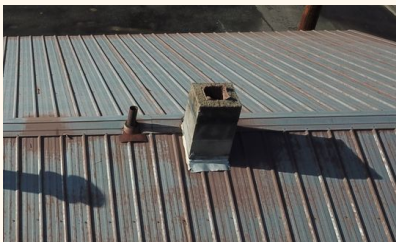
simple metal cap

The unused concrete chimney should be capped to prevent water and ice from entering and damaging the masonry. Hire a mason to further evaluate and install a masonry or metal chimney cap.

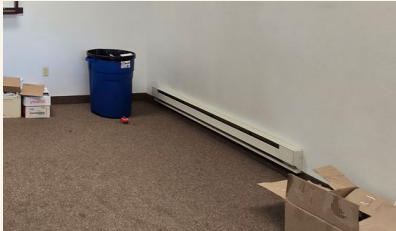
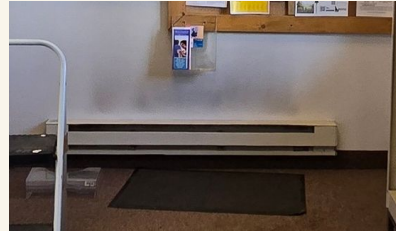
This building has electric baseboard heaters. These can get very hot during operation. Be sure to keep all drapes, curtains, furniture, electric cords and other flammable items away from these heaters when they are on. Baseboard heaters will need annual cleaning. Best practices are to turn power off to the heater and use compressed air to clean the dust from the heating elements. Also be careful with small children to avoid a burn hazard.

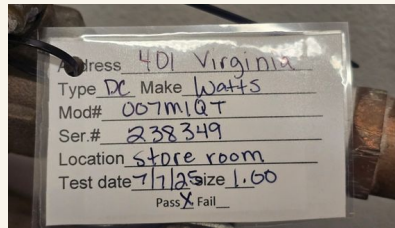
This building has a backflow prevention device installed. Annual inspection and testing of the backflow devices is required as these perform a critical safety task: keeping the drinking water safe from contamination. A current inspection certificate was noted on this device, I recommend keeping this device on a regular inspection schedule.

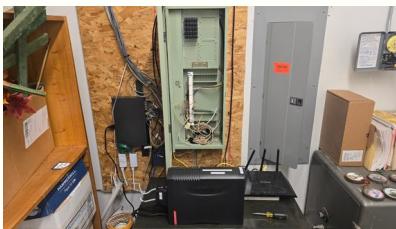
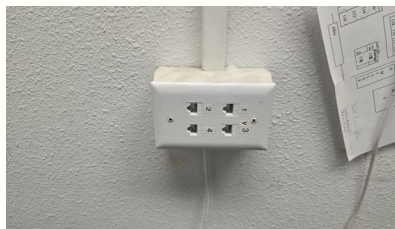
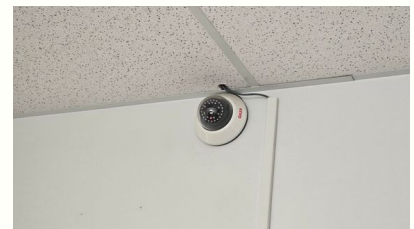
This building does have some low voltage wiring installed. Evaluation of alarm systems, TV, speaker, phone, camera and internet wiring is beyond the scope of this inspection.

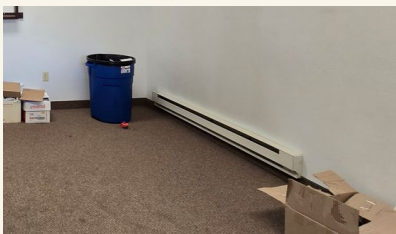
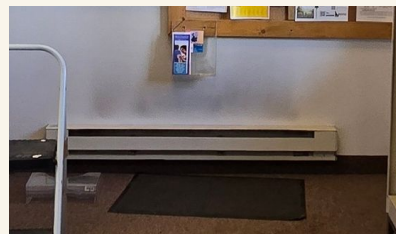
Q (HCFV-2) Maintenance Reminder: This building has electric baseboard heaters. These can get very hot during operation. Be sure to keep all drapes, curtains, furniture, electric cords and other flammable items away from these heaters when they are on. Baseboard heaters will need annual cleaning. Best practices are to turn power off to the heater and use compressed air to clean the dust from the heating elements. Also be careful with small children to avoid a burn hazard.

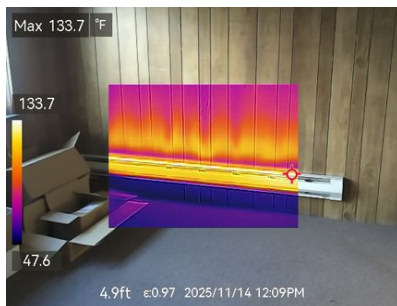
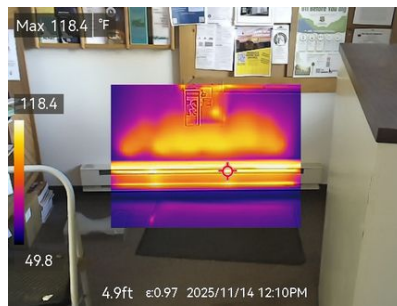
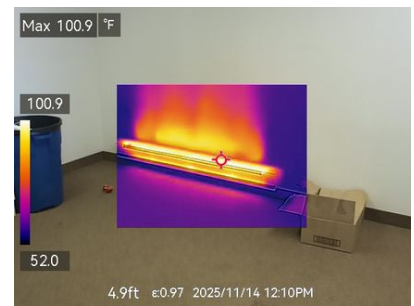
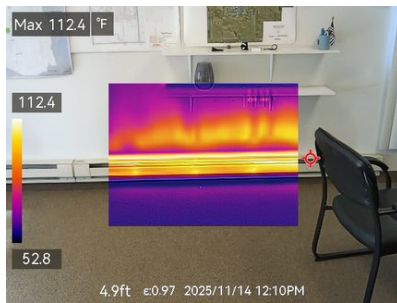
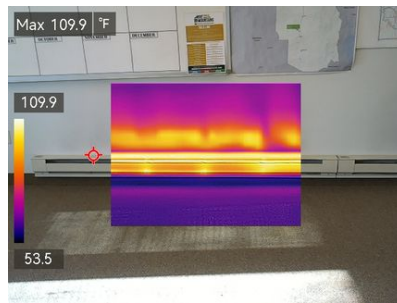
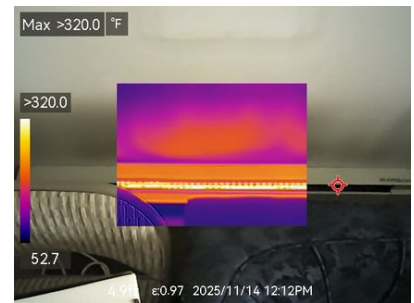
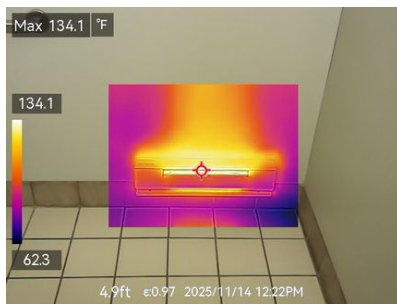
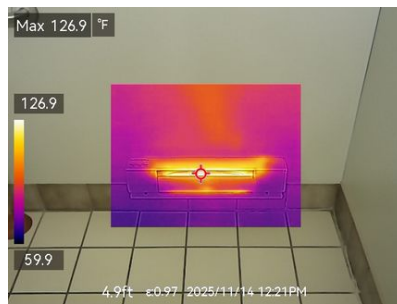
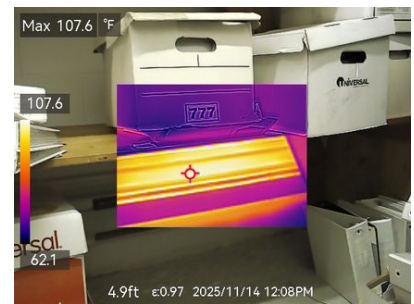
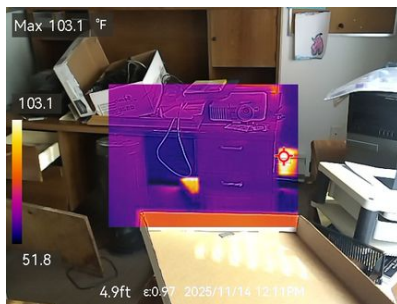
Distribution Method: Electric baseboard heaters (Thermal images)

Thermal images show approximate temperatures at the baseboard heaters. I use these images just to show the heaters were generally functioning during inspection. These are representative photos.

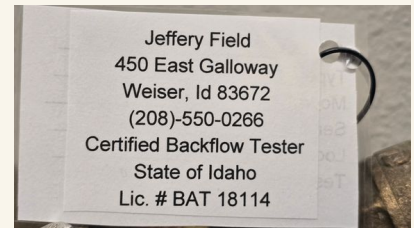
Comments / Observations: Backflow device observed, Annual testing required

Q (AP-1) Maintenance Reminder: This building has a backflow prevention device installed. Annual inspection and testing of the backflow devices is required as these perform a critical safety task: keeping the drinking water safe from contamination. A current inspection certificate was noted on this device, I recommend keeping this device on a regular inspection schedule.

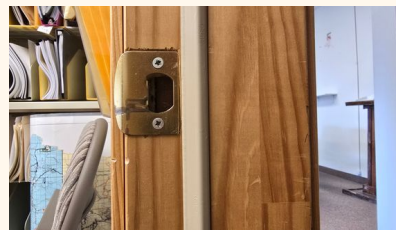
Condition: Overall Appearance/Function Good, Not Latching

✂ (I-2) Recommended Repair: The east office door was not latching correctly and requires the strike height to be adjusted so the door latches closed.

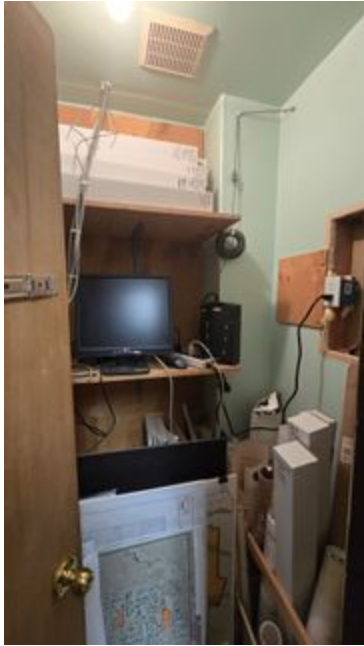
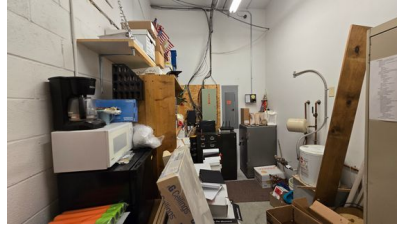
Limited Visibility: Packed with storage

Closet and other storage areas had extensive storage which limited the inspection of these spaces. The front office closet appeared to have been a bathroom at some point.
