**Old Home Rescue**

# **Sullivan: 733 Chautauqua Ave**

# Project Overview

The on-site assessment of the building was completed on January 28, 2025

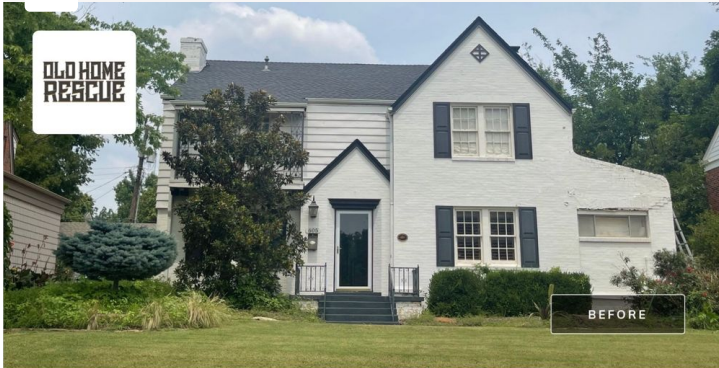
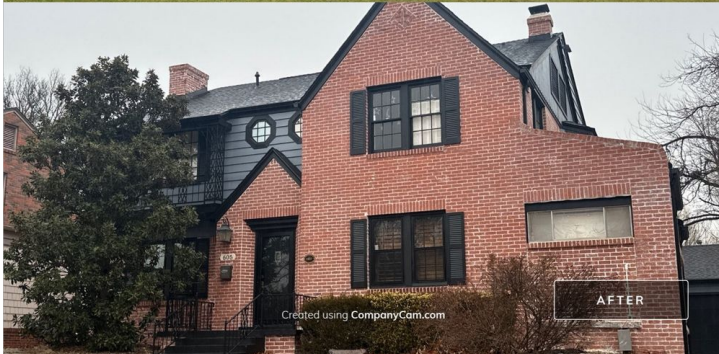
### Previous Paint Removal Project

- OKC-HP approved paint removal project
- Date: 2024
- Location: Crown Heights
- Peel Away 7, power washing with low pressure and a 15 degree tip, and the Restorer tool were utilized for the removal of paint

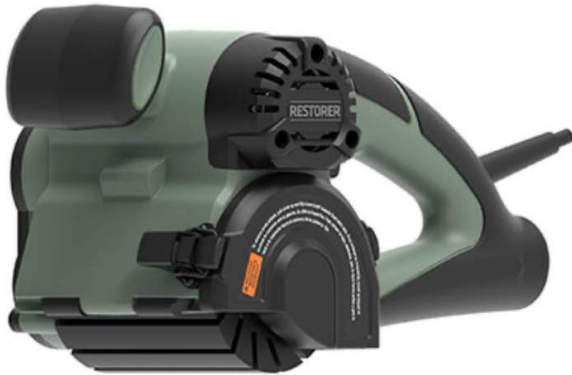
### Restorer Tool

- Successful paint removal without damaging brick utilizing the Restorer tools with stainless wire brush attachment.

- In the particular project and prior experience, I believe that utilizing the Restorer tool, stainless wire brush attachment, and additional attachments provide the gentlest means to remove the paint from the brick.
- Utilizing this method will remove roughly 90-95% of the paint from the brick. It should be noted that small amounts of primer and paint will remain.

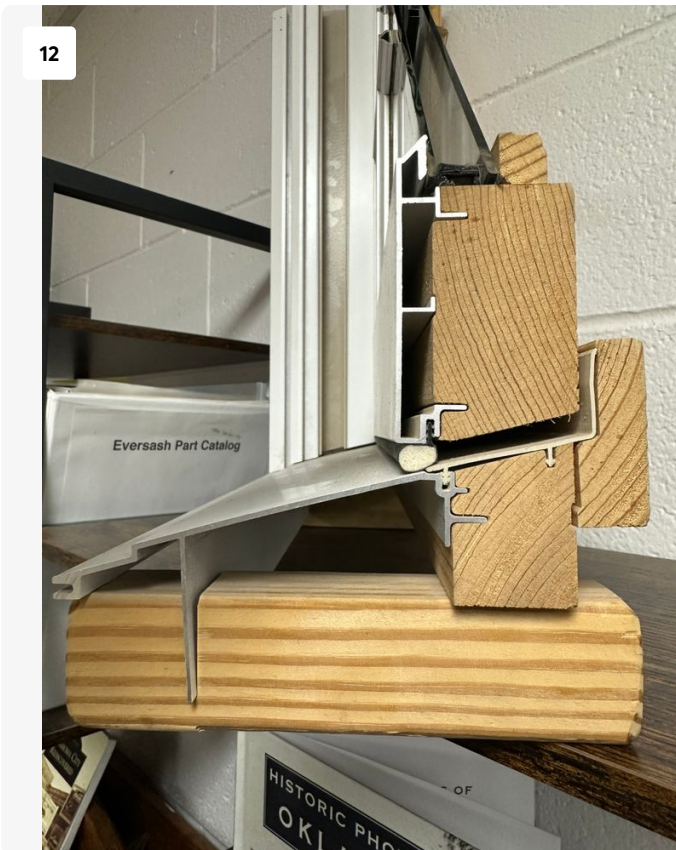
### Sun Clad Window Cross Section

- Note: This is a double hung cross section
- Show for reference of quality in construction

- Removal of existing windows
- Installation of Sun Windows Sun Clad Casement Window
- Type: Aluminum clad, Wood interior
- Aluminum Type: Extruded aluminum with integrated water management system to reduce failure
- Glass: Simulated simulated divided lite with shadow bar
- Exterior Glazing: 1" Putty glazing profile to closely resemble original muntin thickness
- Glass Type: LowE
- Lites: Match original window lite configuration
- All windows are operational
