Lower Imhoff Creek Bank Stabilization Project: Erosion Analysis

Norman, OK

July 25, 2022

Project #: 15NOR01 (Meshek)
Project #: 8275000431 (Wood)

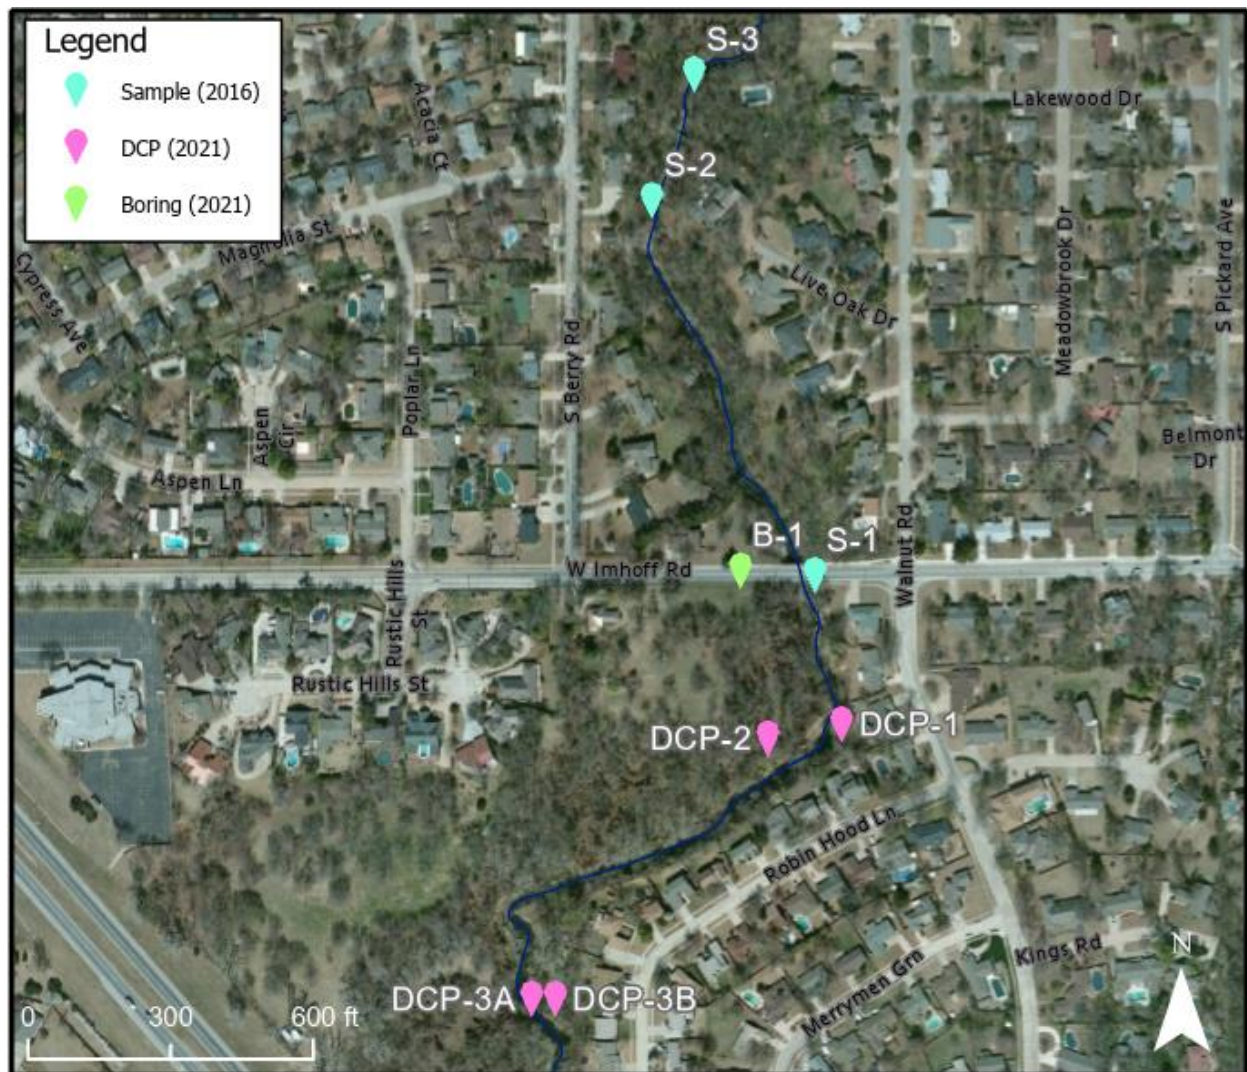
Figure 2-1: Locations of soil samples

The 2016 geotechnical investigation consisted of sieve analysis and pocket penetrometer testing on eight soil samples taken at three locations at various heights along the creek bank (S-1, S-2, and S-3). The 2021 investigation included sieve analysis of one boring (B-1) and four Dynamic Cone Penetrometer (DCP) tests (DCP-1, DCP-2, DCP-3A and DCP-3B). Figure 2-1 shows the locations of the soil samples and penetrometer tests.

Table 2-1 summarizes the sieve analysis results for the 2016 and 2021 soil samples. The 2016 samples taken along the creek bank (S-1, S-2 and S-3) consist predominantly of clay with varying amounts of silt and sand. The boring at B-1 was taken from the west overbank and all three samples were classified as silty sands.

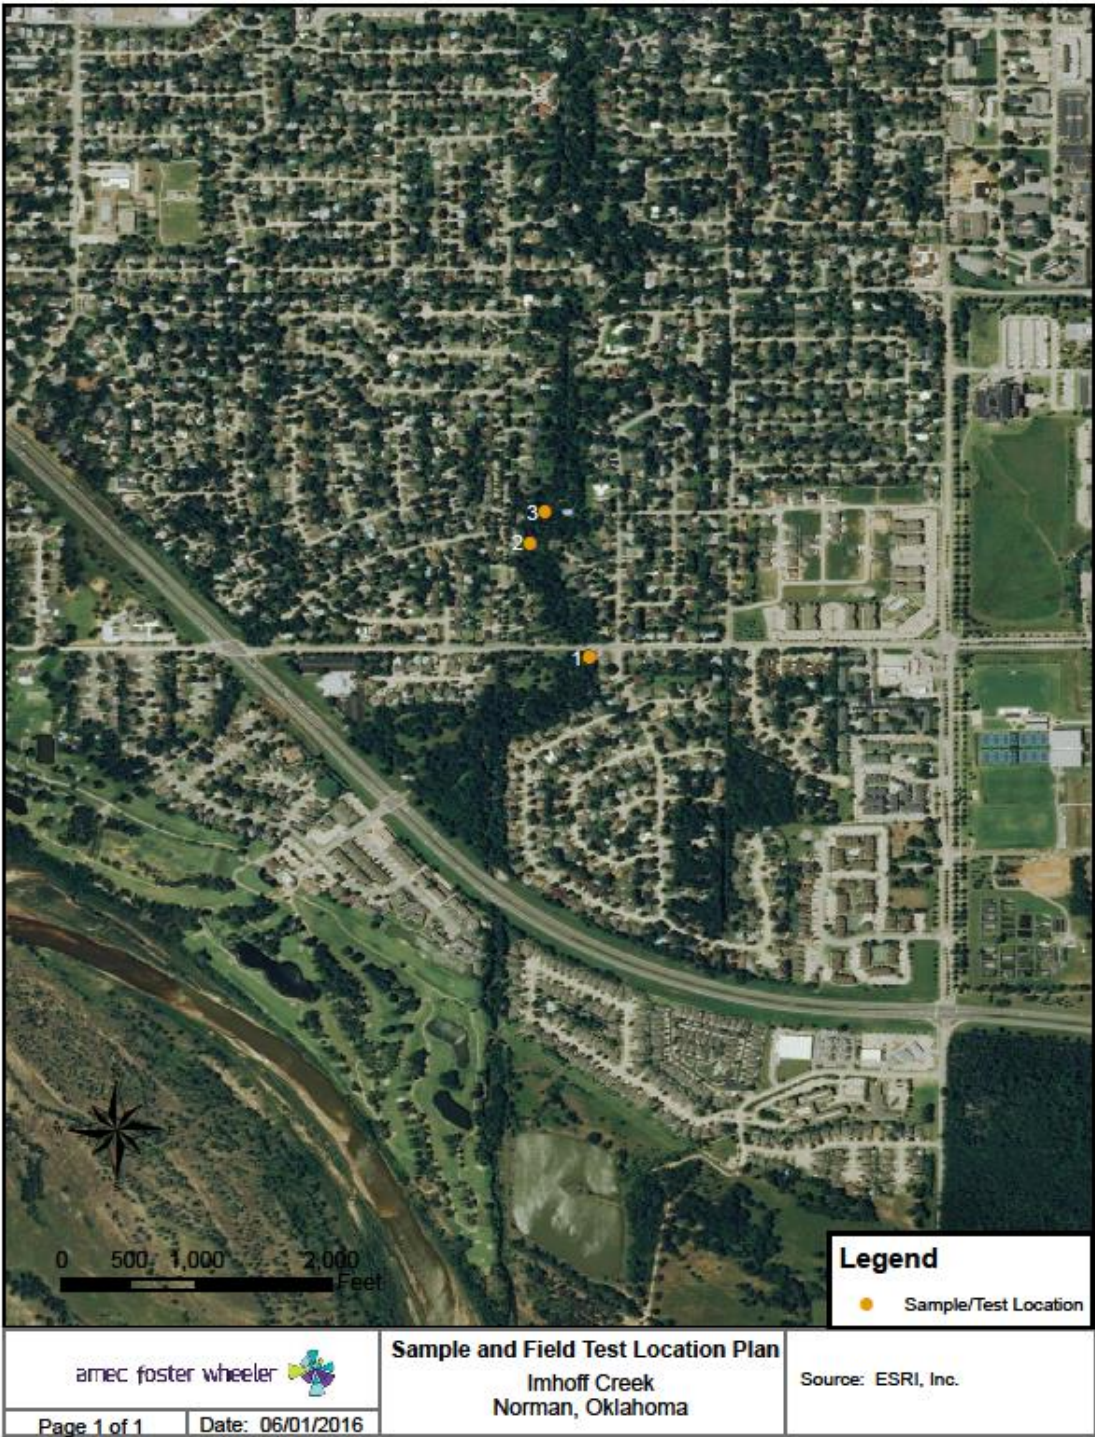
SUMMARY OF LABORATORY TEST RESULTS														
									PROJECT: Imhoff Creek					
									PROJECT NO.: 8275000239					
									DATE: 01-June-2016					
BORING NUMBER	SAMPLE NUMBER	SAMPLE TYPE	DEPTH*	NATURAL MOISTURE	PERCENT GRAVEL	PERCENT SAND	PERCENT SILT /CLAY	SPECIFIC GRAVITY	ATTERBERG LIMITS			UNIFIED SOIL CLASSIFICATION	OTHER TESTS **	SOIL DESCRIPTION
									LIQUID LIMIT	PLASTIC LIMIT	Plasticity Index			
	1A	Grab	9'	11.9	14	39	47		20	12	8	SC		Clayey Sand, brown
	1B	Grab	19'	19.0	0	14	86		34	14	20	CL		Lean Clay, brown
	1C	Grab	21'	19.7	0	46	54		25	12	13	CL		Lean Clay, sandy, reddish brown
	2A	Grab	15'	15.2	0	32	68		22	16	6	CL-ML		Silty Clay, sandy, dark brown
	2B	Grab	21'	10.6	0	56	44		NV	NP	NP	SM		Silty Sand, reddish brown
	2C	Grab	25'	17.3	0	42	58		29	12	17	CL		Lean Clay, sandy, brown
	3A	Grab	10'	7.6	0	18	82		23	17	6	CL-ML		Silty Clay, with sand, brown
	3B	Grab	18'	17.4	0	32	68		27	15	12	CL		Lean Clay, sandy, reddish brown
