# Department of Public Works Water and Sewer Division

## Pre-Stressed Concrete Pipe Assessment and Inspection Program 2019

# Condition Assessment Report

The City of Novi (Novi) contracted Pure Technologies, a Xylem brand (Pure Technologies), to conduct a condition assessment of the 36-, 30-, and 24-inch Novi Road PCCP Water Transmission Main located in Novi, Michigan. The Novi Road PCCP Water Transmission Main consists of prestressed concrete cylinder pipe (PCCP), specifically lined cylinder pipe (LCP).

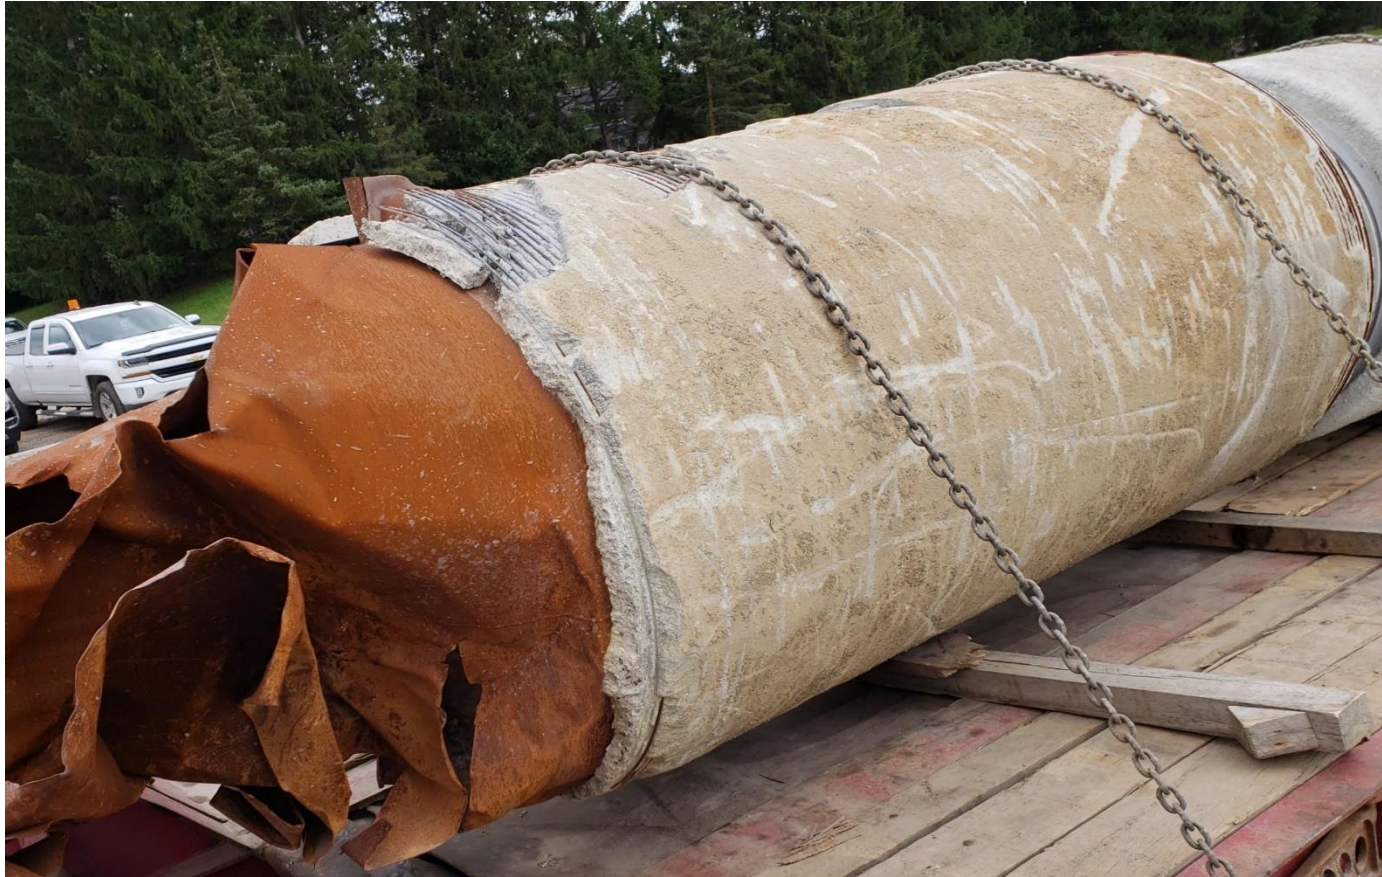
# Pre-Stressed Concrete Cylinder Pipe from GLWA Break 14 Mile Main Break

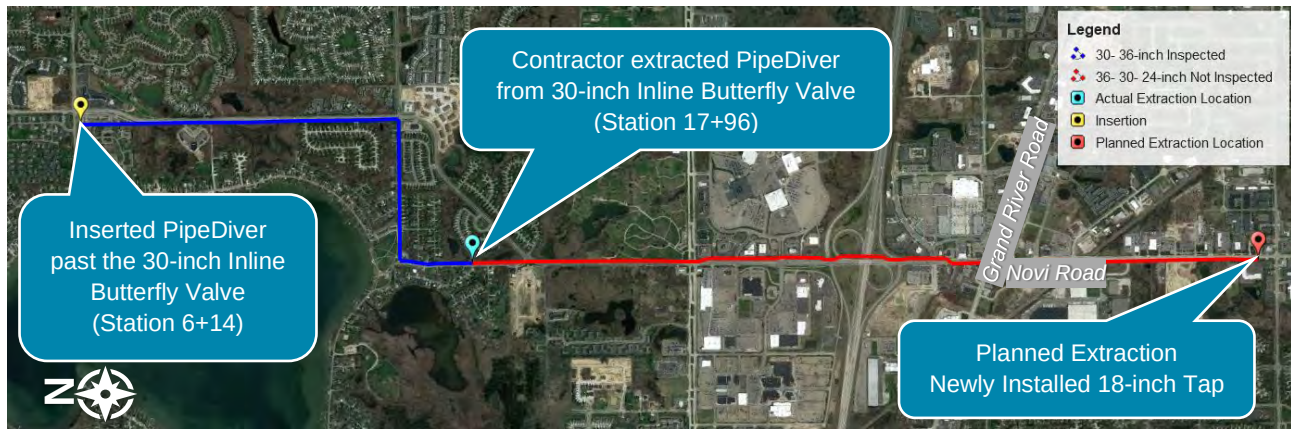
The 2020 inspection took place during a mid-winter break of the elementary school, so that isolation of the insertion locations did not affect normal school operations. During the inspection, the PipeDiver tool was stopped on all but one (1) of the butterfly valves it encountered. Each valve was exercised the help the tool maneuver around the valve. When the tool reached the valve near the intersection of Austin Drive and Old Novi Road, the valve exercising was unsuccessful. It appeared the gears on the valve actuator were worn and turning the key did not move the valve. Flows were adjusted to try and free the tool, but it remained stopped at the valve. The PipeDiver tool was removed from the pipe on Friday April 17, 2020. In total, the 30-inch and 36-inch LCP-PCCP PipeDiver inspection spanned 9,593 feet (1.8 miles) from the 30-inch butterfly valve (Station 6+14) located just downstream of the meter vault, NV-04, to the 30-inch butterfly valve (Station 17+96) near the intersection of Austin Drive and Old Novi Road. An overview of the 2020 PipeDiver inspection is shown in Figure 3.1.

Figure 3.1: Planned PipeDiver electromagnetic inspection scope. Note the red line indicates the part of the planned scope that was not inspected.

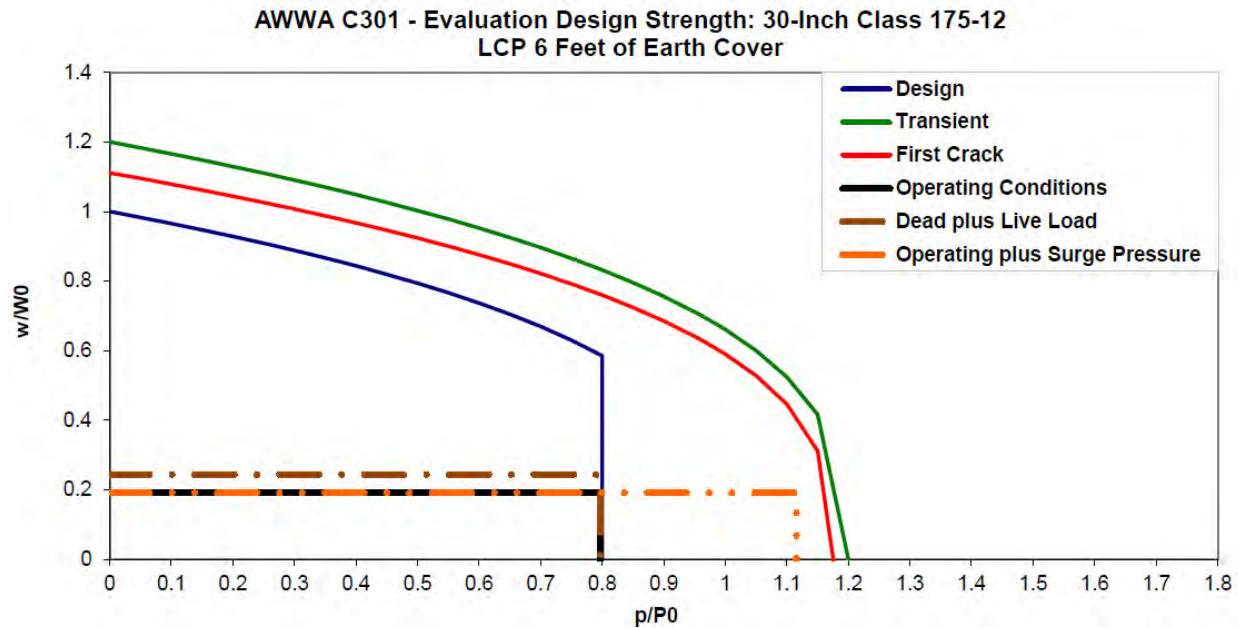
Figure 5.3: AWWA C301-Curve for the 30-inch Class 175-12 LCP pipe with 6 feet of Earth Cover.

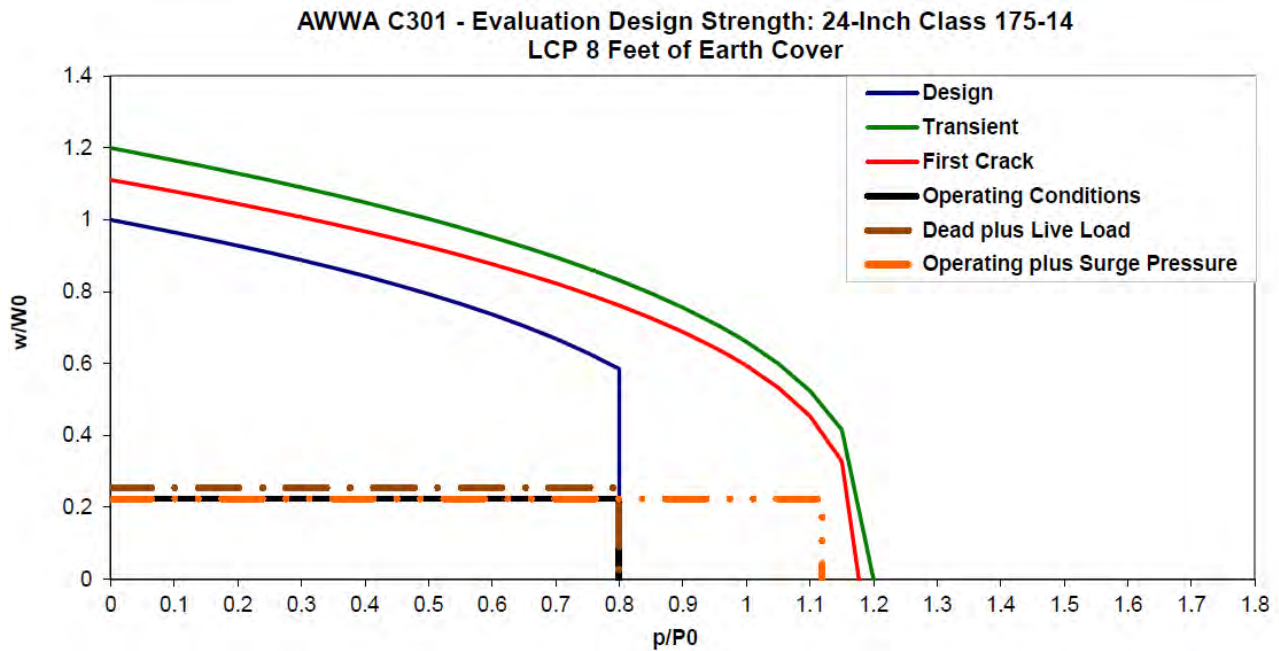
Figure 5.4: AWWA C301-Curve for the 24-inch Class 175-14 LCP pipe with 8 feet of Earth Cover.

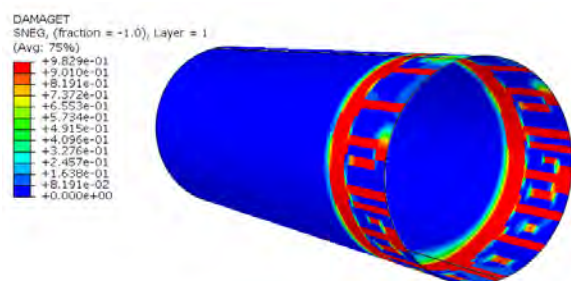
Figure 5.7 (a): Damage in the Concrete Core

Cracking in PCCP is due to excessive tension in the concrete core and the mortar coating. Figure 5.7 shows the damage due to tension in the concrete core and mortar coating of a pipe with 35 broken wire wraps. In this figure, the color gradients indicate the probability of visible cracking for each element in the FEA model. Dark blue areas indicate sections of the model where there is a very low probability of visible cracking. By contrast, bright red areas indicate sections of the model where there is over a 90 percent probability of visible cracking.

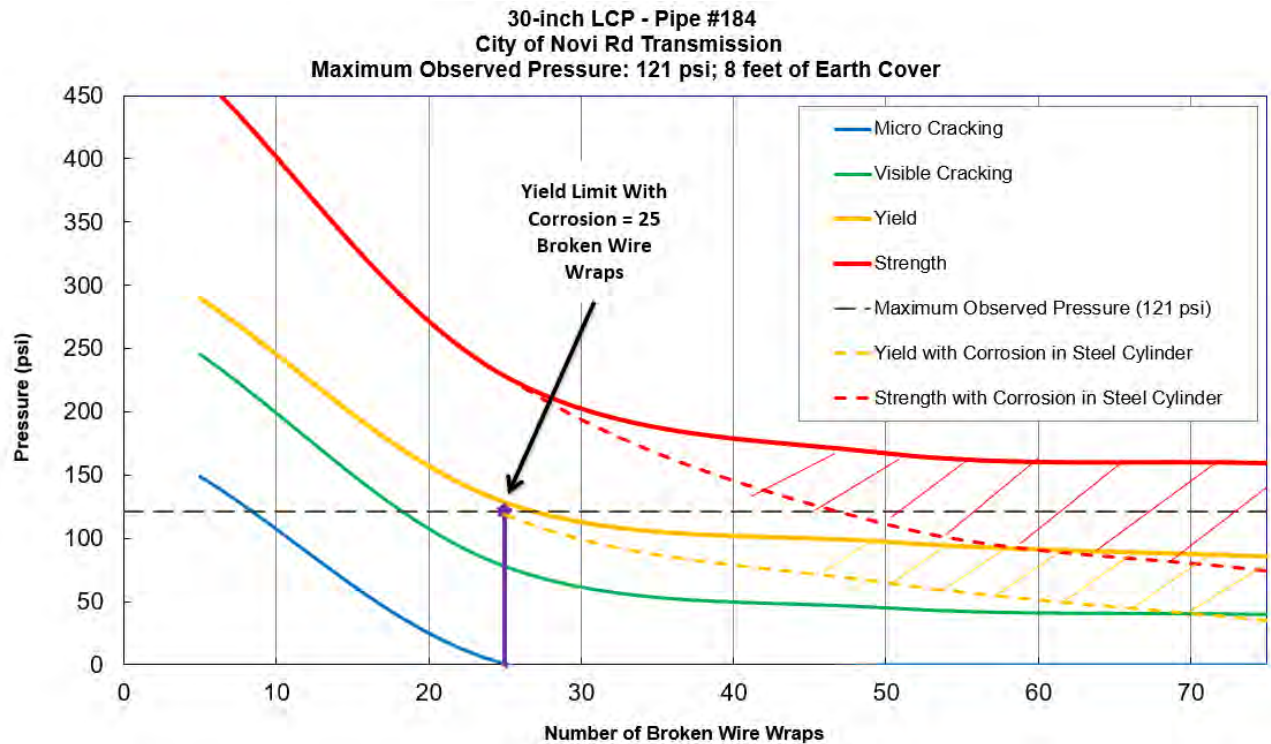
Figure 5.9: Performance curve for the 30-inch Class #184 LCP pipe at maximum observed pressure.

As per the designs an FEA curve was created for each of the 36-inch Class A, 30-inch Class #184, and 24-inch Class 175-14 pipes at 8 feet of earth cover. An FEA curve was created for the 30-inch Class 175-12 pipes at 6 feet of earth cover. Based on the analyses, plots were generated that show the Limits in terms of the number of broken wire wraps and the applied internal pressure. Figures 5.8-5.11 show the performance curves generated for the design at the maximum observed pressure. Yield and Strength limits are when the prestressing wires or steel cylinder reach their yield strength or ultimate tensile strength, respectively. A more detailed description of the FEA methodology and limitations is provided in Appendix G.

Pure Technologies typically recommends repair or replacement once a pipe has reached the yield limit of the performance curve. One (1) pipe evaluated exceeded the yield limit at the maximum observed pressure and zero (0) pipes exceeded the strength limit at the maximum observed pressure.

Pure Technologies typically recommends mitigating the risk associated with operating a particular pipe when the model predicts that the pipe meets or exceeds the Yield Limit. In reality, the Limit that a pipe exceeds is only one factor to consider when deciding whether to rehabilitate a pipe. Other variables that are critical for the City of Novi (e.g., redundancy, consequence of failure, and criticality) should be evaluated when determining the risk tolerance associated with a distressed pipe. When the wire breaks in lined cylinder pipes approach 25 - 30 wire breaks, Pure Technologies assumes the steel cylinder is corroding (dashed line extensions of the yield and strength curves), this is due to the makeup of lined cylinder pipes, as the prestressing wires line the steel cylinder. The assumed spread of corrosion effectively reduces the pressure and wire break counts for a particular pipe to exceed the yield and strength curves. Once the number of broken wire wraps on a pipe reaches the Yield Limit, a pipe may experience a higher rate of wire breaks until it reaches the Strength Limit. Due to the conservative nature of the FEA, reaching the Strength Limit does not necessarily indicate an immediate failure.

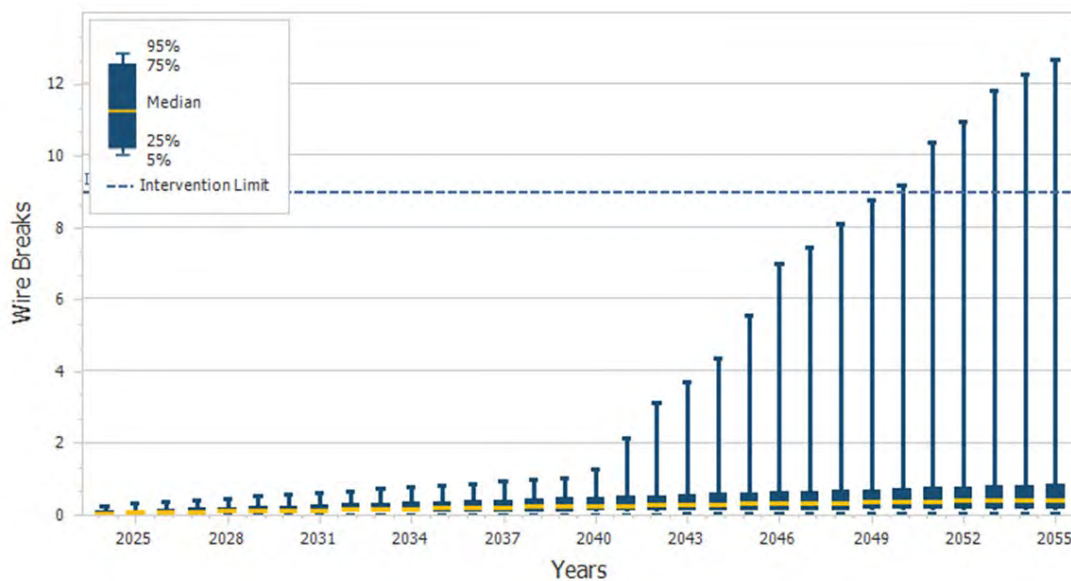
Figure 7.5: Predicted BWVs for a Pipe with Zero (0) BWVs Using 2020 Condition Assessment Data, until 2055.

Figure 7.5 and Figure 7.6 below present the distribution of the projected number of broken wire wraps from 2025 to 2055 for a sample pipe with zero (0) BWWs, based on the 2020 and 2024 condition assessment data, respectively. for the Novi Road PCCP Water Transmission Main with zero (0) broken wire wraps based on the 2020 and 2024 electromagnetic inspections, using 10,000 Monte Carlo iterations of the degradation model for each year. The yellow bar shows the median number of predicted broken wire wraps. The thick blue bar shows the 25 percent and 75 percent confidence intervals of the results, while the thin blue line shows the 5 percent and 95 percent confidence intervals.

Based on the projected number of broken wire wraps, it is projected with 95 percent confidence that by 2055, the number of broken wire wraps of a pipe with zero (0) broken wire wraps in 2020 will be between 0 and 13 broken wire wraps. It should be noted that as the prediction extends further into the future, the uncertainty associated with the predictions increases. In the future, as more inspection data is collected, it is anticipated that the uncertainty associated with this analysis will reduce.

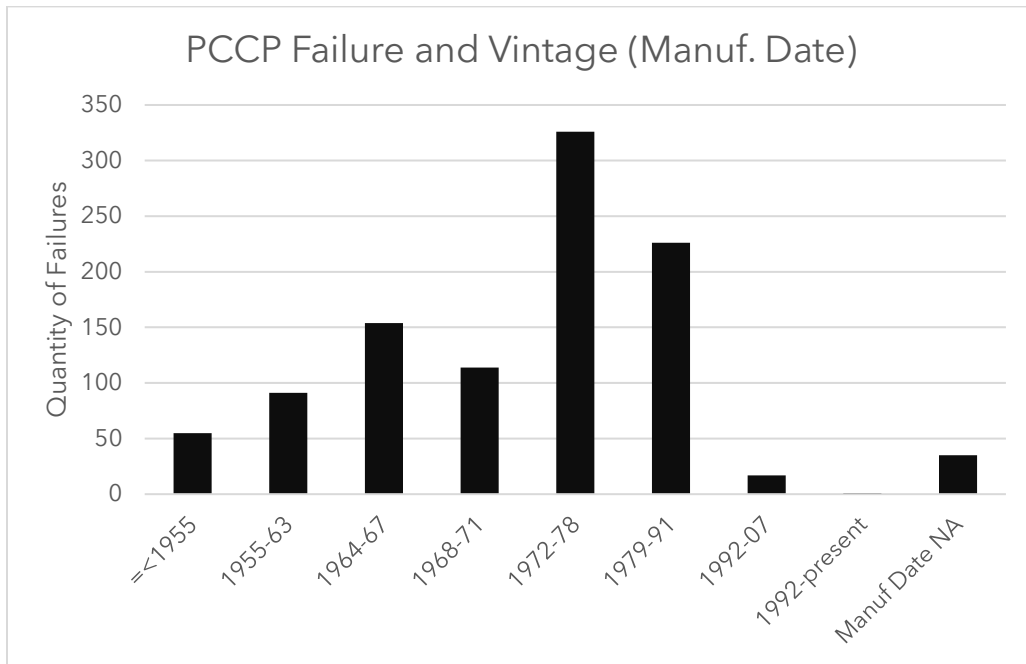
Figure B.3: Pipe Failures Recorded by Manufacturing Date

A comparison study of pipe failures to their manufactured date indicates the consequence of "Class IV" wire showing a failure rate that is orders of magnitude higher than other vintages. The failure rate for pipes manufactured between 1979 and 1991 decreased dramatically as liberal design and manufacturing standards were identified and corrected beginning in the late 1970s and early 1980s. The summary of pipe failures by manufacturing date is shown in Figure B.3 and the rates of PCCP distress are shown in Figure B.4.

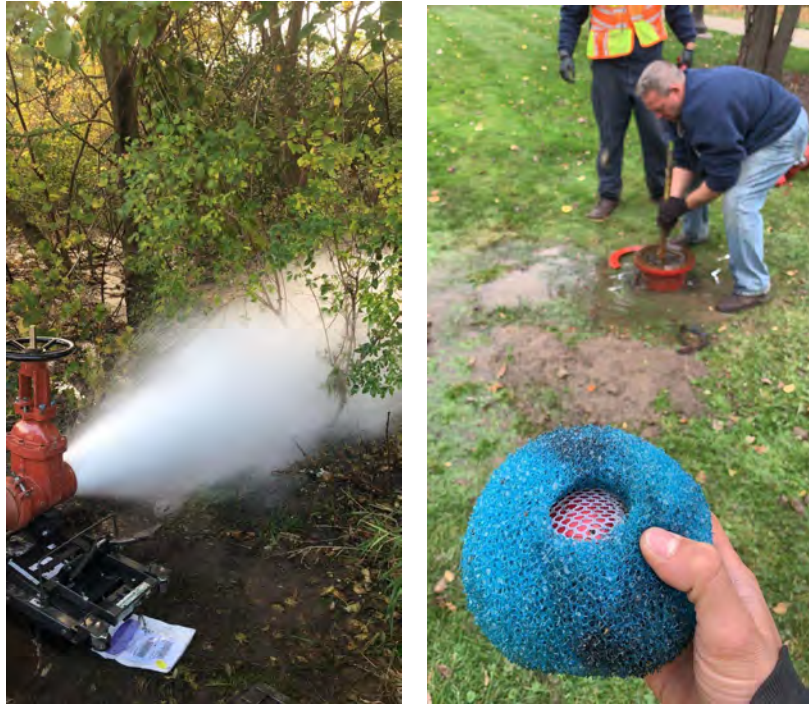
*Figure 2.10: SmartBall Tool Extraction*

The SmartBall tools were extracted from the 16-inch PCCP water main by use of a 6-inch fire hydrant (Station 3+00 and Station 4+92 for the east and west portions, respectively). The SmartBall tool arrived within 13 minutes for the faster-flowing and shorter eastern inspection. Flow rates were slowed down a bit, and the SmartBall arrived at the extraction location within 1 hour and 10 minutes for the longer western inspection. Figures below show the SmartBall tool being removed from the pipeline.

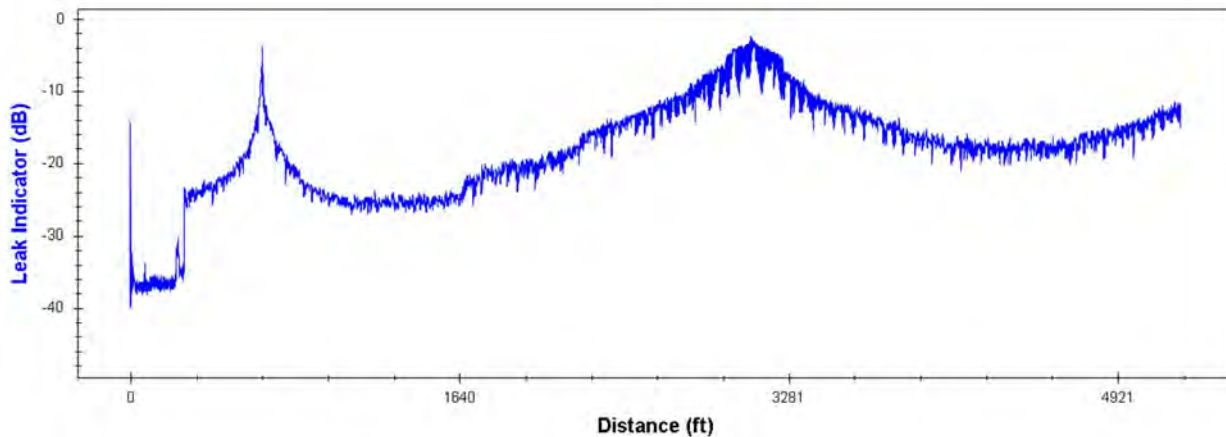
*Figure 3.3: Acoustic summary of the West Inspection versus Distance Traveled*

Figure 3.3 shows the acoustic profile of the inspection with respect to the position of the tool within the pipeline, as detected by the SmartBall technology. The magnitude of leaks is estimated by correlating the value of the acoustic signal with historical calibration data.

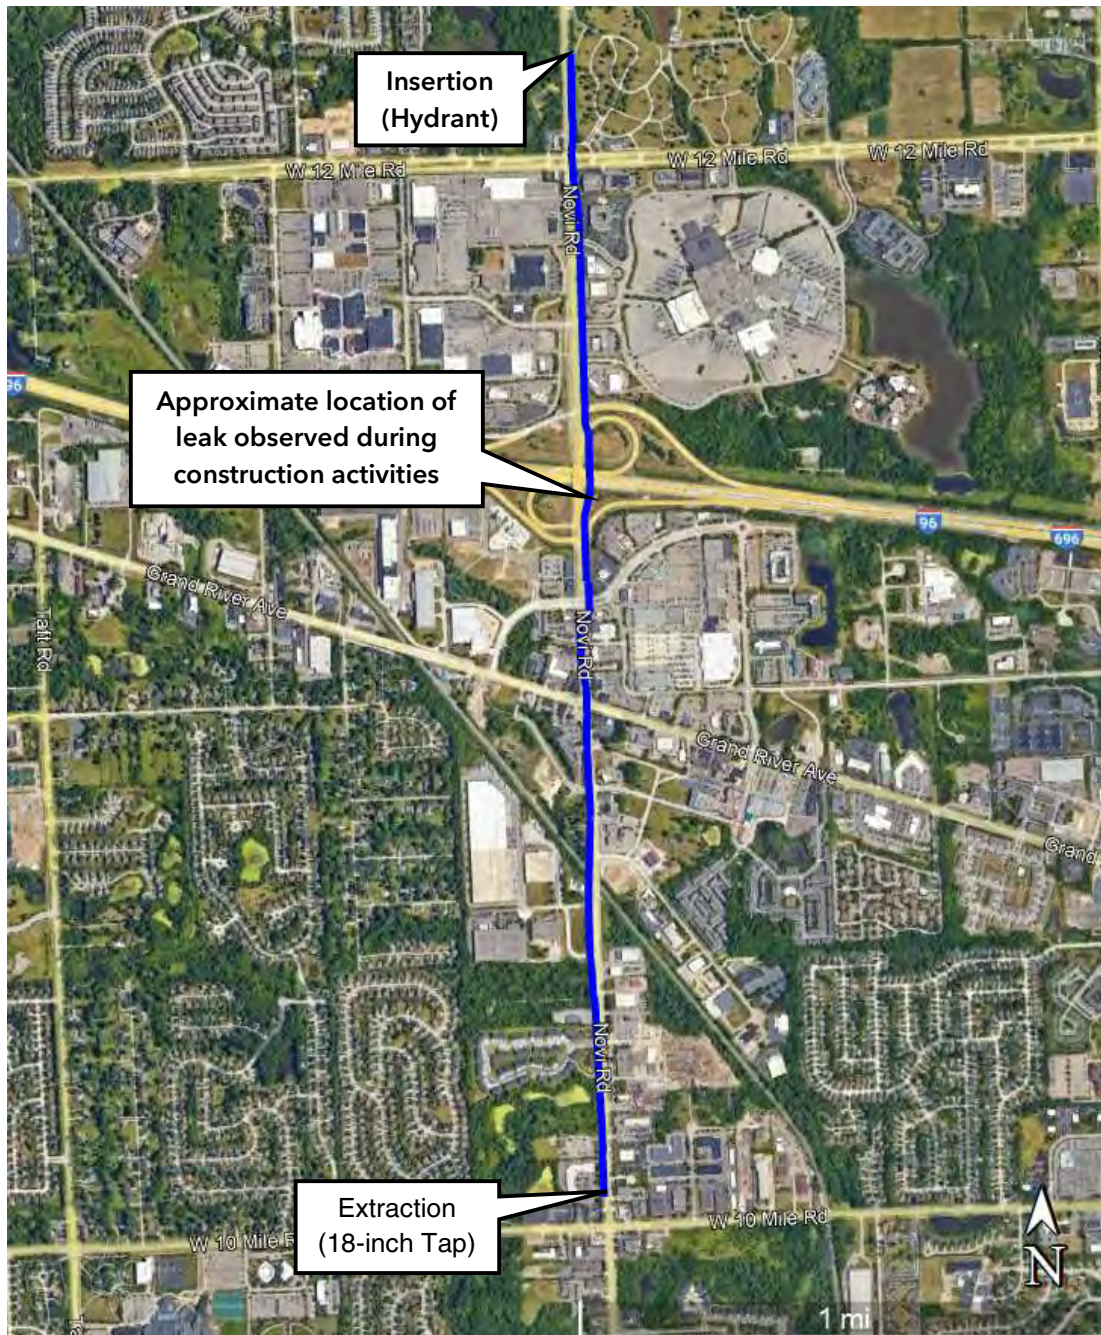
Figure 1.1: Aerial View of the 36-, 30-, and 24-inch Novi Road PCCP Water Transmission Main

The SmartBall inspection was performed to identify and locate a leak that was observed at a welded joint of an encasement pipe under Interstate 96 during construction activities. Note that this leak was observed for a few days and then the leak appeared to stop as it was no longer observed at the joint. The approximate pipeline location is shown in Figure 1.1. Flow proceeds from Insertion to Extraction.

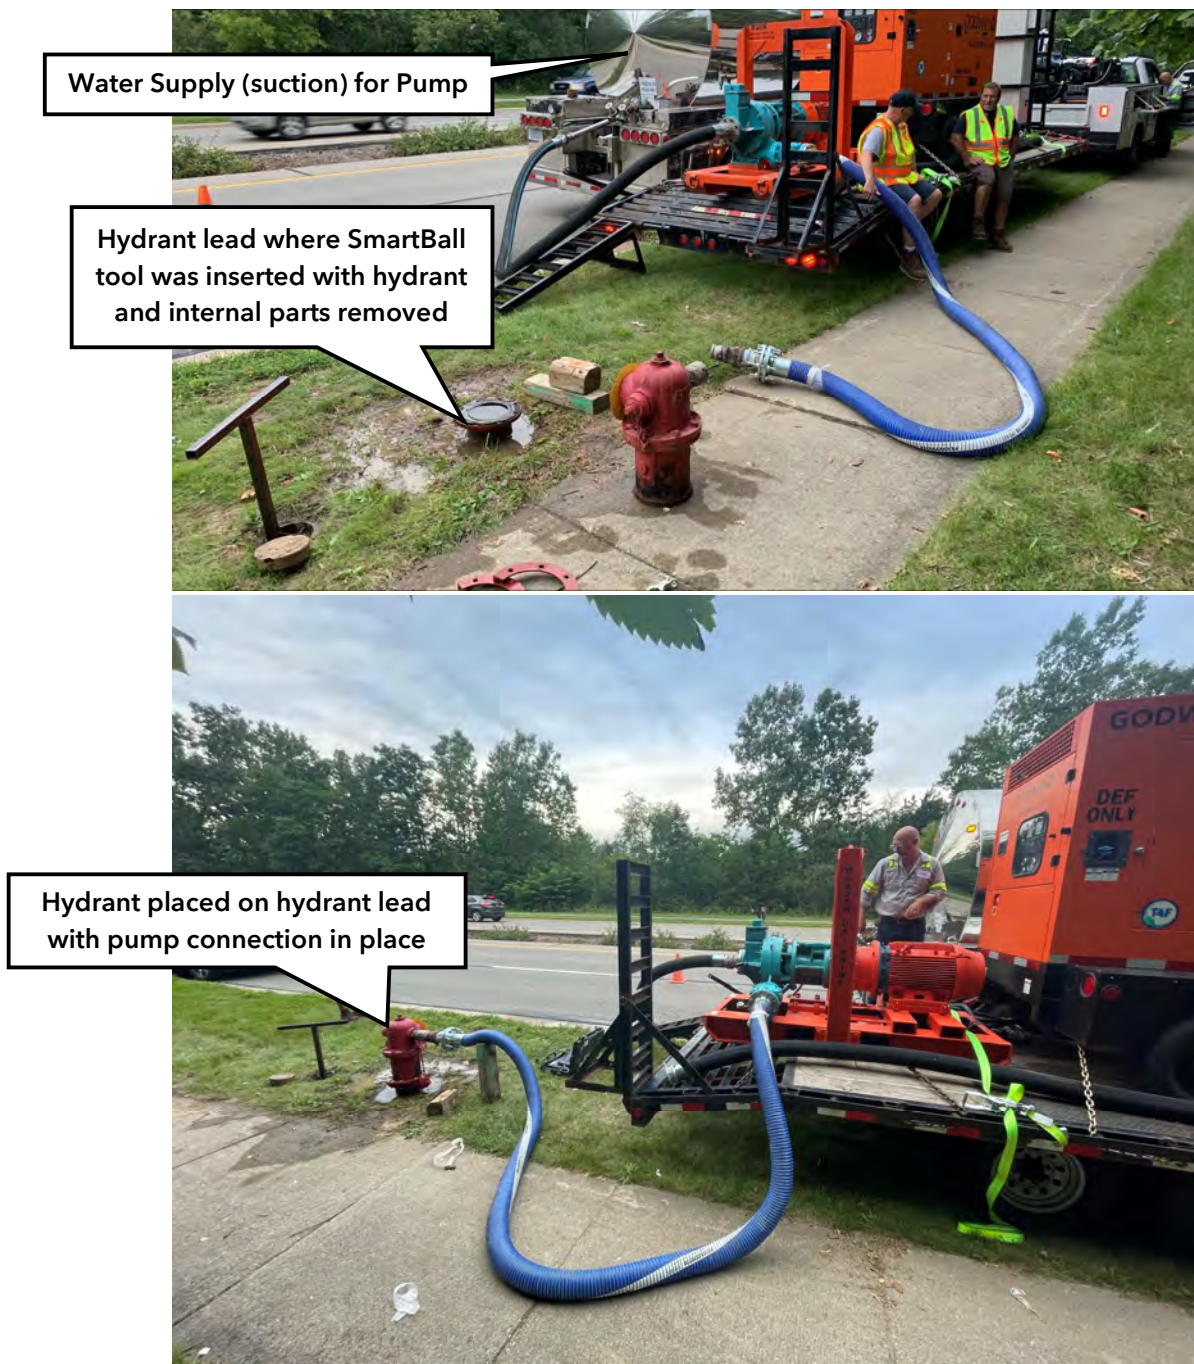
Figure 2.1: View of SmartBall Insertion Location, Pump used to push SmartBall Tool into the Main

The SmartBall Insertion was performed by pumping the SmartBall tool into the transmission main through a hydrant. The internal components of the hydrant were removed in order to allow the SmartBall tool to pass through.

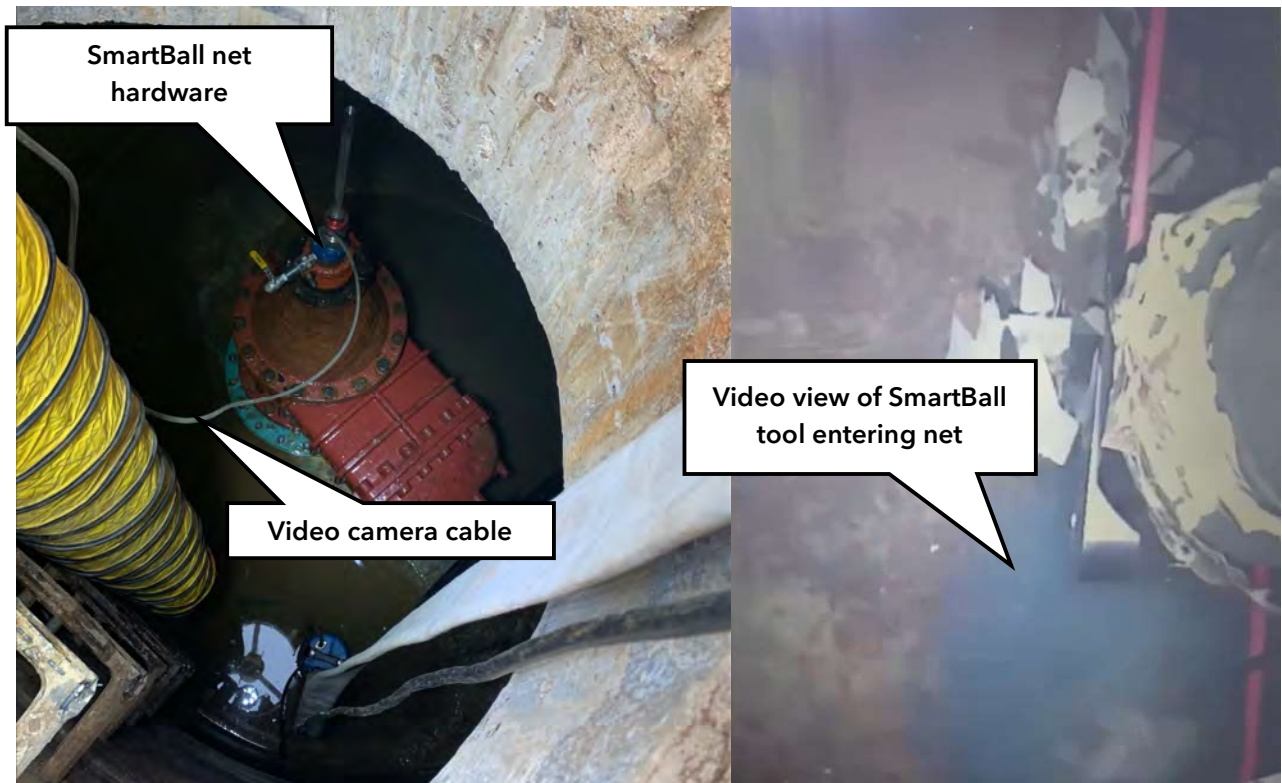
Figure 2.2: Extraction Location, Net installation (left), SmartBall Tool entering Net (right)

The SmartBall Extraction was performed by using a SmartBall net at an 18-inch tap. The tap was installed in 2019. The SmartBall net was installed during an isolation and shutdown of this section of the main the day before the inspection, on Tuesday August 22, 2023. Once the SmartBall arrived at the net, the main was isolated so the net and SmartBall could be recovered.

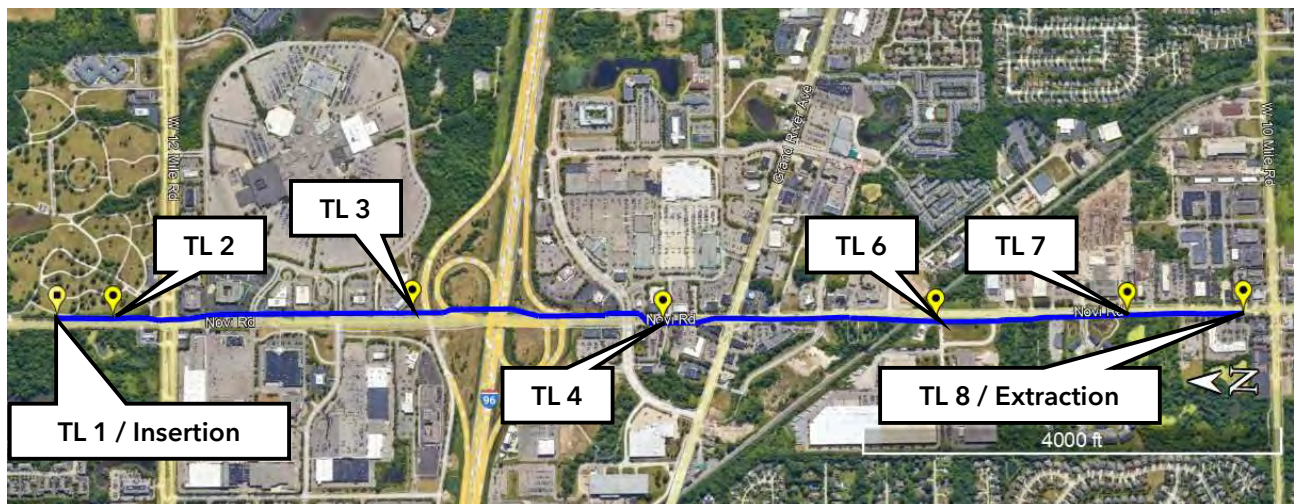
Figure 2.3: Aerial View of Tracking Locations

\*The tracking sensor at TL #2 was held in place using a PVC pipe as there was not enough room to install a sensor on the pipe wall. This sensor was not able to detect the SmartBall tool.

Note: TL 5 was not used as it was in an intersection.

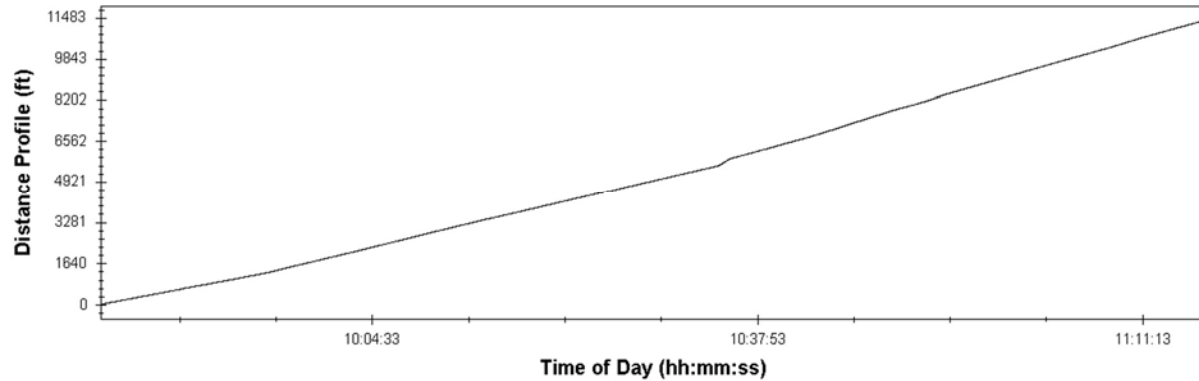
Figure 2.4: Distance Traveled by SmartBall Tool versus Time of Day during the Inspection

A plot was created showing the distance traveled by the SmartBall inspection tool versus time of day based on the tracking data collected and is shown in Figure 2.4. The slope of the black line indicates the instantaneous velocity of the SmartBall inspection tool.
