PHASE I ENVIRONMENTAL SITE ASSESSMENT (ESA)

December 13, 2023

1799 Washington St (State ID: 22E29 01402)
aka 1795 Washington St
NE Portion of Former Stimson Lumber Mill Property - Parcel 2
Oregon City, OR 97045

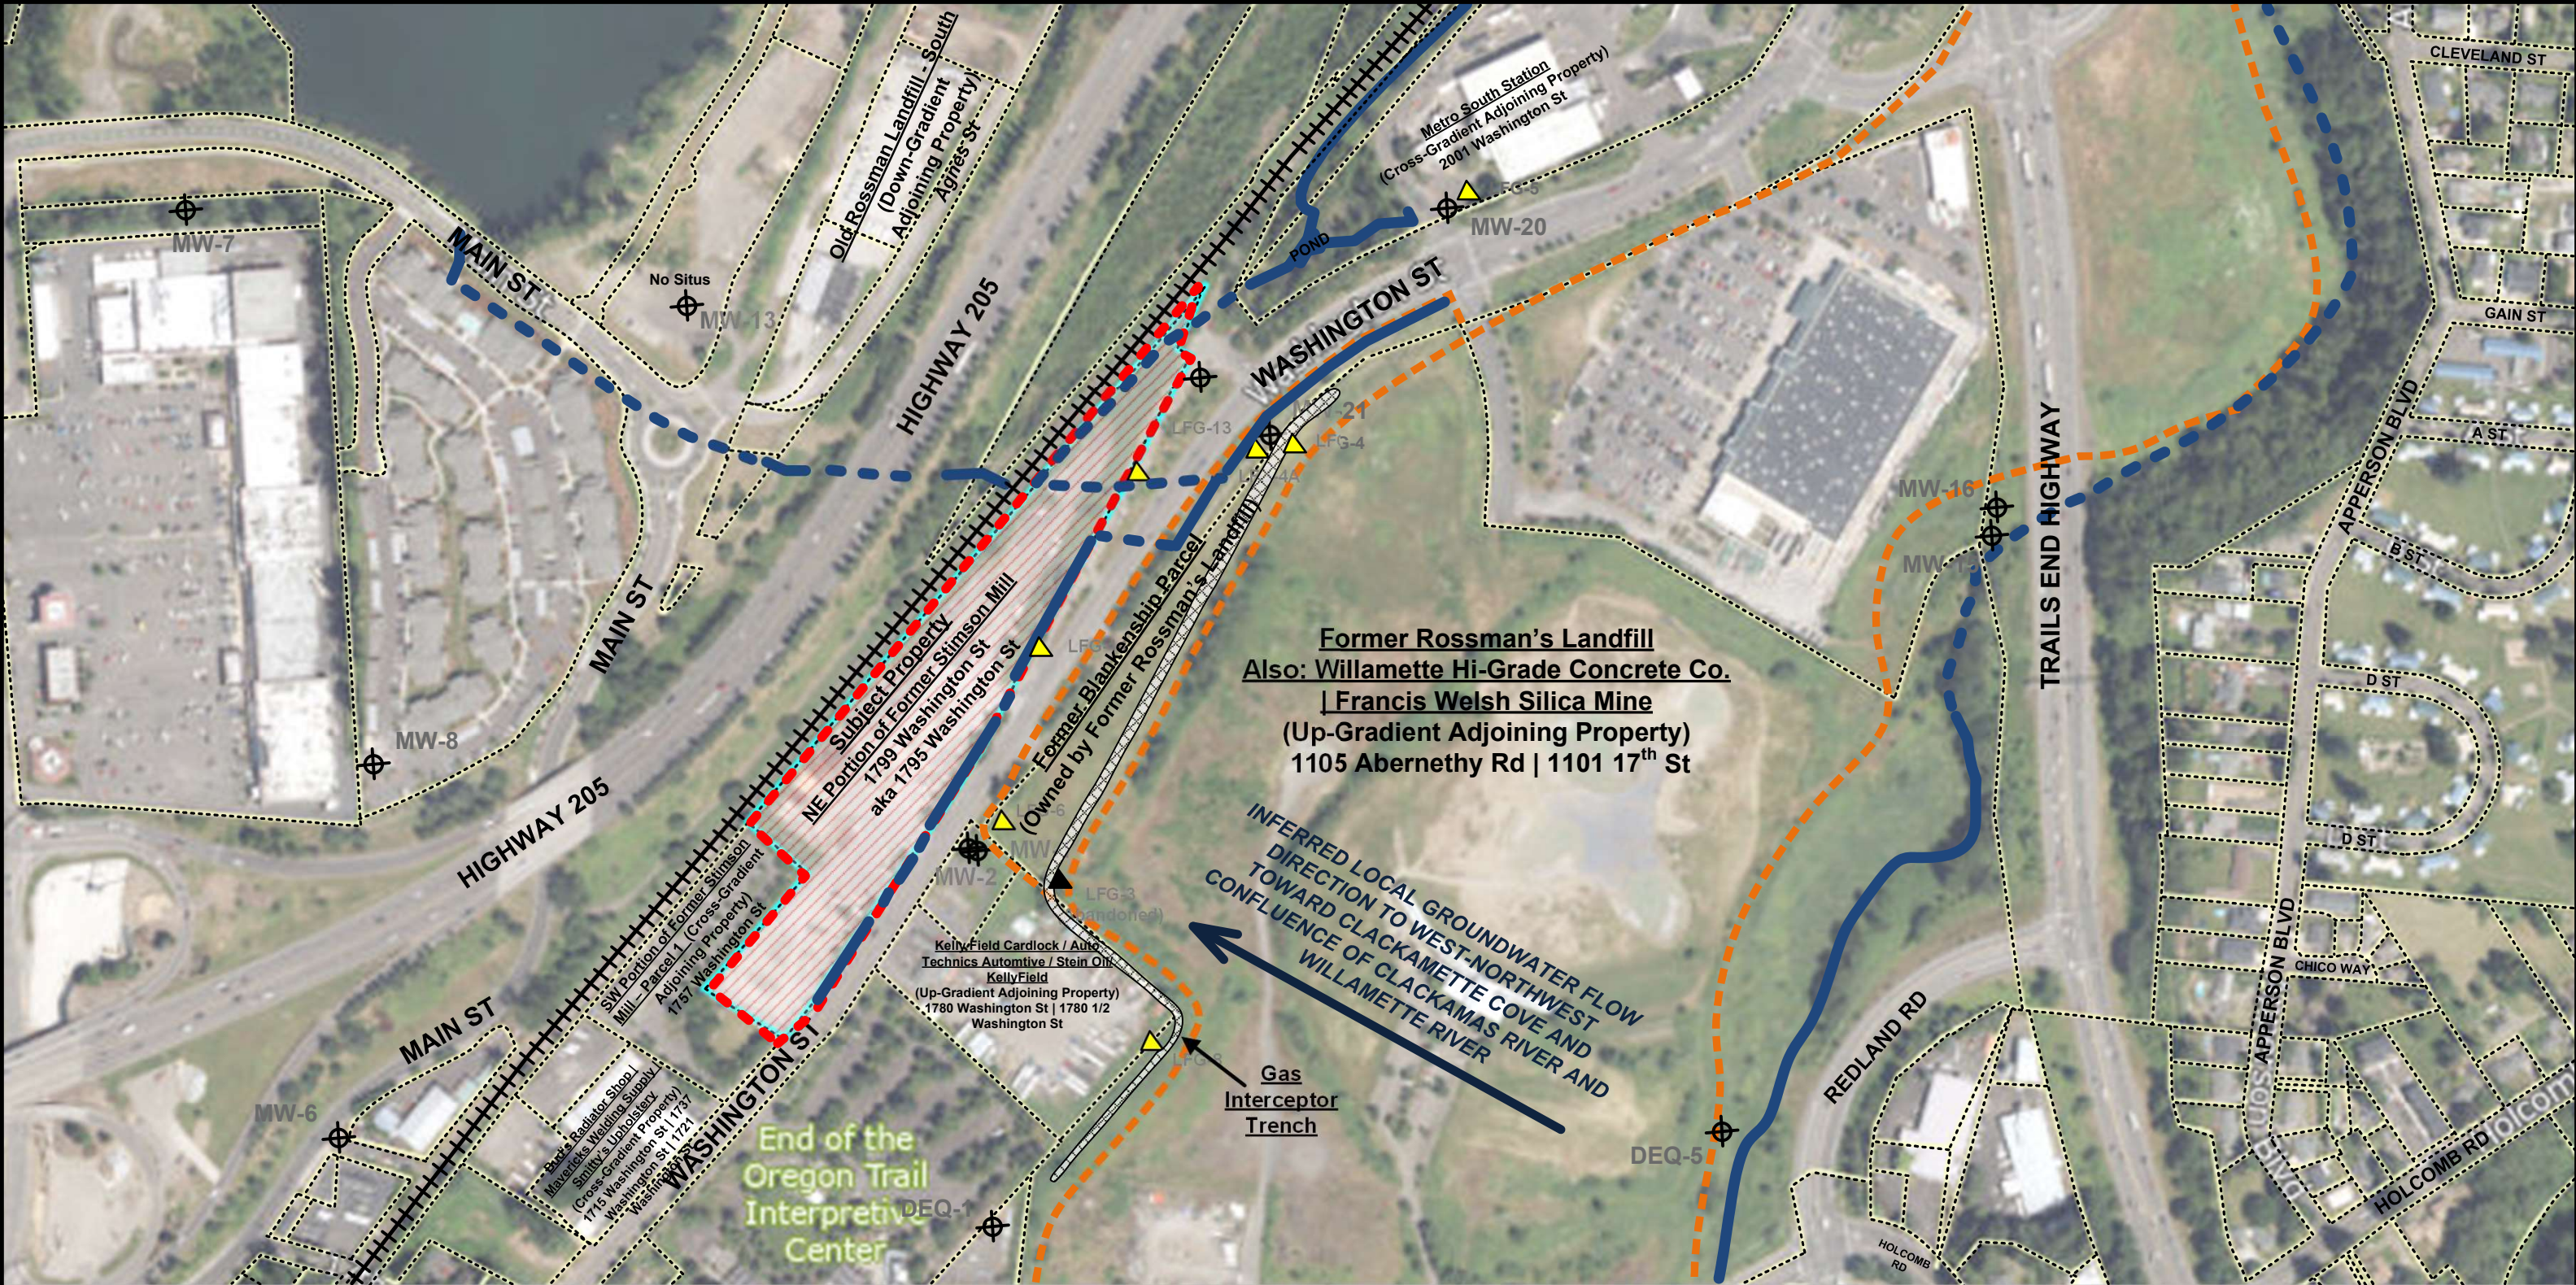
FIGURE 4: SUBJECT PROPERTY AND FORMER ROSSMAN'S LANDFILL LOCATION

Stormwater drainage ditched and/or buried culverts appeared to be located along portions of Washington Street, along the northwest property boundary, and across the northeast portion of the property. The approximate locations of drainage ditches and buried culverts are depicted in Figure 4.
