TRANSMISSION RELIABILITY

Island to Island: An Alaskan High-Voltage Submarine Cable Failure

A utility serving several isolated Alaskan communities works to repair a severed power lifeline to the mainland.

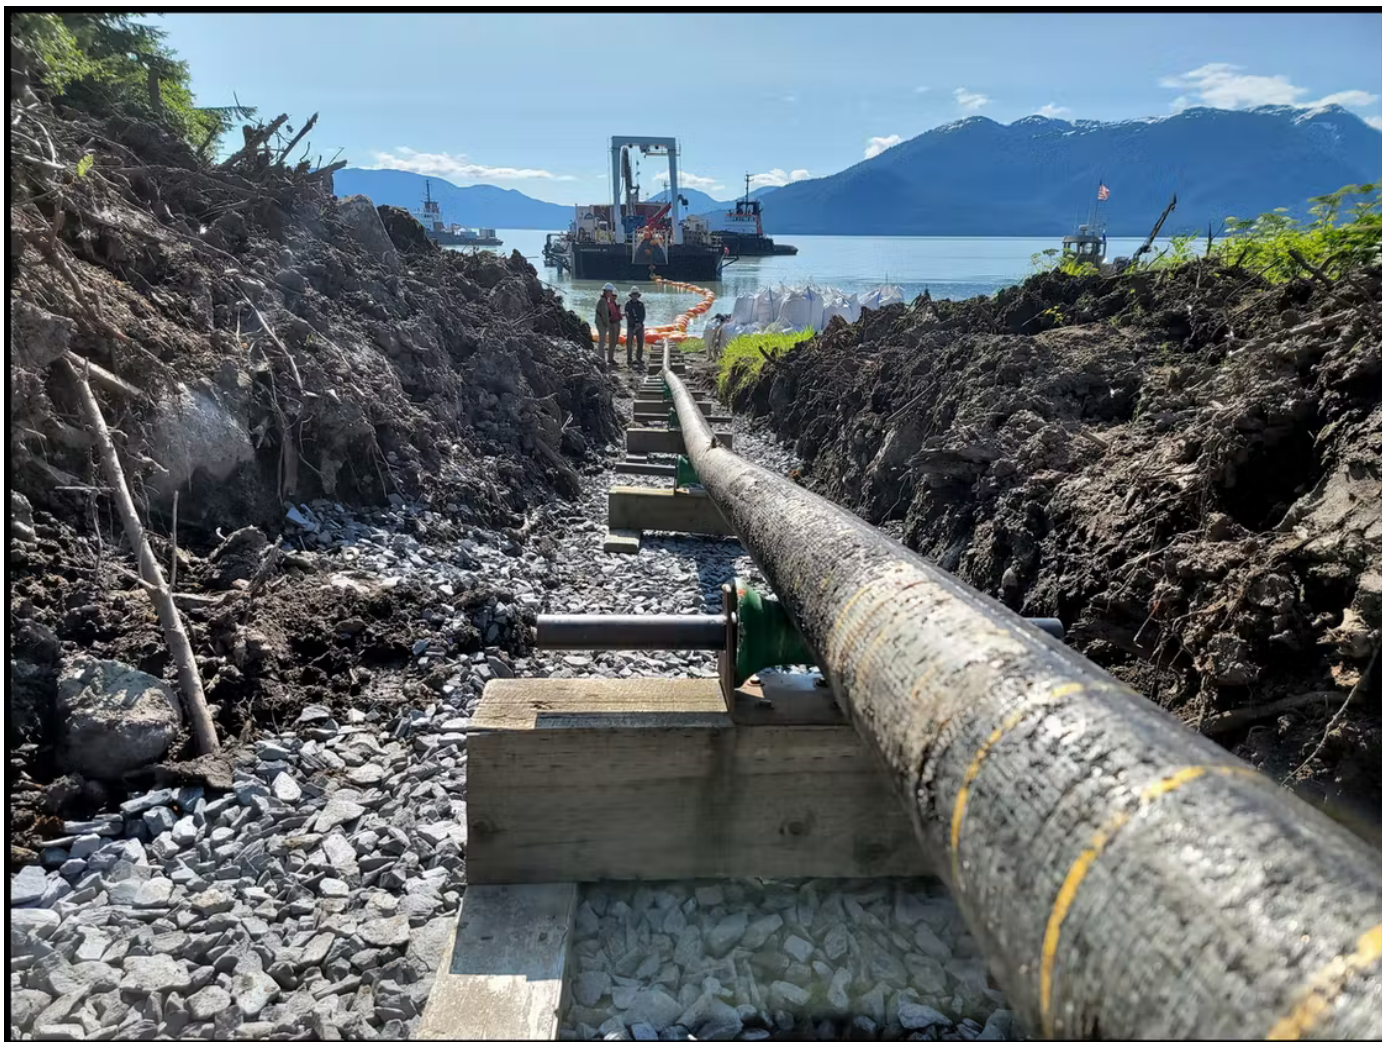
Without SEAPA's subsea transmission connection to the mainland, several Alaska island communities would be entirely dependent on diesel generators for power.

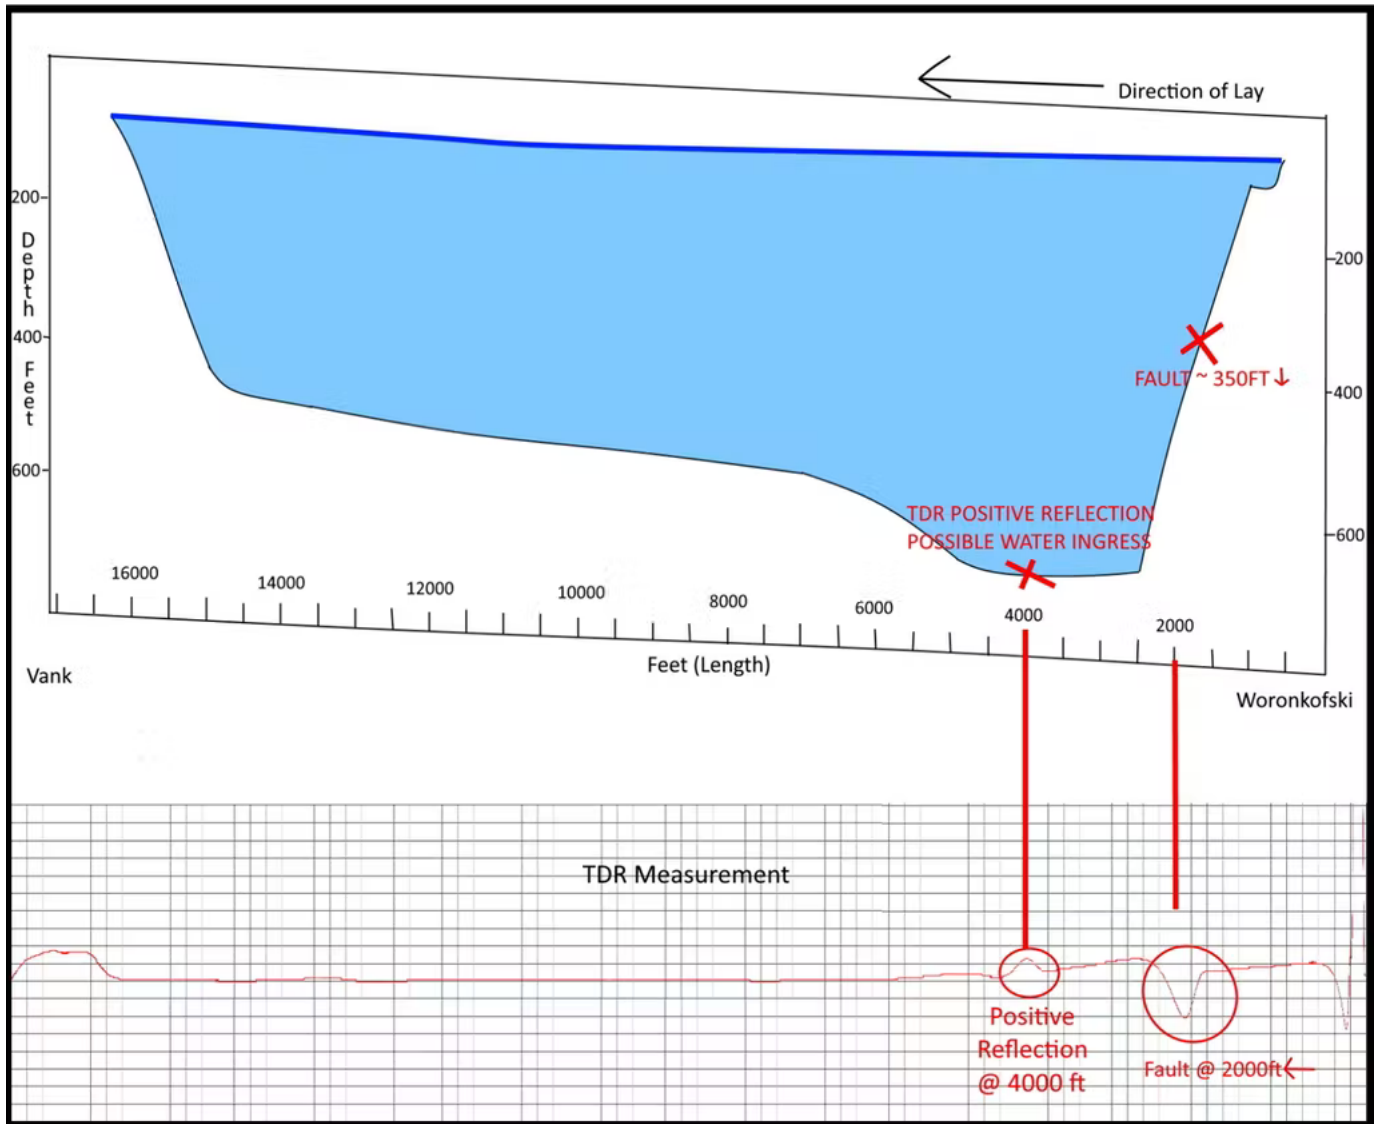
Remotely operated vehicle (ROV) footage revealed the failed cable was severed and that water ingress was highly probable at the point of failure to the deepest part of the cable. Although SEAPA had 2000 feet of oil-filled cable in storage, when considering the probability of water ingress over a cable length greater than 2000 ft, the agency concluded it was not possible to repair the cable.
