May 12, 2014

Subject: Drainage at Rollingwood Community Park

EXHIBIT 1

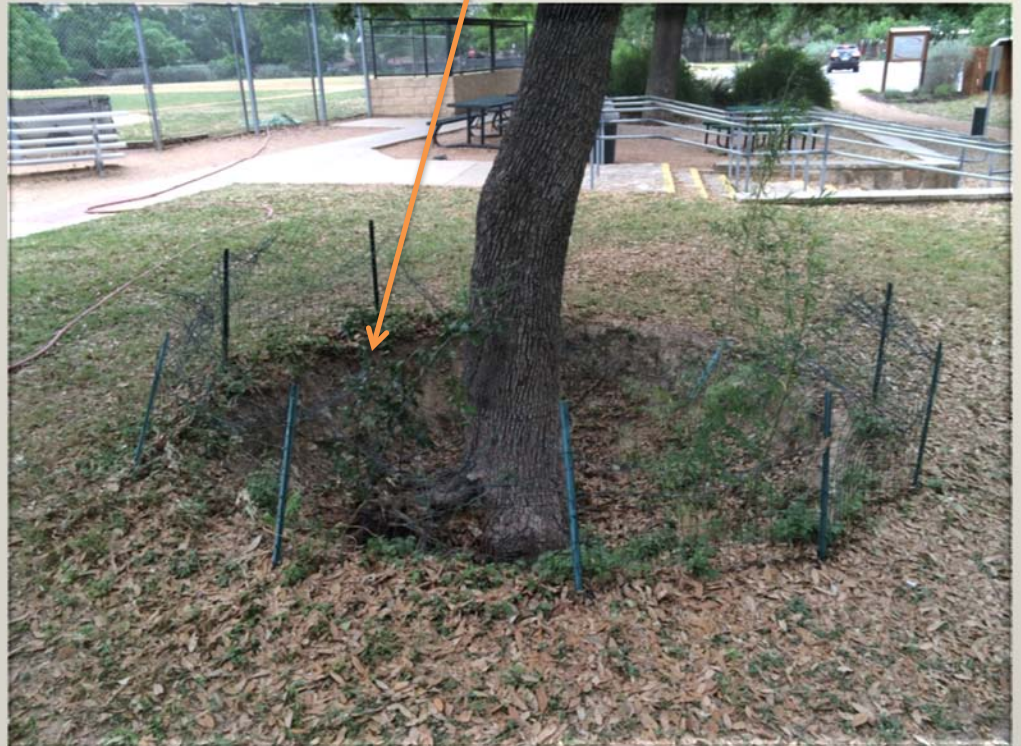
**NATURAL GRADE
AT TRAIL YOU CAN
SEE HOW MUCH
DIRT ADDED**

**NON STANDARD TREE
WELL MADE AFTER THE
FACT SHOULD USE
STANDARD DETAIL**

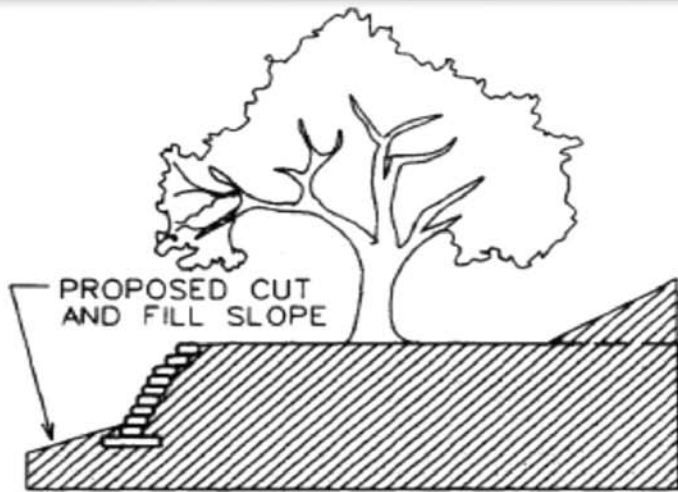
PERMANENT PROTECTIVE WALL

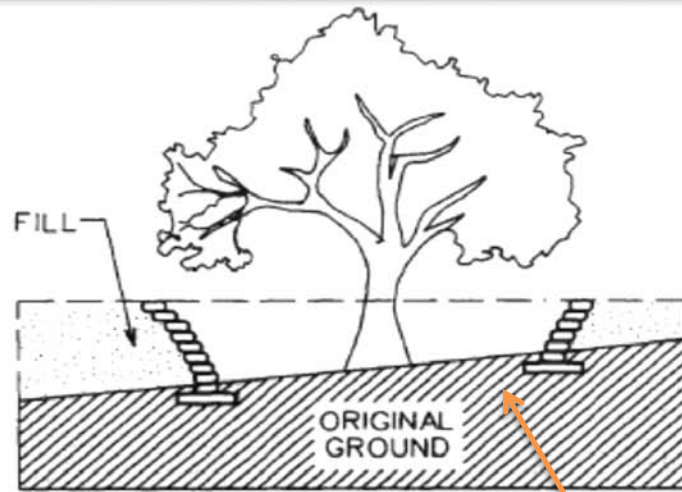
OPEN TREE WELL

**STANDARD TREE WELL
DETAIL WITH FILL
ADDED AROUND TREE**

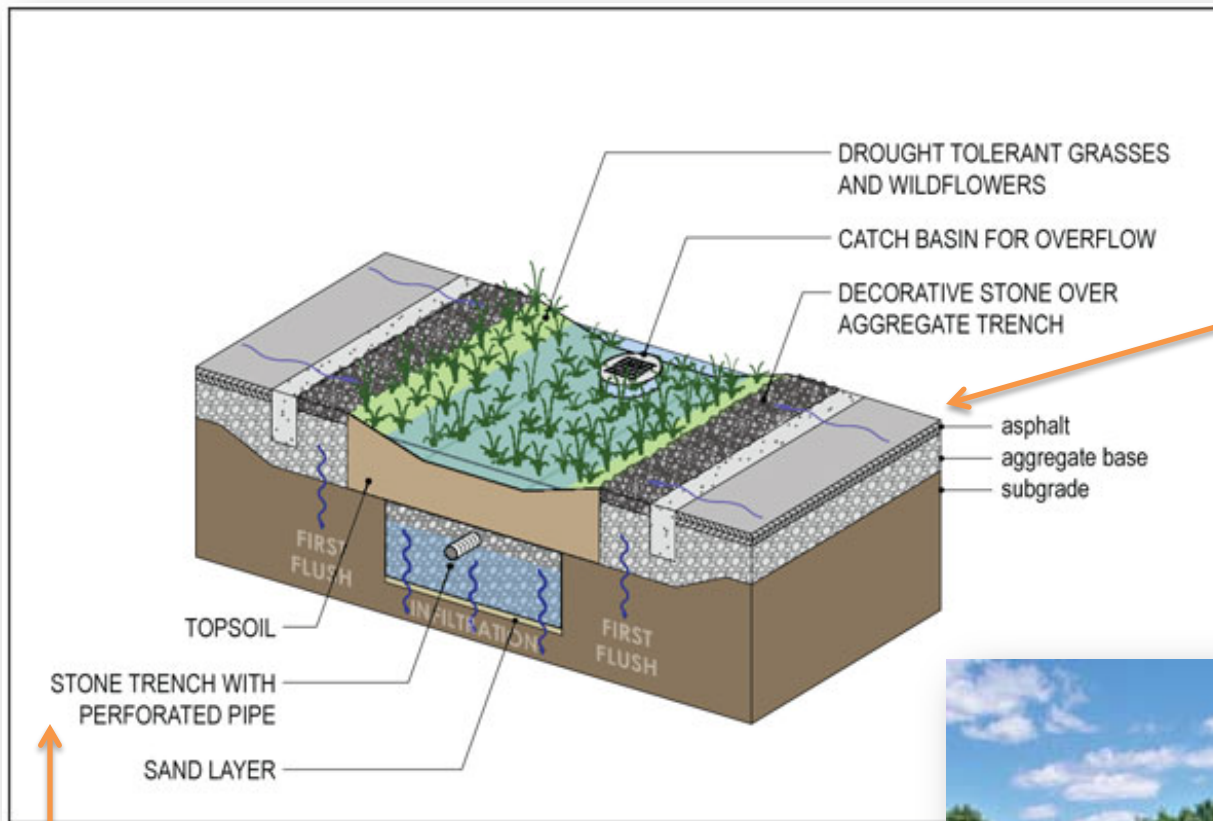
EXHIBIT 3

This is a fairly recent addition to the park and is constructed entirely of asphalt with a concrete ribbon curb around the perimeter. The asphalt is considered 100% impervious cover (IC) along with the ribbon curb. Any rainfall that falls onto the parking does not infiltrate but rather runs down hill into the natural/bluff area. Additionally any stormwater that is up gradient of the parking runs onto the asphalt does not infiltrate and just continues downhill into the natural/bluff area. This area is a concern because it has started to erode the natural area and ruts and small gullies are starting to form. These are the first signs that significant erosion is starting to happen and methods need to be developed to control the runoff velocity.

There are numerous methods for controlling stormwater runoff from parking lots depending on what the ultimate goals are. The main purpose for the walkthrough and the letter memo was to look at the control and management of stormwater runoff as it relates to water quantity. Additional measures could be applied to the BMPs' designed for the parking lot to provide some treatment to improve water quality. Possible methods are provided in Exhibit 3. Once the actual volume of stormwater is calculated a better determination of the methods to be utilized can be recommended. With the limited data and information known a rain garden or bio-swale could possibly be constructed along the perimeter of the downstream edge of the parking lot with any overflow to be directed to the existing on-site pond assuming there is enough slope between the two locations.

A SMALL SECTION OR STRIP COULD BE REMOVED ALONG THE DOWNSLOPE OF THE PARKING LOT AND REPLACED WITH A SECTION OF PERMEABLE PAVER SYSTEM WHICH HAS A GRAVEL BASE AND ACTS AS A DEVICE TO INFILTRATE WATER BACK INTO GROUNDWATER.

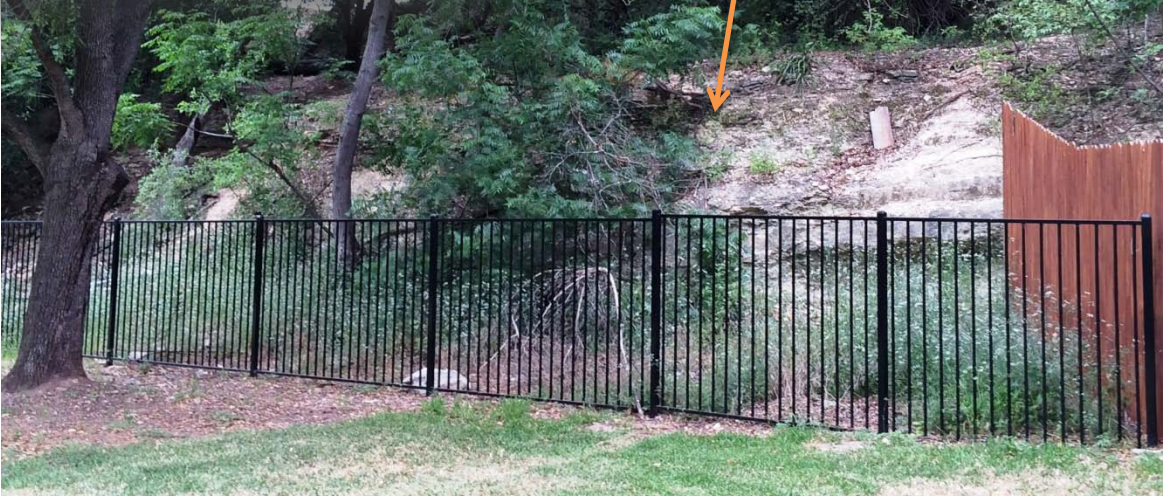
issue and at minimum this should be examined to determine the likely hood that larger chunks may break loose and actually hurt someone.

PORTIONS OF THE FACE OF THE BLUFF ARE BREAKING AWAY. FENCE KEEPS PEOPLE OFF AND SOME PIECES OUT OF THE PARK BUT IT STILL MAY A SAFETY CONCERN

One mitigation method for this area could be that a living wall be constructed in front of this area to allow for vegetation to take hold and help protect the face from further damage. The living wall would be considered a “green” solution such that it would beautify the area and add some color depending on the type plants utilized. Another benefit would be that the plants would stabilize the face of the bluff to limit future erosion. An alternative method could be limestone block stack wall that could be terraced or arranged such that some plants could be installed but the main purpose would be to protect the public from rocks falling onto the trail or actually hurting someone. A third method would be to shotcrete the exposed face and then build a concrete wall in front of this area to construct a large tank. This tank would then become part of a rain water collection system in which the water could used at the park or residents could come and take it and utilize it for their own house.

**LIVING WALL DETAIL
SOMETHING SIMILAR TO
THIS UTILIZING LOCALLY
ADAPTED PLANTS AND
GRASSES FROM THE LADY
BIRD WILDFLOWER CENTER
THAT ARE DROUGHT
TOLERANT AND SOME ARE
SPECIFICALLY ENGINEERED
FOR LIVING ROOFS OR
WALLS**
