**Draft**  
**Saxman Sewer Condition Assessment**

May 24<sup>th</sup>, 2024

**Stephl Engineering, LLC.**  
**3900 Arctic Blvd., Suite 204**  
**Anchorage, Alaska 99503**  
**907-562-1468**

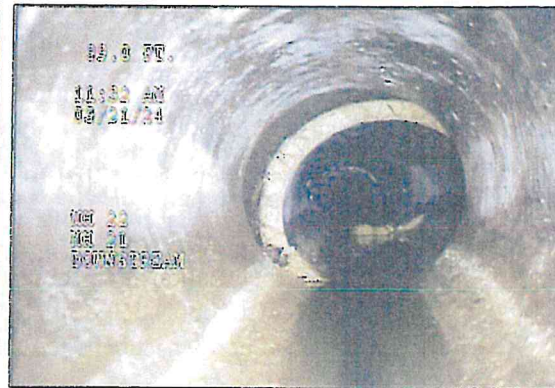
*MH 22 to MH 21, offset at joint*

| Saxman Sewer Pipe Summary Table | | | | | | | | | | LOF Score: 0=No defect, 1=Minor Defect, 2=Minor to moderate Defect, 3=Moderate defect, 4=Significant defect, 5=Most significant defect | | | | | | | | | |
|---|---|---|---|---|---|---|---|---|---|---|---|---|---|---|---|---|---|--|--|
| MH 22 | MH 21 | Tongass Hwy. | 8 | HOPE Truss Pipe | 62 | No | March 2024 | 44 | Downstream | 1 | 3 | 3 | - 24 LF, 2-3" debris dam with infiltration dipper at 12:00 position<br>- 31 LF, 1-2" offset at joint from 1:00 to 5:00 position<br>- 42 LF, 2" offset at joint from 7:00 to 2:00 position, survey abandoned<br>- 42 LF to 44 LF, fracture with infiltration dipper at 2:00 position | | | | | | |

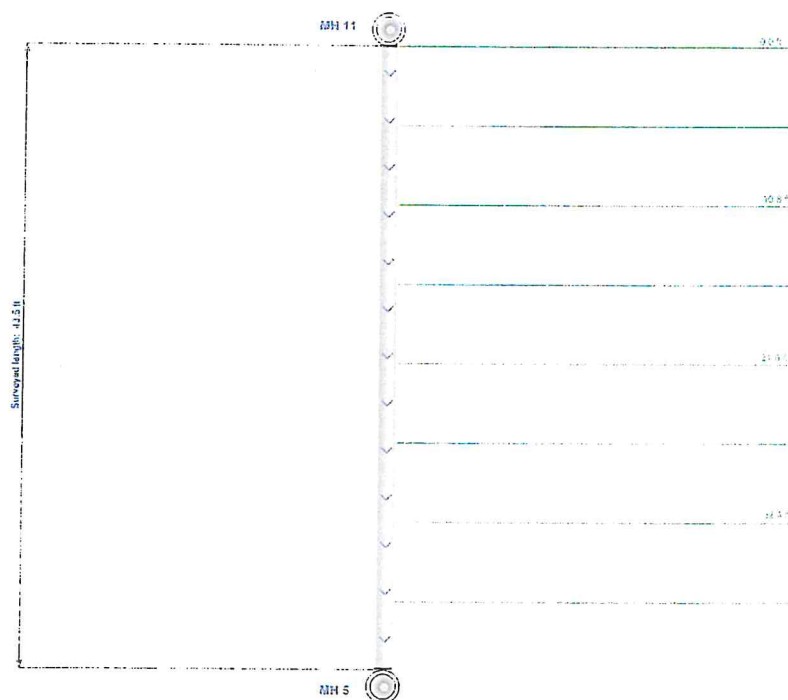
- Water level 1" from 0 LF to 43 LF
- Grease deposits at 5:00 and 7:00 position throughout pipe
- Grade: 1

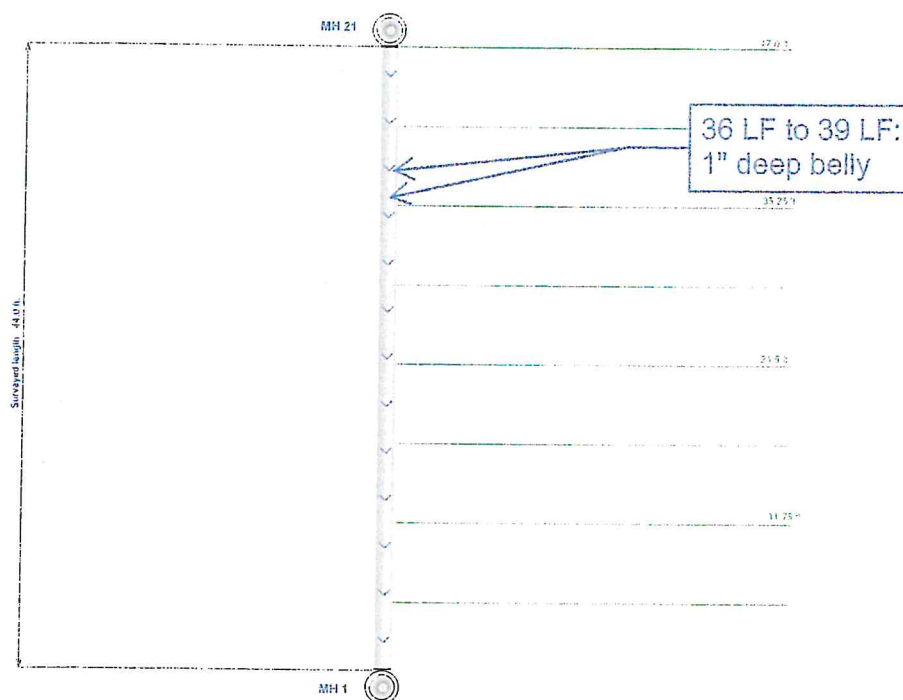
- Water level <1" from 0 LF to 47 LF
- Debris <1" throughout pipe
- Grade: 2

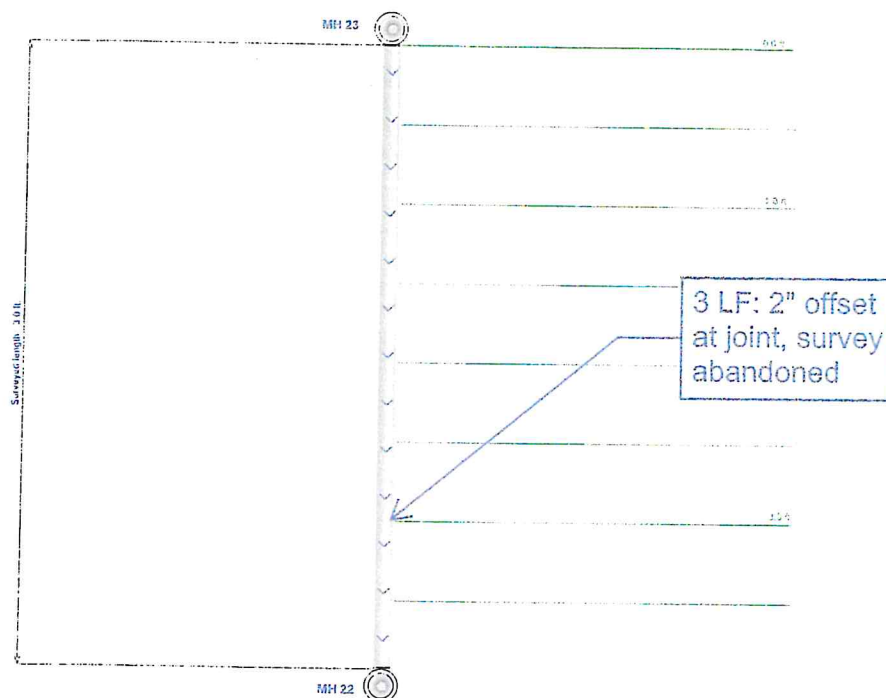
- Water level <1" from 0 LF to 3 LF
- Grade: 3

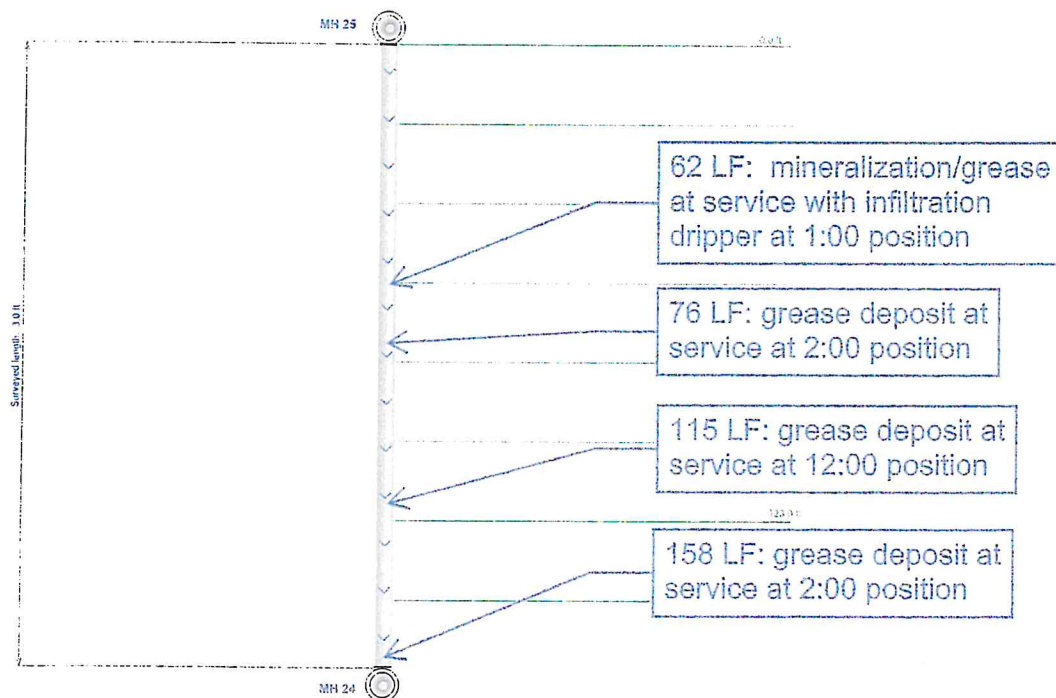
- Water level <1" from 0 LF to 160 LF, 4" from 160 LF to 163 LF
- Grease deposits at 5:00 and 7:00 position
- Grade: 2

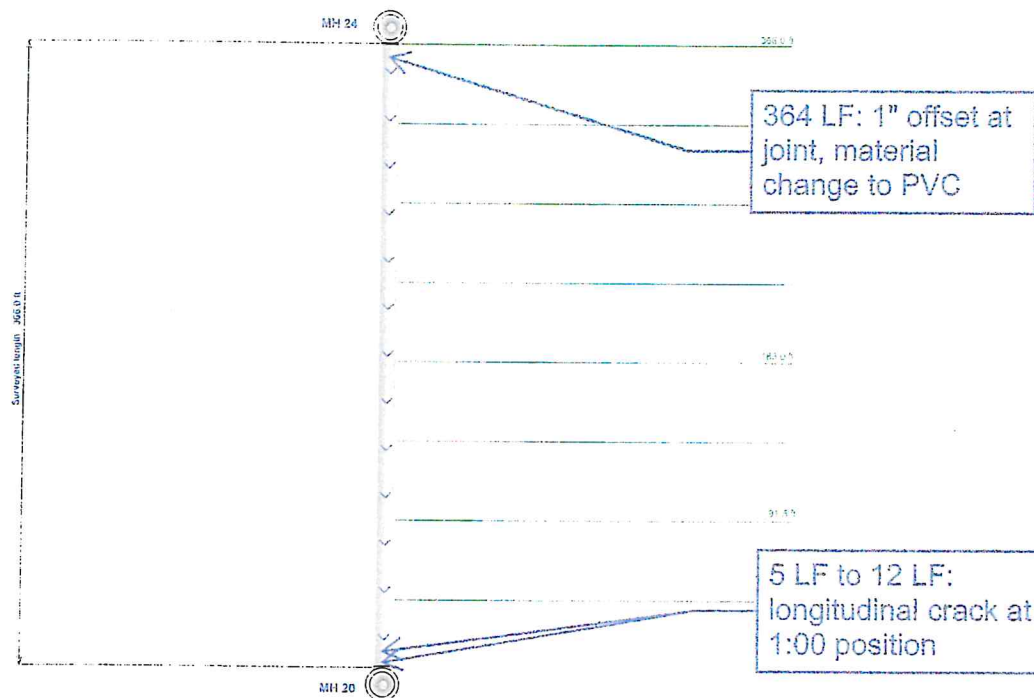
- Water level <1" from 0 LF to 96 LF, 103 LF to 366 LF, 2" from 96 LF to 103 LF
- Grade: 2

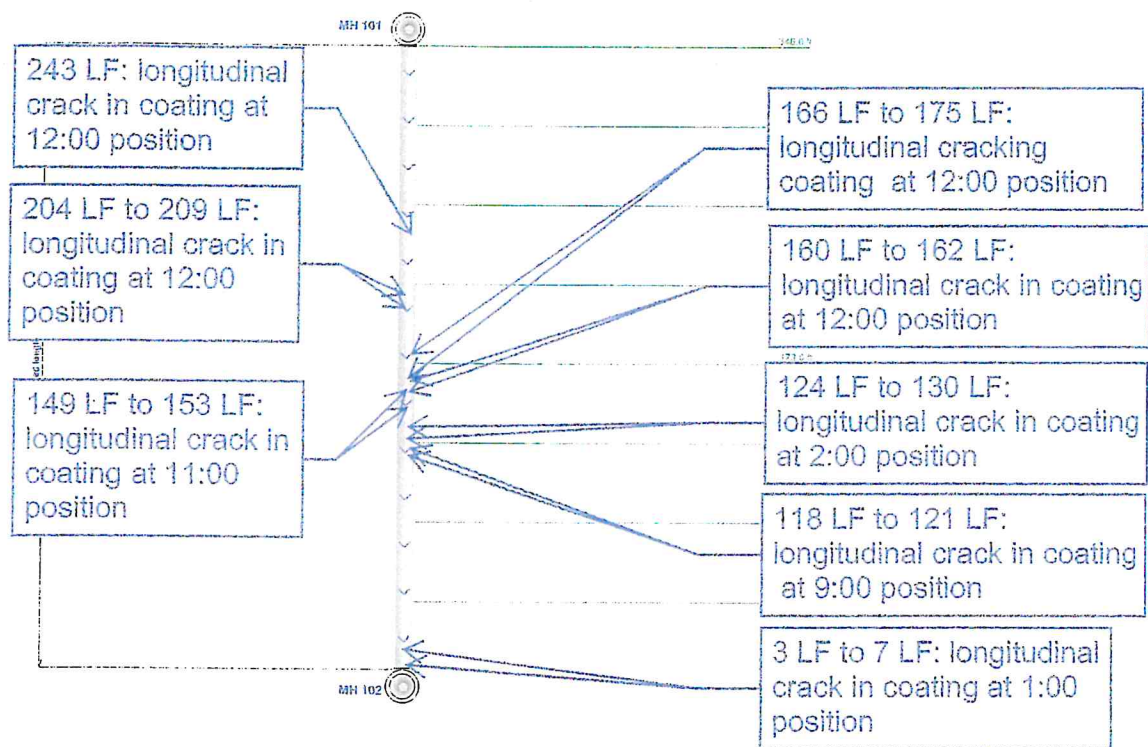
- Water level <1" from 0 LF to 346 LF
- Pipe wall spalling at various locations throughout pipe
- Grade: 2

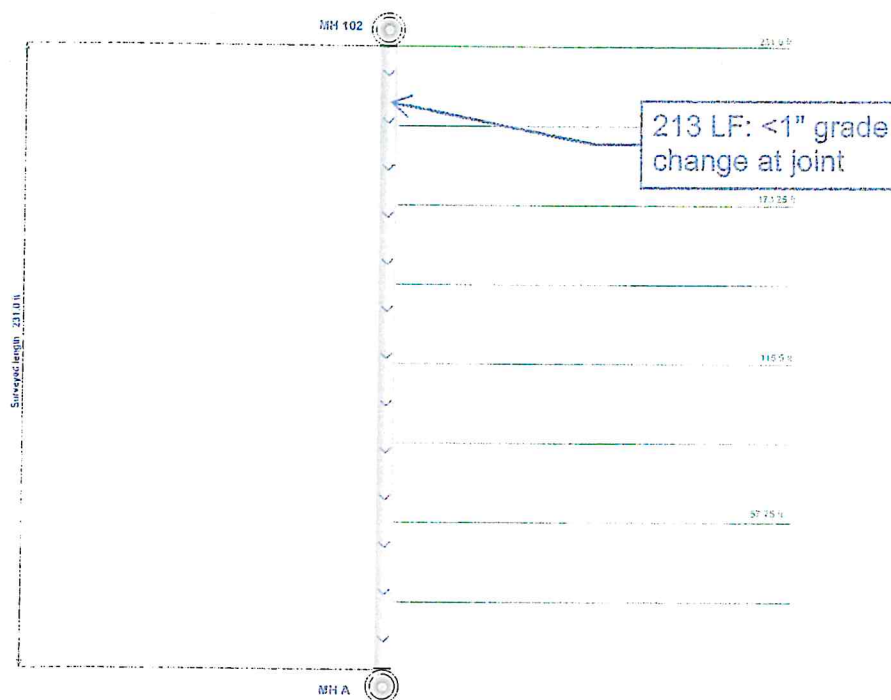
- Water level <1" from 0 LF to 231 LF
- Grease at 5:00 and 7:00 position throughout pipe
- Grade: 1

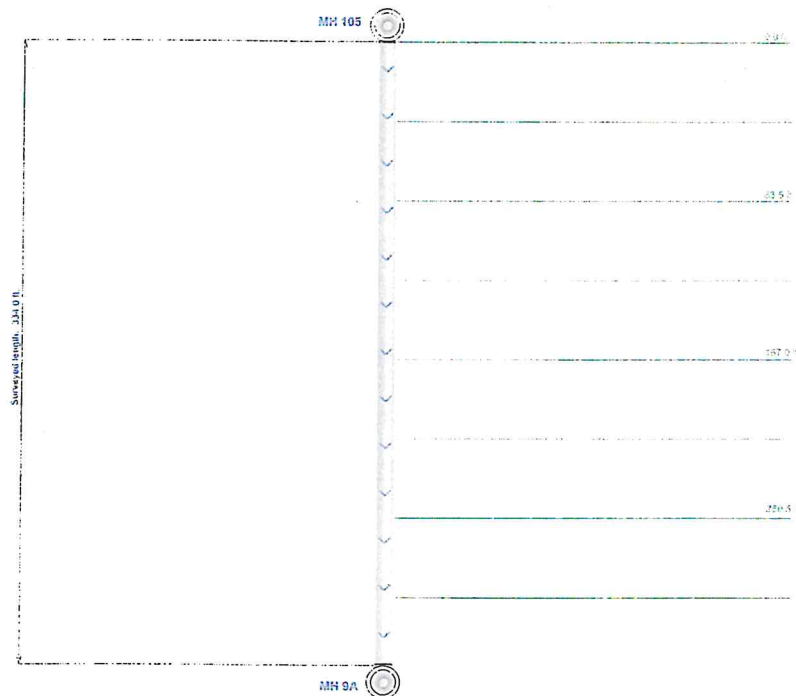
- Water level 1-2" from 0 LF to 106 LF, 119 LF to 334 LF, <1" from 106 LF to 119 LF,
- Grease deposits at 5:00 and 7:00 throughout pipe, significant build up from 328 LF to 334 LF
- Varying amounts of debris and grease joints throughout pipe
- Grade: 1

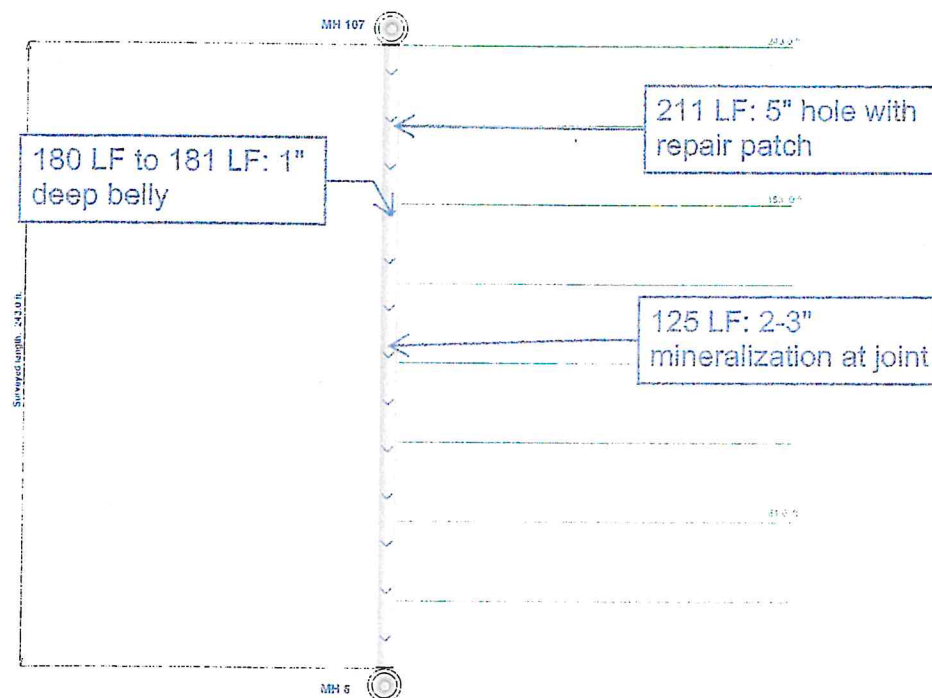
Notes:  
- Water level 1" from 0 LF to 6 LF,  
<1" from 6 LF to 243 LF  
- Grade: 2

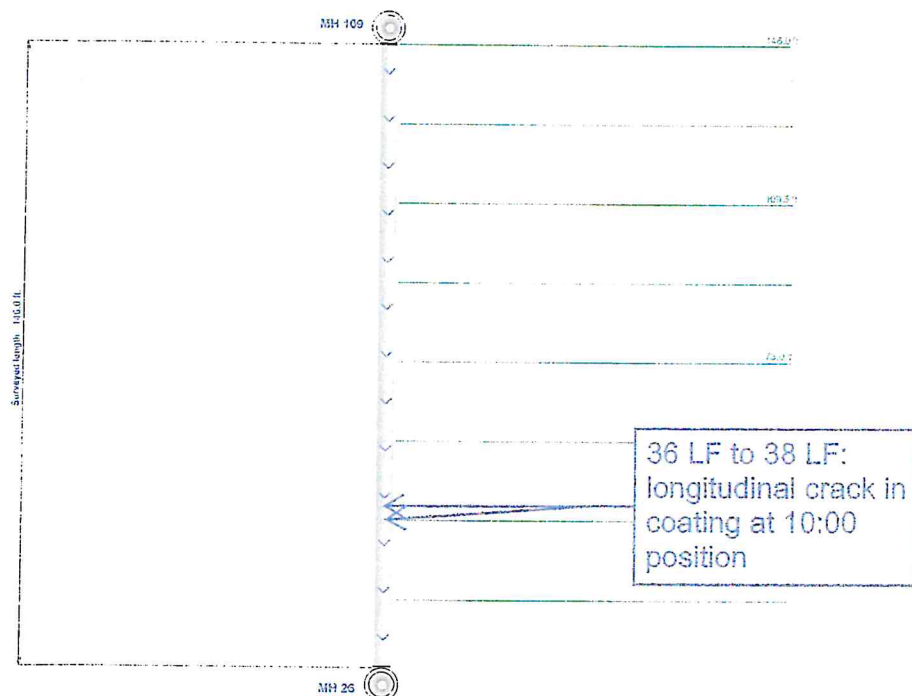
- Water level <1" from 0 LF to 146 LF
- 1-2" of grease at invert of pipe from 0 LF to 135 LF
- Grade: 2

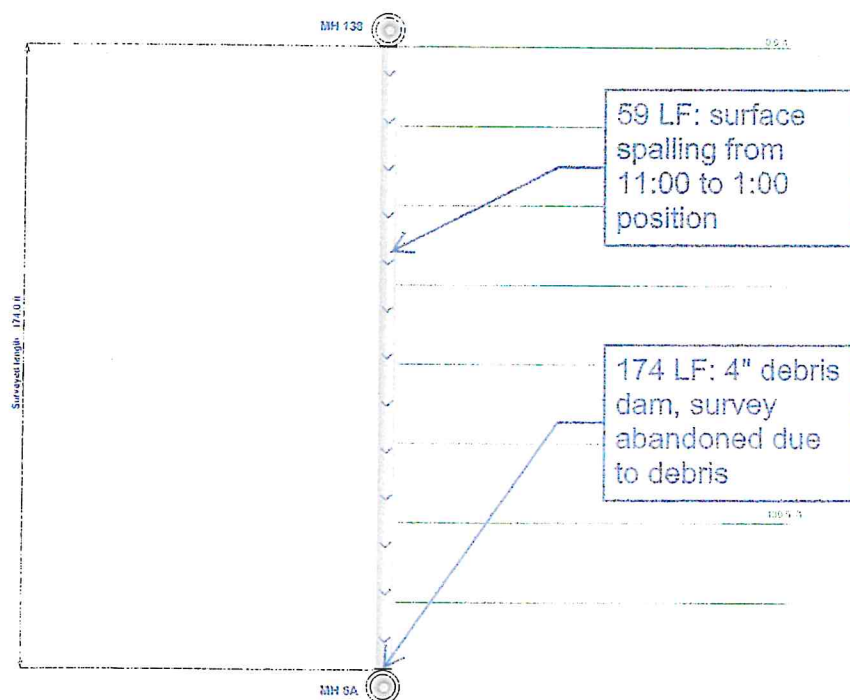
- Water level <1" from 0 LF to 174 LF
- 1" of debris from 0 LF to 6 LF
- Grade: 1

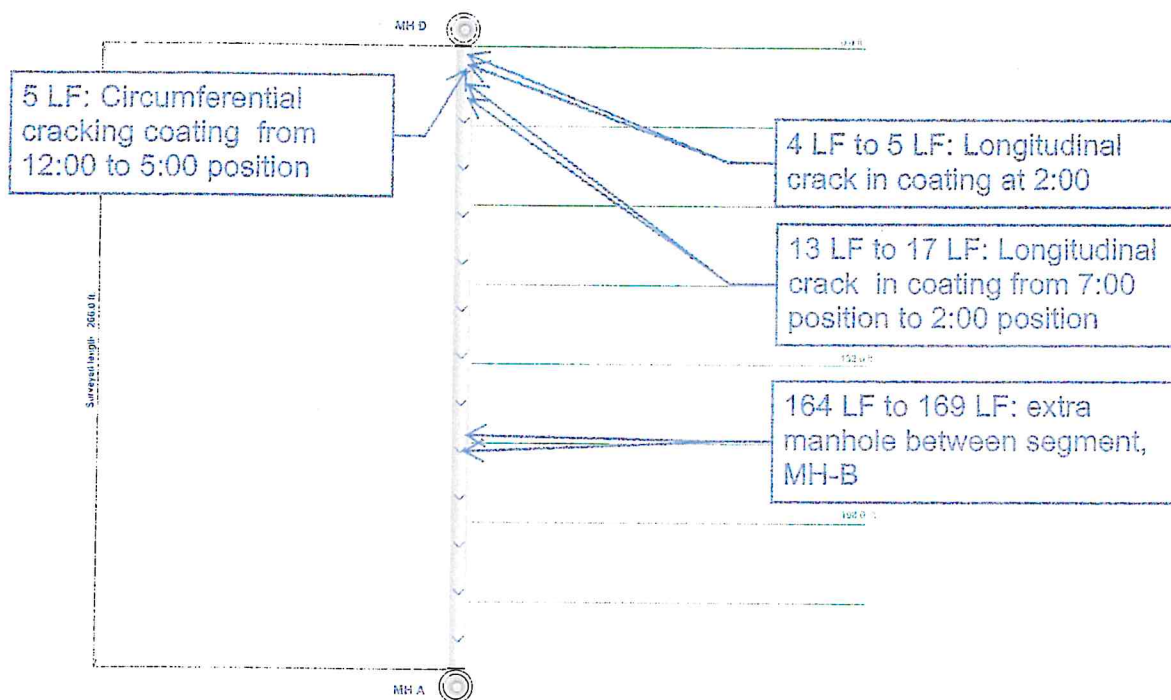
- Water level <1" from 0 LF to 160 LF, 169 LF to 262 LF, 3-4" from 160 LF to 164 LF, 2-3" from 262 LF to 266 LF
- 3-4" of debris at 163 LF
- grease deposits at 5:00 and 7:00 position throughout pipe
- Grade: 2

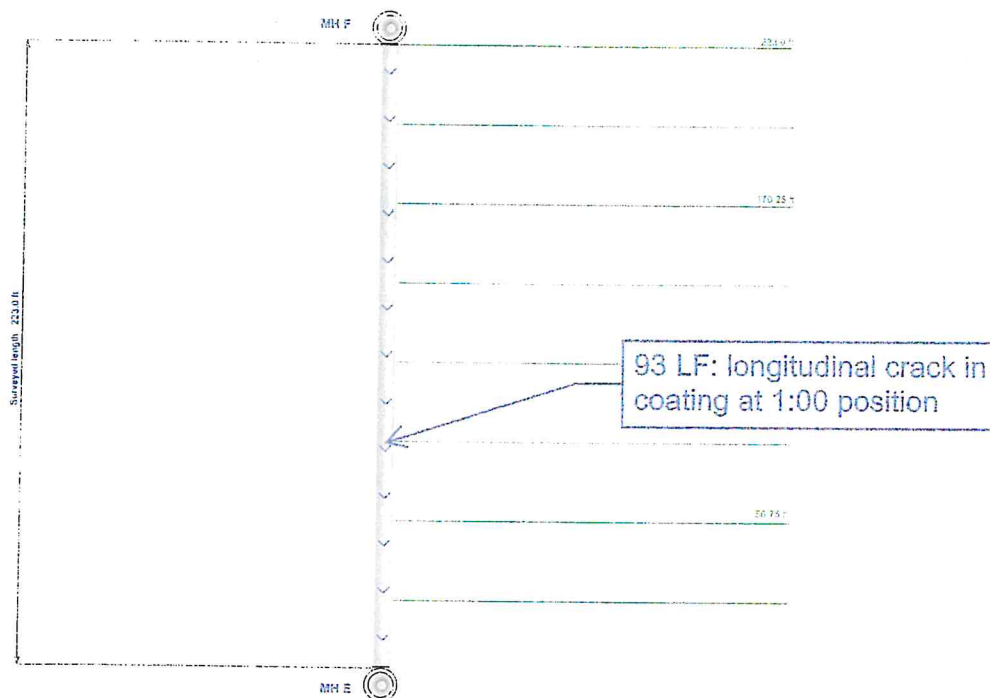
- Water level 1" from 0 LF to 30 LF, 39 LF to 65 LF, 119 LF to 130 LF, 187 LF to 196 LF, <1" from 30 LF to 39 LF, 65 LF to 119 LF, 130 LF to 187 LF, 196 LF to 223 LF
- 2-3" of debris from 42 LF to 53 LF
- Varying levels of grease deposits at 5:00 and 7:00 position throughout pipe
- Grade: 2

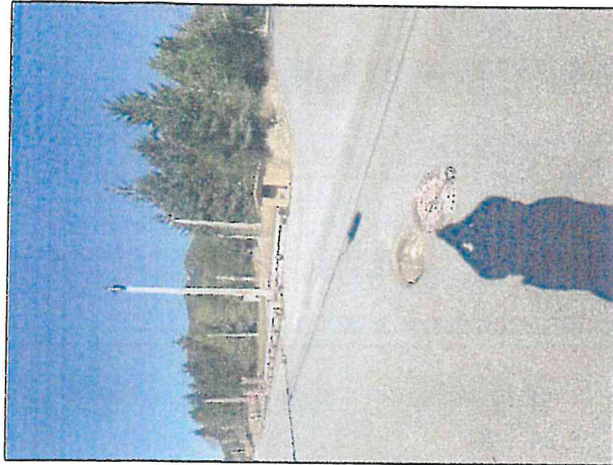
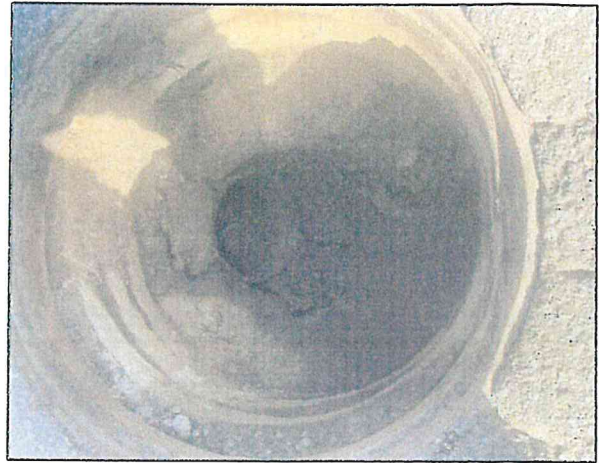
*Image 1 – CO 6A, facing SE*

| Saxman Sewer Structure Summary Table | | | | | | | | | | LOF Grades: 0=No Defect, 1=Minor Defect, 2=Minor to Moderate Defect, 3=Moderate Defect, 4=Significant Defect, 5=Most Significant Defect | | | | | | | | | |
|---|---|---|---|---|---|---|---|---|---|---|---|---|---|---|---|---|--|---|--|
| CO 6A | N/A | | Clean out | 2 | 2 | 2 | 2 | | N/A | N/A | N/A | N/A | N/A | N/A | | 3 | | - Surface corrosion on frame and lid<br>- Concrete cracking around pipe 1<br>- Needs to be cleaned and plug installed in pipe | |

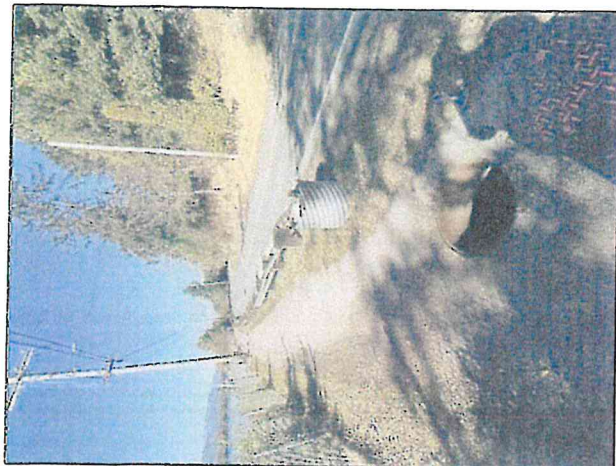
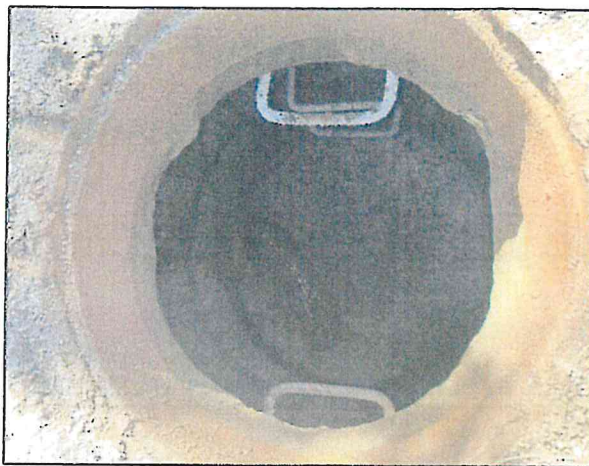
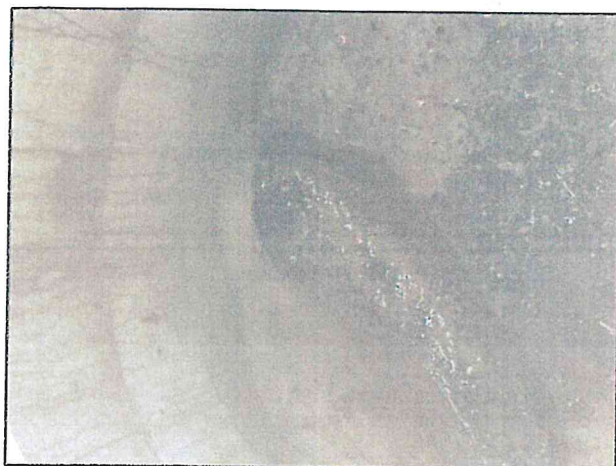
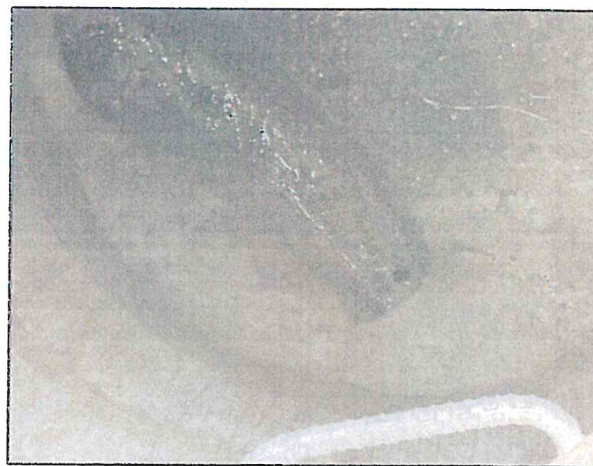
*Image 1 – MH 1, facing NE*

| Saxman Sewer Structure Summary Table | | | | | | | | | | LOF Grades: 0=No Defect, 1=Minor Defect, 2=Minor to Moderate Defect, 3=Moderate Defect, 4=Significant Defect, 5=Most Significant Defect | | | | | | | | | |
|---|---|---|---|---|---|---|---|---|---|---|---|---|---|---|---|---|--|--|--|
| MH 1 | 62 | Pre-cast Concrete | 2 | 3 | 2 | 2 | N/A | 2 | N/A | 1 | 1 | 1 | 1 | 1 | 1 | - Surface corrosion on frame and lid<br>- Infiltration at barrel section and base joint | | | |

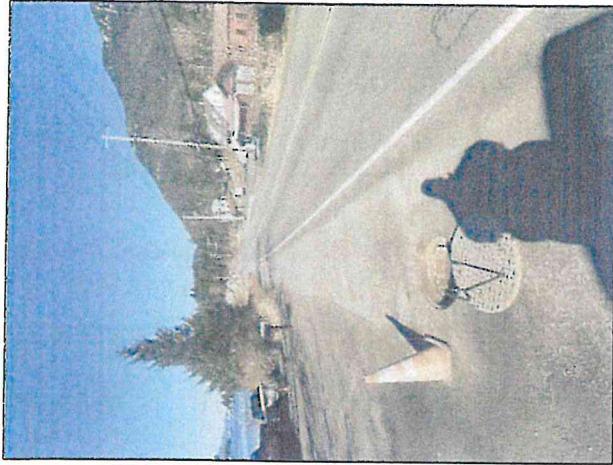
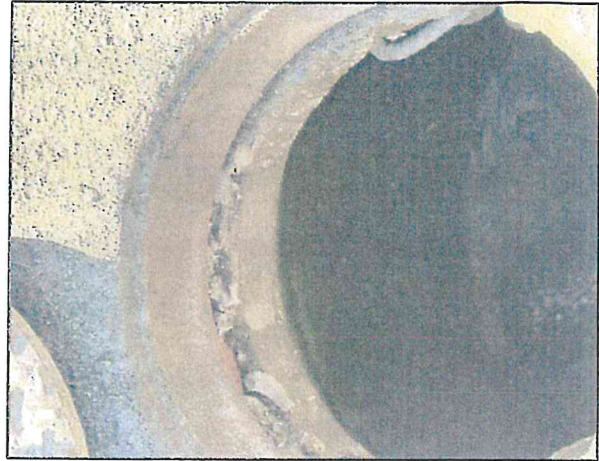
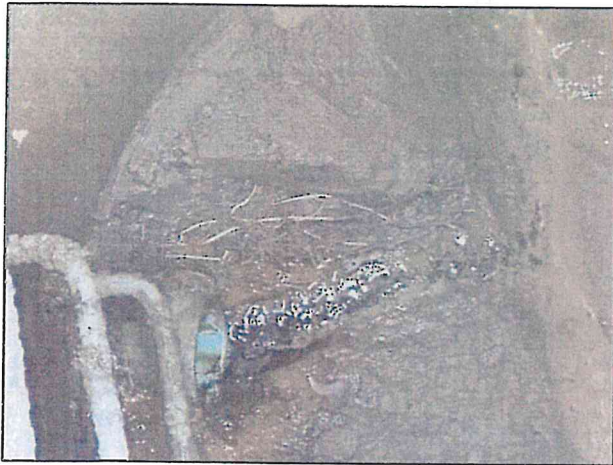
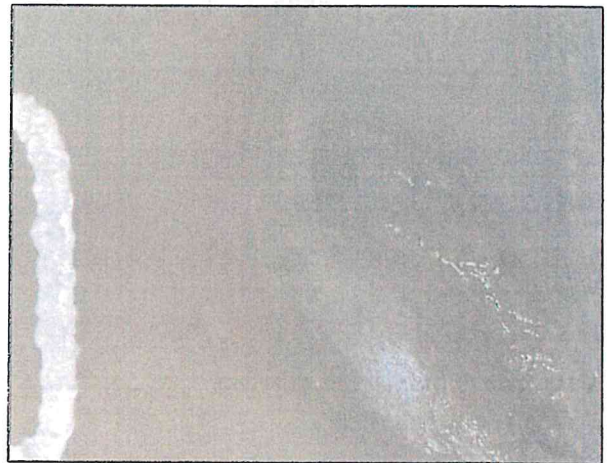
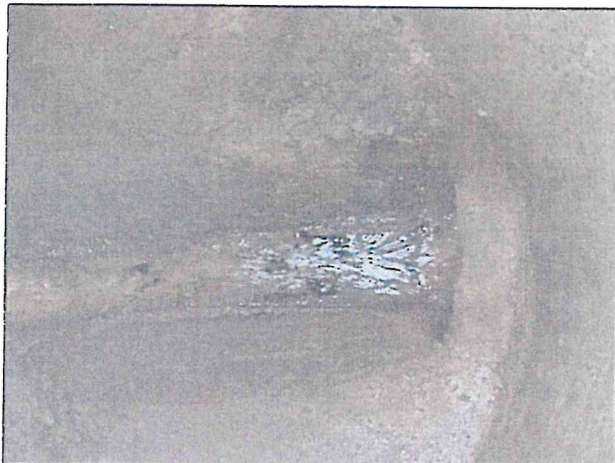
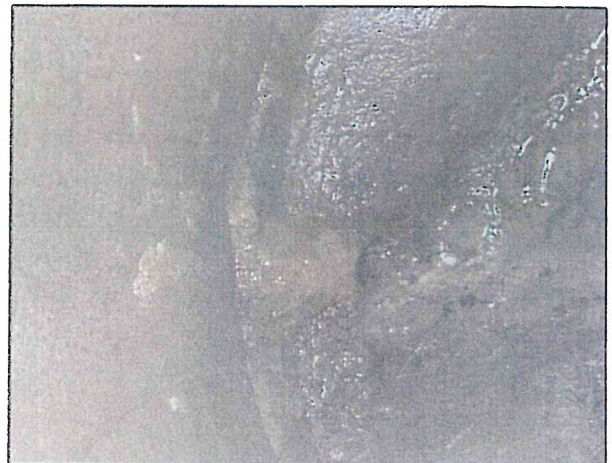
*Image 1 – MH 6, facing SE*

| Saxman Sewer Structure Summary Table | | | | | | | | | | LOF Grades: 0=No Defect, 1=Minor Defect, 2=Minor to Moderate Defect, 3=Moderate Defect, 4=Significant Defect, 5=Most Significant Defect | | | | | | | | | |
|---|---|---|---|---|---|---|---|---|---|---|---|---|---|---|---|---|--|--|--|
| MH 6 | 84 | Pre-cast Concrete | 3 | 3 | 2 | 2 | 3 | N/A | 2 | 3 | 2 | 2 | 2 | 3 | 2 | - Surface corrosion on frame and lid<br>- Infiltration at barrel section and base joint<br>- Infiltration with rebar at pipe 2 connection | | | |

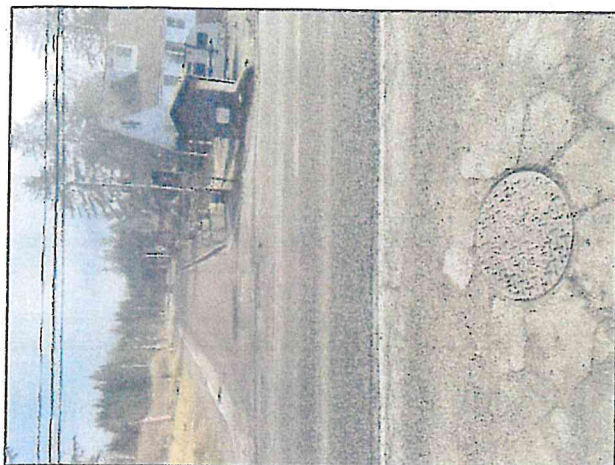
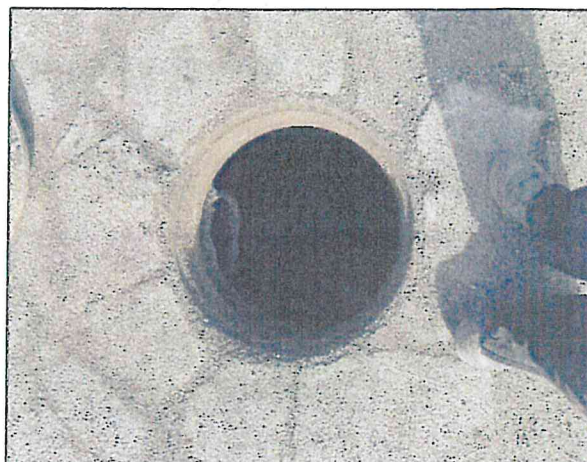
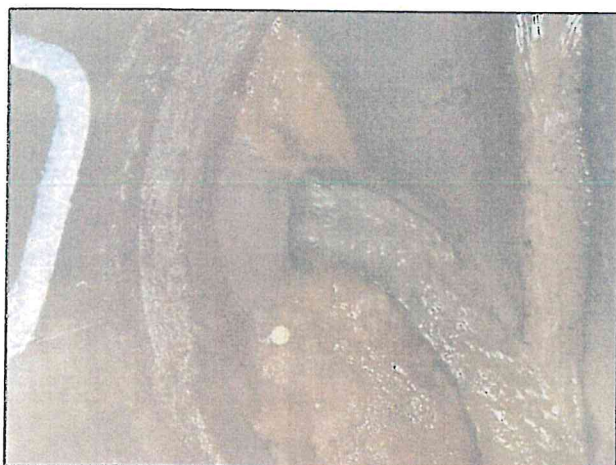
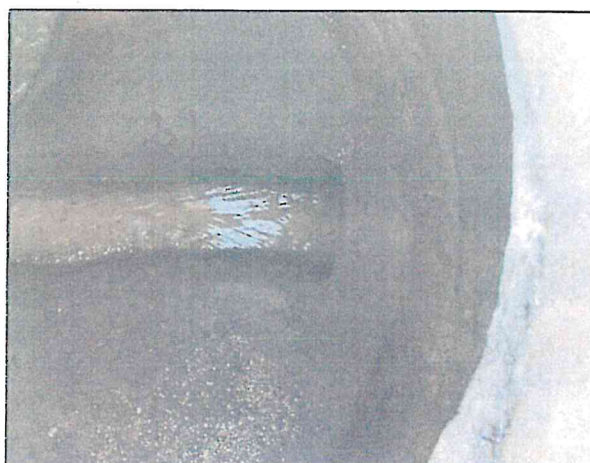
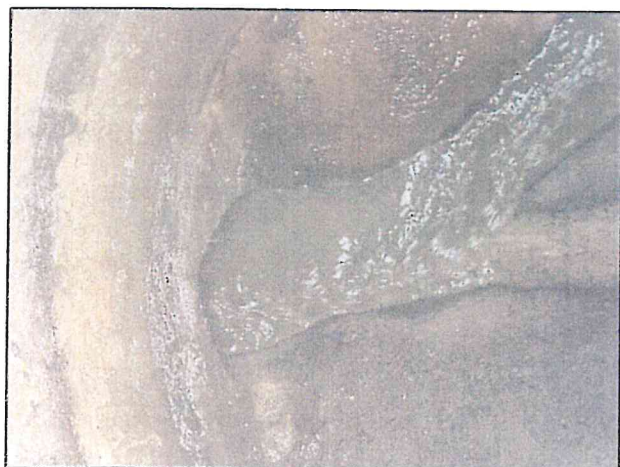
*Image 1 – MH 5, facing NE*

| Saxman Sewer Structure Summary Table | | | | | | | | | | LOF Grades: 0=No Defect, 1=Minor Defect, 2=Minor to Moderate Defect, 3=Moderate Defect, 4=Significant Defect, 5=Most Significant Defect | | | | | | | | | |
|---|---|---|---|---|---|---|---|---|---|---|---|---|---|---|---|---|--|--|--|
| MH 5 | 69 | Pre-cast Concrete | 3 | 3 | 2 | 2 | 1 | 2 | N/A | 2 | 3 | 2 | 3 | 2 | 2 | - Surface corrosion on frame and lid<br>- Significant infiltration at barrel section and cone joint | | | |

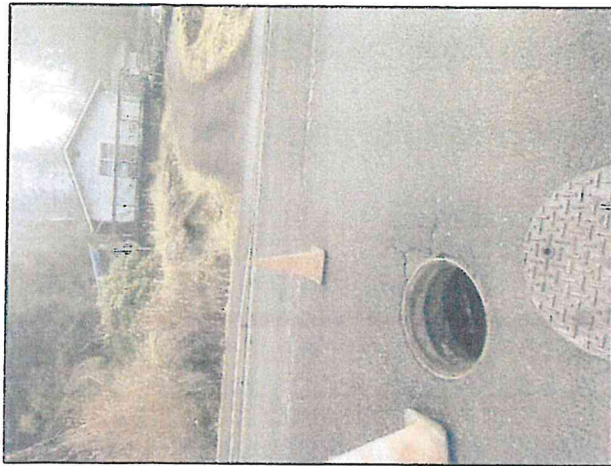
*Image 1 – MH 5A, facing NE*

| Saxman Sewer Structure Summary Table | | | | | | | | | | LOF Grades: 0=No Defect, 1=Minor Defect, 2=Minor to Moderate Defect, 3=Moderate Defect, 4=Significant Defect, 5=Most Significant Defect | | | | | | | | | |
|---|---|---|---|---|---|---|---|---|---|---|---|---|---|---|---|---|--|--|--|
| MH 5A | 99 | Pre-cast Concrete | 3 | 2 | 2 | 2 | 3 | 2 | N/A | 3 | 3 | 2 | 2 | 2 | 2 | - Surface corrosion on frame and lid<br>- Infiltration at barrel section and base joint<br>- Infiltration with rebar at pipe 2 connection | | | |

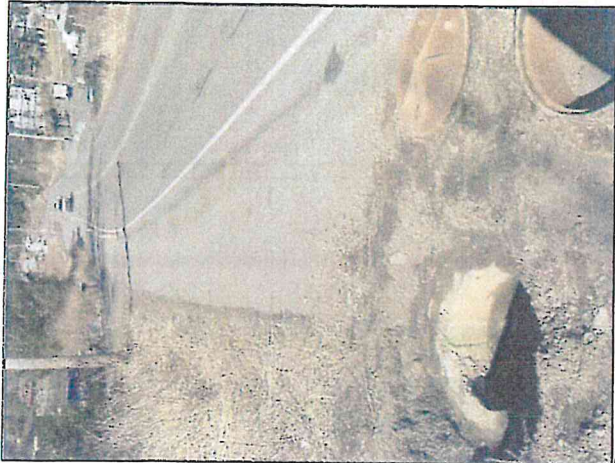
| Saxman Sewer Structure Summary Table | | | | | | | | | | LOF Grades: 0=No Defect, 1=Minor Defect, 2=Minor to Moderate Defect, 3=Moderate Defect, 4=Significant Defect, 5=Most Significant Defect | | | | | | | | | |
|---|---|---|---|---|---|---|---|---|---|---|---|---|---|---|---|---|--|--|--|
| MH 6A | 78 | Pre-cast Concrete | 3 | 3 | 2 | 2 | 2 | 2 | N/A | 2 | 3 | 2 | 2 | 3 | 3 | - Surface corrosion on frame and lid<br>- Infiltration around all pipe connections, and at barrel and base joint | | | |

*ge 1 – MH 6A, facing NE*

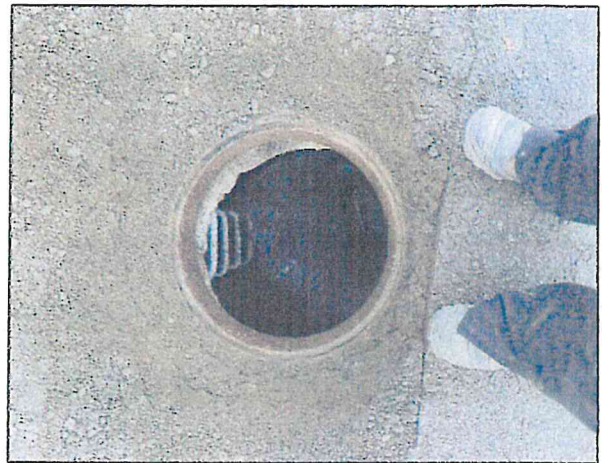
| Saxman Sewer Structure Summary Table | | | | | | | | | | LOF Grades: 0=No Defect, 1=Minor Defect, 2=Minor to Moderate Defect, 3=Moderate Defect, 4=Significant Defect, 5=Most Significant Defect | | | | | | | | | |
|---|---|---|---|---|---|---|---|---|---|---|---|---|---|---|---|---|--|--|--|
| MH 8 | 79 | Pre-cast Concrete | 2 | 3 | 2 | 2 | N/A | 2 | N/A | 2 | 3 | 2 | 2 | 3 | 2 | - Surface corrosion on frame and lid<br>- Infiltration at barrel section and base joint<br>- Evidence of infiltration at connection 1 | | | |

*Image 1 – MH 8, facing E*

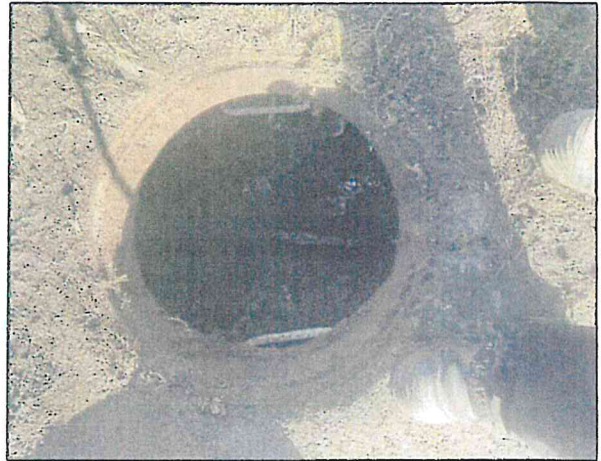
| Saxman Sewer Structure Summary Table | | | | | | | | | | LOF Grades: 0=No Defect, 1=Minor Defect, 2=Minor to Moderate Defect, 3=Moderate Defect, 4=Significant Defect, 5=Most Significant Defect | | | | | | | | | |
|---|---|---|---|---|---|---|---|---|---|---|---|---|---|---|---|---|--|--|--|
| MH 9 | 69 | Pre-cast Concrete | 3 | 3 | 2 | 2 | 3 | N/A | 2 | 3 | 3 | 2 | 2 | 2 | 2 | - Surface corrosion on frame and lid<br>- Infiltration at barrel section joints with attached deposits | | | |

*Image 1 – MH 9, facing SW*

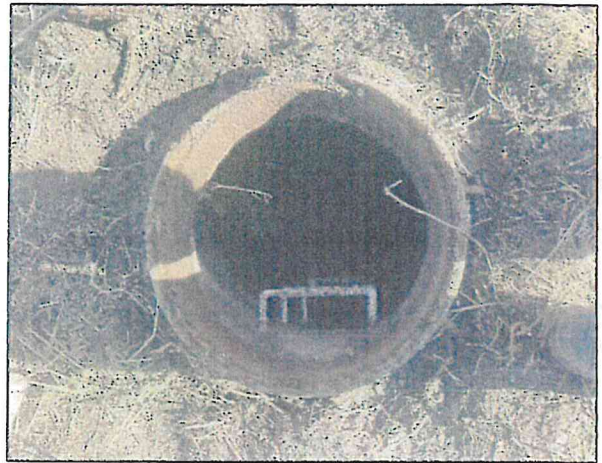
| Saxman Sewer Structure Summary Table | | | | | | | | | | LOF Grades: 0=No Defect, 1=Minor Defect, 2=Minor to Moderate Defect, 3=Moderate Defect, 4=Significant Defect, 5=Most Significant Defect | | | | | | | | | |
|---|---|---|---|---|---|---|---|---|---|---|---|---|---|---|---|---|--|--|--|
| MH 9A | 71 | Pre-cast Concrete | 3 | 3 | 2 | 3 | N/A | 2 | N/A | 2 | 2 | 2 | 2 | 3 | 3 | - Surface corrosion on frame and lid<br>- Infiltration at barrel section and base joint<br>- Rim of frame broken at NE end | | | |

*Image 1 – MH 9A, facing NW*

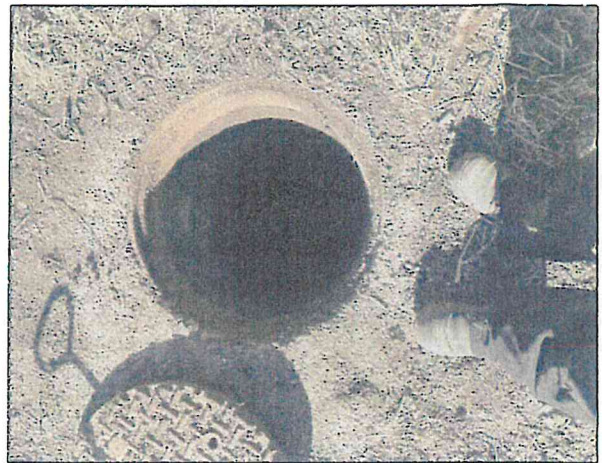
| Saxman Sewer Structure Summary Table | | | | | | | | | | LOF Grades: 0=No Defect, 1=Minor Defect, 2=Minor to Moderate Defect, 3=Moderate Defect, 4=Significant Defect, 5=Most Significant Defect | | | | | | | | | |
|---|---|---|---|---|---|---|---|---|---|---|---|---|---|---|---|---|--|--|--|
| MH 10 | 73 | Pre-cast Concrete | 3 | 2 | 2 | 2 | 2 | 2 | N/A | 2 | 3 | 2 | 3 | 2 | 2 | - Surface corrosion on frame and lid<br>- Infiltration at barrel section and base joint | | | |

*Image 1 – MH 10, facing SE*

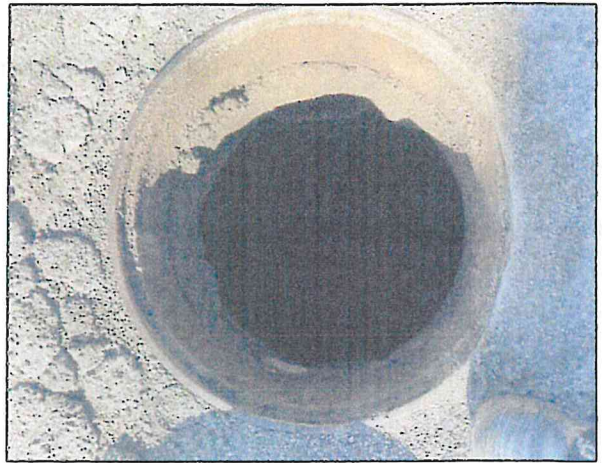
| Saxman Sewer Structure Summary Table | | | | | | | | | | LOF Grades: 0=No Defect, 1=Minor Defect, 2=Minor to Moderate Defect, 3=Moderate Defect, 4=Significant Defect, 5=Most Significant Defect | | | | | | | | | |
|---|---|---|---|---|---|---|---|---|---|---|---|---|---|---|---|---|--|--|--|
| MH 11 | 62 | Pre-cast Concrete | 3 | 3 | 2 | 2 | 3 | 2 | N/A | 3 | 3 | 2 | 2 | 2 | 2 | - Surface corrosion on frame and lid<br>- Infiltration at barrel section and base joint<br>- Crack in chimney at N. end | | | |

*Image 1 – MH 11, facing SE*

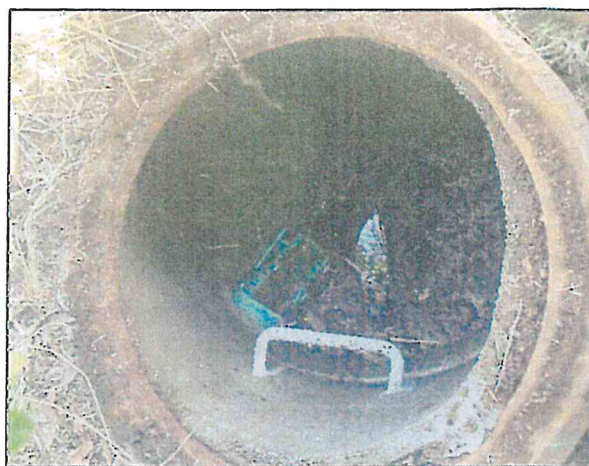
| Saxman Sewer Structure Summary Table | | | | | | | | | | LOF Grades: 0=No Defect, 1=Minor Defect, 2=Minor to Moderate Defect, 3=Moderate Defect, 4=Significant Defect, 5=Most Significant Defect | | | | | | | | | |
|---|---|---|---|---|---|---|---|---|---|---|---|---|---|---|---|---|--|--|--|
| MH 12 | 90 | Pre-cast Concrete | 3 | 2 | 2 | 2 | 3 | 1 | N/A | 1 | 2 | 2 | 2 | 3 | 2 | - Surface corrosion on frame and lid<br>- Exposed rebar around pipe 4 connection | | | |

*Image 1 – MH 12, facing North*

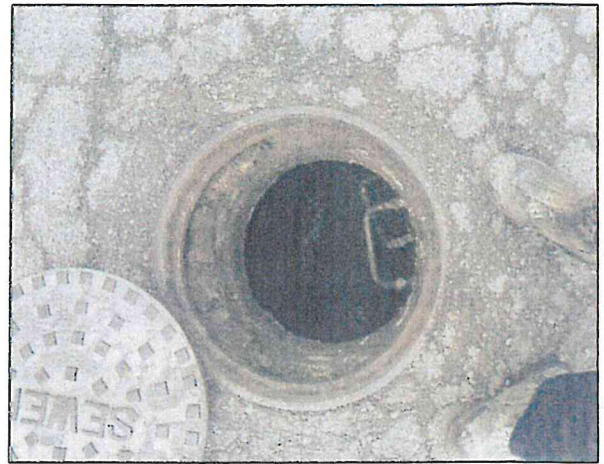
| Saxman Sewer Structure Summary Table | | | | | | | | | | LOF Grades: 0=No Defect, 1=Minor Defect, 2=Minor to Moderate Defect, 3=Moderate Defect, 4=Significant Defect, 5=Most Significant Defect | | | | | | | | | |
|---|---|---|---|---|---|---|---|---|---|---|---|---|---|---|---|---|--|--|--|
| MH 20 | 78 | Pre-cast Concrete | 2 | 2 | 2 | 2 | 3 | 1 | N/A | 1 | 2 | 2 | 2 | 2 | 2 | - Surface corrosion on frame and lid<br>- Chimney crumbling | | | |

Image 1 – MH 20, facing NW

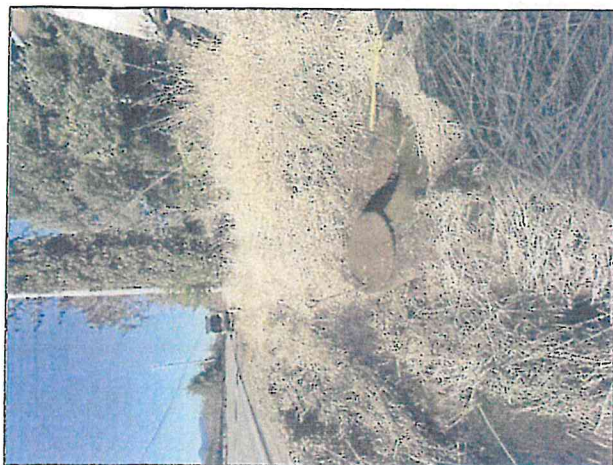
*Image 1 – MH 21, facing NW*

| Saxman Sewer Structure Summary Table | | | | | | | | | | LOF Grades: 0=No Defect, 1=Minor Defect, 2=Minor to Moderate Defect, 3=Moderate Defect, 4=Significant Defect, 5=Most Significant Defect | | | | | | | | | |
|---|---|---|---|---|---|---|---|---|---|---|---|---|---|---|---|---|--|--|--|
| MH 21 | 36 | Pre-cast Concrete | 3 | 3 | 3 | 3 | 3 | 3 | 2 | N/A | 2 | N/A | 2 | 2 | 2 | - Surface corrosion on frame and lid<br>- Infiltration and roots through cover and all through shaft manhole | | | |

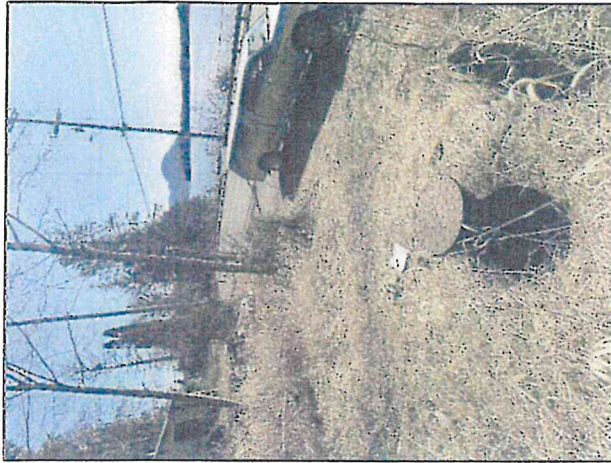
*Image 1 – MH 22, facing S*

| Saxman Sewer Structure Summary Table | | | | | | | | | | LOF Grades: 0=No Defect, 1=Minor Defect, 2=Minor to Moderate Defect, 3=Moderate Defect, 4=Significant Defect, 5=Most Significant Defect | | | | | | | | | |
|---|---|---|---|---|---|---|---|---|---|---|---|---|---|---|---|---|--|--|--|
| MH 22 | 69 | Pre-cast Concrete | 3 | 3 | 2 | 2 | N/A | 2 | N/A | N/A | 3 | 2 | 2 | 3 | 2 | - Surface corrosion on frame and lid | | | |

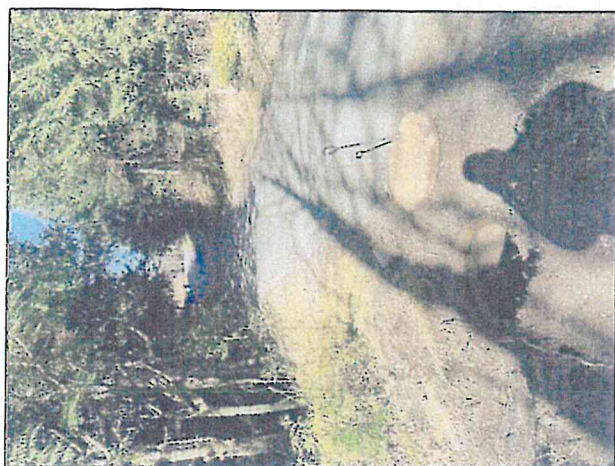
*Image 1 – MH 23, facing NW*

| Saxman Sewer Structure Summary Table | | | | | | | | | | LOF Grades: 0=No Defect, 1=Minor Defect, 2=Minor to Moderate Defect, 3=Moderate Defect, 4=Significant Defect, 5=Most Significant Defect | | | | | | | | | |
|---|---|---|---|---|---|---|---|---|---|---|---|---|---|---|---|---|--|--|--|
| MH 23 | 103 | Pre-cast Concrete | 3 | 2 | 2 | 2 | N/A | 3 | N/A | 3 | 3 | 2 | 2 | 2 | 2 | - Surface corrosion on frame and lid<br>- Infiltration at barrel section and base joint | | | |

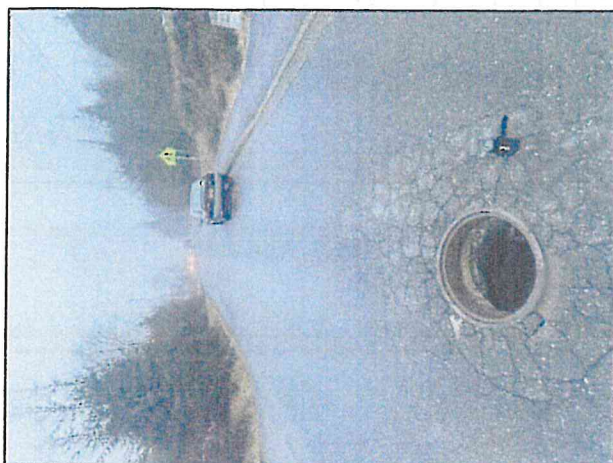
*Image 1 – MH 7, facing NW*

| Saxman Sewer Structure Summary Table | | | | | | | | | | LOF Grades: 0=No Defect, 1=Minor Defect, 2=Minor to Moderate Defect, 3=Moderate Defect, 4=Significant Defect, 5=Most Significant Defect | | | | | | | | | |
|---|---|---|---|---|---|---|---|---|---|---|---|---|---|---|---|---|--|--|--|
| MH 7 | 34 | Pre-cast Concrete | 2 | 2 | 2 | 2 | N/A | N/A | 1 | N/A | 2 | N/A | 1 | 3 | 2 | - Surface corrosion on frame and lid<br>- Frame 3-4" offset | | | |

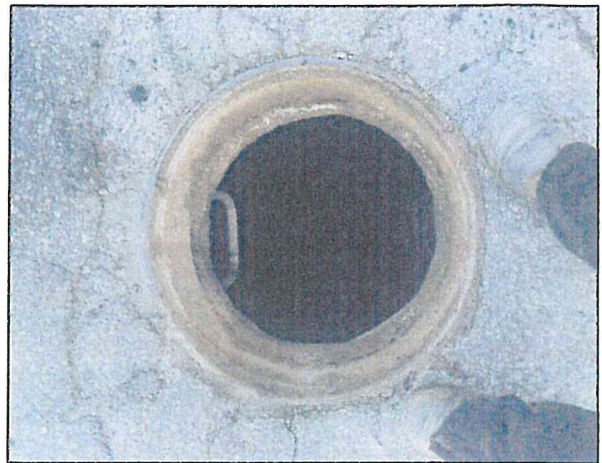
*Image 2 – Shelf and connections*

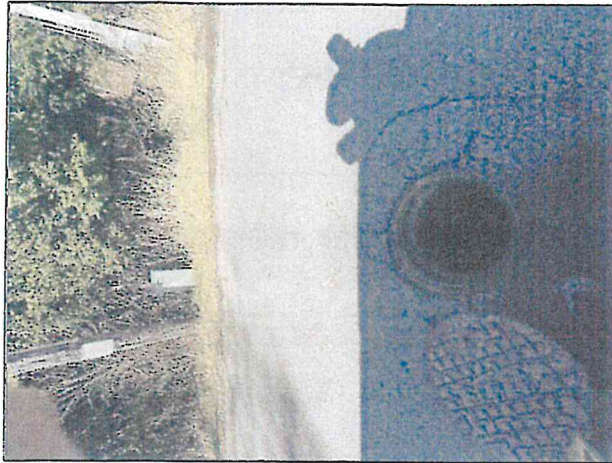
*Image 5 – Base infiltration*

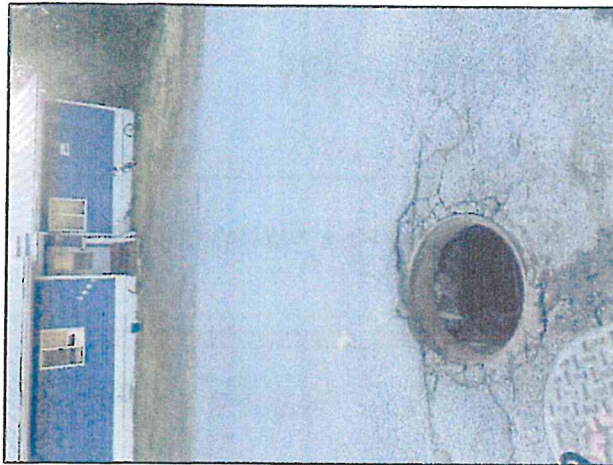
*Image 4 – Chimney and Frame offset*

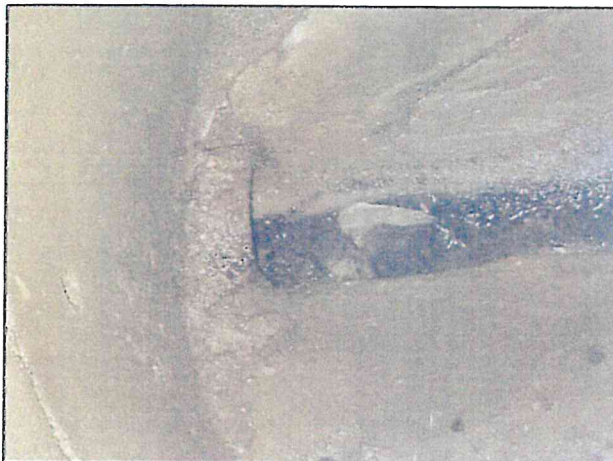
*Image 3 – Connection 1*

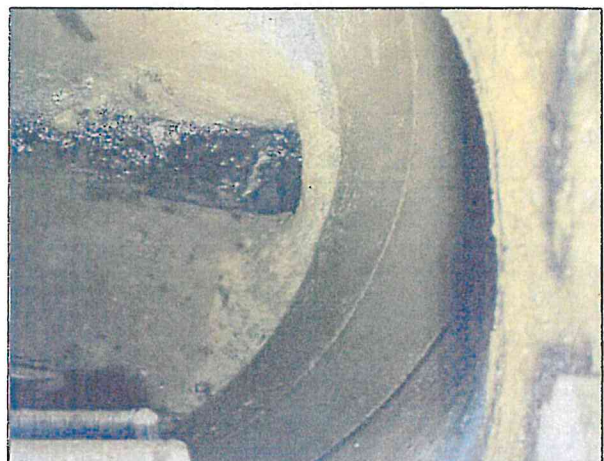
*Image 4 – Connection 2*

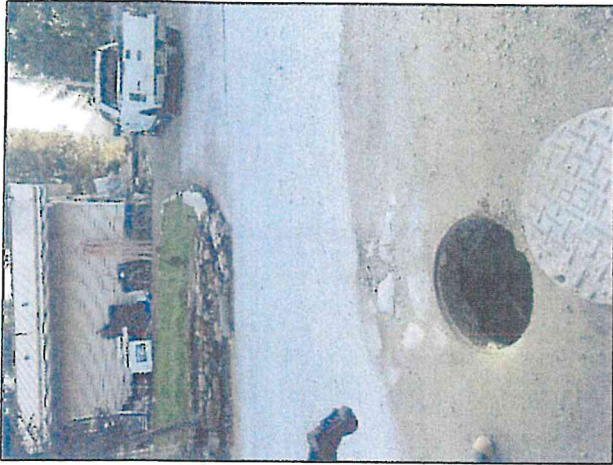
*Image 1 – MH F, facing SW*

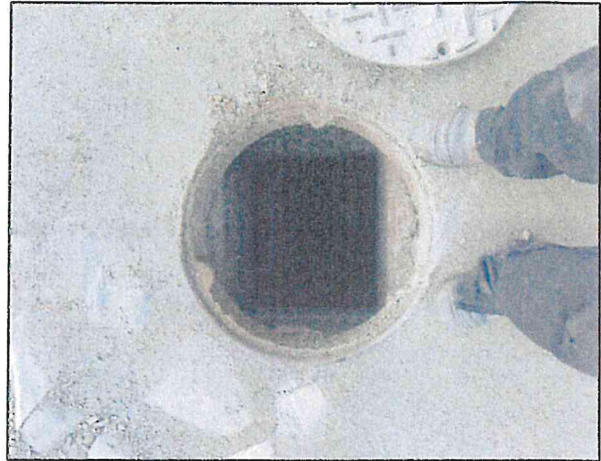
*Image 2 – Shelf and connections*

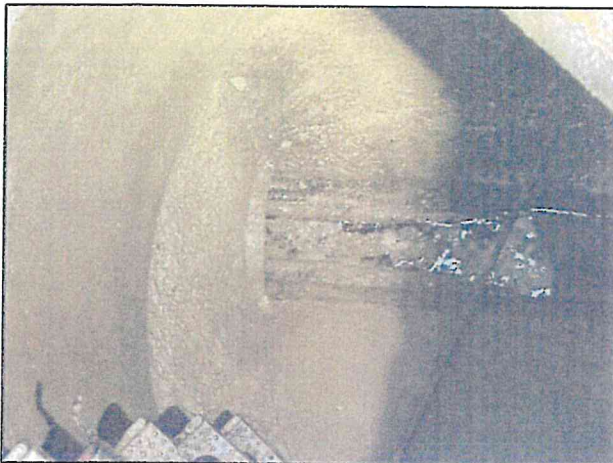
*Image 3 – Connection 3*
