**Draft**  
**Saxman Sewer Condition Assessment**

May 24<sup>th</sup>, 2024

**Stephl Engineering, LLC.**  
**3900 Arctic Blvd., Suite 204**  
**Anchorage, Alaska 99503**  
**907-562-1468**

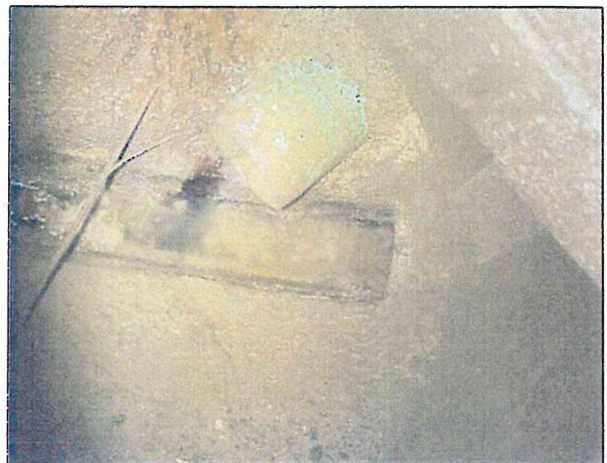
*Image 4 – Connection 1 and 2*
