**Underdrain and IMS Cap  
Trip Report**

## **Filter #6**

**Sheboygan WTP**

**February 14, 2023**

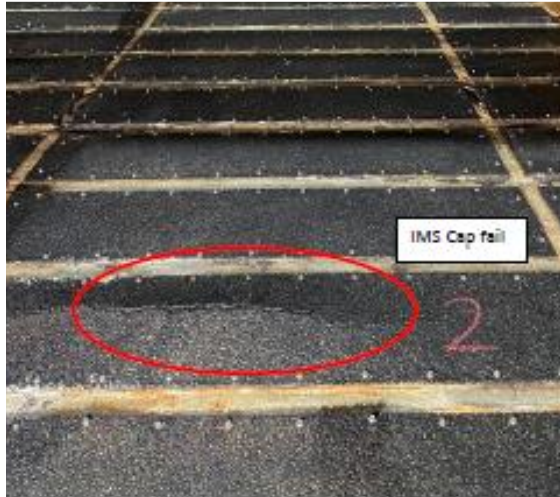
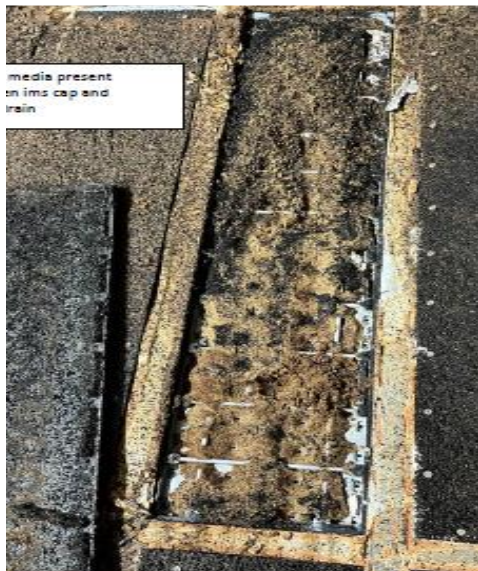
Filter 6 IMS Cap Fail

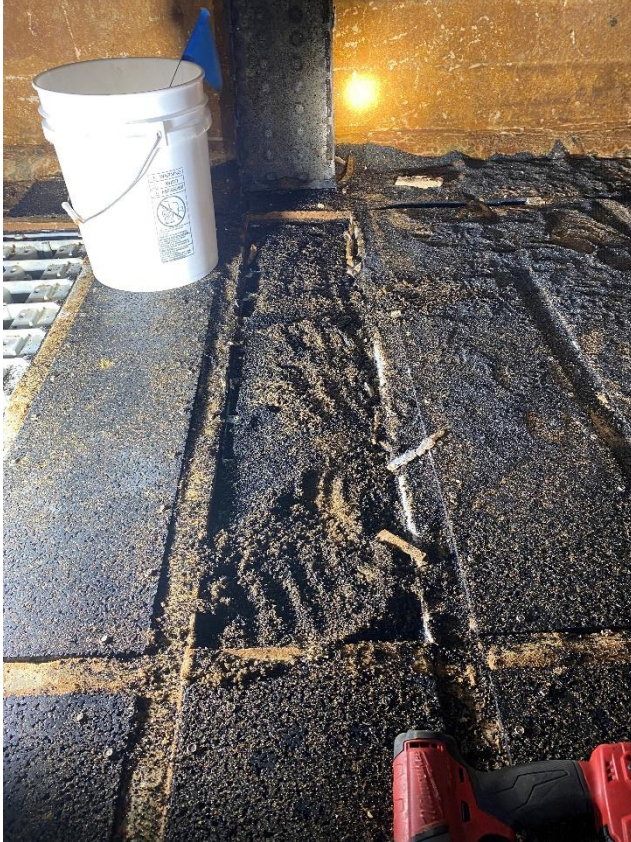
Several I.M.S Caps were removed prior to Leopold arrival. The caps removed had similar coating as filter #5. The bottom side of the caps had a white coating.

Leopold did a visual inspection on filter #6. The seal breach under the hold down angle as shown on the above photo was the cause of media inflowing into the underdrain primary chamber. The media was then pushed into the filter underdrain laterals during backwash causing the caps to bow upward and, in some cases, split the caps down the middle. Other caps within the filters had screws that were also lifted due to the excessive pressure. The I.M.S Caps at this point are damaged beyond repair and will need to be replaced.

As previously stated, Filter #6 Type S underdrains are in good condition but the I.M.S caps need to be removed and replaced. We recommend a similar procedure to what was done on filter #5. Remove the I.M.S Caps, flush the effected laterals and replace with I.M.S 200 media retainer. This process will provide many additional years of service for the existing system. Leopold will provide a proposal and price for I.M.S. cap replacement with I.M.S. 200 media retainers and field services along with procedures for flushing the underdrains to remove trapped filter media.
