Change Order

Project: Mulberry Street Roadway and Sidewalk Improvements	Owner: Town of Shallotte	Owner's Contract No.:
Contract: Mulberry Street Roadway and Sidewalk Improvements		Date of Contract: August 7, 2024
Contractor: J.P. Russ & Son, INC.		Engineer's Project No.: 22.07019

FOUNDATION OBSERVATIONS REPORT

Mulberry Street RT Wall
120 Mulberry Street
Shallotte, NC 28470

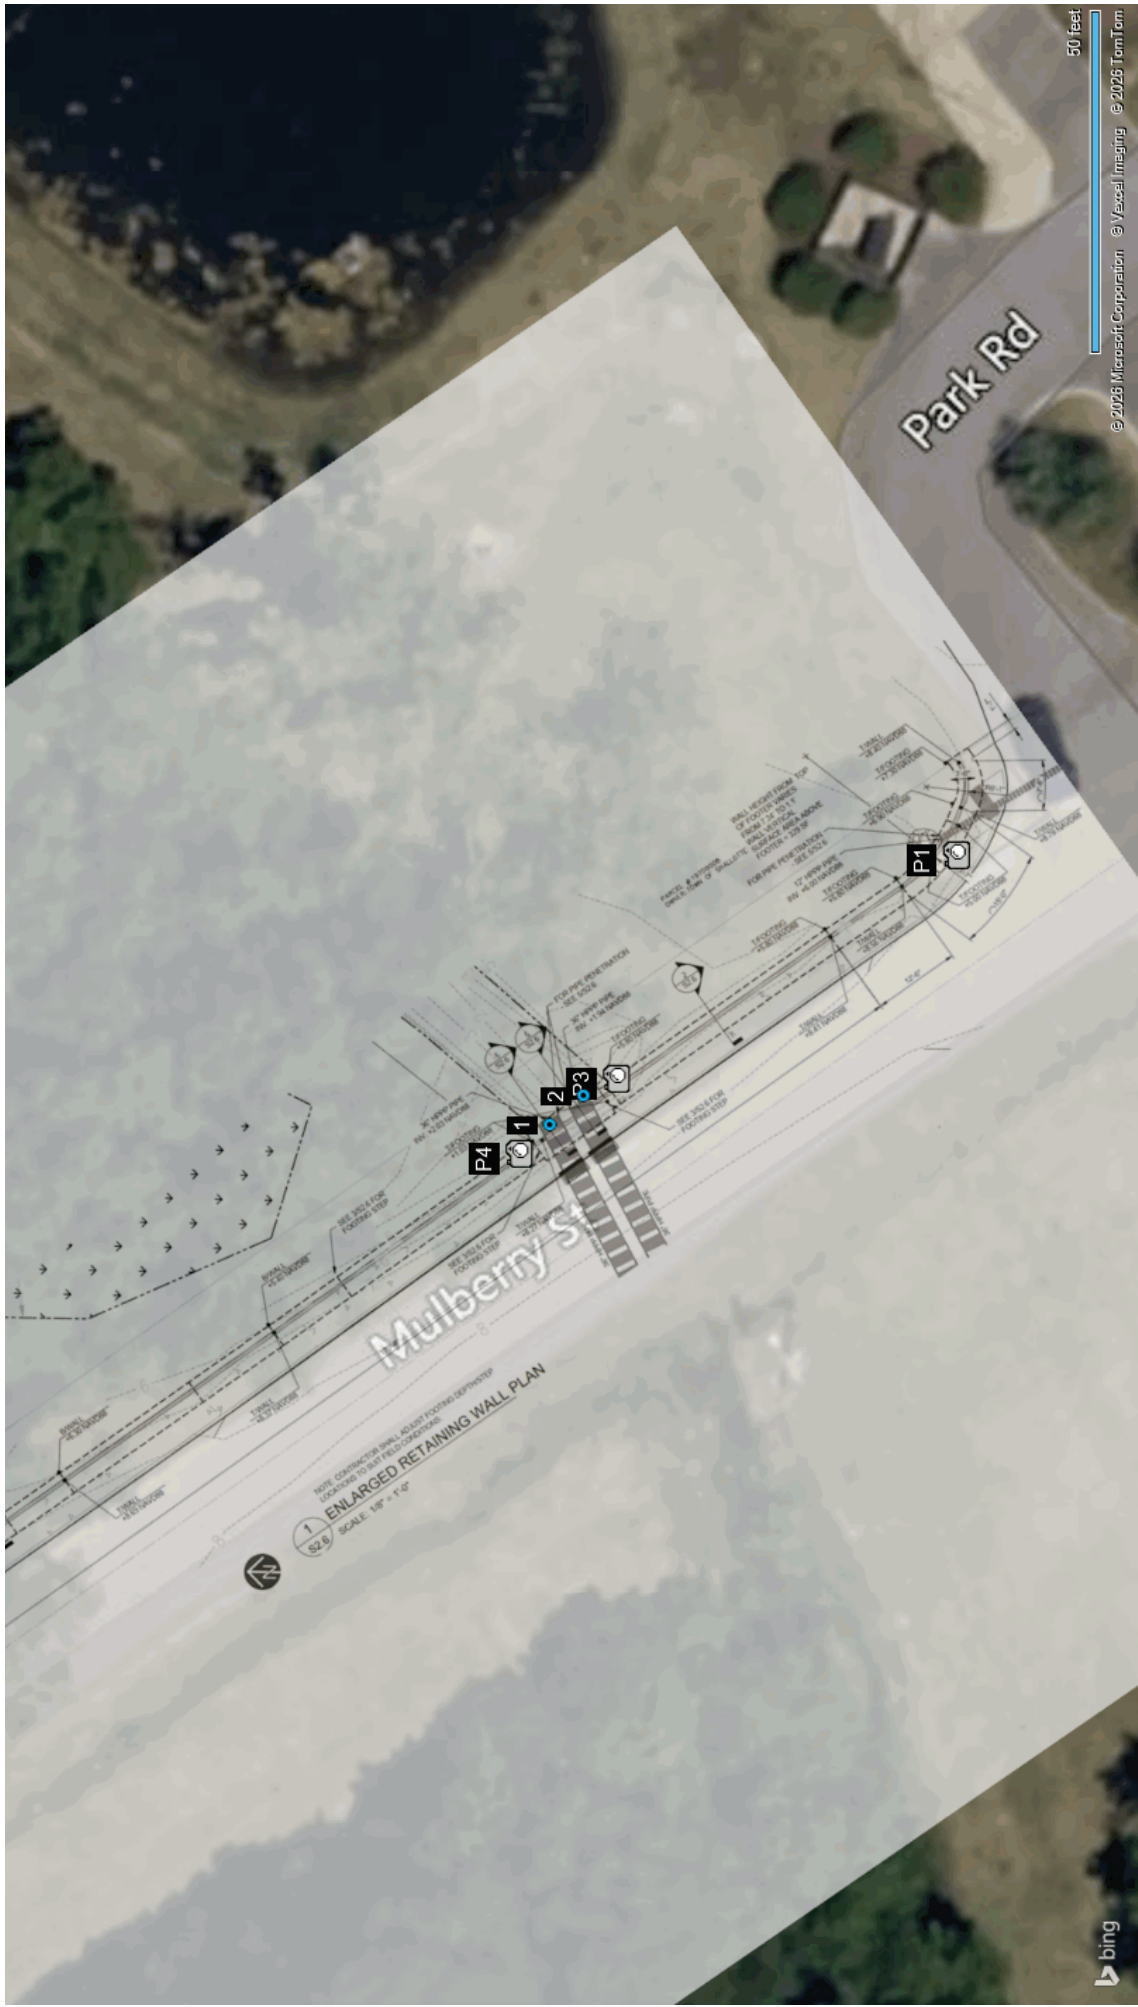
Exhibit	A-1
	Mulberry Street RT Wall
Foundation Observations

Test No./Element/ Location	Test Results	Bearing Strata	Status	Comments
(1) Continuous Footing(s)/ South end of Northwest retaining wall footings	BOF: 1, 1, 3 -1: 1, 2, 3 -2: 4, 4, 5 -3: 3, 3, 4	Moist Brown clay Existing Subgrade	Complies (after remediation)	Undercut: 48' Length X 5' Width x 2' Depth = 480cf/27 = 17.8cy Geotextile Fabric: 48' Length x 2' Depth = 96sf/9 = 10.7sy (sides) x2 = 21.3sy 48' Length x 5' Width = 240sf/9 = 26.7sy (bottom)

(2) Continuous Footing(s)/ South end of Northwest retaining wall footings	BOF: 2, 2, 2 -1: 2, 2, 3 -2: 2, 3, 4 -3: 7, 12, 13	Moist Brown clay Existing Subgrade	Complies (after remediation)	Undercut: 48' Length X 5' Width x 2' Depth = 480cf/27 = 17.8cy Geotextile Fabric: 48' Length x 2' Depth = 96sf/9 = 10.7sy (sides) x2 = 21.3sy 48' Length x 5' Width = 240sf/9 = 26.7sy (bottom)

In area(s) 1, 2, and 3, Terracon recommends a 1 undercut and replacing with washed stone with fabric on the bottom and sides of footing.

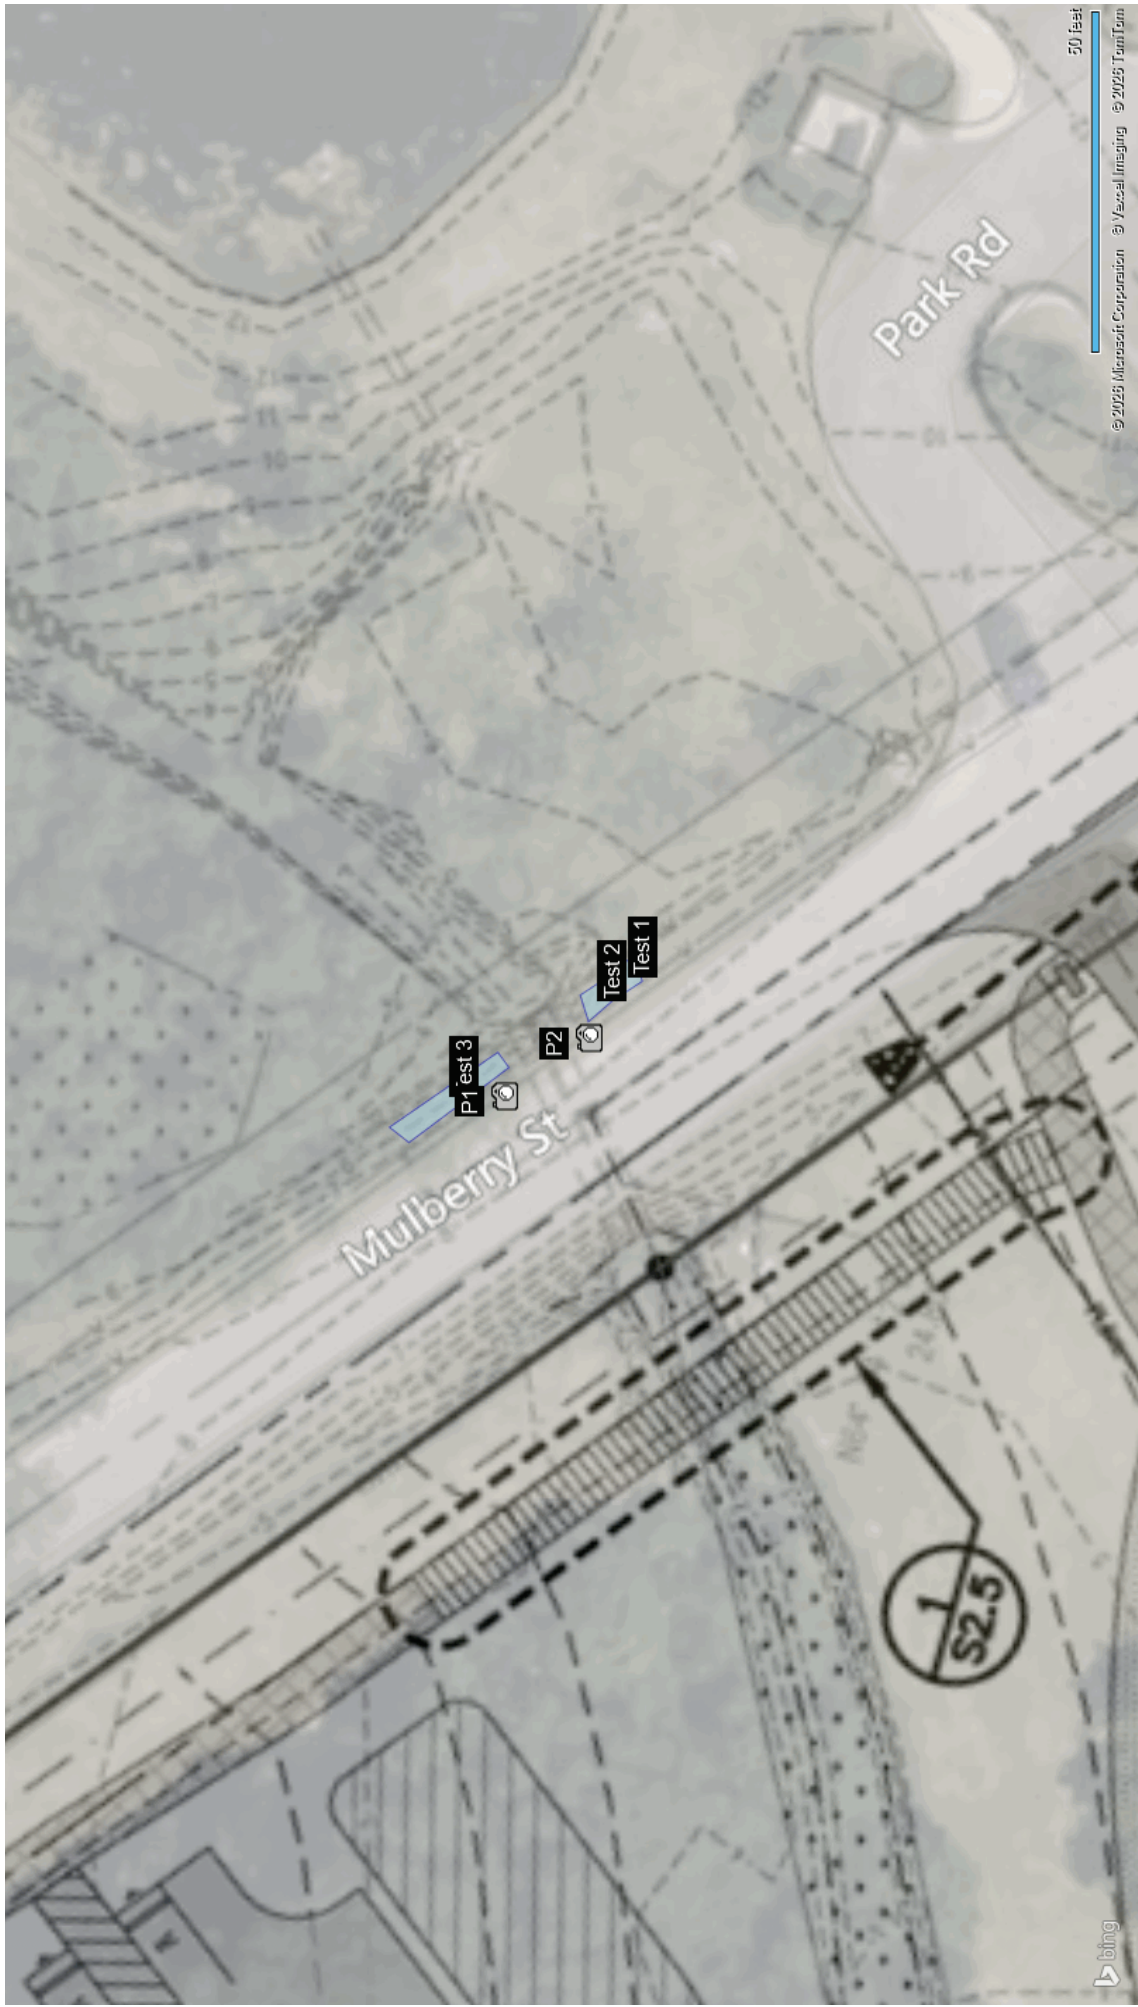
Mulberry Street RT Wall	Exhibit
	A-1
Foundation Observations

(P2) South end of Northwest retaining wall

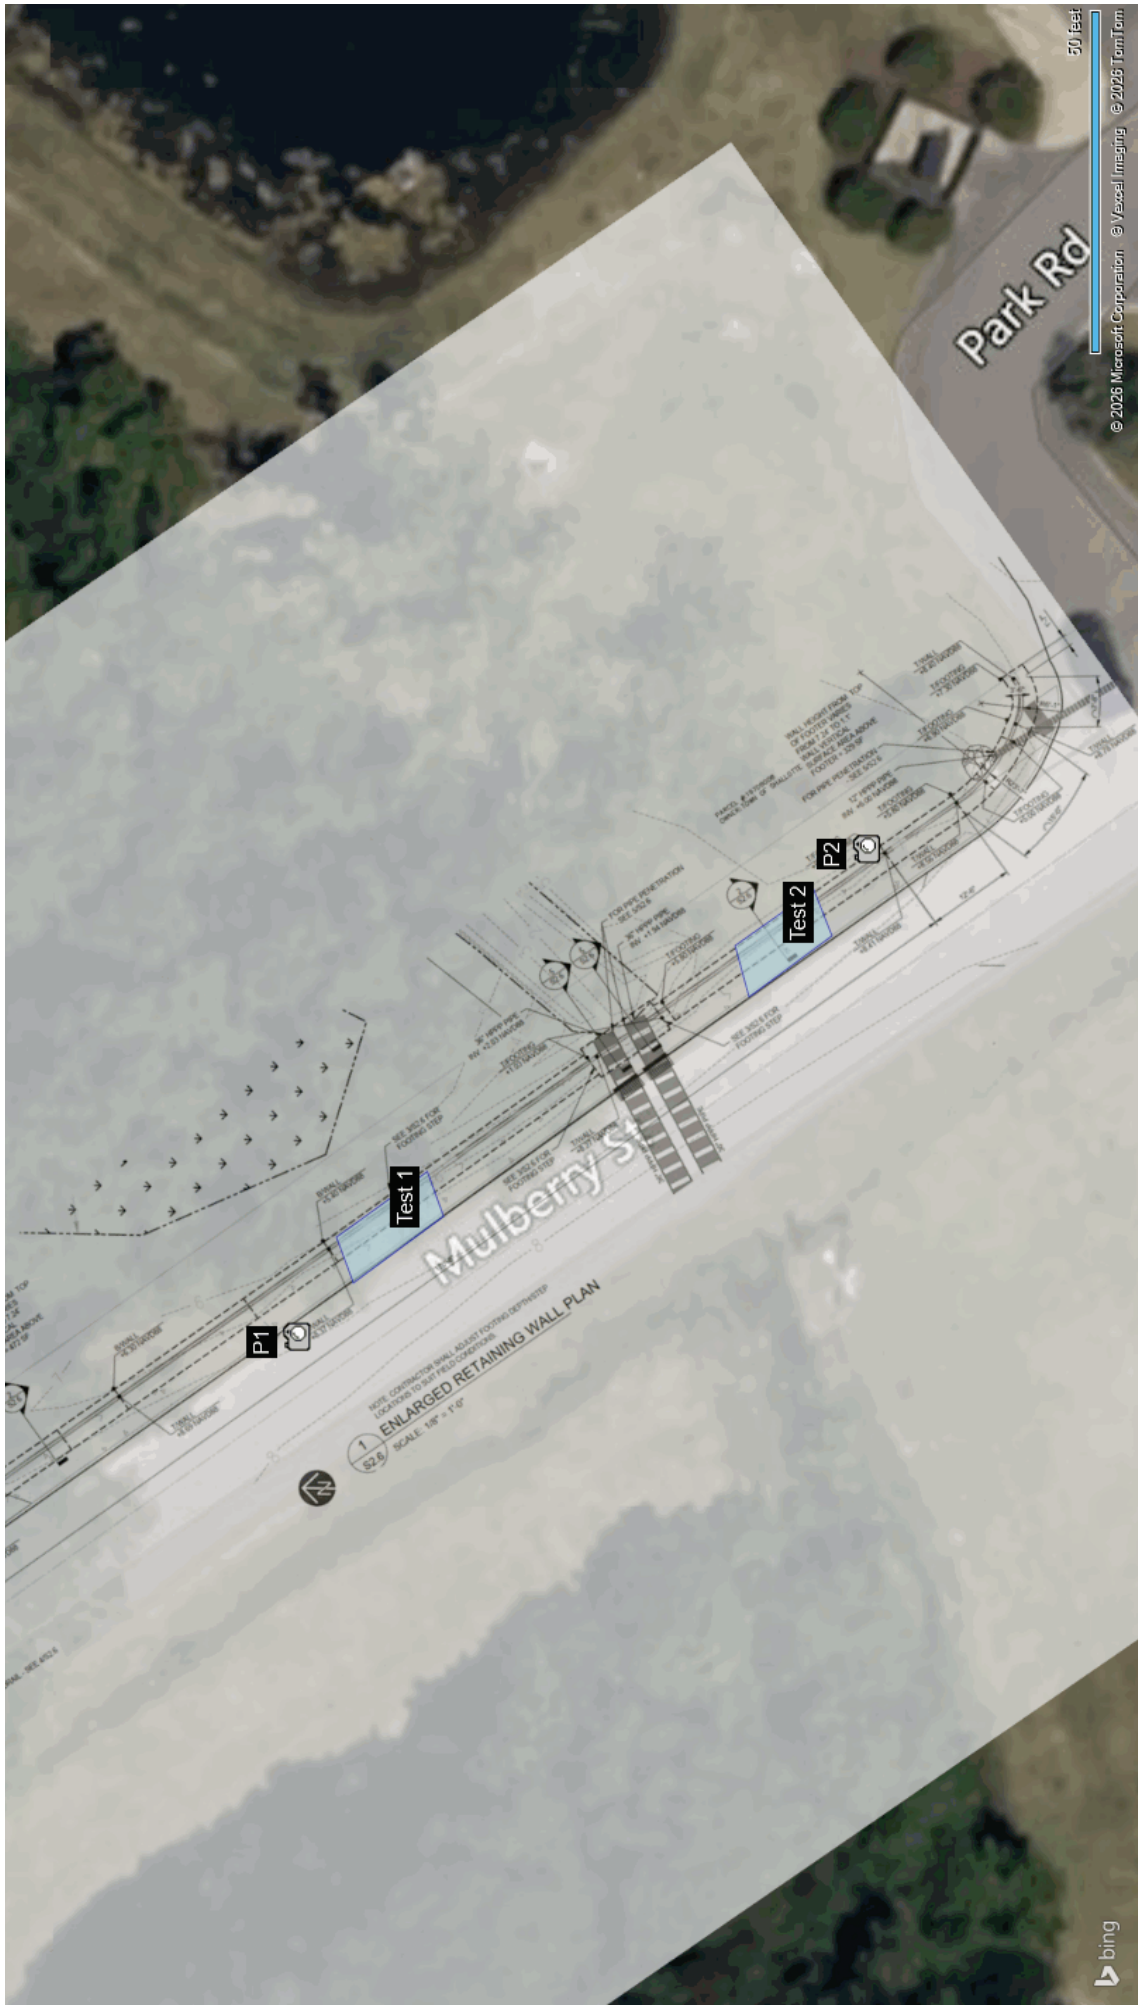
Mulberry Street RT Wall	Exhibit
	A-1
Foundation Observations

Test No./Element/ Location	Test Results	Bearing Strata	Status	Comments
(1) Continuous Footing(s)/ North end of Northwest retaining wall	BOF: 2, 2, 3 -1: 3, 3, 4 -2: 3, 6, 12 -3: 3, 6, 12	Dark Brown Silty Clay Existing Subgrade	Complies (After Remediation)	Undercut: 40' Length X 5' Width x 1' Depth = 200cf/27 = 7.4cy Geotextile Fabric: 40' Length x 1' Depth = 40sf/9 = 4.4sy (sides) x2 = 8.9sy 40' Length x 5' Width = 200sf/9 = 22.2sy (bottom)
(2) Continuous Footing(s)/ South end of Northwest retaining wall	BOF: 1, 1, 3 -1: 3, 4, 5 -2: 3, 4, 7 -3: 2, 2, 3	Moist Gray Clay Existing Subgrade	Complies (After Remediation)	Undercut: 20' Length X 5' Width x 1' Depth = 100cf/27 = 3.7cy Geotextile Fabric: 20' Length x 1' Depth = 20sf/9 = 2.2sy (sides) x2 = 4.4sy 20' Length x 5' Width = 100sf/9 = 11.1sy (bottom)
