# **Division Avenue Road Safety Audit**

**Prepared for:  
Sandpoint, Idaho**

December 14, 2020

UT20-2220

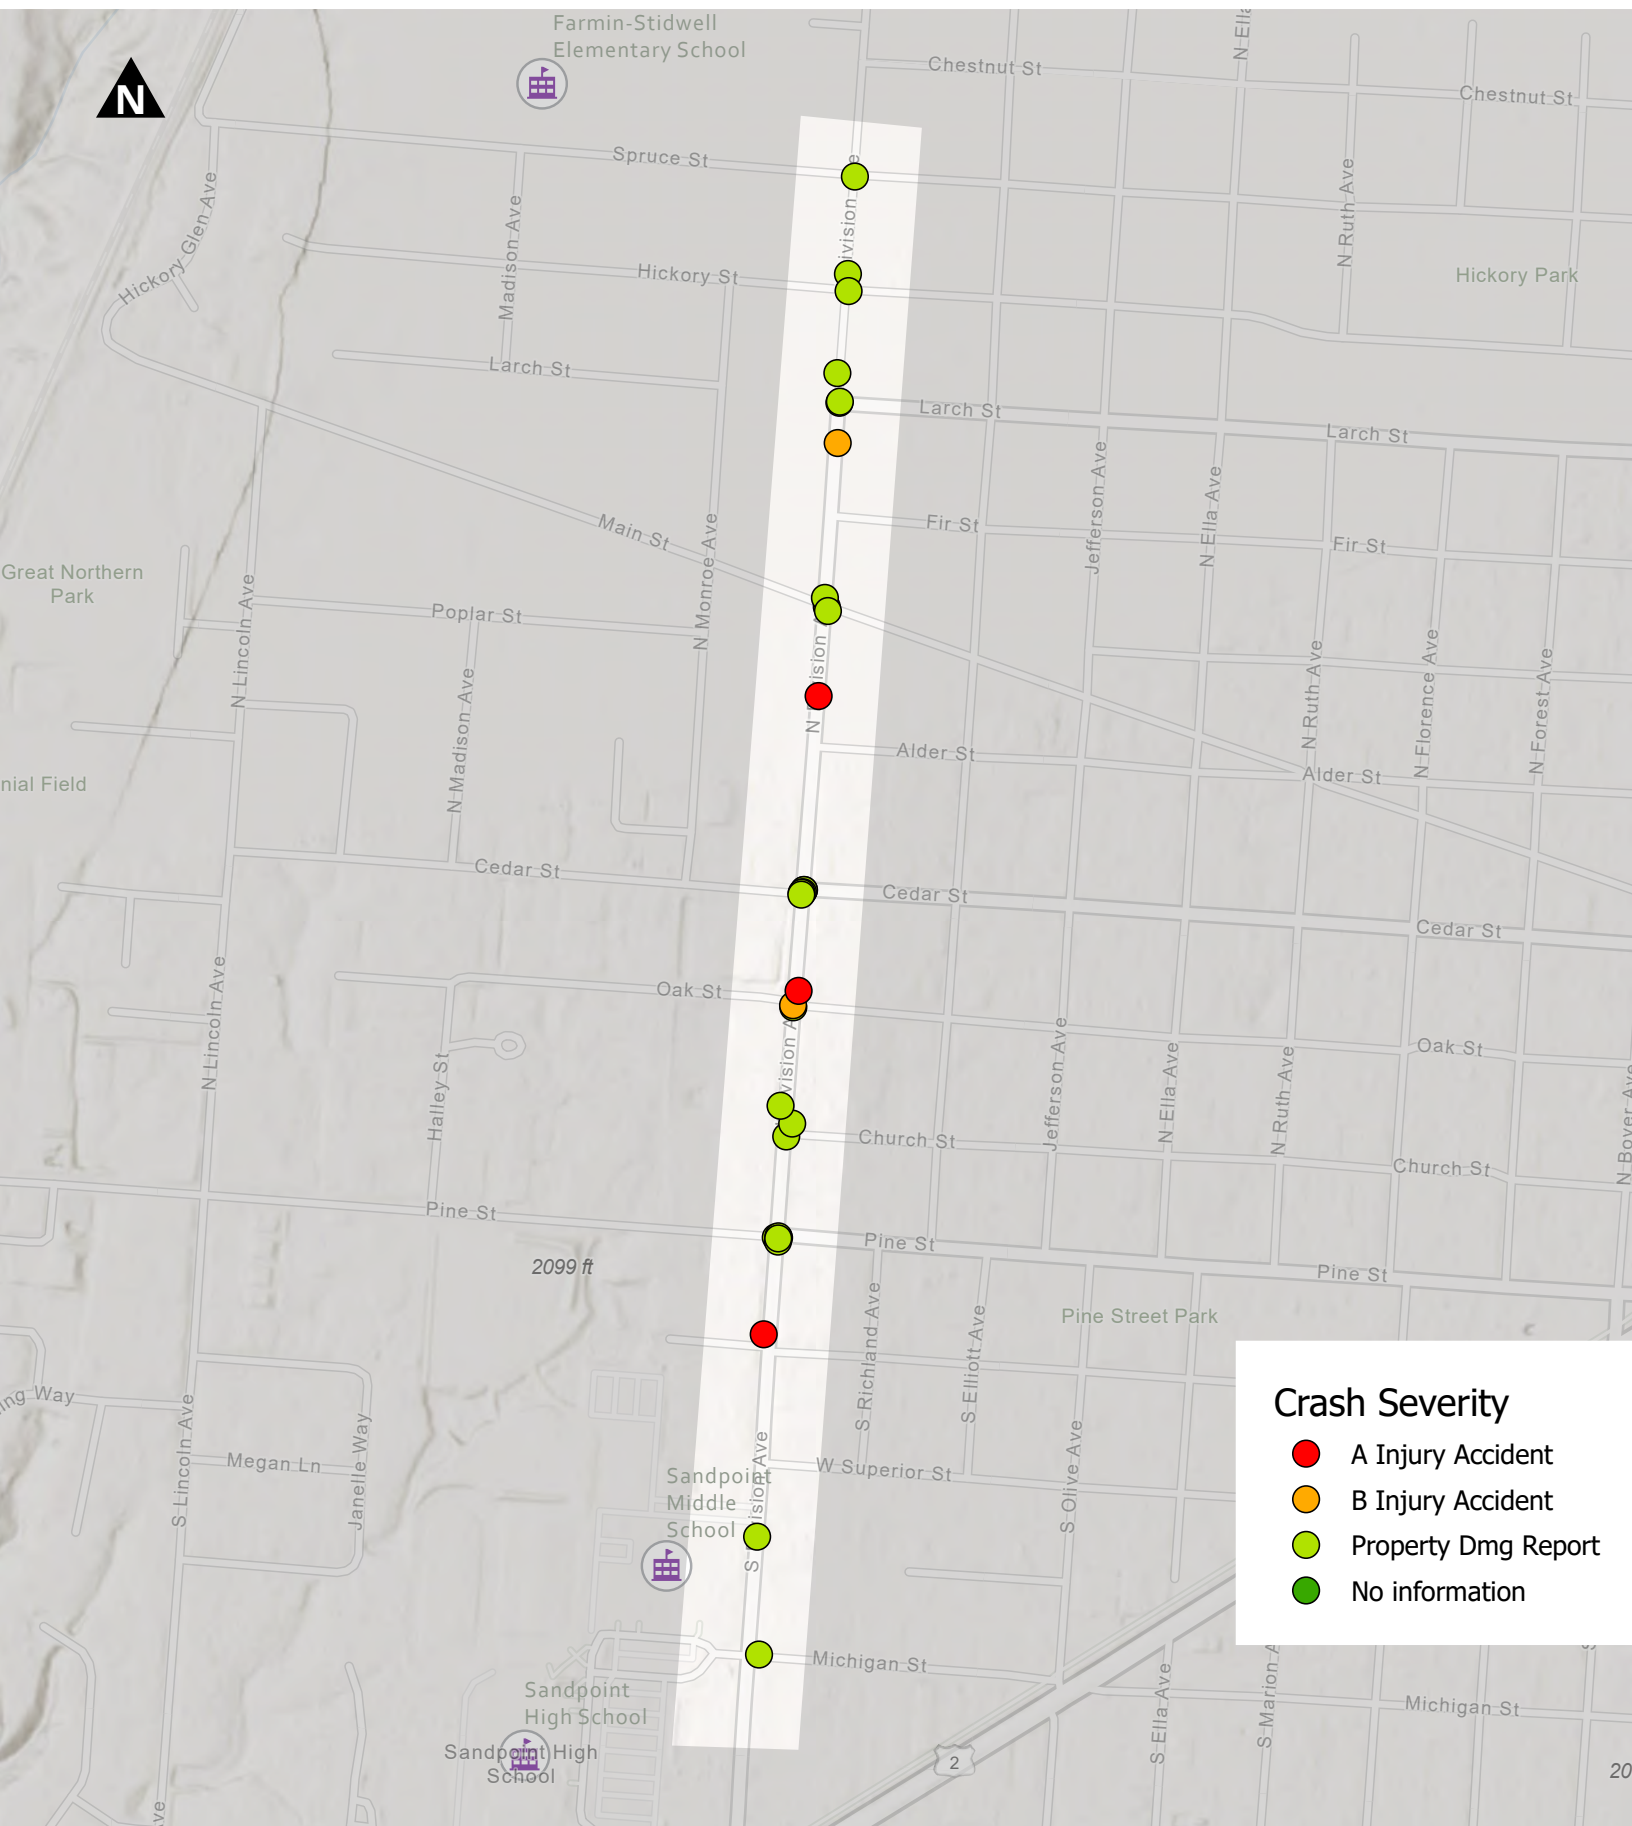
Figure 3

**Figure 3** shows a map of the crashes within the RSA study area by severity, **Figure 4** shows a map of the crashes within the RSA study area by type, and **Figure 5** shows a heatmap of the crashes in the study area to indicate crash density.

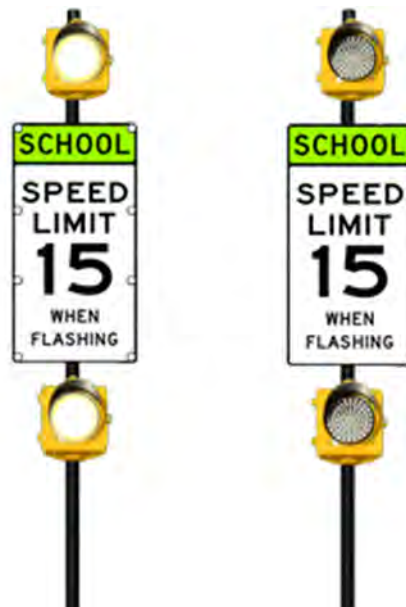
Figure 7: School Speed Limit Signs with Flashing Beacons

The school zone speed limit is 20mph (5mph lower than the normal speed limit on Division Avenue) and active from 7:30 AM to 3:30 PM. To increase compliance with the school zone speed limit, the RSA team

recommends adding flashing lights to the school zone speed reduction signs (see **Figure 7** for example); the flashing lights should be either automatically scheduled, or manually activated by a crossing guard. The RSA team also recommends that the school zone speed limit reduction should only active during school opening and closing peak periods, when students are likely to be present. If speeds continue to be an issue during the school opening and closing peak period, then reducing the school zone speed limit to 15mph (10mph lower than the normal speed limit) would be appropriate. Police presence to enforce the speeds should continue to be a priority.
