CITY PARKING LOT IMPROVEMENTS 2025

218 CHURCH STREET, SANDPOINT, IDAHO

Idaho Department Of Lands Tree Inventory

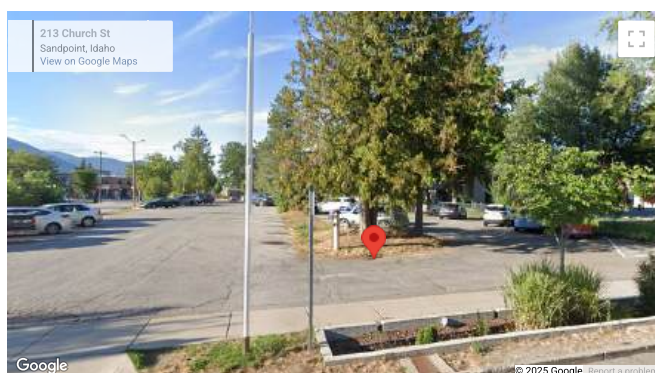
IMG_2707.jpg
9/29/2018

Tree Id:	7764
Latin Name:	Thuja plicata
Common Name:	Western Redcedar
Cultivar:	
Genus:	Thuja
Code:	THPL
Status:	Alive
Year Planted:	
DBH:	14
DBH Range:	12-18in
Tree Height:	
Number of Stems:	1
Condition:	Good - No Apparent Problems
Percent Dieback:	None
Crown Class:	Co-Dominant
Clearance Conflicts:	None

Observations:	
Stock Type:	
Tree Comments:	
Family:	Cupressaceae
Has Ecobenefits:	Yes
Last Modified:	09/29/2018
Upload ID:	upld_5818ec7cd30a8
User - Upload:	
Last Inspection:	
Next Inspection:	
Inspection Cycle:	
Crown Light Exposure:	
Archived:	No
Tree Protection Zone(TPZ):	
Critical Root Zone(CRZ):	
TPZ Ratio:	
CRZ Ratio:

Management Needs	
Primary Maintenance:	Large Tree (routine)
Secondary Maintenance:	None Needed
Wires:	No Lines
Watch This Tree? :	No
Maintenance Comments:	Consider removing one of the two trunks to prevent future problem. Not high priority.
Organization:	Sandpoint
User:	SP_sdrinkard

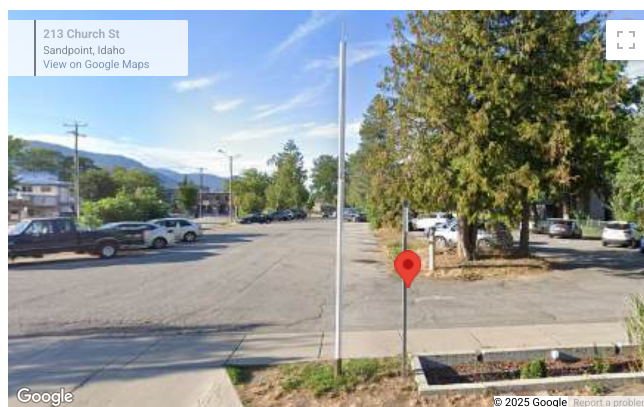
IMG_2707.jpg
9/29/2018

Condition:	Good - No Apparent Problems
Percent Dieback:	None
Crown Class:	Co-Dominant
Clearance Conflicts:	None
Observations:	Poor Structure, Double Leader
Stock Type:	
Tree Comments:	Two trunked cedar.
Family:	Cupressaceae
Has Ecobenefits:	Yes
Last Modified:	09/29/2018
Upload ID:	upld_5818ec7cd30a8
User - Upload:	
Last Inspection:	
Next Inspection:	
Inspection Cycle:	
Crown Light Exposure:	
Archived:	No
Tree Protection Zone(TPZ):	
Critical Root Zone(CRZ):	
TPZ Ratio:	
CRZ Ratio:

Management Needs	
Primary Maintenance:	Large Tree (routine)
Secondary Maintenance:	Monitor, Prune-structural
Wires:	No Lines
Watch This Tree? :	No
Maintenance Comments:	Consider removing one of the two trunks to prevent future problem. Not high priority.
Organization:	Sandpoint
User:

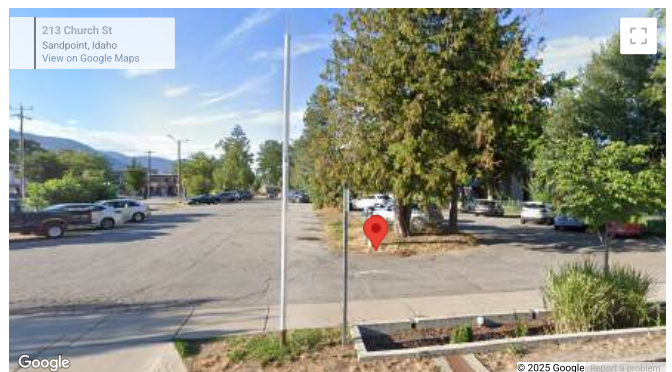
IMG_2707.jpg
9/29/2018

Tree Id:	7765
Latin Name:	Thuja plicata
Common Name:	Western Redcedar
Cultivar:	
Genus:	Thuja
Code:	THPL
Status:	Alive
Year Planted:	
DBH:	14
DBH Range:	12-18in
Tree Height:	
Number of Stems:	1
Condition:	Good - No Apparent Problems
Percent Dieback:	None
Crown Class:	Co-Dominant
Clearance Conflicts:	None

Observations:	
Stock Type:	
Tree Comments:	
Family:	Cupressaceae
Has Ecobenefits:	Yes
Last Modified:	09/29/2018
Upload ID:	upld_5818ec7cd30a8
User - Upload:	
Last Inspection:	
Next Inspection:	
Inspection Cycle:	
Crown Light Exposure:	
Archived:	No
Tree Protection Zone(TPZ):	
Critical Root Zone(CRZ):	
TPZ Ratio:	
CRZ Ratio:

Management Needs	
Primary Maintenance:	Large Tree (routine)
Secondary Maintenance:	None Needed
Wires:	No Lines
Watch This Tree? :	No
Maintenance Comments:	Consider removing one of the two trunks to prevent future problem. Not high priority.
Organization:	Sandpoint
User:	SP_sdrinkard

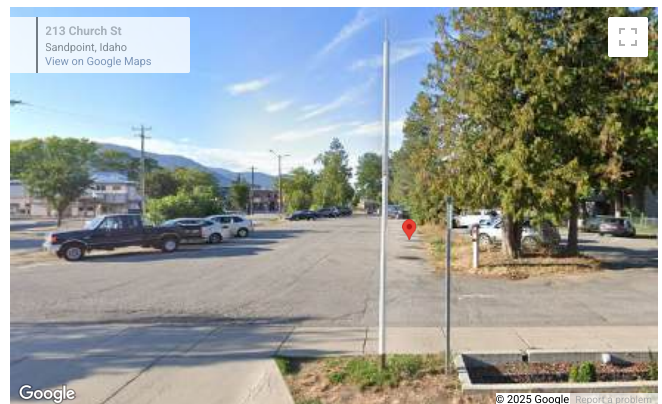
IMG_2708.jpg
9/29/2018

Tree Id:	7766
Latin Name:	Betula papyrifera
Common Name:	Paper Birch
Cultivar:	
Genus:	Betula
Code:	BEPA
Status:	Alive
Year Planted:	
DBH:	25
DBH Range:	24-30in
Tree Height:	
Number of Stems:	Multiple Stems
Condition:	Dead / Dying

Percent Dieback:	50-75%
Crown Class:	Co-Dominant
Clearance Conflicts:	None
Observations:	Crown Dieback
Stock Type:	
Tree Comments:	Tree in serious decline
Family:	Betulaceae
Has Ecobenefits:	Yes
Last Modified:	09/29/2018
Upload ID:	upld_5818ec7cd30a8
User - Upload:	
Last Inspection:	
Next Inspection:	
Inspection Cycle:	
Crown Light Exposure:	
Archived:	No
Tree Protection Zone(TPZ):	
Critical Root Zone(CRZ):	
TPZ Ratio:	
CRZ Ratio:

Management Needs	
Primary Maintenance:	Large Tree (routine)
Secondary Maintenance:	Remove
Wires:	No Lines
Watch This Tree? :	Yes
Maintenance Comments:	Remove. Serious decline. Not aesthetically pleasing in popular lot.
Organization:	Sandpoint
User:	SP_sdrinkard

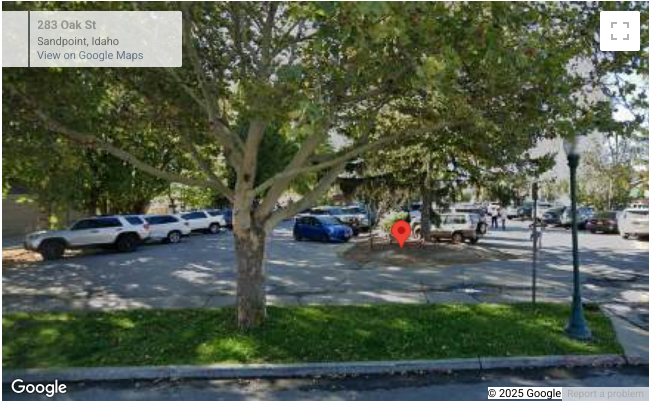
IMG_2715.jpg
9/30/2018

Tree Id:	7770
Latin Name:	Rhus spp
Common Name:	Sumac
Cultivar:	
Genus:	Rhus
Code:	RHSP
Status:	Alive
Year Planted:	
DBH:	3
DBH Range:	3-6in
Tree Height:	
Number of Stems:	Multiple Stems
Condition:	Poor - Major Problems

Percent Dieback:	25-50%
Crown Class:	Overtopped
Clearance Conflicts:	None
Observations:	Nutrient Deficiency, Poor Location, Poor Structure, Serious Decline, Crown Dieback
Stock Type:	
Tree Comments:	There are three "shrub trees" in a row. Perhaps Sumac is species, but in any case there is significant "crown" dieback. Don't really belong if they cannot be trained to be one trunk trees.
Family:	Anacardiaceae
Has Ecobenefits:	Yes
Last Modified:	09/30/2018
Upload ID:	upld_5818ec7cd30a8
User - Upload:	
Last Inspection:	
Next Inspection:	
Inspection Cycle:	
Crown Light Exposure:	
Archived:	No
Tree Protection Zone(TPZ):	
Critical Root Zone(CRZ):	
TPZ Ratio:	
CRZ Ratio:

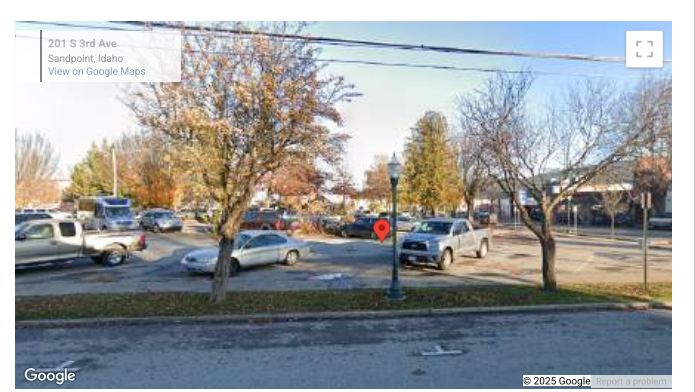
IMG_2705.jpg
9/29/2018

Tree Id:	7763
Latin Name:	Rhus spp
Common Name:	Sumac
Cultivar:	
Genus:	Rhus
Code:	RHSP
Status:	Alive
Year Planted:	
DBH:	3
DBH Range:	3-6in
Tree Height:	
Number of Stems:	Multiple Stems
Condition:	Fair - Minor Problems
Percent Dieback:	25-50%
Crown Class:	Overtopped
Clearance Conflicts:	None

Observations:	Improperly Pruned, Poor Location, Poor Structure
Stock Type:	
Tree Comments:	Not sure that this is a sumac. In any case it needs to be heavily pruned for tree shape or removed.
Family:	Anacardiaceae
Has Ecobenefits:	Yes
Last Modified:	09/29/2018
Upload ID:	
User - Upload:	
Last Inspection:	
Next Inspection:	
Inspection Cycle:	
Crown Light Exposure:	
Archived:	No
Tree Protection Zone(TPZ):	
Critical Root Zone(CRZ):	
TPZ Ratio:	
CRZ Ratio:

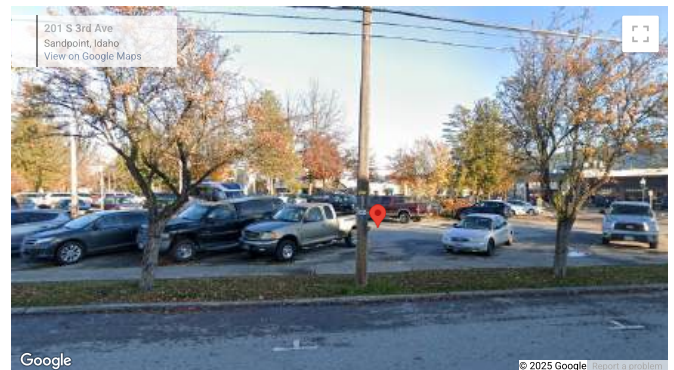
IMG_2702.jpg
9/29/2018

Tree Id:	7762
Latin Name:	Amelanchier spp
Common Name:	Serviceberry
Cultivar:	
Genus:	Amelanchier
Code:	AM
Status:	Alive
Year Planted:	
DBH:	3
DBH Range:	3-6in
Tree Height:	
Number of Stems:	Multiple Stems
Condition:	Fair - Minor Problems
Percent Dieback:	25-50%
Crown Class:	Overtopped
Clearance Conflicts:	None

Observations:	Improperly Pruned, Poor Location
Stock Type:	
Tree Comments:	Not sure that this is a service berry. In any case it needs to be heavily pruned for tree shape or removed.
Family:	Rosaceae
Has Ecobenefits:	Yes
Last Modified:	09/29/2018
Upload ID:	
User - Upload:	
Last Inspection:	
Next Inspection:	
Inspection Cycle:	
Crown Light Exposure:	
Archived:	No
Tree Protection Zone(TPZ):	
Critical Root Zone(CRZ):	
TPZ Ratio:	
CRZ Ratio:

Management Needs	
Primary Maintenance:	Small Tree (routine/train)
Secondary Maintenance:	Prune-structural, Remove, Remove Suckers
Wires:	No Lines
Watch This Tree? :	Yes
Maintenance Comments:	
Organization:	Sandpoint
User:	SP_sdrinkard

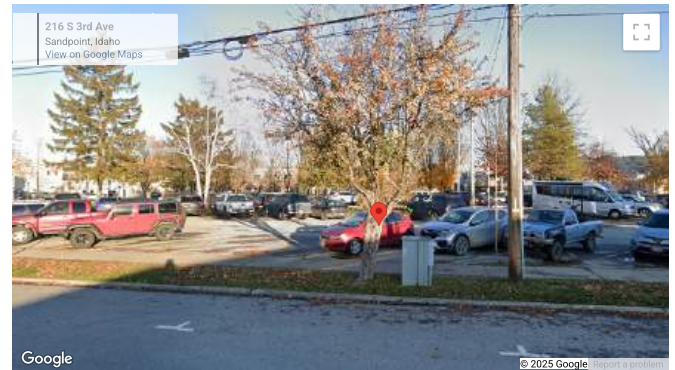
IMG_2700.jpg
9/29/2018

Tree Id:	7761
Latin Name:	Other
Common Name:	Other
Cultivar:	
Genus:	Other
Code:	
Status:	Alive
Year Planted:	
DBH:	
DBH Range:	
Tree Height:	3
Number of Stems:	Multiple Stems
Condition:	Fair - Minor Problems
Percent Dieback:	25-50%
Crown Class:	Overtopped
Clearance Conflicts:	None

Observations:	Improperly Pruned, Poor Location, Poor Structure
Stock Type:	
Tree Comments:	This is tree turned shrub. Not sure at this time is species.
Family:	
Has Ecobenefits:	No
Last Modified:	12/19/2022
Upload ID:	
User - Upload:	
Last Inspection:	
Next Inspection:	
Inspection Cycle:	
Crown Light Exposure:	Three sides of the crown are exposed to light.
Archived:	No
Tree Protection Zone(TPZ):	
Critical Root Zone(CRZ):	
TPZ Ratio:	
CRZ Ratio:

Primary Maintenance:	Remove Tree
Secondary Maintenance:	Remove
Wires:	No Lines
Watch This Tree? :	Yes
Maintenance Comments:	Need to replace with a single trunk tree that doesn't "hide" areas of the lot.
Organization:	Sandpoint
User:	SP_sdrinkard

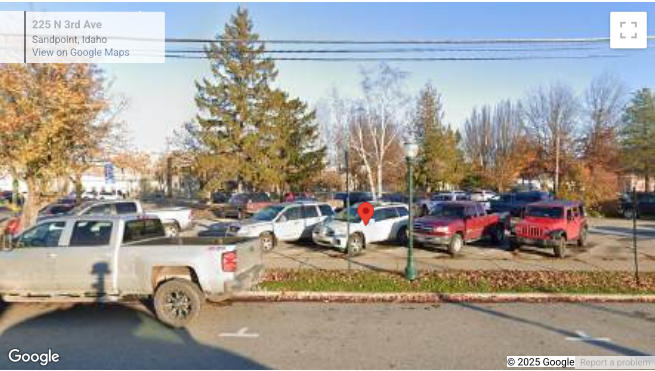
IMG_2698.jpg
9/29/2018

Condition: Poor - Major Problems

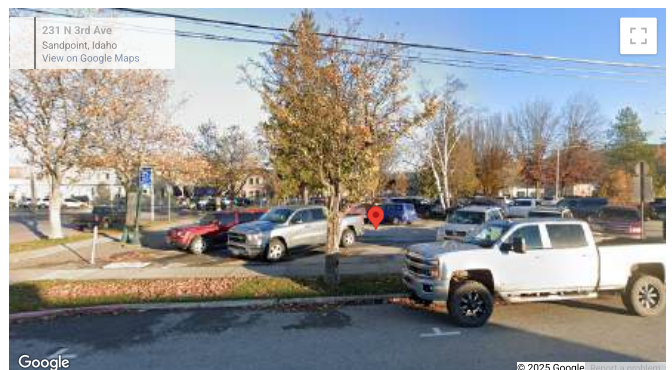
1538156107113336297303.jpg
9/28/2018

Tree Id:	
Latin Name:	Betula papyrifera
Common Name:	Paper Birch
Cultivar:	
Genus:	Betula
Code:	BEPA
Status:	Alive
Year Planted:	
DBH:	20
DBH Range:	18-24in
Tree Height:	
Number of Stems:	Multiple Stems
Condition:	Fair - Minor Problems
Percent Dieback:	25-50%
Crown Class:	Intermediate
Clearance Conflicts:	None

Observations:	Improperly Mulched, Crown Dieback
Stock Type:	
Tree Comments:	
Family:	Betulaceae
Has Ecobenefits:	Yes
Last Modified:	09/29/2018
Upload ID:	upld_5818ec7cd30a8
User - Upload:	
Last Inspection:	
Next Inspection:	
Inspection Cycle:	
Crown Light Exposure:	
Archived:	No
Tree Protection Zone(TPZ):	
Critical Root Zone(CRZ):	
TPZ Ratio:	
CRZ Ratio:

Management Needs	
Primary Maintenance:	Large Tree (routine)
Secondary Maintenance:	Crown Cleaning, Prune- structural, Remove Suckers
Wires:	No Lines
Watch This Tree? :	Yes
Maintenance Comments:	Lots of suckers. Including what may be all the plant material immediately south of this tree.
Organization:	Sandpoint
User:

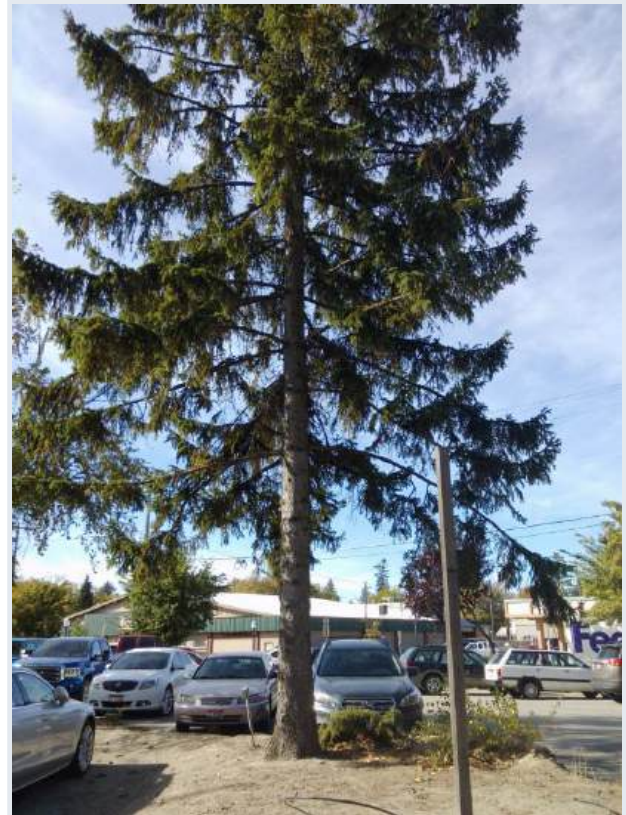
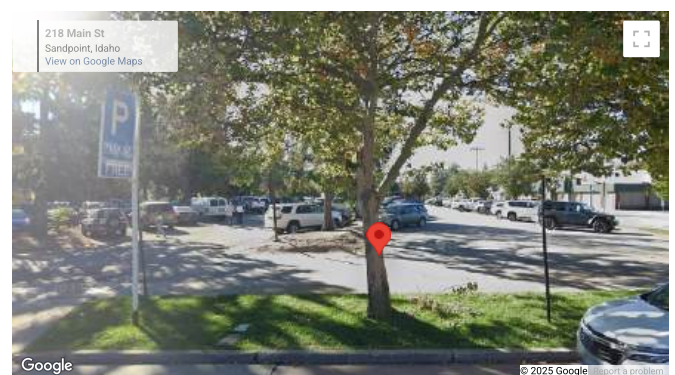
1538155840724929344579.jpg
9/28/2018

Tree Id:	
Latin Name:	Picea engelmannii
Common Name:	Engelmann Spruce
Cultivar:	
Genus:	Picea
Code:	PIEN
Status:	Alive
Year Planted:	
DBH:	14
DBH Range:	12-18in
Tree Height:	
Number of Stems:	1
Condition:	Good - No Apparent Problems
Percent Dieback:	<25%
Crown Class:	Dominant
Clearance Conflicts:	None

Management Needs	
Primary Maintenance:	Large Tree (routine)
Secondary Maintenance:	None Needed
Wires:	No Lines
Watch This Tree? :	No
Maintenance Comments:	
Organization:	Sandpoint
User:
