## Memorandum

**Re:** **Geologic Hazard Assessment – Canyon Springs Water Transmission Pipeline, King County, Washington**

**Project No.:** 26000080

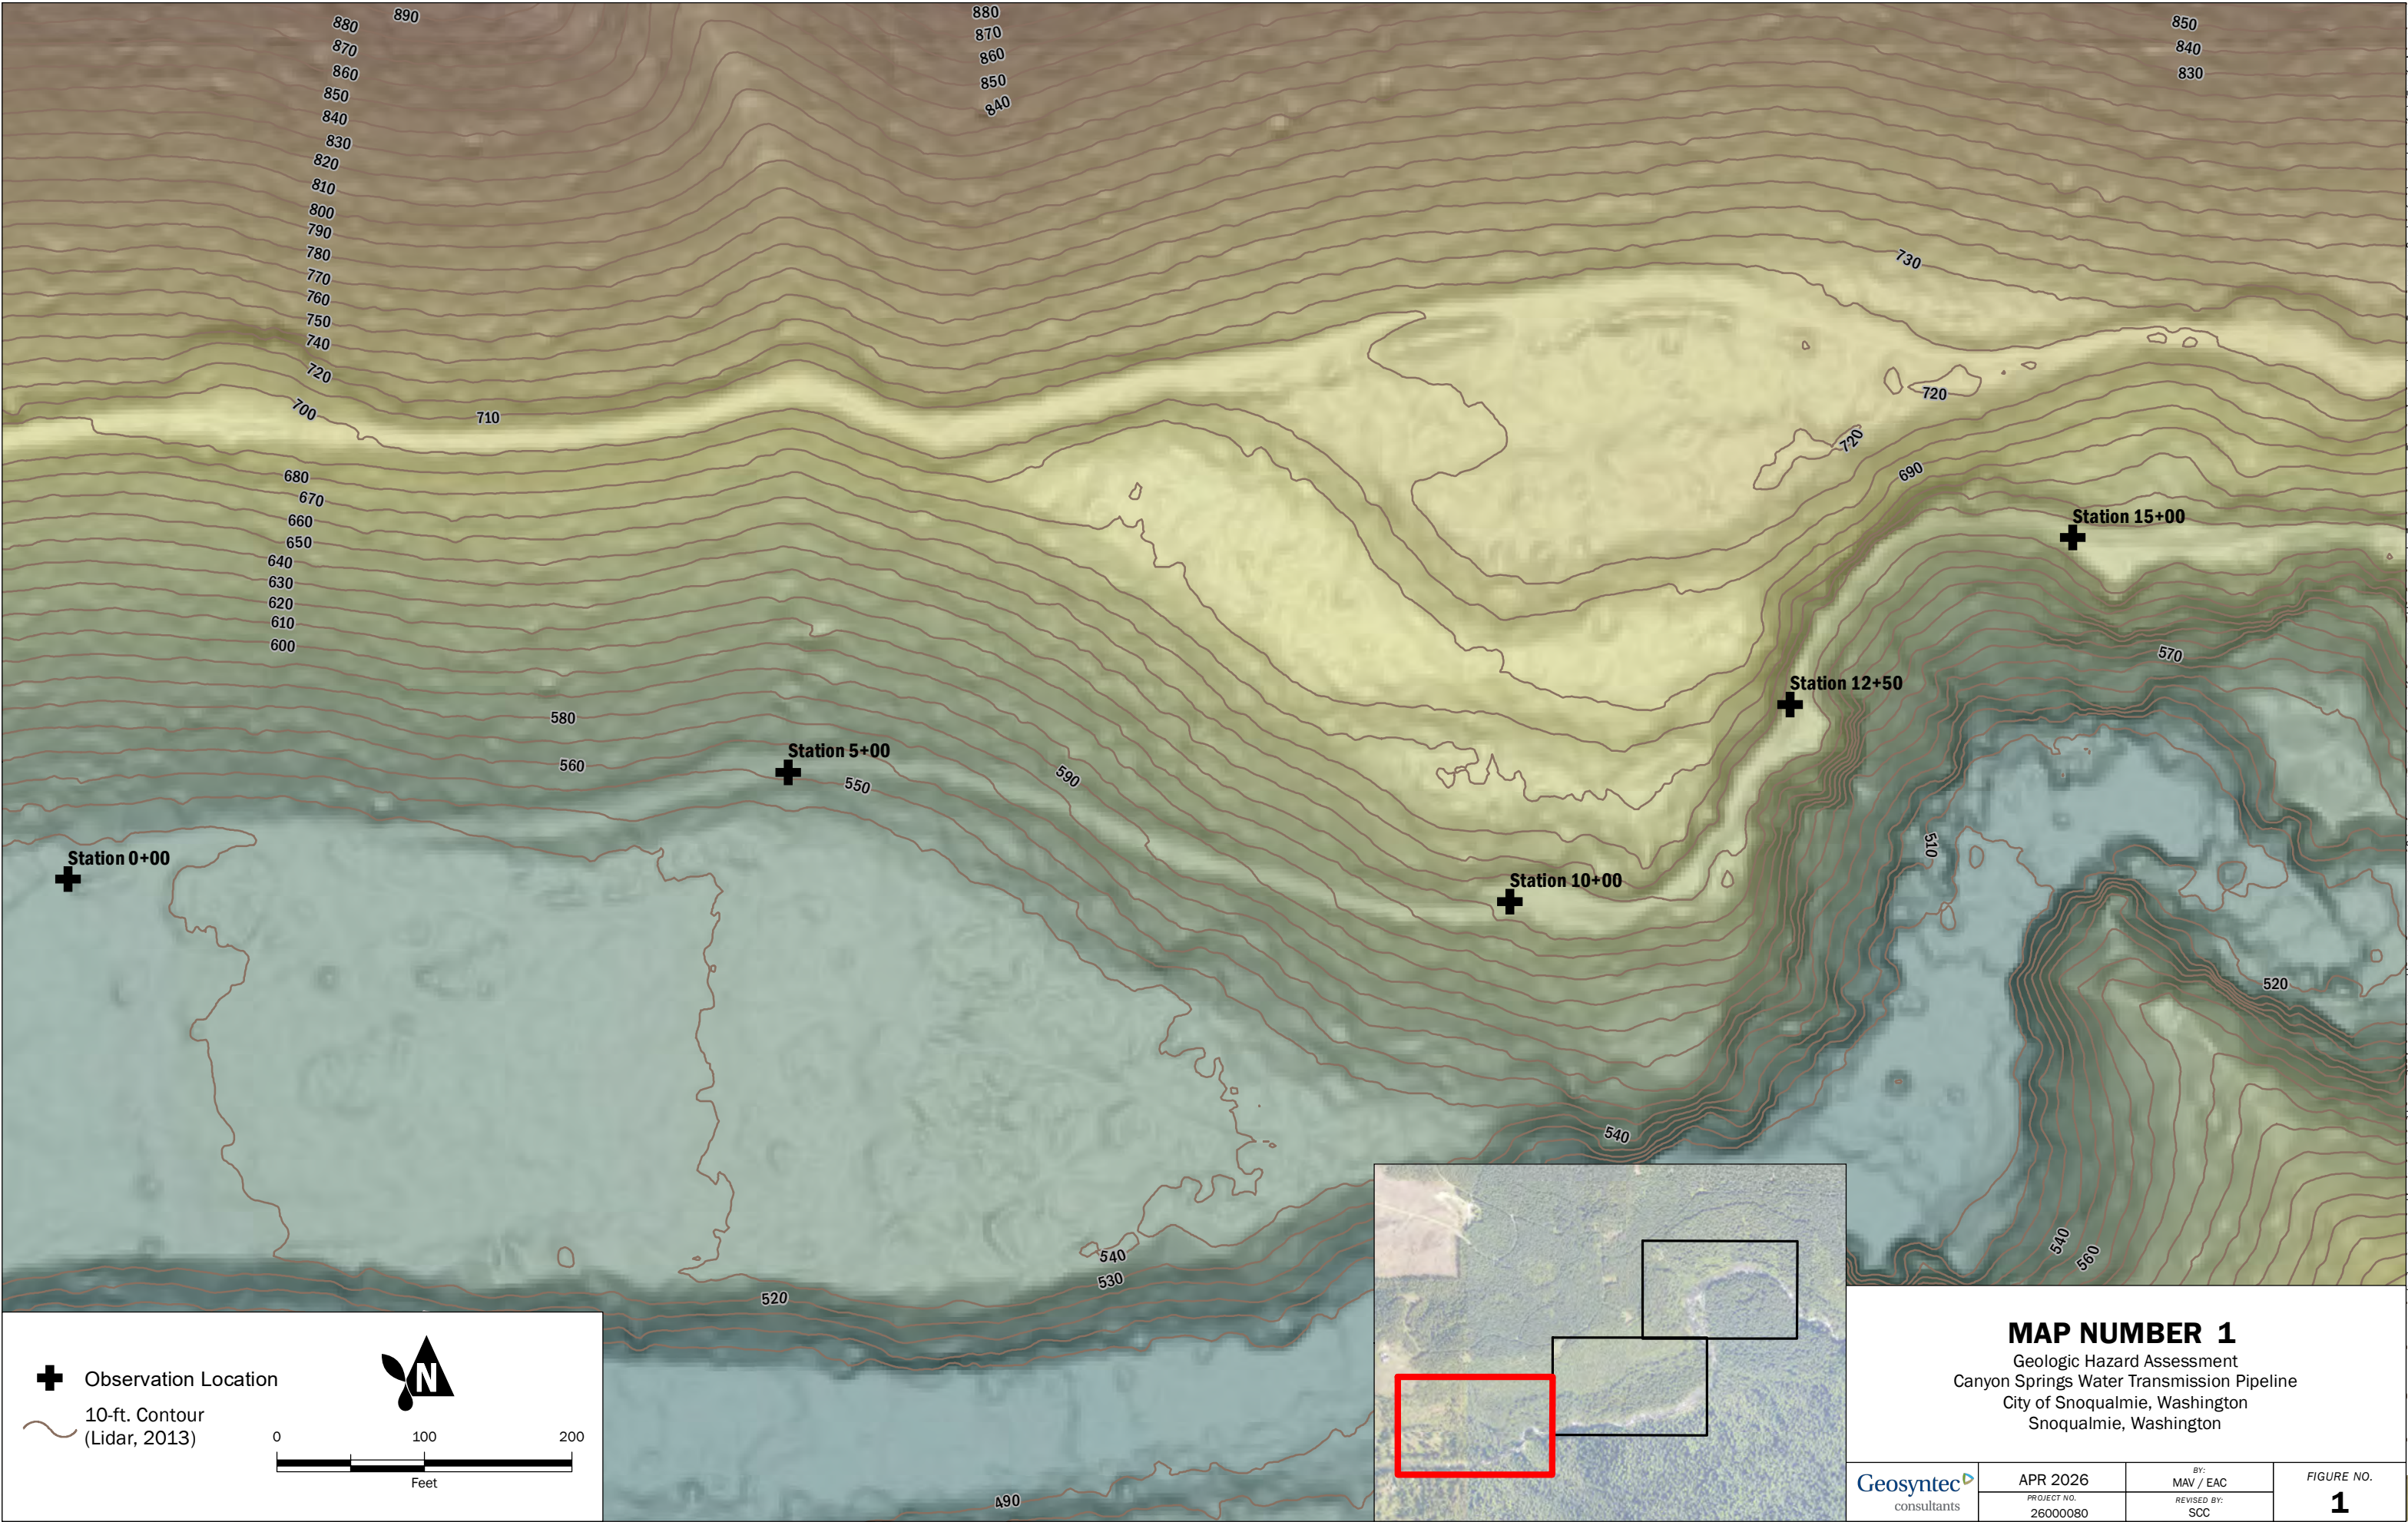
FIGURE NO.  
**1**

From the PRV at Station (STA) 00+00 to STA 37+25 (Figures 1 and 2), the steep slope into which the pipeline and access trail are cut is underlain by mostly intact bedrock. Because of this, the geologic hazard to the City's infrastructure continues to be low, though some areas should be monitored. These areas are described in detail in the following sections.

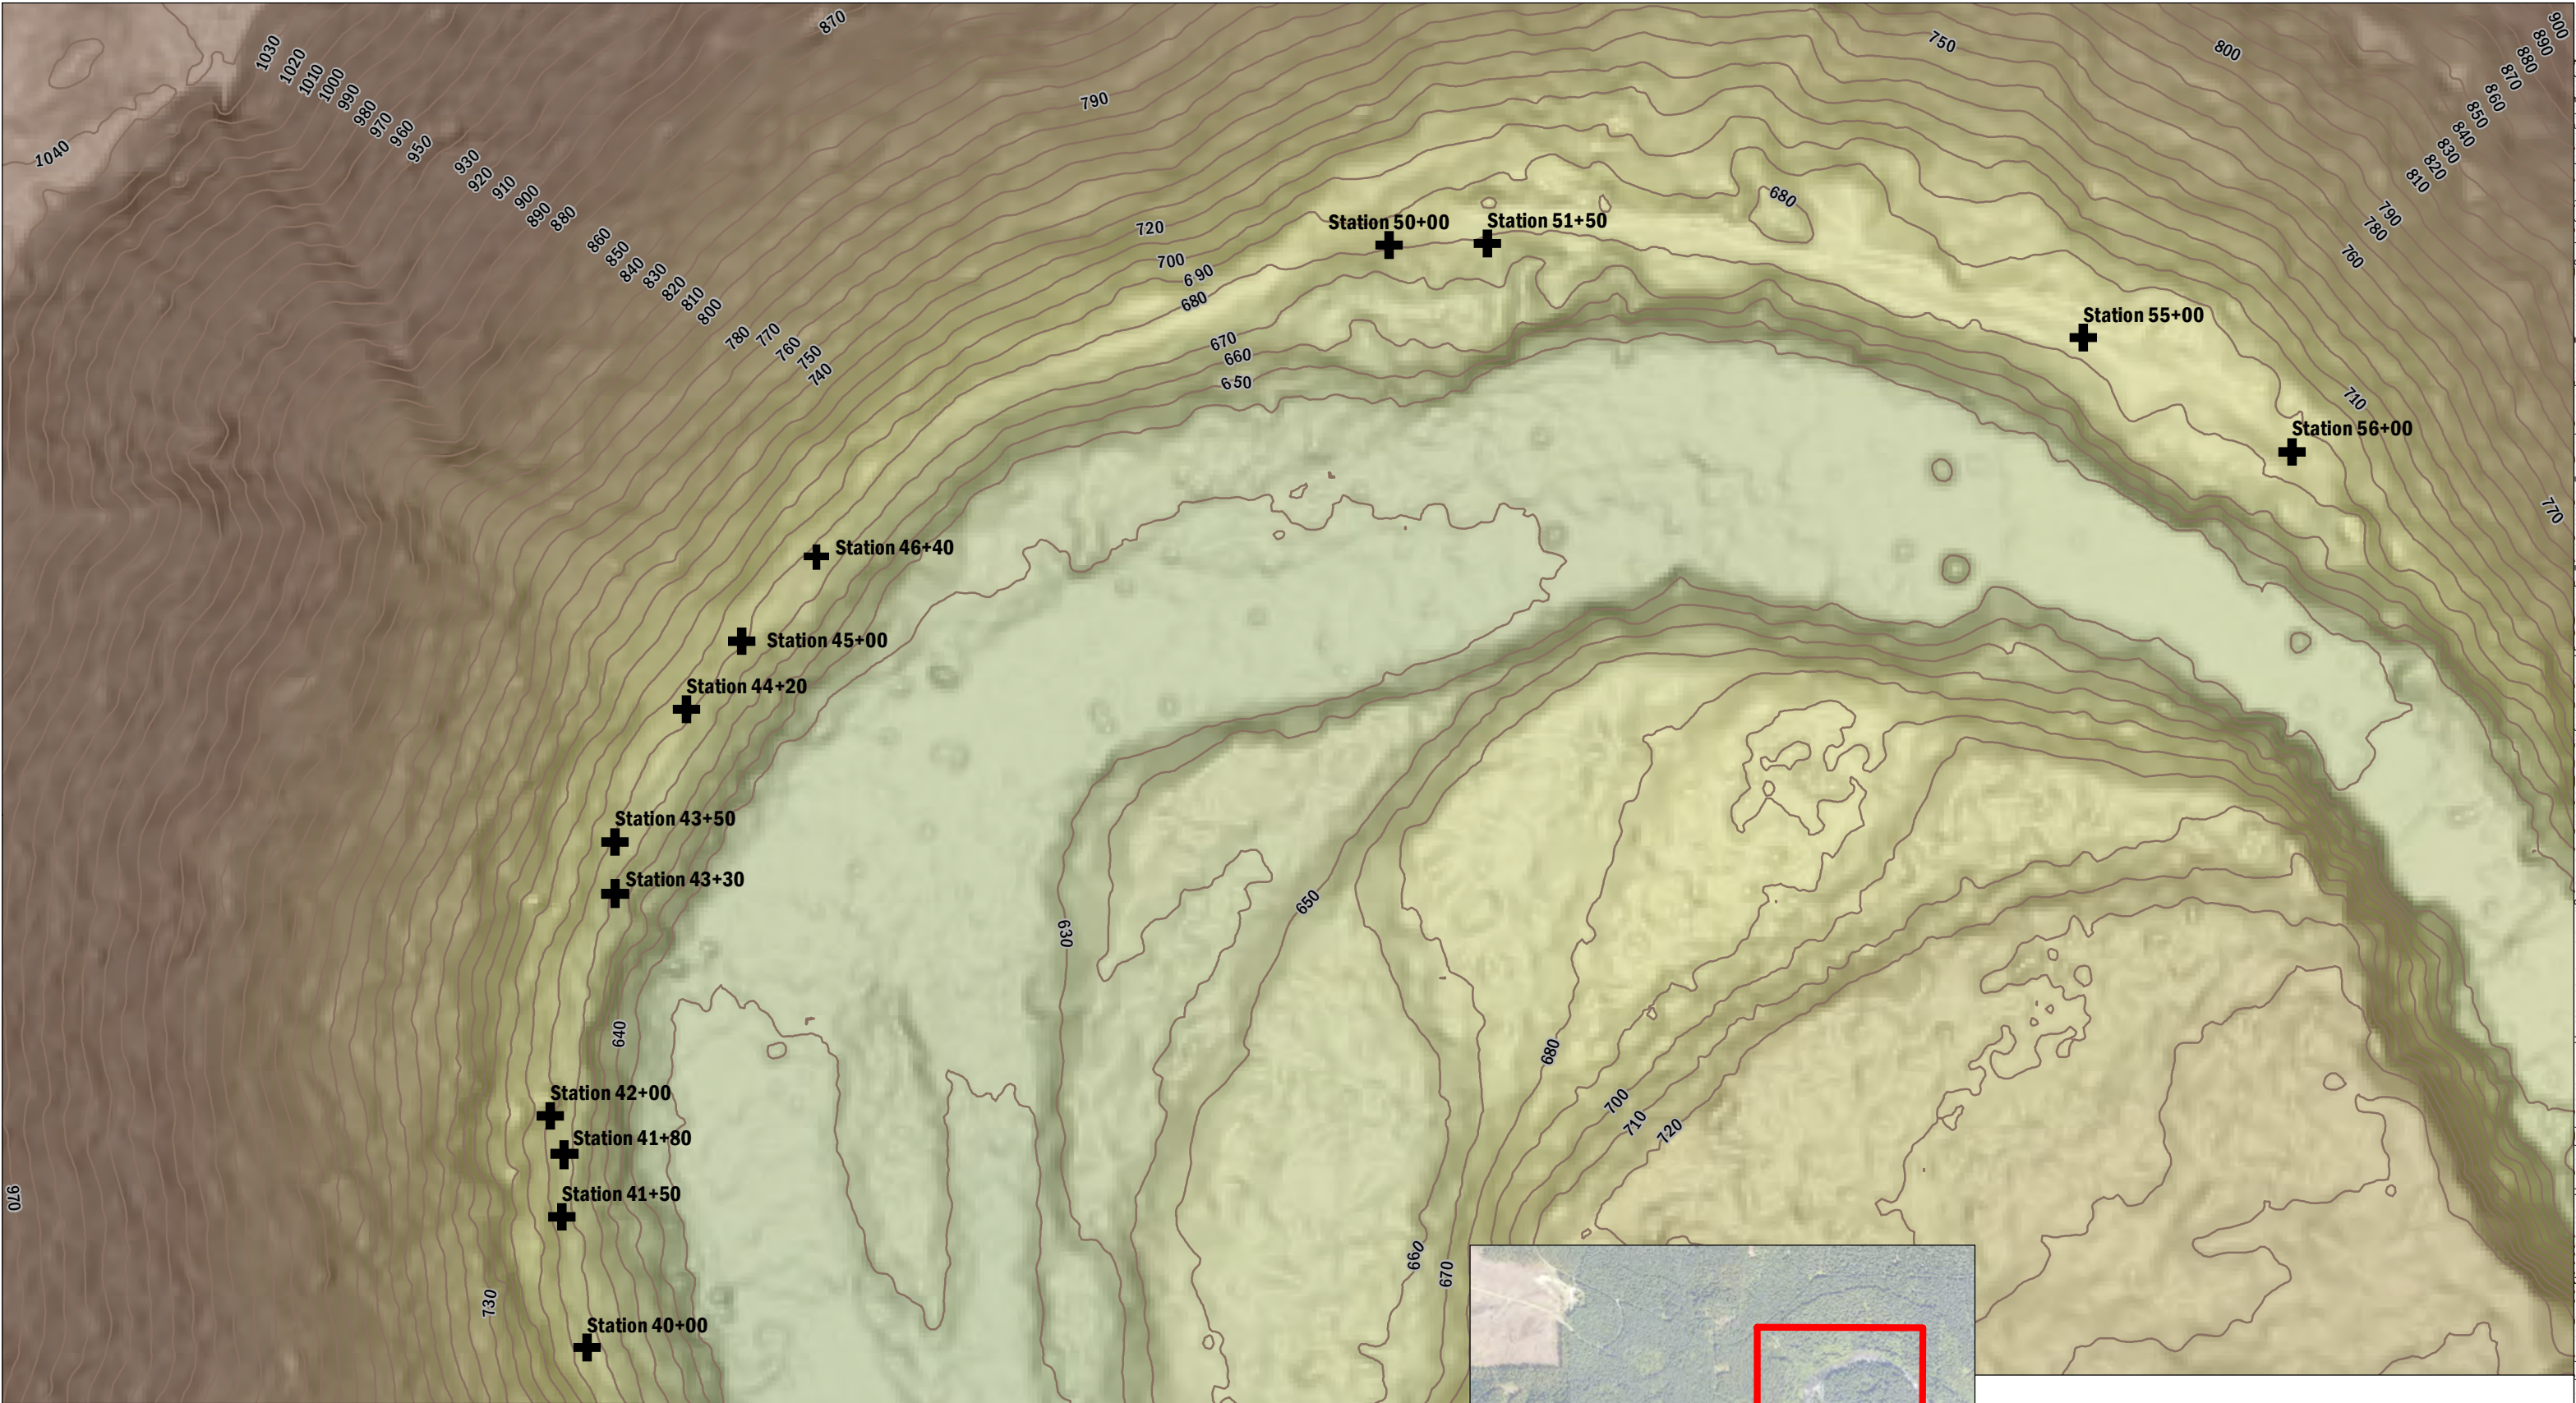
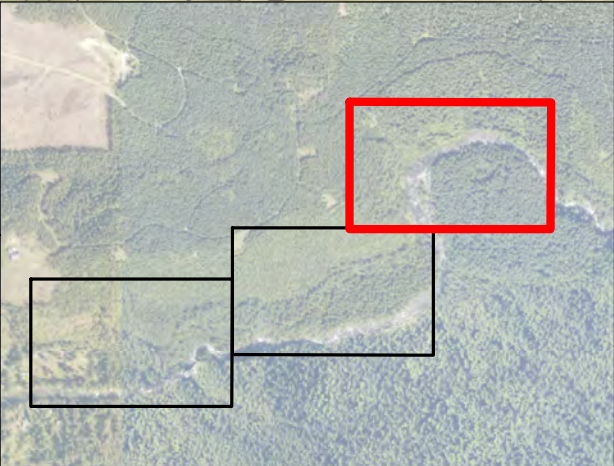
MAP NUMBER 3

In contrast, from STA 37+25 to the end of the pipeline at the collectors at STA 56+00 (Figure 3), the pipeline and access trail are cut into a steep slope underlain by sand and gravel glacial outwash deposits. Here, the geologic hazards to the City's infrastructure continue to be higher. As of March 2026, we have identified an elevated hazard to the segment of pipeline between STA 41+50 and 43+50.

The Glacial Outwash Slope extends from the 2019 landslide repair (STA 37+25) to the spring boxes located at the eastern end of the pipeline alignment (STA 56+00; Figure 3). The geologic hazards to the pipeline are higher where it traverses the glacial outwash slope along the meander bends of the North Fork Snoqualmie River in this slope segment. As in the previous traverses of the alignment, we observed evidence of shallow colluvial landslide activity in several locations that originate both upslope and downslope of the pipeline alignment.
