PROJECT S 1st and St Helens Intersection Improvements
CONTRACTOR Moore Excavation Inc.
PROJECT WALK-THROUGH May 29th, 2025

PROJECT NO. R-685
DATE May 30th, 2025

PROJECT PUNCH LIST

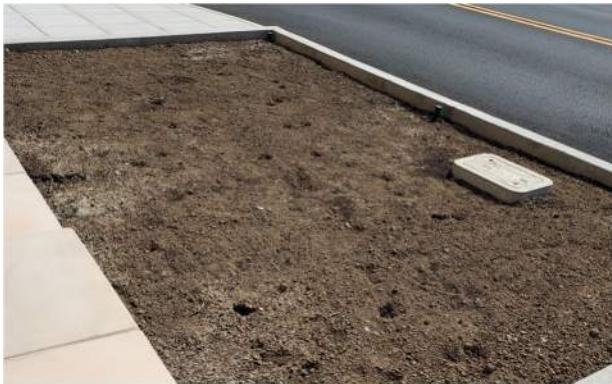
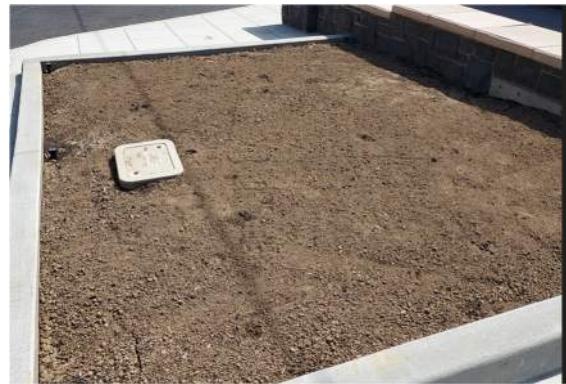
- Install Hanging Baskets and Irrigation Arms per Sheet L3.01.
- Test Irrigation controller with Parks Department and ensure controller is operating correctly. Provide O&M manuals to City/Parks Department. Sheet L2.01.
- Mark or flag the location of buried gateway foundation so it can be easily located in the future without having to tear up all the landscaping (both locations)

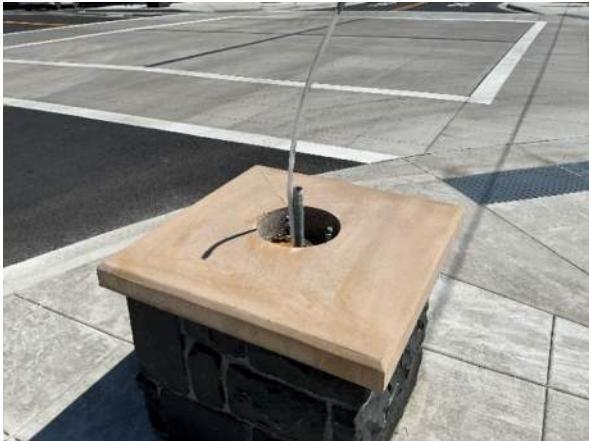
- Install light poles and wayfinding pole at the intersection. Sheet L1.01 and IL-2.
