Amador Regional Sanitation Authority

STAFF REPORT

TO: ARSA BOARD
MEETING DATE: AUGUST 15, 2024
FROM: DAN LAFONTAINE, OPERATIONS
SUBJECT: FRESH WATER DIVERSION UPDATE
TYPE: INFORMATION AND DISCUSSION

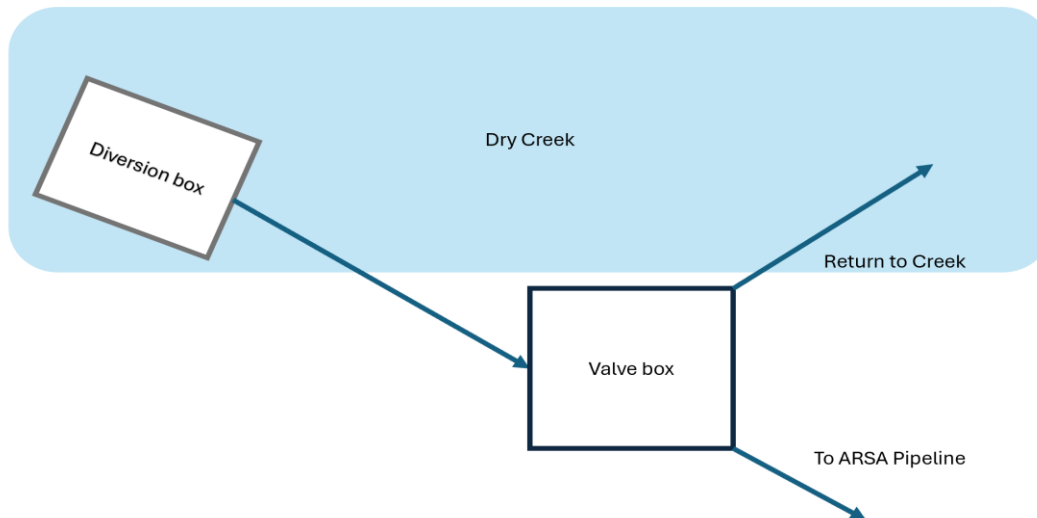
The freshwater diversion to protect CDCR water diversion rights must be repaired as a condition of the settlement. The freshwater diversion has been operational but has not been used in quite some time. An exploratory investigation into the status of the diversion has occurred very recently (within the last few weeks). The diversion box in the creek bed and the valve box have been unearthed and an assessment can be made (see PFD below):
