**City of Sutter Creek  
Design Review Application**

**Project Address:** 40 Gold Dust Trail, Sutter Creek, CA,

Project: Sutter Creek Kingdom Hall Major Renovation  
Address: 40 Gold Dust Trail, Sutter Creek, CA 95685  
Subject: Response to Design Review Committee Questions

An on-site investigation and condition assessment was made on January 21, 2023. The purpose of the site visit was to determine if the URM portion of this Kingdom Hall would meet the Life Safety Structural Performance Level (S-3) of ASCE 41-17, *Seismic Evaluation and Retrofit of Existing Buildings*.

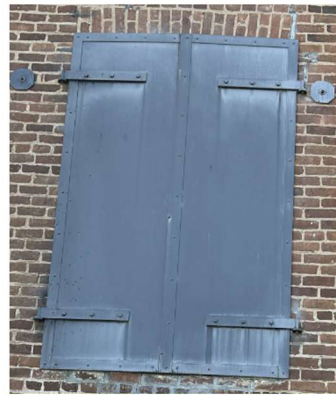
Figure 7 – Shutter Doors Added to Preserve History

Shutters and Metal Front Door. In 1991, the front entry door and the metal shutters were installed to replicate those found on other properties within the County. The manufacturing process was undertaken by volunteers. Figure 7 and Figure 8 illustrates the effort to preserve architectural elements consistent with the Gold Rush era.

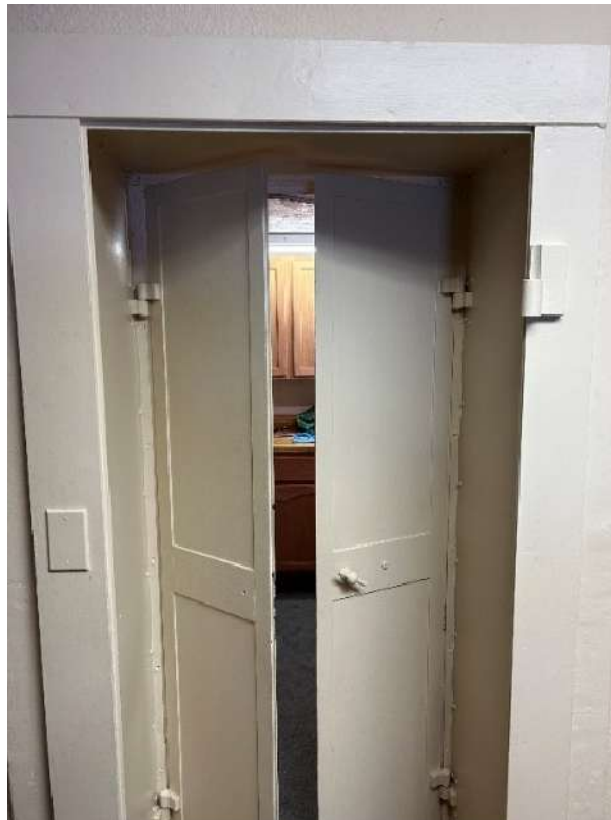
Figure 8 – Vault Doors

Concrete Vault. The concrete vault was likely constructed during the 1930s (See Figure 3). It was likely constructed in the 1930s because of the automobiles in Figure 3. The two automobiles noted in the photo may have been the 1926 Buick Master Six and the 1936 Ford Model 68, 3 window coupe. The concrete vault consists of a concrete slab on grade, concrete walls and flat concrete roof. The concrete exterior walls are covered with stucco.

About the significance of the concrete vault, documents could not be found to determine the use of the vault. However, it was likely used to store precious metals, money, and/or important documents.

Figure 8 is a photo of the vault door. Originally, there were two sets of doors as noted by the metal frames. Today, one set of doors remain. A metal frame is used to support the metal doors.

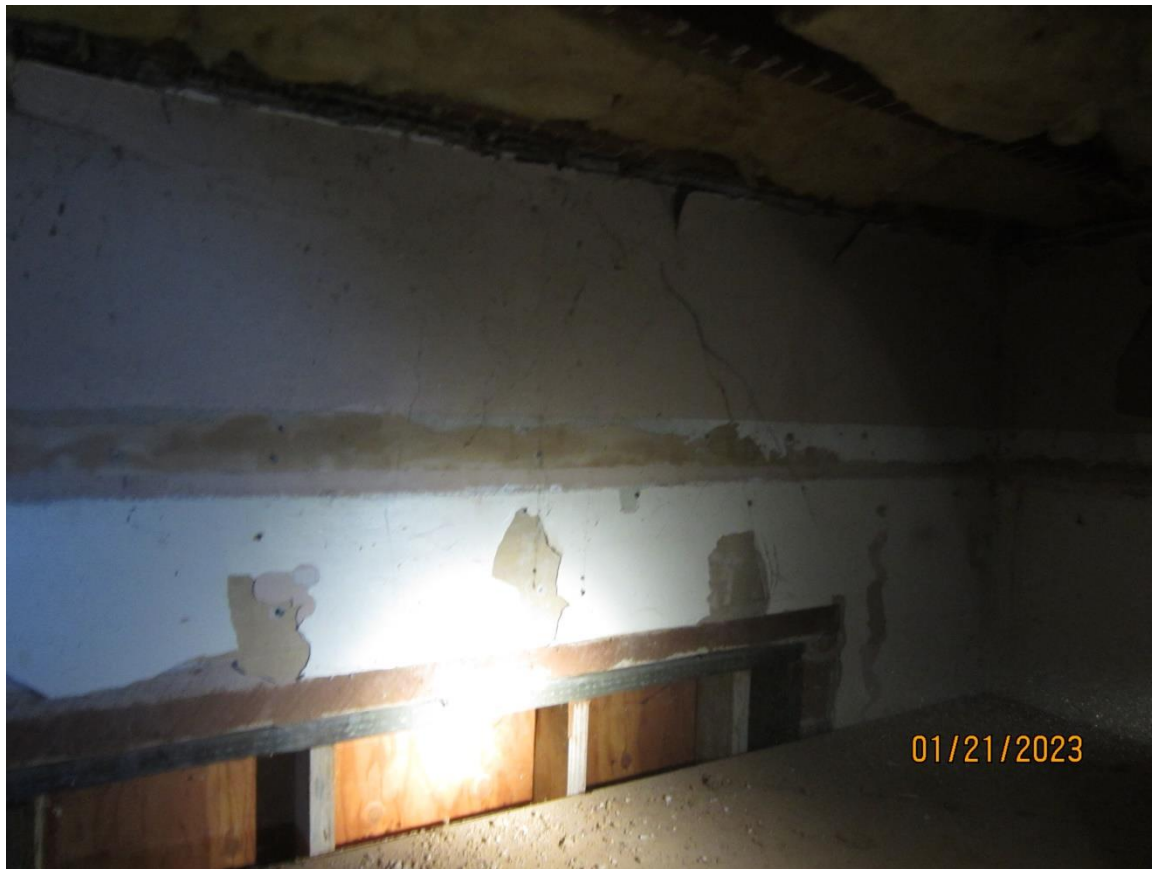
An attic floor composed of 2"x11.25" floor joists @ 24"cc is located above the hard-lid ceiling detailed on Sheet S2 of the 1991 Structural Plans. The attic floor at one point was sheathed entirely with 1x floor planks and supported a one foot thick layer of dirt that was used for insulation, which has since been removed and replaced with rolled insulation. The hard-lid ceiling can be seen in Pics 8 and 9. The bottom of the 2"x11.25" attic floor joists occur approximately 3'-6" above the hard-lid plywood installed per the 1991 Structural Plans.

Pic 8- Hard lid ceiling with ½" plywood at west wall added per 1991 structural plans w/ attic floor joists above.

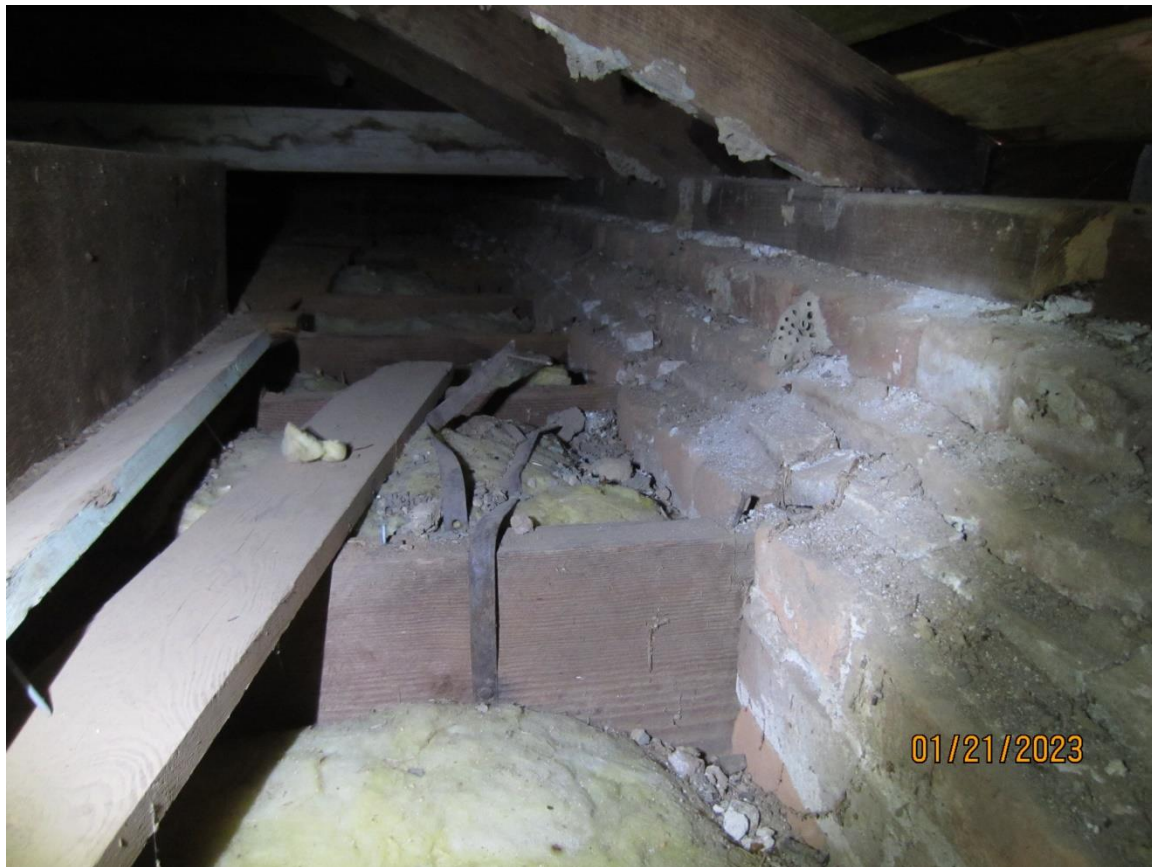
Pic 9 – Added hard lid ceiling below attic ceiling joists at northwest corner of URM building.
