INSPECTION REPORT

For the Property at:
203 CHURCH STREET
SWANSBORO, NC 28584

Prepared for: TANK BATES
Inspection Date: Tuesday, October 15, 2024
Prepared by: Kelly Honeycutt, 4741

Report No. 1846

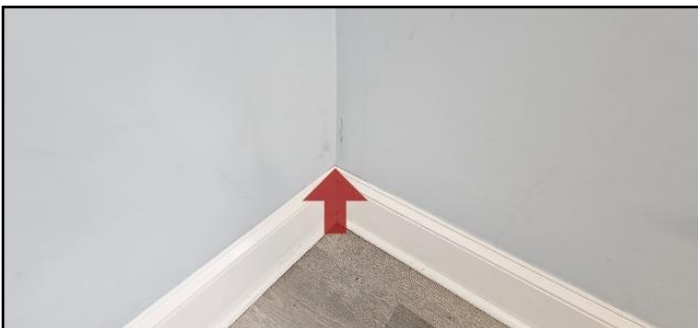
3. Visible growth at corner of wall

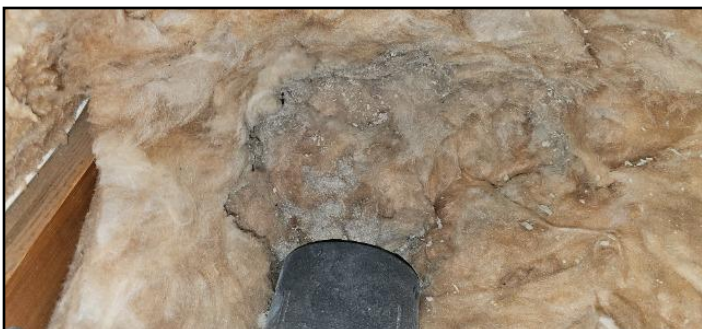
41. Discolored insulation should be removed

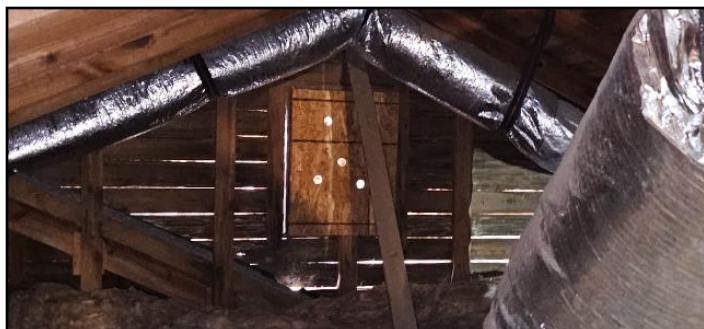
42. Gaps in siding - no wall sheathing installed

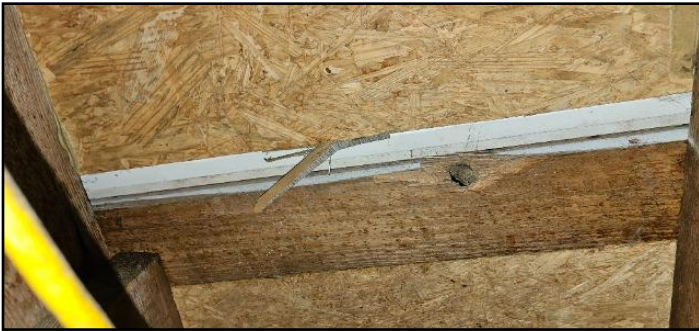
The subfloor is not complete down the middle of the property and the drywall from the middle interior wall is exposed to the unconditioned crawlspace. It is not recommended to have drywall exposed to the exterior in any area. I recommend removing the drywall on the middle wall, inspecting the stud wall for signs of moisture damage and mold growth, and removing the wall in order to install subfloor under the wall. This may require some temporary supports be built to support the structure if this middle wall is structural. That should be determined by a licensed general contractor before removing the stud wall.

56. *Drywall form middle wall visible*

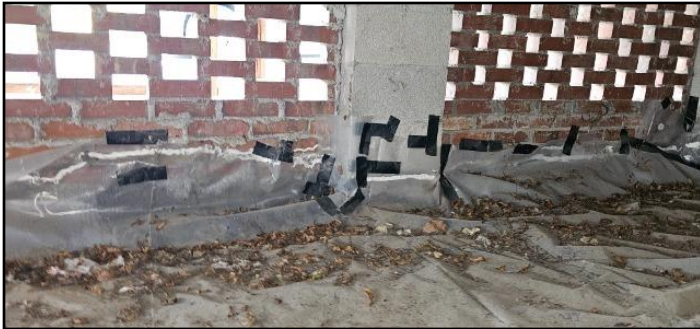
68. Vapor barrier "taped" to wall

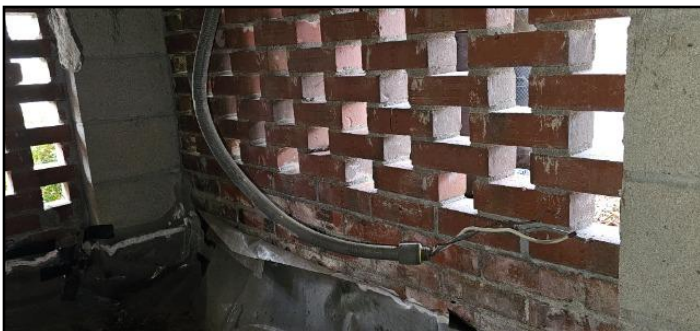
70. Crawlspace below grade

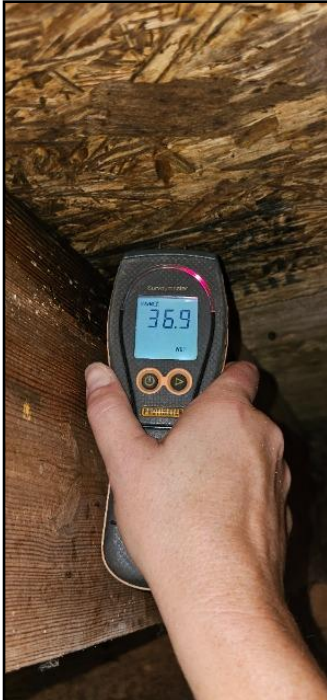
72. Wet subfloor near HVAC plenum

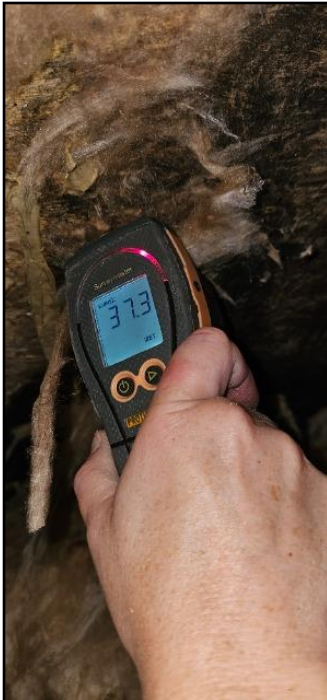
74. Wet subfloor near HVAC plenum

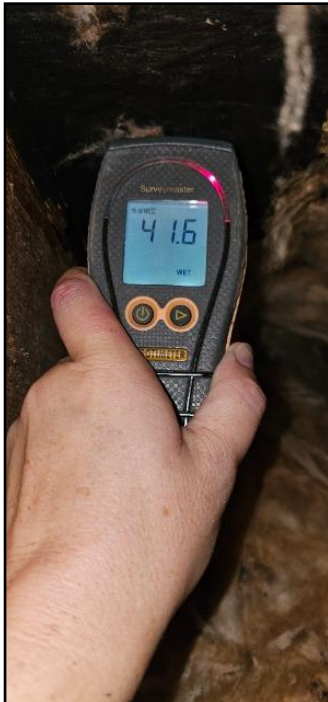
76. Wet subfloor near HVAC plenum

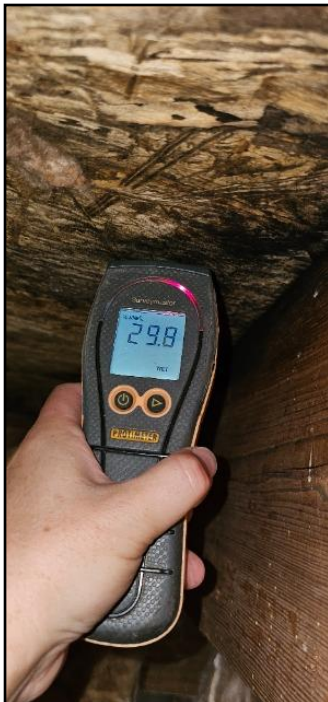
78. Wet subfloor near HVAC plenum

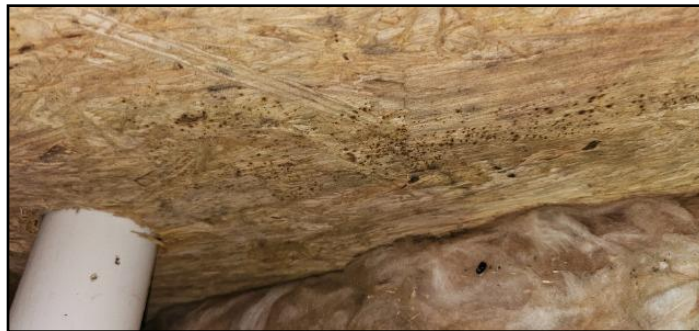
82. *Visible growth on subfloor*
