July 22, 2019

Job#: 19-0275

**RE: Structural review of bandstand at Sankey park, 877 14<sup>th</sup> Ave, Sweet Home, Oregon**

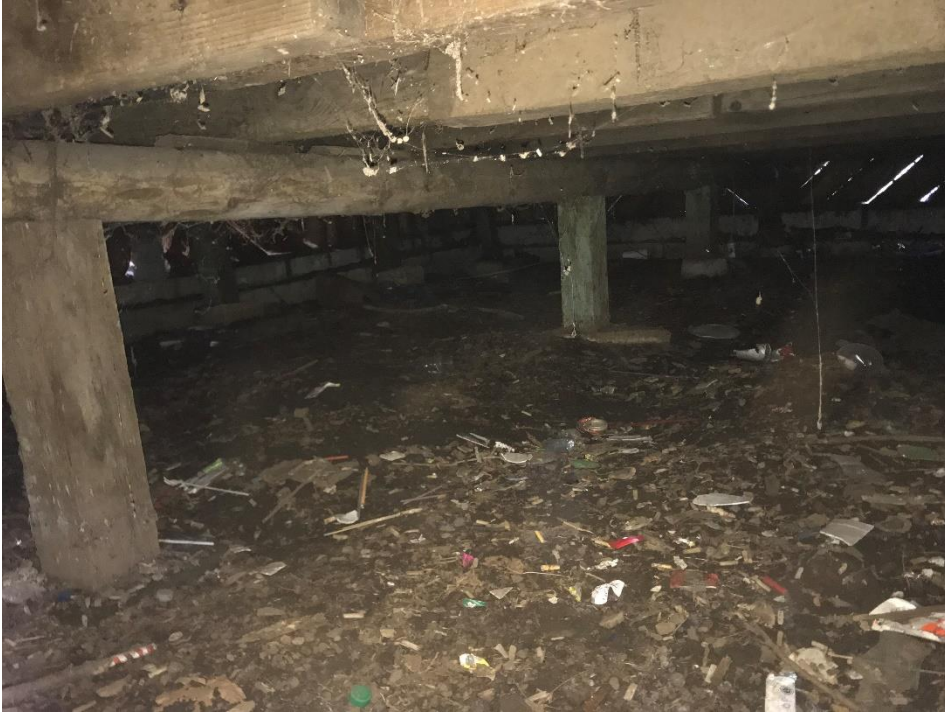
We did enter the crawlspace and found footings that had settled and shifted over time. (picture 13, 14). The foundation appears to have been replaced or repaired relatively recently (in relation to the age of the structure). The posts are dimensional lumber instead of the round members use for the rest of the structure, we also noted pressure treated lumber used for the sill plate on the continuous footing.

Picture 14 – shifted footings
