mwa architects

Architectural Report

Project: Tenino City Hall Renovation
Project No: 201906.00

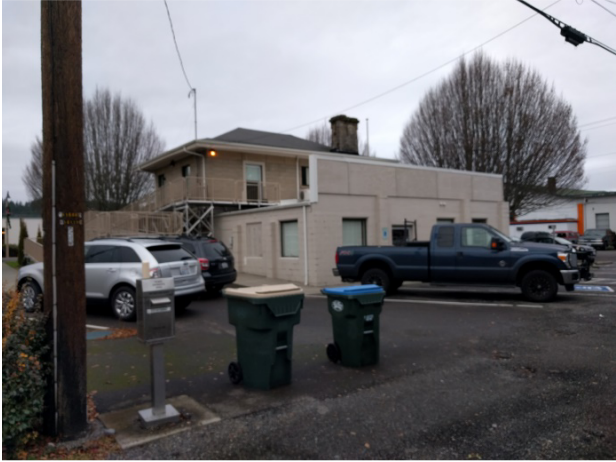
Image 15

Due to the date that this addition was added it is assumed that it is of minimal or non-reinforced CMU construction.

This is an image of the CMU addition taken from the southwest direction.
