State of California - The Resources Agency
DEPARTMENT OF PARKS AND RECREATION
PRIMARY RECORD

*Resource Name or #: THRI - 40 (1998: KEC-134-T-3)

c. Address 10236 Donner Pass Road

*P11. Report Citation: Christensen et al. 2004.
Town of Truckee: Historic Resources and
Architectural Inventory. Kautz Environmental
Consultants, Inc., Reno, Nevada.

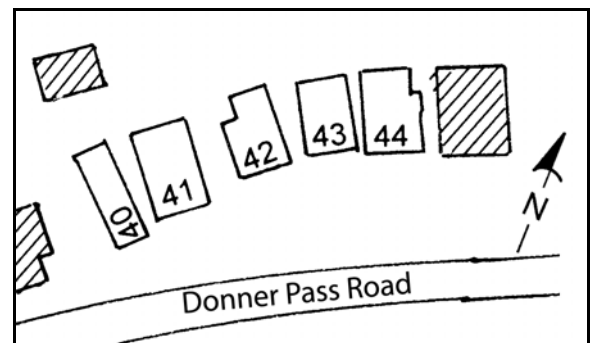
This is a one story, vernacular, gable-front building that is narrow and rectangular in plan. The wood-frame building sets on a raised, wood pier foundation and is covered with c. 1970s horizontal aluminum siding and horizontal wood planks. The steep pitched gable-front roof is covered in corrugated metal sheeting. It has a narrow eave with enclosed rafters on both the gable-front and porch. The east elevation appears to have a closed eave with only a roofing sheet metal overhang. An external metal pipe extends from the east elevation. The primary elevation faces south and has a beveled, arched, four-panel door offset to the east. Centered to the west of the door are paired, vertical, two-over-two, double-hung windows. The south gable is covered with a full-width, dropped, shed roof porch that wraps around the west elevation for 3/4 of its length. The western portion of the porch is partially enclosed with fixed windows in the upper half of the balustrade and aluminum siding in the lower half. The balustrade on the south elevation is built of simple stick design with plain, square support posts. There is another porch addition in the rear of the building. Windows include tall, rectangular, vertical, two-over-two, double-hung, six-over-one, wood-framed, double-hung, one-over-one replacement metal, metal framed full-light vertical, and metal framed full-light horizontal types.

This is one of the smaller, more modest residences built in the neighborhood, and stands in sharp economic contrast to the larger building to the east. The building is in good condition, but its integrity of design, materials, and workmanship has been diminished by the loss of historic details (windows, balustrade, porch enclosure, rear additions). The aluminum siding is a distraction from the historic fabric, but may only be covering the original cladding. In its present condition, the building is not recommended as eligible for the NRHP. It does, however, continue to embody enough of the historic architectural characteristics and reflect a sense of the historic time and place to be considered a contributory property within the proposed Truckee National Register District. The overall form and feeling provides a sense of the mixed economic status from the historic period for this neighborhood.

- Remove aluminum siding and restore original cladding if present beneath
- Replace metal-frame windows with appropriate historic restoration forms
- Remove porch on the rear; restore enclosed section of front porch (stick balustrade and square post supports)
-
-
