Appendix E: Capital Project Modeling Results

Appendix F: Stream Assessment TM (TM4)

Stream Channel Condition Survey

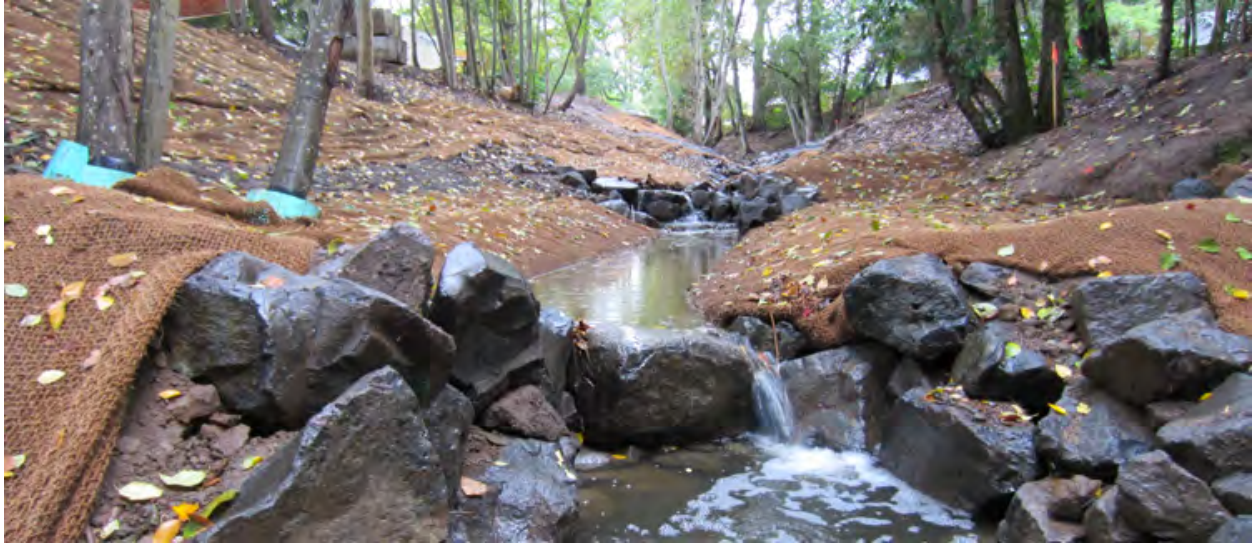
Photo 2. Otak photo of newly constructed Saum Creek channel in Chieftan/Dakota Greenway (c. 2013)

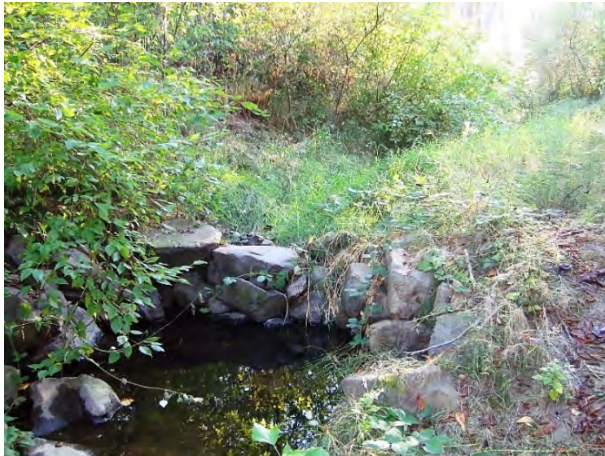
The channel upstream of SW Blake Street was restored in 2014 with a series of rock check dams and pools. This project was constructed in conjunction with a neighborhood water quality project. Prior to the restoration, the channel in this reach was significantly incised and banks were being eroded from high rates and volumes of stormwater runoff emanating from the surrounding residential development (Otak, 2013). A new stream channel gradient was established through the reach using rock weirs and splash pools to dissipate the energy (Photo 2) and the entire corridor was revegetated with native vegetation. A current view of the restoration area is shown in Photo 3. The channel structure (boulders and drop pools) is intact and erosion does not appear to be a current problem in this reach. However, the lower portion of the reach immediately upstream of SW Blake Street is very flat, and the ground is saturated (Photo 4). Saturated conditions, as well as the presence of invasive vegetation appear to be impacting native plants that have been planted in this corridor. There is a need for ongoing vegetation maintenance in the entire reach, but particularly in this area where an investment has already been made on the stream restoration project. Plant selection and/or locations may need some adjustment for the best chance of success.

Photo 3. Saum Creek restoration in Chieftan/Dakota Greenway (September 2017)

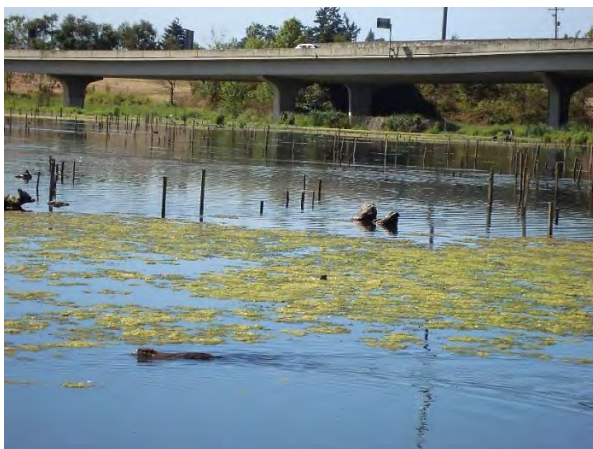
Nyberg Reach #1 and Nyberg Reach #2 were mostly lacking stream channel characteristics at the time of the stream assessment. These reaches are wetland complexes with significant open water components (Photos 5 and 6). Beaver activity is prevalent, and is likely the reason for the extensive open water in these two reaches. There was evidence of past efforts to address the beaver activity in Nyberg Creek Reaches #1 and #2. However, the beaver activity observed did not appear to be in areas of concern with regard to infrastructure or flooding. Vegetation in Nyberg Creek Reaches #1 and #2 consisted of wetland vegetation. Due to the on-going beaver activity and the changing nature of the flooded areas that currently have wetland characteristics, there is no recommendation for vegetation management.

Photo 6. Nyberg Creek Reach #2 downstream of I-5, with beaver swimming in foreground.

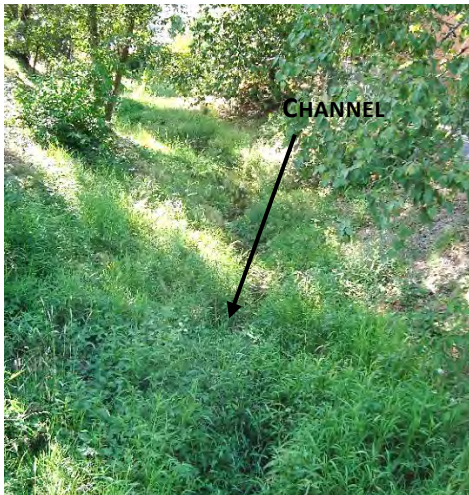
Nyberg Creek Reach #3, between SW Martinazzi Avenue and Boones Ferry Rd has much different physical characteristics than Nyberg Creek Reach #1 and Reach #2. This reach is primarily confined to a narrow swath of open space between commercial development. Immediately upstream of SW Martinazzi Avenue, a notched concrete dam is present, creating a pond (known by City staff as Izzy's Pond) on the upstream side. Upstream of the pond, the channel is piped for approximately 100 feet in a strip mall parking lot. The remainder of the reach consists of open channel that is straight, narrow, and dominated by reed canary grass (Photo 7). Vegetation management is needed in this entire reach, including removal of invasive reed canary grass and replacement with other appropriate native vegetation.

Photo 7. Nyberg Creek Reach #3 upstream of SW Martinazzi Avenue.

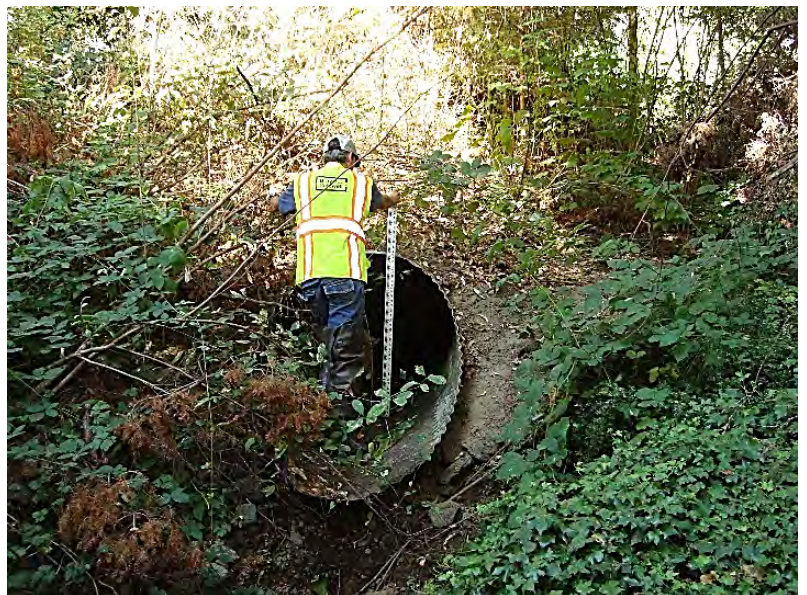
Hedges Reach #3B has a much steeper gradient than Reach #3A and the channel is incised with the width to depth ratio decreasing upstream along the reach. The channel is not stable in this reach. Adjacent slopes have failed on both banks (Photo 14) and the culvert under SW Alsea Ct. is perched resulting from erosion and downcutting at the base (Photo 15).

Photo 15. Perched culvert on downstream side of SW Alsea Ct.

Further upstream of SW Alsea Ct. to SW 99th Ave, there is more evidence of erosion and downcutting. A culvert delivering water to the head of the channel near 9999 SW Alsea Ct. is perched approximately 6 feet above the current channel. The culvert is actively eroding the channel. It appears the channel receives a large volume of water from the upstream catchment. BC estimates approximately 140 acres of residential development is collected and conveyed undetained to this stream reach. Given the susceptibility to headwater channels to experience erosion due to the flashiness of stormwater runoff, flow control and onsite retention standards and policies are recommended for the City’s consideration in Hedges Reach #3B to mitigate for areas of active erosion and preserve the integrity of the headwater channels.

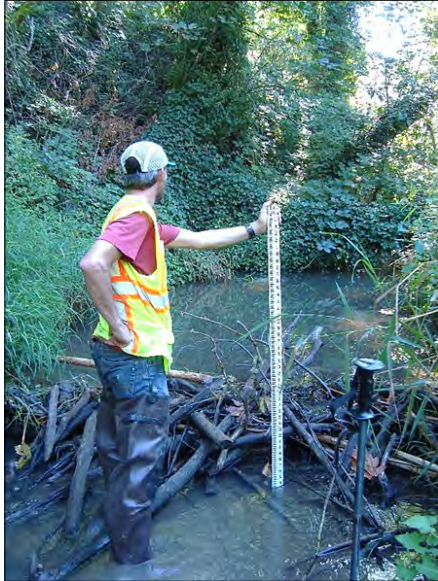
Beaver dam ~ 700 ft. downstream of Borland Rd (photo location shown below with camera icon)

Stream	Saum Creek
Reach	#1 (Tualatin River to SW Prosperity Park Rd)
General Characteristics	
Reach Length:	~6,775 ft.
Gradient:	~0.6%
Valley Width:	~100—200 ft
Planform:	Meandering
Average BFW:	~13' (range 12' to 15')
Average BFD:	~6' (range 4' to 7')
Substrate:	Predominantly silt, some small gravel
Vegetation:	Invasive vegetation (reed canary grass, blackberries, ivy), Douglas fir
Beaver Activity:	Yes. Four beaver dams observed.
Issues:	Minor erosion downstream of Borland Rd.

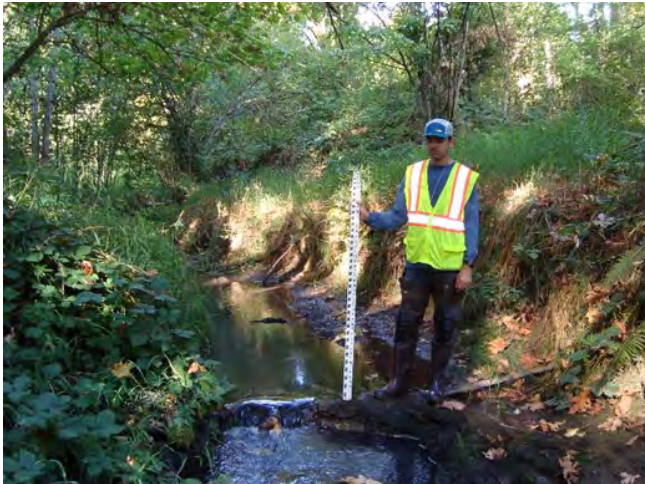
Hard clay forming pools within channel bed in Saum Creek Reach #2 (photo location shown below with camera icon)

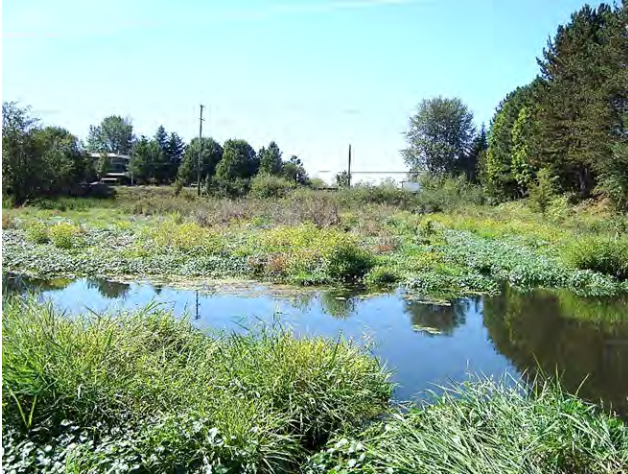
Ponded area in Nyberg Creek Reach #1 downstream of 65th Avenue (photo location shown below with camera icon)

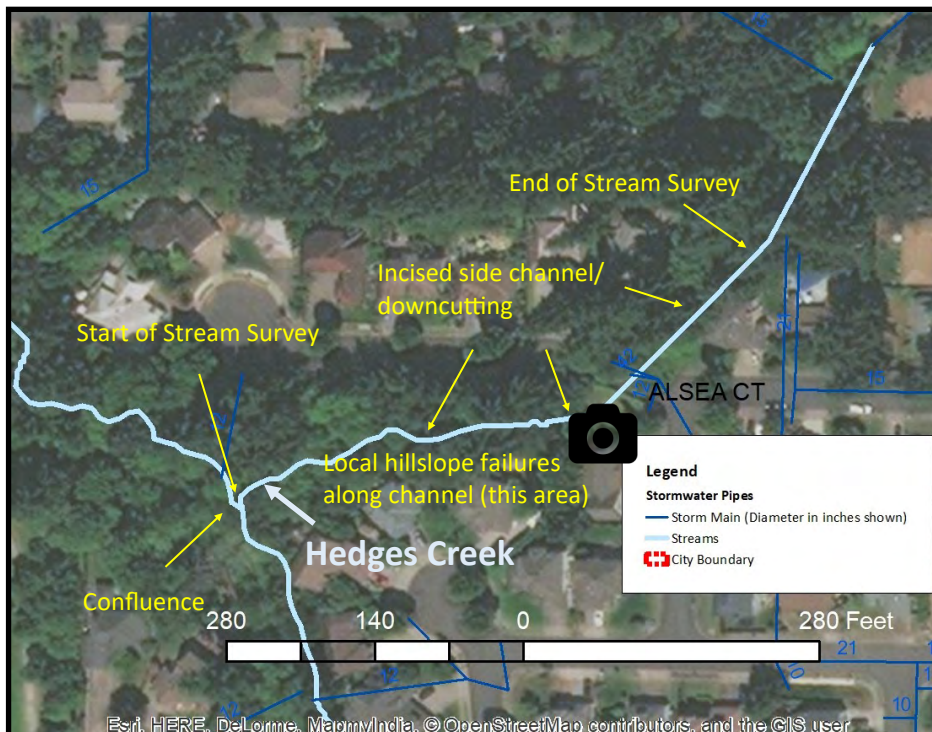
Aerial view of Hedges Creek Reach #3B (Confluence with S. Tributary to SW 99th Avenue)

Stream	Hedges Creek
Reach	#3B (Confluence with S. Tributary to SW 99th Ave)
General Characteristics	
Reach Length:	~560 ft.
Gradient:	~3.7%
Valley Width:	~50-150'
Planform:	Straight
Average BFW:	5.5'
Average BFD:	2.8'
Substrate:	Varies. Hard silt, gravel, and loose silt.
Vegetation:	Conifer and deciduous trees, reed canary grass, nettles, blackberries.
Beaver Activity:	None observed.
Issues:	Extreme erosion/channel downcutting in proximity to private property, and hillslope failures.

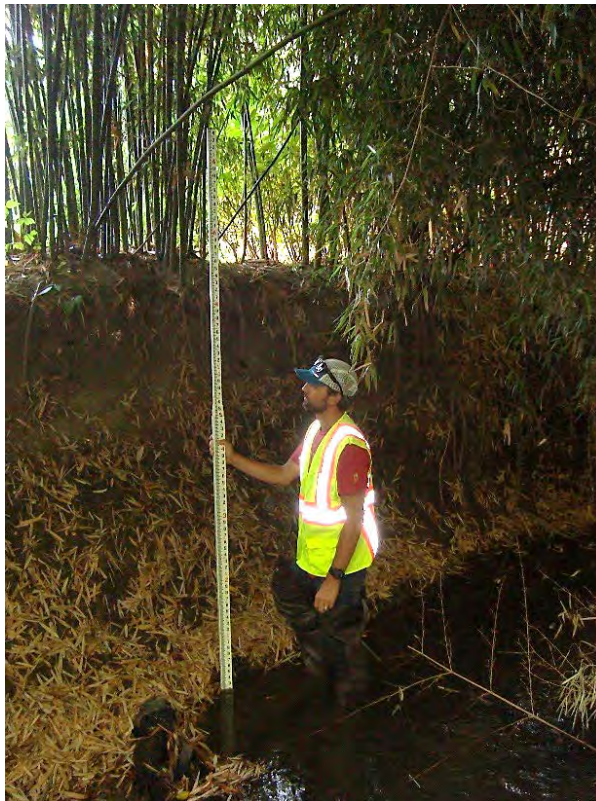
Site location: 30' upstream
Photo number: S1-2
Description: 7' high vertical bank (right bank) unstable, bamboo

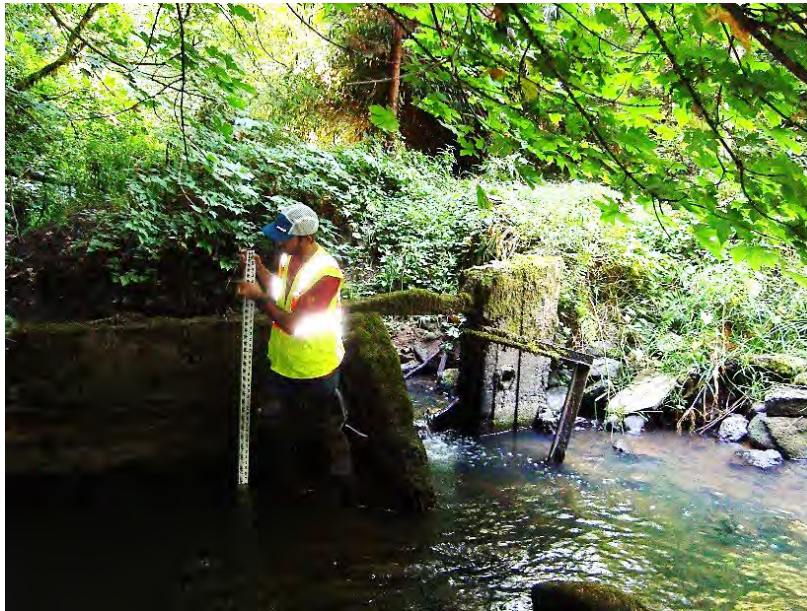
Site location: ~850' upstream of Tualatin, 20' upstream of culvert
Photo number: S1-7
Description: Old 3' high concrete weir wall (2 ½' wide opening) with pool on downstream end. Weir is leaning downstream and sediment has deposited behind it on upstream side.

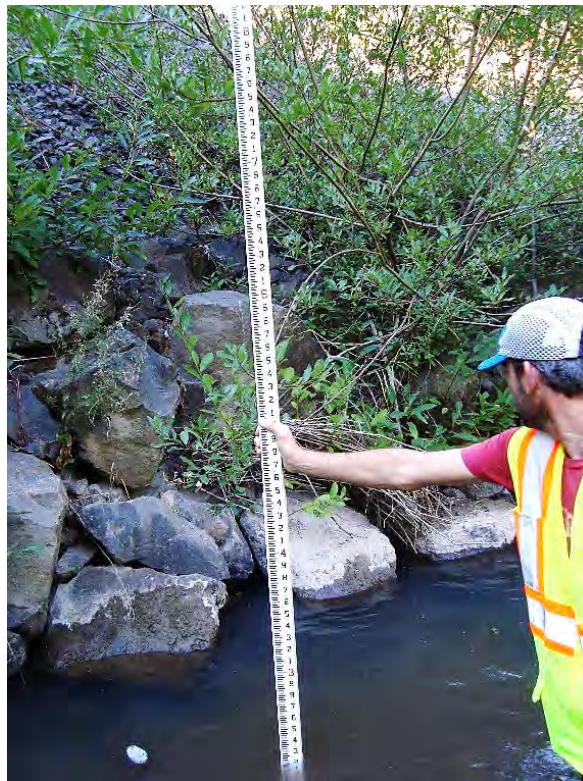
Site location: 300' downstream of SW Borland Rd.
Photo number: S1-18
Description: Riprap left bank outside bend

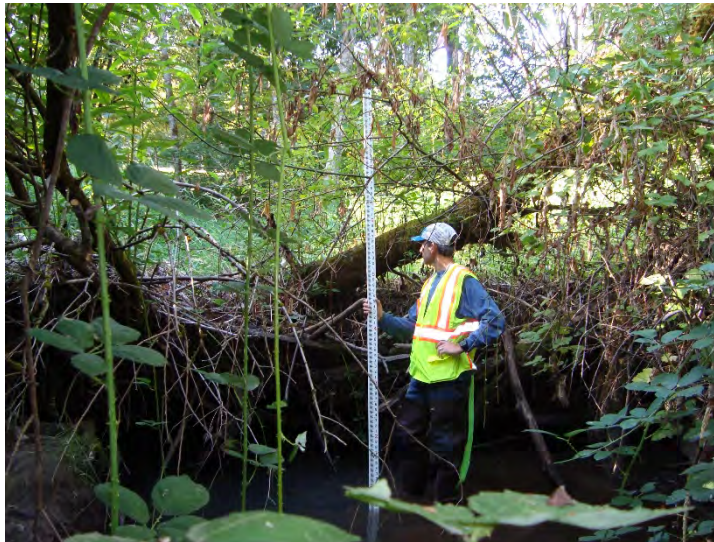
Site location: Between SW 55th and SW 56th, near I-205
Photo number: S2-4
Description: Channel spanning debris blockage, ~4' above channel bed, looking south and upstream

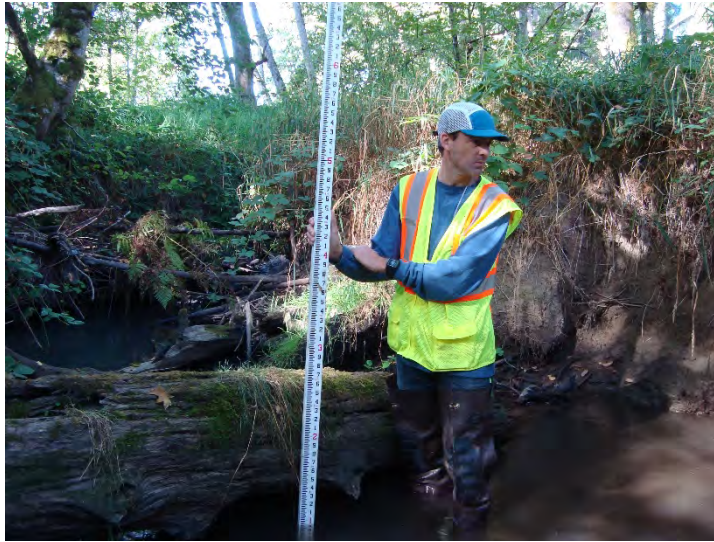
Photo number: S2-7

Description: Looking upstream at debris in channel and associated bank erosion on edges

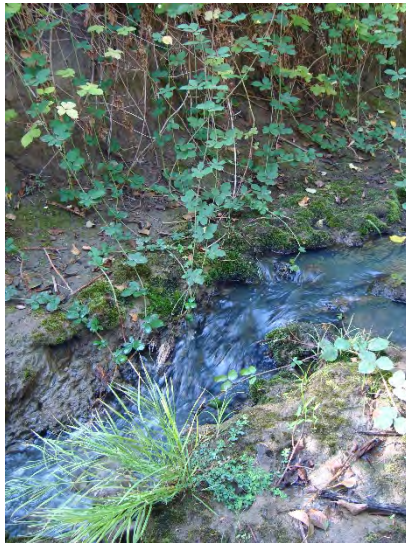
Photo number: S2-8

Description: Looking downstream, hard clay unit in bed, slight knick point in channel, minor incision just upstream of debris jam

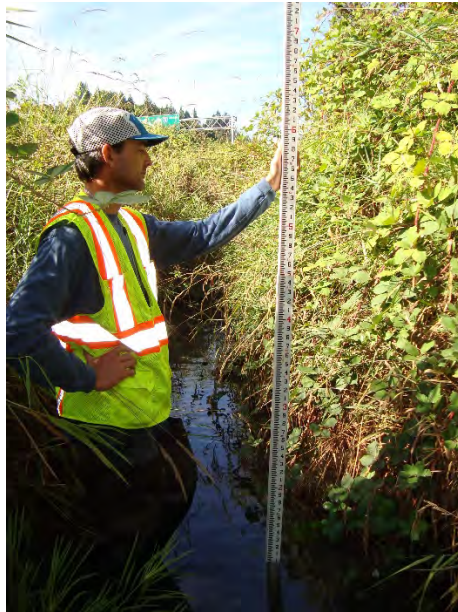
Site location: South of SW 59th
Photo number: S2-10
Description: Location of 12" steel pipe in channel disconnected from vertical segment. Some gravel in channel at this location.

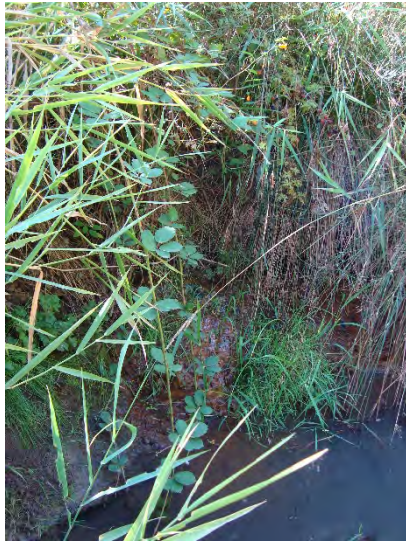
Site location: Upstream of Photo S2-10
Photo number: S2-11
Description: Groundwater seepage on right bank

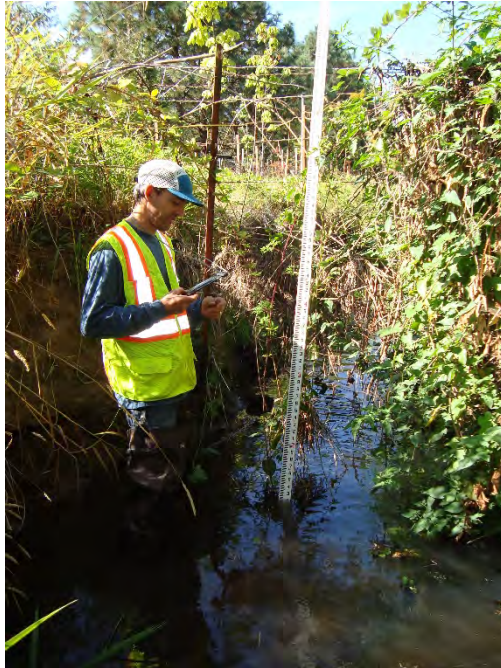
Photo number: S2-13

Site location: 1200' east of SW 65th Ave.

Description: Fence, looking west

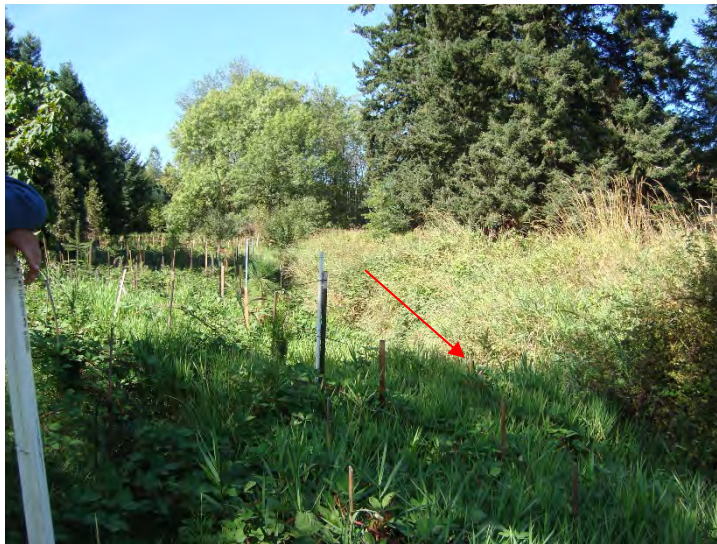
Photo number: S2-14

Site location: 1000' east of SW 65th Ave.

Description: Mitigation site on right bank (I-205 side), left side of photo. Red arrow shows channel location.

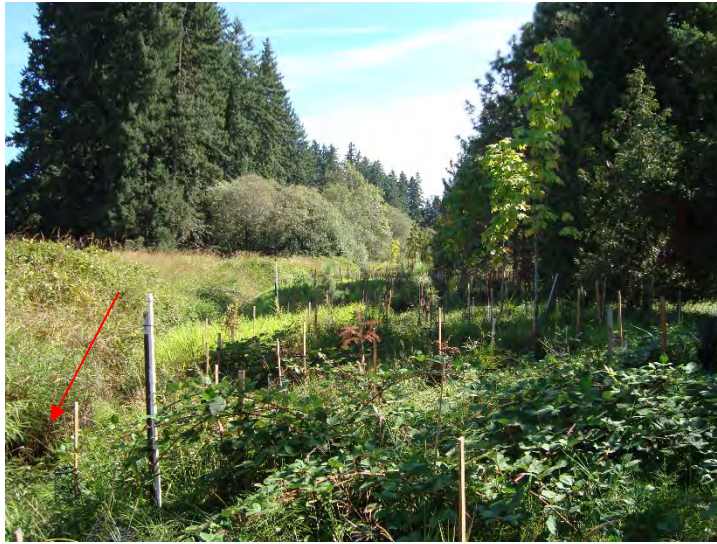
Site location: 1000' east of SW 65th Ave.
Photo number: S2-15
Description: Looking east (downstream) at mitigation site. Red arrow shows channel location.

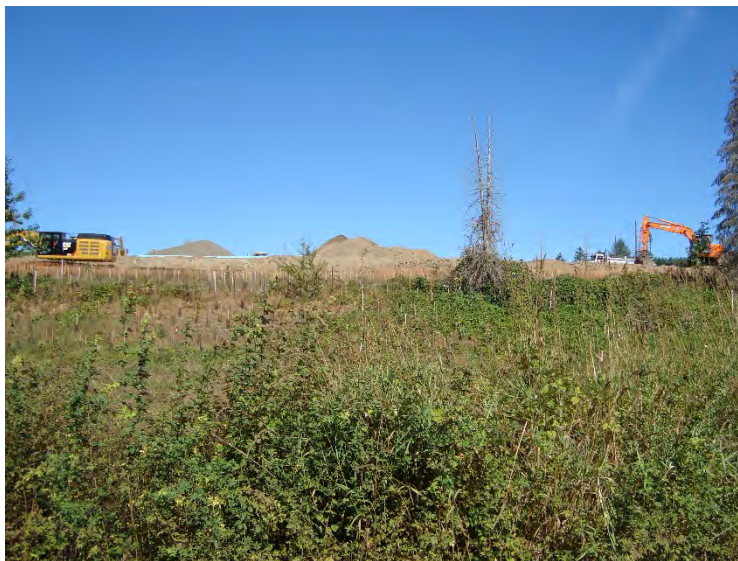
Site location: 1000' east of SW 65th Ave.
Photo number: S2-16
Description: Looking north at construction site across channel

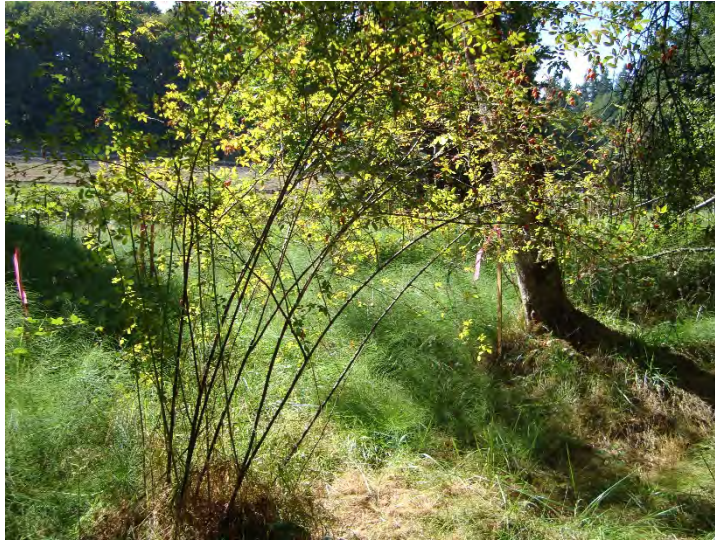
Site location: 600' east of SW 65th Ave.
Photo number: S2-17
Description: Right bank swale on west side of mitigation area.

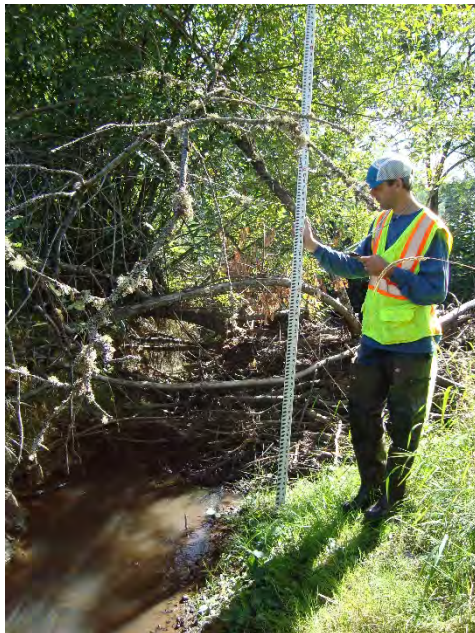
Site location: 100' east of SW 65th Ave.
Photo number: S2-18
Description: Debris jam looking downstream

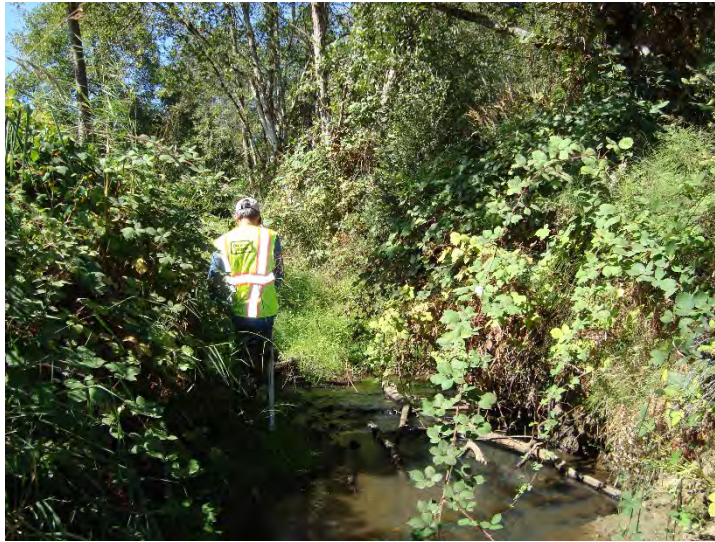
Photo number: S2-19

Site location: 100' east of SW 65th Ave

Description: Looking upstream from same location as Photo S2-18. Gravel in channel at this point.

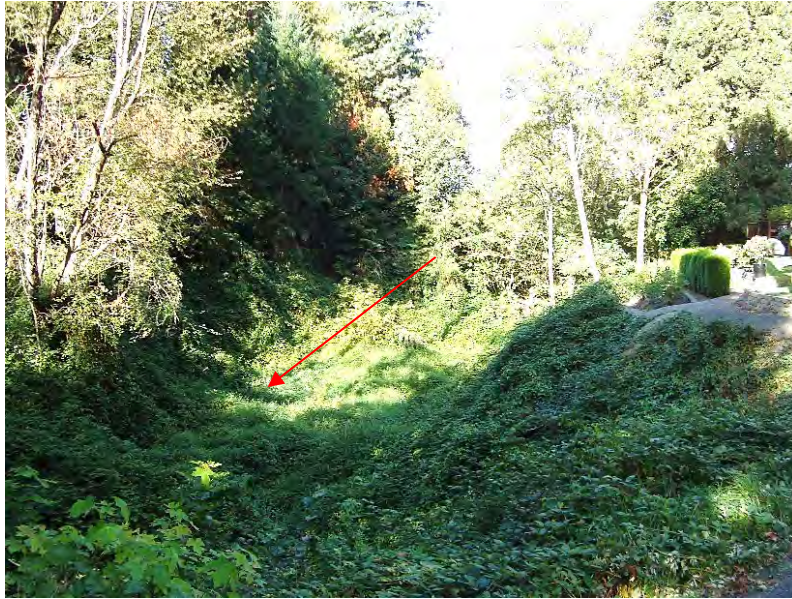
Photo number: S3-1

Site location: Downstream of SW Blake St.

Description: Looking down at valley bottom from above. Red arrow indicates location of channel.

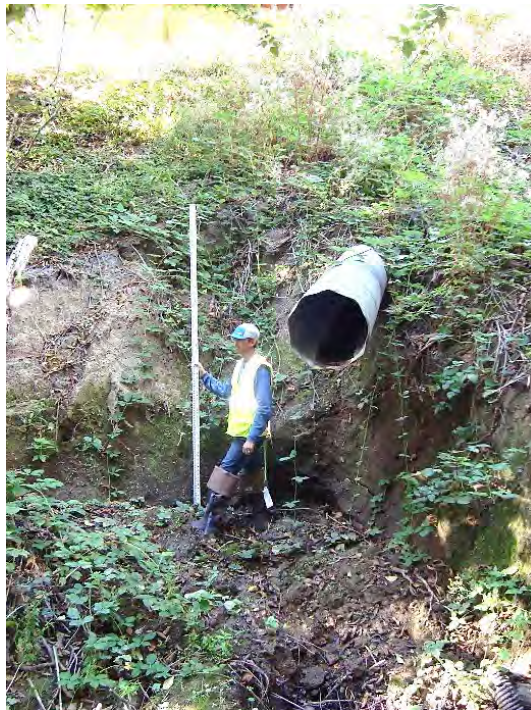
Photo number: S3-2

Results of the stream assessment identified one location where a capital project may be developed to address City infrastructure potentially susceptible to failure. A perched stormwater pipe above the stream channel in Saum Creek Reach #3 was identified during the stream assessment. Stormwater discharge from this pipe will cause further erosion of the slope around it if left in its current position. A capital project is recommended to replace the pipe and repair the hillslope failure in the vicinity in conjunction with the pipe replacement. The new pipe should be placed on the hillside (i.e., thick-walled flexible pipe or similar) to the bottom of the slope, with energy dissipation provided. A geotechnical evaluation is recommended in order to determine the cause of the slope failure in the vicinity of the perched pipe, and provide input to the slope repair design.

Stream	Saum Creek
Reach	#3 (Vicinity of Blake Street)
General Characteristics	
Reach Length:	~600 ft.
Gradient:	~1.1 % (ds of Blake), ~3% (us of Blake)
Valley Width:	~75' to 100' (confined)
Planform:	Straight
Average BFW:	~6'
Average BFD:	~2'
Substrate:	Fine sediment
Vegetation:	Conifer and deciduous trees (many down in channel), reed canary grass, ivy
Beaver Activity:	None observed.
Issues:	Unstable hillslope and perched culvert, invasive vegetation.

Site location: Downstream of SW Blake St.

Description: Hillslope failure and perched culvert

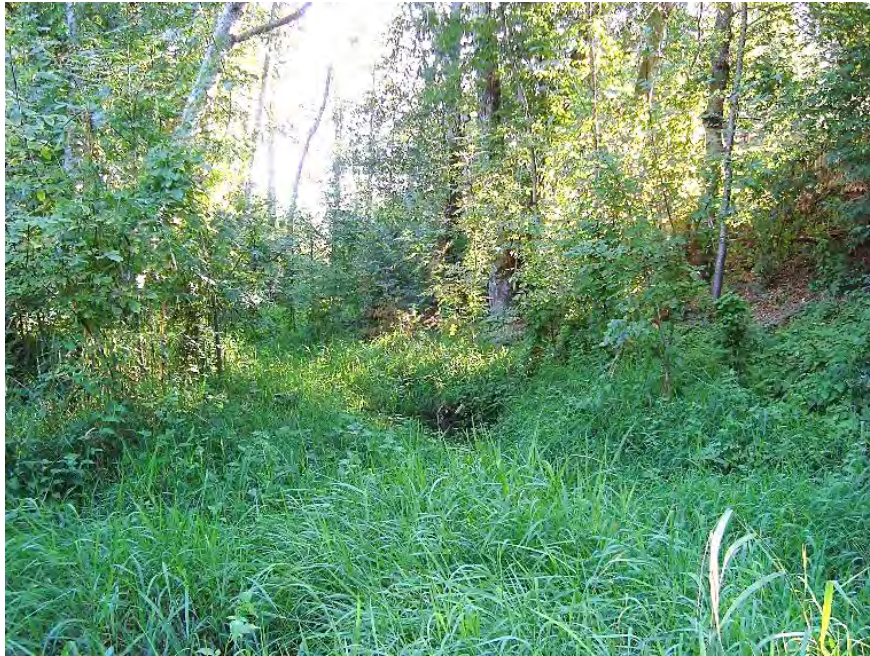
Site location: Upstream of SW Blake St. crossing
Photo number: S3-4
Description: Beginning of restoration area, very wet

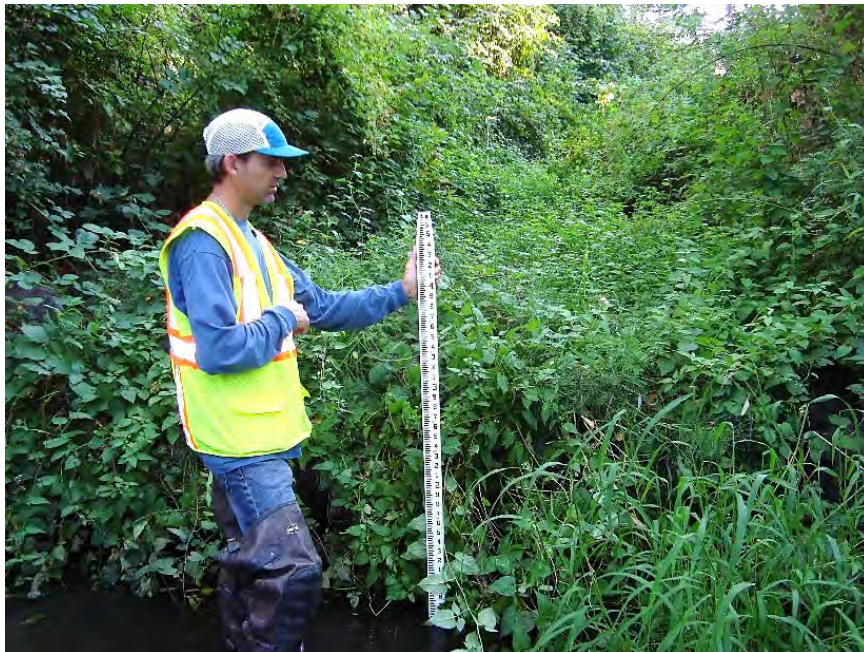
Site location: ~130' upstream of SW Blake St.
Photo number: S3-6
Description: Looking downstream, swale on right bank, rock on outside bend (near stadia- obscured by vegetation)

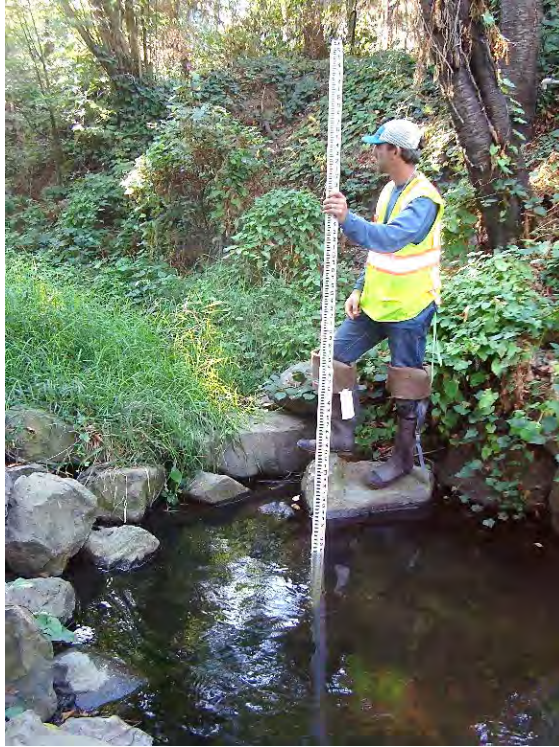
Site location: ~300' upstream of SW Blake St.
Photo number: S3-7
Description: Constructed rock drop pool (restoration)

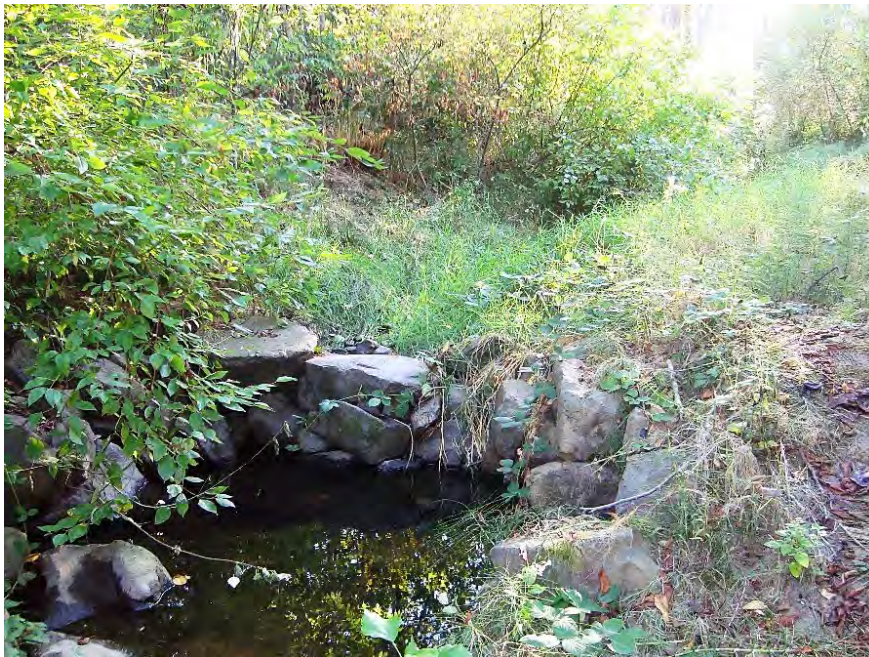
Site location: ~350' upstream of SW Blake St.
Photo number: S3-8
Description: Constructed rock pool

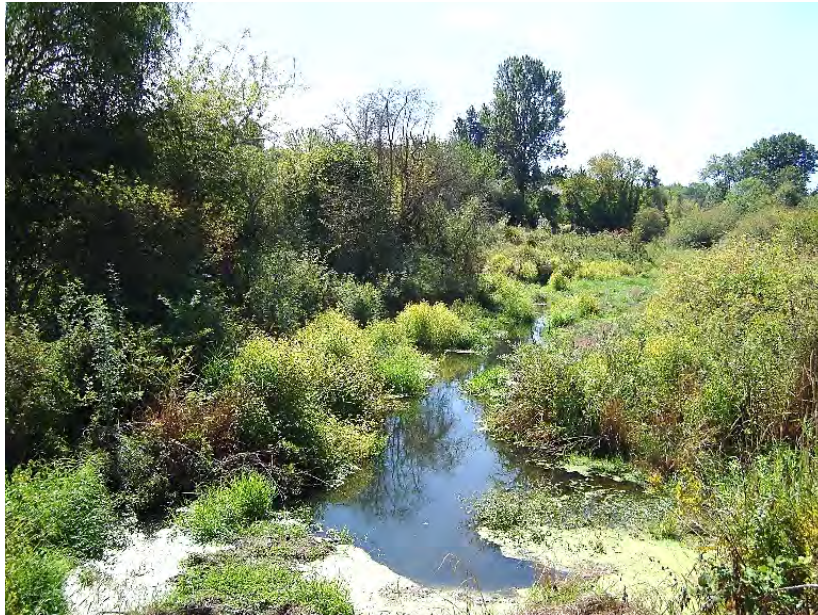
Site location: Upstream side of SW Nyberg Lane
Photo number: N1-2
Description: Nyberg Creek where it flows under SW Nyberg Lane through three 48" culverts

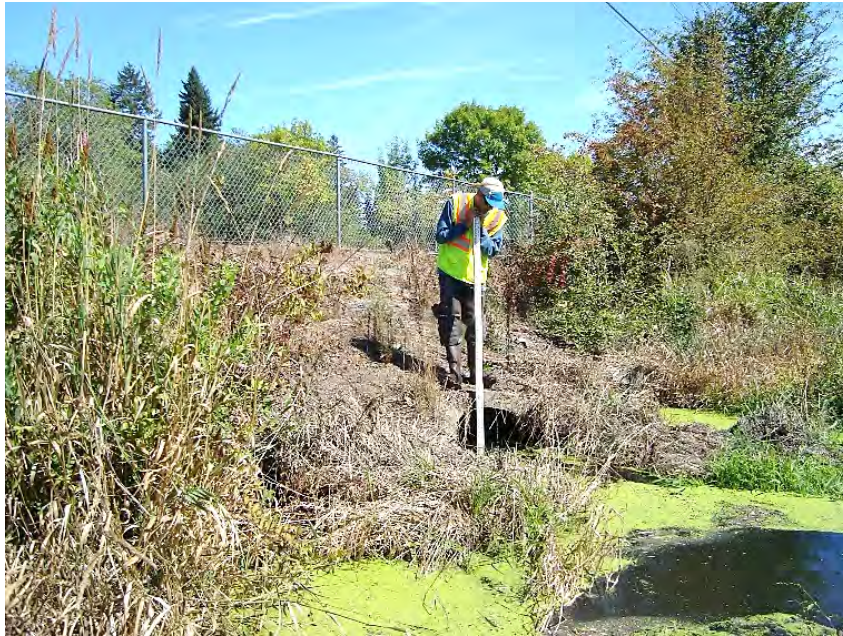
Site location: Upstream side of SW Nyberg Lane
Photo number: N1-3
Description: Looking downstream at culverts, same location as Photo N1-2

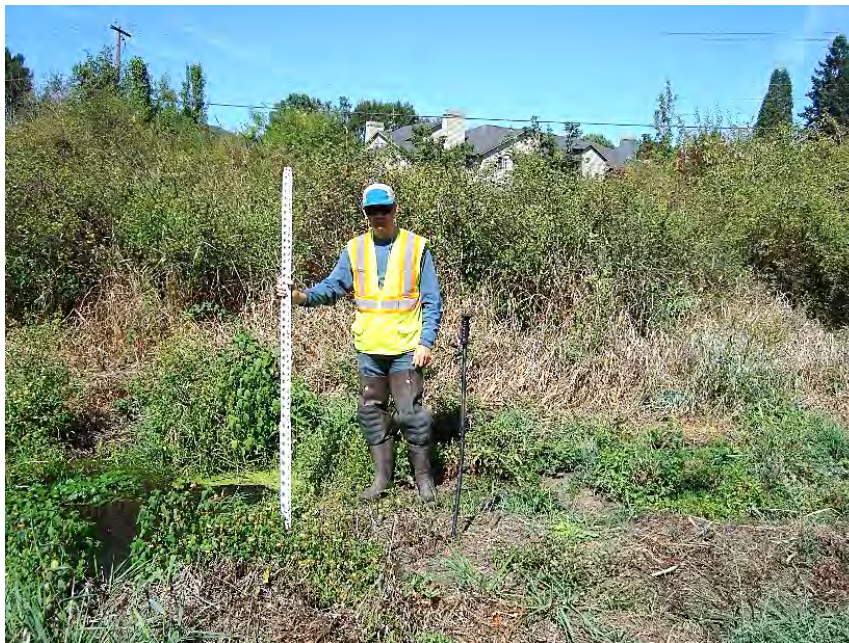
Site location: 200' upstream from SW Nyberg Lane
Photo number: N1-4
Description: Old roadbed. Stream is in 30" CMP culvert under road.

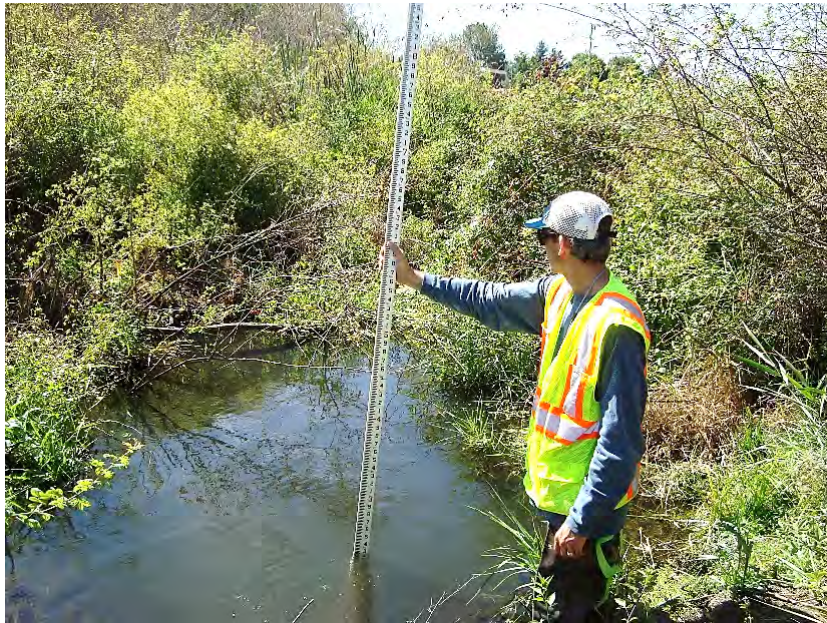
Site location: 250' upstream of SW Nyberg Lane
Photo number: N1-5
Description: Deep, narrow main channel, flow is spread-out in multiple paths across wetland area

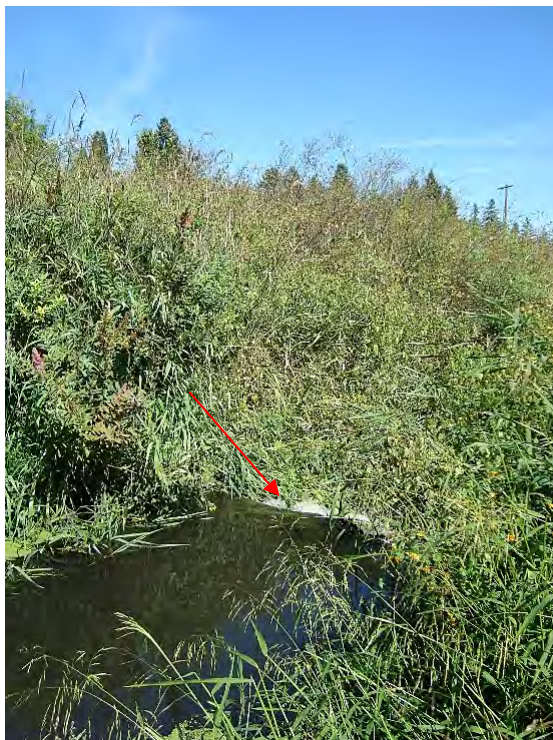
Site location: 400' upstream of SW Nyberg Lane
Photo number: N1-6
Description: Looking downstream at top of beaver dam. Red arrow points to top of dam. Drop is approximately 3 feet.

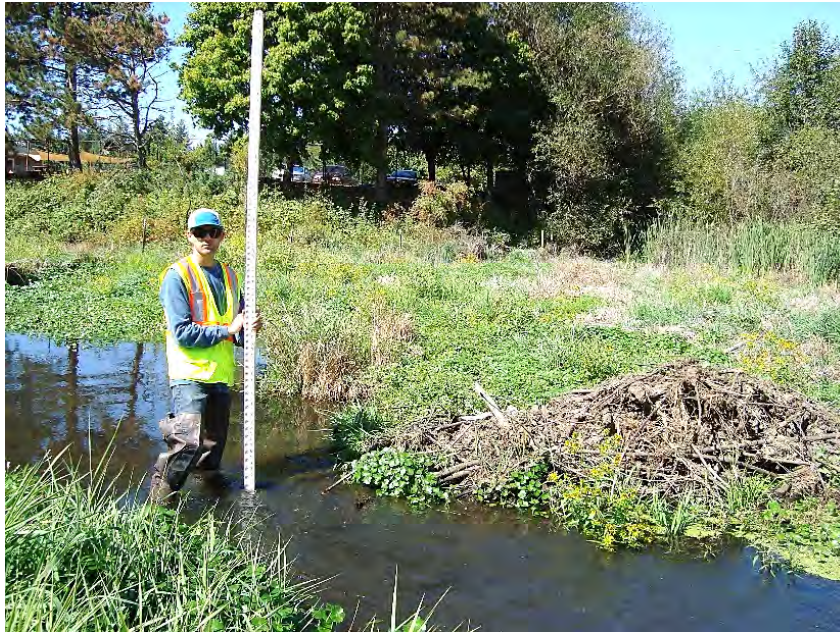
Photo number: N1-7

Site location: 450' upstream of SW Nyberg Lane

Description: Recently removed beaver debris

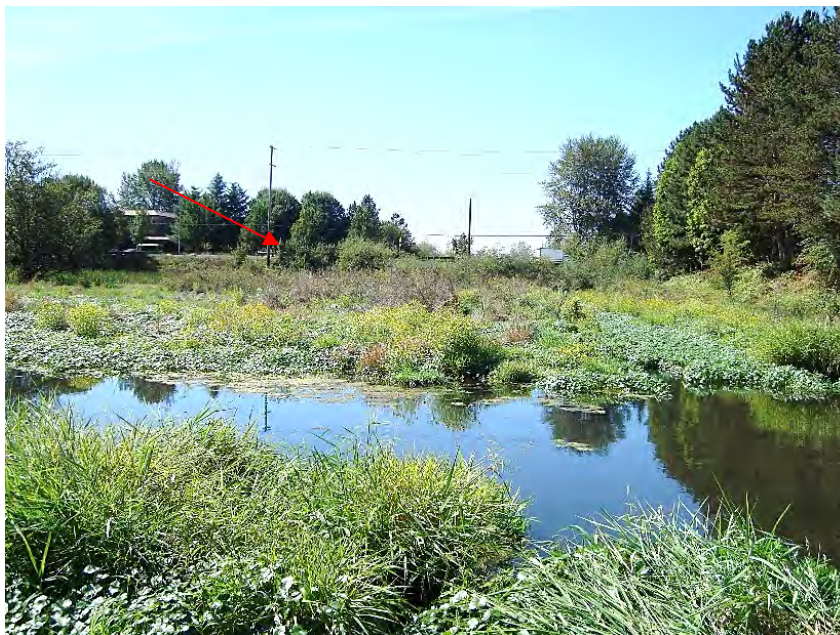
Photo number: N1-8

Site location: 300' downstream of SW 65th Ave.

Description: Looking upstream at ponded area. Red arrow shows location of SW 65th Ave.

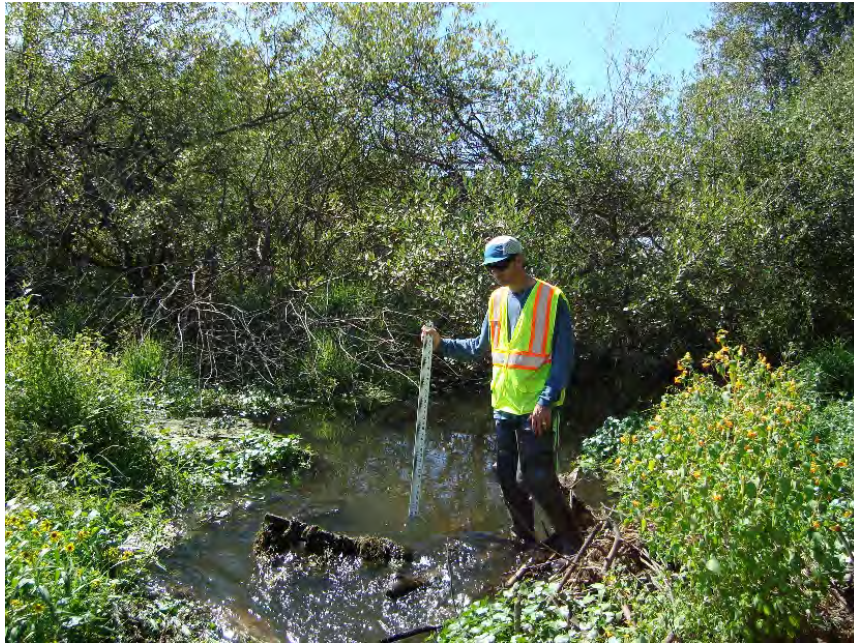
Photo number: N1-9

Site location: 100' downstream of SW 65th Ave.

Description: Upstream end of ponded area

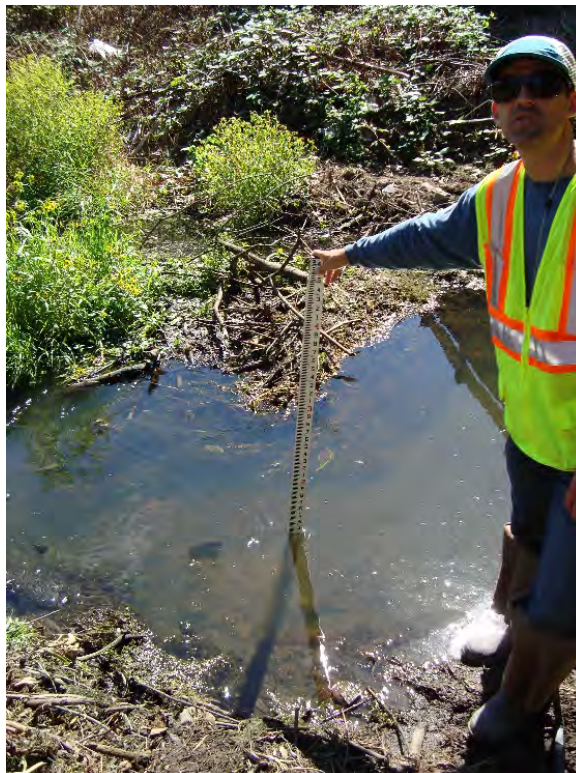
Photo number: N1-10

Site location: Nyberg Creek on downstream side of SW 65th Ave.

Description: Same view as Photo N1-9

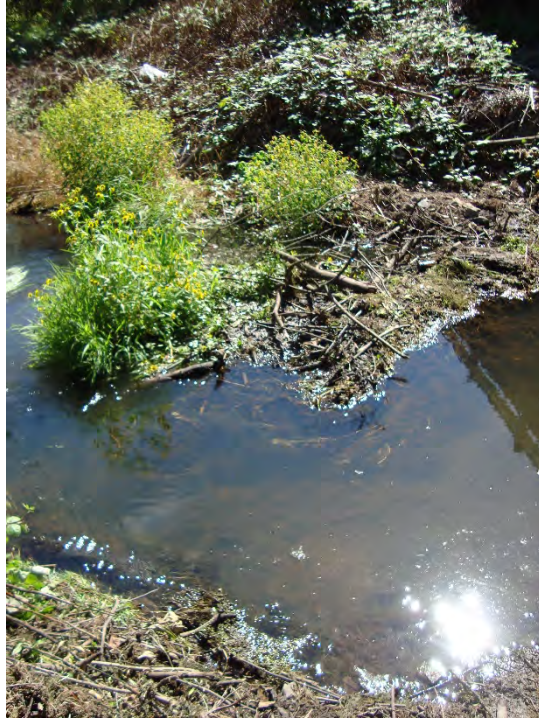
Site location: Nyberg Creek on downstream side of SW 65th Ave.
Photo number: N1-11
Description: Photo taken from left bank (north side) on 9/12. Additional debris was removed between 9/11 and 9/12. See photo N1-12 for comparison.

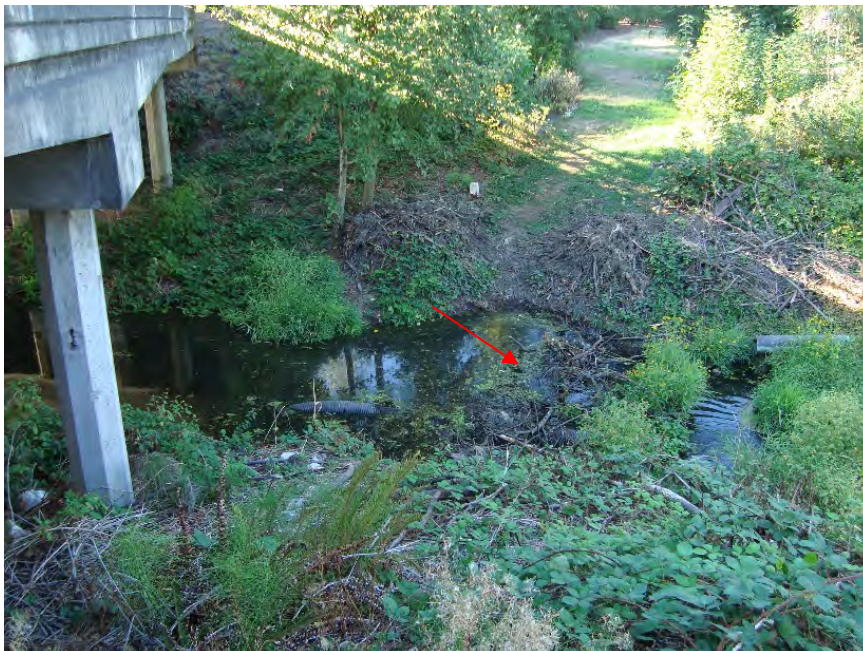
Site location: Nyberg Creek on downstream side of SW 65th Ave (east side)
Photo number: N1-12
Description: Photo taken from south side on 9/11. Red arrow shows debris removed from beaver activity.

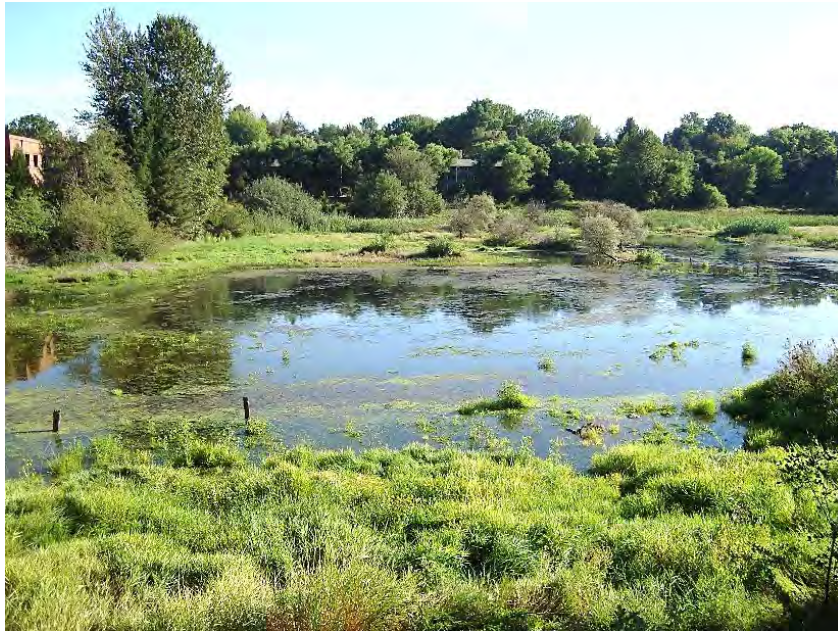
Photo number: N2-1

Site location: South of 7-11, West of SW 65th Ave.

Description: Nyberg Creek Wetlands

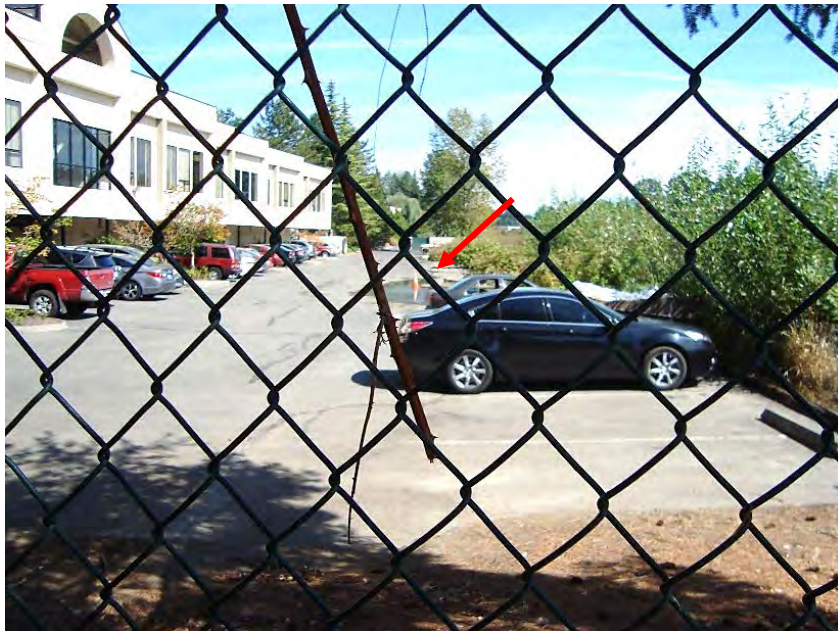
Photo number: N2-2

Site location: Business park between Nyberg wetlands and SW Nyberg St.

Description: Ponded area shown indicated by red arrow.

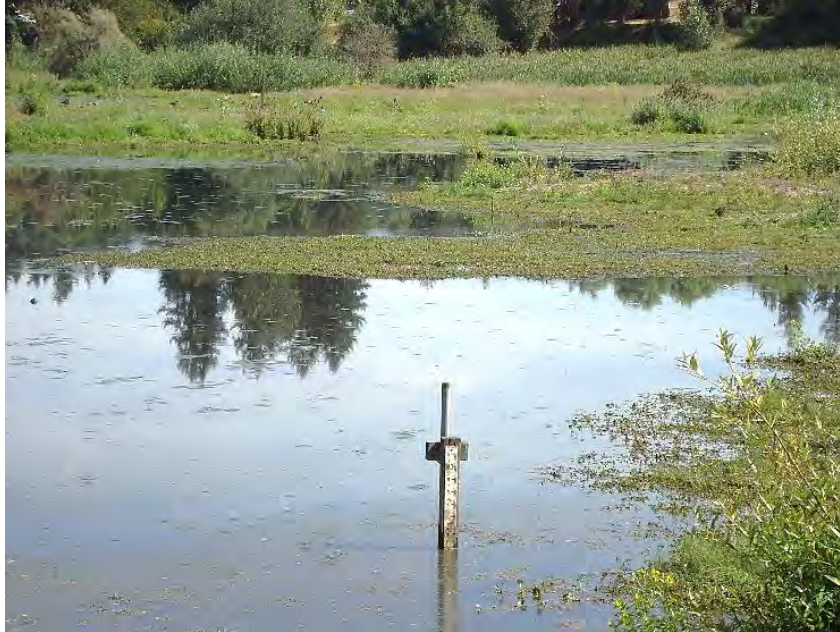
Site location: Nyberg Wetlands, downstream side of beaver dam
Photo number: N2-3
Description: Staff gauge in ponded area
