Appendix E: Capital Project Modeling Results

Appendix F: Stream Assessment TM (TM4)

Stream Channel Condition Survey

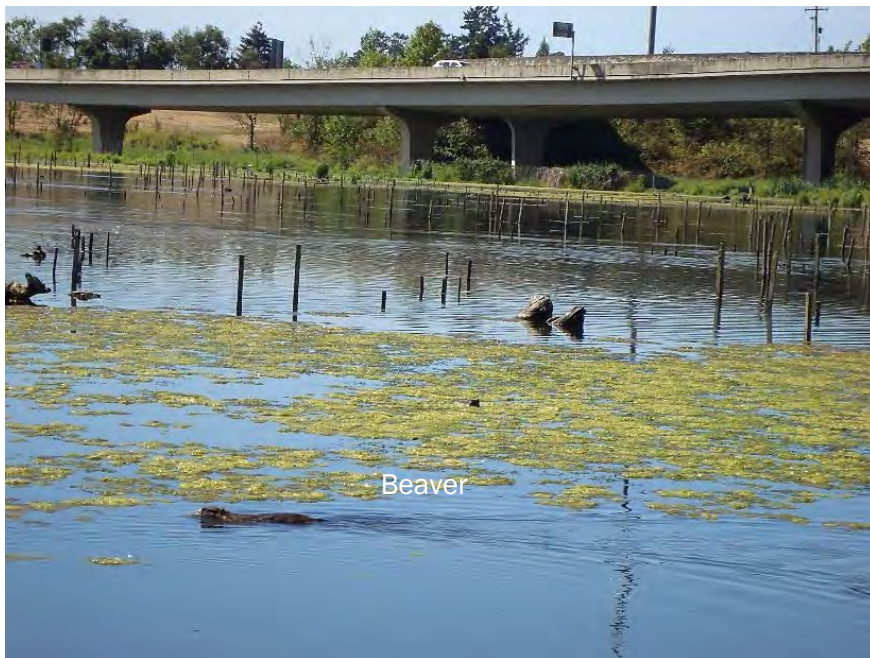
Site location: Poned area downstream of I-5
Photo number: N2-6
Description: Baby beaver in foreground

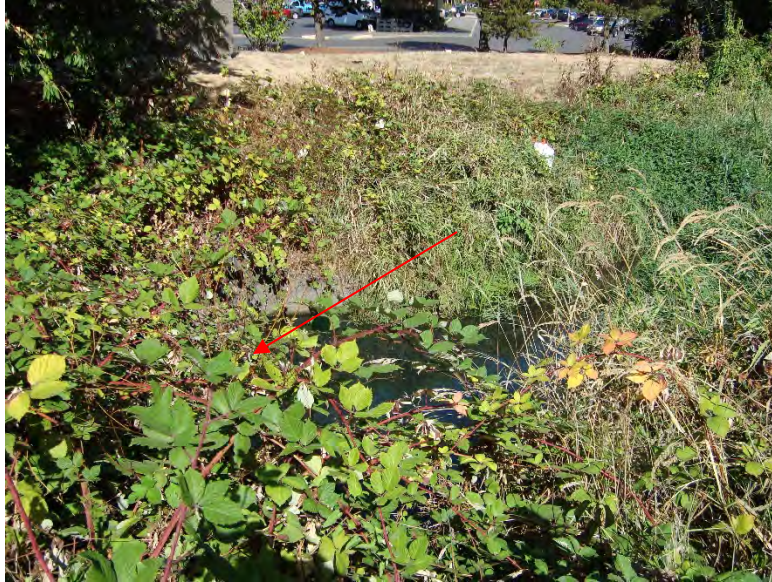
Site location: East side of SW SW Martinazzi Ave.
Photo number: N3-1
Description: Looking downstream of SW Martinazzi Ave. where 48-inch diameter stormwater pipe enters Nyberg Creek (approximately where red arrow is pointing)

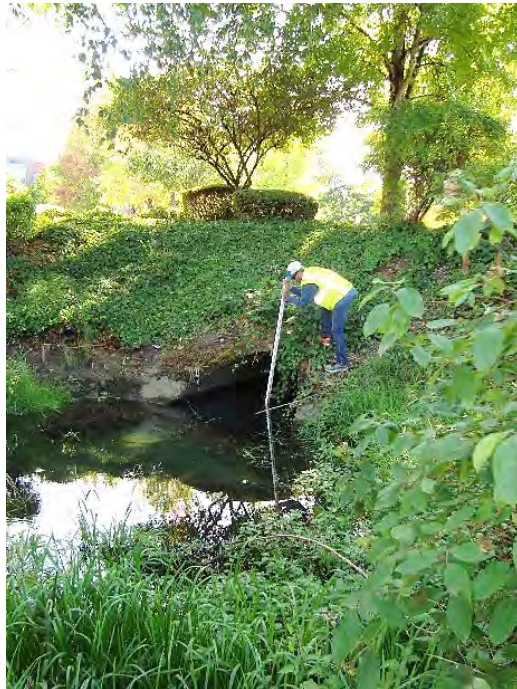
Photo number: N3-3

Site location: ~200' upstream of SW Martinazzi Ave.

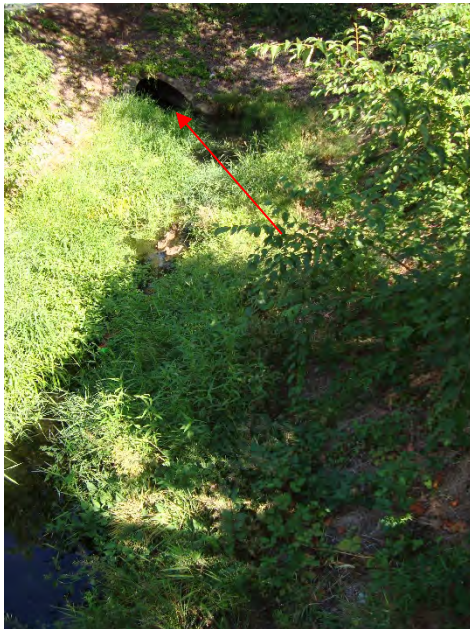
Photo number: N3-4

Description: Looking at the upstream end of the culvert next to Shari's restaurant (shown by red arrow)

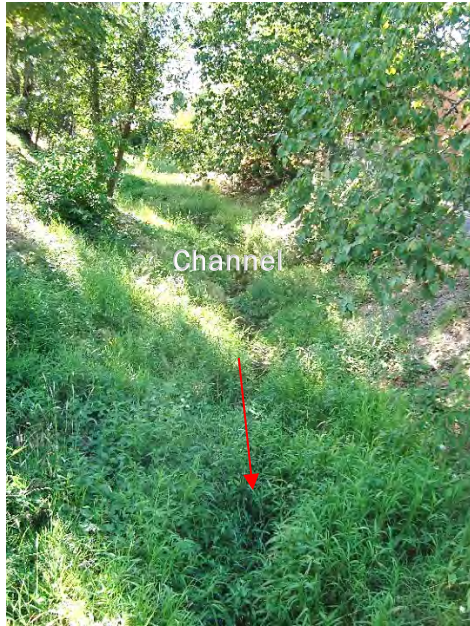
Photo number: N3-5

Description: Looking downstream from footbridge at upstream end of parking lot culvert (obscured by reed canary grass)

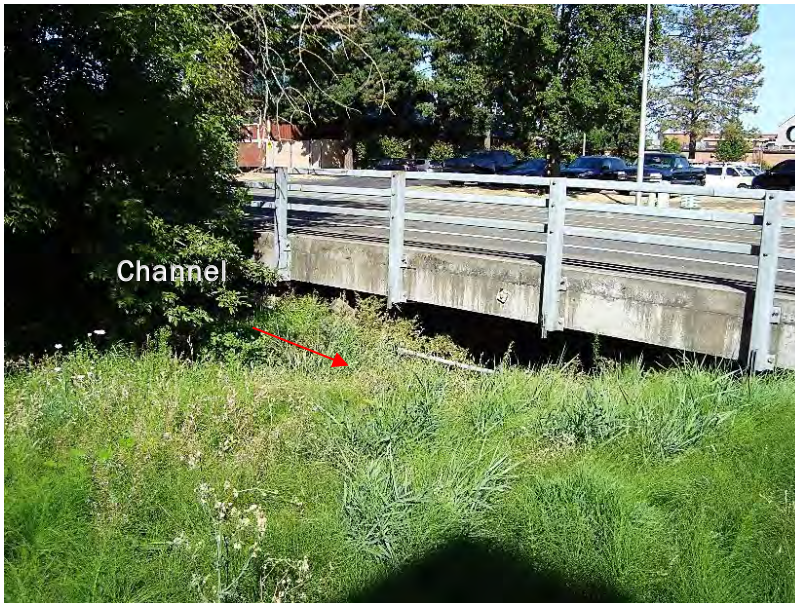
Photo number: N3-6

Description: Looking in downstream direction

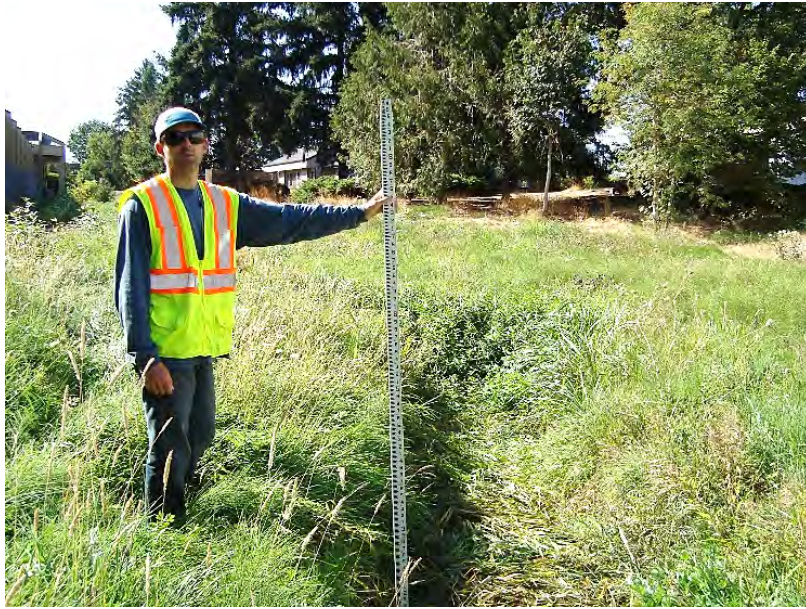
Photo number: N3-7

Description: Looking upstream, narrow channel

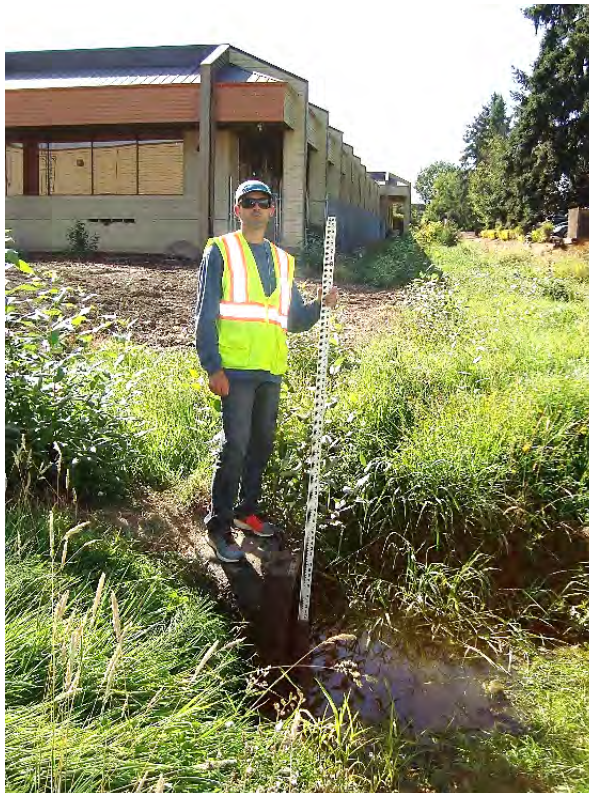
Photo number: N3-8

Description: 42" outfall on south side of channel (1/2 full)

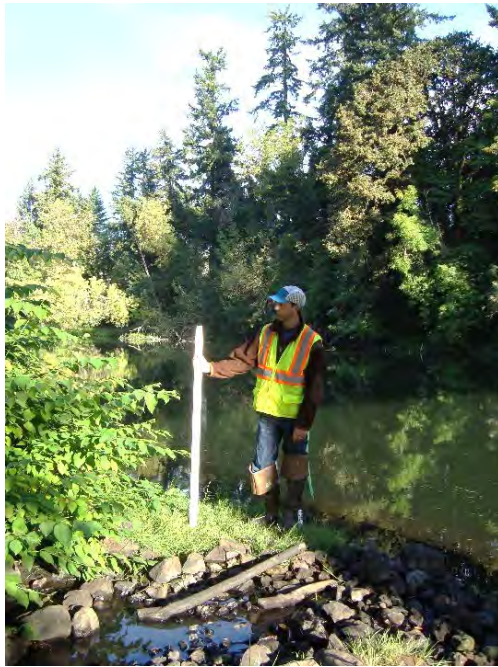
Site location: Mouth of Hedges Creek below Boones Ferry Road bridge at Tualatin River
Photo number: H1-1
Description: 3" to 1.5' rocks in channel (rip-rap stabilization)

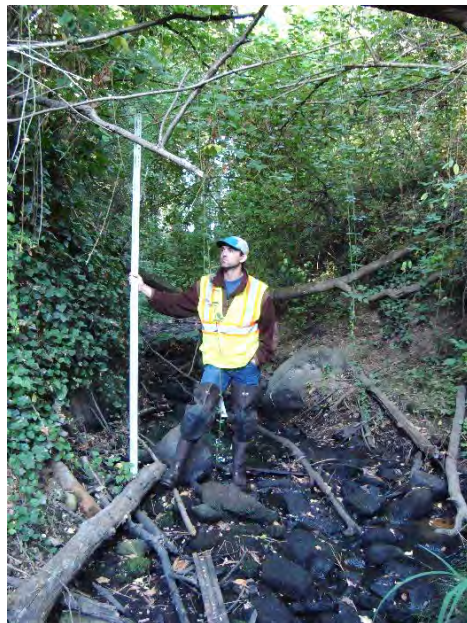
Site location: 30' upstream of Tualatin River
Photo number: H1-2
Description: 1' - 2' rocks in channel, high water mark on bridge abutment corresponds to about 6' above channel bed in this location, steep gradient to mouth

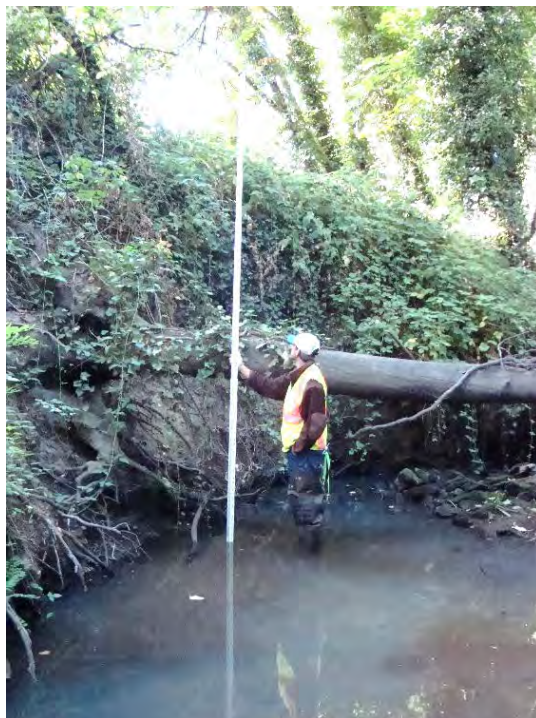
Site location: 150' upstream of Tualatin River
Photo number: H1-4
Description: Looking upstream, right bank erosion, downed trees, slumping on right bank

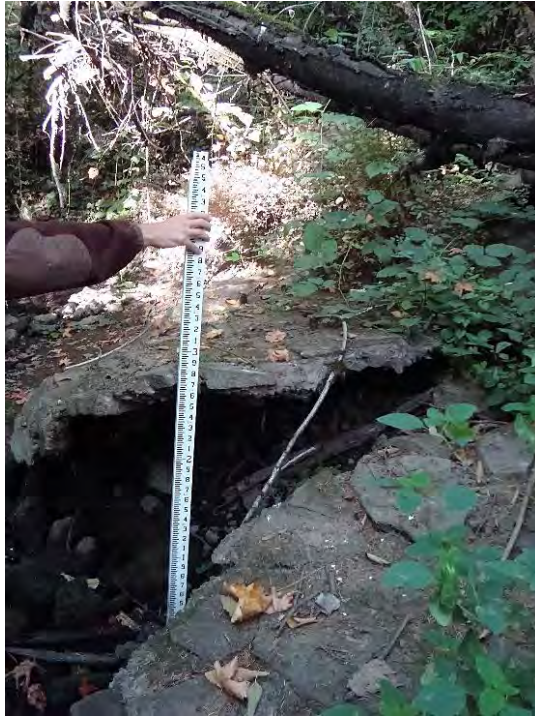
Site location: 200' upstream of Tualatin River
Photo number: H1-5
Description: Concrete poured in channel from left bank

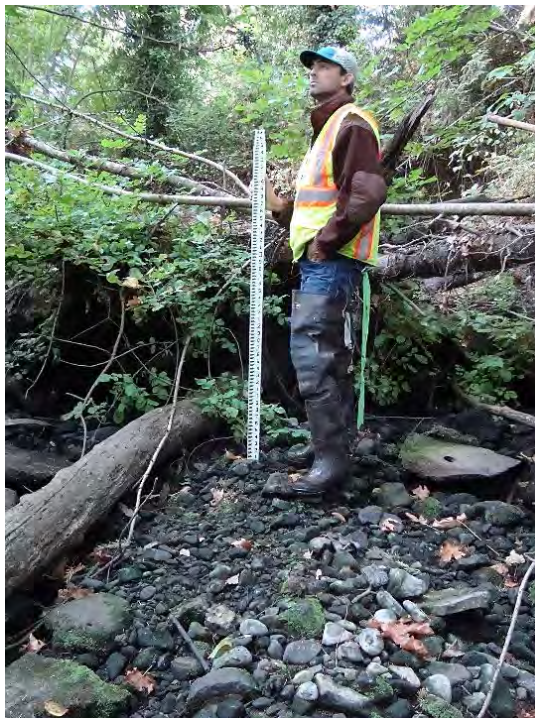
Site location: 300' upstream of Tualatin River
Photo number: H1-6
Description: Looking upstream, gravel deposit in center of channel below channel-spanning debris jam

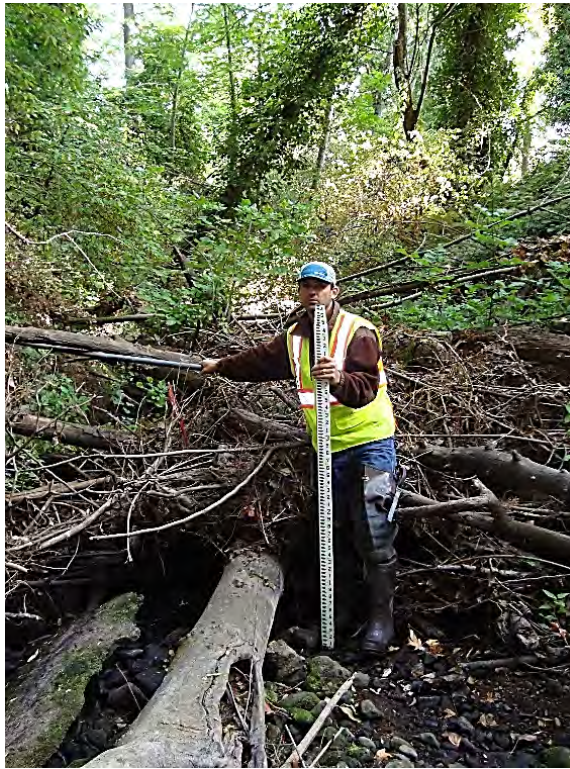
Photo number: H1-7

Description: Looking downstream at debris jam, Ryan is touching water line (?) pipe across debris

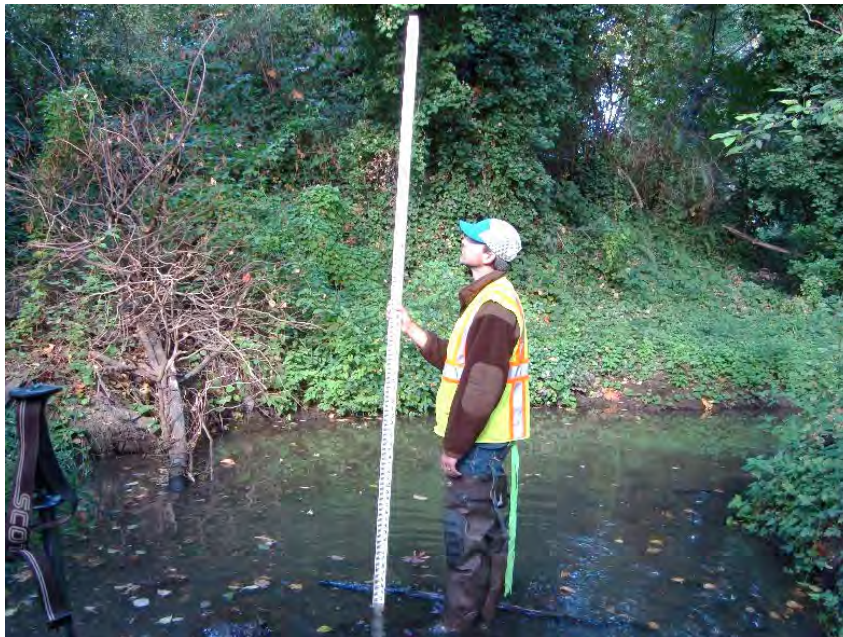
Photo number: H1-8

Description: Looking upstream at outside bend (adjacent to SW Boones Ferry Road)

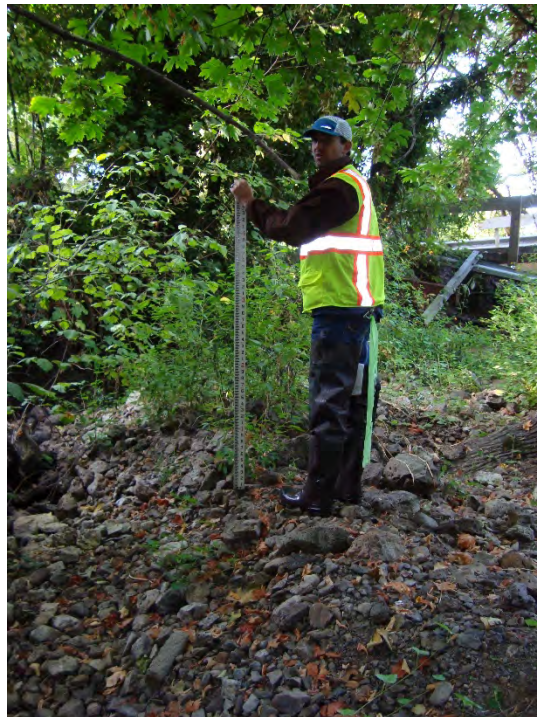
Site location: 500' upstream of Tualatin River (near SW Martinazzi Avenue)
Photo number: H1-10
Description: Debris deposited downstream of washed out driveway bridge

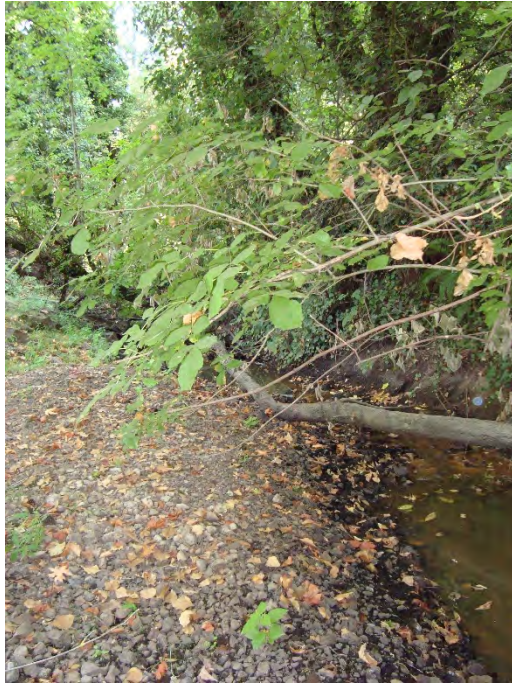
Photo number: H1-11

Description: Looking downstream at debris and creek, right bank (outside bend) is downstream of culvert constriction (washed out) where flow is concentrated. This area is vulnerable to erosion.

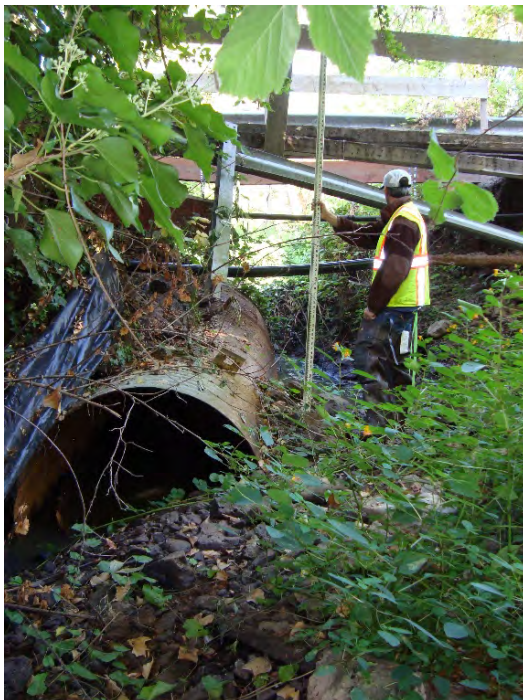
Photo number: H1-12

Description: Looking upstream at culvert under washed out bridge amongst debris that has not been removed

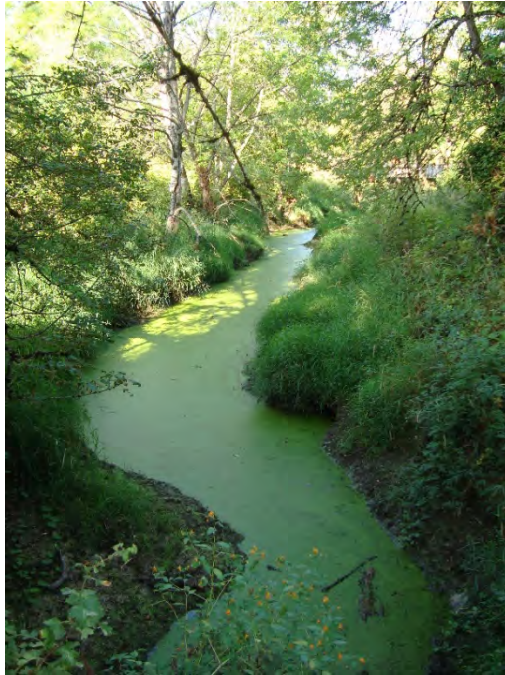
Photo number: H1-13

Description: Channel upstream of washed out bridge, stagnant water. Flow is restricted by debris and washed out culvert.

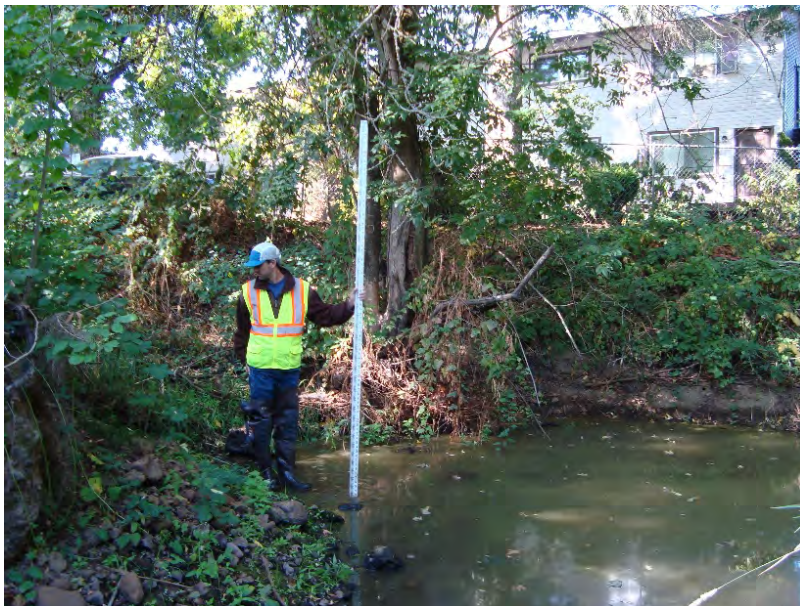
Photo number: H1-16

Description: Old culvert (where Ryan is standing), photo is looking upstream at outside bend where stream takes a sharp turn to the north

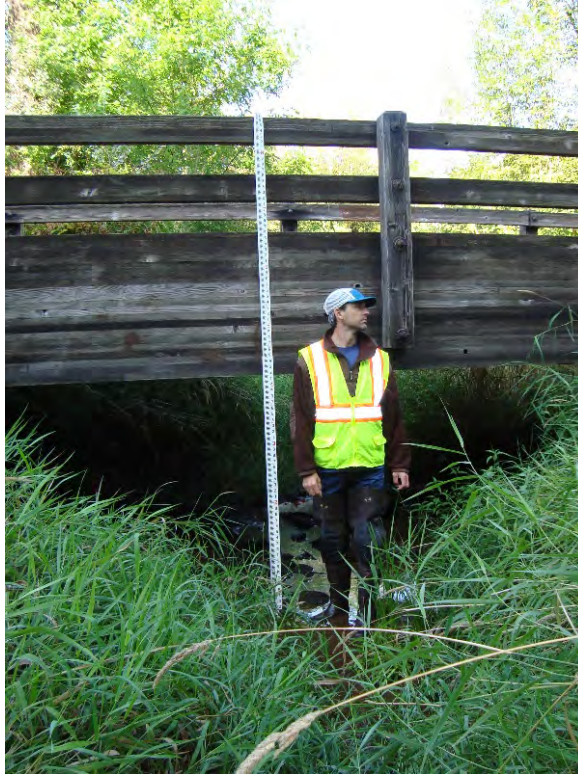
Photo number: H1-17

Description: Tualatin-Greenway bridge, channel choked with reed canary grass

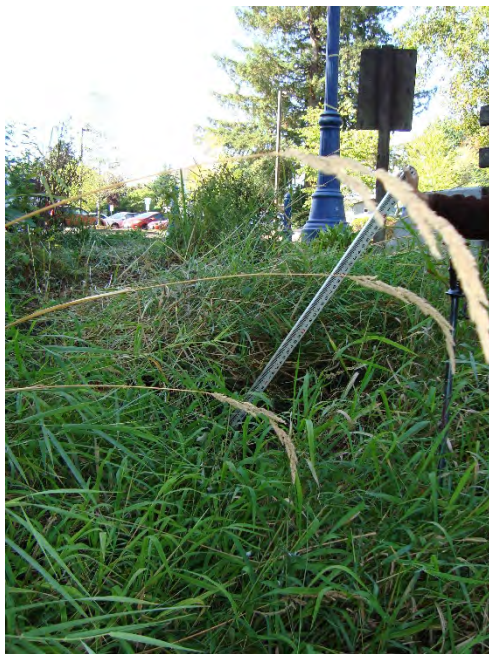
Photo number: H1-18

Description: Same location as photo H1-17. 18" diameter stormwater pipe enters channel on right bank where stadia rod is pointed.

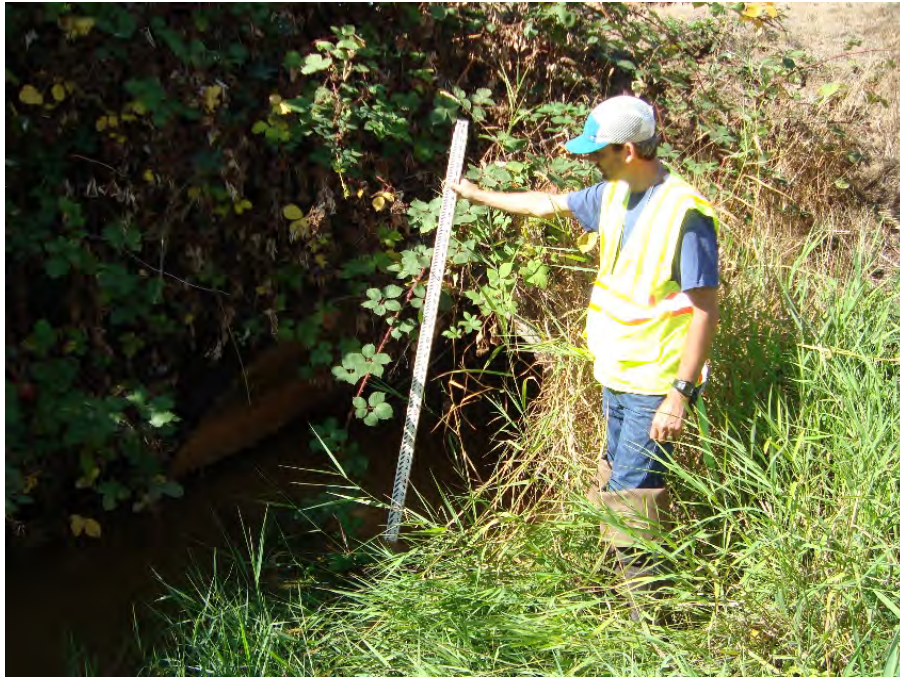
Site location: SW Boones Ferry Road
Photo number: H1-25
Description: Looking upstream at culvert under SW Boones Ferry Road

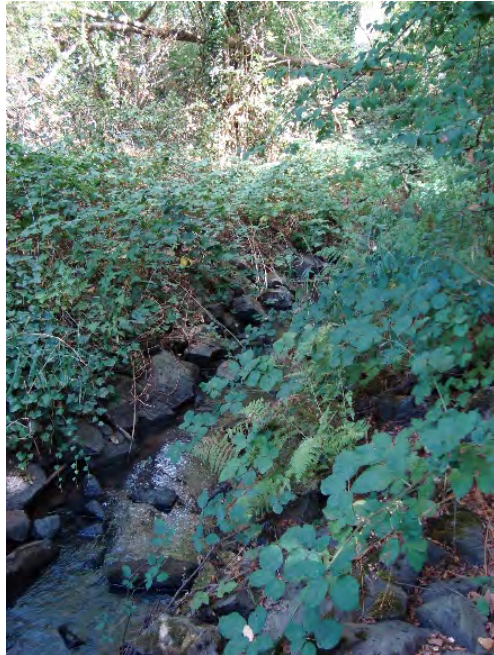
Site location: Culvert at SW Tualatin-Sherwood Road
Photo number: H2-1
Description: Armored channel with rip-rap, looking downstream

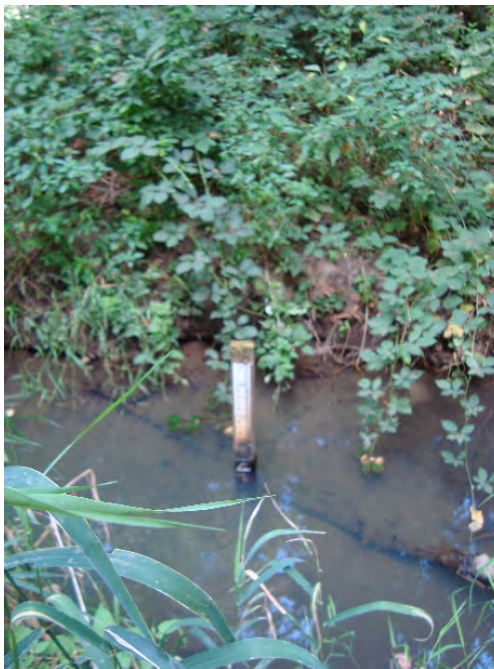
Site location: 100' upstream of SW Tualatin-Sherwood Road
Photo number: H2-2
Description: Staff gauge in channel

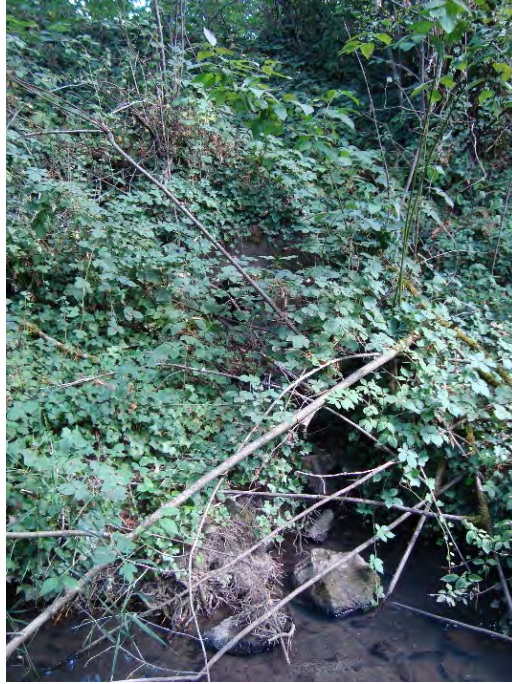
Photo number: H2-3

Description: Right bank outfall

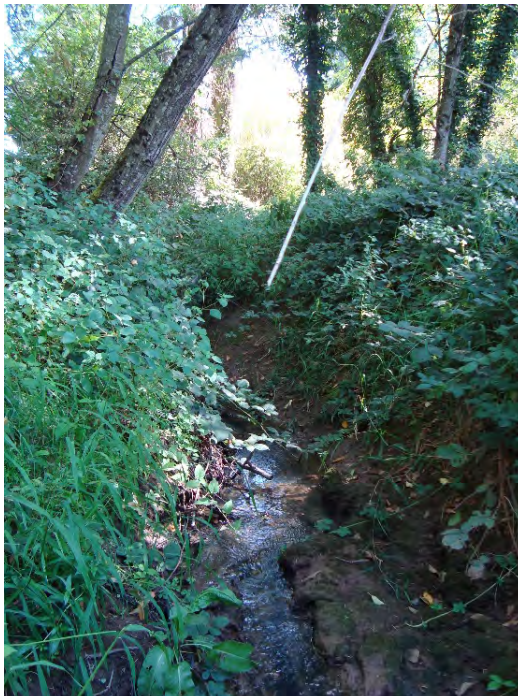
Photo number: H2-4

Description: Looking upstream, wide floodplain, banks 4- 5' high, width ~ 8 - 10 ', hard silt bed

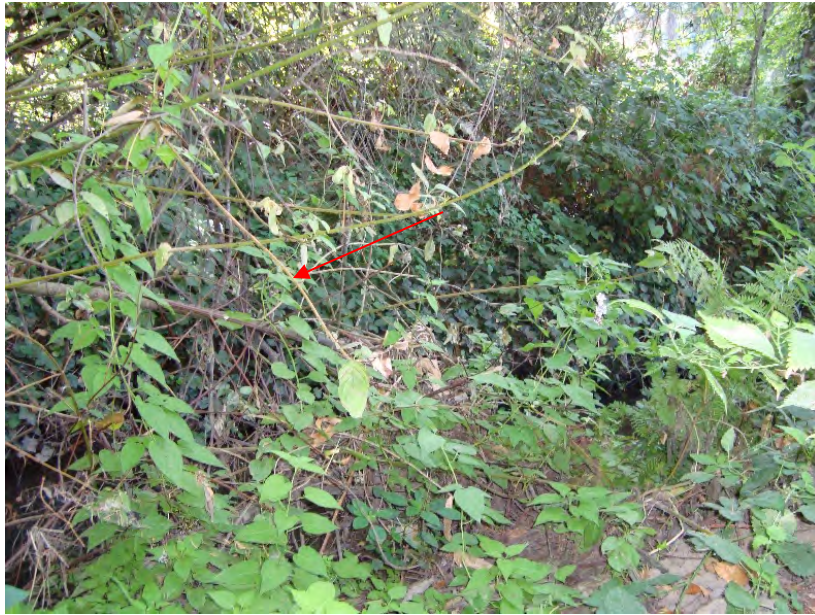
Site location: 500' upstream of SW Tualatin-Sherwood Road
Photo number: H2-5
Description: Debris on branches above channel (~4') indicating high water mark (red arrow)

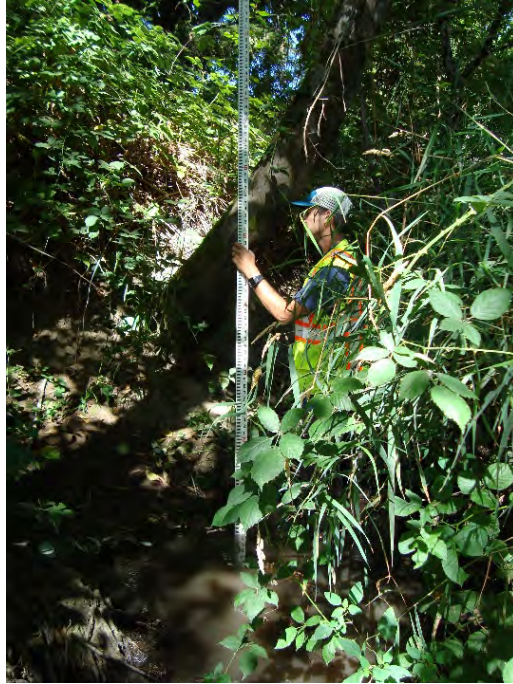
Photo number: H2-9

Site location: 900' upstream of SW Tualatin-Sherwood Road

Description: Looking upstream, exposed roots in channel. Left bank debris (high water ~4')

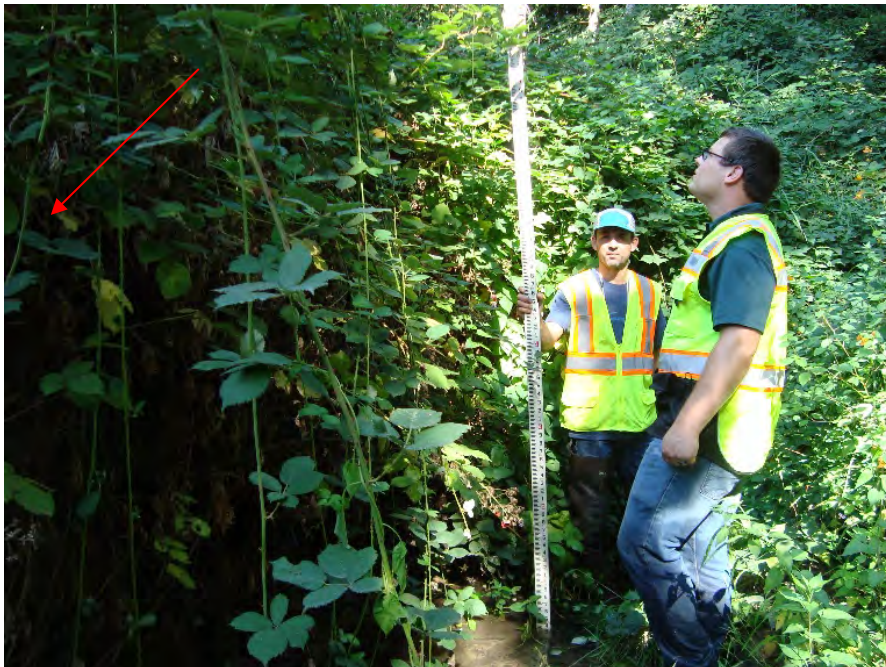
Photo number: H2-12

Site location: 1300' upstream of SW Tualatin-Sherwood

Description: Right bank erosion (red arrow)

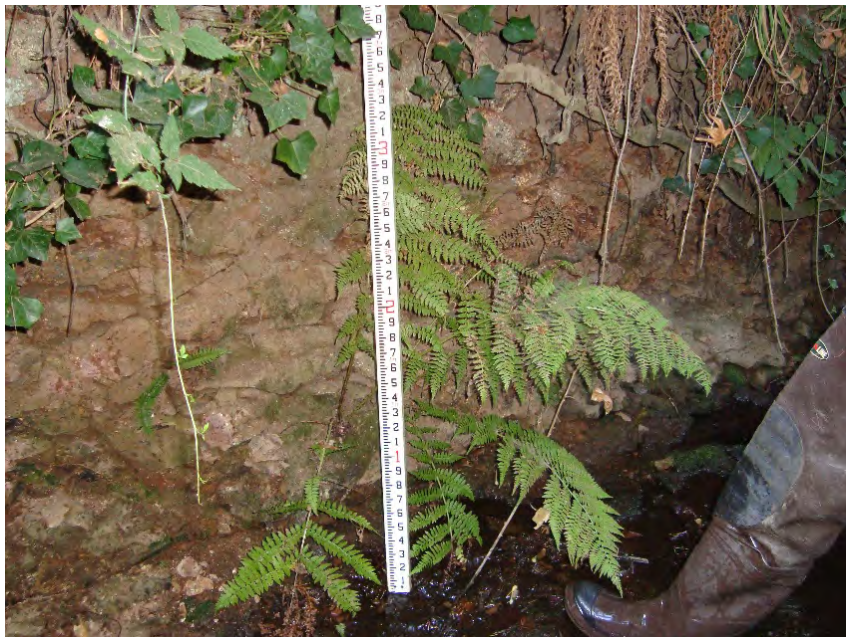
Photo number: H3-6

Site location: 500' upstream of SW 105th Ave.

Description: Bedrock outcrop in channel

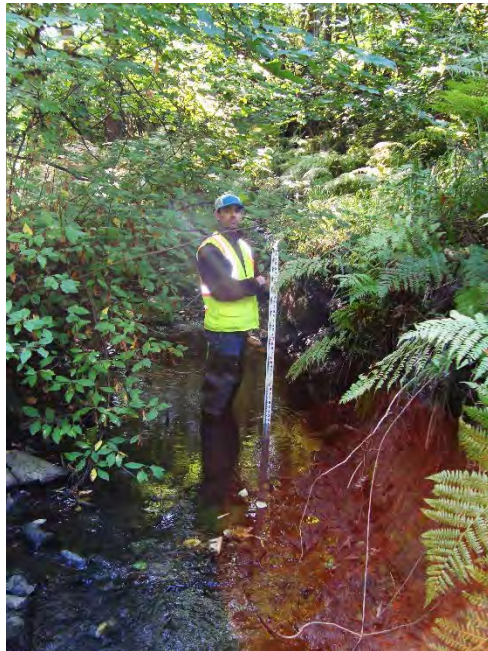
Photo number: H3-8

Site location: 600' upstream of SW 105th Ave.

Description: Seepage on left bank, 2' above channel

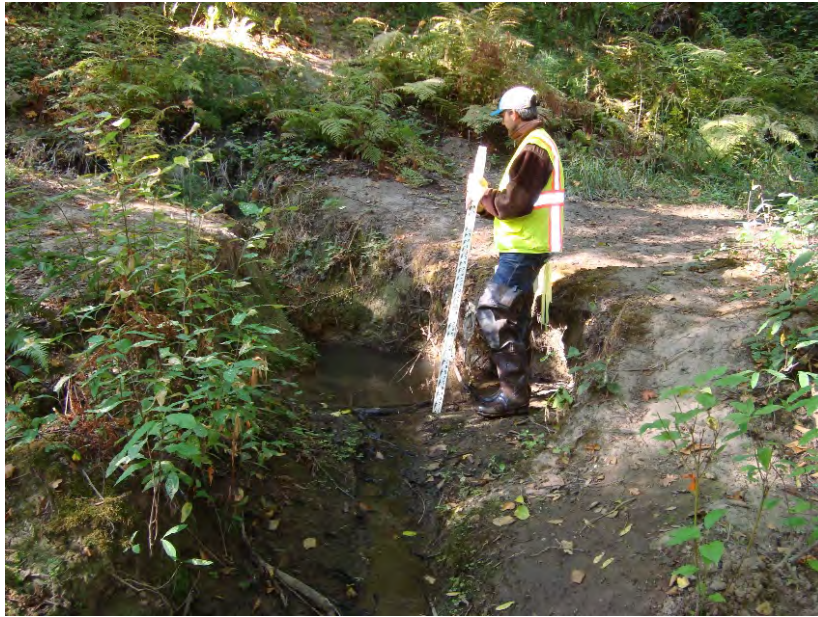
Site location: 700' upstream of SW 105th Ave.
Photo number: H3-9
Description: Incised side channel on left bank, looking upstream from confluence

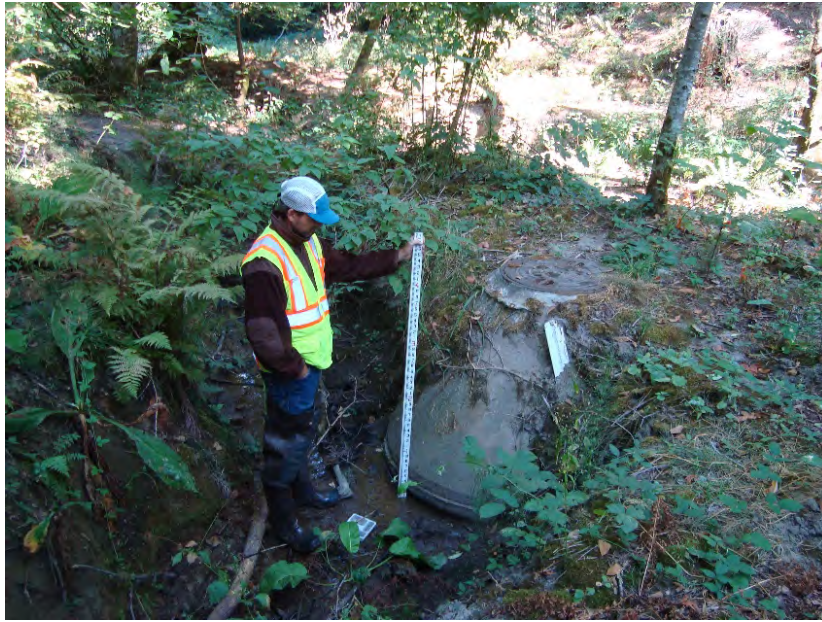
Photo number: H3-11

Site location: 750' upstream of SW 105th Ave.

Description: Side channel, adjacent to sewer manhole being eroded by channel. Manhole is 15' from start of headcut (erosion)

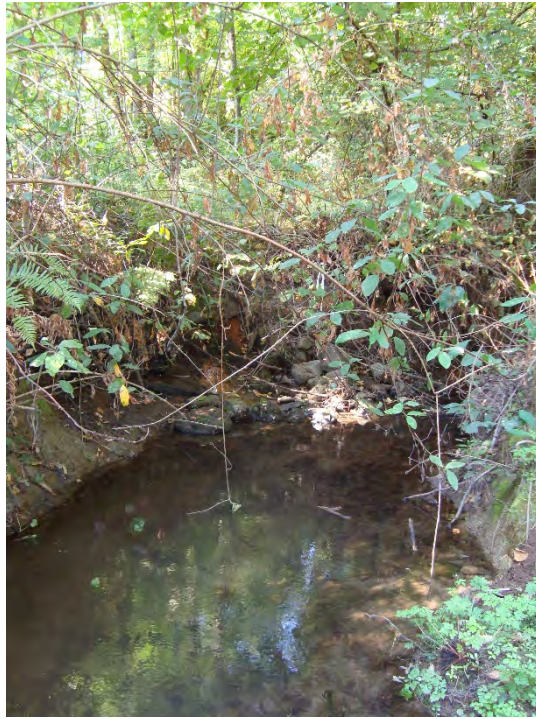
Site location: 800' upstream of SW 105th Ave.
Photo number: H3-13
Description: Looking downstream at outside bend, eroding left bank

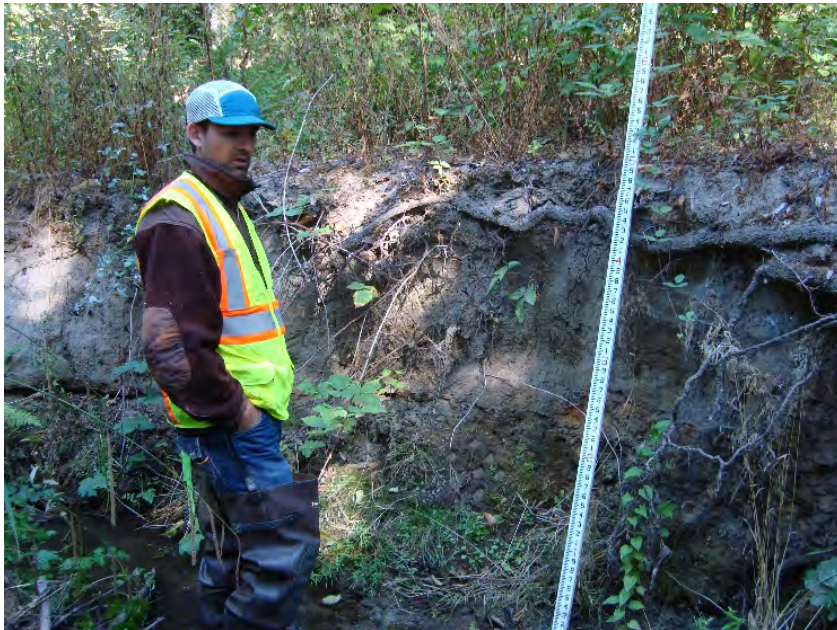
Site location: 900' upstream of SW 105th Ave.
Photo number: H3-14
Description: Outside bend erosion

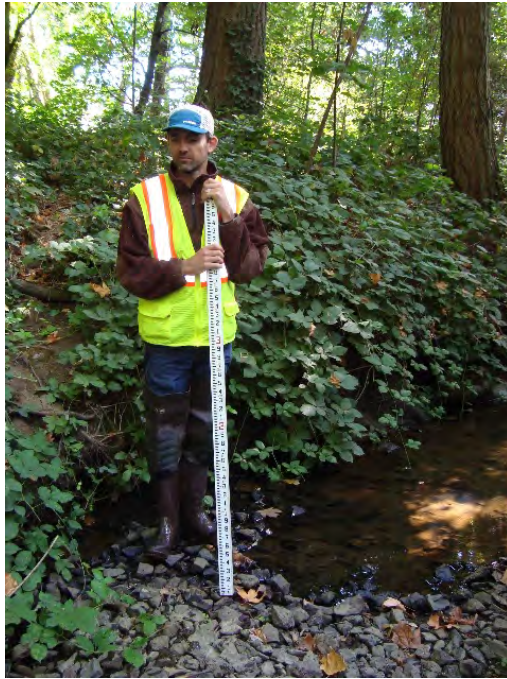
Photo number: H3-17

Site location: 1300' upstream of SW 105th Ave.

Description: Rock in channel, moved downstream from upstream restoration project

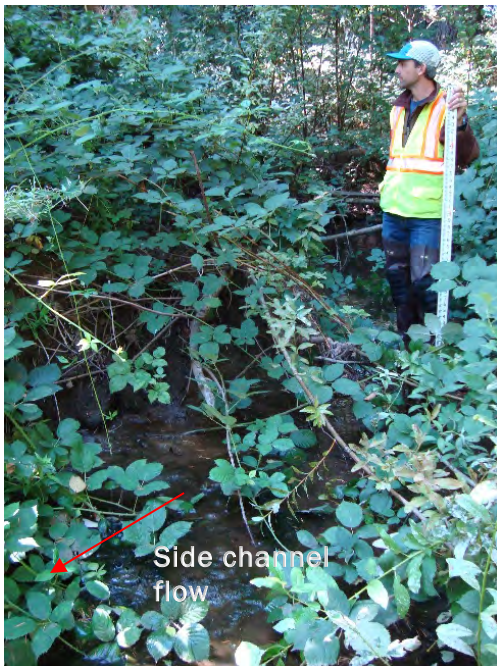
Photo number: H3-20

Site location: 400' downstream from confluence with S. Tributary

Description: Looking upstream, flow is coming in from right bank (very small channel not visible from left side of photo), stagnant water in this location

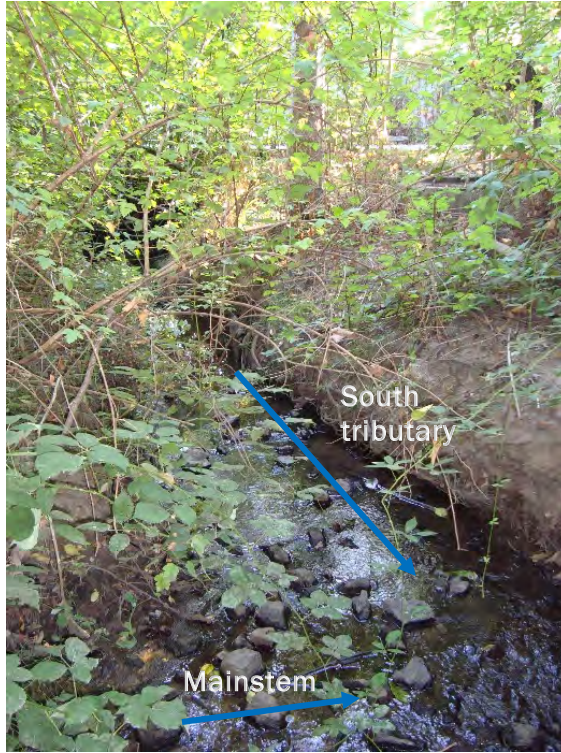
Site location: 300' upstream of confluence with S. tributary
Photo number: H3-24
Description: Looking upstream, hard silt in channel, incised

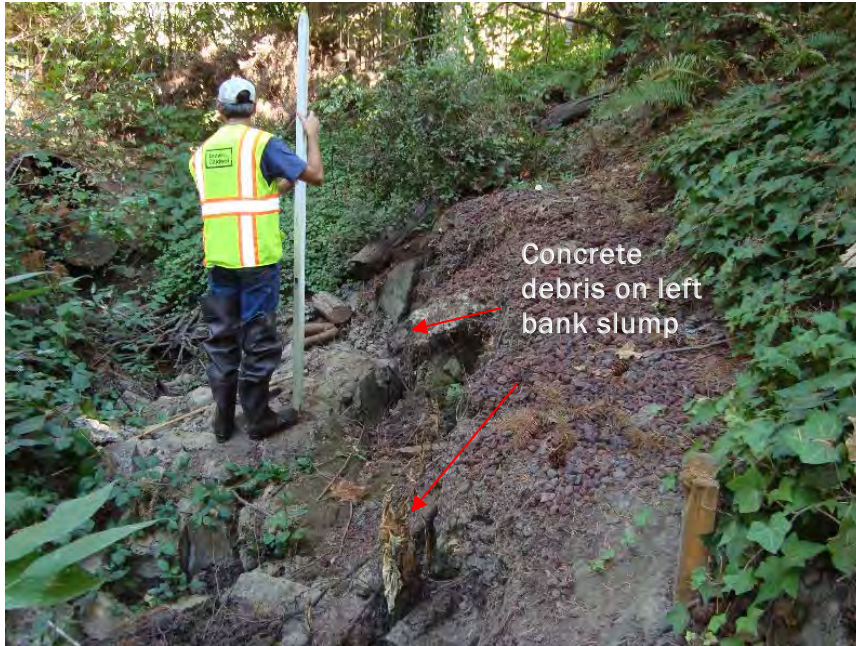
Photo number: H3-27

Site location: 650' upstream of confluence with S. tributary

Description: Left bank instability with concrete

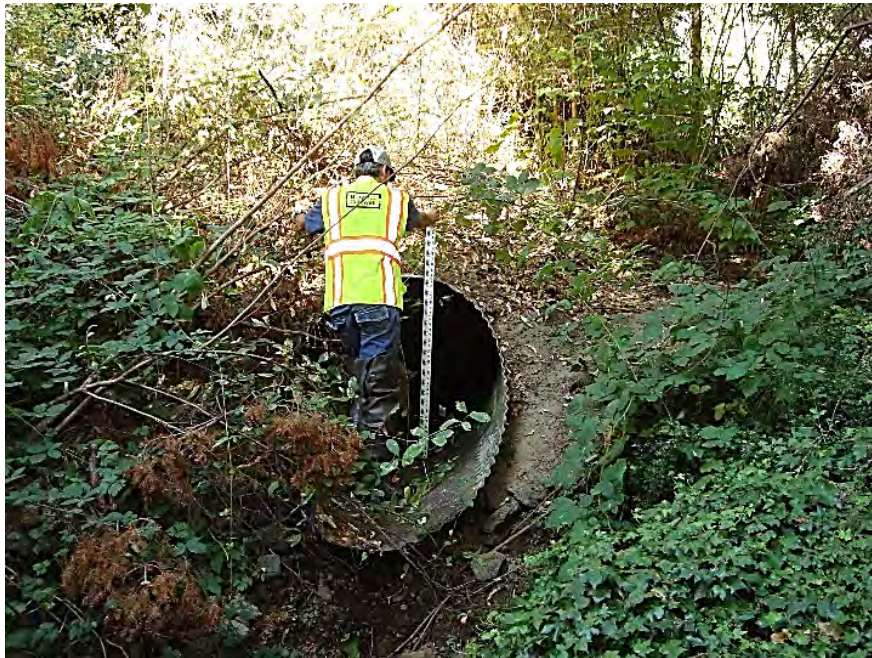
Photo number: H3-28

Site location: Culvert at SW Alsea Ct.

Description: Looking upstream, downstream of SW Alsea Ct.. Culvert is perched. No water.

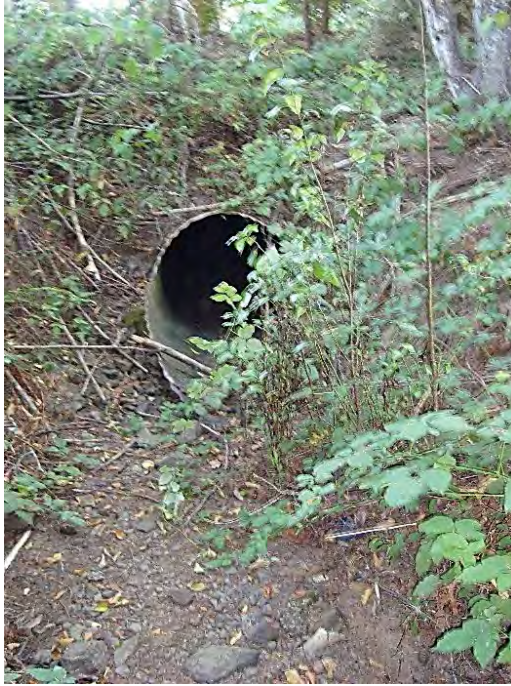
Photo number: H3-29

Site location: Culvert at SW Alsea Ct.

Description: Looking downstream, upstream of SW Alsea Ct. Dry channel.

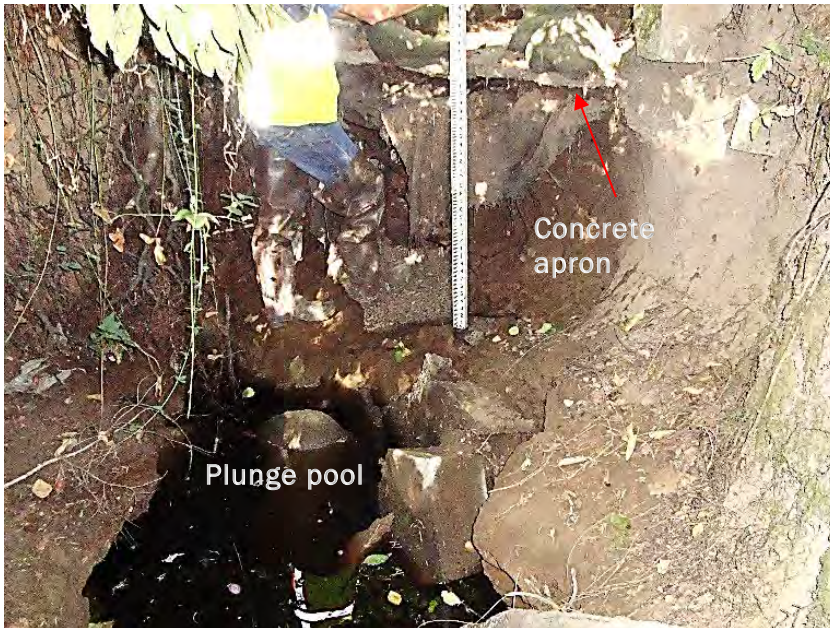
Photo number: H3-31

Description: Head cut below culvert, culvert is 6' above channel bottom (red arrow points to culvert)

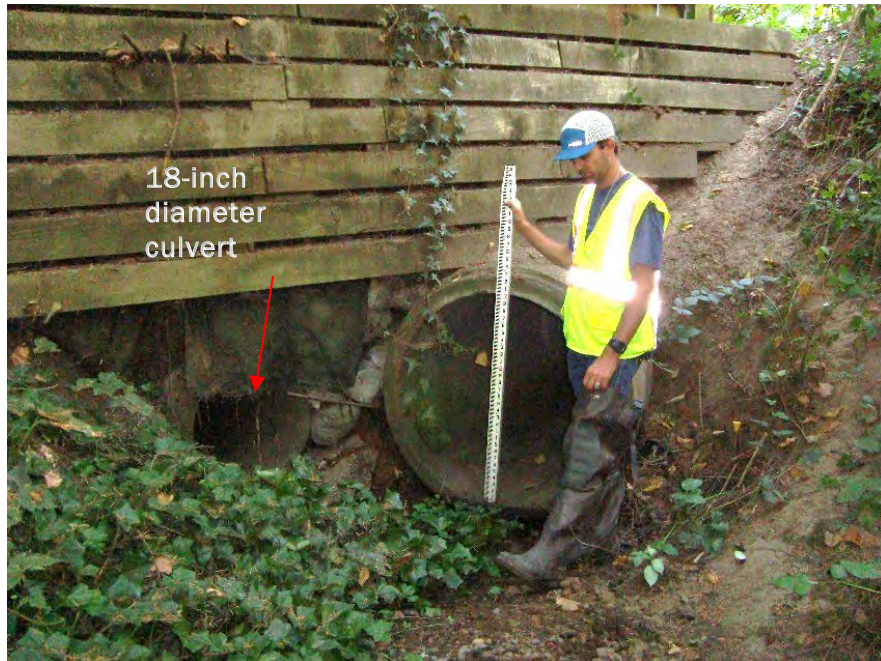
Photo number: H3-32

Description: Plunge pool below culvert. Concrete apron below culvert indicated with red arrow.
