# CROSBY HOUSE

## STRUCTURAL OBSERVATION & ASSESSMENT

For: City of Tumwater

Observation Dates:  
Feb. 9<sup>th</sup>, 2021 & July 7<sup>th</sup>, 2021

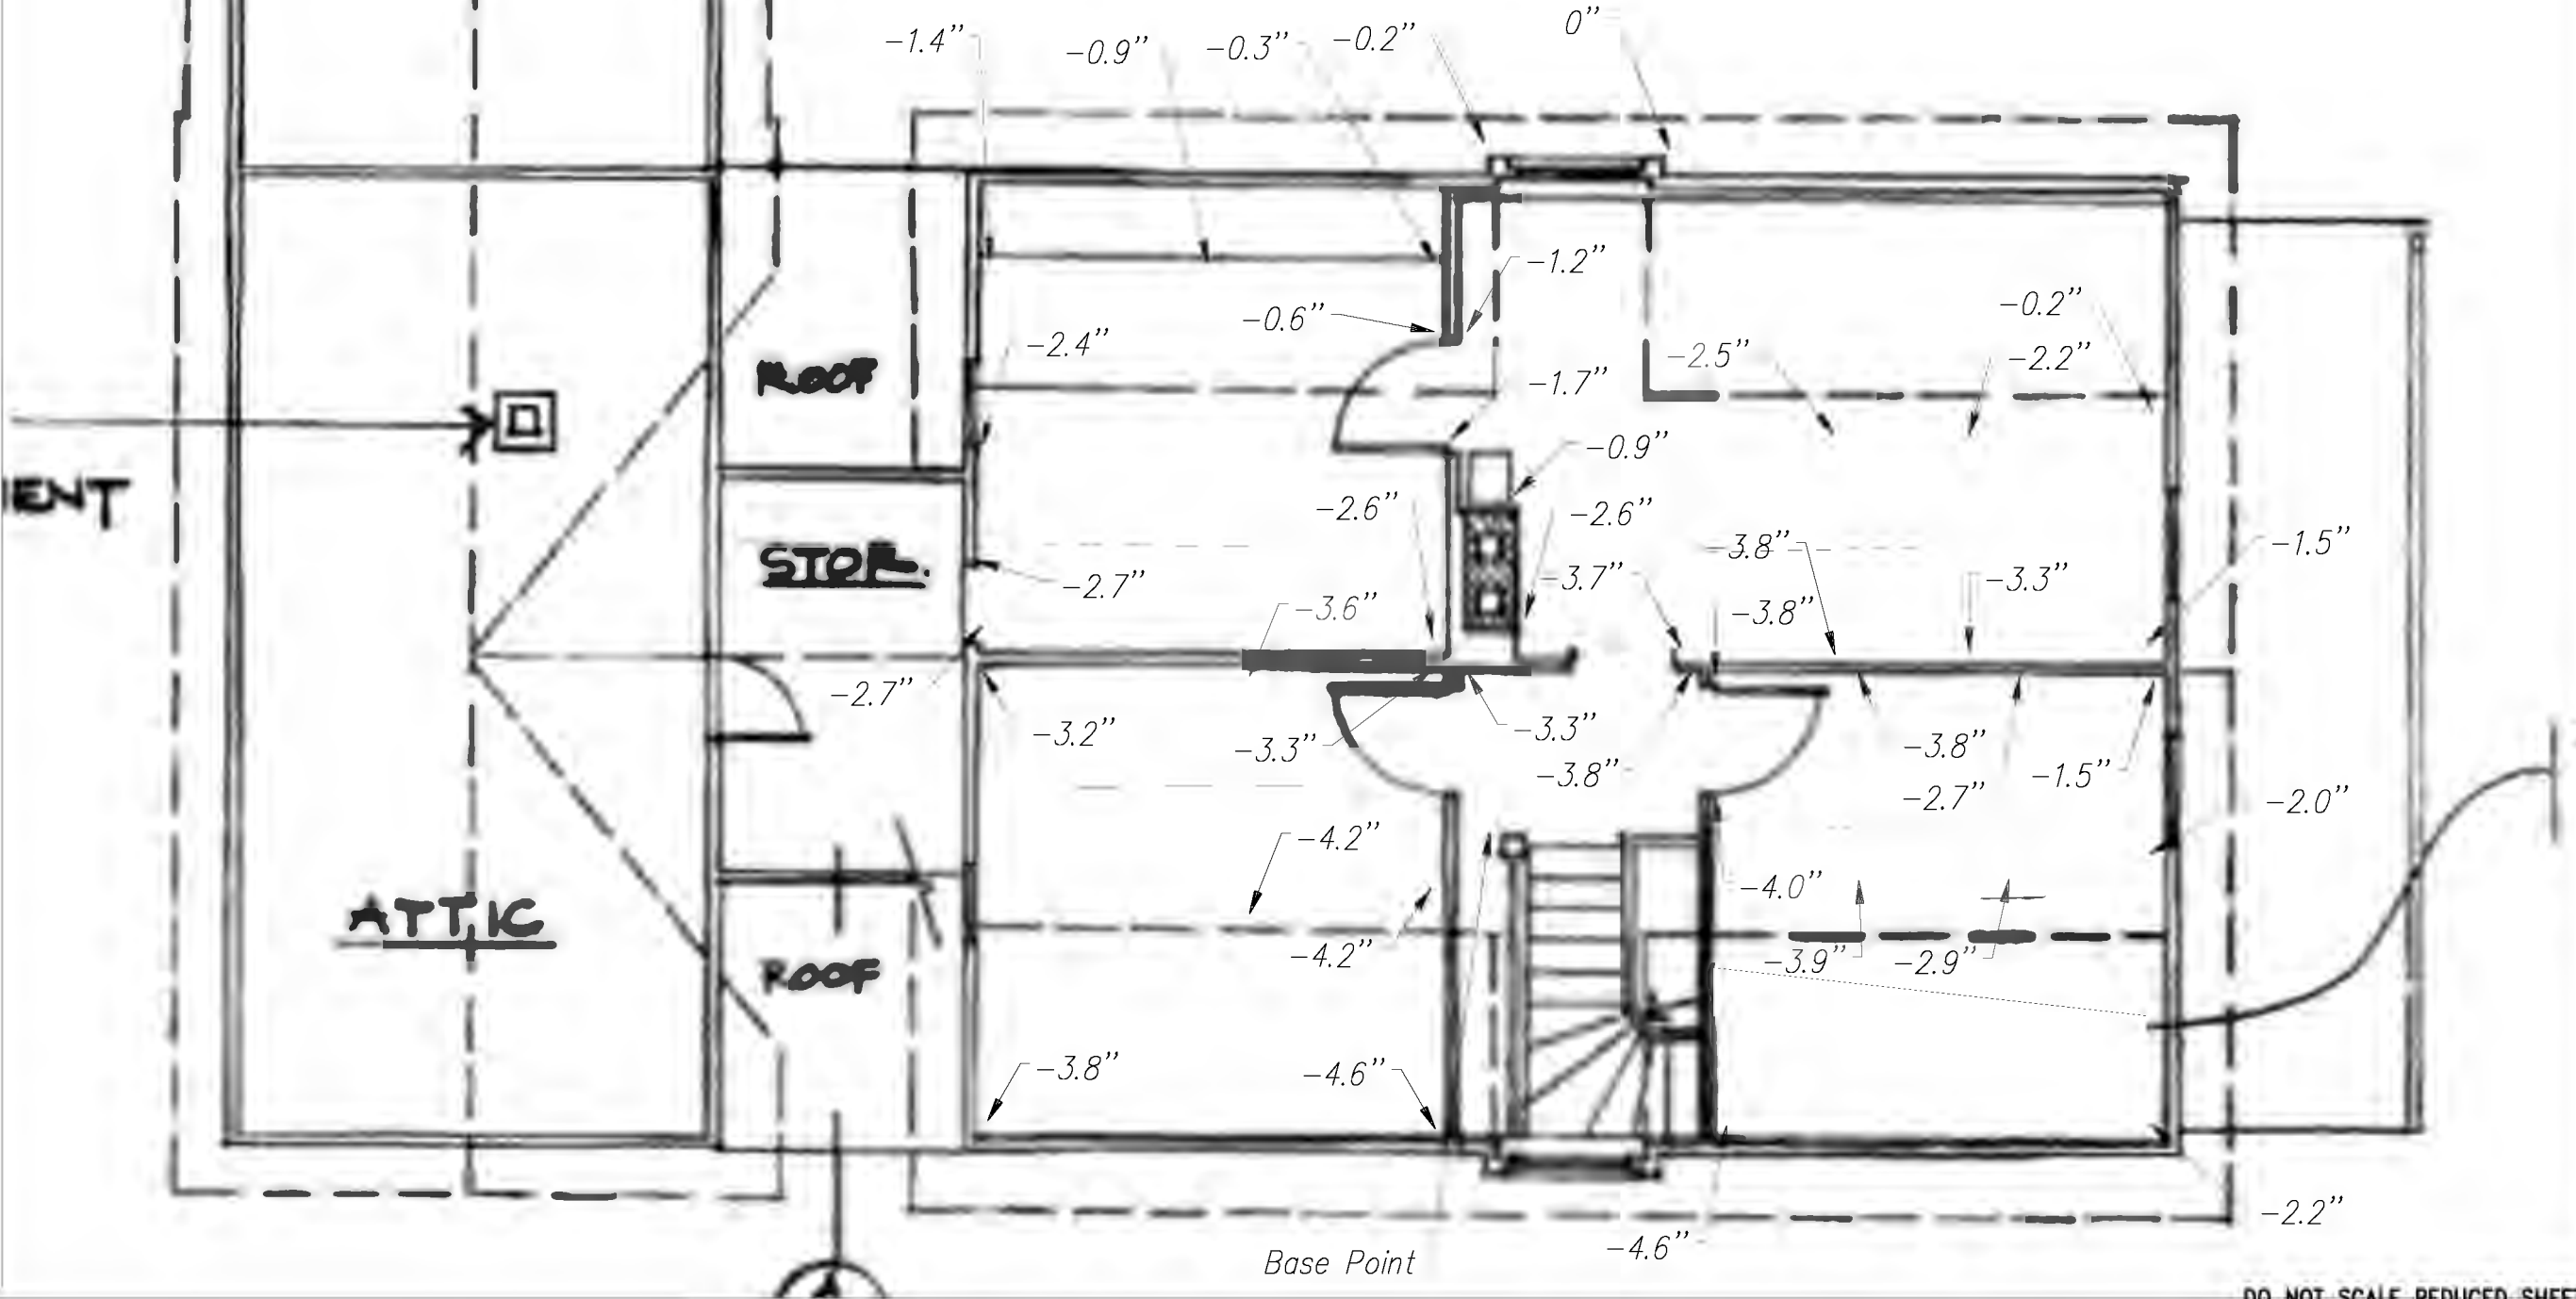
### RELATIVE CHANGES IN ELEVATION LAYOUTS

NOTES  
All measurements are in inches and represent the distance below the highest point of the initial visit (see sheet S1.1)
