Todd Prager & Associates
LLC

Tree Risk Assessment for the Davis-Meeker Oak

Date: February 7, 2025

Site Address: 7525 Old Highway 99 SE
Tumwater, Washington 98501

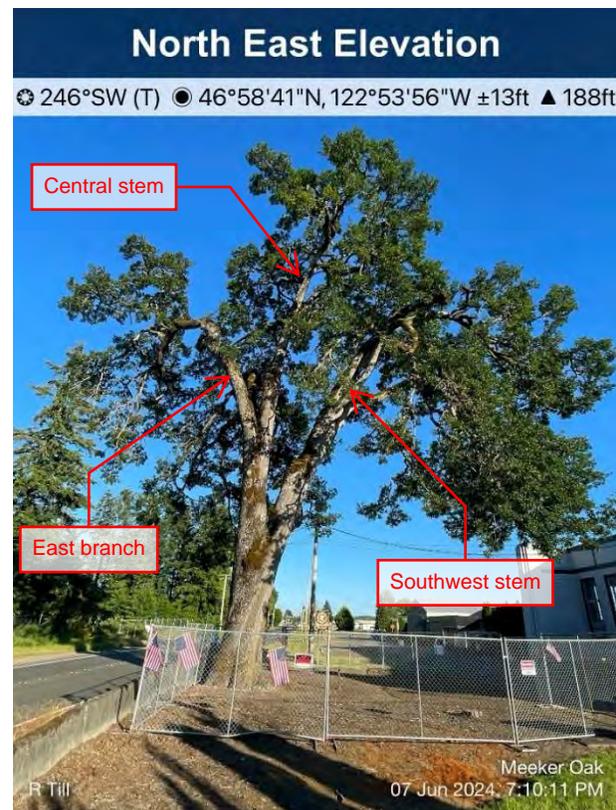
Figure 3 View of tree anatomy and crown shape.

The mass of the crown is to the south or southwest of the central trunk. The crown is split into three stems, which are depicted in Figure 3 and Attachment 3. The approximate outline of the crown and the three primary stems are depicted in the aerial photo in Attachment 4. The main trunk forks at approximately 16 feet into a southwest and northeast stem. The southwest stem arches to the southwest toward the hanger. The northeast stem forks again at approximately 33 feet into a central stem that forms the top of the tree and a second branch system that extends to the east and southeast. The central stem has a historic decay pocket on the south side at approximately 46 feet that is used as a nesting cavity by kestrels (*Falco sparverius*). The cavity is also identifiable from a cascara (*Frangula purshiana*) sapling growing from the cavity. The east/southeast branch system forks into two branches, one extends directly over Old Highway 99 and the second extends to the south/southeast parallel to Old Highway 99.

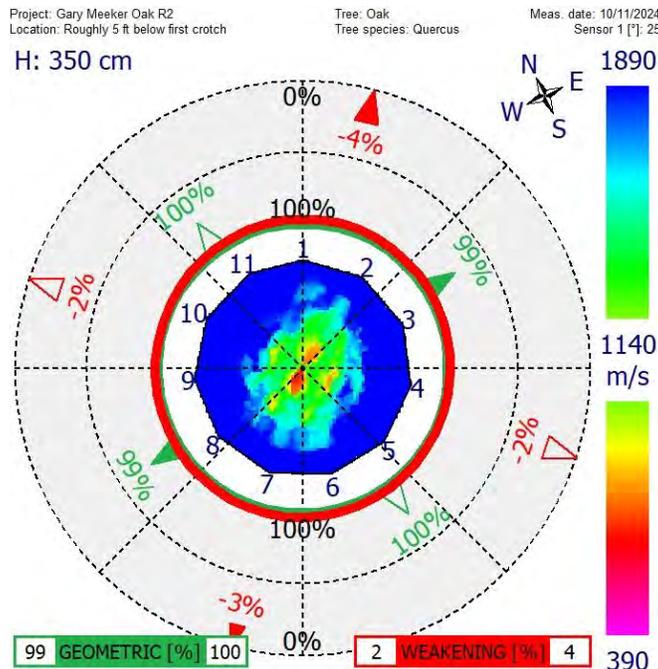
Oak – Reading 2- 350cm

At this level there is a small amount of compromised wood in the center of the stem. The green indicates where the co-dominant inclusion is causing a weak attachment point.

At this level there is between 2% and 4% strength loss. This is low strength loss.

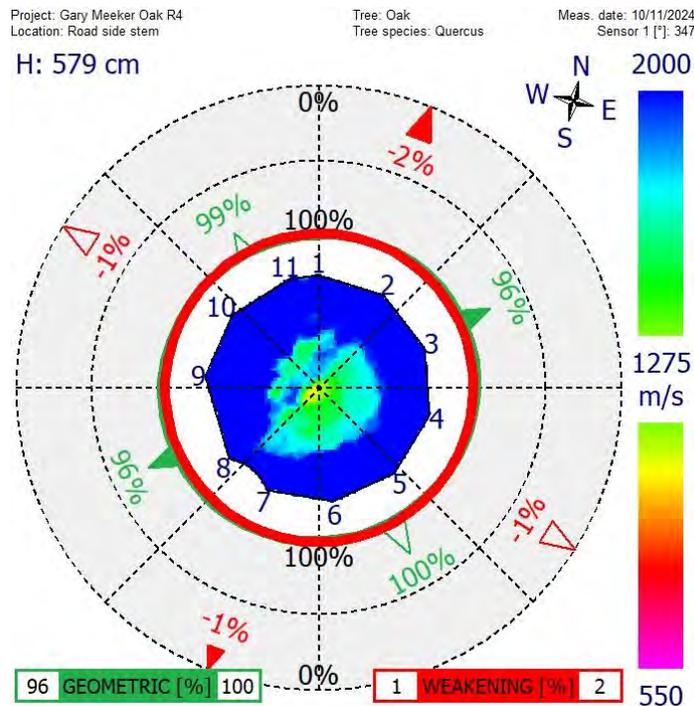
Oak – Reading 3- 563cm

At this level there is no sign of compromised wood.

At this level there is between 1% and 2% strength loss. This is minimal strength loss.

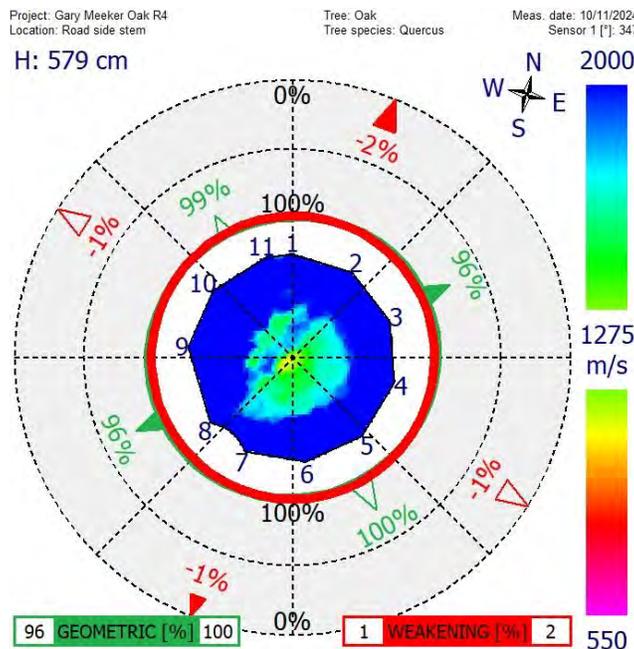
Oak – Reading 4- 579cm

At this level there is no sign of compromised wood.

At this level there is between 1% and 2% strength loss. This is minimal strength loss.

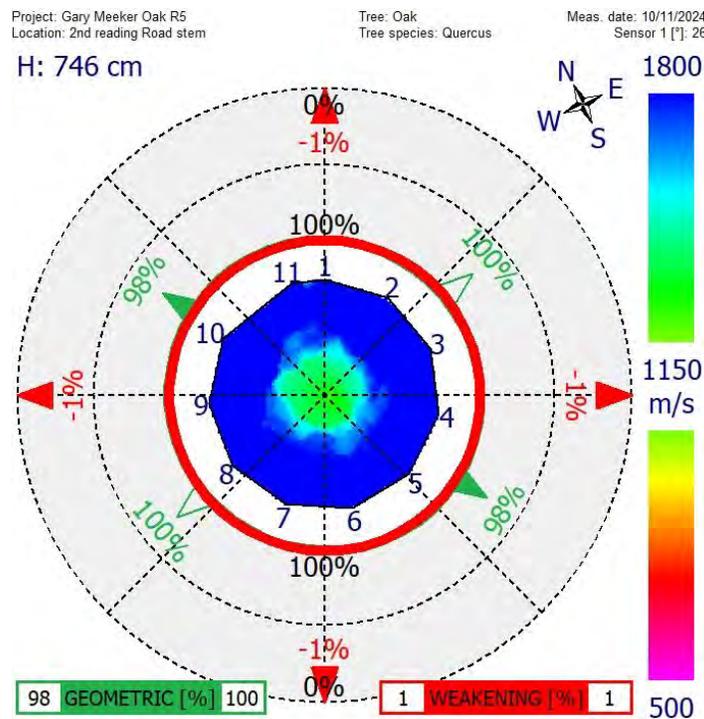
Oak – Reading 5- 746cm

At this level there are no signs of compromised wood.

At this level there is less than 2% strength loss. This is minimal strength loss.

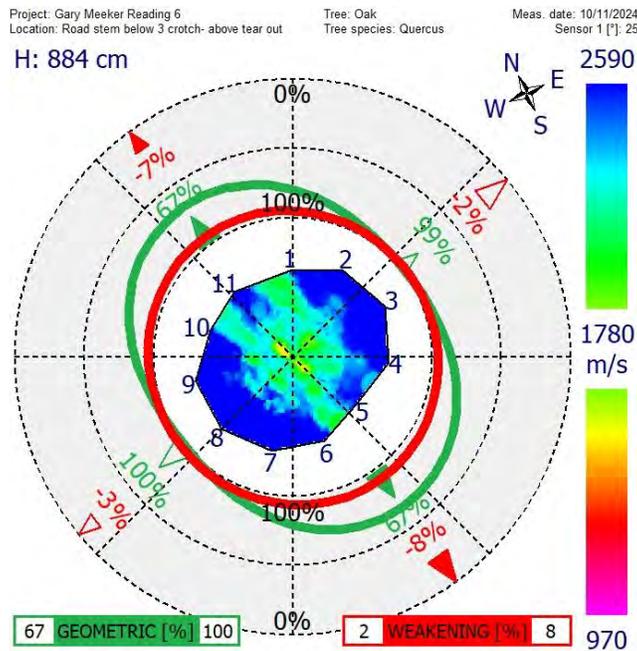
Oak – Reading 6- 884cm

At this level there is included bark throughout the center of the stem, where the three stems connect.

At this level there is between 2% and 8% strength loss. This is minimal strength loss.

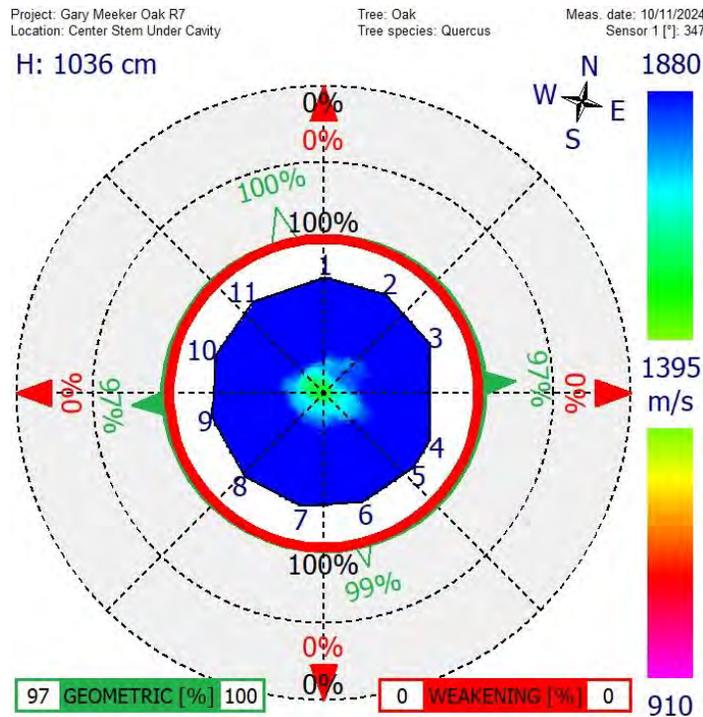
Oak – Reading 7- 1036cm

At this level there is no sign of compromised wood.

At this level there is no strength loss.

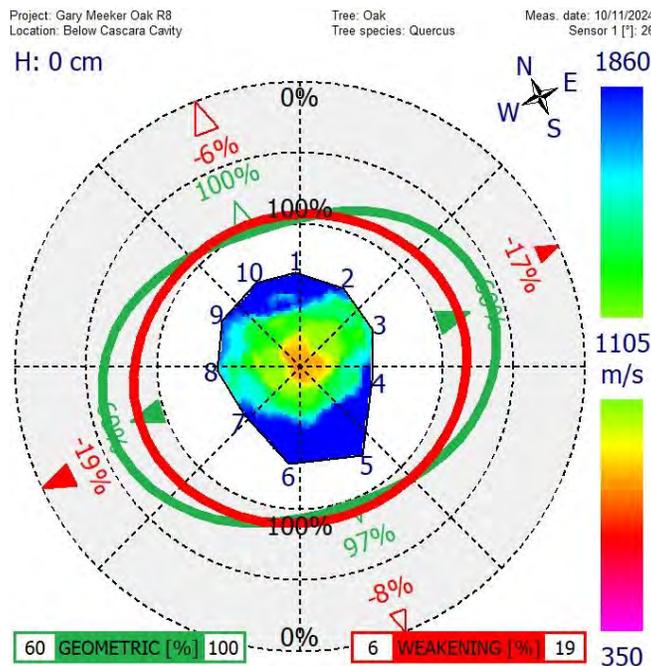
Oak – Reading 8- 1381cm

At this level there is less dense wood in the center of the stem. The center yellow spot indicates where the cavity above extends too.

At this level there is between 6% and 19% strength loss. This is minimal strength loss.

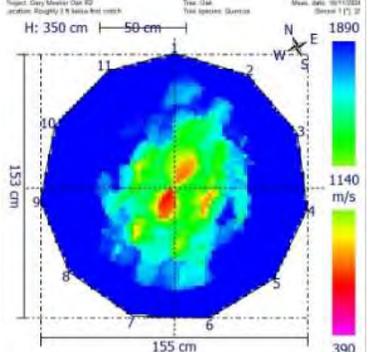
<p>2</p>	<p>350 cm/ 11.5 ft</p>	<p>Main stem below codominant union.</p>

<p>At this level there is a small amount of compromised wood in the center of the stem. The green indicates where the co-dominant inclusion is potentially reducing the strength of the attachment point.</p> <p>At this level there is between 2% and 4% strength loss. This is low strength loss.</p>
<p>1</p>	<p>50 cm/ 1.6 ft</p>	<p>Main stem near ground level.</p>

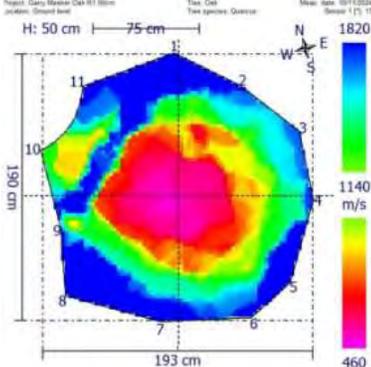
<p>At this level there is significant compromised wood throughout the stem. A wood decay fungi has created a significant amount of compromised wood and hollow trunk.</p> <p>At this level there is between 14% and 21% strength loss depending on direction.</p>
<p>1</p>	<p>50 cm/ 1.6 ft</p>	<p>Main stem near ground level.</p>

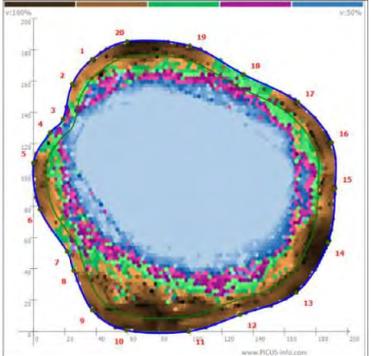
<p>Tree Solutions sonic tomography reading. Conclusion was that there is sufficient wood to support existing tree. The sonic tomography strength limit appears to have been set at approximately 80 percent hollow, or approximately 4-inches (10 cm) of sound wood based on the tree's diameter at the measurement point.</p>

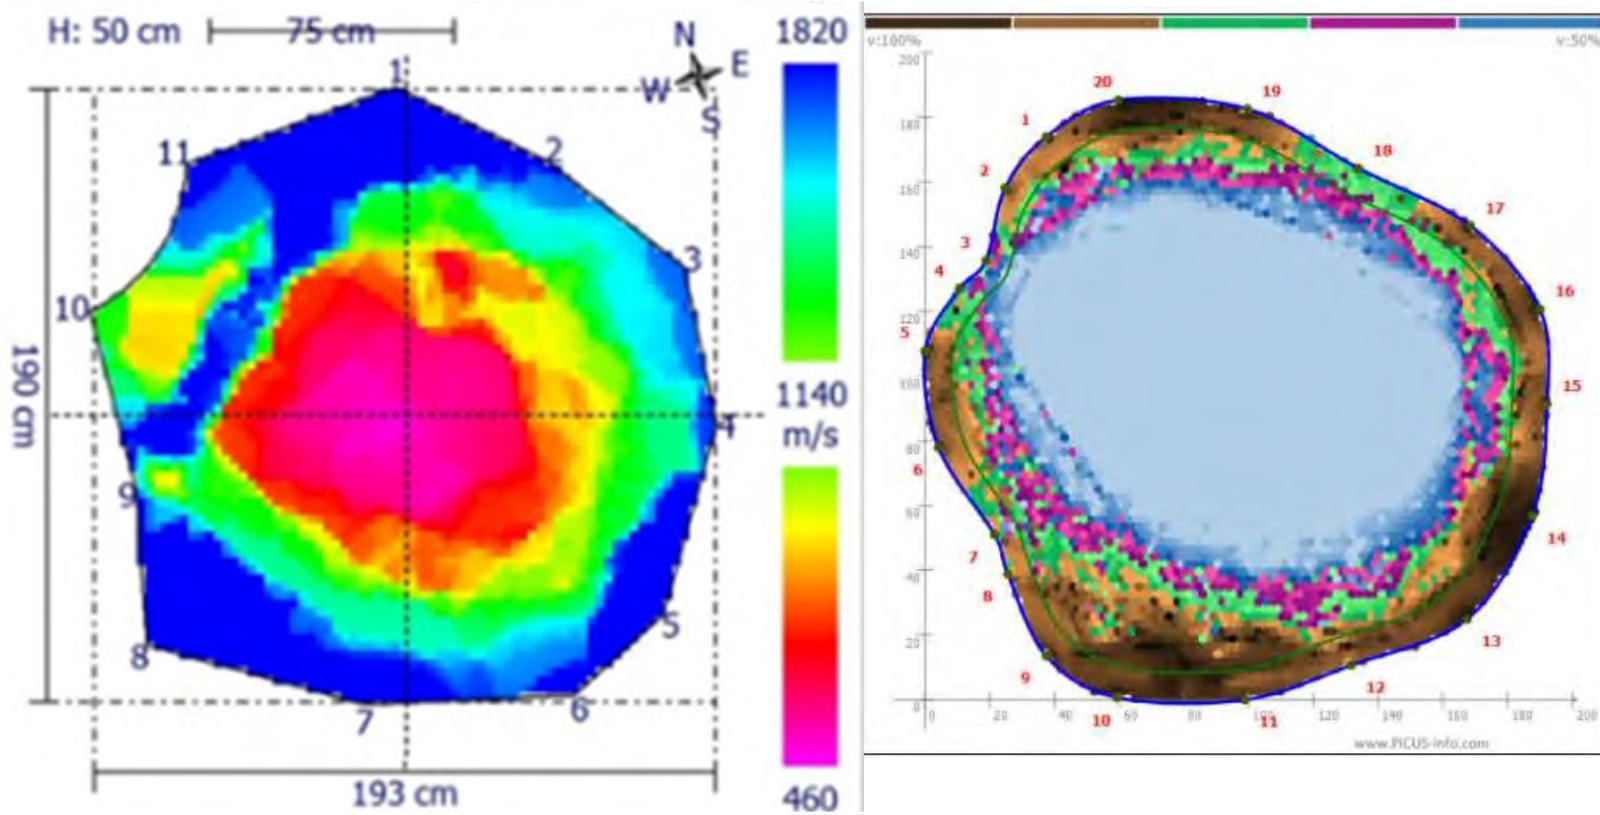
Side-by-side comparison of the 2024 sonic tomography reading using the Arbotom® system and the 2023 sonic tomography using the PiCUS system

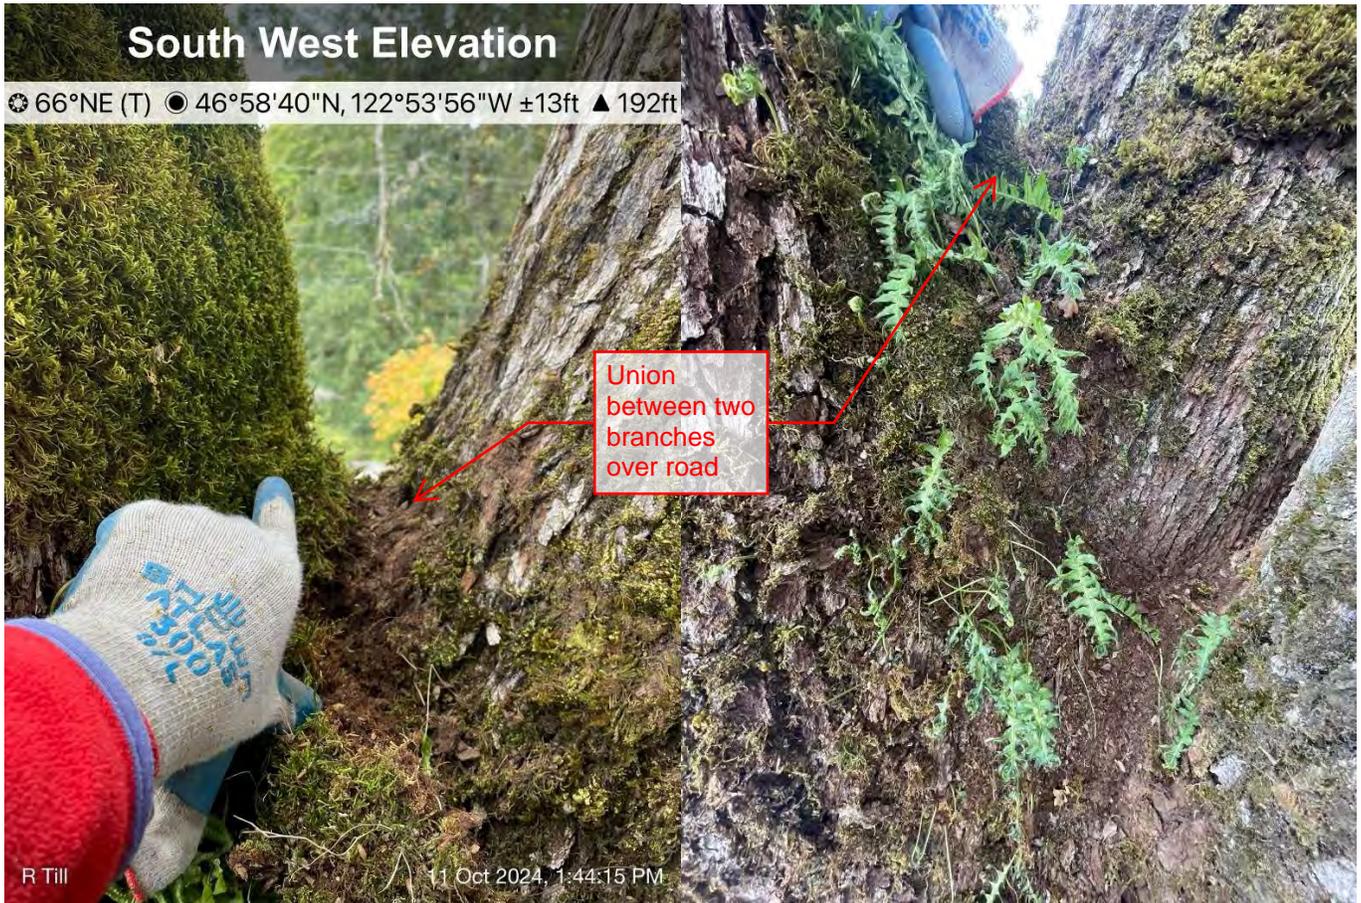
Figures 7 and 8 Southwest view of attachment between two secondary stems extending over the road. Exterior signs indicate a sound union.

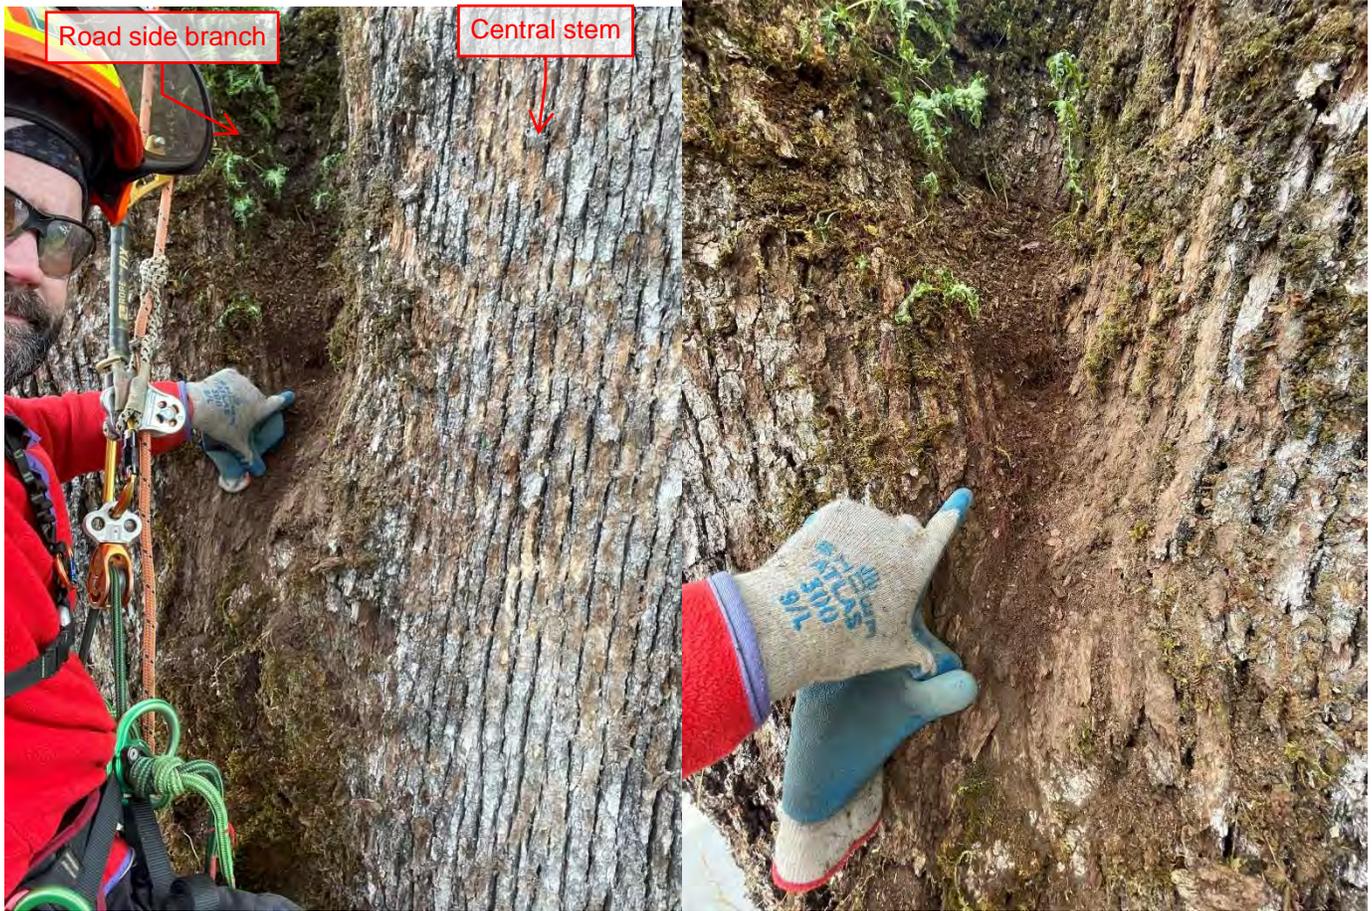
Figures 9 and 10 Northwest view of second codominant union. Included bark transitions into sound wood attachment.

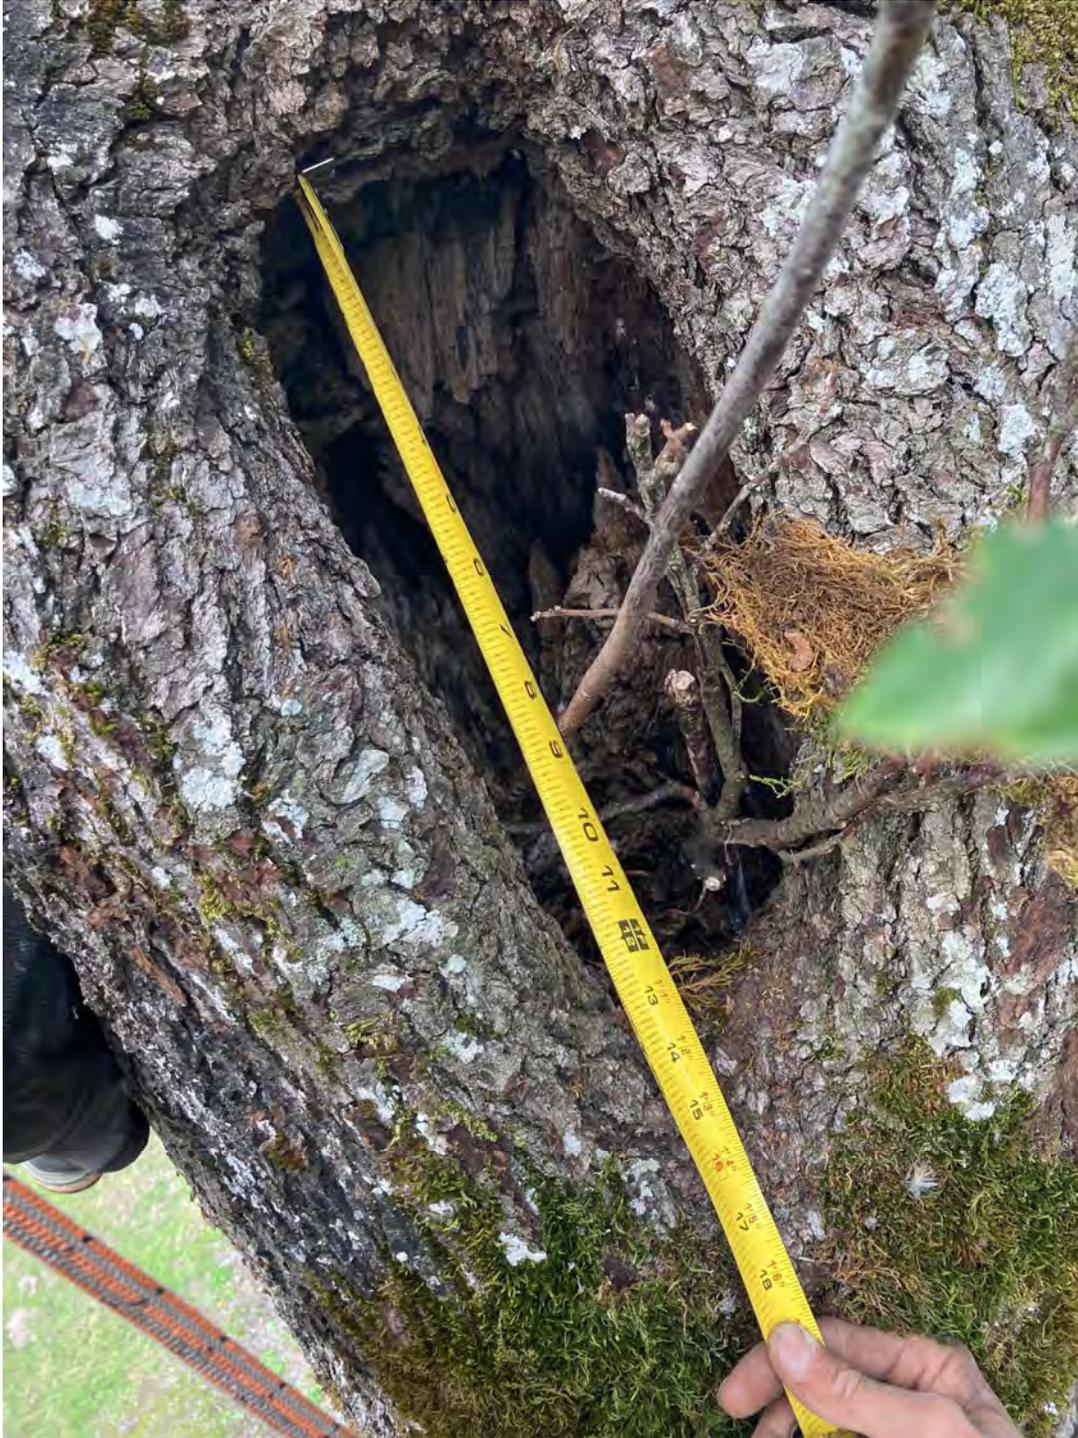
Figure 19 Depth measurement at approximately 24 inches to interior edge of cavity.

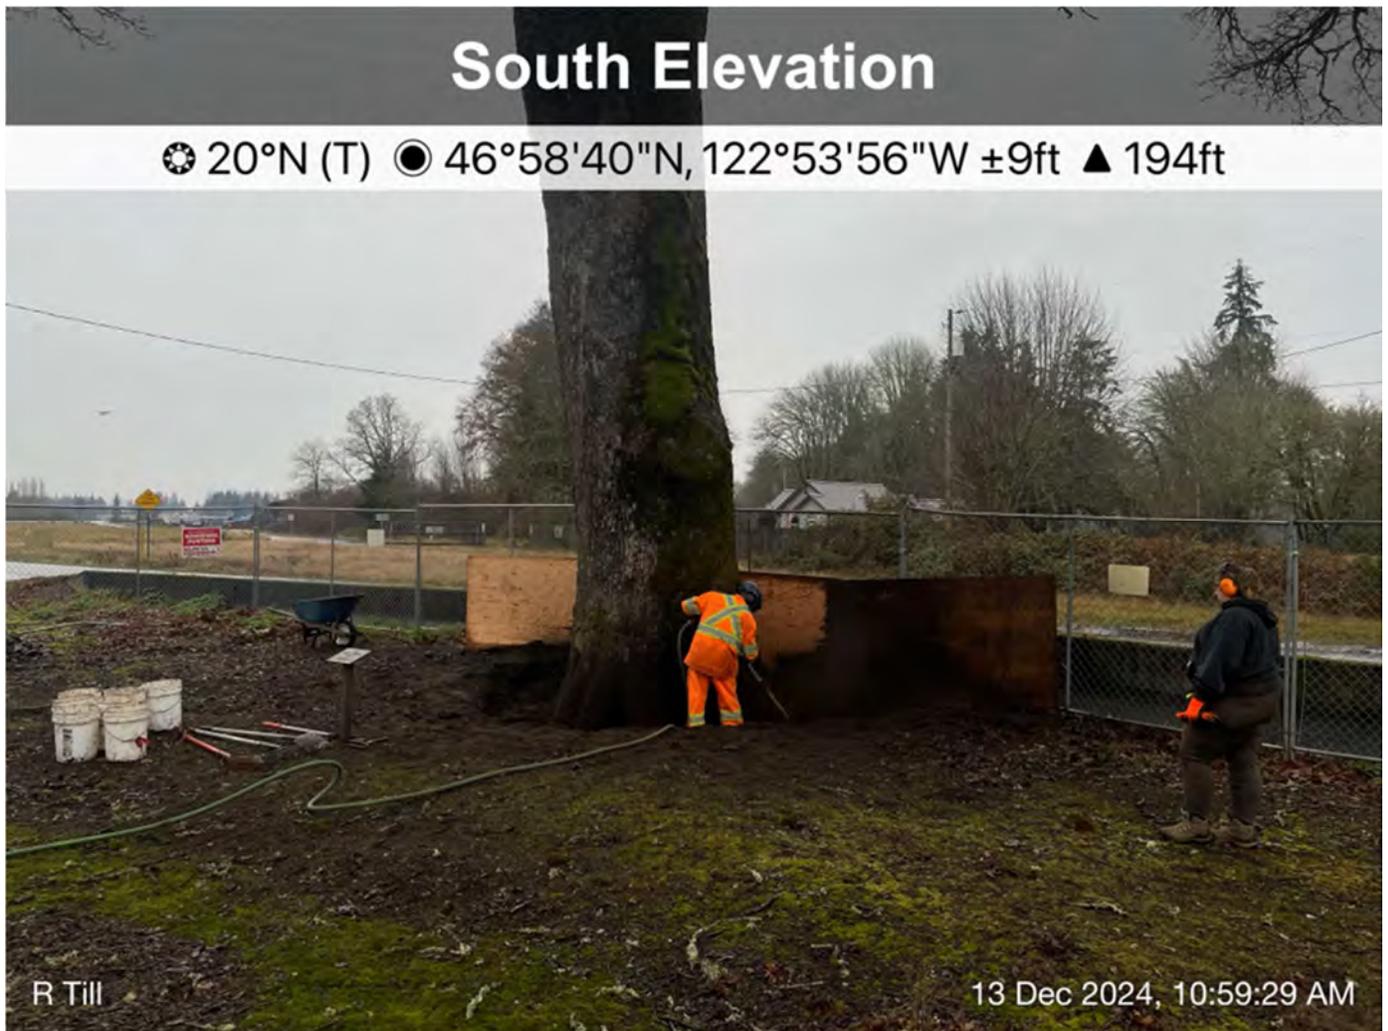
The inspection revealed adequate to robust buttress root growth around the entire tree. One historic decay cavity was revealed to be closing with substantial wound wood growth.

Figure 1 Root crown excavation employed an “air spade” that uses compressed air to remove fine soil. The excavation involved alternating between air spade removal of soil with hand removal of river cobble that was backfilled over the root flare after a prior root crown excavation. The project archaeologist oversaw all work.

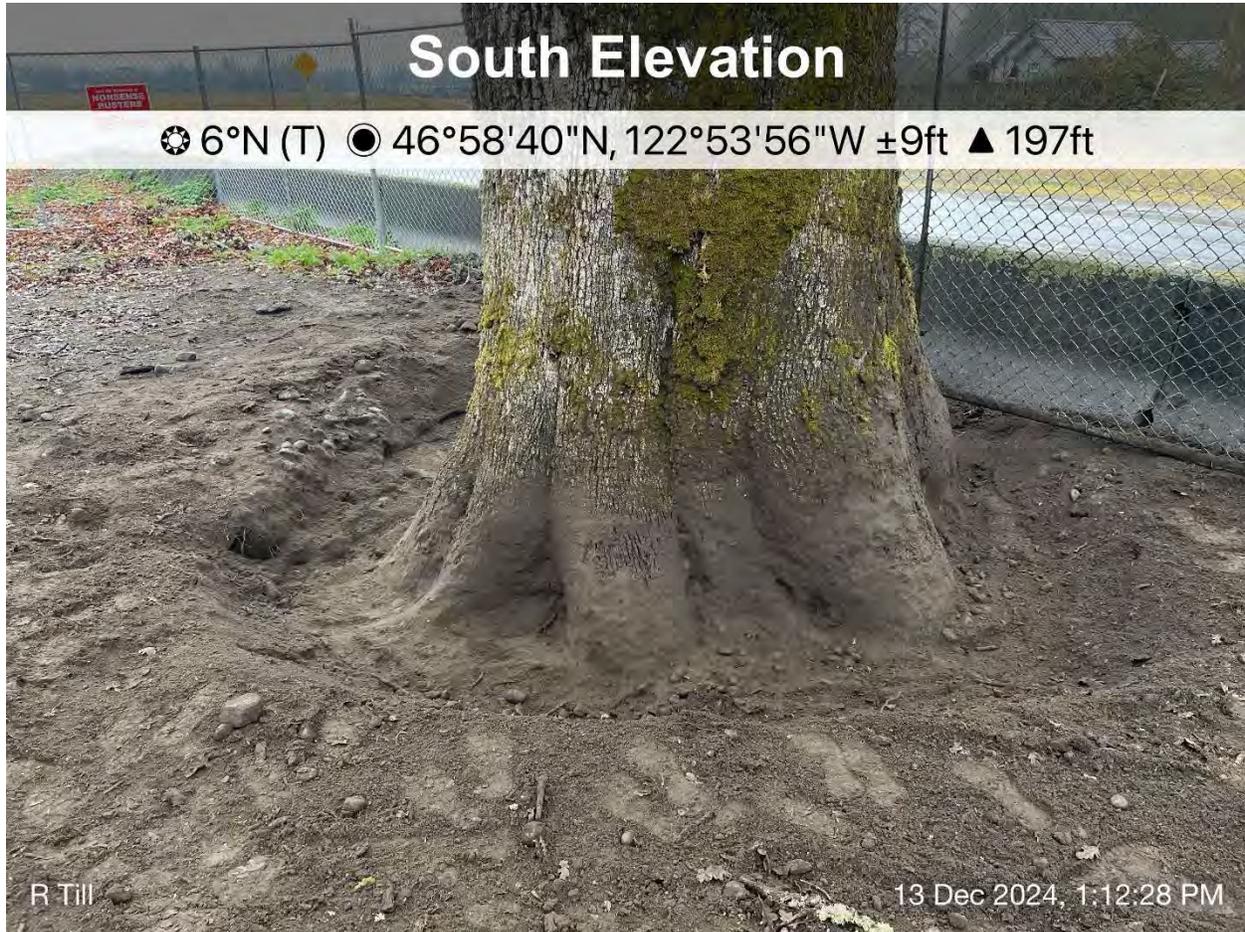
Figure 8 Temporary finished grade.

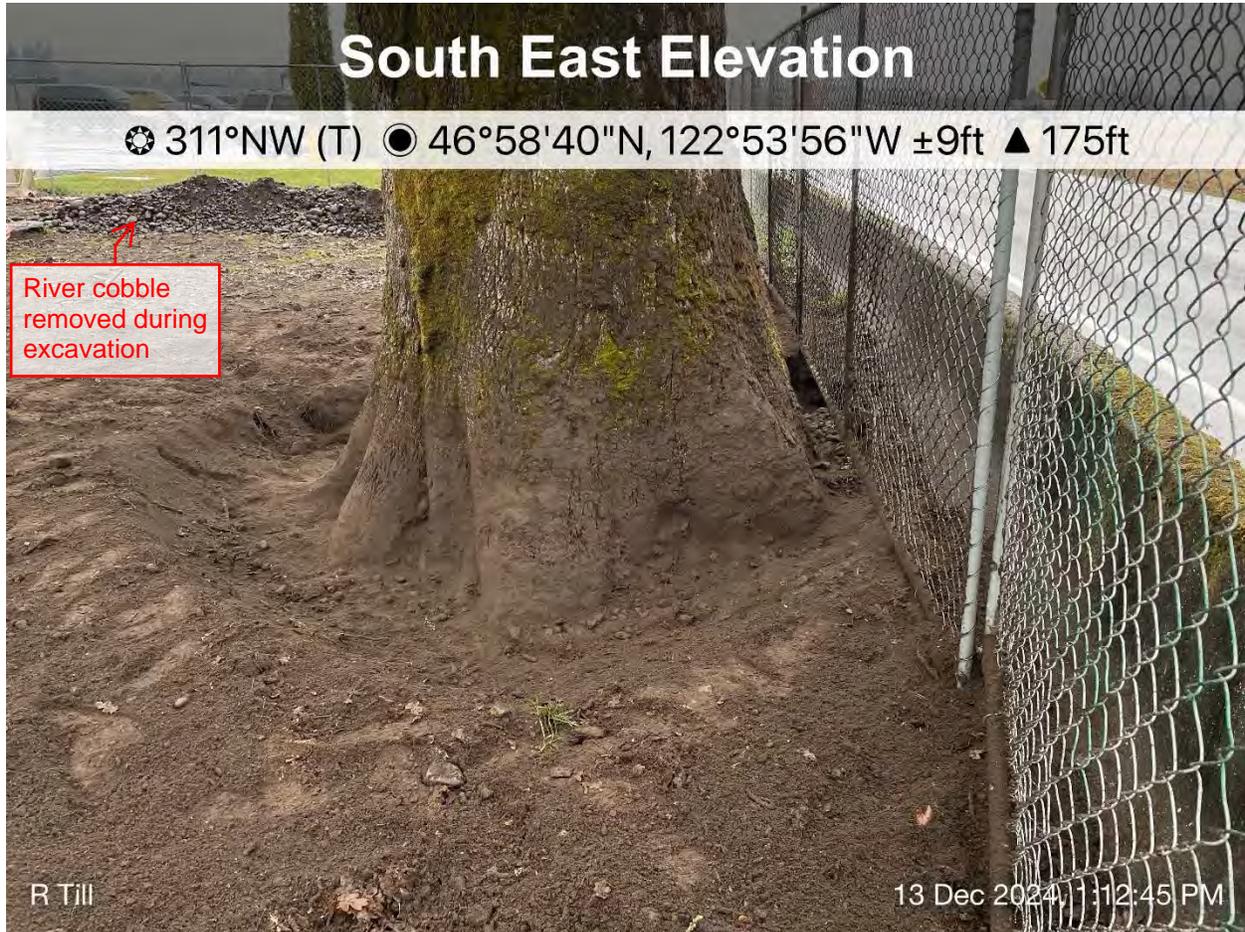
Figure 4 Temporary finished grade with river rock that was removed stacked in background.
