SOUND URBAN FORESTRY, LLC

RE: Proposed Heritage Trees – Mills & Mills Funeral Home and Memorial Park Chestnut Trees

Upon the request of the City of Tumwater, I have conducted an assessment of two chestnut trees located within the Mills & Mills Funeral Home and Memorial Park property at 5725 Littlerock Road SW, as part of the City's Heritage Tree nomination process. I visited the site on November 22, 2022.

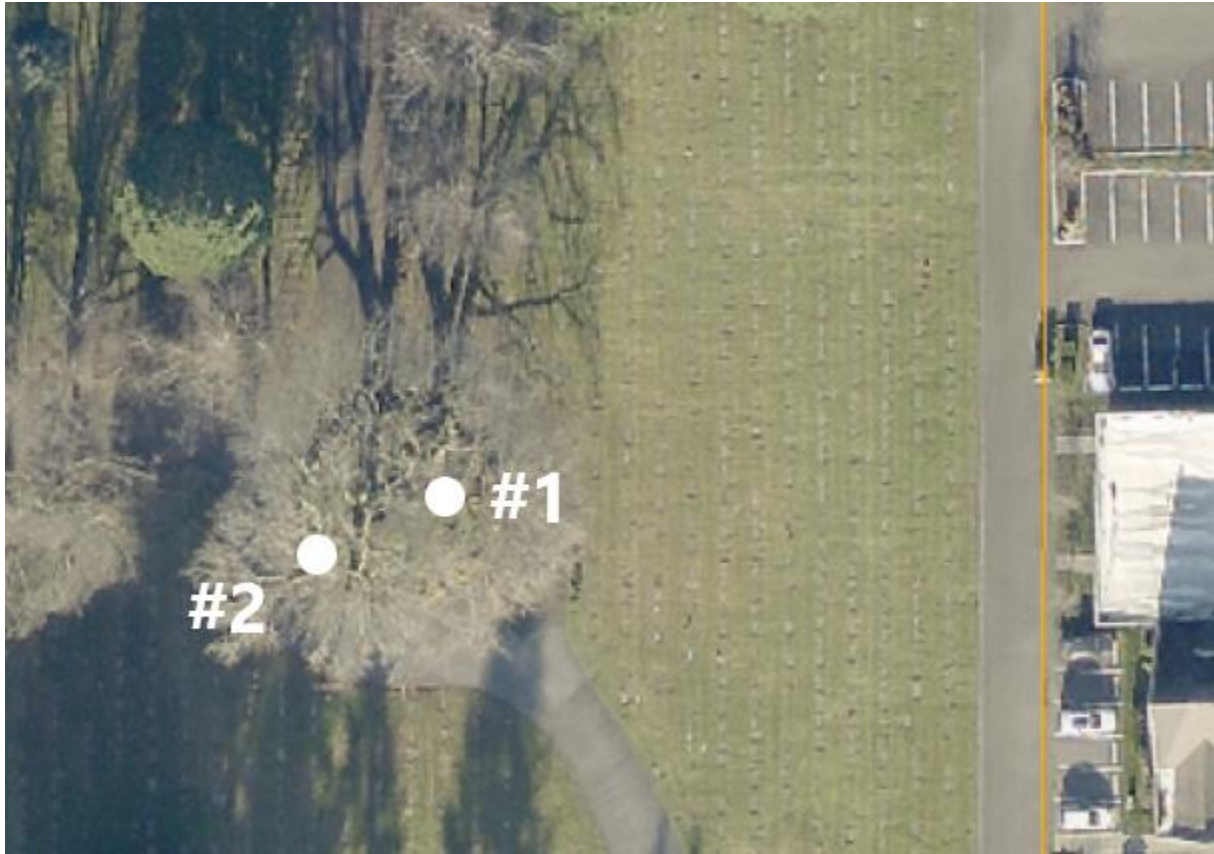
Locations of Nominated Trees

The identified chestnut trees are located within a raised roundabout to the west of the main funeral building. They are situated on each side of a memorial wall (see aerial and photos).

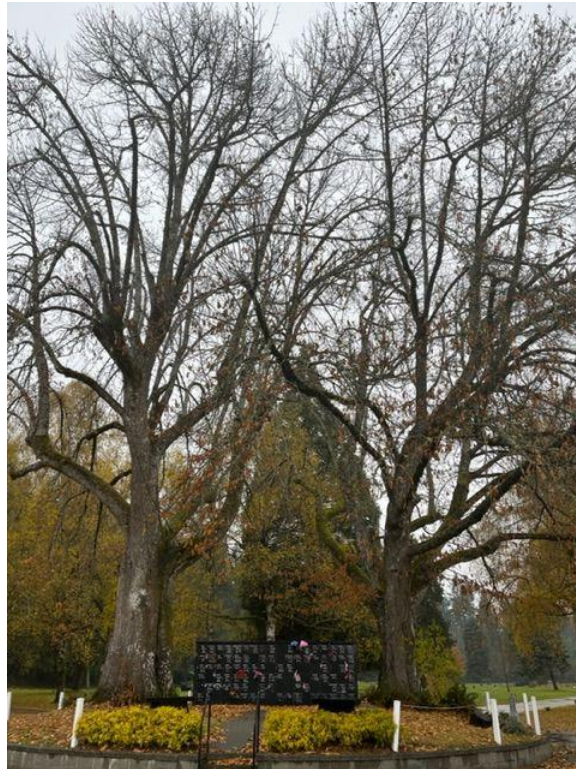
Photo of Trees within Memorial Roundabout
