Todd Prager & Associates
LLC

Tree Risk Assessment for the Davis-Meeker Oak

Date: February 7, 2025

Site Address: 7525 Old Highway 99 SE
Tumwater, Washington 98501

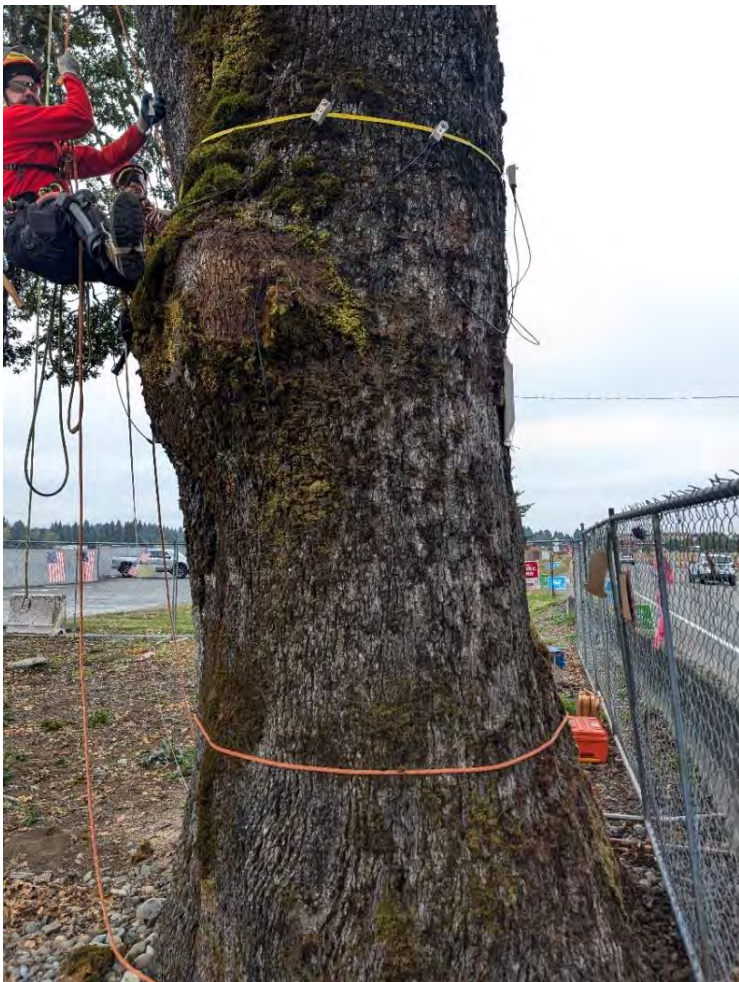
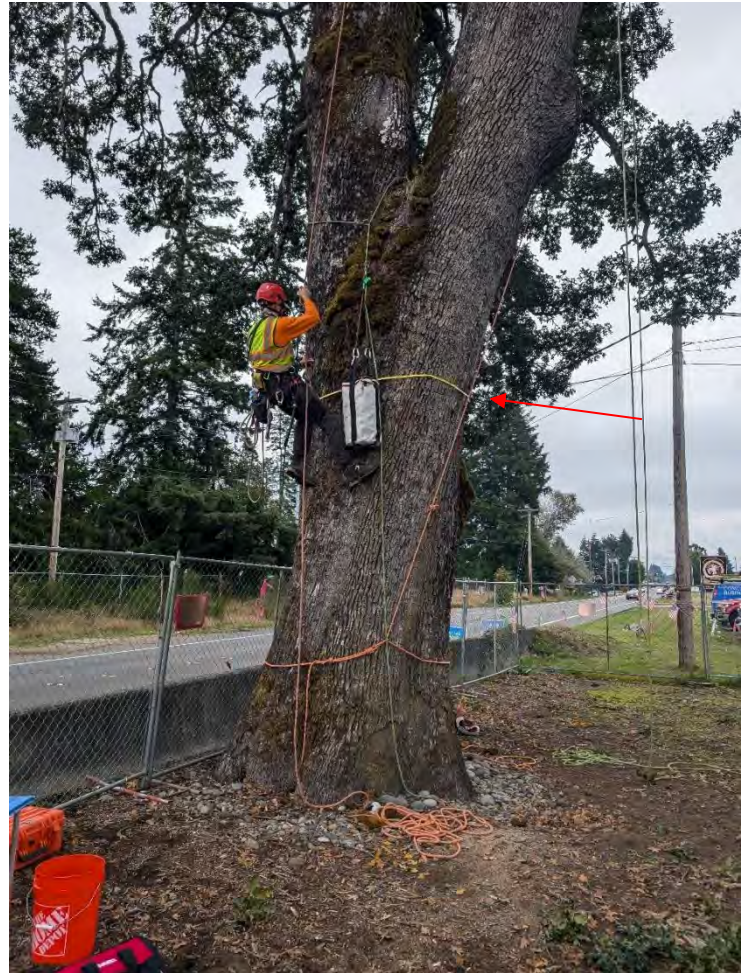
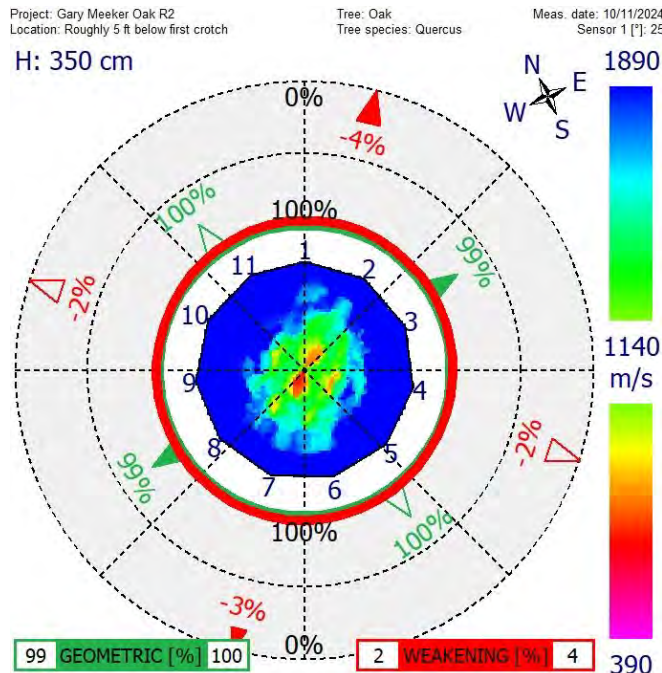
Oak – Reading 2- 350cm

At this level there is a small amount of compromised wood in the center of the stem. The green indicates where the co-dominant inclusion is causing a weak attachment point.

At this level there is between 2% and 4% strength loss. This is low strength loss.

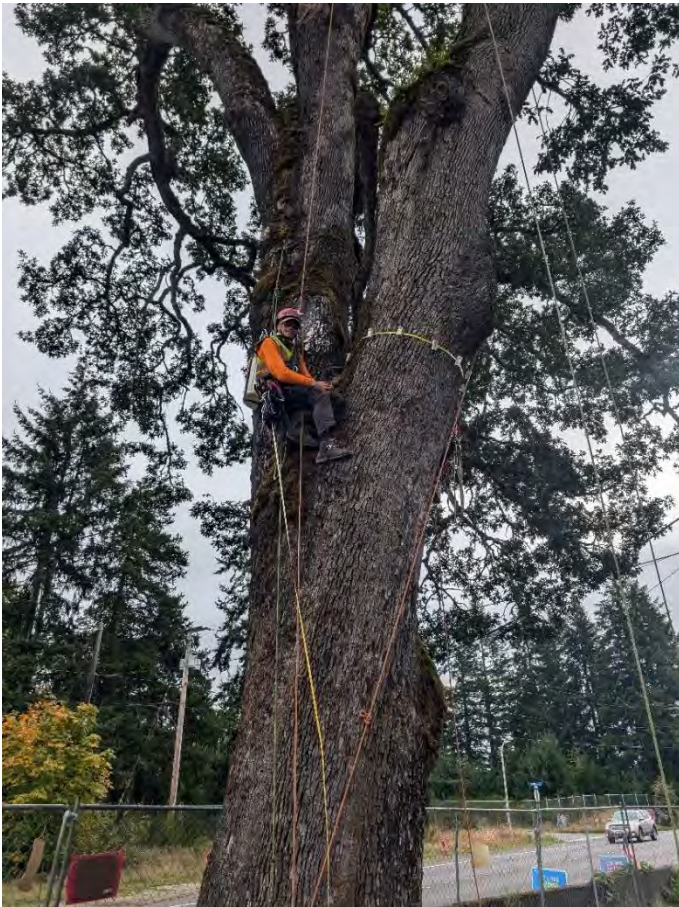
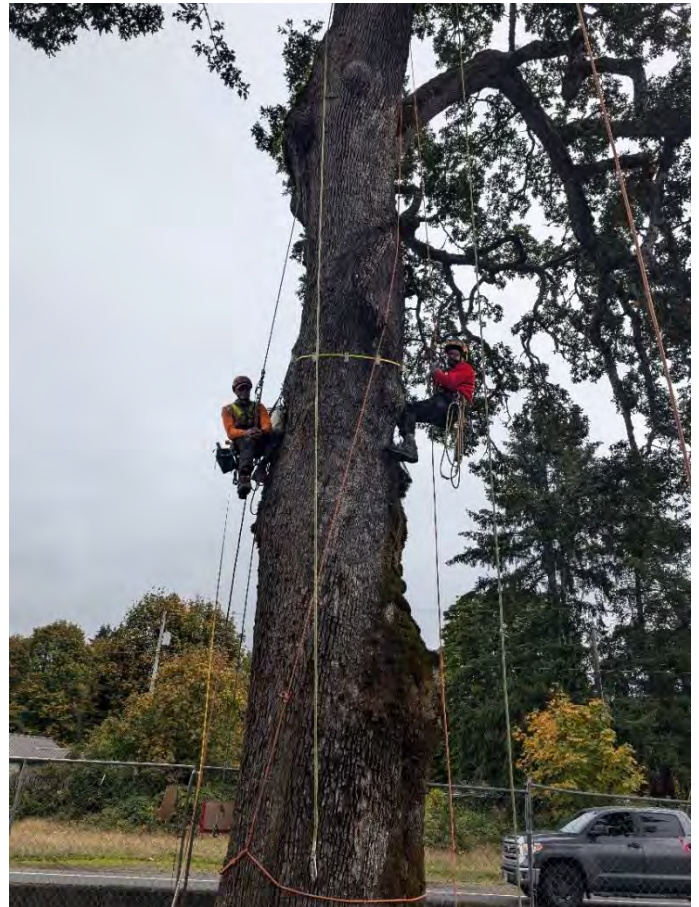
Oak – Reading 3- 563cm

At this level there is no sign of compromised wood.

At this level there is between 1% and 2% strength loss. This is minimal strength loss.

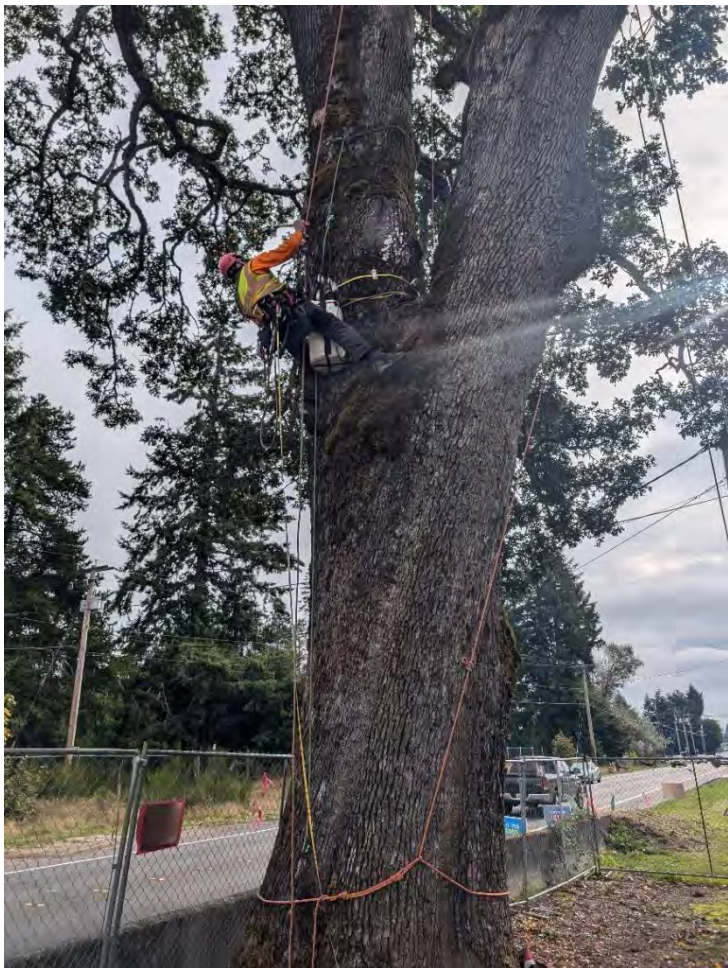
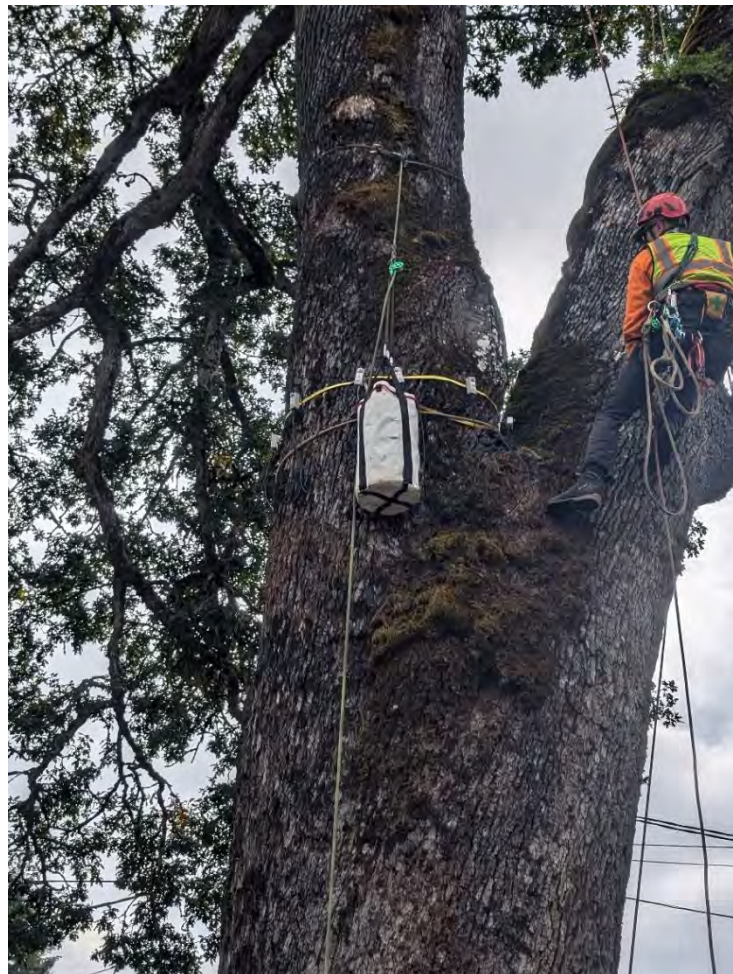
Oak – Reading 4- 579cm

At this level there is no sign of compromised wood.

At this level there is between 1% and 2% strength loss. This is minimal strength loss.

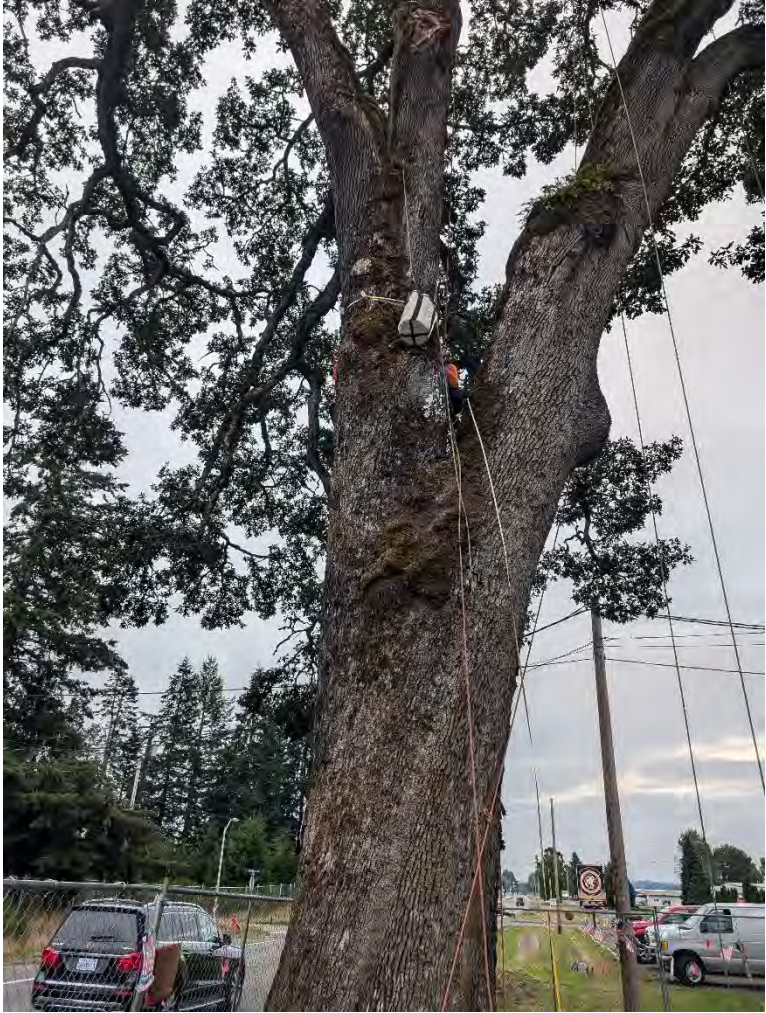
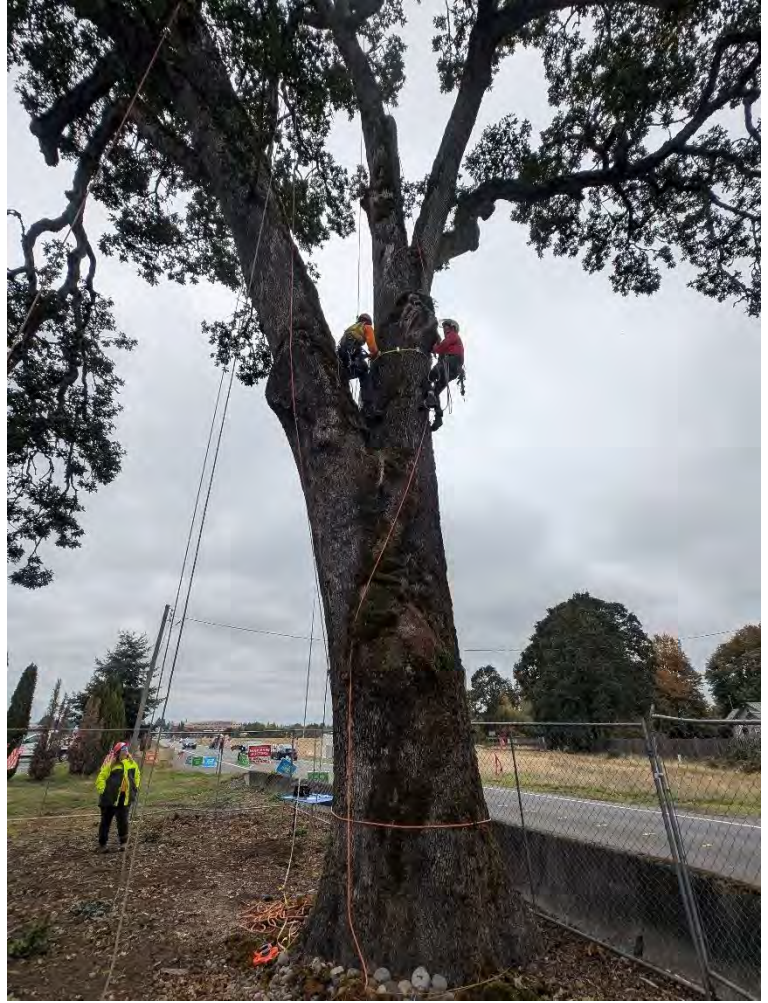
Oak – Reading 5- 746cm

At this level there are no signs of compromised wood.

At this level there is less than 2% strength loss. This is minimal strength loss.

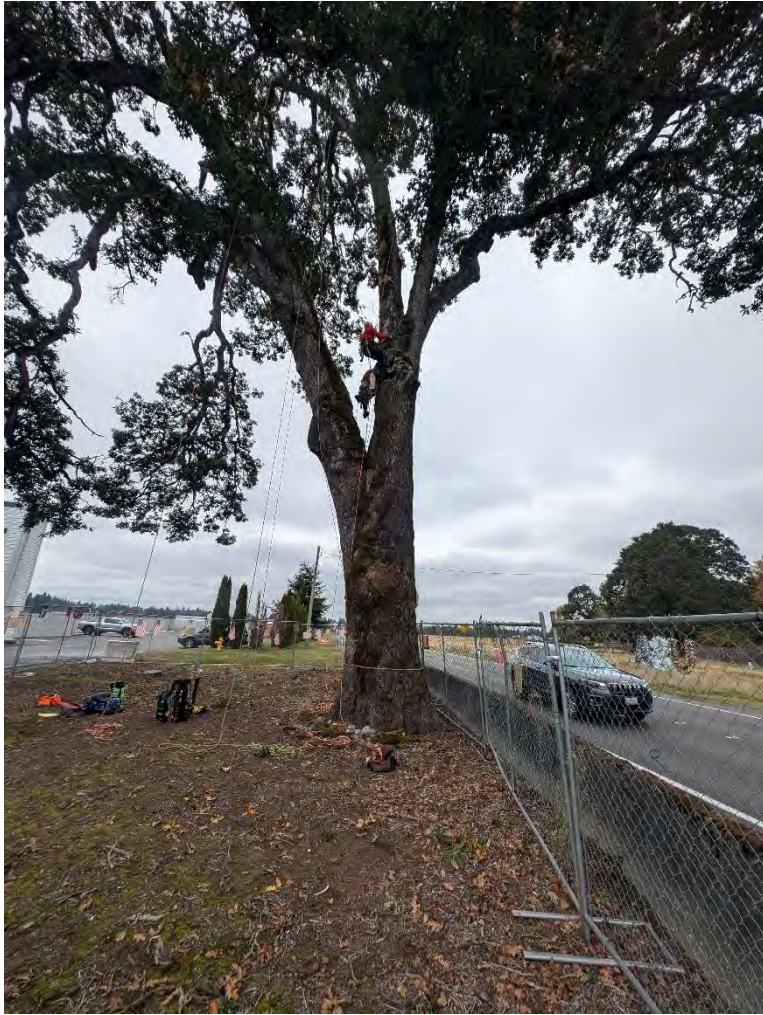
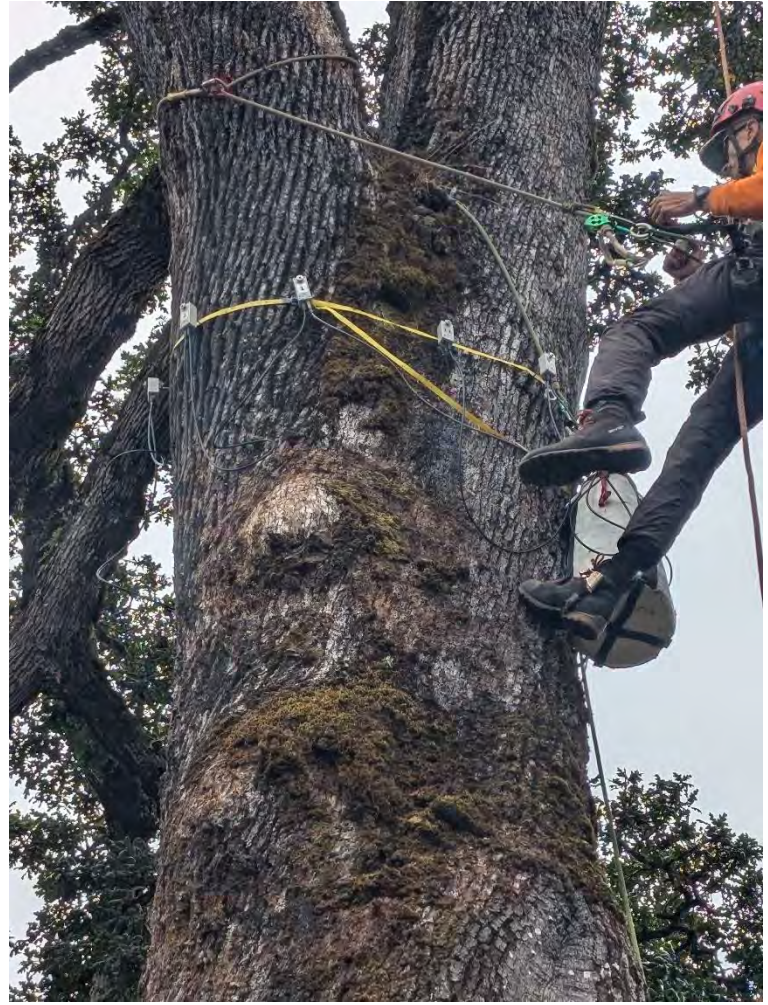
Oak – Reading 6- 884cm

At this level there is included bark throughout the center of the stem, where the three stems connect.

At this level there is between 2% and 8% strength loss. This is minimal strength loss.

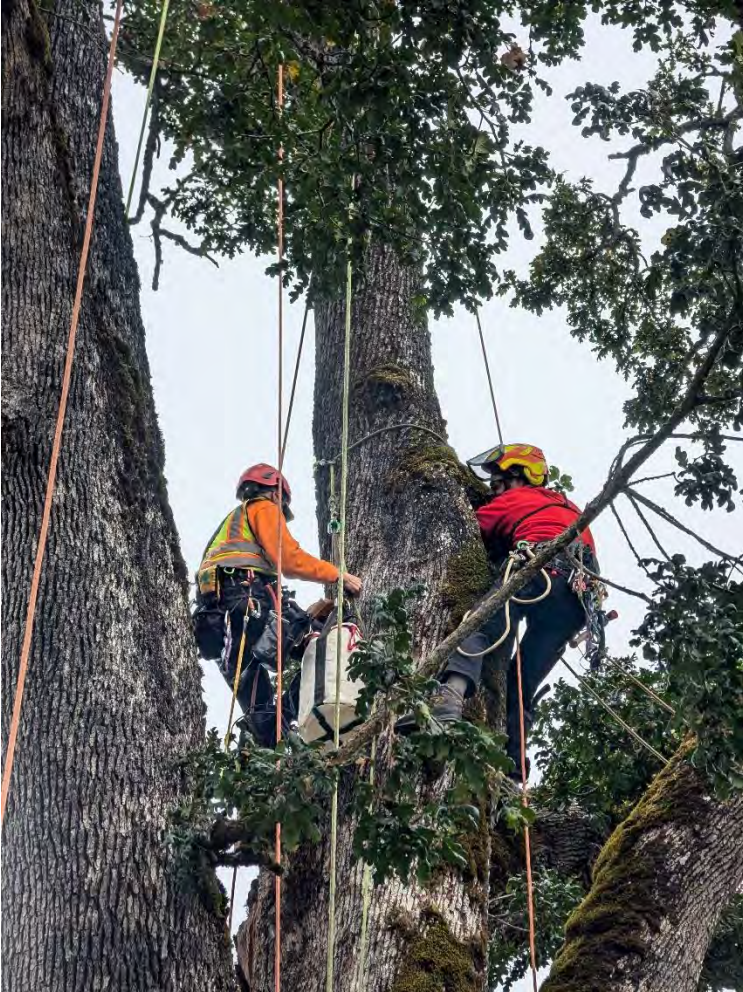
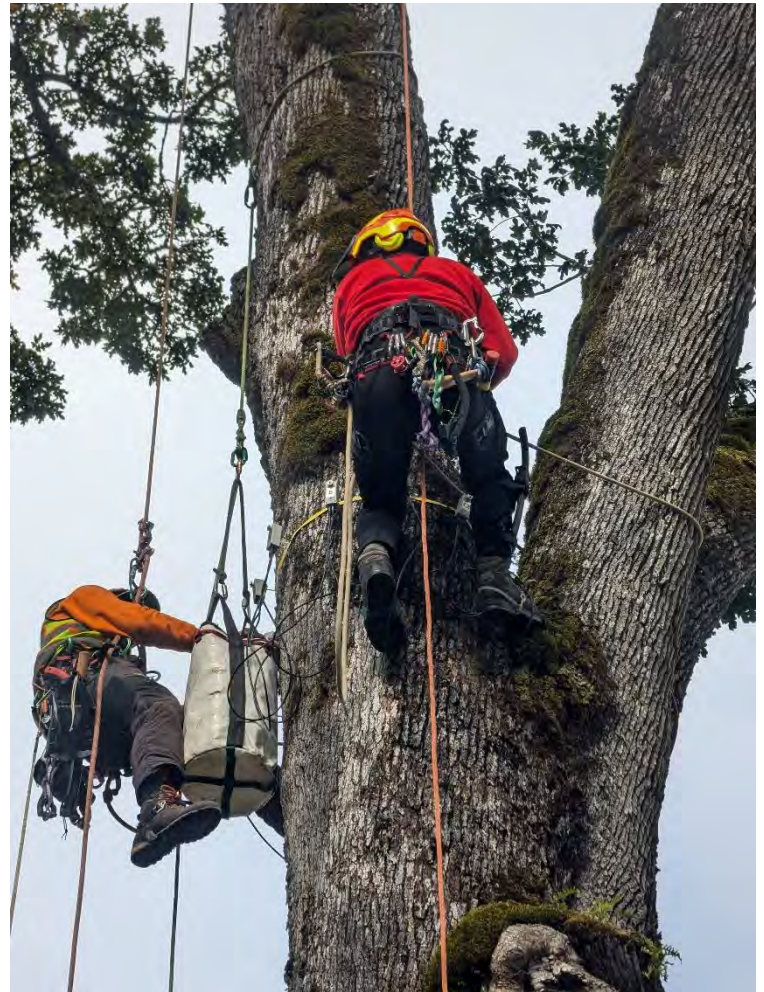
Oak – Reading 7- 1036cm

At this level there is no sign of compromised wood.

At this level there is no strength loss.

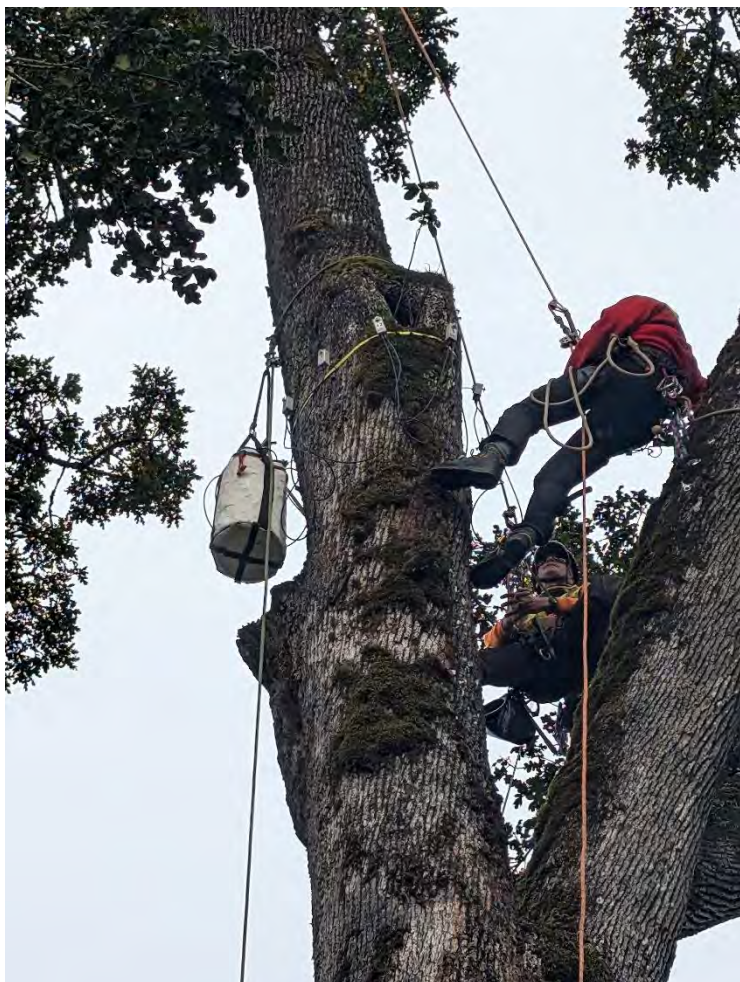
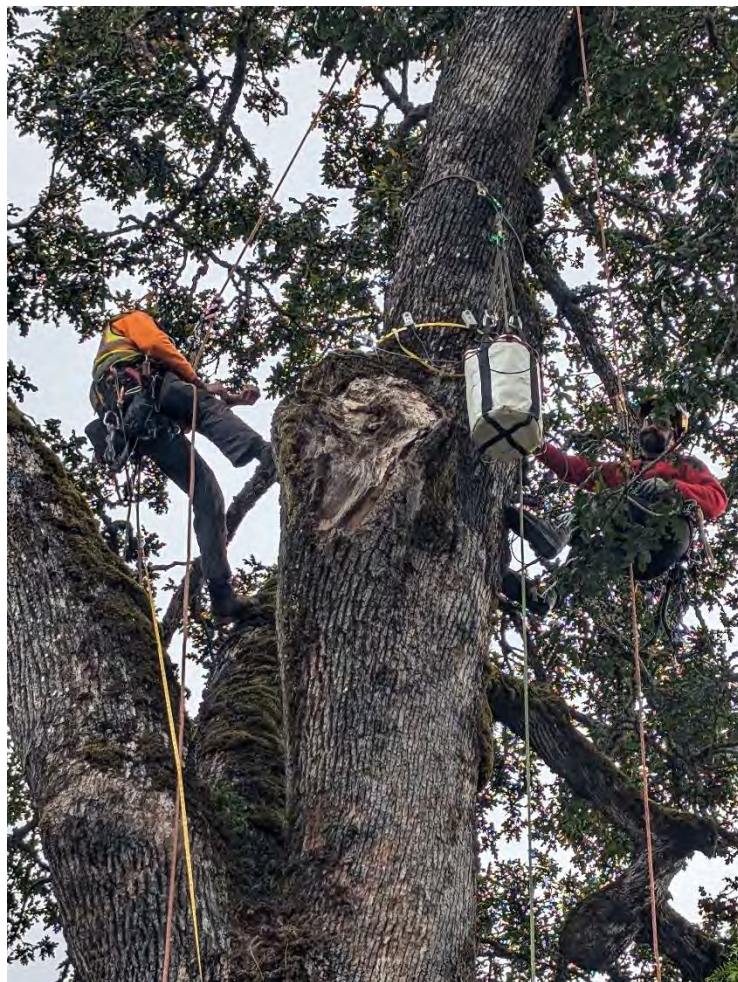
Oak – Reading 8- 1381cm

At this level there is less dense wood in the center of the stem. The center yellow spot indicates where the cavity above extends too.

At this level there is between 6% and 19% strength loss. This is minimal strength loss.

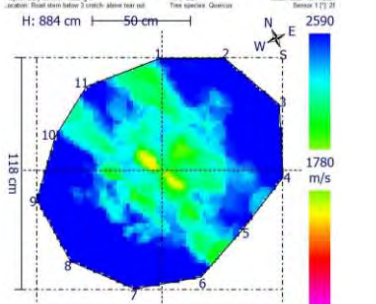
<p>At this level there is likely included bark within the center of the stem, where the codominant stems connect.</p> <p>At this level there is between 2% and 8% strength loss. This is minimal strength loss.</p>

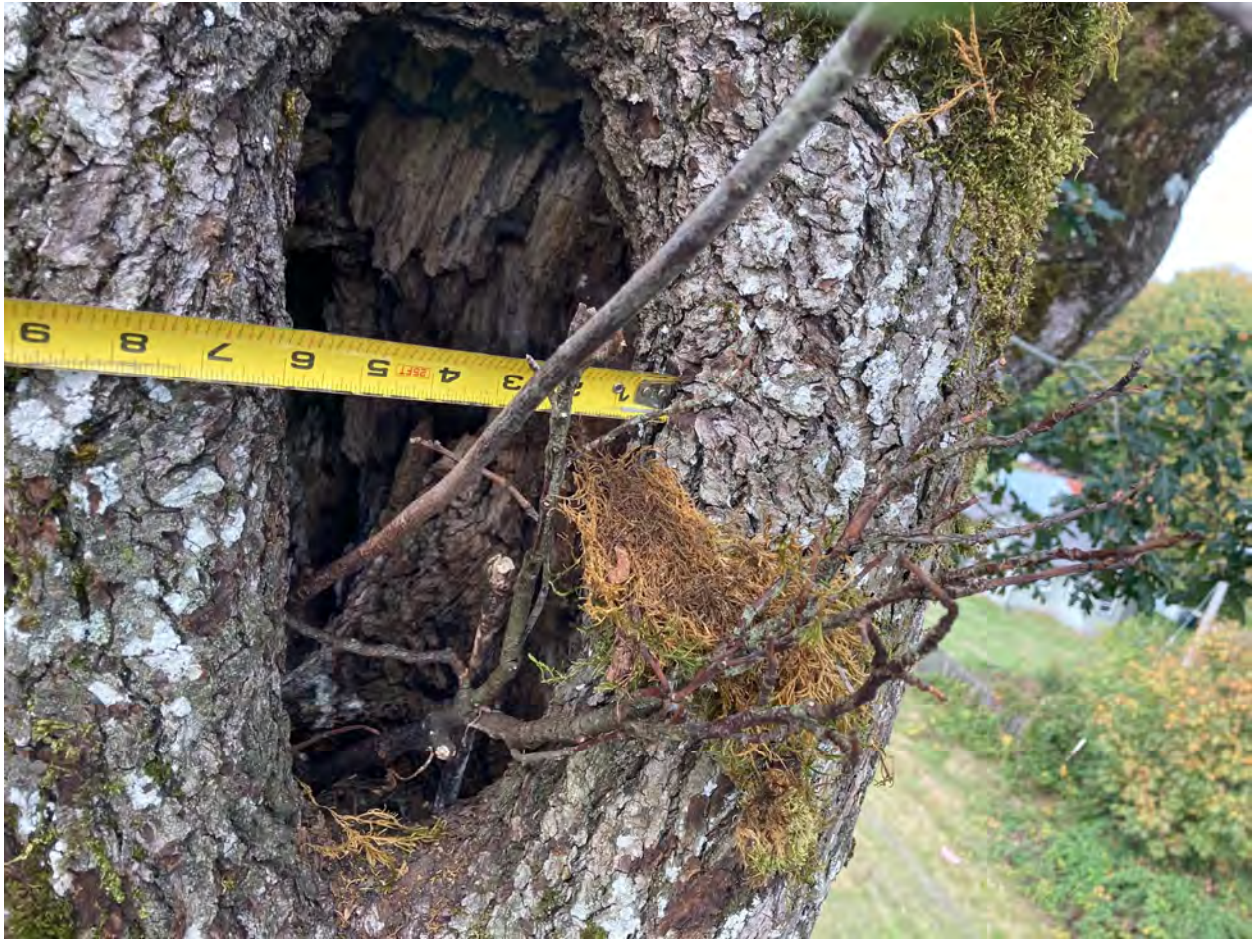
Figure 20 Measurement of diameter of cavity at 6 inches.

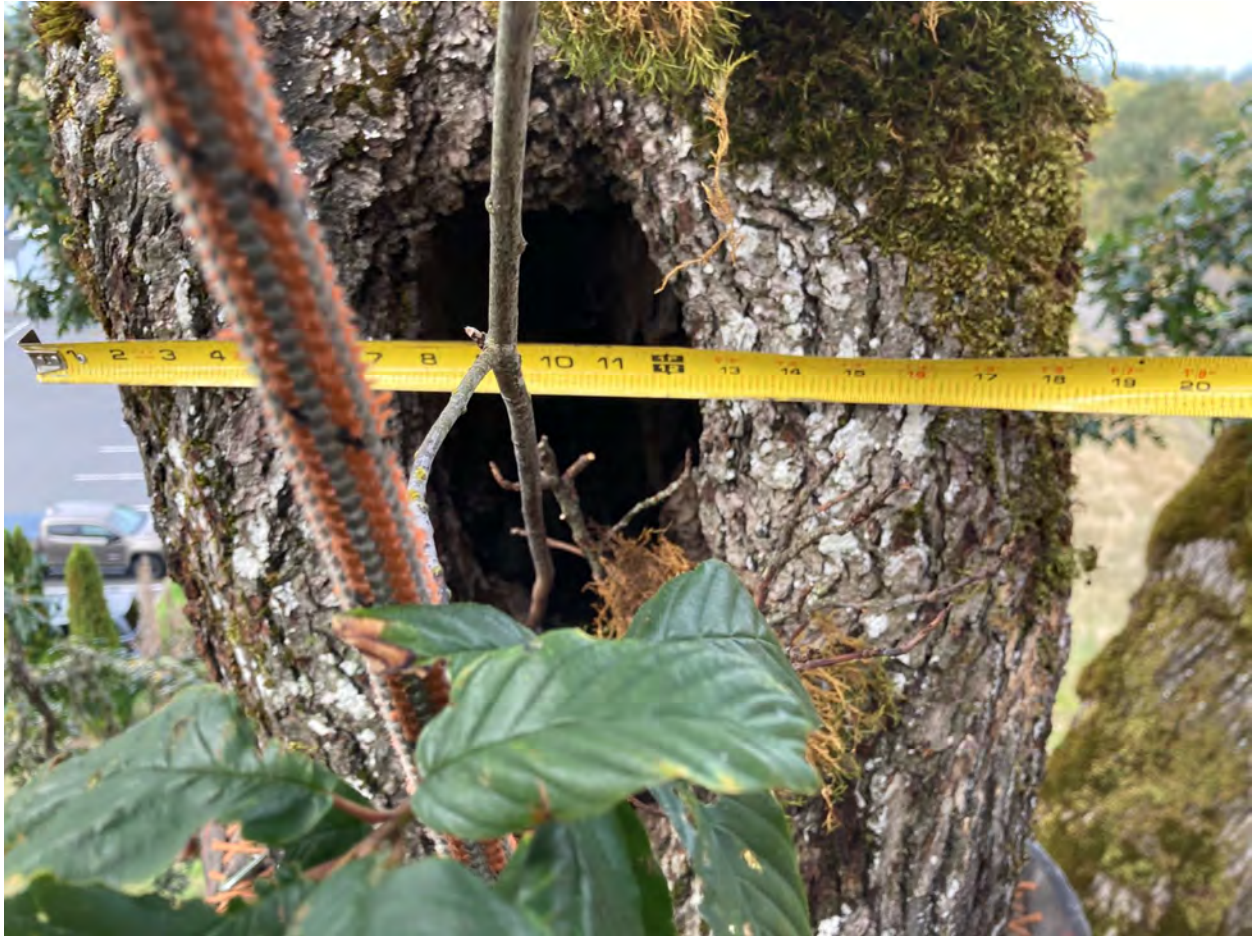
Figure 21 Measurement of diameter perpendicular to cavity opening at approximately 17 inches.

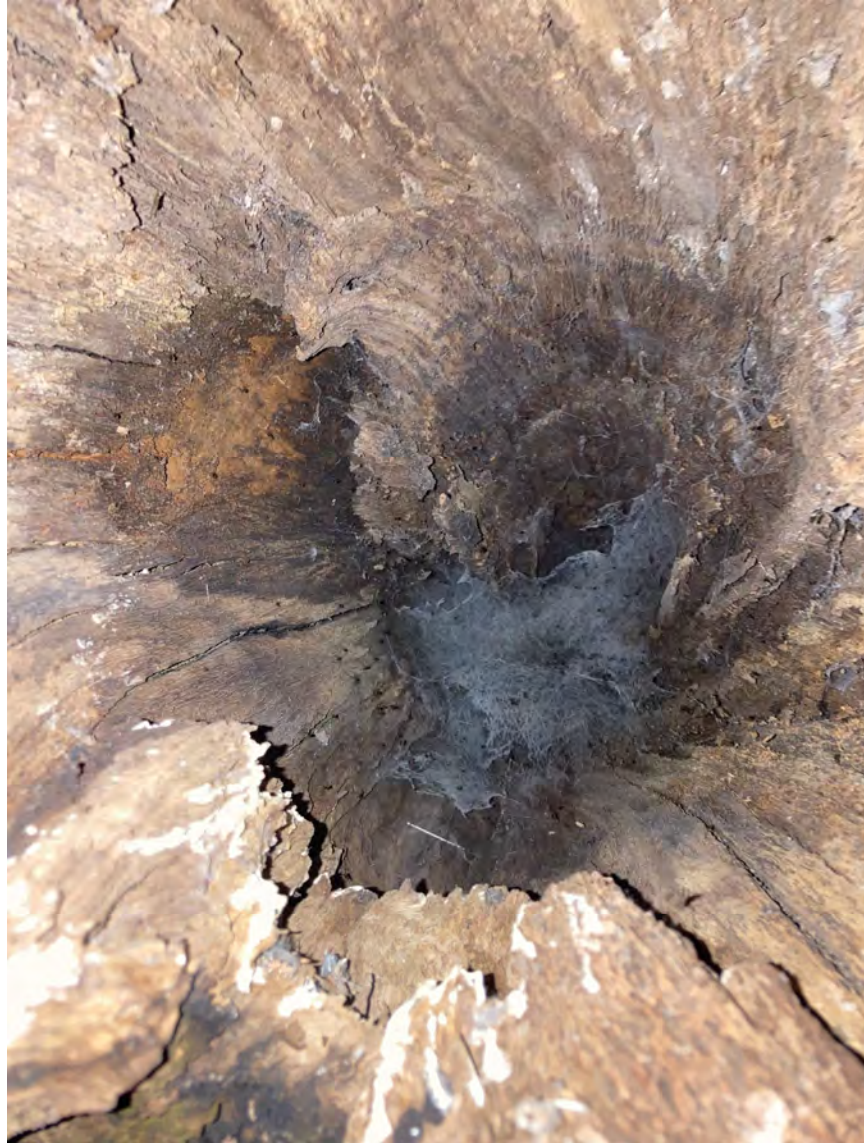
Figure 24 View vertically up the cavity.
