Todd Prager & Associates
LLC

Tree Risk Assessment for the Davis-Meeker Oak

Date: February 7, 2025

Site Address: 7525 Old Highway 99 SE
Tumwater, Washington 98501

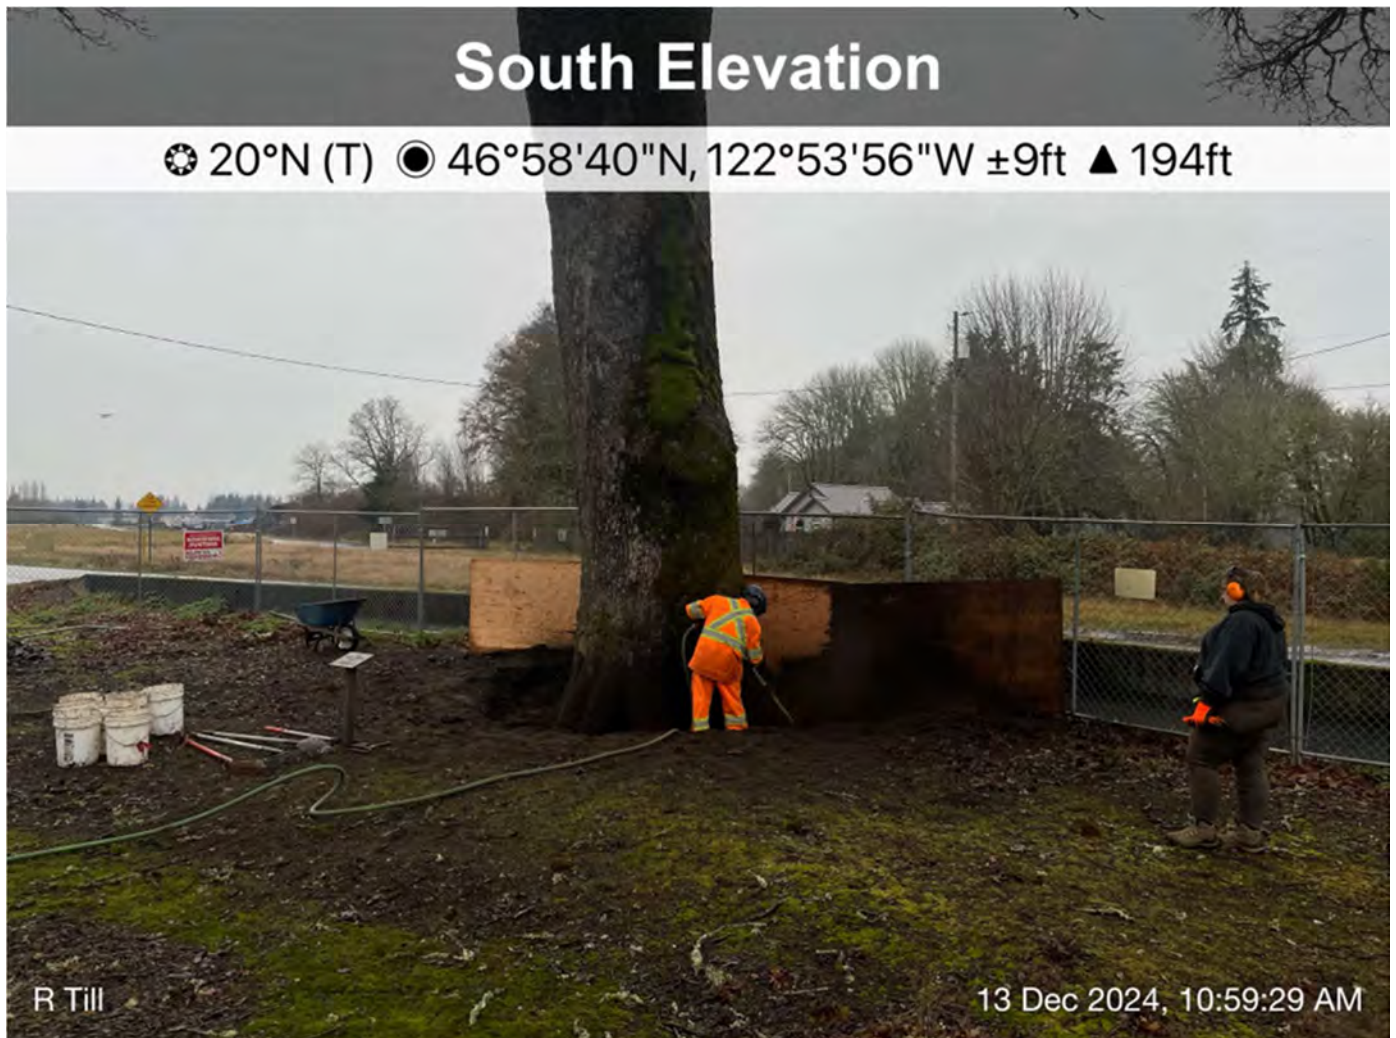
The inspection revealed adequate to robust buttress root growth around the entire tree. One historic decay cavity was revealed to be closing with substantial wound wood growth.

Figure 1 Root crown excavation employed an “air spade” that uses compressed air to remove fine soil. The excavation involved alternating between air spade removal of soil with hand removal of river cobble that was backfilled over the root flare after a prior root crown excavation. The project archaeologist oversaw all work.

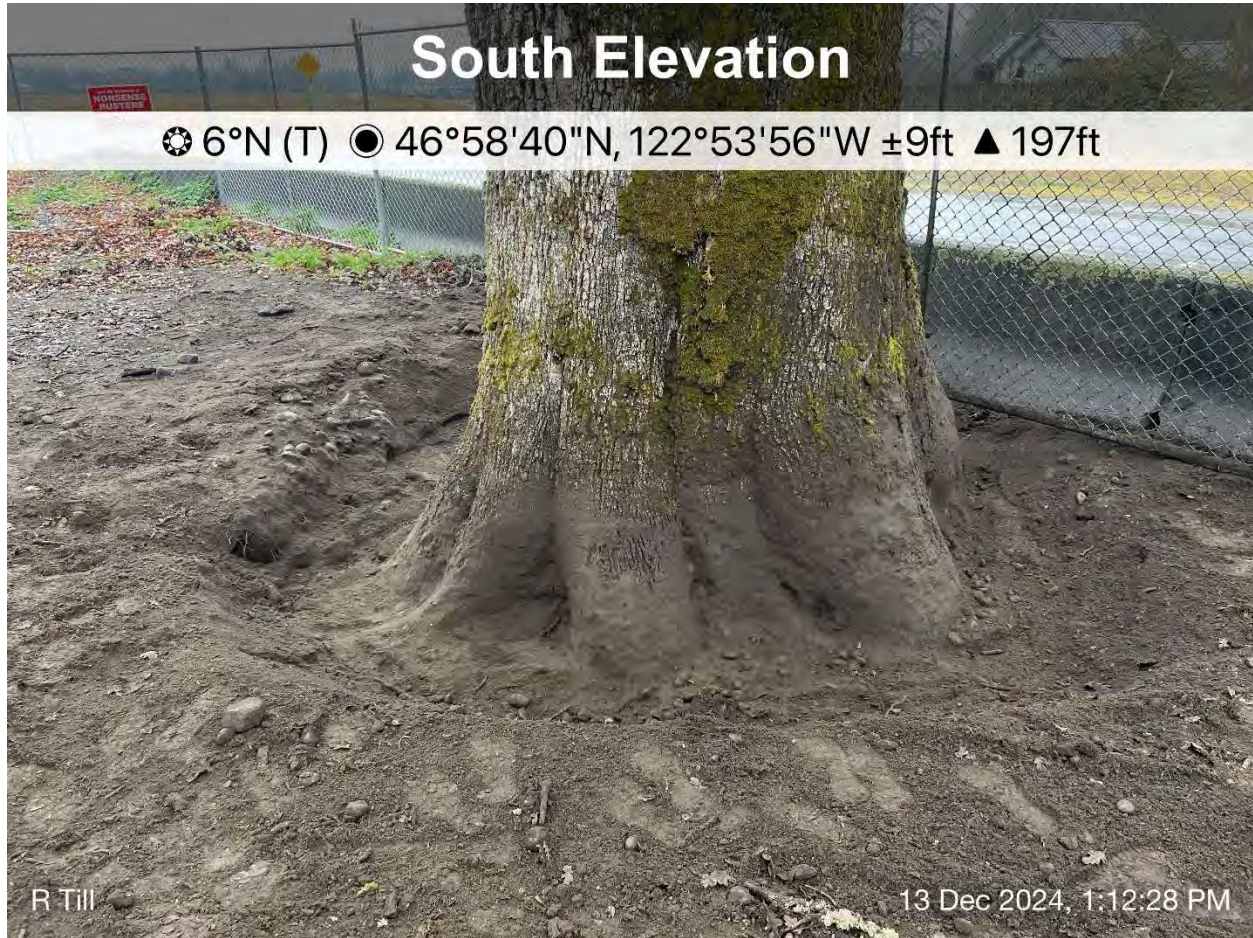
Figure 8 Temporary finished grade.
