# **Watertown Rock River Seawall**

## **Wall Condition Assessment and Feasibility Study**

**City of Watertown  
Watertown, Wisconsin**

**July 2026**

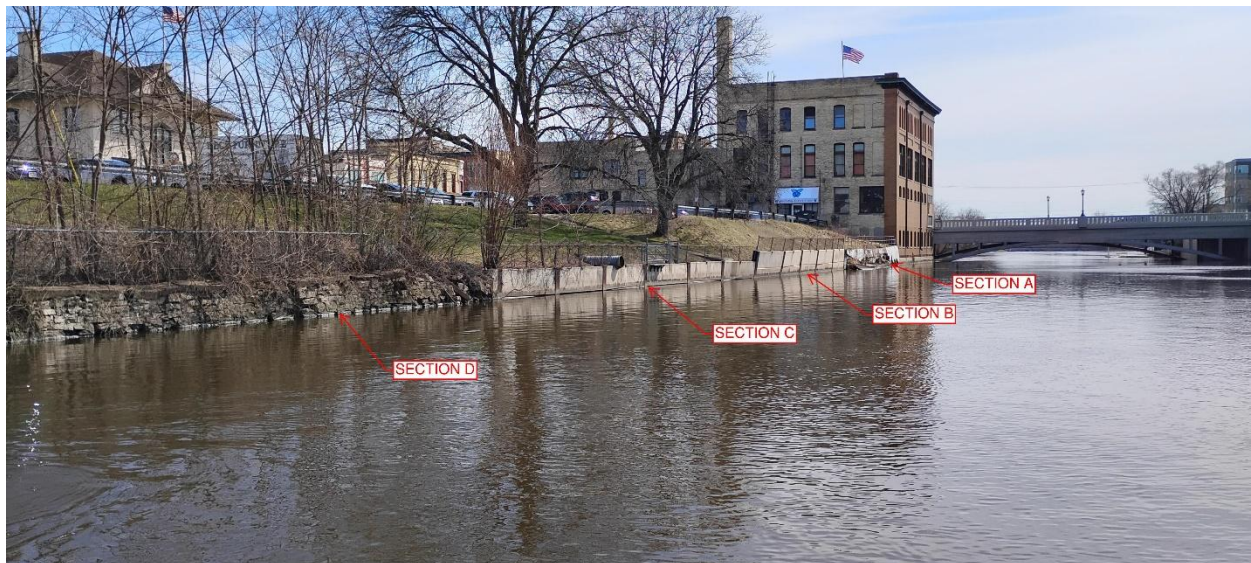
Per the request-for-proposal, Section E was not meant to be included in the scope of the study. However, given the wall's similarity to Section D and that each of the alternatives explored could easily be applied to Section E, this study includes this segment of the wall. A photograph of Sections A through D is shown in Figure 1. Section E is not shown but is identical to Section D.

**Figure 1. Each section of seawall along the east bank of the Rock River.**
