604 W Main Street

Rear Door

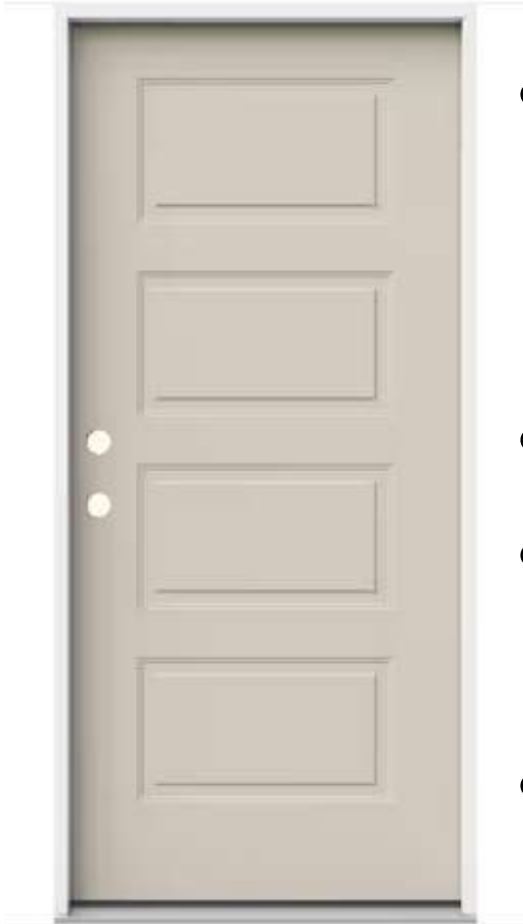
Similar style to what we think was original kitchen door, from a 2010 picture of a door in the storage room

- Replace storm door with an insulated fiberglass door, no windows
- No hardware
- Paint either off white or green
- Leave transom as is

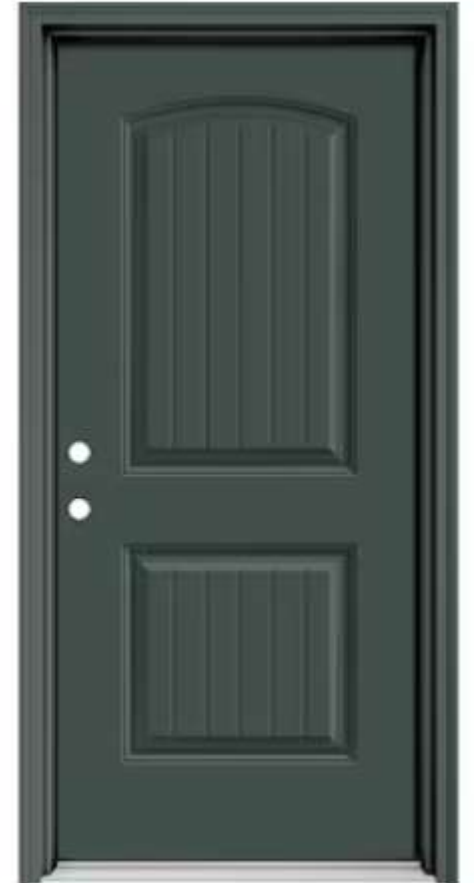
Similar style to original side door by ramp
