Time Range: 10/1/2025-10/31/2025

<h1 style="margin: 0;">City of Whitewater</h1>	<h2 style="margin: 0;">Storm Water Outfall Inspection Report</h2> <p style="margin: 0;">Prepared by WATER RESOURCE ASSOCIATES</p>
--	--

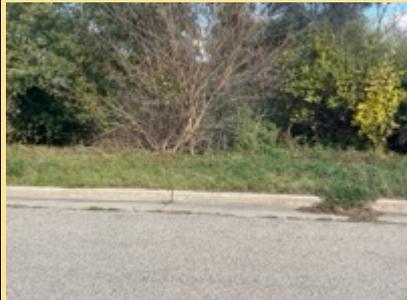
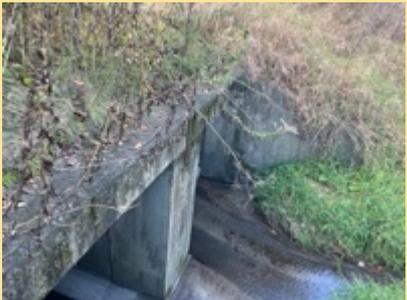
Site Photo	Outfall Photo

Outfall Condition	
Pipe Condition	Average
Rip-Rap Condition	No Rip-Rap Present
Erosion Condition	No Erosion
Comments

Flow Data			
Active Flow	N	Flow Rate	N/A
Odor	No	Ammonia	N/A
Turbidity	N/A	Chlorine	No
Color	N/A	pH	N/A
Floatables	No	Detergents	N/A
Comments	N/A

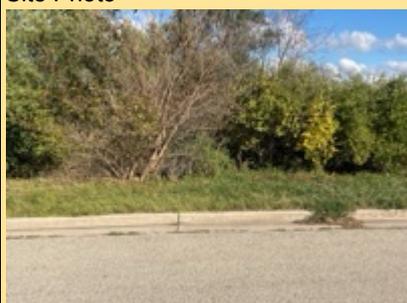
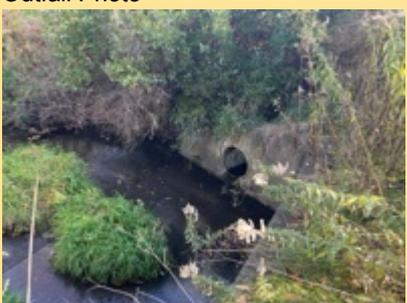
Site Photo	Outfall Photo

Outfall Condition	
Pipe Condition	Average
Rip-Rap Condition	No Rip-Rap Present
Erosion Condition	No Erosion
Comments

Flow Data			
Active Flow	Y	Flow Rate	1 - 3 ft/sec
Odor	No	Ammonia	* > 0.1 mg/l *
Turbidity	None	Chlorine	No
Color	N/A	pH	7.00
Floatables	No	Detergents	* > 0.5 mg/l *
Comments

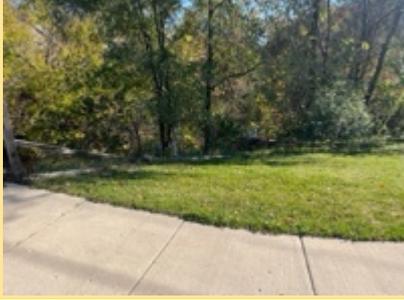
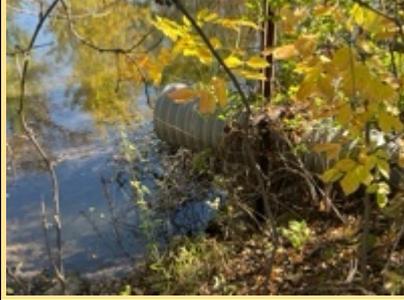
Site Photo	Outfall Photo

Outfall Condition	
Pipe Condition	Average
Rip-Rap Condition	No Rip-Rap Present
Erosion Condition	Minor Erosion
Comments	End of pipe approx 3' above grade

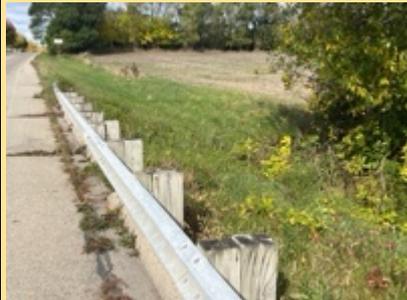
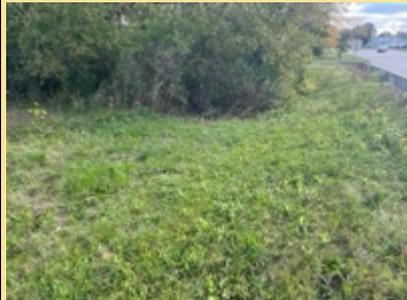
Site Photo	Outfall Photo

Outfall Condition	
Pipe Condition	No Pipe Present
Rip-Rap Condition	No Rip-Rap Present
Erosion Condition	No Erosion
Comments

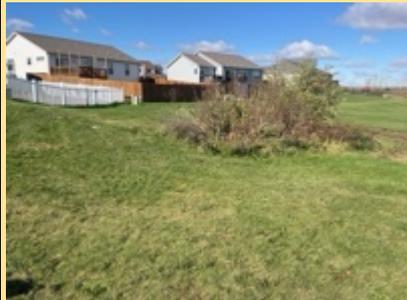
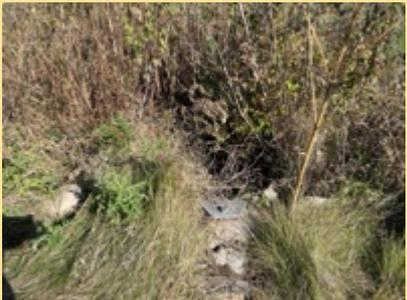
Site Photo	Outfall Photo

Outfall Condition	
Pipe Condition	Average
Rip-Rap Condition	No Rip-Rap Present
Erosion Condition	Heavy Accumulated Sediment (Consider Repair)
Comments	Pipe more than 50% full of debris. Invasive brush at end of pipe.

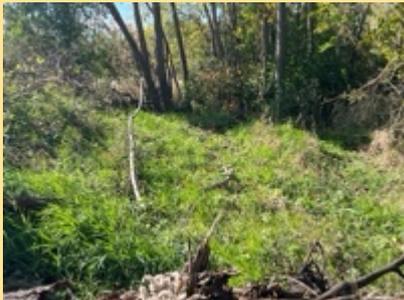
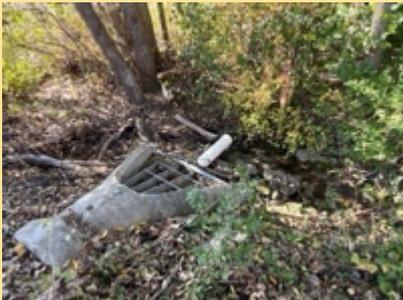
Site Photo	Outfall Photo

Outfall Condition	
Pipe Condition	Average
Rip-Rap Condition	Average
Erosion Condition	Minor Erosion
Comments	Flow from 6" PVC.

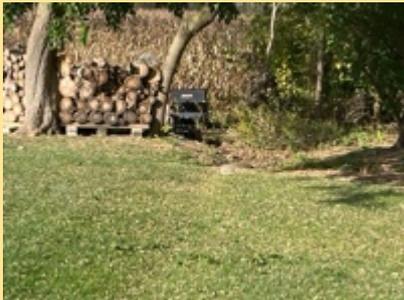
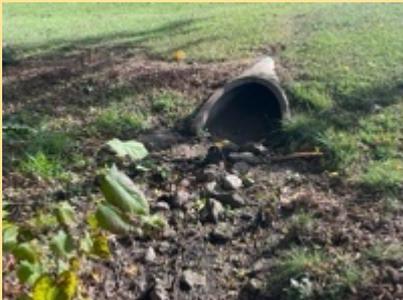
Site Photo	Outfall Photo

Outfall Condition	
Pipe Condition	Average
Rip-Rap Condition	Poor (Consider Repair)
Erosion Condition	Minor Erosion
Comments	Minor erosion extends 40' to edge of field

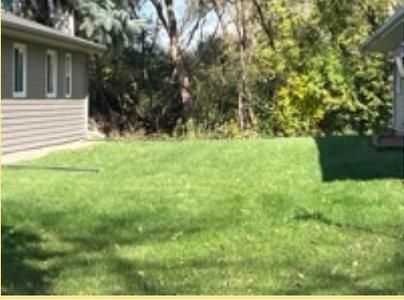
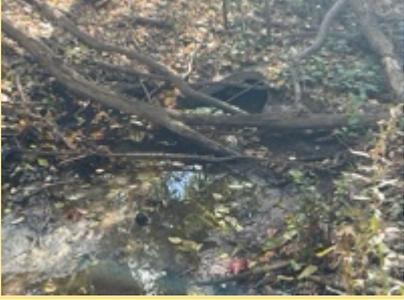
Site Photo	Outfall Photo

Outfall Condition	
Pipe Condition	Average
Rip-Rap Condition	No Rip-Rap Present
Erosion Condition	Minor Erosion
Comments

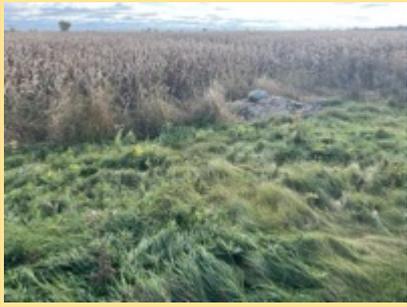
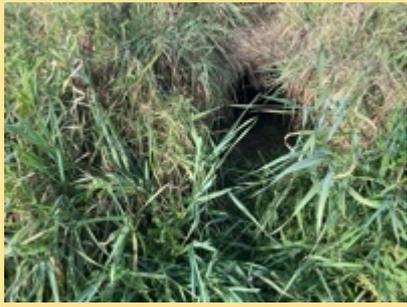
Site Photo	Outfall Photo

Outfall Condition	
Pipe Condition	Average
Rip-Rap Condition	No Rip-Rap Present
Erosion Condition	No Erosion
Comments

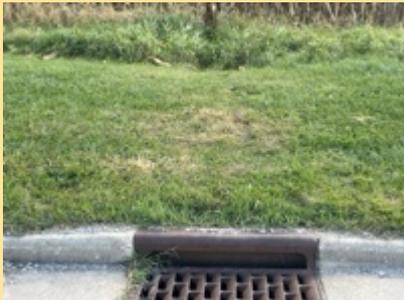
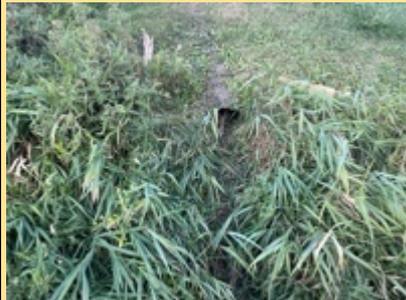
Site Photo	Outfall Photo

Outfall Condition	
Pipe Condition	Average
Rip-Rap Condition	No Rip-Rap Present
Erosion Condition	Accumulated Sediment
Comments

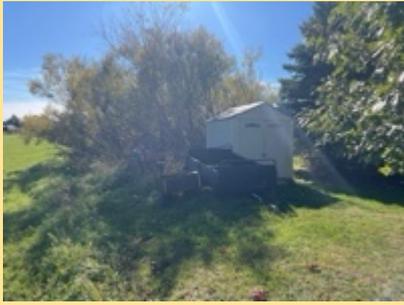
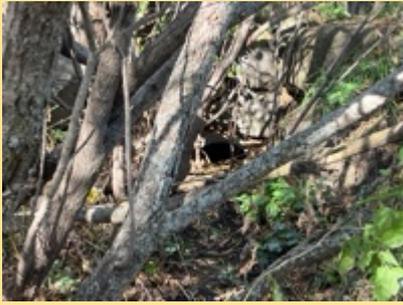
Site Photo	Outfall Photo

Outfall Condition	
Pipe Condition	Average
Rip-Rap Condition	No Rip-Rap Present
Erosion Condition	Heavy Accumulated Sediment (Consider Repair)
Comments	Pipe more than 50% obstructed. Heavy vegetation obstructing downstream flow. Shed built over pipe.

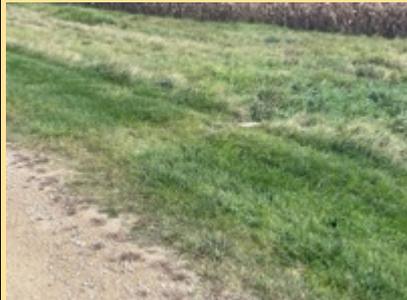
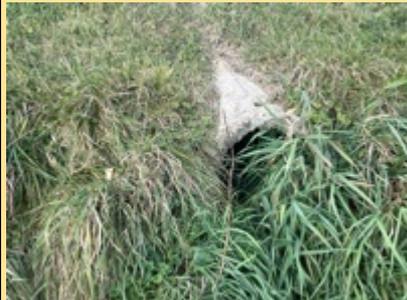
Site Photo	Outfall Photo

Outfall Condition	
Pipe Condition	Average
Rip-Rap Condition	No Rip-Rap Present
Erosion Condition	Accumulated Sediment
Comments

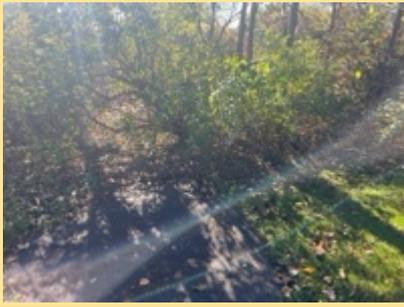
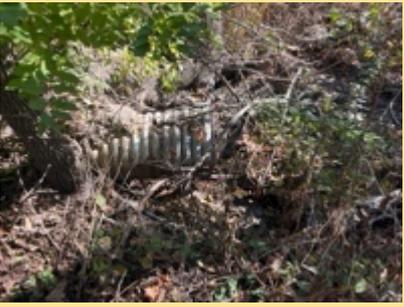
Site Photo	Outfall Photo

Outfall Condition	
Pipe Condition	Average
Rip-Rap Condition	No Rip-Rap Present
Erosion Condition	Minor Erosion
Comments

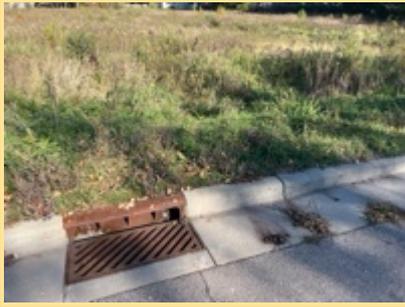
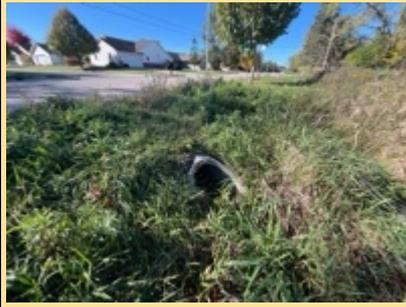
Site Photo	Outfall Photo

Outfall Condition	
Pipe Condition	Average
Rip-Rap Condition	No Rip-Rap Present
Erosion Condition	No Erosion
Comments

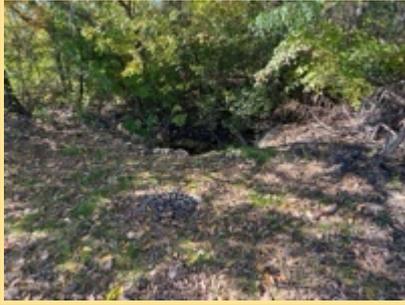
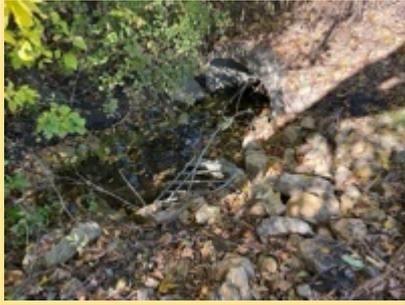
Site Photo	Outfall Photo

Outfall Condition	
Pipe Condition	Average
Rip-Rap Condition	Average
Erosion Condition	No Erosion
Comments

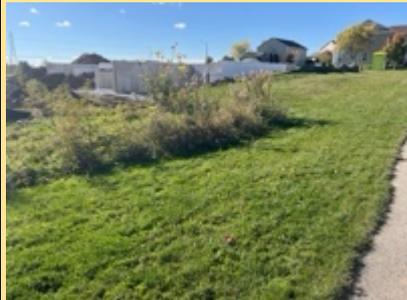
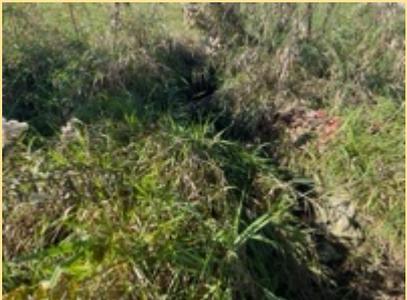
Site Photo	Outfall Photo

Outfall Condition	
Pipe Condition	Average
Rip-Rap Condition	Poor (Consider Repair)
Erosion Condition	Minor Erosion
Comments

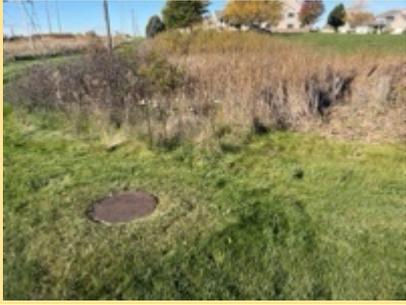
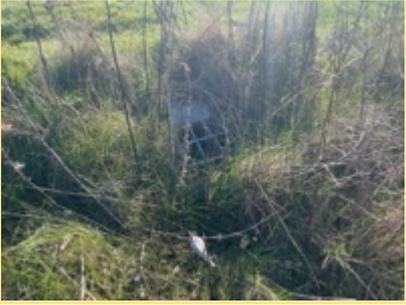
Site Photo	Outfall Photo

Outfall Condition	
Pipe Condition	Good
Rip-Rap Condition	Average
Erosion Condition	No Erosion
Comments

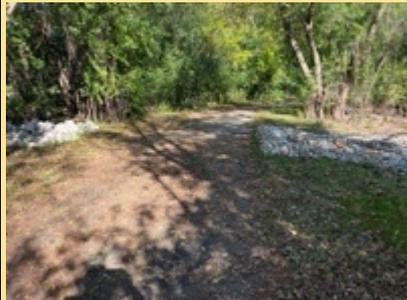
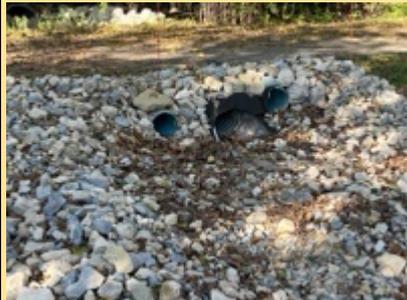
Site Photo	Outfall Photo

Outfall Condition	
Pipe Condition	Good
Rip-Rap Condition	Good
Erosion Condition	No Erosion
Comments

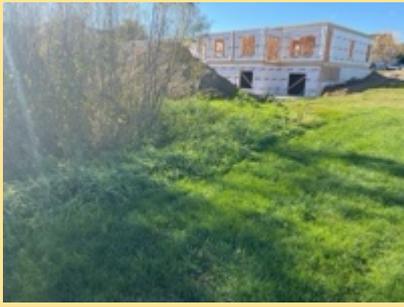
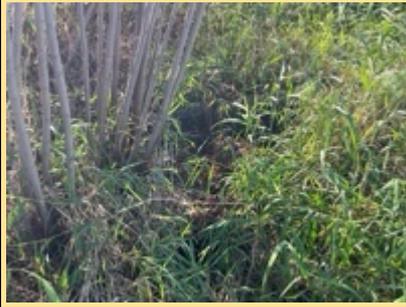
Site Photo	Outfall Photo

Outfall Condition	
Pipe Condition	Average
Rip-Rap Condition	Poor (Consider Repair)
Erosion Condition	Minor Erosion
Comments	Brush obstructing flow beyond end section

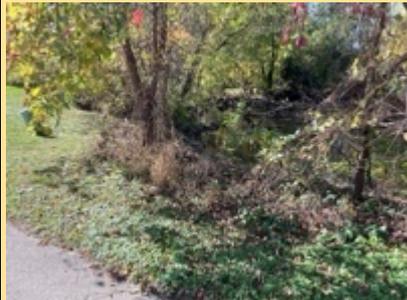
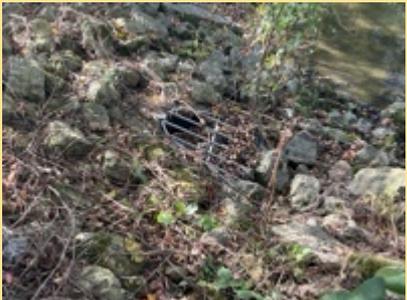
Site Photo	Outfall Photo

Outfall Condition	
Pipe Condition	Average
Rip-Rap Condition	Average
Erosion Condition	Accumulated Sediment
Comments	Pipe 20% filled with debris

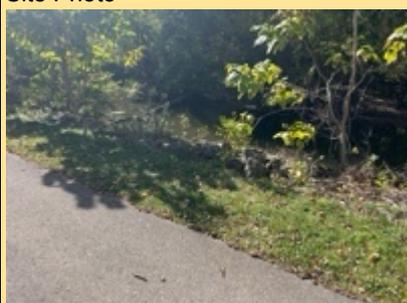
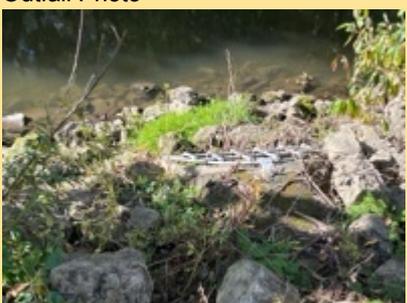
Site Photo	Outfall Photo

Outfall Condition	
Pipe Condition	Average
Rip-Rap Condition	Average
Erosion Condition	No Erosion
Comments

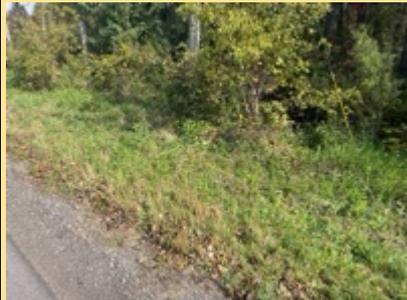
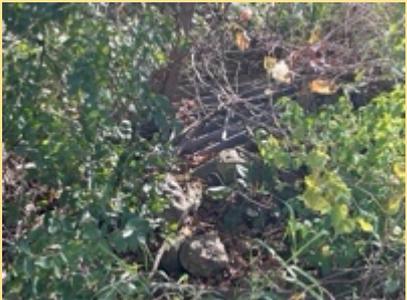
Site Photo	Outfall Photo

Outfall Condition	
Pipe Condition	Average
Rip-Rap Condition	Average
Erosion Condition	Minor Erosion
Comments	Trees obstructing end of pipe.

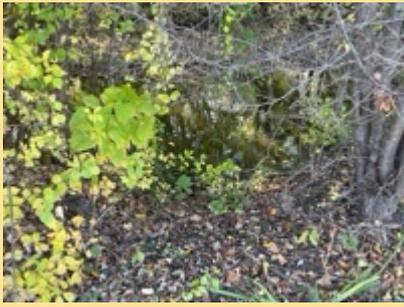
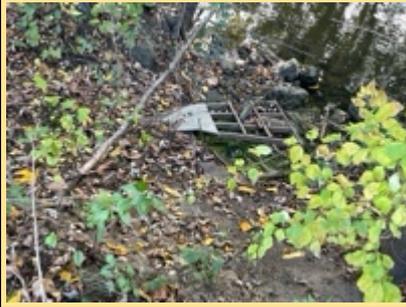
Site Photo

Outfall Condition	
Pipe Condition	Average
Rip-Rap Condition	Average
Erosion Condition	Heavy Accumulated Sediment (Consider Repair)
Comments	Pipe nearly fully clogged with debris

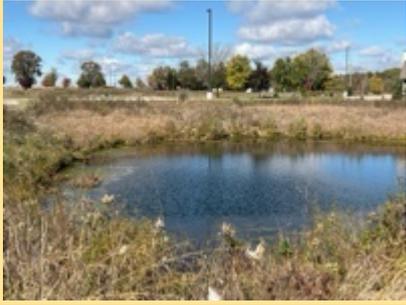
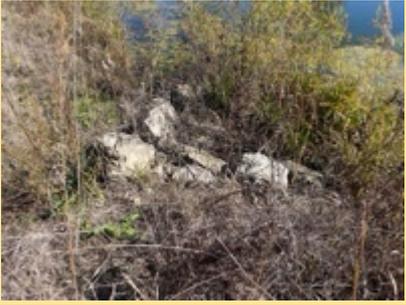
Site Photo	Outfall Photo

Outfall Condition	
Pipe Condition	Average
Rip-Rap Condition	Average
Erosion Condition	No Erosion
Comments	This point is not an MS4 outfall. Not an MS4 outfall.

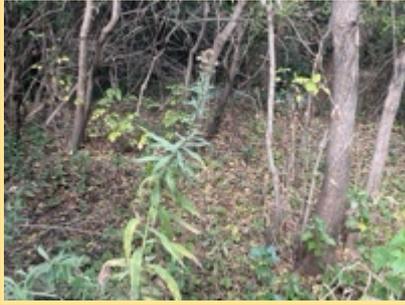
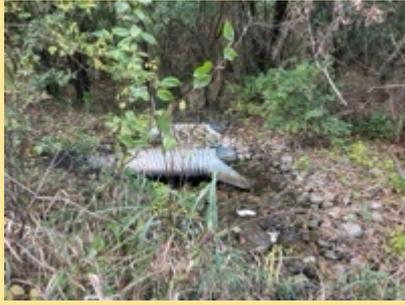
Site Photo	Outfall Photo

Outfall Condition	
Pipe Condition	Average
Rip-Rap Condition	Average
Erosion Condition	Minor Erosion
Comments

Flow Data			
Active Flow	Y	Flow Rate	1 - 3 ft/sec
Odor	No	Ammonia	* > 0.1 mg/l*
Turbidity	None	Chlorine	No
Color	N/A	pH	7.00
Floatables	No	Detergents	* > 0.5 mg/l*
Comments

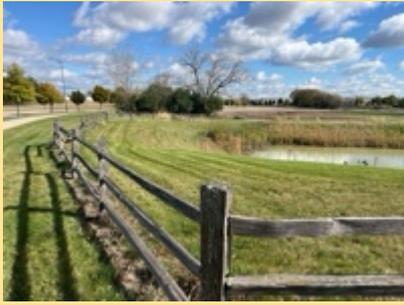
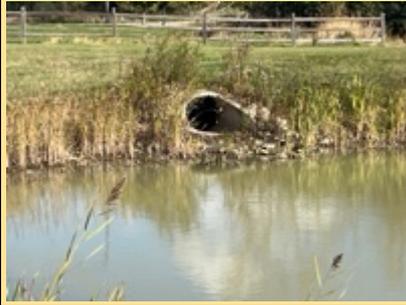
Site Photo	Outfall Photo

Outfall Condition	
Pipe Condition	Average
Rip-Rap Condition	Average
Erosion Condition	No Erosion
Comments	Verify with city - this seems to drain into pond with outfall at opposite corner. Not an MS4 outfall.

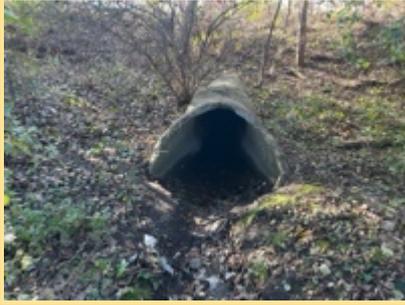
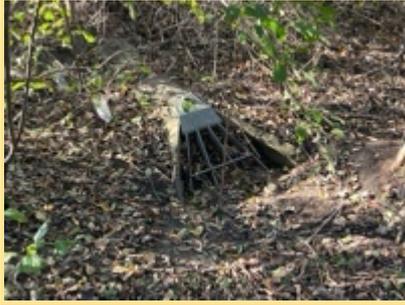
Site Photo	Outfall Photo

Outfall Condition	
Pipe Condition	Average
Rip-Rap Condition	Poor (Consider Repair)
Erosion Condition	Significant Erosion (Consider Repair)
Comments	Smaller pipe fully obstructed with debris

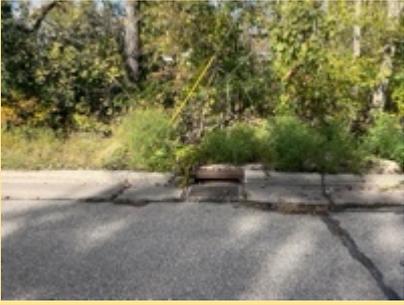
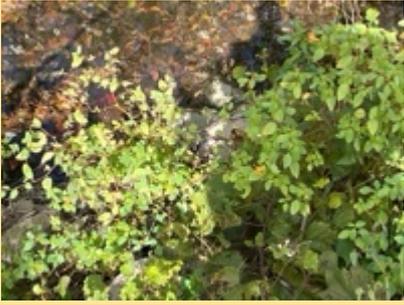
Site Photo	Outfall Photo

Outfall Condition	
Pipe Condition	Average
Rip-Rap Condition	No Rip-Rap Present
Erosion Condition	No Erosion
Comments	Pipe is approx 2' above grade

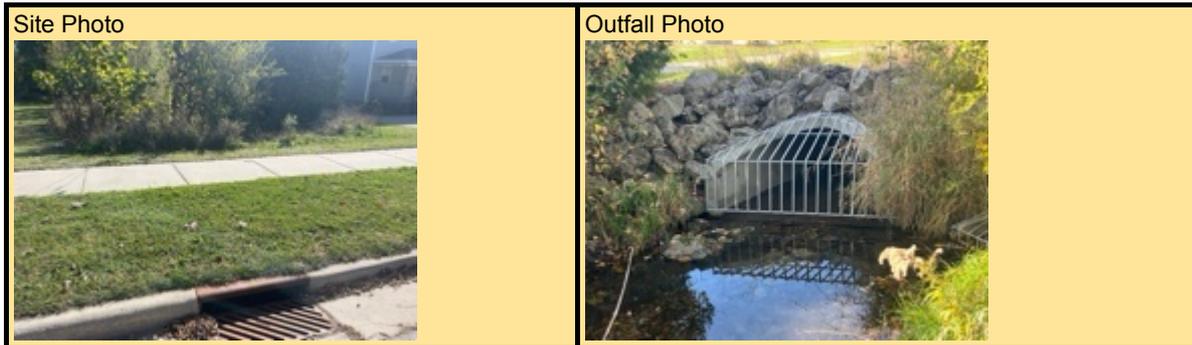
Outfall Condition	
Pipe Condition	Good
Rip-Rap Condition	Average
Erosion Condition	Minor Erosion
Comments

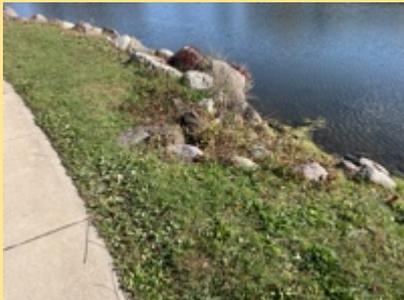
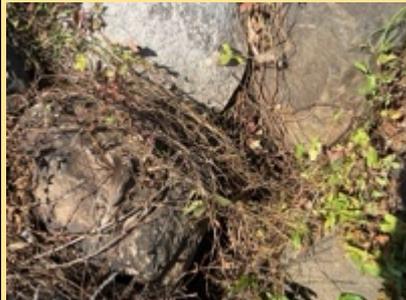
Site Photo

Outfall Condition	
Pipe Condition	Average
Rip-Rap Condition	Average
Erosion Condition	No Erosion
Comments	Pipe partially obstructed by one large stone

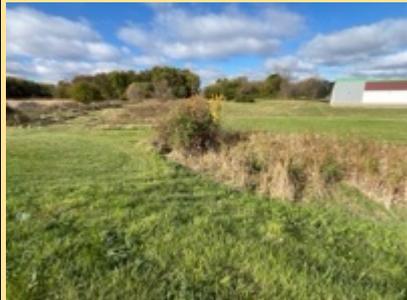
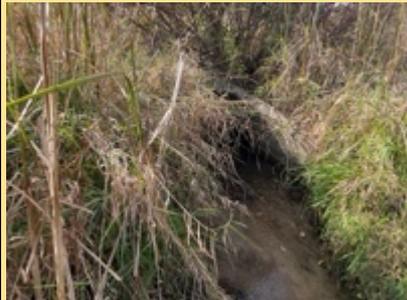
Site Photo	Outfall Photo

Outfall Condition	
Pipe Condition	Average
Rip-Rap Condition	No Rip-Rap Present
Erosion Condition	Minor Erosion
Comments

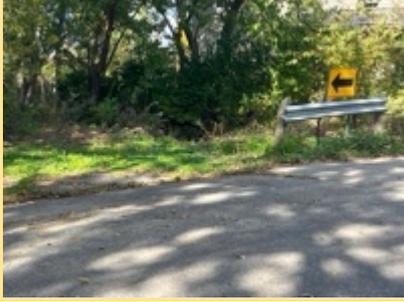
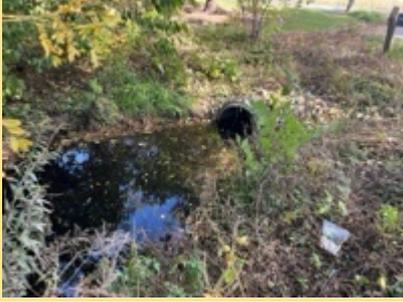
Site Photo	Outfall Photo

Outfall Condition	
Pipe Condition	Average
Rip-Rap Condition	No Rip-Rap Present
Erosion Condition	No Erosion
Comments	Standing water but no flow.

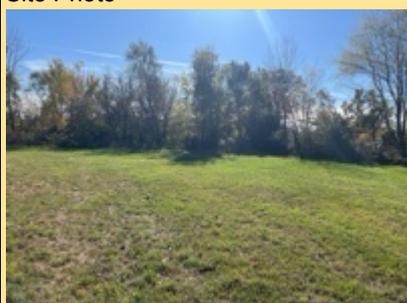
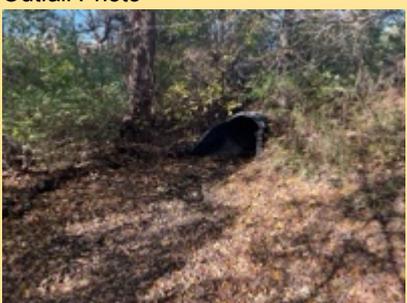
Site Photo	Outfall Photo

Outfall Condition	
Pipe Condition	Average
Rip-Rap Condition	No Rip-Rap Present
Erosion Condition	Minor Erosion
Comments

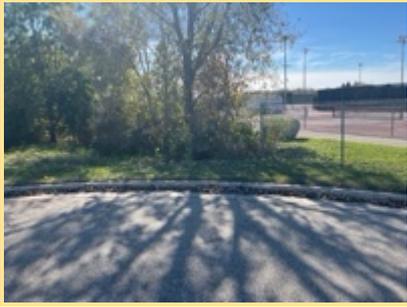
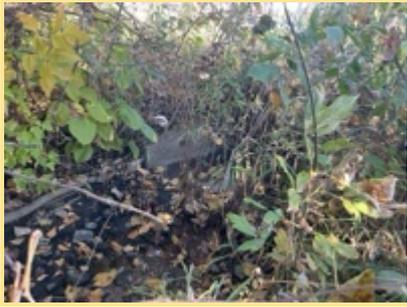
Outfall Condition	
Pipe Condition	Average
Rip-Rap Condition	No Rip-Rap Present
Erosion Condition	Significant Erosion (Consider Repair)
Comments	Downstream ditch is eroded and has significant invasive trees and brush

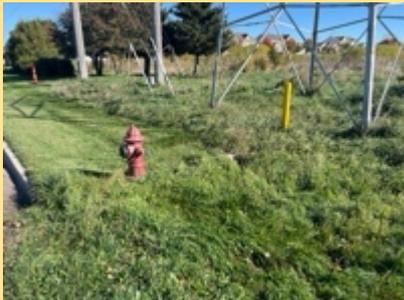
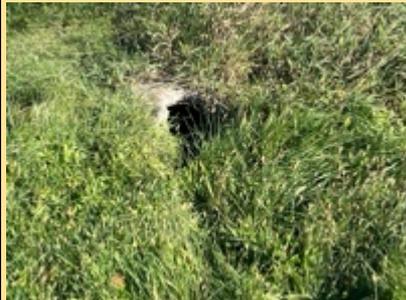
Outfall Condition	
Pipe Condition	Average
Rip-Rap Condition	No Rip-Rap Present
Erosion Condition	No Erosion
Comments

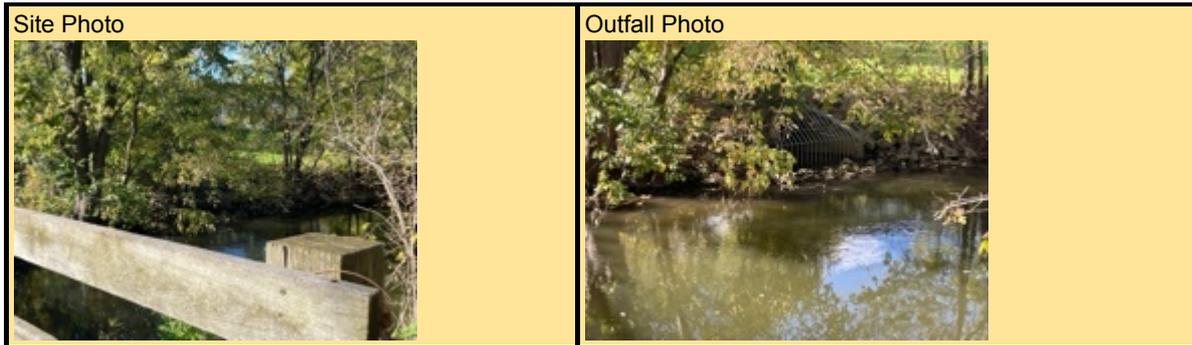
Outfall Condition	
Pipe Condition	Average
Rip-Rap Condition	Average
Erosion Condition	No Erosion
Comments

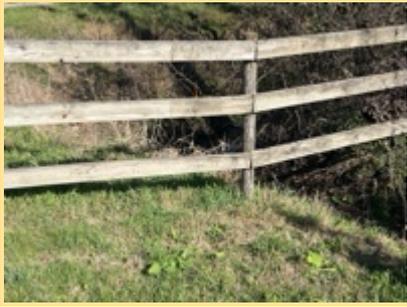
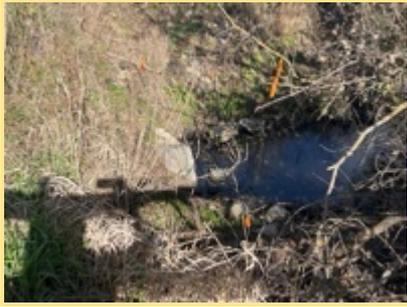
Outfall Condition	
Pipe Condition	Average
Rip-Rap Condition	Average
Erosion Condition	No Erosion
Comments

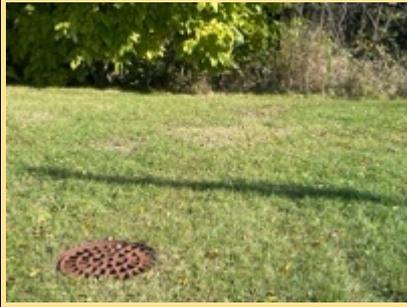
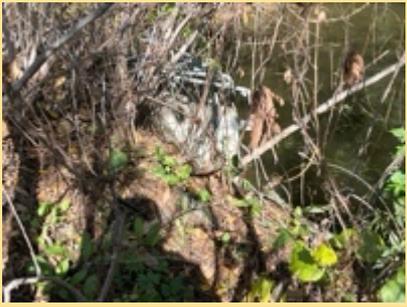
Outfall Condition	
Pipe Condition	Average
Rip-Rap Condition	No Rip-Rap Present
Erosion Condition	No Erosion
Comments

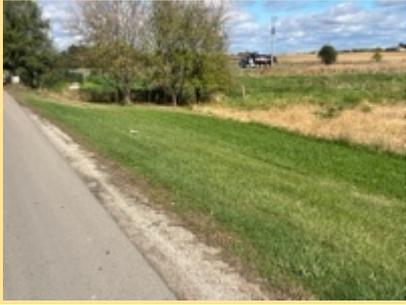
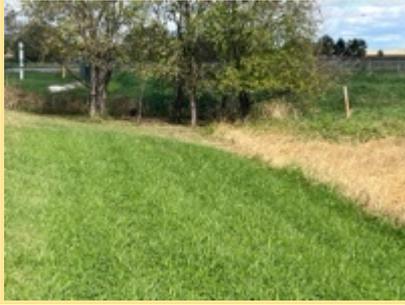
Outfall Condition	
Pipe Condition	No Pipe Present
Rip-Rap Condition	No Rip-Rap Present
Erosion Condition	No Erosion
Comments

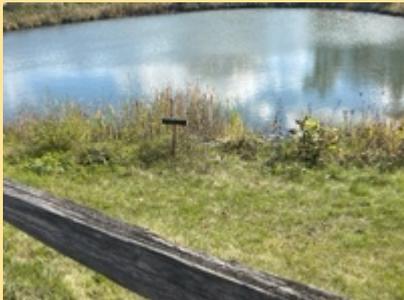
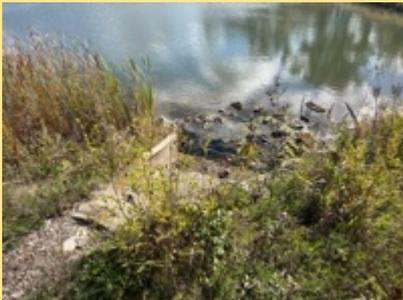
Outfall Condition	
Pipe Condition	Average
Rip-Rap Condition	Average
Erosion Condition	No Erosion
Comments

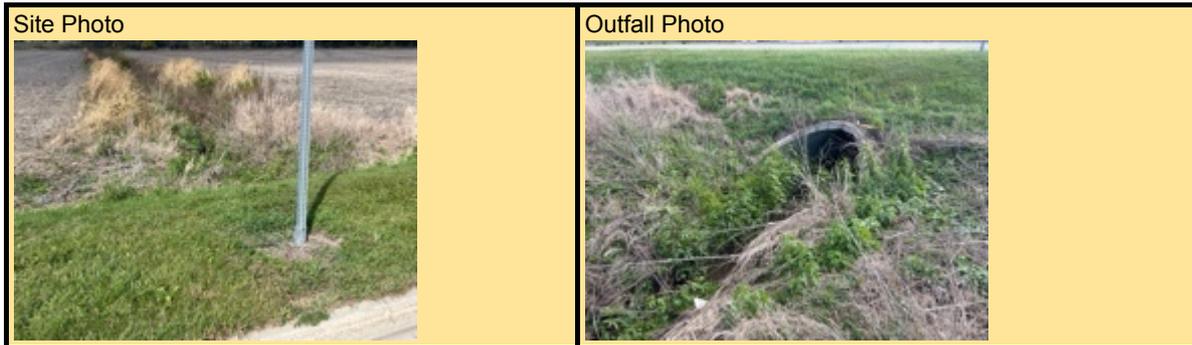
Outfall Condition	
Pipe Condition	Average
Rip-Rap Condition	No Rip-Rap Present
Erosion Condition	Minor Erosion
Comments

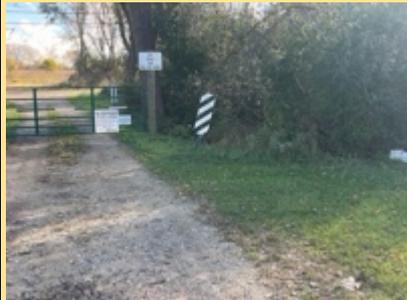
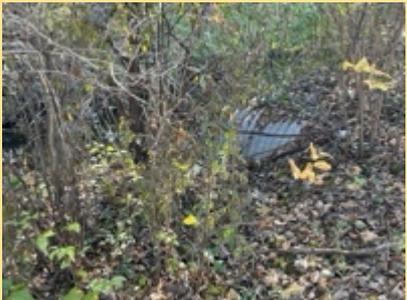
Outfall Condition	
Pipe Condition	Average
Rip-Rap Condition	No Rip-Rap Present
Erosion Condition	Minor Erosion
Comments

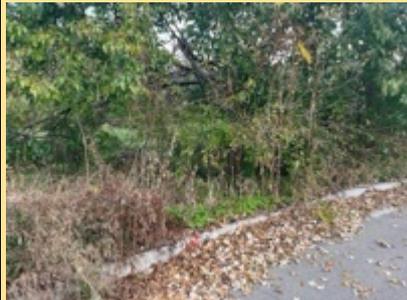
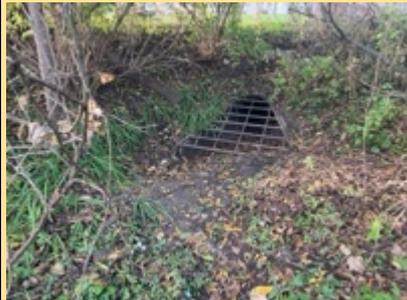
Outfall Condition	
Pipe Condition	Average
Rip-Rap Condition	No Rip-Rap Present
Erosion Condition	Heavy Accumulated Sediment (Consider Repair)
Comments	Significant sediment build up just beyond end of pipe.

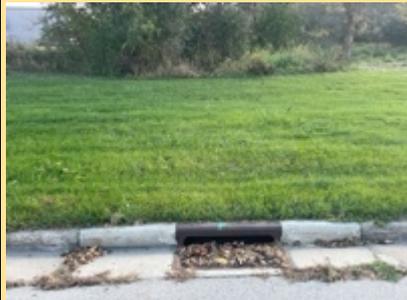
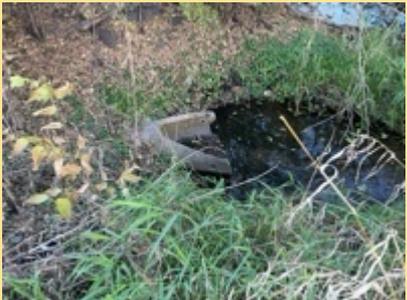
Outfall Condition	
Pipe Condition	Average
Rip-Rap Condition	No Rip-Rap Present
Erosion Condition	Significant Erosion (Consider Repair)
Comments

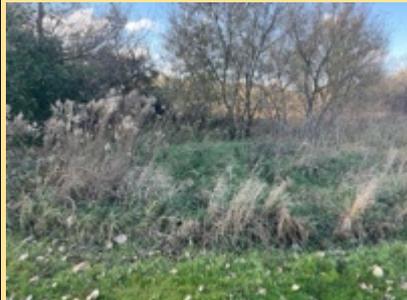
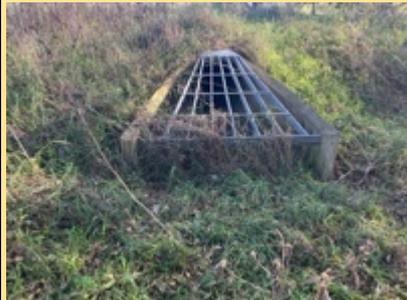
Outfall Condition	
Pipe Condition	Average
Rip-Rap Condition	No Rip-Rap Present
Erosion Condition	No Erosion
Comments

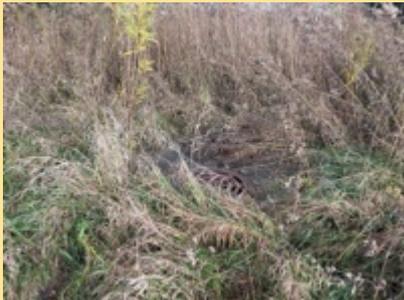
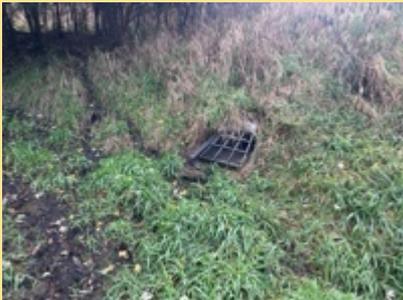
Outfall Condition	
Pipe Condition	Average
Rip-Rap Condition	No Rip-Rap Present
Erosion Condition	No Erosion
Comments

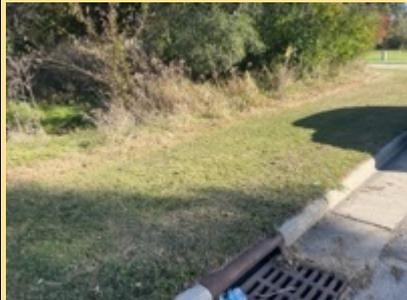
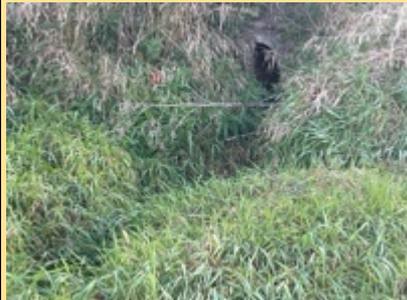
Outfall Condition	
Pipe Condition	Average
Rip-Rap Condition	No Rip-Rap Present
Erosion Condition	Significant Erosion (Consider Repair)
Comments

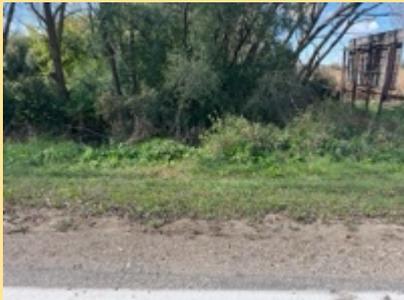
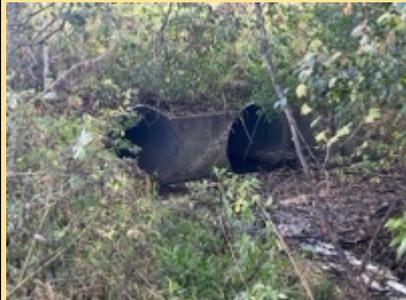
Outfall Condition	
Pipe Condition	Average
Rip-Rap Condition	No Rip-Rap Present
Erosion Condition	No Erosion
Comments

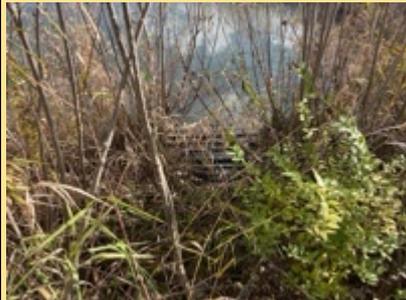
Outfall Condition	
Pipe Condition	Average
Rip-Rap Condition	No Rip-Rap Present
Erosion Condition	No Erosion
Comments	Partially submerged

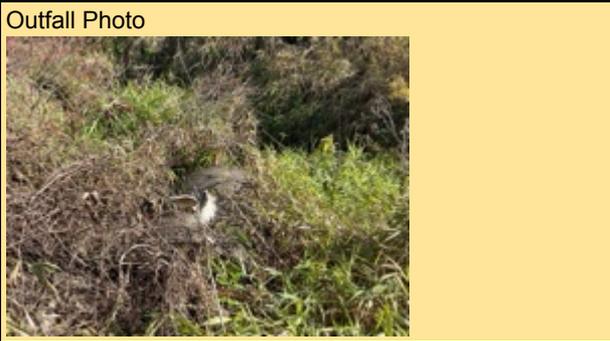
Outfall Condition	
Pipe Condition	Average
Rip-Rap Condition	Average
Erosion Condition	No Erosion
Comments

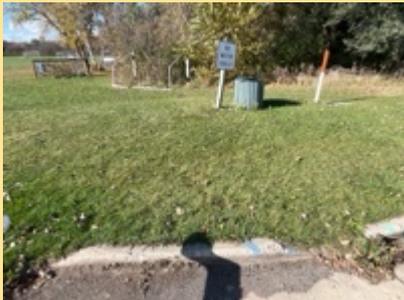
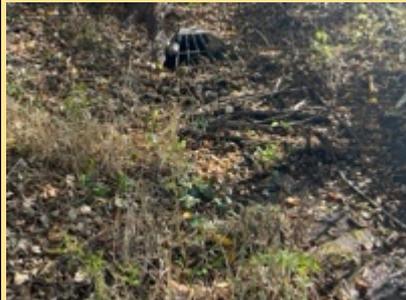
Outfall Condition	
Pipe Condition	Average
Rip-Rap Condition	Poor (Consider Repair)
Erosion Condition	Accumulated Sediment
Comments	Minor accumulated sediment in pipe and erosion in downstream swale.

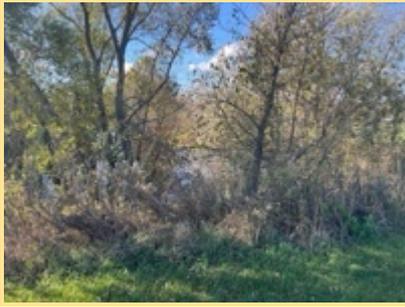
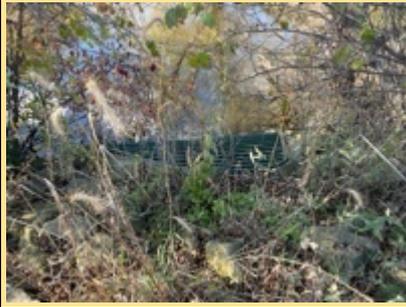
Outfall Condition	
Pipe Condition	Average
Rip-Rap Condition	Average
Erosion Condition	No Erosion
Comments	Not an MS4 outfall.

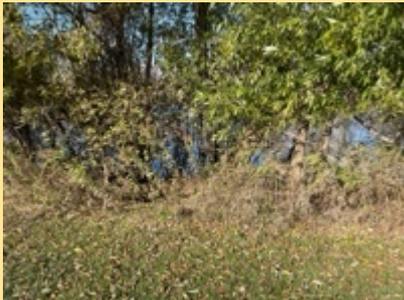
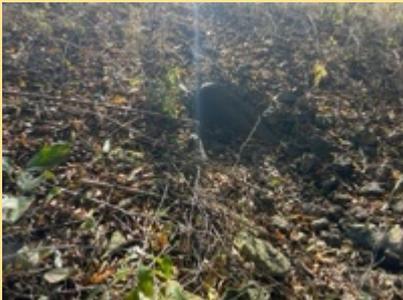
Outfall Condition	
Pipe Condition	Average
Rip-Rap Condition	Average
Erosion Condition	No Erosion
Comments	Invasive brush obstructing flow beyond end section. Not an MS4 outfall.

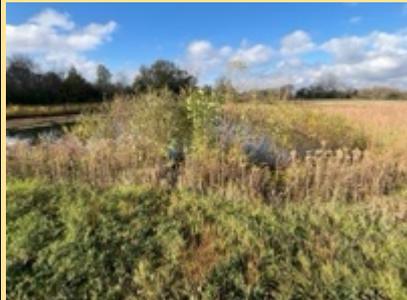
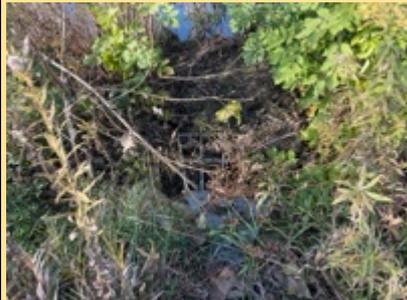
Outfall Condition	
Pipe Condition	Average
Rip-Rap Condition	No Rip-Rap Present
Erosion Condition	Accumulated Sediment
Comments	Invasive brush beginning to obstruct flow. Not an MS4 outfall.

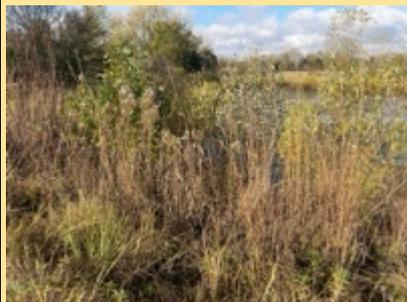
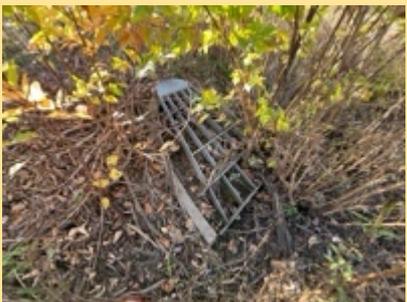
Outfall Condition	
Pipe Condition	Average
Rip-Rap Condition	No Rip-Rap Present
Erosion Condition	Heavy Accumulated Sediment (Consider Repair)
Comments	End section 30% obstructed with debris. Invasive brush blocking flow. Not an MS4 outfall.

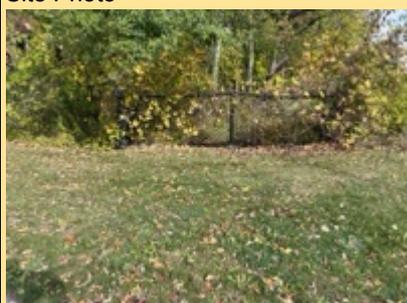
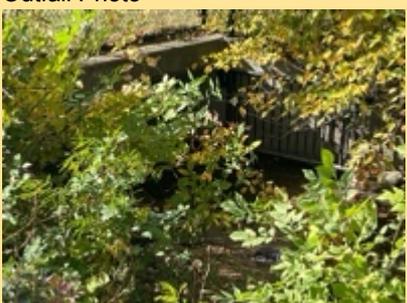
Outfall Condition	
Pipe Condition	Good
Rip-Rap Condition	No Rip-Rap Present
Erosion Condition	Minor Erosion
Comments	Standing water but no active flow

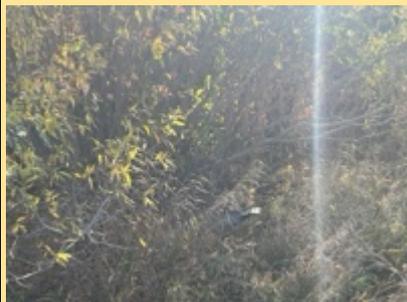
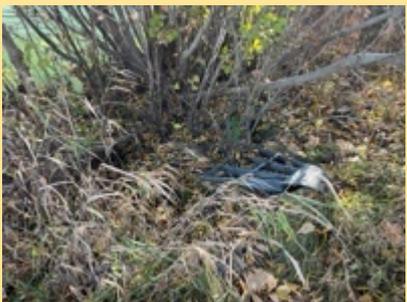
Outfall Condition	
Pipe Condition	Average
Rip-Rap Condition	Poor (Consider Repair)
Erosion Condition	Heavy Accumulated Sediment (Consider Repair)
Comments	Pipe 75%obstructed with debris and flow blocked by invasive brush. Not an MS4 outfall.

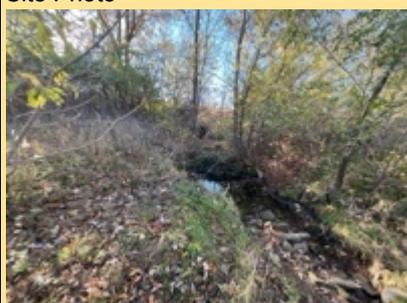
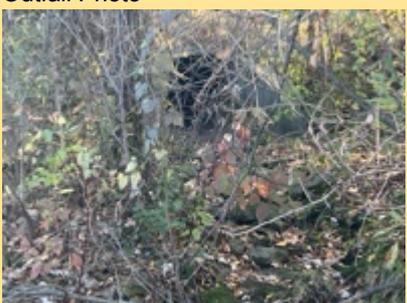
Outfall Condition	
Pipe Condition	Poor (Consider Repair)
Rip-Rap Condition	Poor (Consider Repair)
Erosion Condition	Significant Erosion (Consider Repair)
Comments	Significant erosion with sediment transport into pond. Not an MS4 outfall.

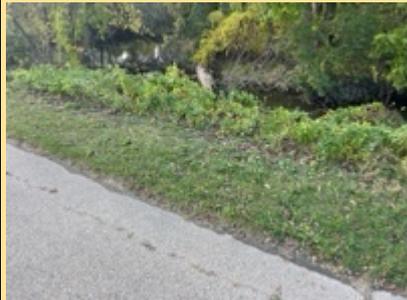
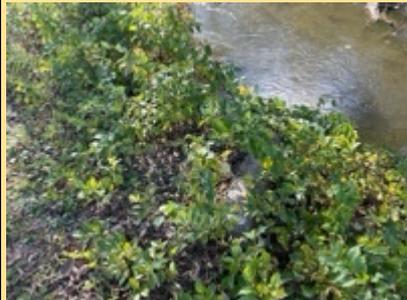
Outfall Condition	
Pipe Condition	Average
Rip-Rap Condition	No Rip-Rap Present
Erosion Condition	No Erosion
Comments

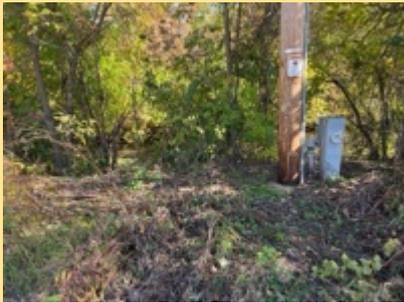
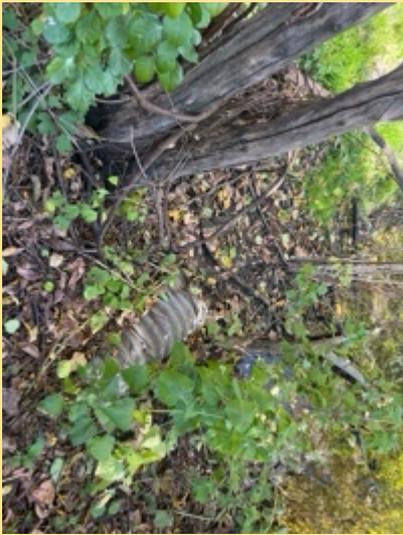
Outfall Condition	
Pipe Condition	Average
Rip-Rap Condition	No Rip-Rap Present
Erosion Condition	No Erosion
Comments

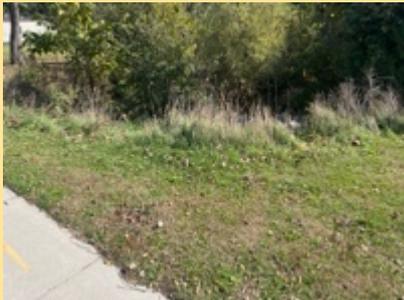
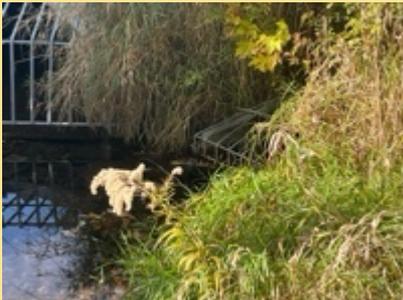
Outfall Condition	
Pipe Condition	Good
Rip-Rap Condition	Average
Erosion Condition	Minor Erosion
Comments

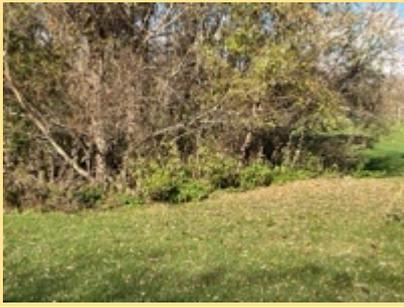
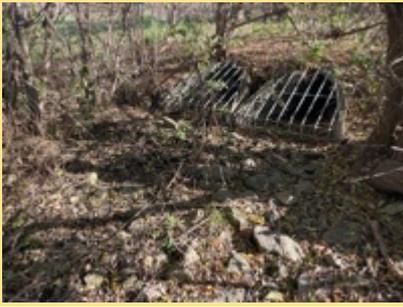
Outfall Condition	
Pipe Condition	Average
Rip-Rap Condition	Average
Erosion Condition	No Erosion
Comments

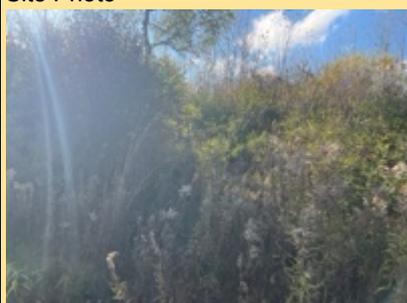
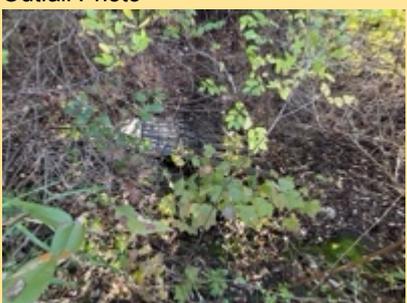
Outfall Condition	
Pipe Condition	Average
Rip-Rap Condition	No Rip-Rap Present
Erosion Condition	No Erosion
Comments

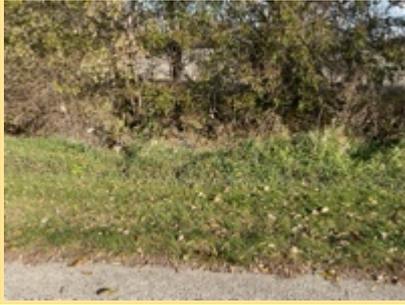
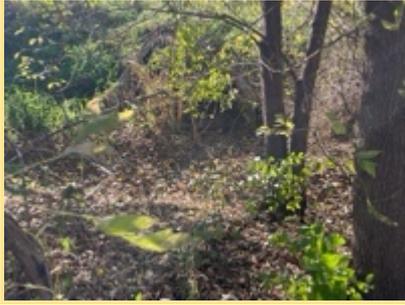
Outfall Condition	
Pipe Condition	Average
Rip-Rap Condition	No Rip-Rap Present
Erosion Condition	Minor Erosion
Comments

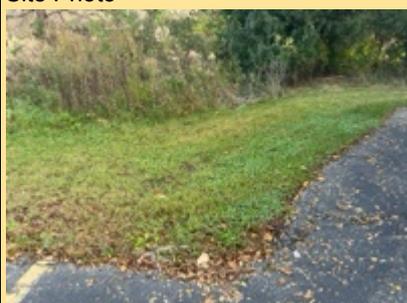
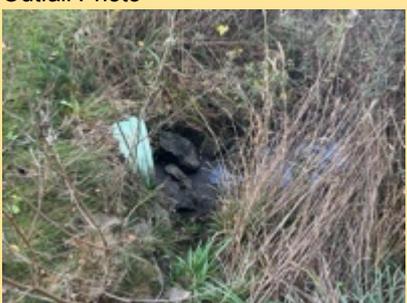
Outfall Condition	
Pipe Condition	Average
Rip-Rap Condition	Average
Erosion Condition	Minor Erosion
Comments
