Starin Park Water Tower Structural Analysis Report

Project Address: 504 W. Starin Road
Whitewater, WI 53190

Prepared by: McEnroe Consulting Engineers, LLC
Eileen McEnroe Hankes, P.E.

Date: January 5, 2023

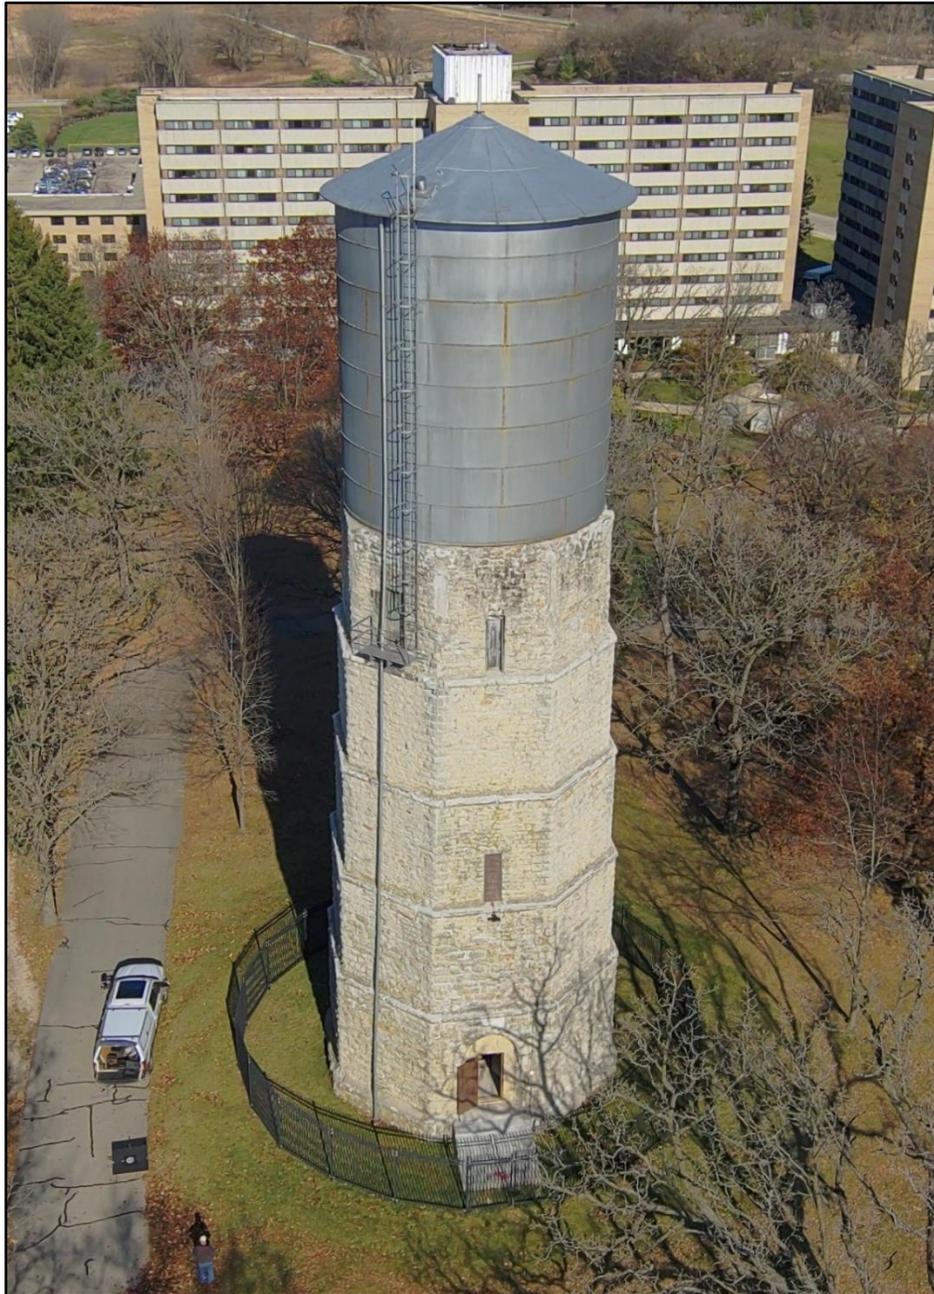
Photo 1: Starin Park Water Tower

The structure is approximately 100 feet tall with a masonry base and steel tank (Photo 1). It was constructed in 1889 and has been a functioning water tank since that time. It was decommissioned in late 2022 and the water was removed from the tank as of December 14, 2022. The structure is comprised of a 70 foot tall masonry structure with a 30 foot tall, 185,000 gallon, cylindrical steel tank at the top.

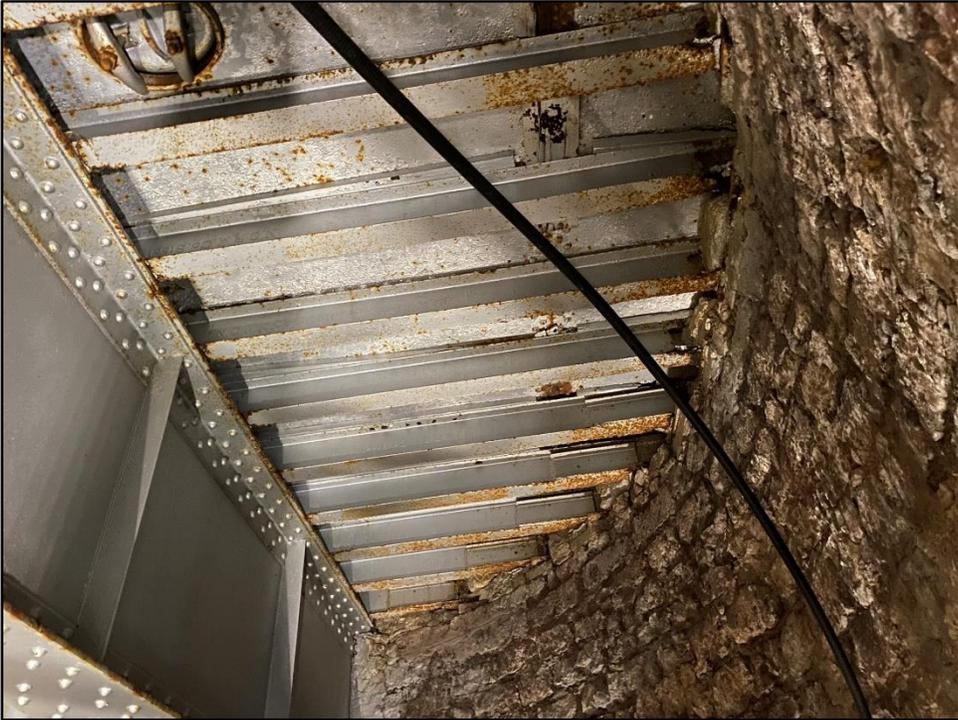
Photo 2: Steel beams below tank

The steel tank is placed on a series of I beams spanning over the water tower and bearing on the masonry walls (Photo 2). There are two large plate girders that support the small beams (Photo 3). There is also a floor system below the plate girders that is comprised of steel beams and wood planks (Photos 4 and 5).

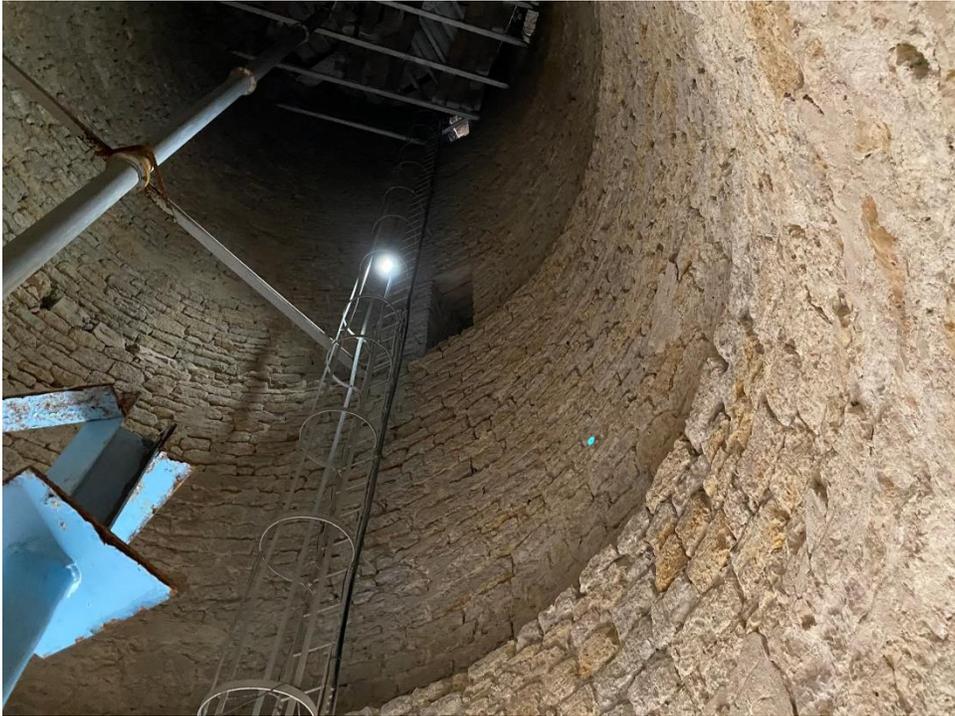
Photo 6: Ladder inside masonry tower

The structure is accessed by a ladder and cage on the interior wall that extends to the floor below the plate girders (Photo 6). There is a door through the masonry at that level that leads to a platform cantilevered off the masonry (Photo 7). A second steel ladder and cage run up the masonry and steel tank from the platform to the roof (Photos 8 and 9).
