Subject: Request for Approval for Retaining wall.

I hope this message finds you well. I am writing to request for variance, to construct a retaining wall within the utility easement located at 3201 Trailing Vines Bnd Wylie TX 75098.

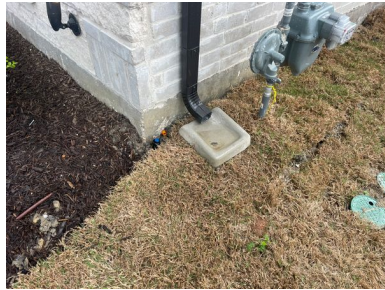
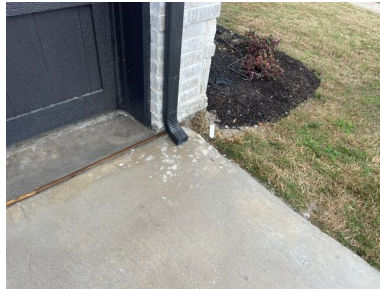
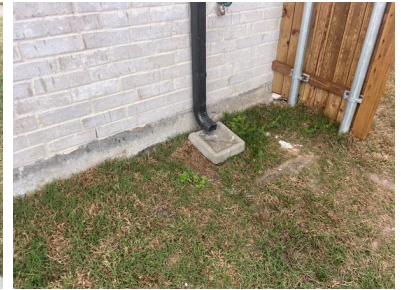
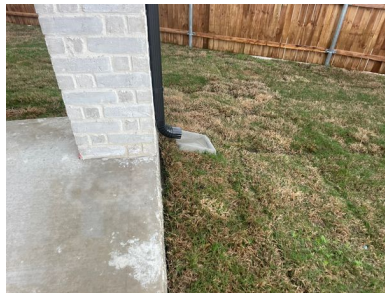
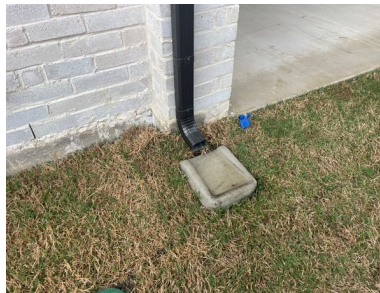
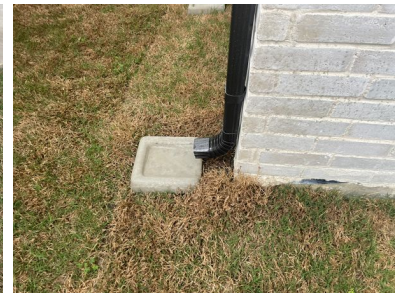
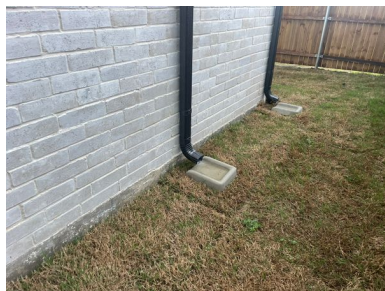
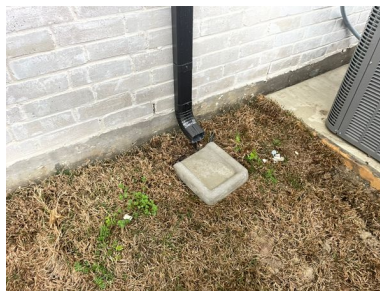
2: Steep Grading

The grade is excessively steep in areas around the home. This can lead to erosion and the soil around the home should be monitored.

Recommendation: Recommend monitoring.

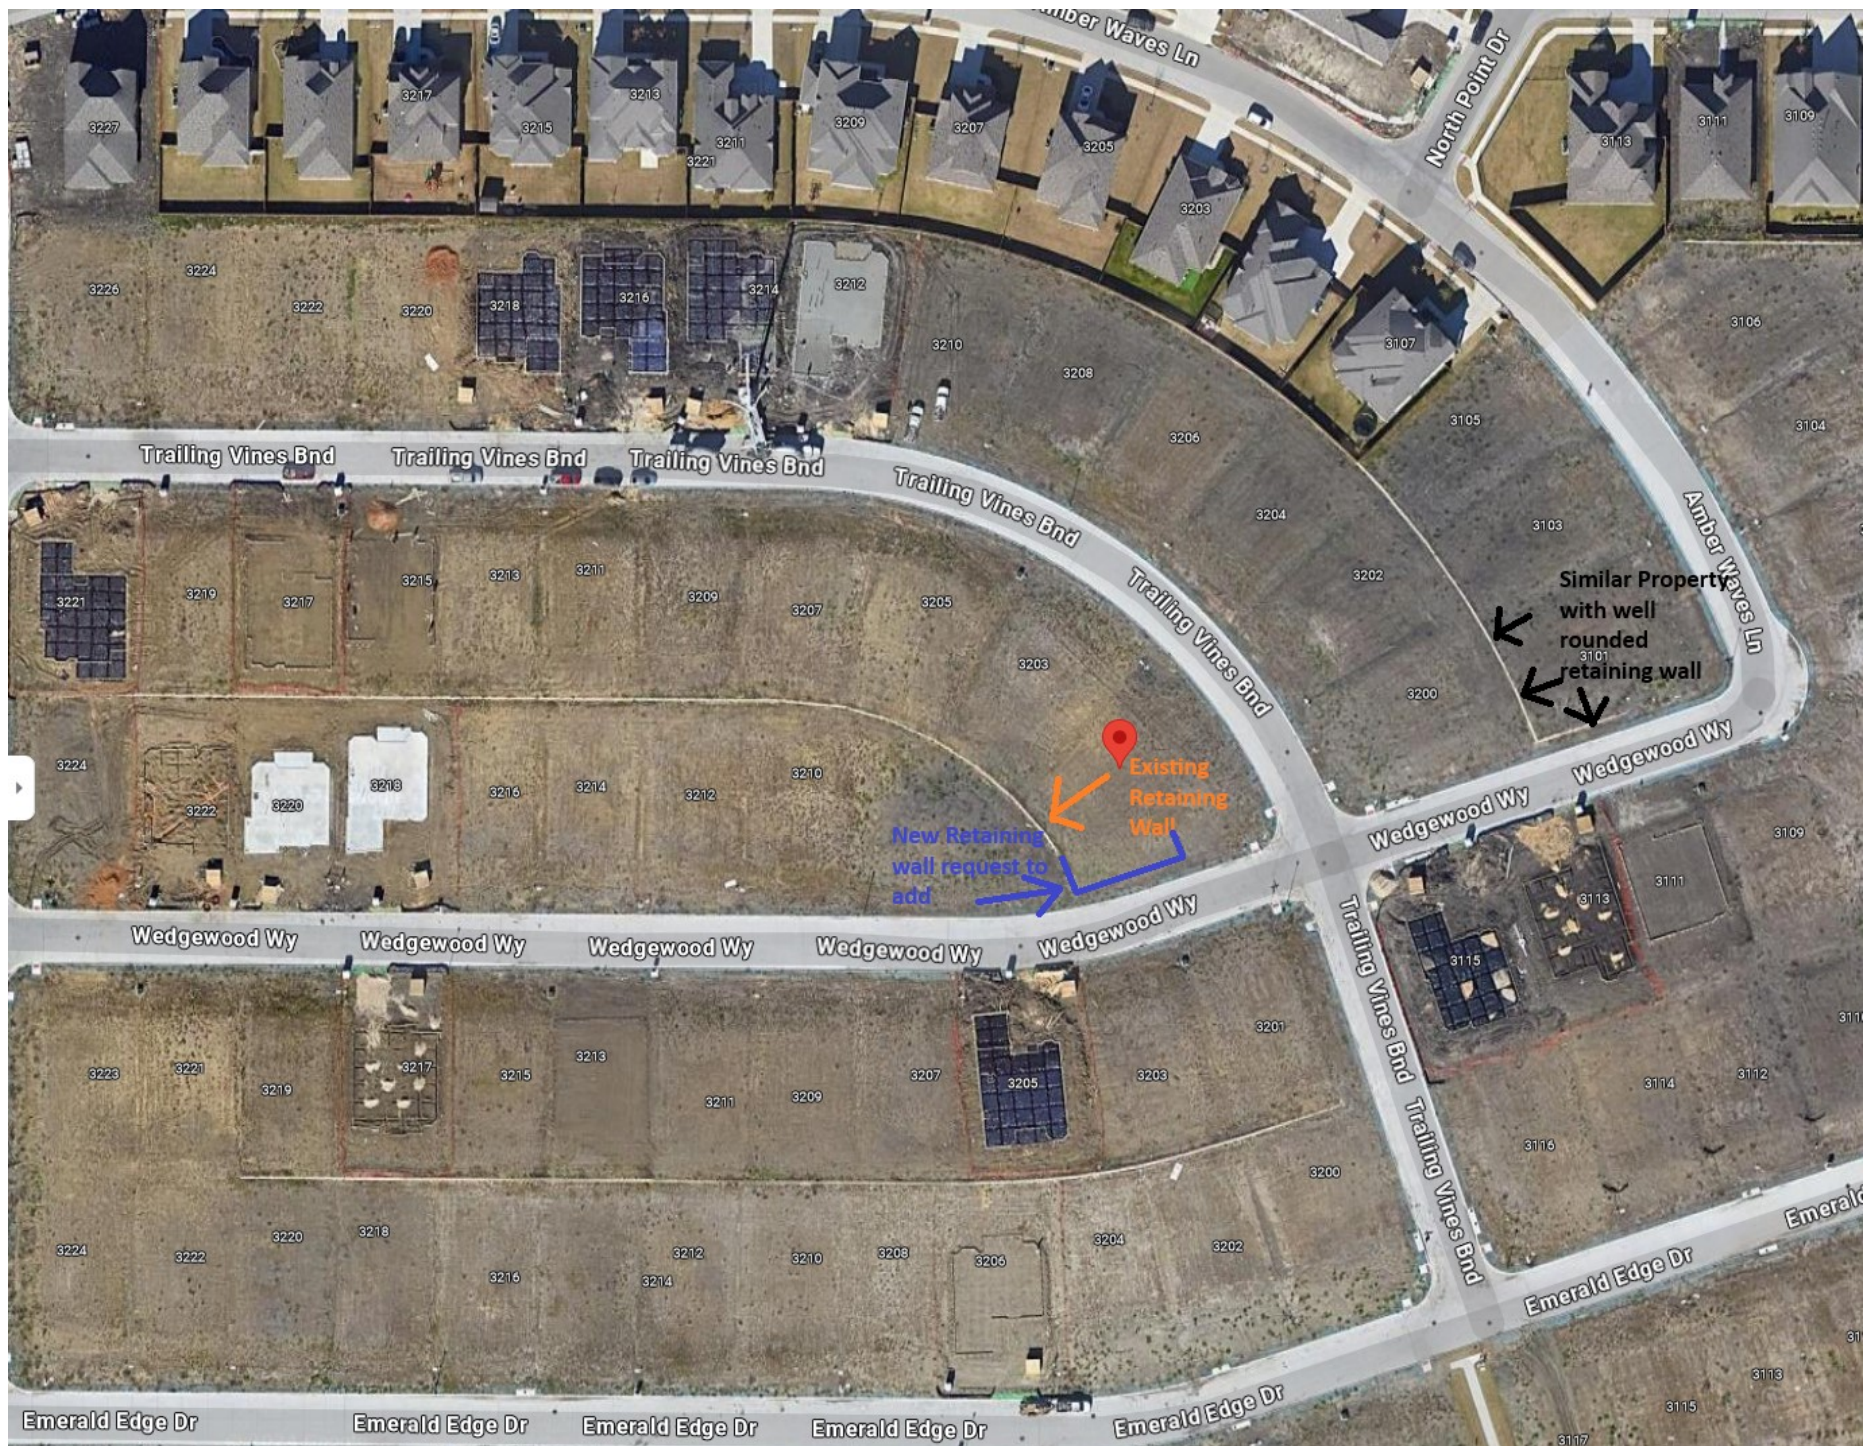
Rise:

30

Run:

127

0.2362

23.62%

13.29°
