# Bladensburg Flood Reduction Preliminary Design Report

October 2025

## Flood Reduction Preliminary Design Report

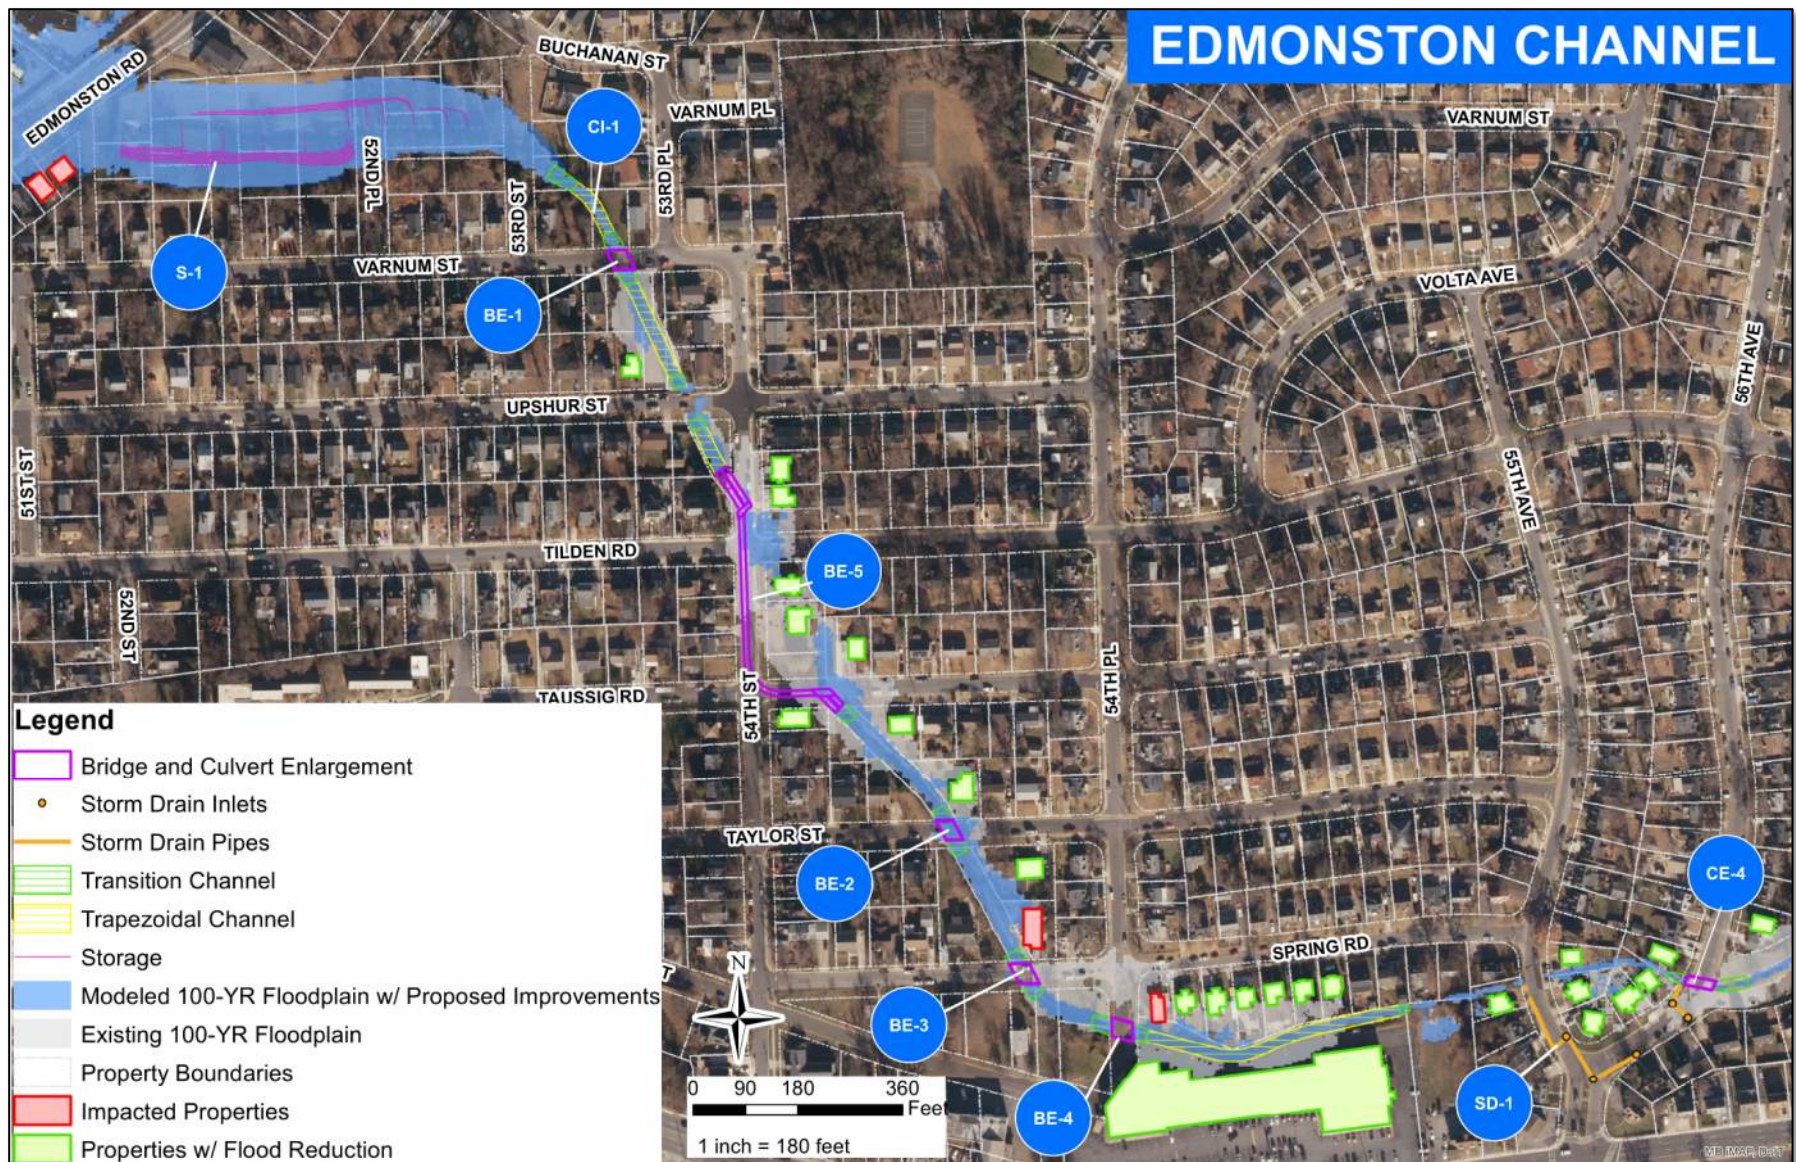
Figure ES-1 Recommended Flood Reduction Improvements for Edmonston Channel

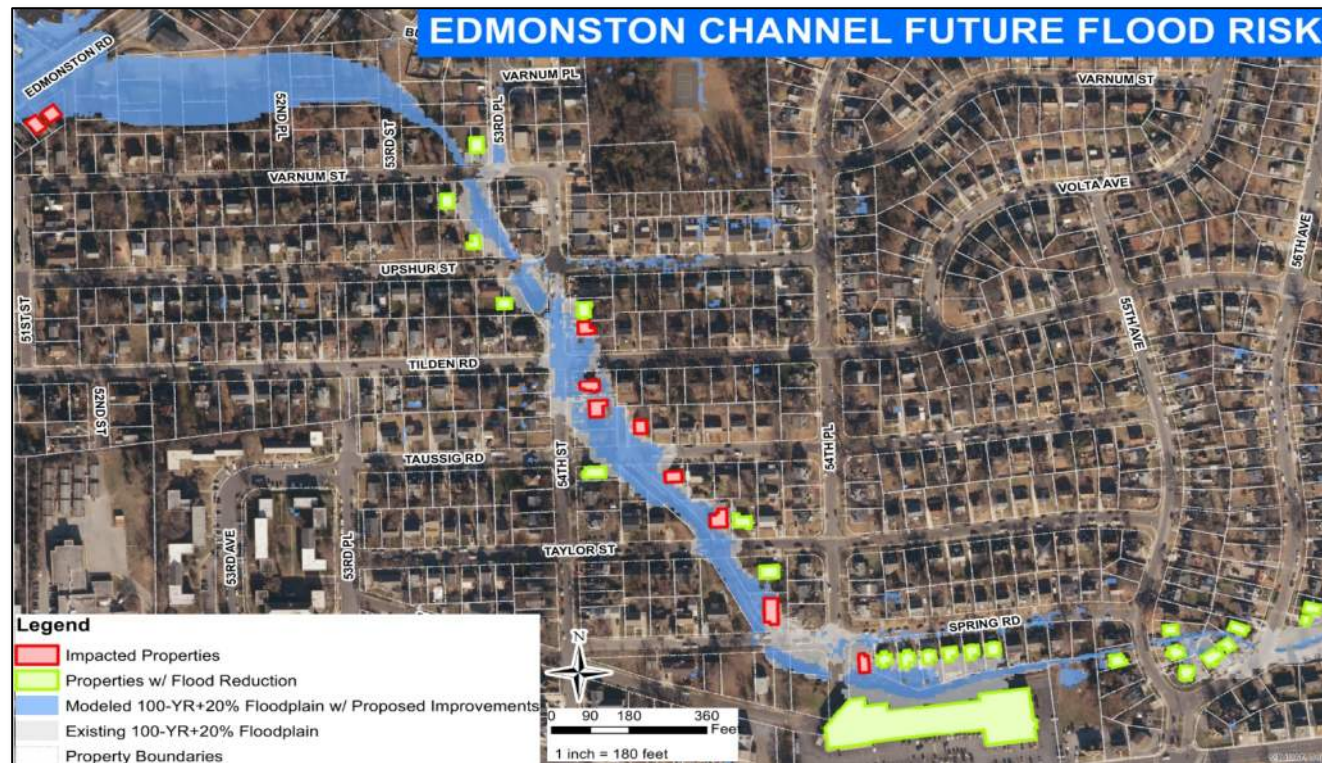
Figure 2-1 Edmonston Channel 100-yr + 20% Flood Risk

To assess future storm impacts on the Edmonston Channel, the 100-year, 24-hr NOAA Atlas 14 precipitation data was increased by 20%. This strategy was implemented in lieu of using NOAA Atlas 15 data which has yet to be released. Under the 100-yr + 20% conditions, 34 structures are projected to be impacted. This is five more than under the existing 100-yr storm event. Implementing the proposed improvements under the 100-yr + 20% conditions would reduce the flood risk for 24 of the 34 structures. Most of the impacted structures are located between Tilden Rd. and Taylor St. therefore, further improving the capacity of the Taussig Culvert (BE-5) and Taylor St. bridge (BE-2) would reduce the flooding risk in this area. Additionally, the weir control structure at Edmonston Rd. would require further improvements to ensure that no adverse downstream impacts occur. Figure 2-1 presents the 100-yr + 20% floodplain during existing and proposed conditions and highlights the impacted structures.

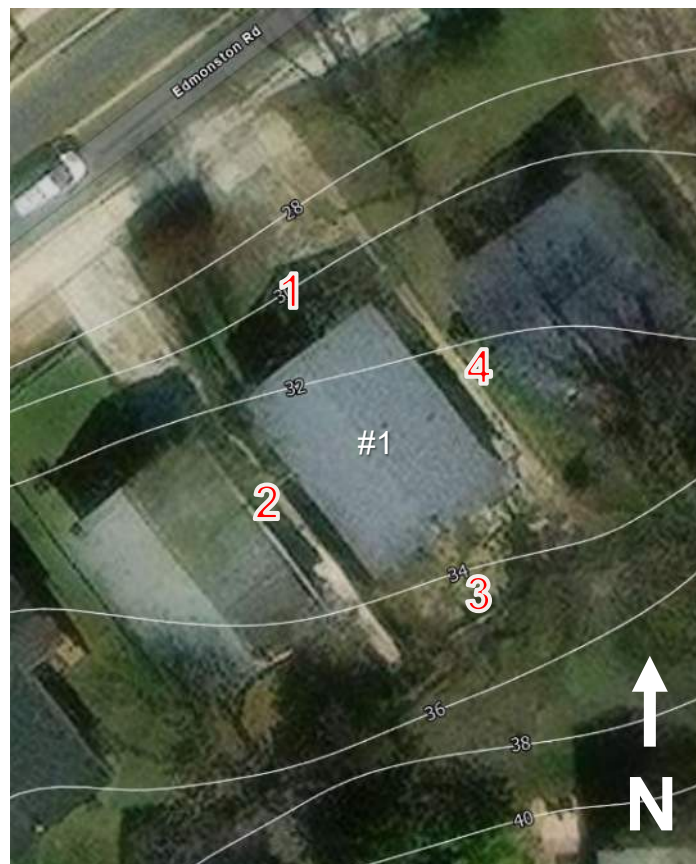
*Figure 2.1.1.1 Property #1: Aerial view with elevation contours and photo numbering*

The property at 4319 Edmonston Road consists of a one-story building with a first-floor entrance on the northwest side and a lowest floor (basement) entrance on the northeast side. Basement windows are located at the northwest (front), northeast, and southwest sides of the building. There are several wall penetrations, such as a hose bib, dryer vent, and electrical panel. The HVAC unit is located at grade level on the southeast (back) side of the building. Figure 2.1.1.1 below provides an aerial view of the home with topographic elevation contours, and is further depicted in Figure 2.1.1.2, Figure 2.1.1.3, Figure 2.1.1.4, and Figure 2.1.1.5

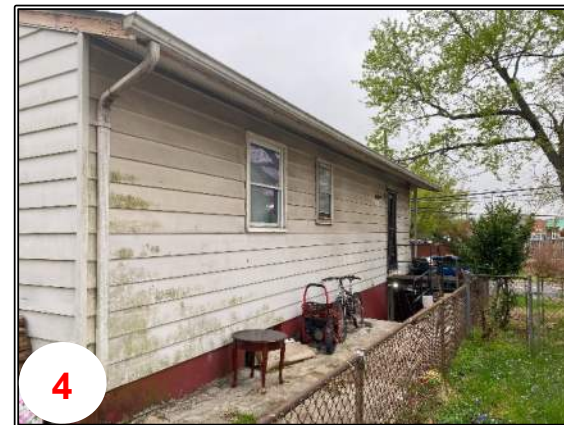
Figure 2.1.1.5 Property #1: Side (northeast side) with side door above and basement door below

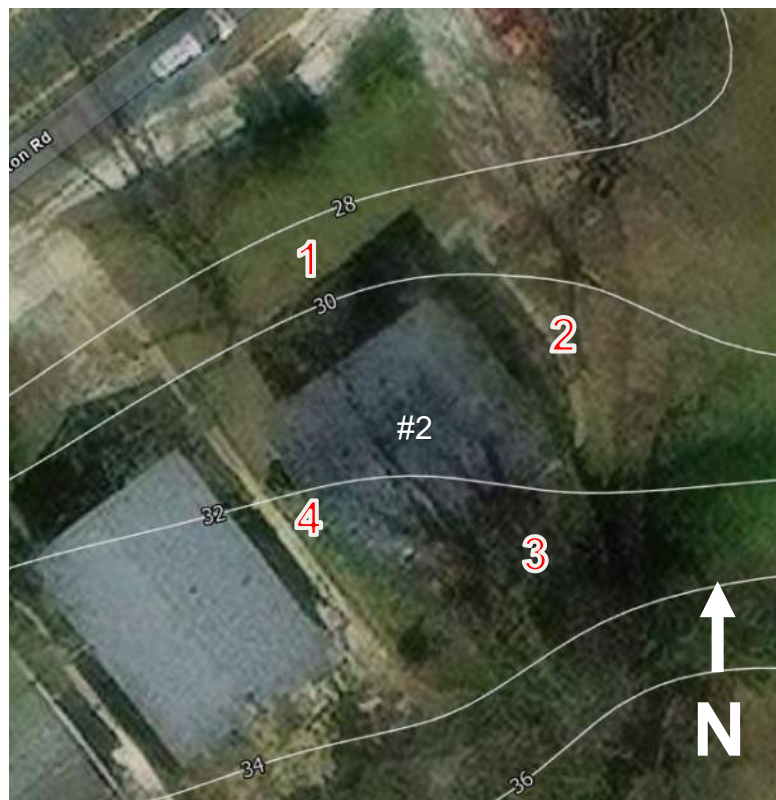
*Figure 2.2.1.1 Property #2: Aerial view with elevation contours and photo numbering*

The property at 4321 Edmonston Road consists of a split-level building with the front door on the northwest side and ground floor entrance on the southeast side (back). The grade slopes from the backyard towards the front of the house. There are four ground floor windows at the northwest (front) side of the building near grade level. There is an additional window on the back (southeast) side and one on the southwest side of the building, both above grade. The HVAC unit is roughly at grade level on the southwest side of the building. Figure 2.2.1.1 below provides an aerial view of the home with topographic elevation contours, and is further depicted in Figure 2.2.1.2, Figure 2.2.1.3, Figure 2.2.1.4, and Figure 2.2.1.5.

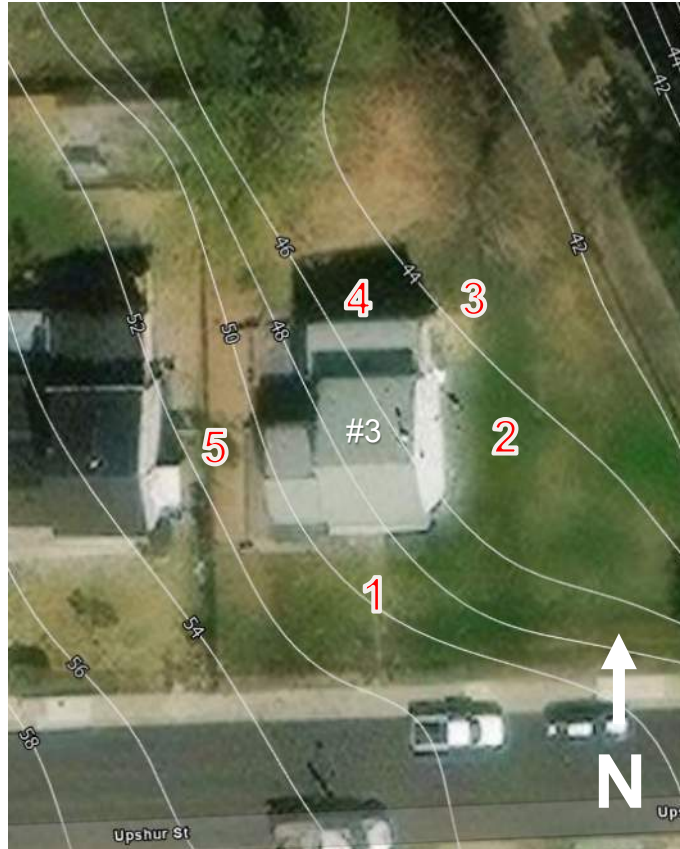
*Figure 2.3.1.1 Property #3: Aerial view with elevation contours and photo numbering*

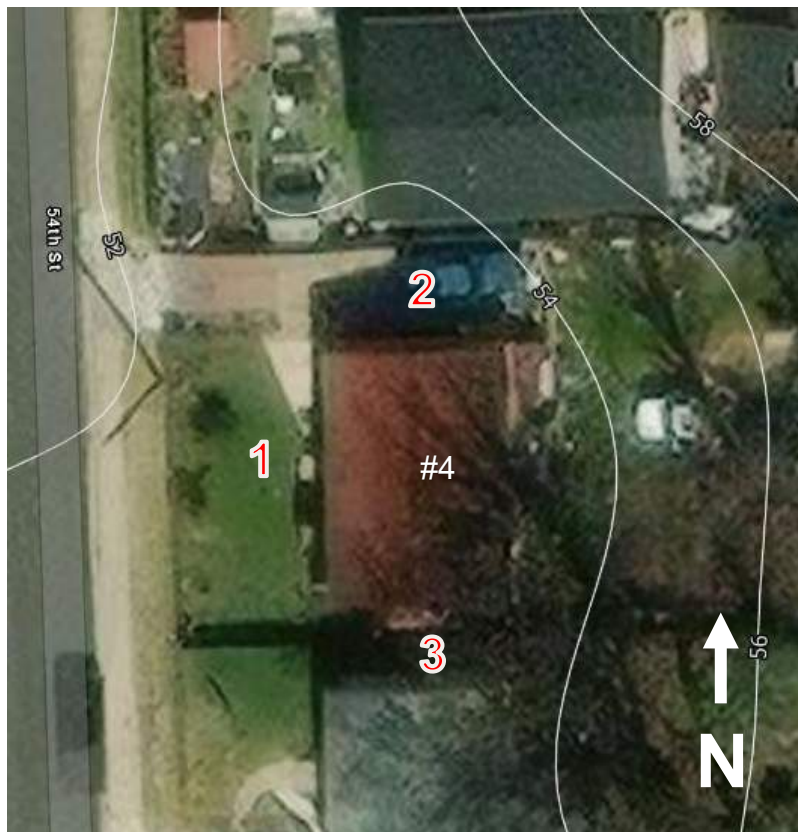
*Figure 2.4.1.1 Property #4: Aerial view with elevation contours and photo numbering*

The property at 4305 54<sup>th</sup> Street consists of a one-story building with a basement. The basement has a newly installed sump pump system that does not include a battery power backup. According to the homeowner, the sump pump was provided by the local government and drains directly into the Edmonston Channel. The building has a front door elevated at the top of a stair landing on the front (west) side, while a side door is positioned near grade level on the south side. There are two basement windows near grade level with one located on the west side and one on the north side. There is also an electrical panel on the north side of the house positioned a few feet above grade. Figure 2.4.1.1 below provides an aerial view of the home with topographic elevation contours, and the property is further depicted in Figure 2.4.1.2, Figure 2.4.1.3, and Figure 2.4.1.4. Only three sides of the home were photographed as the homeowner did not grant access to the backyard of the property.

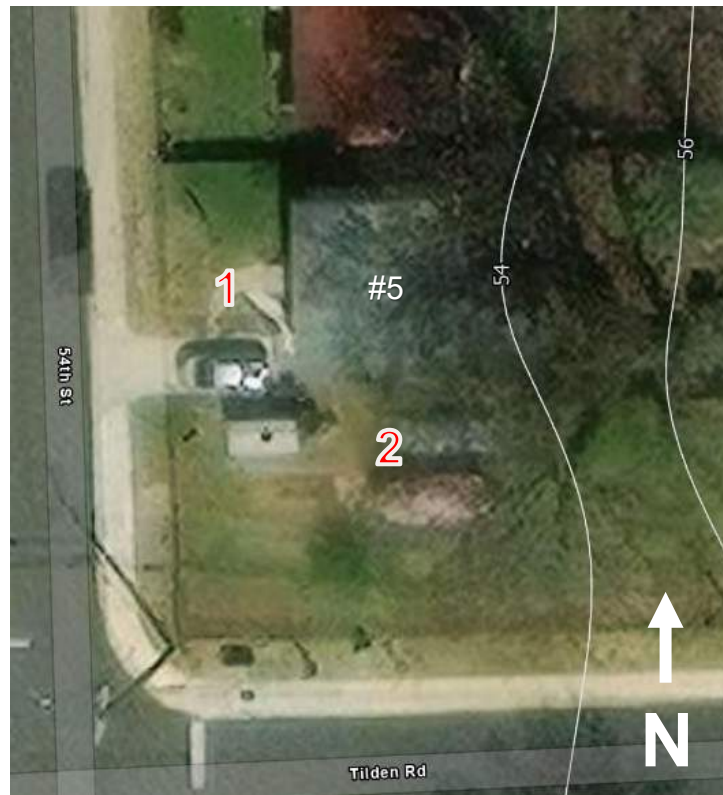
*Figure 2.5.1.1 Property #5: Aerial view with elevation contours and photo numbering*

The property at 4303 54<sup>th</sup> Street consists of a one-story building with a basement and sump pump. The building has a front door elevated at the top of a stair landing on the front (west) side, while a side door to the building is positioned near grade level on the south side. The building has two basement windows and a hose bib on the front (west) side. A dryer vent penetrates the basement wall approximately 6 inches above grade at the south side. The HVAC unit is located at grade at the southeast corner. Figure 2.5.1.1 below provides an aerial view of the home with topographic elevation contours and the property is further depicted in Figure 2.5.1.2 and Figure 2.5.1.3.

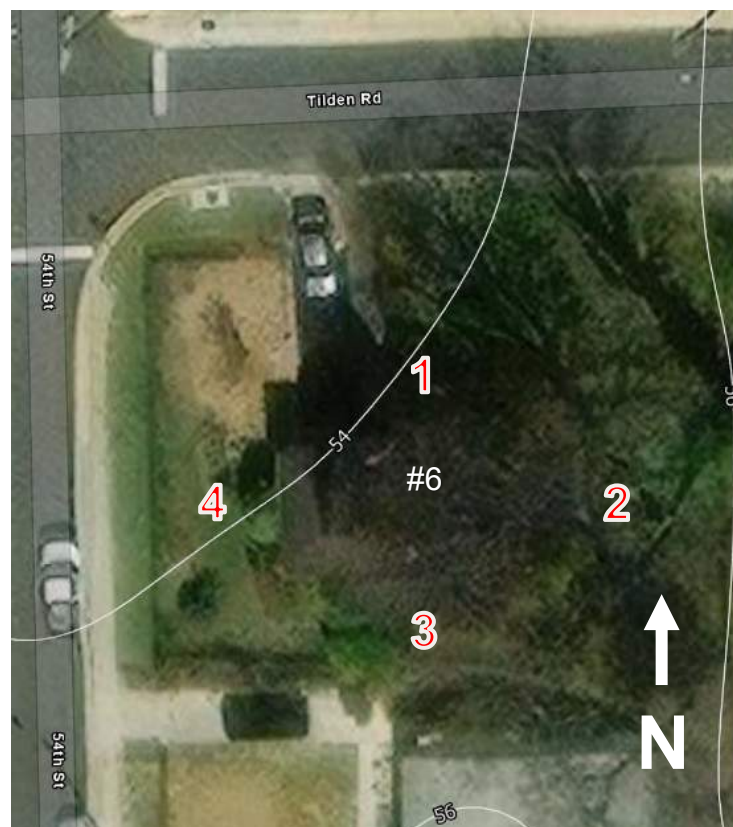
*Figure 2.6.1.1 Property #6: Aerial view with elevation contours and photo numbering*

The property at 5401 Tilden Road consists of a structural brick building with a garage and basement. Stairs at the front (north) of the house lead up to an elevated front entrance landing. The driveway slopes downward from the road to the garage door at the basement level. The garage door is more than a foot below the top of the driveway. There is a trench drain in front of the garage door. Basement windows are located near grade level at each side of the building. The building has several wall penetrations for cable penetrations, a hose bib, a dryer vent, and an electric meter. Each of these penetrations is more than 18 inches above grade. The HVAC unit is at grade along the back (south) side. Figure 2.6.1.1 below provides an aerial view of the home with topographic elevation contours, and the property is further depicted in Figure 2.6.1.2, Figure 2.6.1.3, Figure 2.6.1.4, and Figure 2.6.1.5.

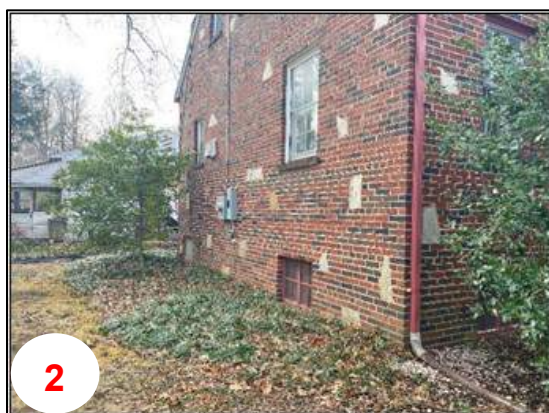
Figure 2.6.1.3 Property #6: Side (east side)

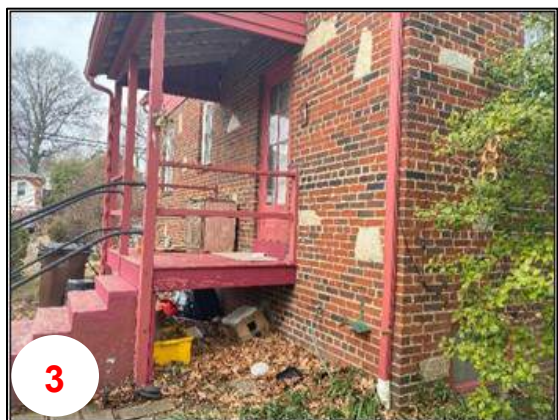
Figure 2.6.1.4 Property #6: Back side (south side)

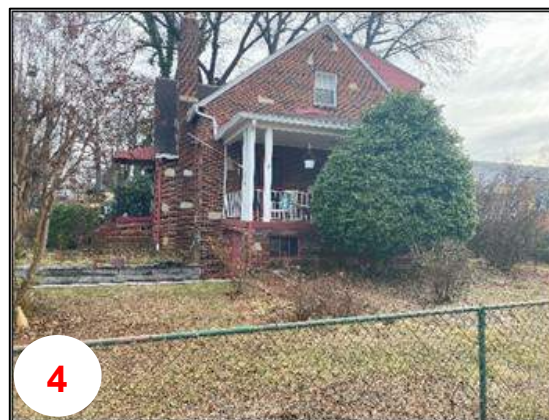
Figure 2.6.1.5 Property #6: Side (west side)

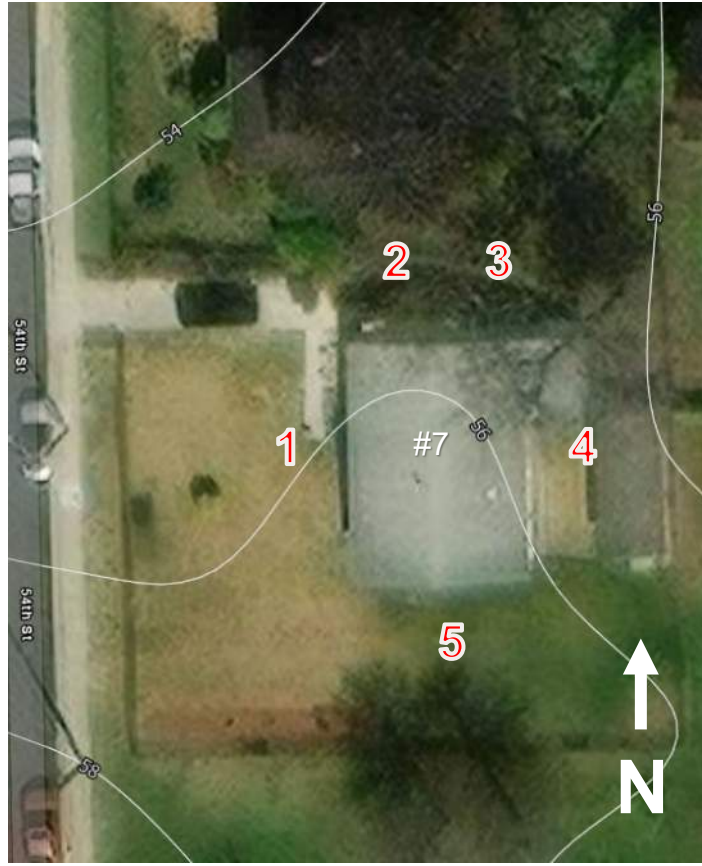
*Figure 2.7.1.1 Property #7: Aerial view with elevation contours and photo numbering*

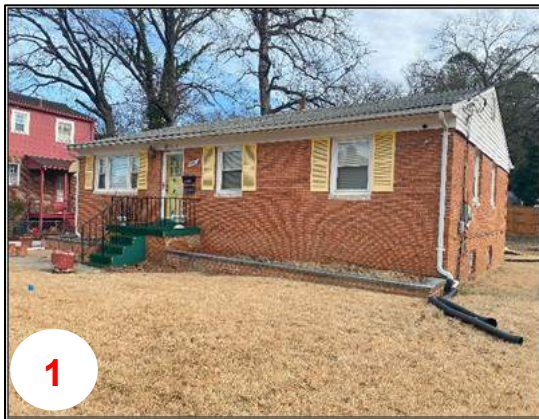
*Figure 2.7.1.2 Property #7: Front side (west side)*

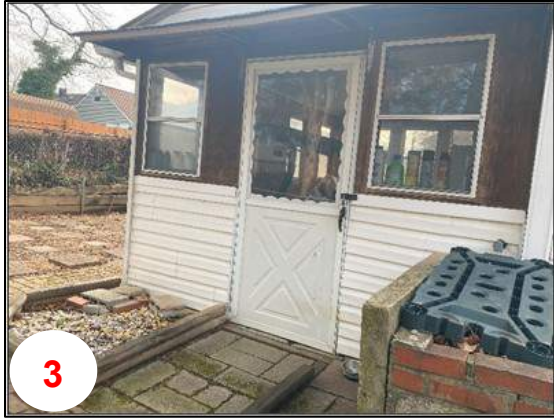
Figure 2.7.1.4 Property #7: Side addition (north)

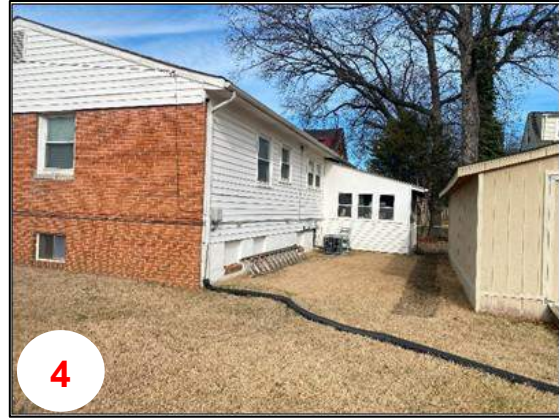
Figure 2.7.1.5 Property #7: Back (east side)

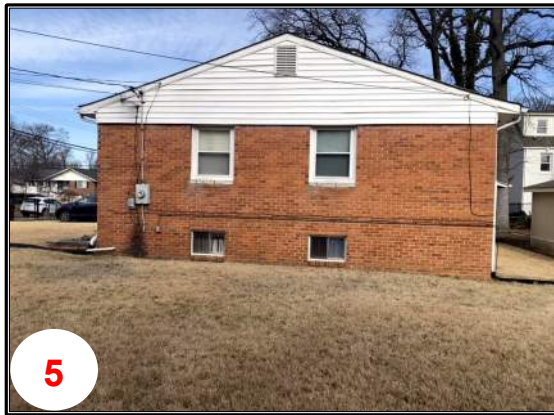
Figure 2.7.1.6 Property #7: Side (south)

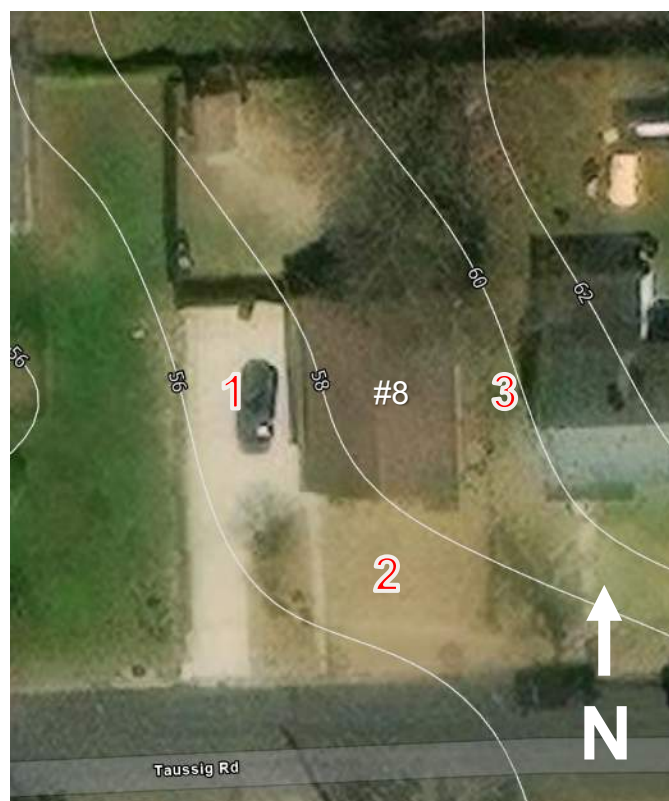
*Figure 2.8.1.1 Property #8: Aerial view with elevation contours and photo numbering*

The property at 5404 Taussig Road consists of a one-story building with a crawlspace. The front entrance has steps leading up to the front door along the front (west) side. Nearby there is a boarded opening to the crawlspace located a few inches above grade. The building has ventilation vents for the crawlspace just below the first floor that allow airflow in and out of the crawlspace. The east side of the building has a door and HVAC unit approximately 0.5 feet above grade. Figure 2.8.1.1 below provides an aerial view of the home with topographic elevation contours, and the property is further depicted in Figure 2.8.1.2, Figure 2.8.1.3 and Figure 2.8.1.4. Only three sides of the home were photographed as the homeowner did not grant access to the backyard of the property.

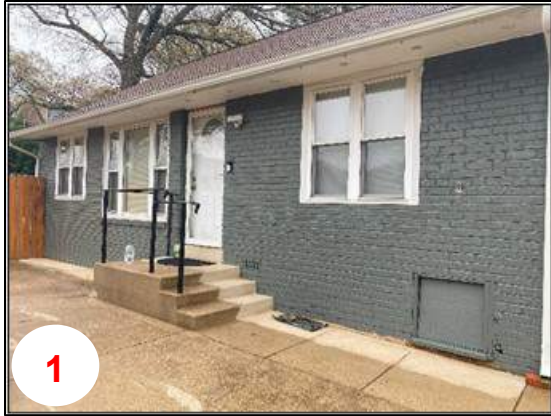
Figure 2.8.1.2 Property #8: Front side (west side)

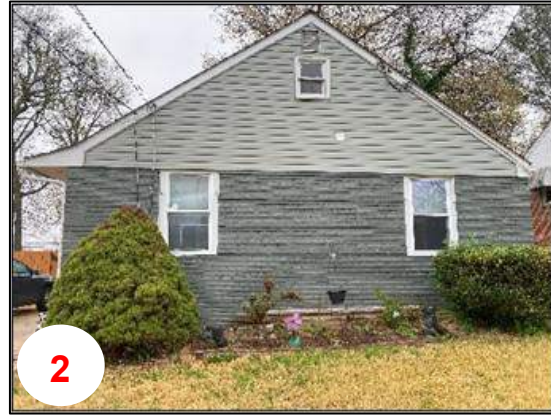
Figure 2.8.1.3 Property #8: Side (south side)

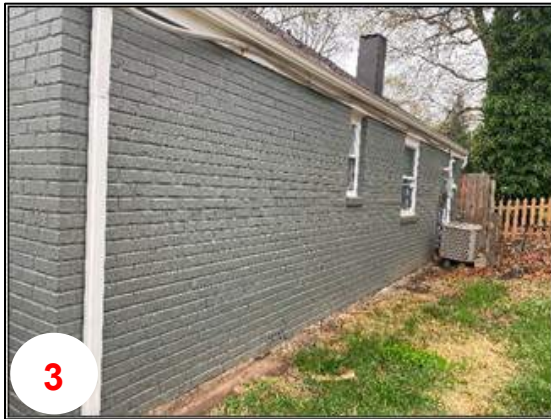
Figure 2.8.1.4 Property #8: Side (east side)

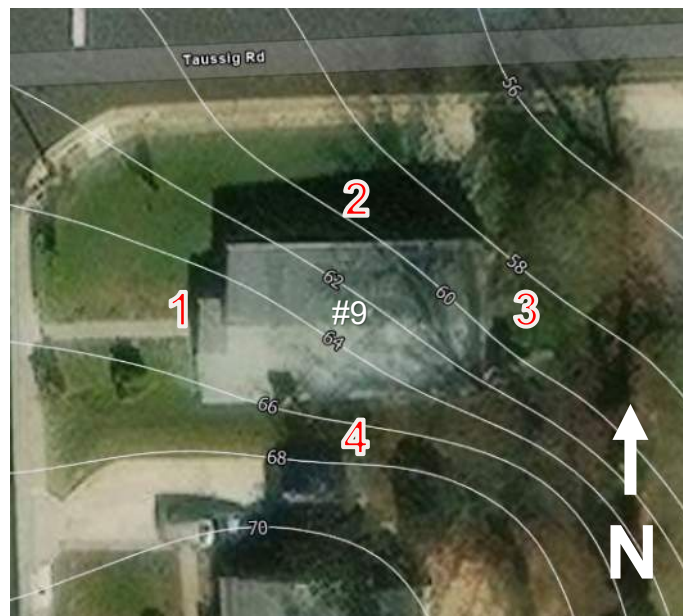
*Figure 2.9.1.1 Property #9: Aerial view with elevation contours and photo numbering*

The Property at 4209 54<sup>th</sup> Street consists of a one-story building with a basement. A garage door on the north side of the home is connected to the basement level and is at grade. There are two basement windows on the north side as well as several wall penetrations such as an electric meter, cable, dryer vent, and hose bib. Each of these penetrations is at least 2.5 feet above the basement floor. The HVAC unit is at grade on the south side. Figure 2.9.1.1 below provides an aerial view of the home with topographic elevation contours, and the property is further depicted in Figure 2.9.1.2, Figure 2.9.1.3, Figure 2.9.1.4, and Figure 2.9.1.5.

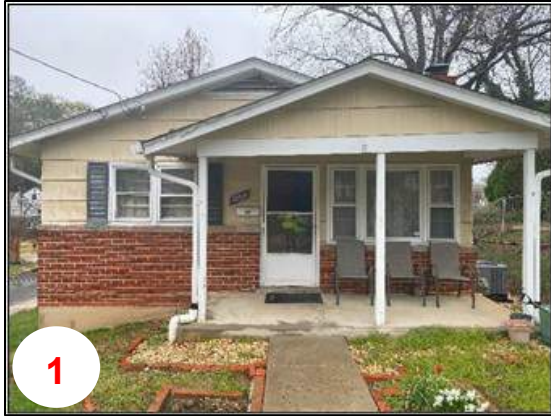
Figure 2.9.1.2 Property #9: Front side (west side)

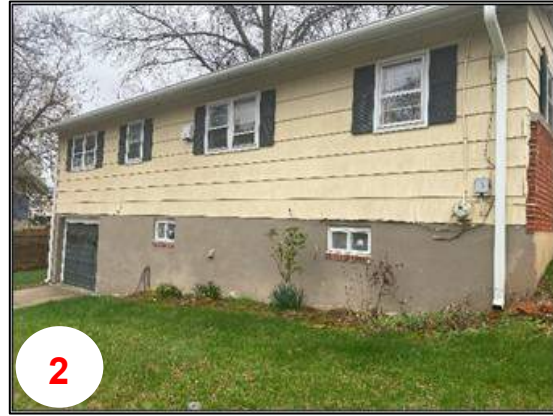
Figure 2.9.1.3 Property #9: Side (north side)

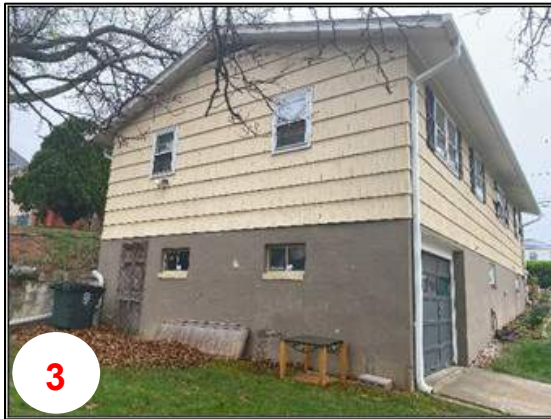
Figure 2.9.1.4 Property #9: Back side (east side)

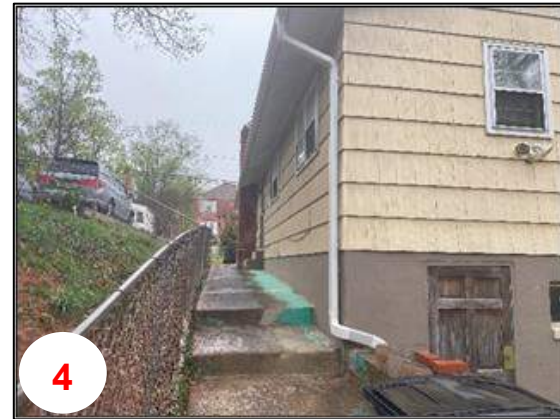
Figure 2.9.1.5 Property #9: Side (south side)

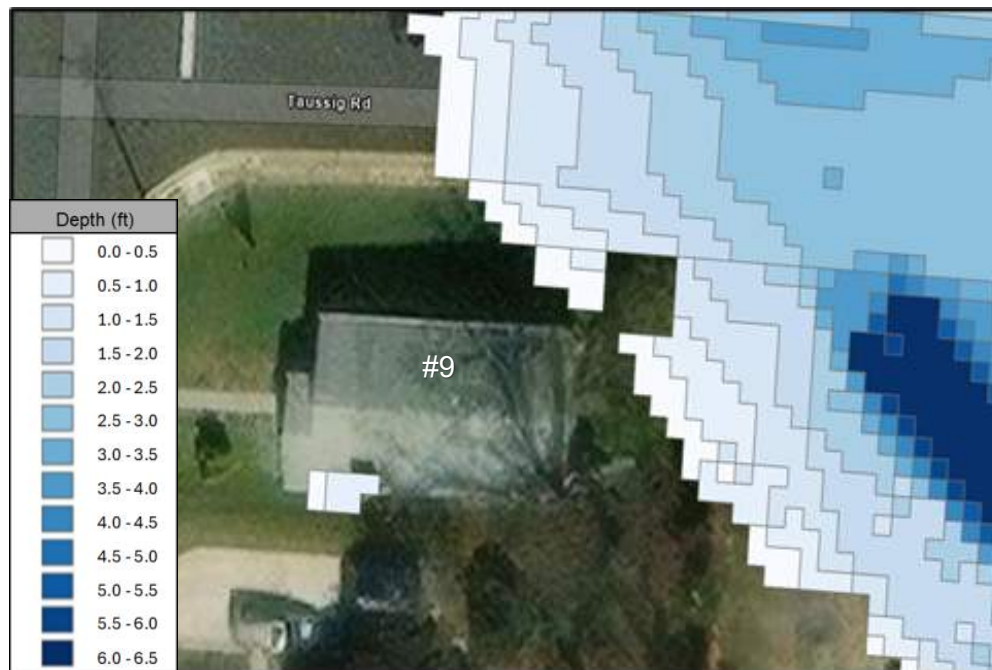
Figure 2.9.2.1 Property #9: 100-year flood depth above grade

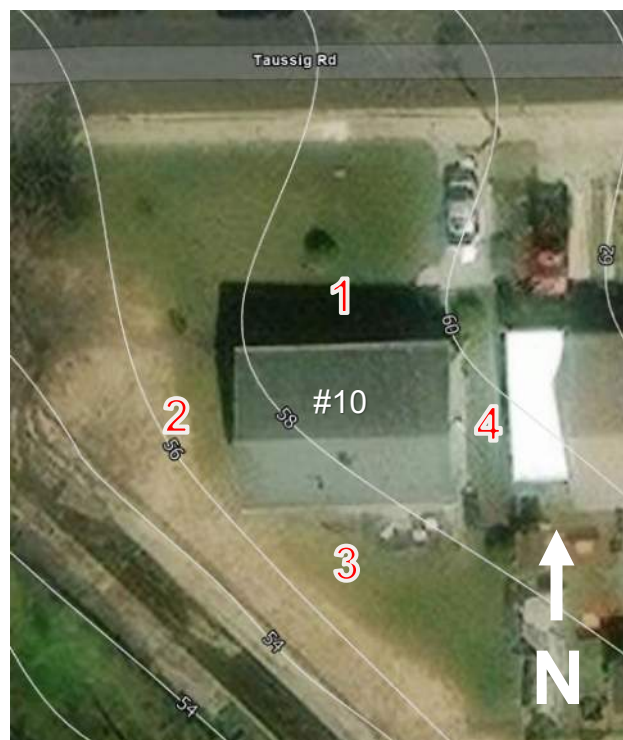
*Figure 2.10.1.1 Property #10: Aerial view with elevation contours and photo numbering*

The property at 5409 Taussig Road consists of a split-level building. There are ground floor windows at the front (north), east, and back (south) sides. The exterior wall at the back (south) side has penetrations for hose bibs, a dryer vent, and electrical service. At the back (south) side the basement door is below grade and accessed by way of an exterior step. Figure 2.10.1.1 below provides an aerial view of the home with topographic elevation contours, and the property is further depicted in Figure 2.10.1.2, Figure 2.10.1.3, Figure 2.10.1.4, and Figure 2.10.1.5.

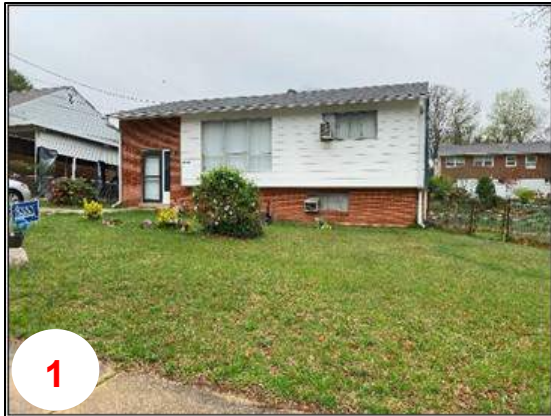
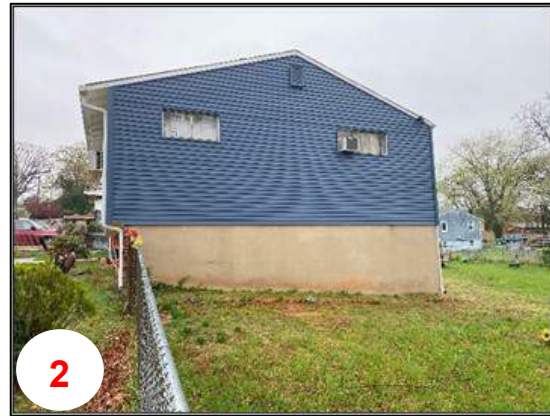
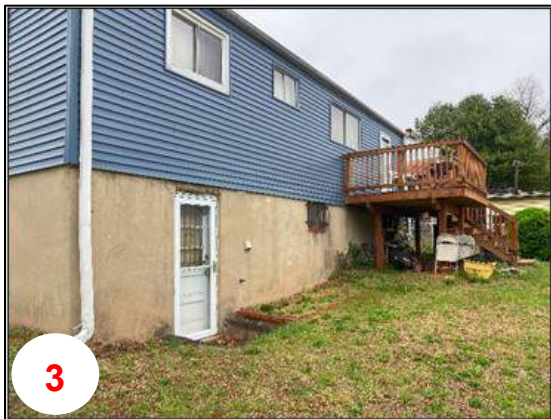
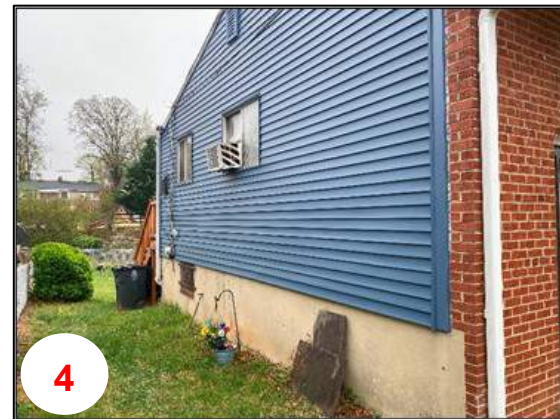
Figure 2.10.1.2 Property #10: Front side (north side) Figure 2.10.1.3 Property #10: Side (west side)

Figure 2.10.1.4 Property #10: Back side (south side) Figure 2.10.1.5 Property #10: Side (east side)

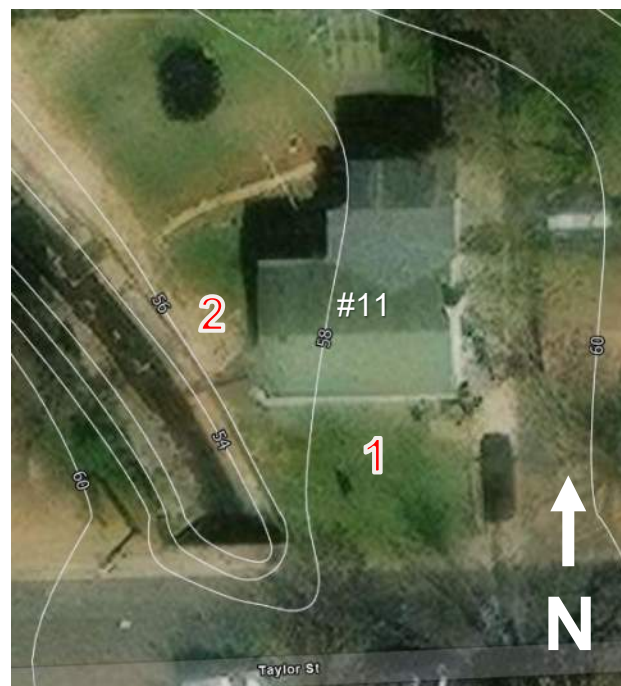
*Figure 2.11.1.1 Property #11: Aerial view with elevation contours and photo numbering*

The property at 5408 Taylor Street consists of a one-story building with a basement and a sump pump system. A few steps lead to the front (south) door at an elevated landing. The back door on the back (north) side of the building is a few inches above grade. There are two basement windows along the front (south) side and two along the west side of the building approximately 1 foot and 2 feet above grade, respectively. Multiple penetrations exist at the exterior wall for electrical components along the west side. Figure 2.11.1.1 below provides an aerial view of the home with topographic elevation contours, and the property is further depicted in Figure 2.11.1.2 and Figure 2.11.1.3. Only two sides of the home were able to be photographed as the homeowner did not grant access to the property.

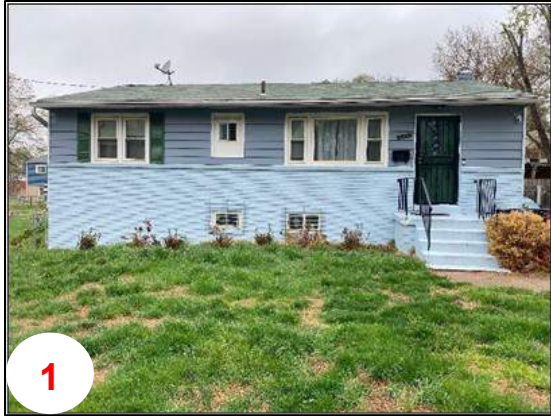
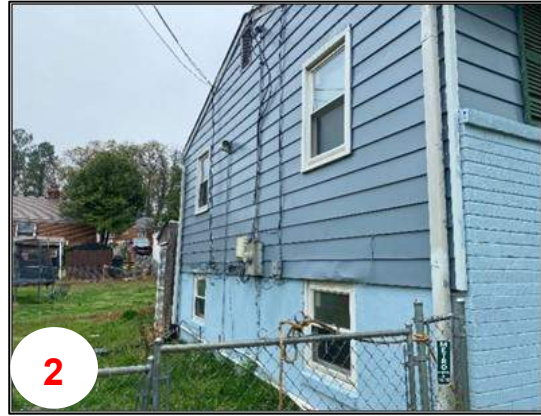
*Figure 2.11.1.2 Property #11: Front side (south side) Figure 2.11.1.3 Property #11: Side (west side)*

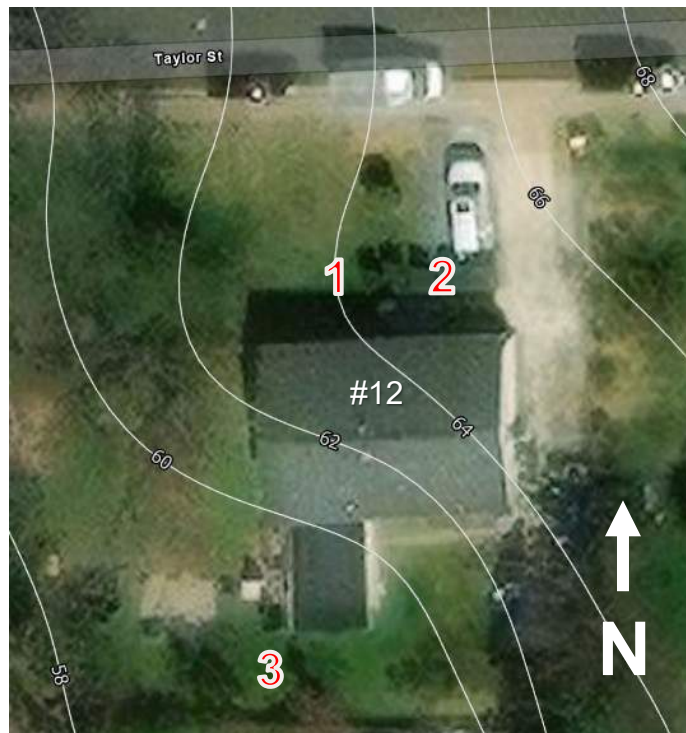
*Figure 2.12.1.1 Property #12: Aerial view with elevation contours and photo numbering*

The property at 5411 Taylor Street consists of a one-story building with a basement and sump pump system. There is an addition on the back (south) side at the same level as the basement. The homeowner did not grant permission for measurements and only permitted limited access for photography. As such there is limited data available and documented, apart from verbal descriptions provided by the homeowner. Figure 2.12.1.1 below provides an aerial view of the home with topographic elevation contours and the property is further depicted in Figure 2.12.1.2, Figure 2.12.1.3, and Figure 2.12.1.4.

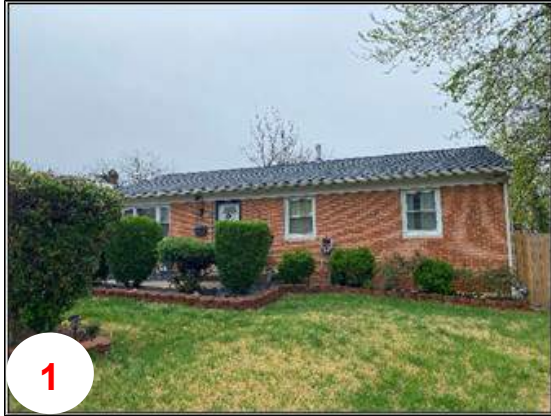
Figure 2.12.1.2 Property #12: Front side (north side) Figure 2.12.1.3 Property #12: Front side (north side)

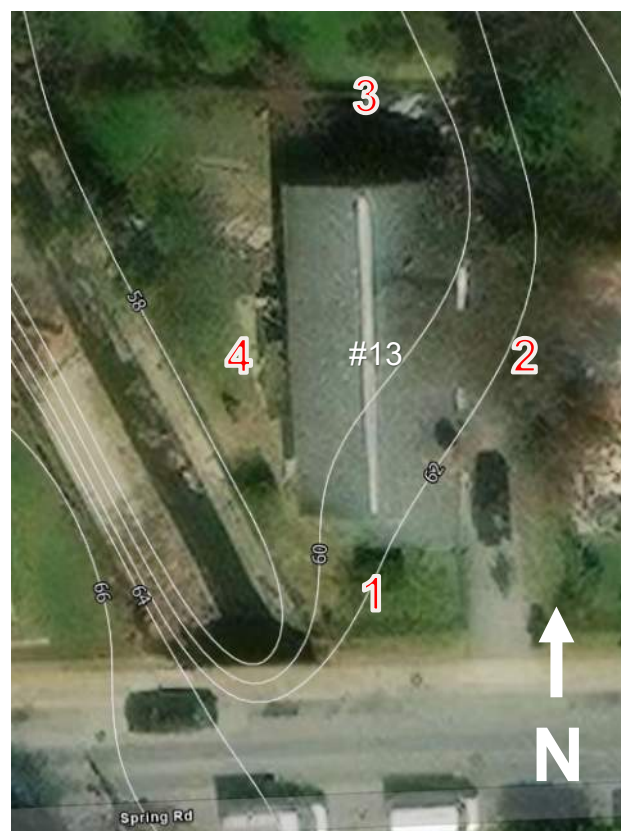
Figure 2.13.1.1 Property #13: Aerial view with elevation contours and photo numbering

The property at 5416 Spring Road consists of a one-story building with a basement. The grade is highest near the front (south) and tapers down to low points at the west side of the building. There are two basement doors at grade on the west side. Additionally, along the west side and a few steps up from the doors, the building has the HVAC unit and window at grade. The building has multiple penetrations through the exterior basement wall at the front (south), west, and back (north) sides for electrical conduits, a hose bib, dryer vents, electrical outlets, and a window A/C unit. The home has a sump pump in the backyard with a trench. Figure 2.13.1.1 below provides an aerial view of the home with topographic elevation contours, and the property is further depicted in Figure 2.13.1.2, Figure 2.13.1.3, Figure 2.13.1.4, and Figure 2.13.1.5.

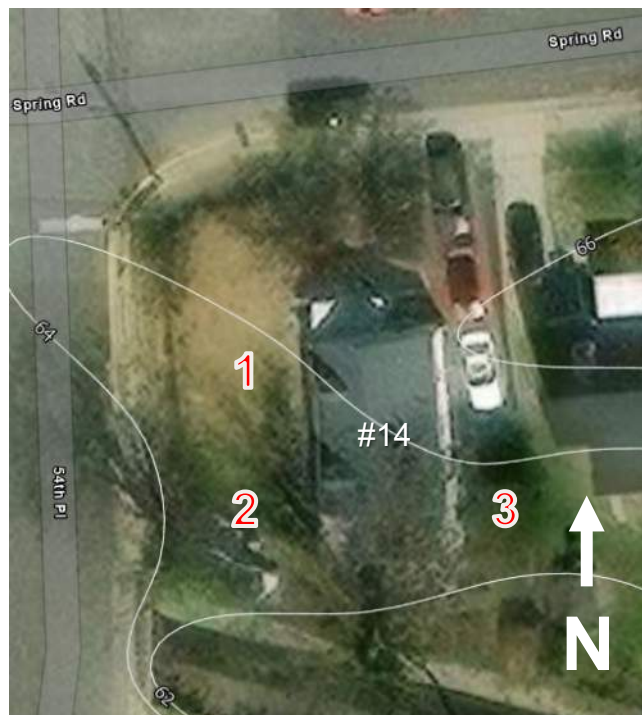
*Figure 2.14.1.1 Property #14: Aerial view with elevation contours and photo numbering*

The property at 5419 Spring Road consists of a one-and-a-half story building with dormers at the roof. There are steps leading up to the front (north) door at a covered porch. The building has a finished basement. Close to the front (north) and along the west side, a basement window is at grade. The grade slopes down from the front to the back (south) of the building. Towards the back of the building, a shortened door at grade along the west side provides access to the basement. Under the back deck, a former basement opening is covered with boards. The building has two sump pumps. The HVAC unit is located a few inches above grade at the east side. Nearby, the HVAC conduit penetrates the exterior wall. Other basement wall penetrations include an electrical conduit and piping. Figure 2.14.1.1 below provides an aerial view of the home with topographic elevation contours, and the property is further depicted in Figure 2.14.1.2, Figure 2.14.1.3 and Figure 2.14.1.4.

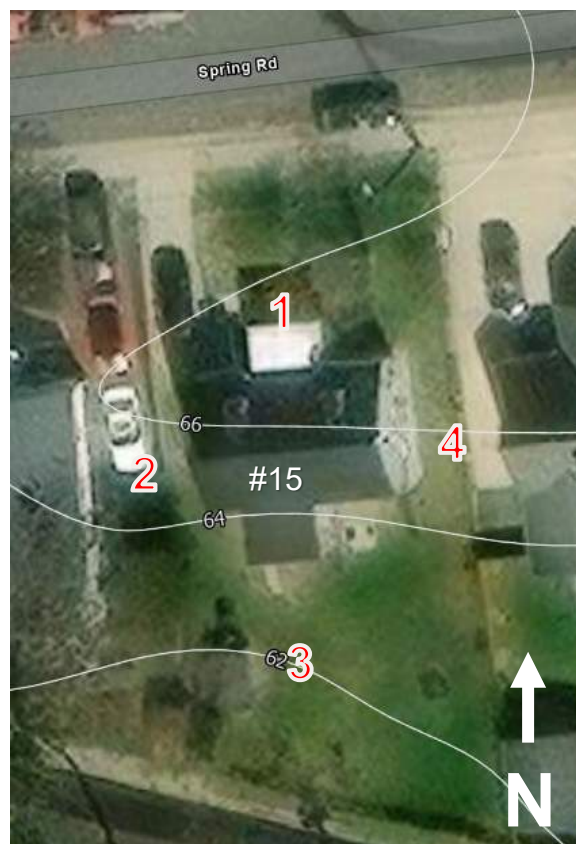
*Figure 2.15.1.1 Property #15: Aerial view with elevation contours and photo numbering*

The property at 5421 Spring Road consists of a one-and-a-half story building with dormers at the roof. The grade slopes down from the front to the back of the building. At the back (south) side of the building, exterior steps lead down from the adjacent grade to a basement door. The HVAC unit is at grade near the basement door. Basement windows exist on the east, south, and west sides of the building. The building also has a sump pump system. There are penetrations through the basement wall for a hose bib (west side), dryer vent (south side), and gas piping (east side). Figure 2.15.1.1 below provides an aerial view of the home with topographic elevation contours, and the property is further depicted in Figure 2.15.1.2, Figure 2.15.1.3, Figure 2.15.1.4, and Figure 2.15.1.5.

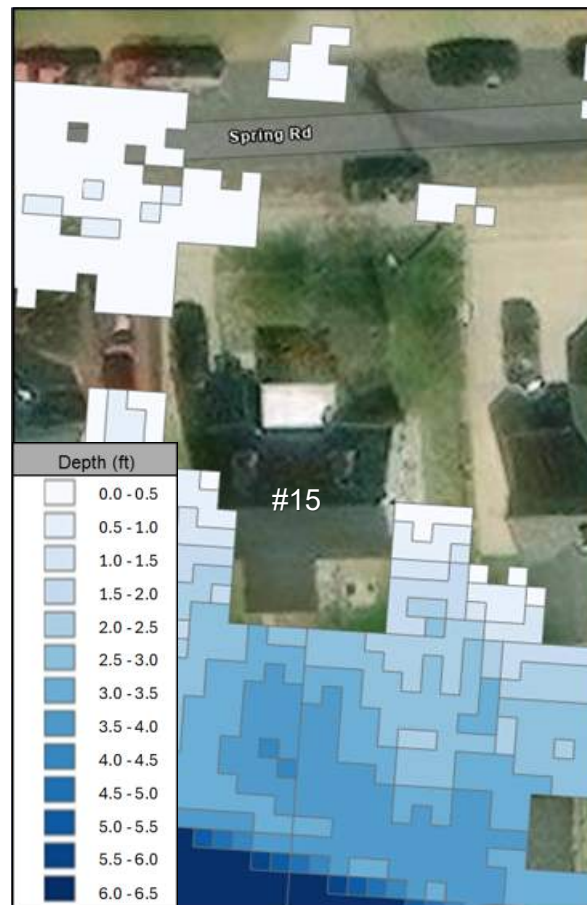
*Figure 2.15.2.1 Property #15: 100-year flood depth above grade*

The property at 5421 Spring Road borders the Edmonston Channel on the back (south) side of the property near the 54<sup>th</sup> Place bridge. Flood modeling indicates that the capacity of the 54<sup>th</sup> Place bridge will be exceeded in a 100-year event, as it will cause floodwater to back up and extend to the east, south, and west walls of the building. See Figure 2.15.2.1. The main floor is 2.8 feet above the 100-year flood. However, floodwater will likely enter the basement at the back (south) side through a basement door as well as through a basement window at the east side. Table 2.15.1 below lists the critical building elevations relative to the 100-year flood level. The lowest point of entry is at the upper stairwell landing to the basement door at 2.0 feet below the 100-year water surface elevation, where the basement door is 4.2 feet below. A dryer vent at the south penetrates the basement wall below the 100-year water surface elevation. Also, the HVAC unit at the south side of the building is approximately a few feet below the 100-year water surface elevation.

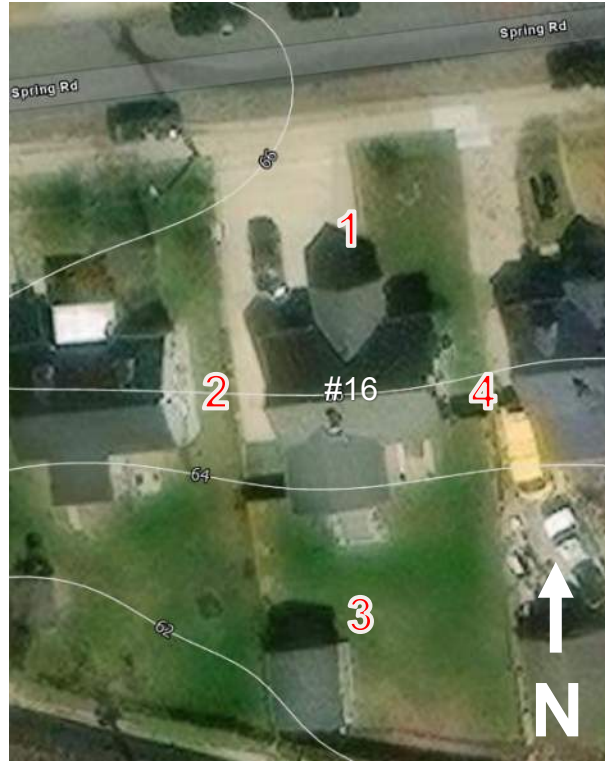
*Figure 2.16.1.1 Property #16: Aerial view with elevation contours and photo numbering*

The property at 5423 Spring Road consists of a one-and-a-half story building with dormers at the roof. There are steps leading up to the front (north) door at a covered porch. The grade slopes down from the front to the back of the building. At the back (south) side, exterior steps lead down from the adjacent grade to a basement door. A roof has been constructed over the exterior stairwell to the basement door (not pictured below). Basement windows exist on the east, south, and west sides of the building. Two of the basement windows have window wells with covers with one on the east side and one on the west side. The HVAC unit on the west side of the building is at grade. There are penetrations through the basement wall for an electrical conduit, gas piping, and HVAC conduit along the west side. Figure 2.16.1.1 below provides an aerial view of the home with topographic elevation contours, and the property is further depicted in Figure 2.16.1.2, Figure 2.16.1.3, Figure 2.16.1.4, and Figure 2.16.1.5.

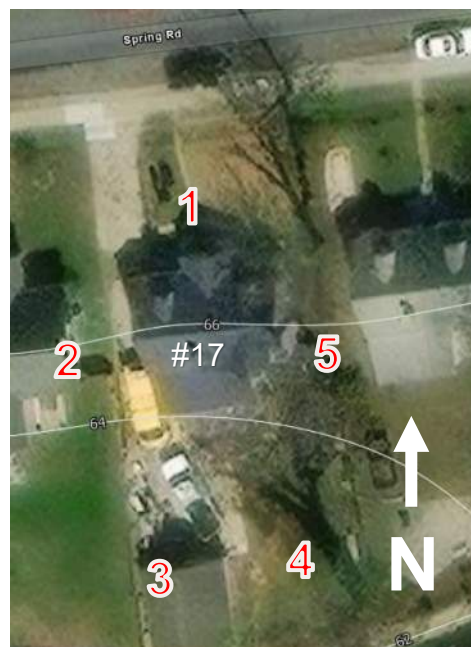
*Figure 2.17.1.1 Property #17: Aerial view with elevation contours and photo numbering*

The property at 5425 Spring Road consists of a one-and-a-half story building with dormers at the roof. The grade slopes down from the front to the back of the building. At the back (south) side of the building, exterior steps lead down from the adjacent grade to a basement door with a basement window at the stairwell. The HVAC unit is at grade near the basement door. Basement windows are located a few inches above grade on the east, south, and west sides of the building. There are penetrations through the basement wall for a hose bib, a plumbing pipe, electrical conduit, gas piping, and HVAC conduit. Figure 2.17.1.1 below provides an aerial view of the home with topographic elevation contours, and the property is further depicted in Figure 2.17.1.2, Figure 2.17.1.3, Figure 2.17.1.4, Figure 2.17.1.5 and Figure 2.17.1.6.
