# Bladensburg Flood Reduction Preliminary Design Report

October 2025

## Flood Reduction Preliminary Design Report

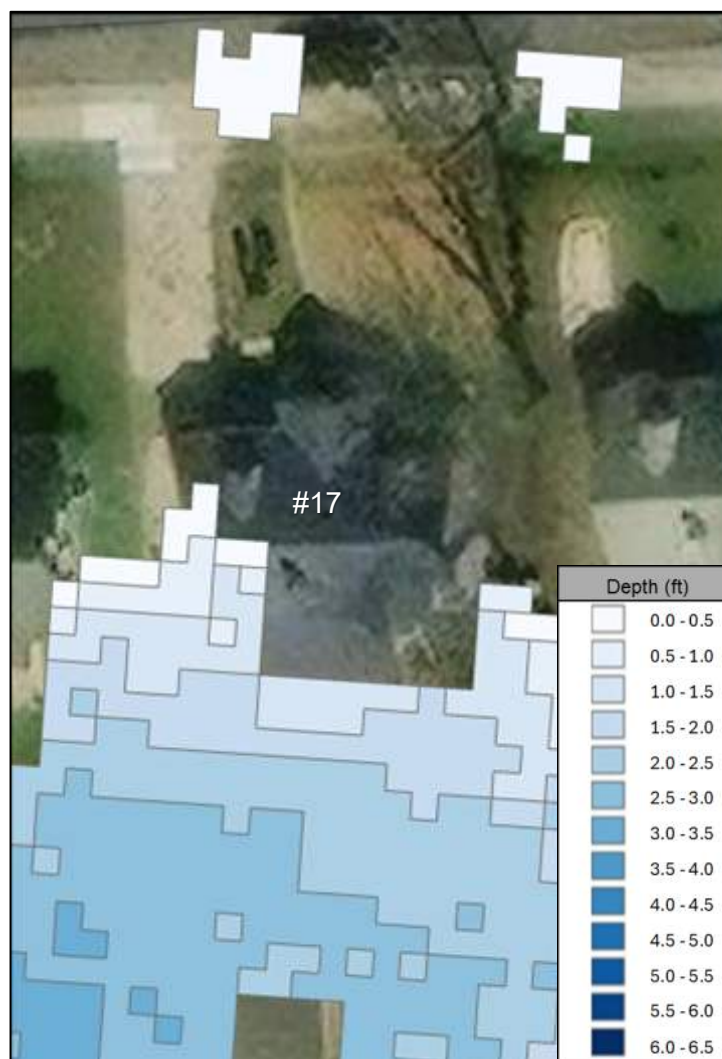
Figure 2.17.2.1 Property #17: 100-year flood depth above grade

The property at 5425 Spring Road borders the Edmonston Channel on the back (south) side of the property. Flood modeling indicates that floodwater from a 100-year event will extend to the east, south, and west walls of the building. See Figure 2.17.2.1. The main floor is 2.6 feet above the 100-year flood level. However, floodwater will likely enter the basement at the south side through a basement door and window. Table 2.17.1 below lists the critical building elevations relative to the 100-year flood level. The lowest point of entry is at the upper stairwell landing to the basement door at 2.0 feet below the 100-year water surface elevation, whereas the basement door is 4.8 feet below. Also, the HVAC unit at the south side of the building is more than 1 foot below the 100-year water surface elevation. The homeowner reported that they've experienced no flooding in the building for the past eight years. Note that the objects under and around the back (south) deck may have prevented the identification of other flood risks.

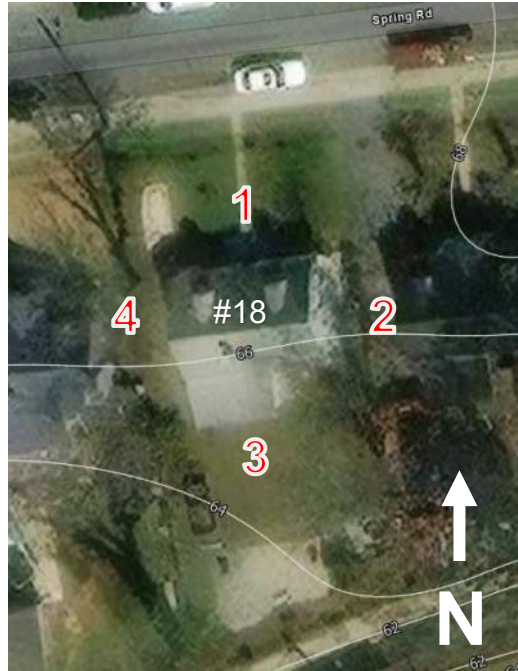
*Figure 2.18.1.1 Property #18: Aerial view with elevation contours and photo numbering*

The property at 5427 Spring Road consists of a one-and-a-half story building with dormers at the roof. The grade slopes down from the front to the back of the building. At the back (south) side of the building, exterior steps lead down from the adjacent grade to a basement door. The HVAC unit is at grade near the basement door. Basement windows are located a few inches above grade on the east and west sides of the building. There are penetrations through the basement wall for a vent, hose bib, plumbing pipes, and gas piping. The back of the building has a boarded-up area below the first-floor addition that could not be accessed. Figure 2.18.1.1 below provides an aerial view of the home with topographic elevation contours, and the property is further depicted in Figure 2.18.1.2, Figure 2.18.1.3, Figure 2.18.1.4, and Figure 2.18.1.5.

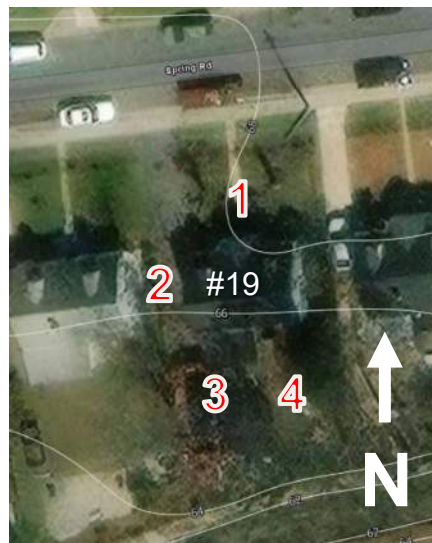
*Figure 2.19.1.1 Property #19: Aerial view with elevation contours and photo numbering*

The property at 5429 Spring Road consists of a one-and-a-half story building with dormers at the roof. The grade slopes down from the front to the back of the building. At the back (south) side of the building, exterior steps lead down from the adjacent grade to a basement door. The HVAC unit is at grade near the basement door. Basement windows are located a few inches above grade on the east and west sides of the building. The building has a sump pump with a battery backup. The back of the building has an area below the first-floor addition that has been closed in with lattice panels. There are penetrations through the basement wall for a hose bib, a plumbing pipe, and dryer vent. Figure 2.19.1.1 below provides an aerial view of the home with topographic elevation contours, and the property is further depicted in Figure 2.19.1.2, Figure 2.19.1.3, Figure 2.19.1.4, and Figure 2.19.1.5.

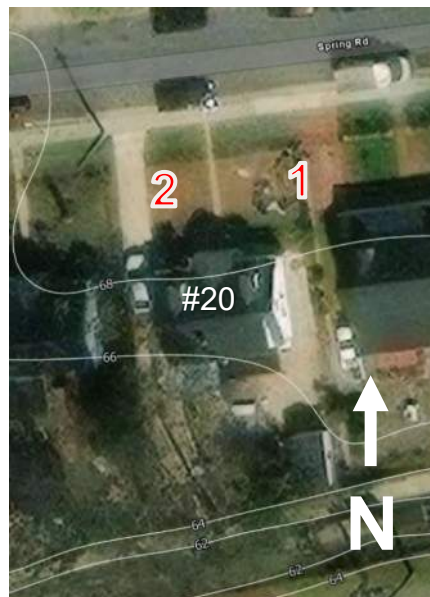
*Figure 2.20.1.1 Property #20: Aerial view with elevation contours and photo numbering*

The property at 5431 Spring Road consists of a one-and-a-half story building with dormers at the roof. The grade slopes down from the front to the back of the building. At the back (south) side of the building, exterior steps lead down from the adjacent grade to a basement door. A dog and “beware of dog” sign was present in the yard that prevented full data collection. Figure 2.20.1.1 below provides an aerial view of the home with topographic elevation, and the property is further depicted in Figure 2.20.1.2 and Figure 2.20.1.3.

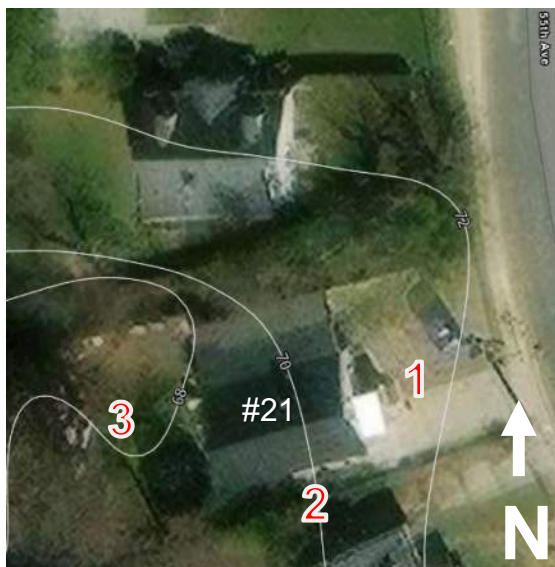
*Figure 2.21.1.1 Property #21: Aerial view with elevation contours and photo numbering*

The property at 4106 55<sup>th</sup> Avenue consists of a one-and-a-half story building. The grade slopes down from the front to the back of the building. A lower level area below the first-floor addition at the north side has been closed in with boards. There are three doors at the back (west) side of the building which are at grade. The HVAC unit nearby is approximately 11 inches above grade. The south side of the building has two basement windows more than a couple feet above grade. There are penetrations through the basement wall for an electrical conduit, a plumbing pipe, and a hose bib. Figure 2.21.1.1 below provides an aerial view of the home with topographic elevation contours, and the property is further depicted in Figure 2.21.1.2, Figure 2.21.1.3 and Figure 2.21.1.4.

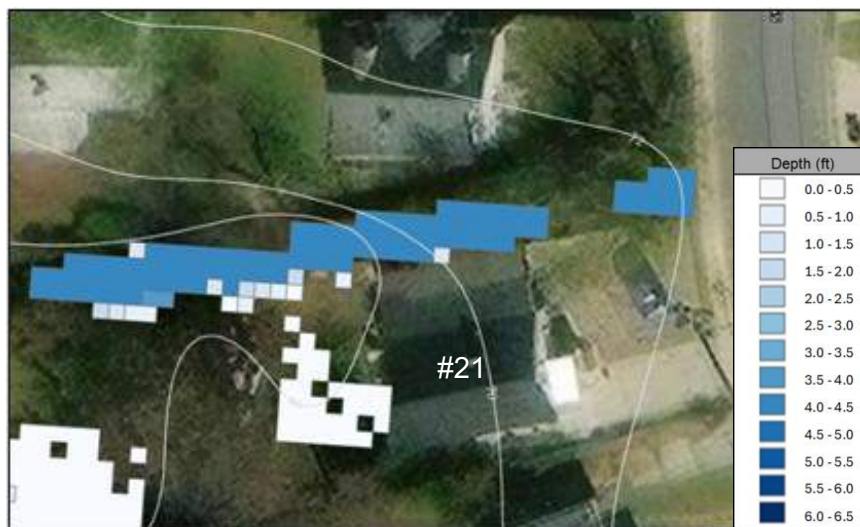
Figure 2.21.2.1 Property #21: 100-year flood depth above grade

The property at 4106 55<sup>th</sup> Avenue abuts the Edmonston Channel on the north side of the property. Flood modeling indicates that floodwater from a 100-year event will extend to the back (west) wall of the building. See Figure 2.21.2.1. The main floor is 6.1 feet above the 100-year flood level. However, floodwater will potentially enter the basement at the back (west) side through a lower level door at the addition. Table 2.21.1 below lists the critical building elevations relative to the 100-year flood level. The lowest point of entry is the lower level door at 0.2 feet below the 100-year water surface elevation. None of the basement wall penetrations observed or HVAC unit are below the 100-year water surface elevation. Note that the boarded-up area under the addition at the north side and the area within the metal enclosure at the back (west) side may have prevented the identification of other flood risks.

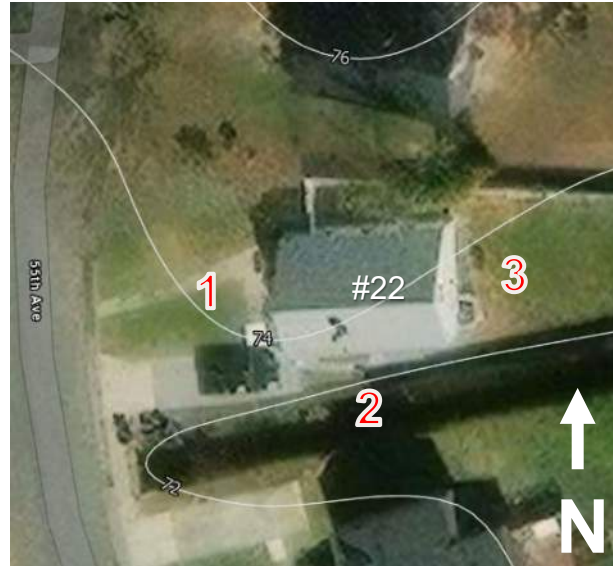
*Figure 2.22.1.1 Property #22: Aerial view with elevation contours and photo numbering*

The property at 4105 55<sup>th</sup> Avenue consists of a one-and-a-half story building with a south side deck and basement door at the bottom of an exterior stairwell. The back (east) side of the building has a basement window a couple feet above grade and the HVAC unit at grade. Additional penetrations could not be identified due to limited access to the property. Figure 2.22.1.1 below provides an aerial view of the home with topographic elevation contours, and the property is further depicted in Figure 2.22.1.2, Figure 2.22.1.3 and Figure 2.22.1.4.

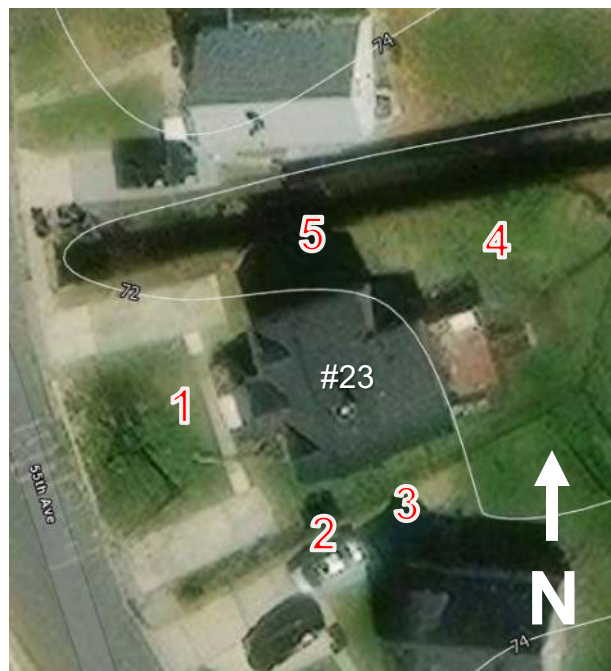
*Figure 2.23.1.1 Property #23: Aerial view with elevation contours and photo numbering*

The property at 5429 Spring Road consists of a one-and-a-half story building with dormers at the roof. At the back (east) side of the building, exterior steps lead down from the adjacent grade to a basement door next to the backyard deck. The building has a sump pump system. There is a window on the north and south sides of the building. The window on the south side is slightly below grade and has a window well which is constructed of corrugated metal. Nearby the HVAC unit sits at grade. The basement window on the north side is a few inches above grade. There are penetrations through the basement wall for a hose bib, a plumbing pipe, electrical conduit, and HVAC conduit. Figure 2.23.1.1 below provides an aerial view of the home with topographic elevation contours, and the property is further depicted in Figure 2.23.1.2, Figure 2.23.1.3, Figure 2.23.1.4, Figure 2.23.1.5 and Figure 2.23.1.6.

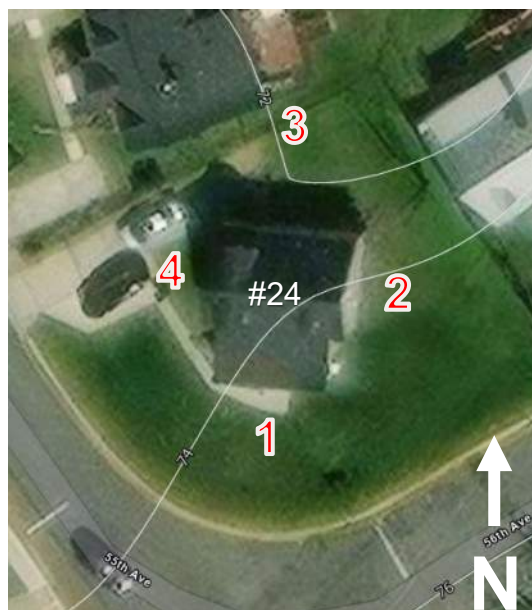
*Figure 2.24.1.1 Property #24: Aerial view with elevation contours and photo numbering*

The property at 4101 55<sup>th</sup> Avenue consists of a one-and-a-half story building with dormers at the roof. The grade slopes down from the front to the back of the building. At the back (north) side of the building, exterior steps lead down from the adjacent grade to a basement door. Along the same side, the HVAC unit is at grade. Basement windows are located between a couple inches to a couple feet above grade on the east, north, and west sides of the building. There are penetrations through the basement wall for plumbing pipes, vents, hose bibs, electrical conduit, gas piping, and cable conduit. Figure 2.24.1.1 below provides an aerial view of the home with topographic elevation contours, and the property is further depicted in Figure 2.24.1.2, Figure 2.24.1.3, Figure 2.24.1.4 and Figure 2.24.1.5.

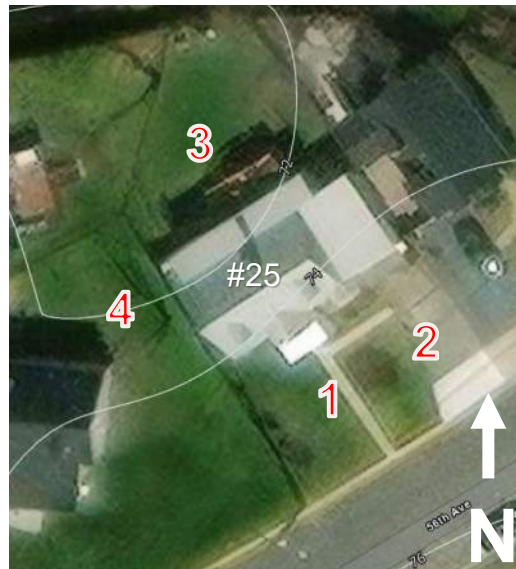
*Figure 2.25.1.1 Property #25: Aerial view with elevation contours and photo numbering*

The property at 4100 56<sup>th</sup> Avenue consists of a one-and-a-half story building with dormers at the roof. The grade slopes down from the front to the back of the building. There is an open sump pump at the back of the house that drains to the channel and an additional sump pump inside the building at the basement level. The basement door and HVAC unit are located at the back (north) side of the building at grade. Basement wall openings are covered with boards on the east, north, and west sides of the building. There are penetrations through the basement wall for a dryer vent, and electrical conduit. Figure 2.25.1.1 below provides an aerial view of the home with topographic elevation contours, and the property is further depicted in Figure 2.25.1.2, Figure 2.25.1.3, Figure 2.25.1.4, and Figure 2.25.1.5.

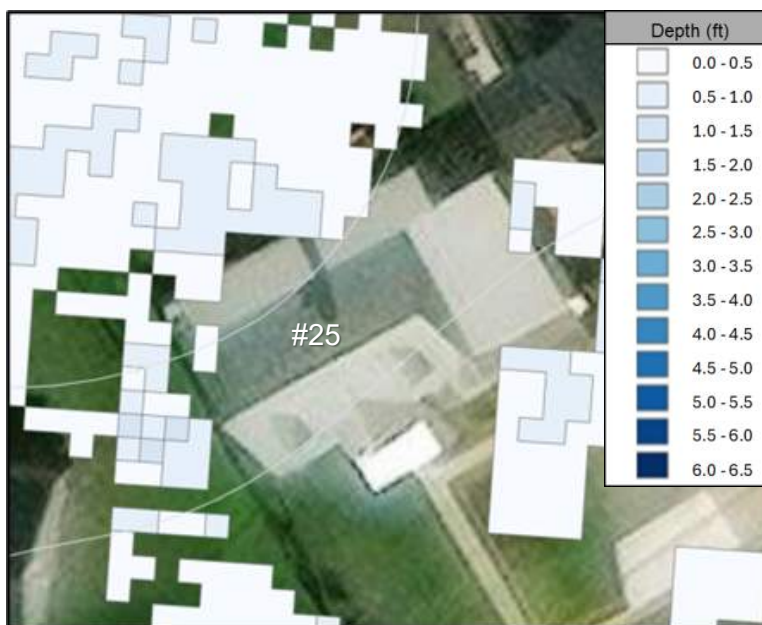
Figure 2.25.2.1 Property #25 100-year flood depth above grade

The property at 4100 56<sup>th</sup> Avenue is located south of the Edmonston Channel. Flood modeling indicates that floodwater from a 100-year event will extend to all four sides of the building. See Figure 2.25.2.1. The main floor is 4.4 feet above the 100-year flood level. However, floodwater will likely enter the basement through a basement door and may enter through a few other boarded openings at the back (north) side. Table 2.25.1 below lists the critical building elevations relative to the 100-year flood level. The lowest point of entry is at the basement door at 2.0 feet below the 100-year water surface elevation. Also, the HVAC unit nearby is more than 1.0 feet below the 100-year water surface elevation. None of the basement wall penetrations are below the 100-year water surface elevation. The homeowner reported that floodwater has previously penetrated the home. Note that the objects adjacent to the exterior wall at the carport may have prevented the identification of other flood risks.

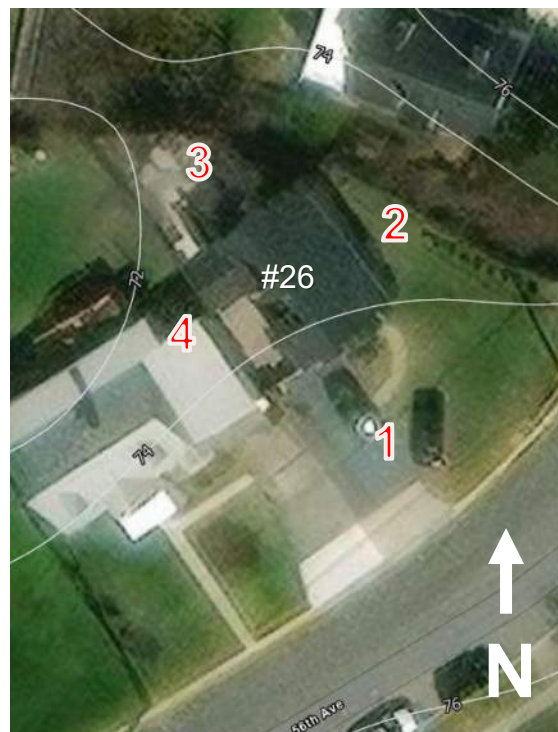
*Figure 2.26.1.1 Property #26: Aerial view with elevation contours and photo numbering*

The property at 4102 56<sup>th</sup> Ave consists of a one-and-a-half story building with a dormer at the roof. The grade slopes down from the front to the back of the building. At the back (north) side of the building, exterior steps lead down from the adjacent grade to a basement door. There are walls at each side that support a small roof at the exterior stairs. The HVAC unit is at grade near the basement door. Basement windows are at or below grade on the east, north, and west sides of the building. The window at the west side has a window well which is constructed of metal. There are penetrations through the basement wall for a plumbing pipe, dryer vent, hose bib, and electrical conduit. Figure 2.26.1.1 below provides an aerial view of the home with topographic elevation contours, and the property is further depicted in Figure 2.26.1.2, Figure 2.26.1.3, Figure 2.26.1.4 and Figure 2.26.1.5.

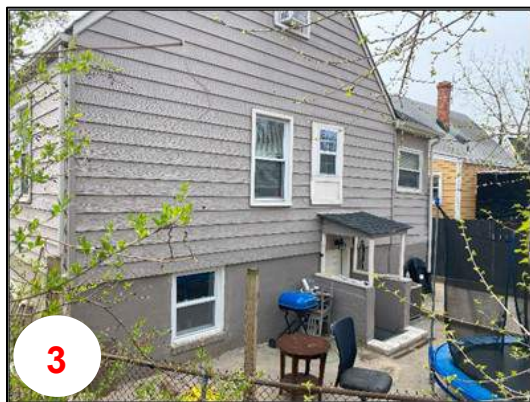
Figure 2.26.1.4 Property #26: Back side (north side) Figure 2.26.1.5 Property #26: Side (west side)

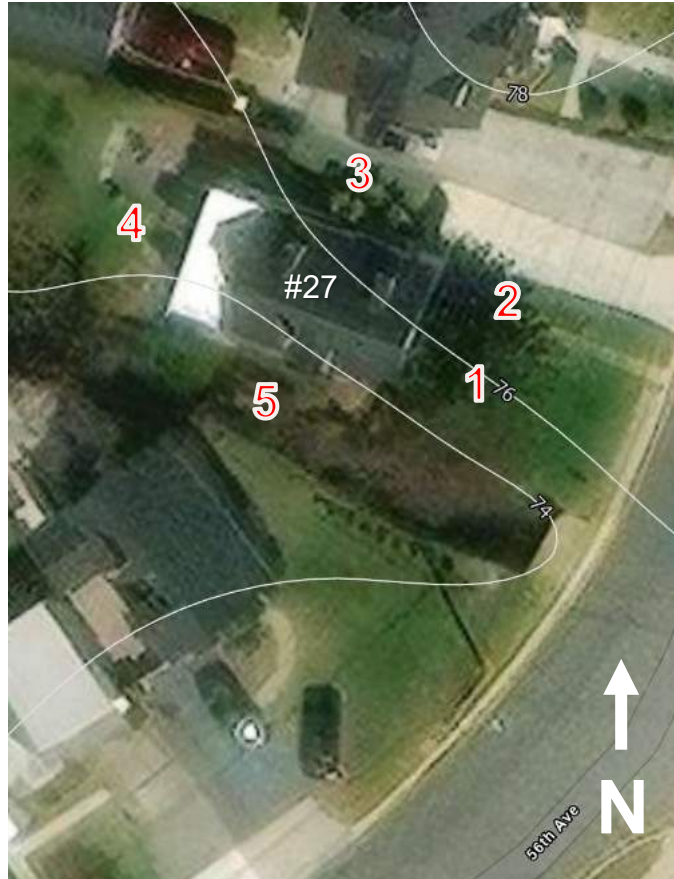
*Figure 2.27.1.1 Property #27: Aerial view with elevation contours and photo numbering*

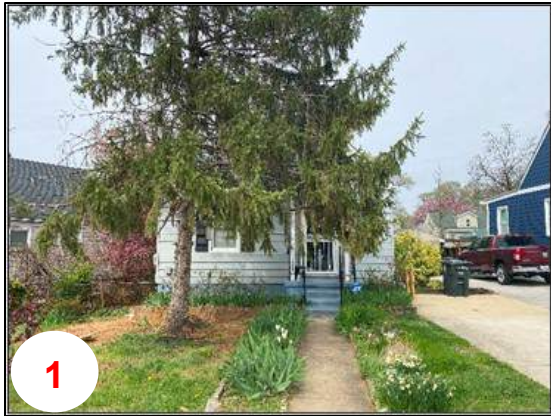
*Figure 2.27.1.2 Property #27: Front side (east side)*

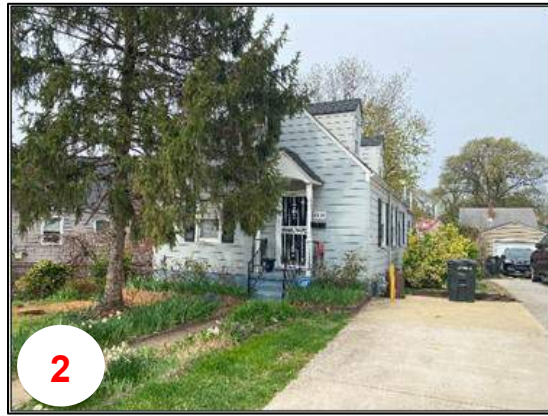
*Figure 2.27.1.3 Property #27: Side (north side)*

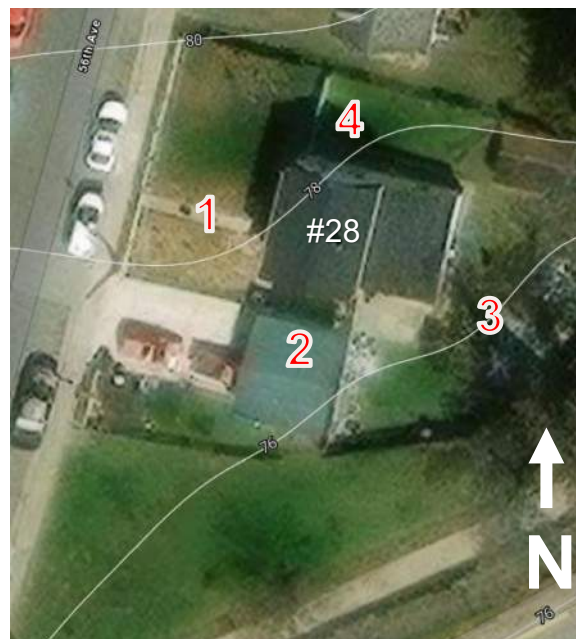
*Figure 2.28.1.1 Property #28: Aerial view with elevation contours and photo numbering*

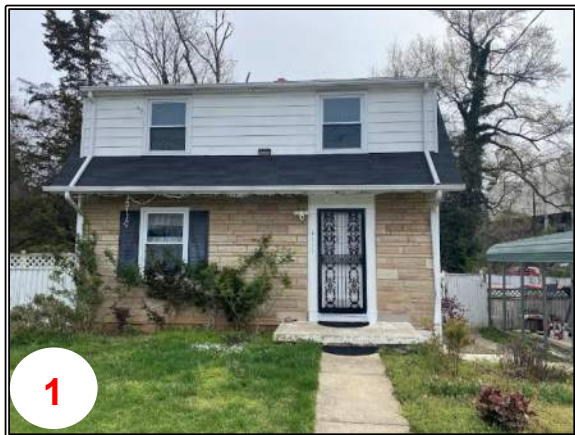
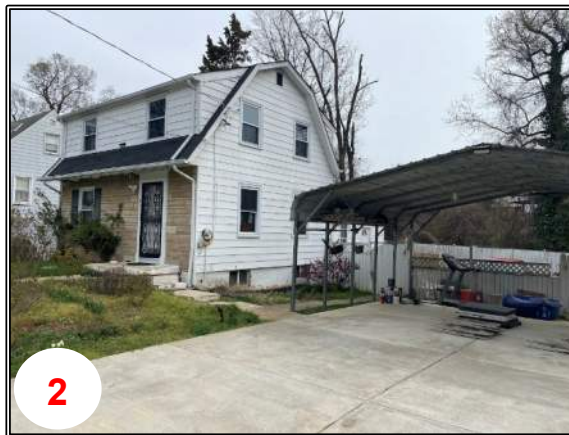
Figure 2.28.1.2 Property #28: Front side (west side) Figure 2.28.1.3 Property #28: Side (south side)

The property at 4111 56<sup>th</sup> Avenue consists of a two-story home with a basement. There is an at-grade addition at the back (east) side of the building. Two basement windows are located a few inches above grade on the north and south sides of the building. The HVAC unit is at grade along the north side. There are penetrations through the basement wall for a dryer vent, hose bib, electrical conduit, and HVAC conduit. Figure 2.28.1.1 below provides an aerial view of the home with topographic elevation contours, and the property is further depicted in Figure 2.28.1.2, Figure 2.28.1.3, Figure 2.28.1.4, and Figure 2.28.1.5.

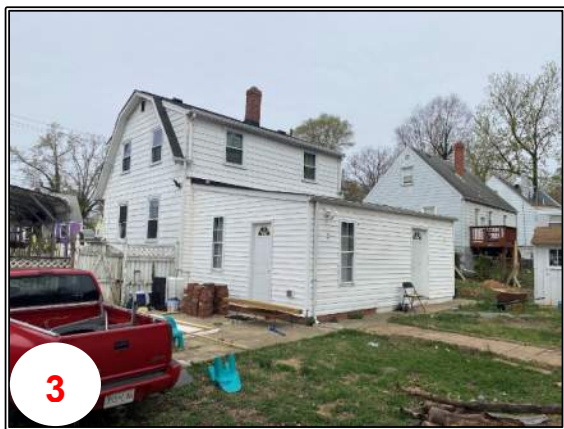
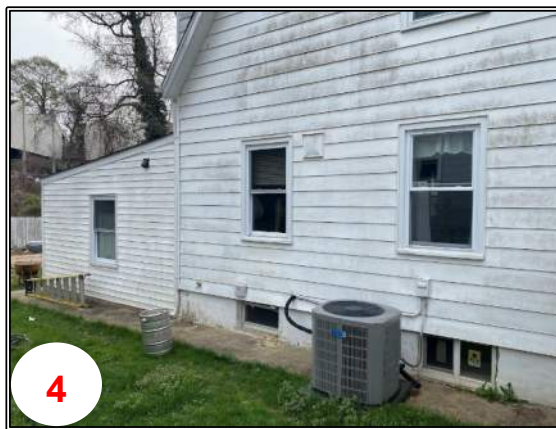
Figure 2.28.1.4 Property #28: Back side (east side) Figure 2.28.1.5 Property #28: Side (north side)

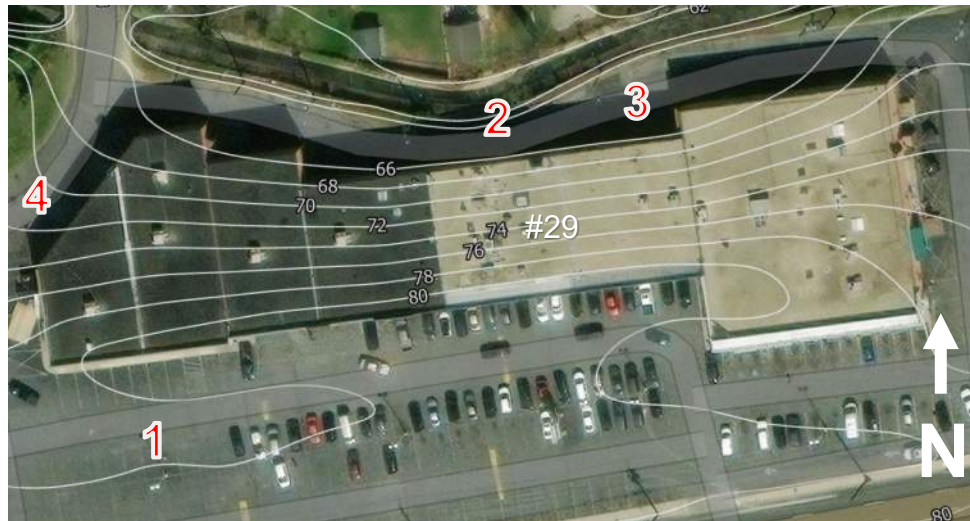
Figure 2.29.1.1 Property #29: Aerial view with elevation contours and photo numbering

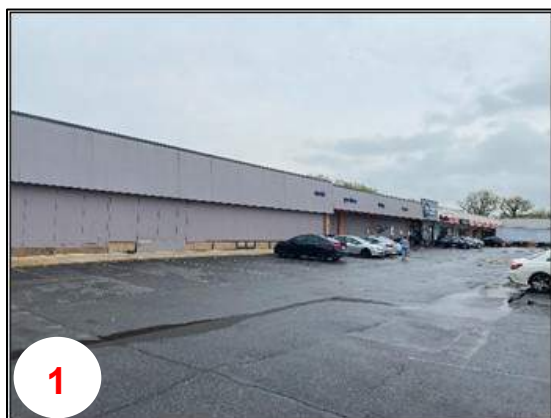
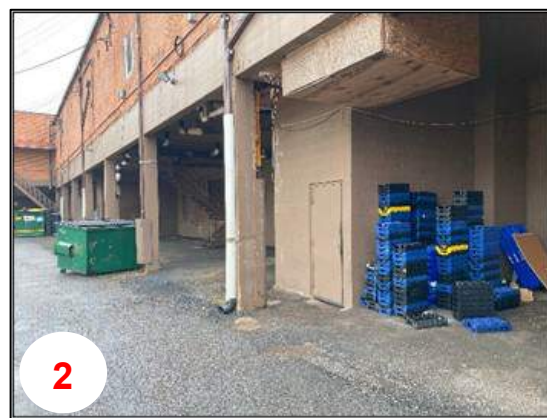
Figure 2.29.1.2 Property #29: Front side (south side) Figure 2.29.1.3 Property #29: Back side (north side)

The property at 5416 Annapolis Road consists of a large one-story shopping center complex located adjacent to the Edmonston Channel. The basement level is constructed with concrete masonry units (CMU). The grade slopes down from the front to the back of the building. At the back (north) side there are several doors at grade and several loading docks approximately 3.5 feet above grade that service the basement. Wall penetrations for electrical are located approximately 1.5 feet above grade at the back (north) side. Figure 2.29.1.1 below provides an aerial view of the complex with topographic elevation contours, and the property is further depicted in Figure 2.29.1.2, Figure 2.29.1.3, Figure 2.29.1.4, and Figure 2.29.1.5.

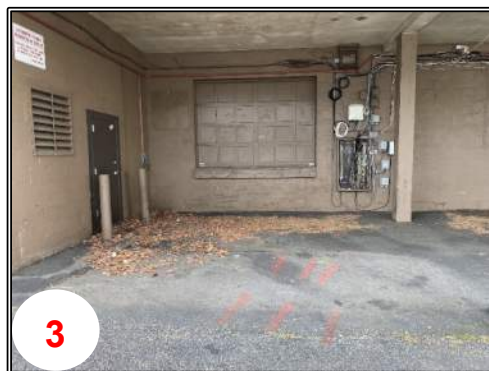
Figure 2.29.1.4 Property #29: Back side (north side) Figure 2.29.1.5 Property #29: Side (west side)

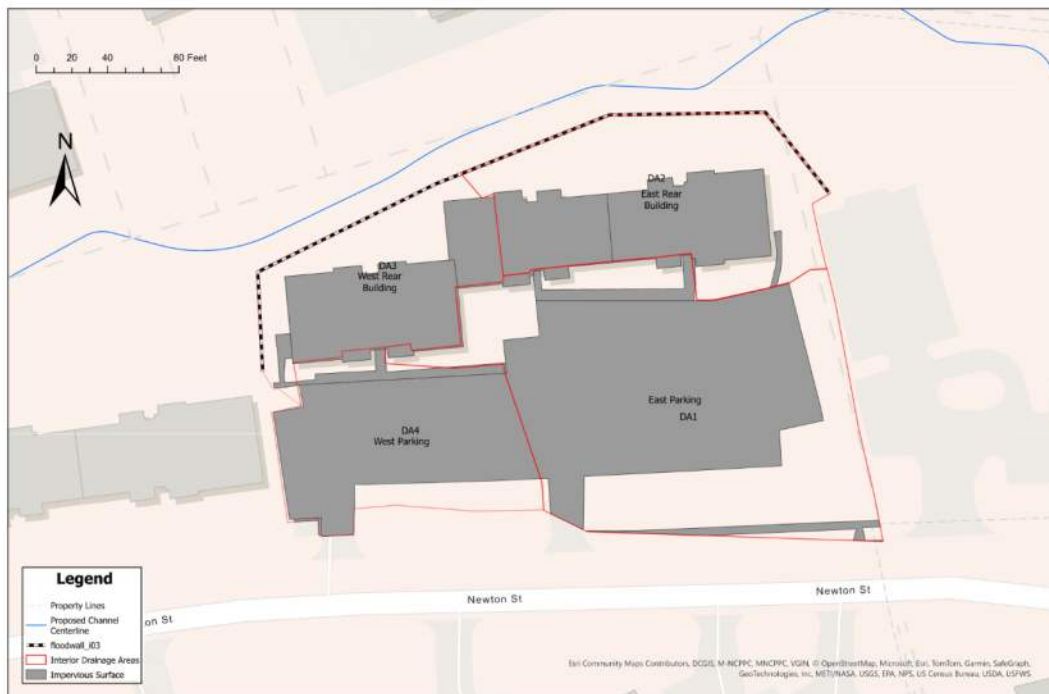
**Figure 3: Impervious Area**

The only two land covers for the site are impervious (buildings and paved areas) and grass/lawn. The impervious areas are depicted in Figure 3. The impervious surfaces dataset is from Prince George's County Planning Department. A conservative assumption that the slopes were greater than 7% was used for the grass/lawn.
