# Bladensburg Flood Reduction Preliminary Design Report

## Flood Reduction Preliminary Design Report

Residents and property owners along Edmonston Channel and Quincy Run in the Town of Bladensburg, Maryland have experienced repetitive flooding on their properties during heavy rainfall events. Corvias Infrastructure Solutions (CIS), the managing partner for the Clean Water Partnership (CWP) with Prince George's County, Maryland, selected Stantec Consulting Services Inc. (Stantec) to evaluate the causes and severity of flooding and to develop alternatives to reduce flooding which is impacting properties along Edmonston Channel and Quincy Run.

Stantec previously conducted a comprehensive analysis and presented its findings and recommendations in the *Bladensburg Flood Reduction Alternatives Evaluation Report*, dated October 2024. This report advances the selected alternatives for Edmonston Channel (Figure ES-1) and Quincy Run (Figure ES-2) from the evaluation study into the preliminary design phase, incorporating surveyed topographic and subsurface utility data to further refine and optimize the designs.

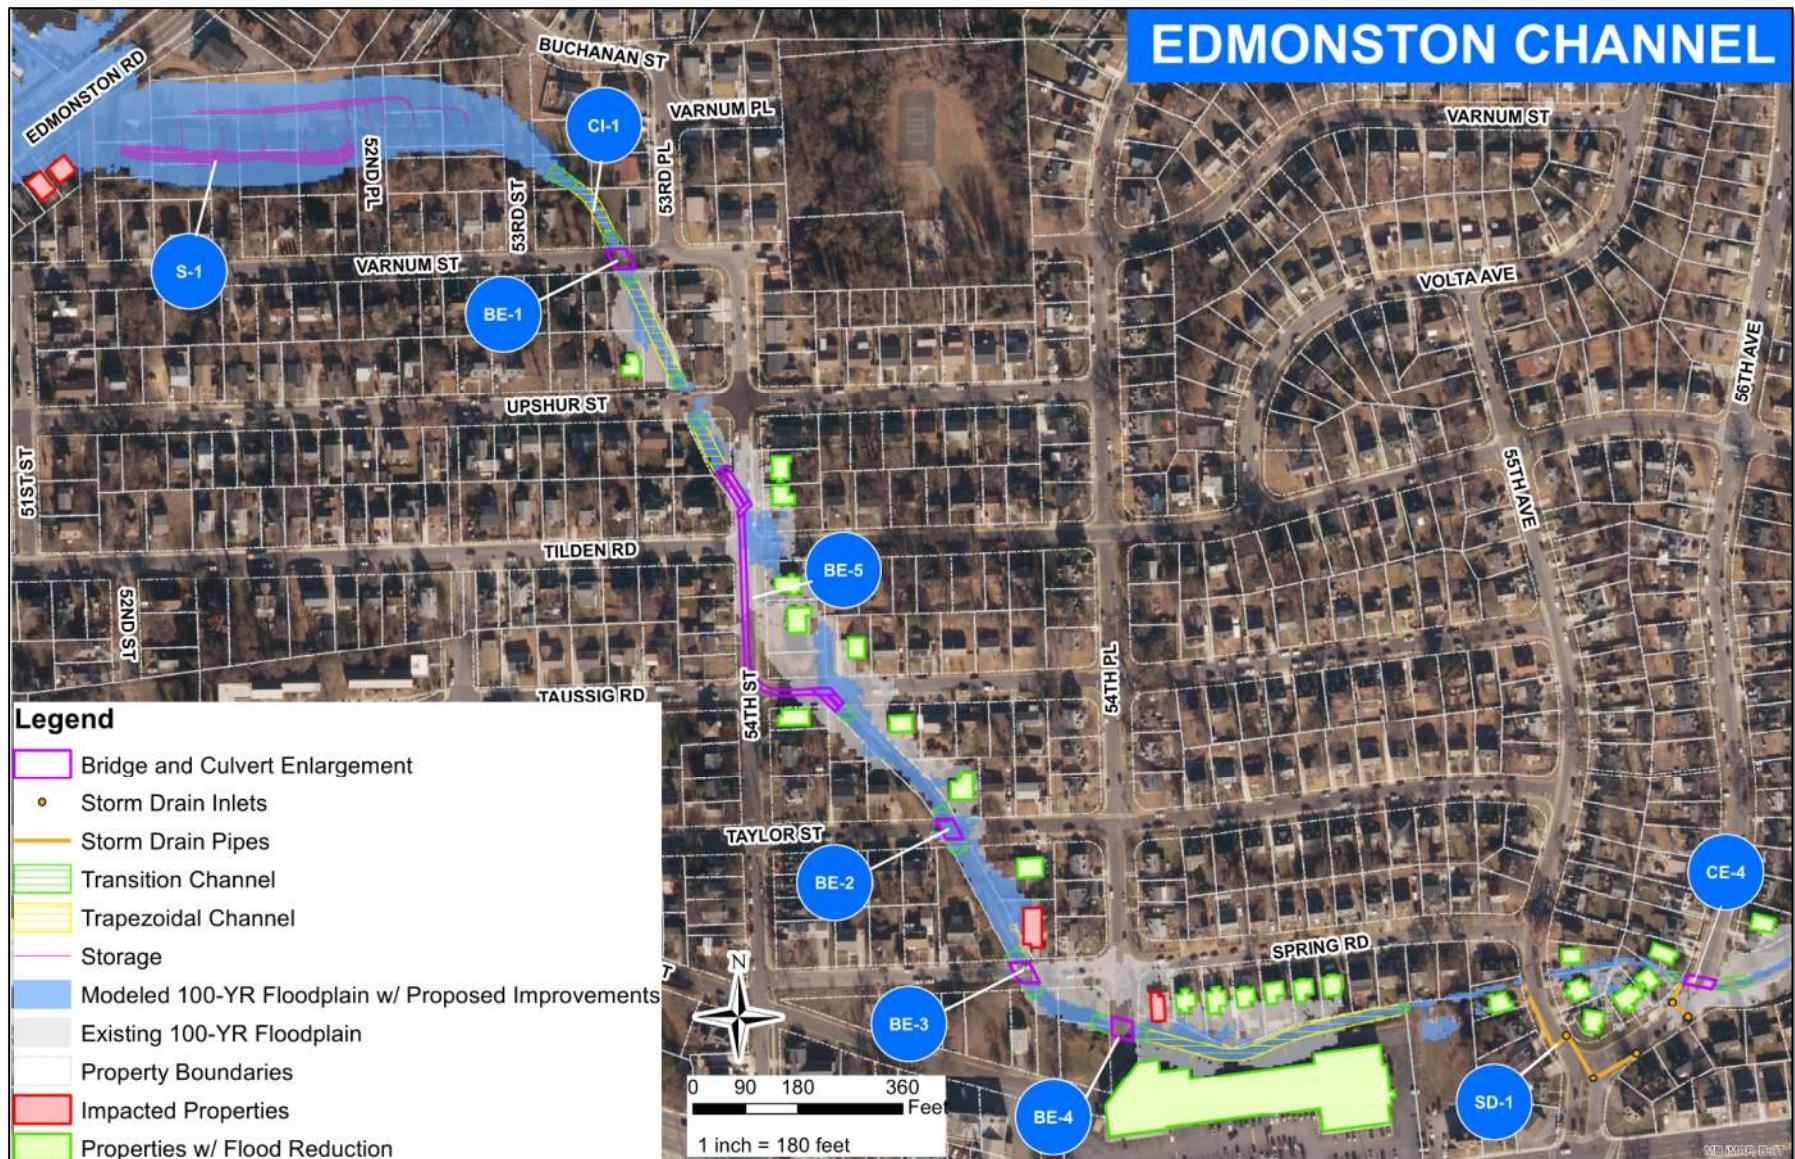
Figure ES-1 Recommended Flood Reduction Improvements for Edmonston Channel

The preliminary designs are expected to reduce 100-year flooding impacts for 25 out of 29 structures along Edmonston Channel by implementing rectangular channel improvements, six bridge and culvert enlargements, one section of storm drain upgrades, and grading of a green space park area upstream of Edmonston Rd. to increase storage during major floods. Likewise for Quincy Run, the proposed stream restoration, permanent floodwall, and bridge enlargement will reduce flooding impacts for all the 7 impacted structures along this channel. The recommended designs for both channels should be implemented from downstream to upstream to prevent worsening flood conditions as upstream conveyance is improved and can be implemented concurrently to meet construction deadlines.

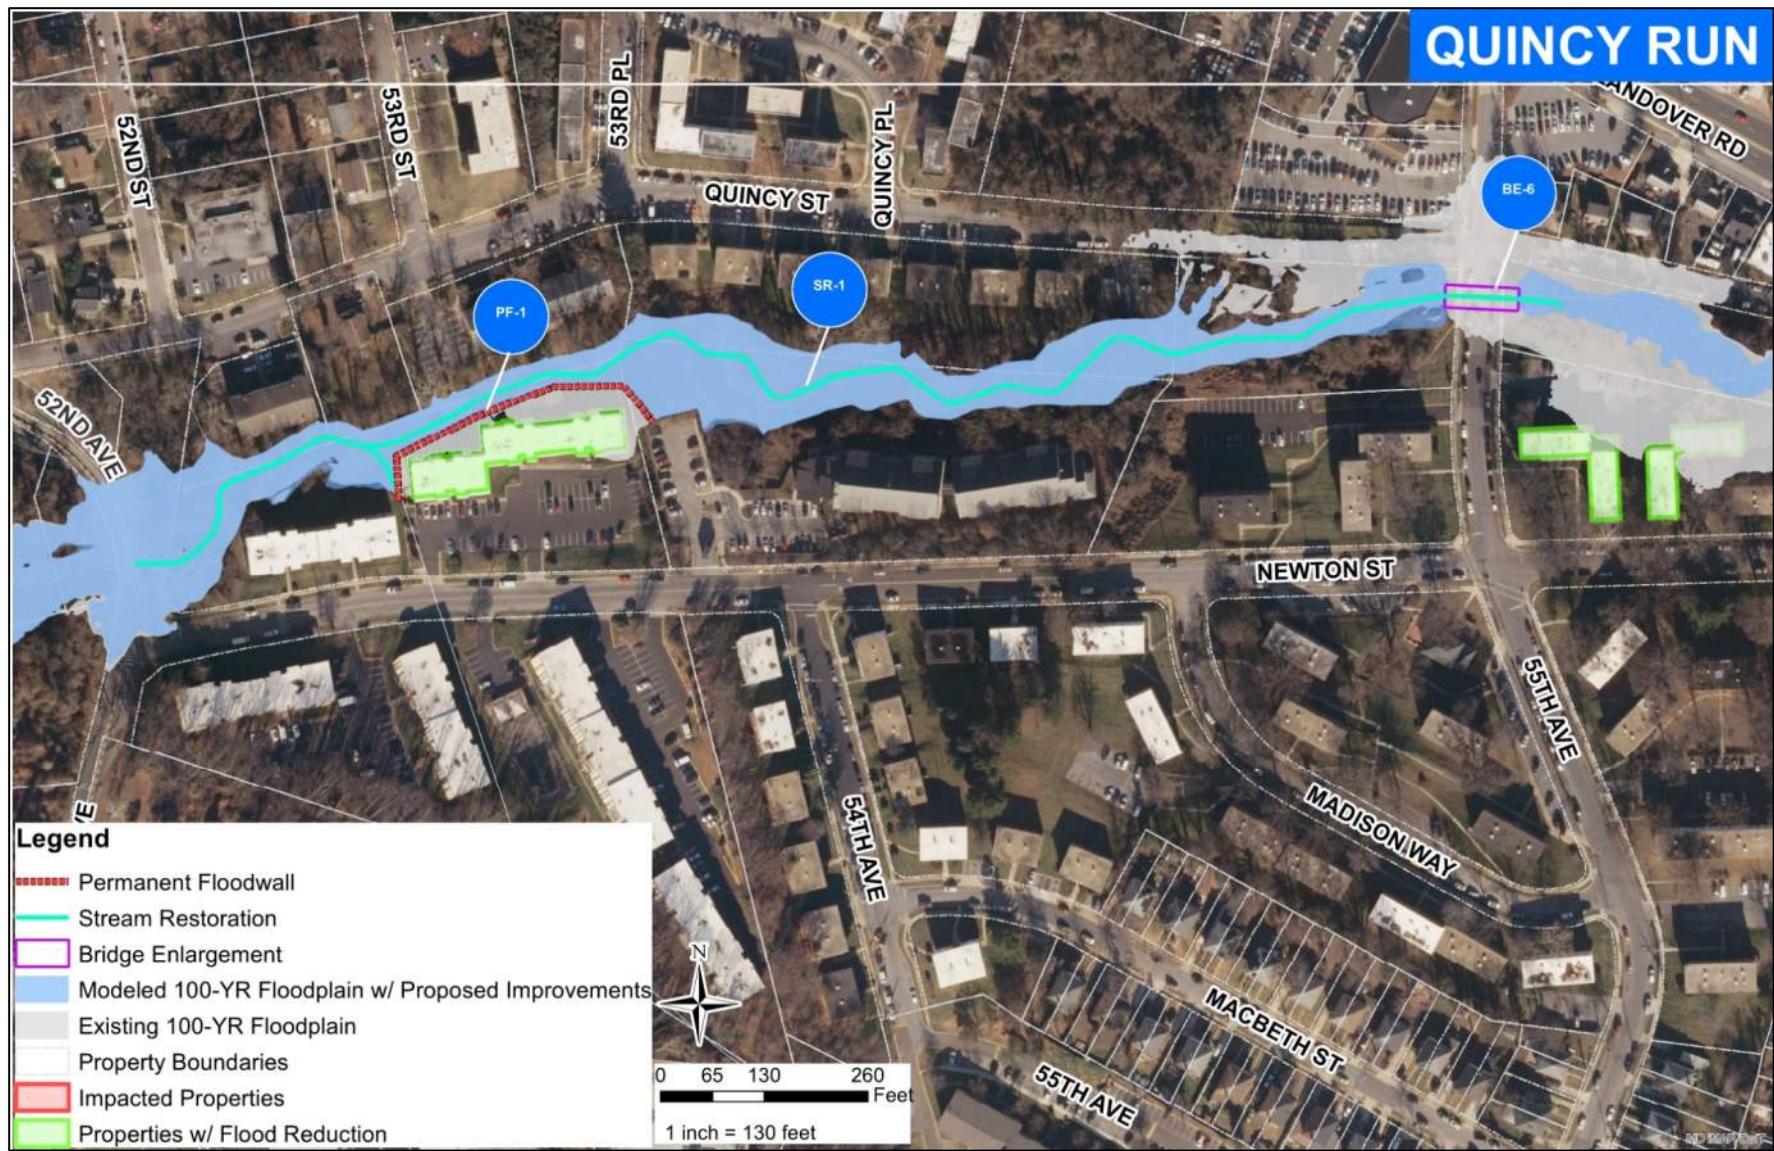
Figure ES-2 Recommended Flood Reduction Improvements for Quincy Run

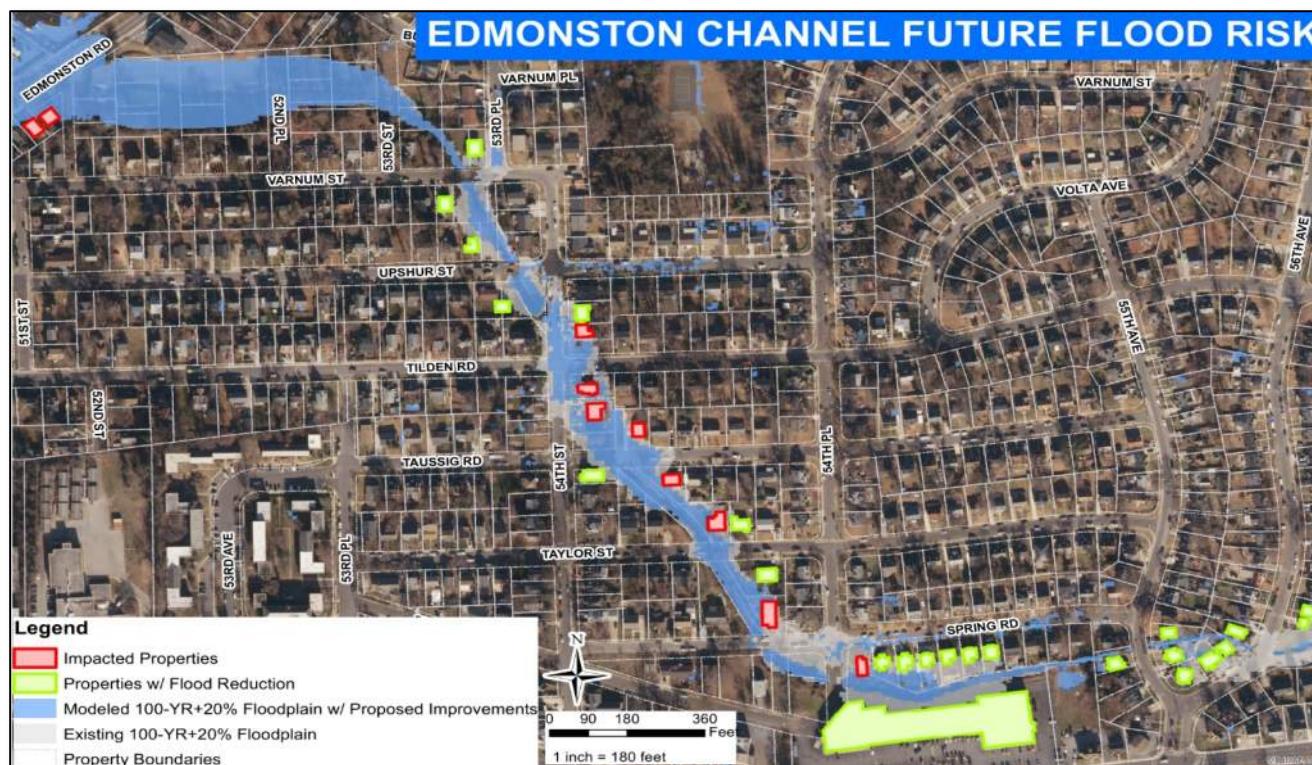
Figure 2-1 Edmonston Channel 100-yr + 20% Flood Risk

To assess future storm impacts on the Edmonston Channel, the 100-year, 24-hr NOAA Atlas 14 precipitation data was increased by 20%. This strategy was implemented in lieu of using NOAA Atlas 15 data which has yet to be released. Under the 100-yr + 20% conditions, 34 structures are projected to be impacted. This is five more than under the existing 100-yr storm event. Implementing the proposed improvements under the 100-yr + 20% conditions would reduce the flood risk for 24 of the 34 structures. Most of the impacted structures are located between Tilden Rd. and Taylor St. therefore, further improving the capacity of the Taussig Culvert (BE-5) and Taylor St. bridge (BE-2) would reduce the flooding risk in this area. Additionally, the weir control structure at Edmonston Rd. would require further improvements to ensure that no adverse downstream impacts occur. Figure 2-1 presents the 100-yr + 20% floodplain during existing and proposed conditions and highlights the impacted structures.

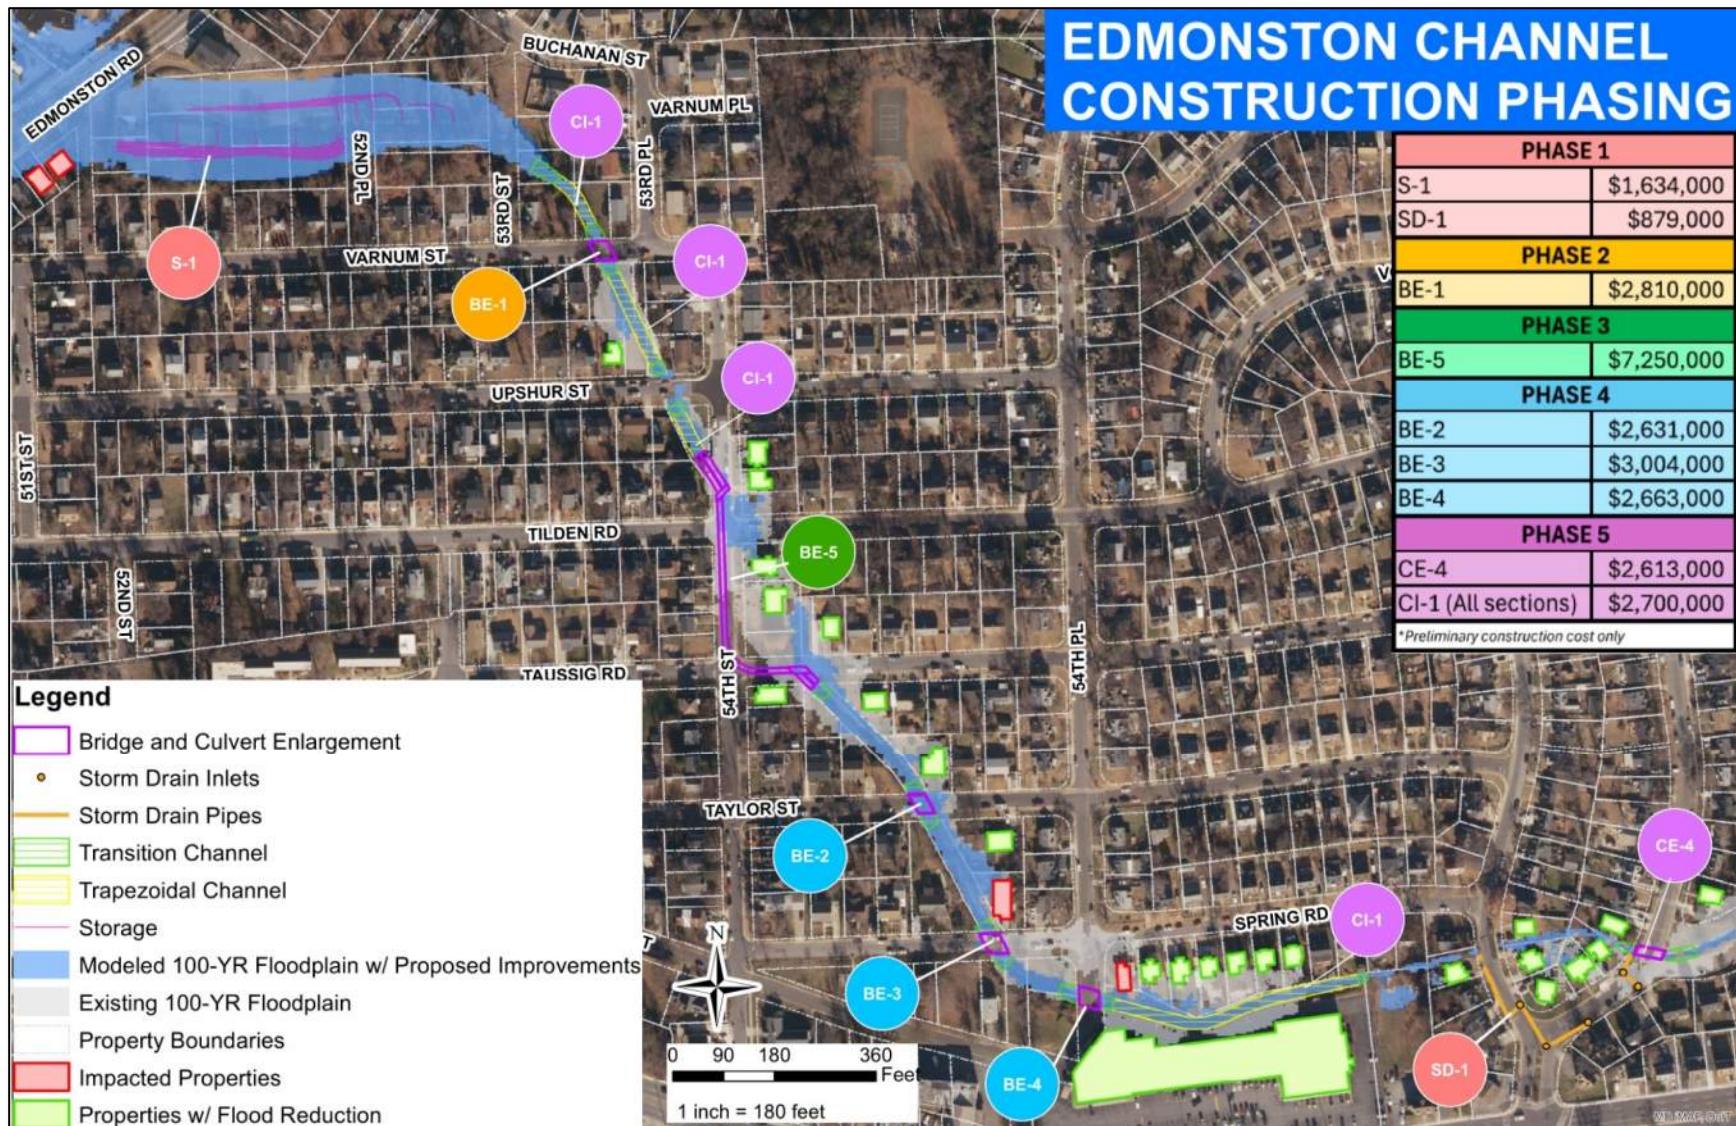
Figure 14-1 Edmonston Channel Project Phasing

The recommended design features should be implemented from downstream to upstream to prevent worsening flood conditions as upstream conveyance is improved. The phasing section outlines the recommended implementation order based on the hydraulic performance of the system, providing a ranked list of design options. Figure 14-1 summarizes the preliminary designs along Edmonston Channel.

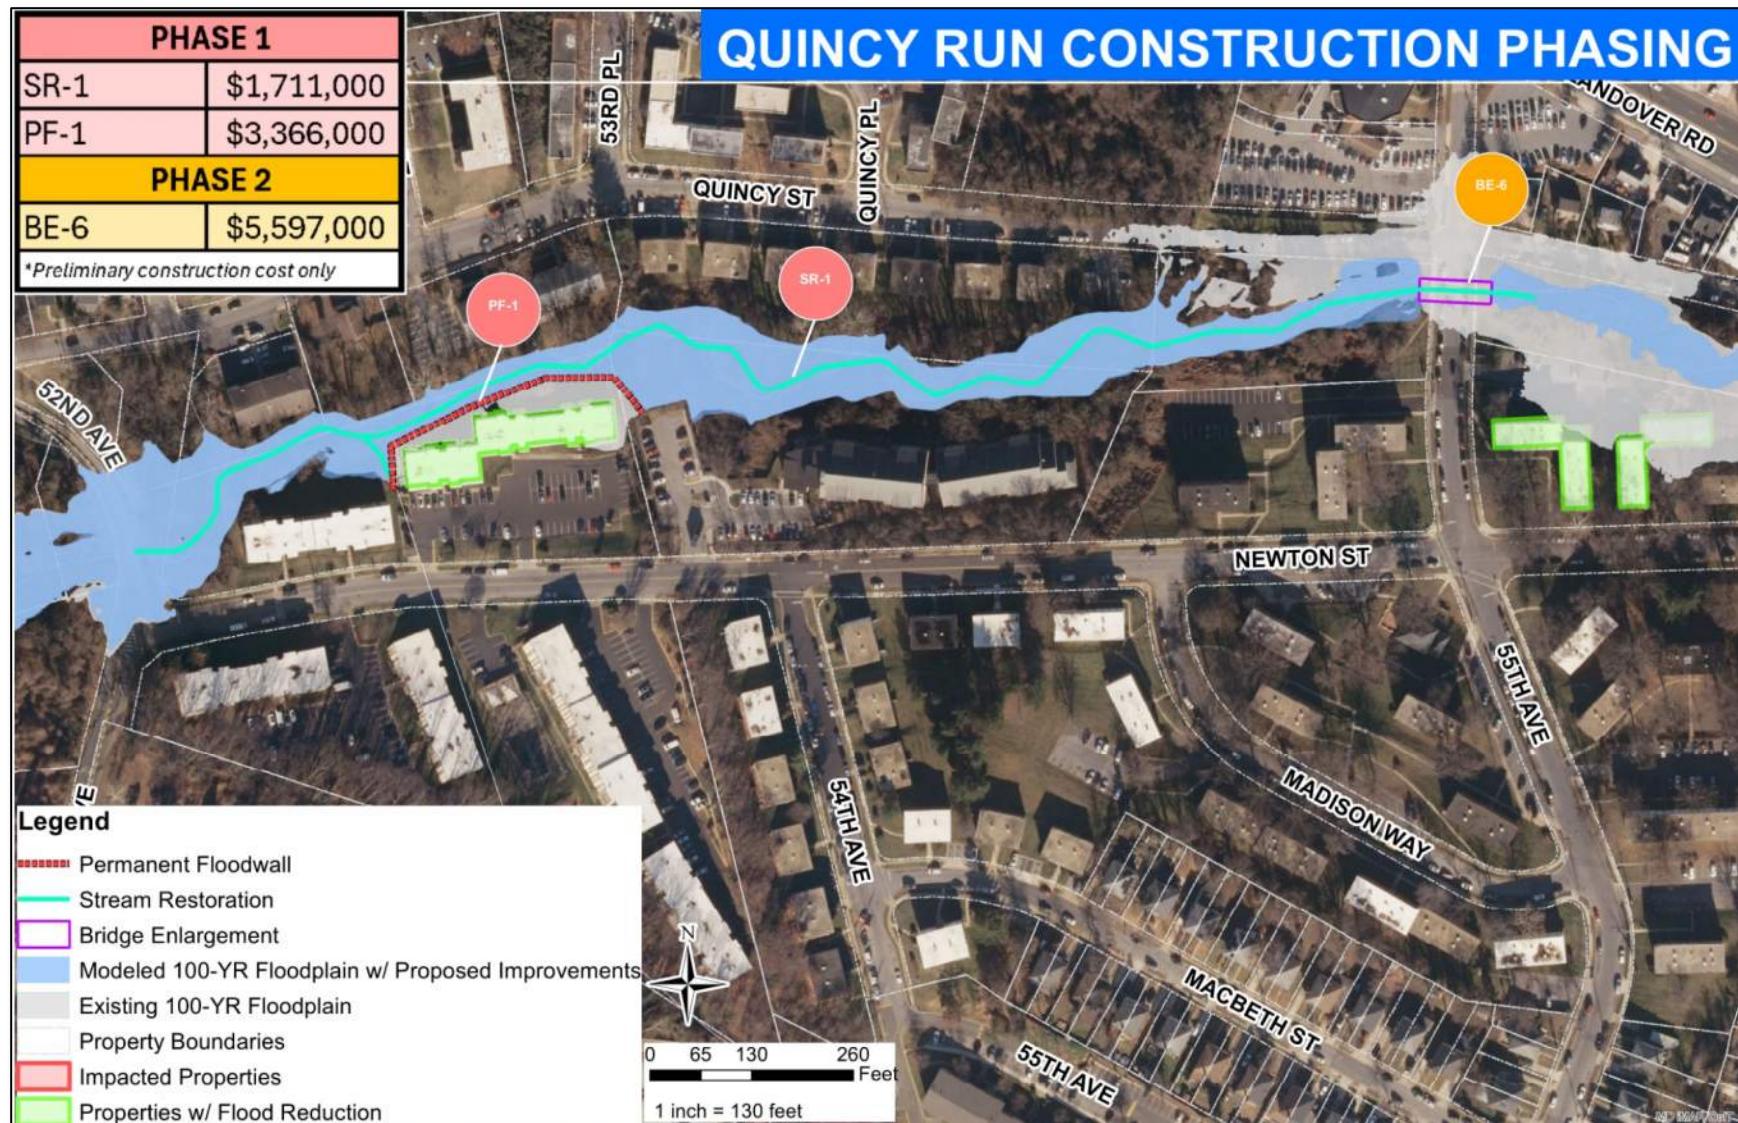
Figure 14-2 Quincy Run Project Phasing

The recommended design features should be implemented from downstream to upstream to prevent worsening flood conditions as upstream conveyance is improved. The phasing section outlines the recommended implementation order based on the hydraulic performance of the system, providing a ranked list of design options. Figure 14-2 summarizes the preliminary designs along Quincy Run.

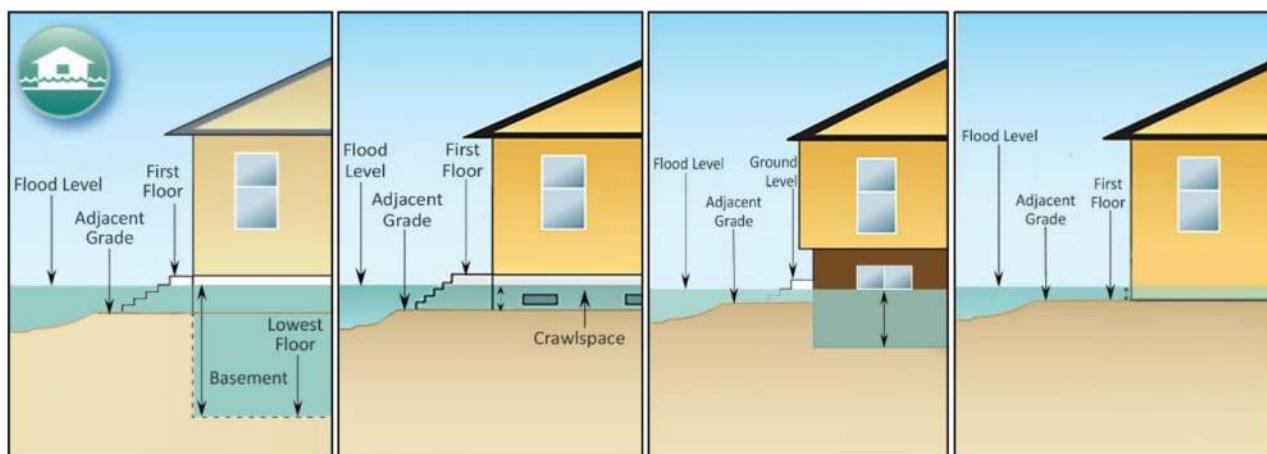
**Property with Subgrade Basement**      **Property with Crawlspace**      **Split level**      **Slab-on-Grade Property**

*The lowest point of entry is the lowest elevation at which floodwater can pour into a lower entry point (i.e., recessed basement door at the of an exterior stairwell) or enter the building directly; (e.g., windows, doors, vents, wall/floor penetrations, or drains).*

Figure 1.3.1 Flood level and critical building elevations by property type

There are several common building types in the Edmonston Channel watershed, including properties with subgrade basements, crawlspaces, split-level homes, and properties without basements (slab-on-grade). Figure 1.3.1 below depicts how these properties could be inundated during a potential 100-year flood event. Floodwater can enter these buildings through doors, windows, wall penetrations, basement wall-to-footing and floor slab joints, or other connection points (both above grade when the flood level exceeds that depth or below grade under conditions where the soil is water-saturated) where a building envelope does not have a watertight seal.

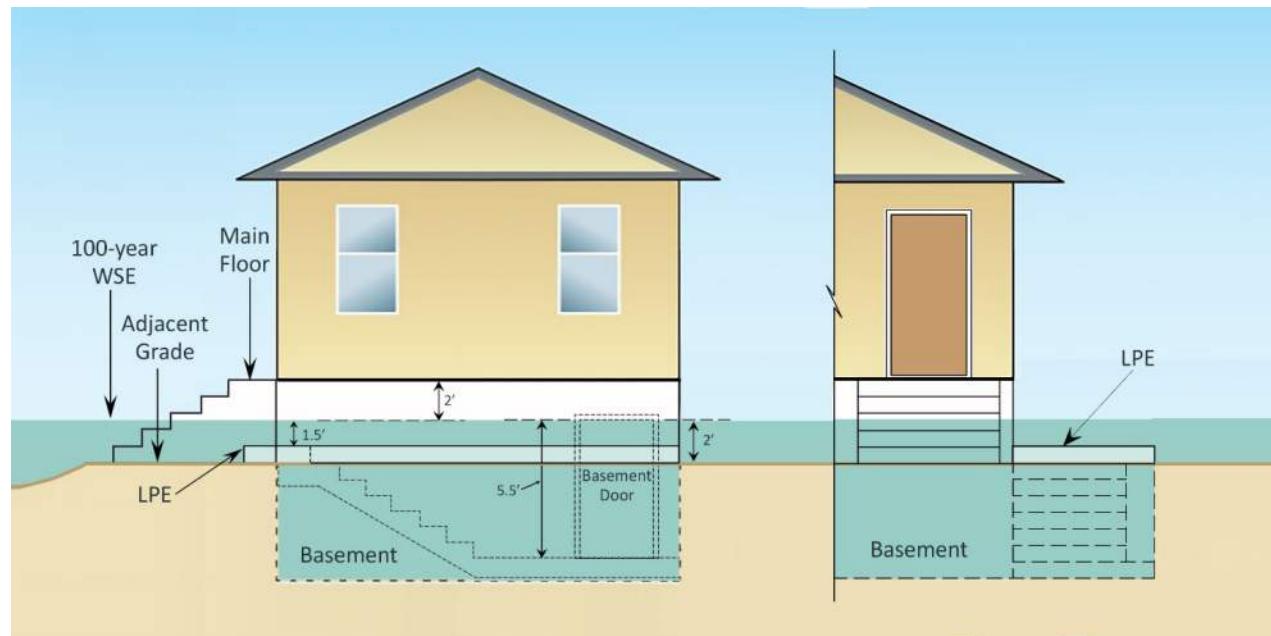
*Figure 1.3.2 Example of critical building elevations relative to 100-year flood level (left: side view; right: front view)*

Table 1.3.1 and Figure 1.3.2 below show an example of critical building elevations relative to the 100-year flood level, as presented for each of the 29 properties in this document.

Item	Elevation	Notes
Main Floor	+2.0 feet	Elevation relative to WSE
<b>100-year Water Surface Elevation (WSE)</b>	<b>58.0 feet</b>	<b>Elevation relative to sea level based on North American Vertical Datum of 1988 measurement</b>
Lowest Point of Entry (LPE)	-1.5 feet	Upper landing to stairs for basement door, elevation relative to WSE
Adjacent Grade	-2.0 feet	Elevation relative to WSE
Basement Door	-5.5 feet	Elevation relative to WSE

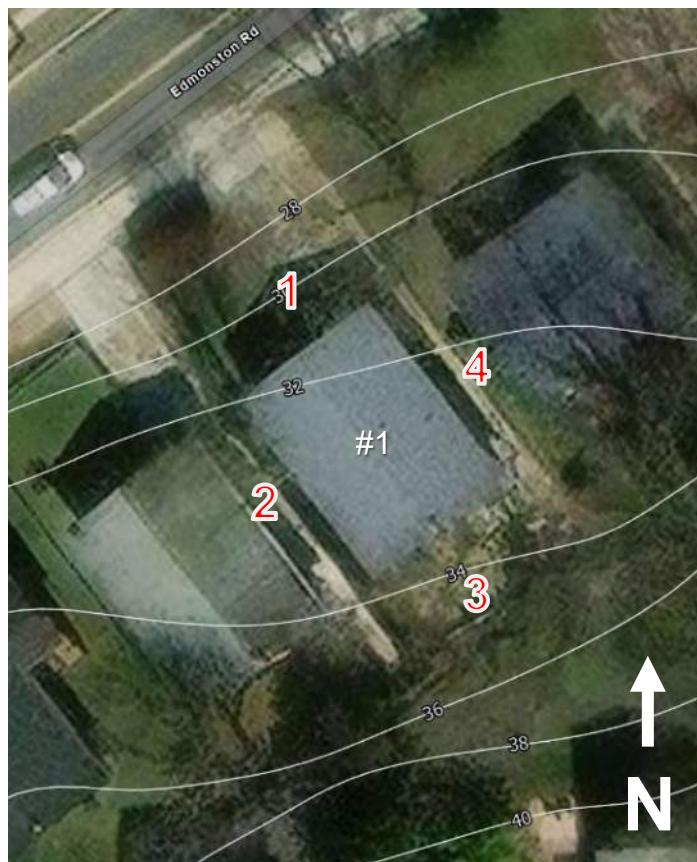
Figure 2.1.1.1 Property #1: Aerial view with elevation contours and photo numbering

The property at 4319 Edmonston Road consists of a one-story building with a first-floor entrance on the northwest side and a lowest floor (basement) entrance on the northeast side. Basement windows are located at the northwest (front), northeast, and southwest sides of the building. There are several wall penetrations, such as a hose bib, dryer vent, and electrical panel. The HVAC unit is located at grade level on the southeast (back) side of the building. Figure 2.1.1.1 below provides an aerial view of the home with topographic elevation contours, and is further depicted in Figure 2.1.1.2, Figure 2.1.1.3, Figure 2.1.1.4, and Figure 2.1.1.5

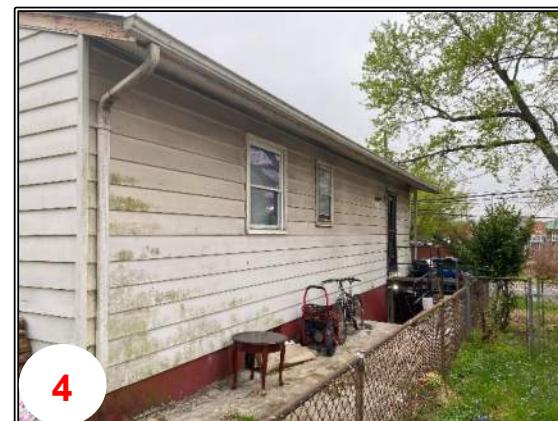
Figure 2.1.1.5 Property #1: Side (northeast side) with side door above and basement door below

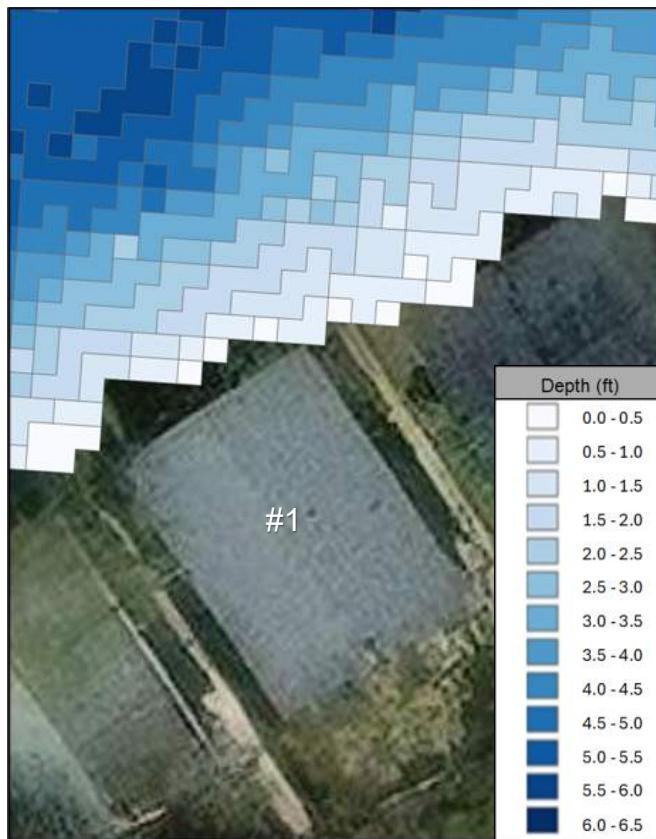
Figure 2.1.2.1 Property #1: 100-year flood depth above grade

The property at 4319 Edmonston Road is located southwest of the Edmonston Channel retention area. Flood modeling indicates that the retention area's capacity is exceeded during the 100-year event, with overland flow moving southwest along Edmonston Road. The 100-year floodplain encroaches on the building's northeast corner at the top of the driveway. See Figure 2.1.2.1. The 100-year flood level is 3.3 feet below the first floor. However, floodwater could potentially enter the basement through a window located on the northwest side. Table 2.1.1 below lists the critical building elevations relative to the 100-year flood level. The lowest point of entry at the basement windowsill is slightly above the 100-year water surface elevation. None of the basement wall penetrations are below the 100-year water surface elevation.

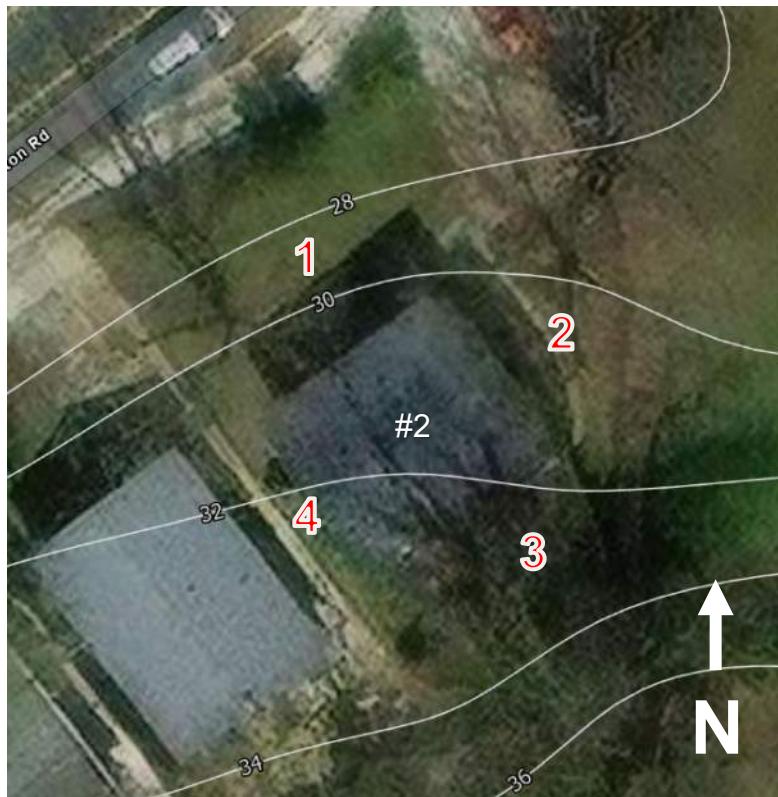
Figure 2.2.1.1 Property #2: Aerial view with elevation contours and photo numbering

The property at 4321 Edmonston Road consists of a split-level building with the front door on the northwest side and ground floor entrance on the southeast side (back). The grade slopes from the backyard towards the front of the house. There are four ground floor windows at the northwest (front) side of the building near grade level. There is an additional window on the back (southeast) side and one on the southwest side of the building, both above grade. The HVAC unit is roughly at grade level on the southwest side of the building. Figure 2.2.1.1 below provides an aerial view of the home with topographic elevation contours, and is further depicted in Figure 2.2.1.2, Figure 2.2.1.3, Figure 2.2.1.4, and Figure 2.2.1.5.

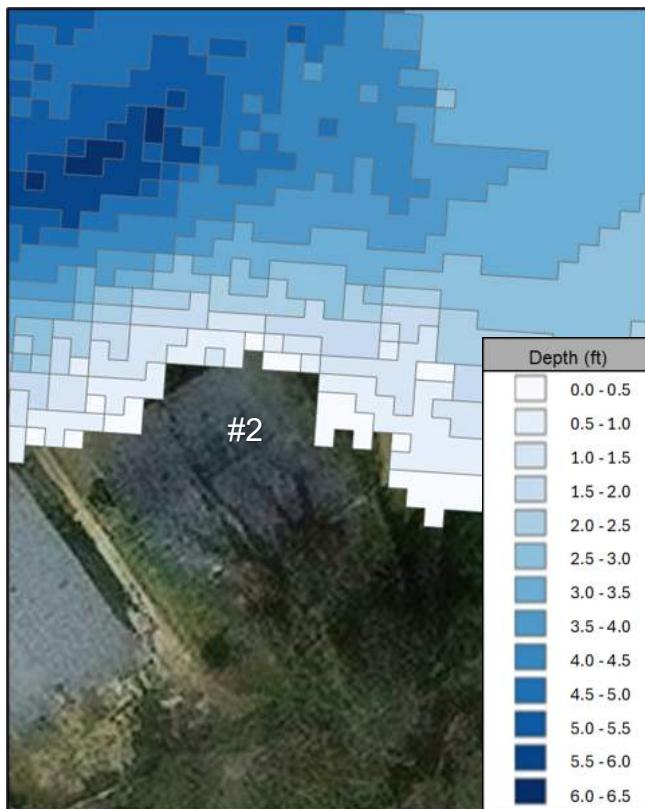
Figure 2.2.2.1 Property #2: 100-year flood depth above grade

The property at 4321 Edmonston Road is located southwest of the Edmonston Channel retention area. Flood modeling indicates that the retention area's capacity will be exceeded in a 100-year event, with overland flow moving southwest along Edmonston Road. The 100-year floodplain extends to the lowest level wall at the northeast and northwest sides of the building. See Figure 2.2.2.1. The 100-year flood level is 2.8 feet below the main floor. However, floodwater could potentially enter through the front door or a window located on the northwest side. Table 2.2.1 below lists the critical building elevations relative to the 100-year flood level. The lowest point of entry at the front door and ground floor windowsill is slightly below the 100-year water surface elevation. An exterior electrical outlet with an elevation similar to the windowsill at the front of the building is also slightly below the 100-year water surface elevation.

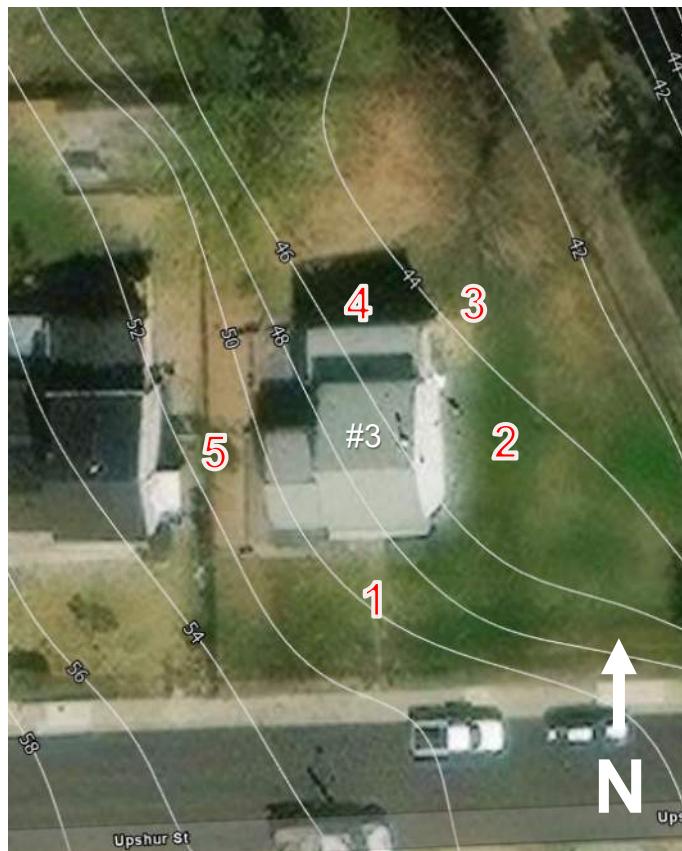
Figure 2.3.1.1 Property #3: Aerial view with elevation contours and photo numbering

The property at 5312 Upshur Street consists of a two-story building with a first-floor addition on the north side (back) of the home. There is a small door under the first-floor addition that likely leads into the basement. The bottom of the door is approximately at grade. There are two electrical panels, one located on the east side and one on the west side of the building, both located a few feet above grade. The east side of the building also has a vent located approximately 2.7 feet above grade along with the HVAC unit at approximately 0.3 feet above grade. The basement is partially finished. Figure 2.3.1.1 below provides an aerial view of the home with topographic elevation contours, and the property is further depicted in Figure 2.3.1.2, Figure 2.3.1.3, Figure 2.3.1.4, Figure 2.3.1.5 and Figure 2.3.1.6.

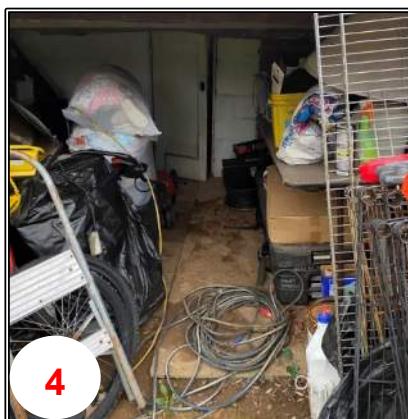
Figure 2.3.1.5 Property #3: Back side (under first-floor addition)

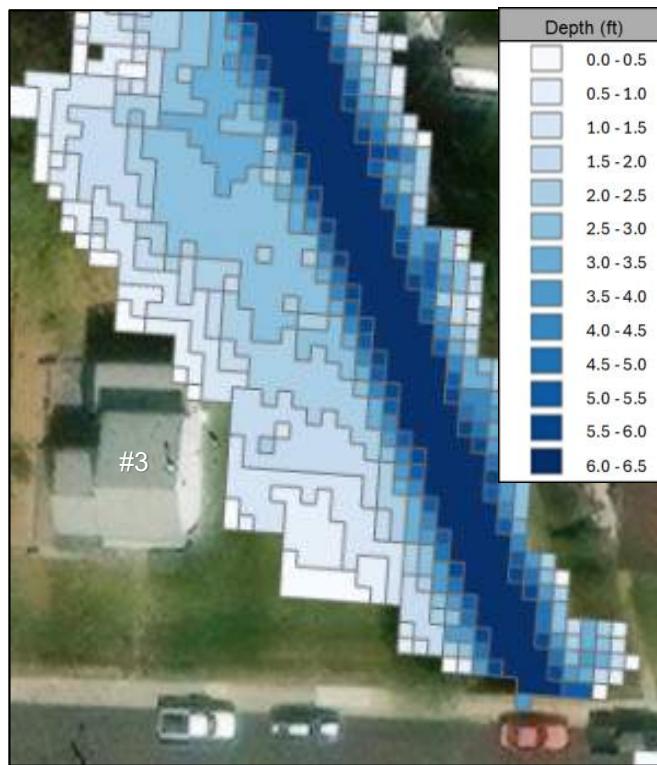
Figure 2.3.2.1 Property #3: 100-year flood depth above grade

The property at 5312 Upshur Street borders the Edmonston Channel on the east side of the property. Floodwater collects in the backyard after encountering blockage at the Varnum Street bridge north of the property. The modeled 100-year flood could extend below the first-floor addition at the building's north side. See Figure 2.3.2.1. Flood modeling indicates that the 100-year flood level is 6.8 feet below the first floor. However, floodwater could potentially enter the basement through a door on the north side. Table 2.3.1 below lists the critical building elevations relative to the 100-year flood level. The lowest point of entry at the basement door is slightly below the 100-year water surface elevation. None of the basement wall penetrations are below the 100-year water surface elevation. The homeowner reported no knowledge of past flooding. Note that the objects under the first-floor addition may have prevented the identification of other flood risks.

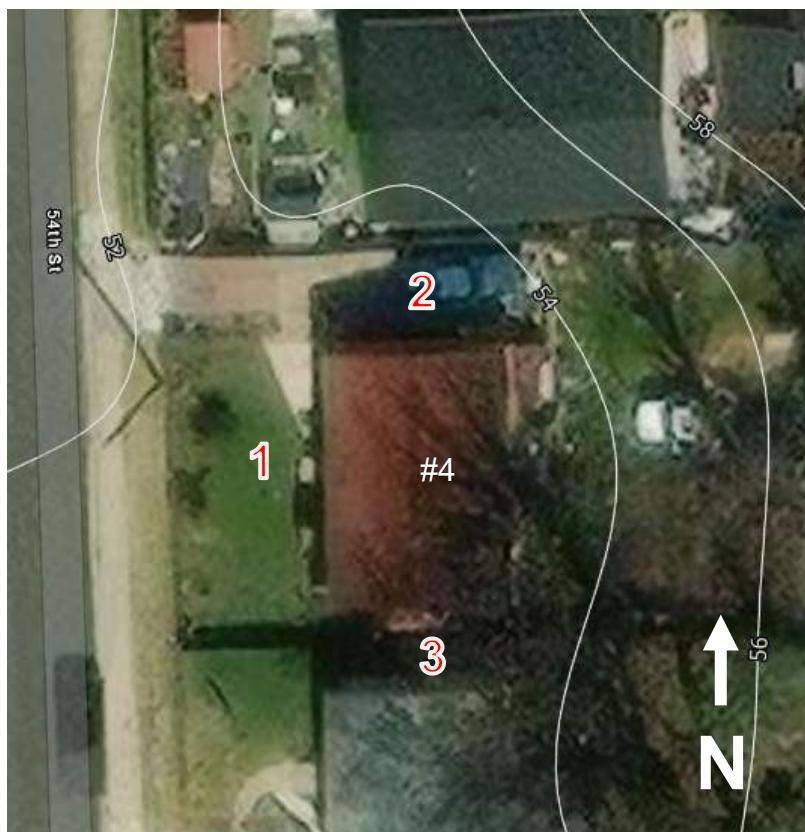
Figure 2.4.1.1 Property #4: Aerial view with elevation contours and photo numbering

The property at 4305 54<sup>th</sup> Street consists of a one-story building with a basement. The basement has a newly installed sump pump system that does not include a battery power backup. According to the homeowner, the sump pump was provided by the local government and drains directly into the Edmonston Channel. The building has a front door elevated at the top of a stair landing on the front (west) side, while a side door is positioned near grade level on the south side. There are two basement windows near grade level with one located on the west side and one on the north side. There is also an electrical panel on the north side of the house positioned a few feet above grade. Figure 2.4.1.1 below provides an aerial view of the home with topographic elevation contours, and the property is further depicted in Figure 2.4.1.2, Figure 2.4.1.3, and Figure 2.4.1.4. Only three sides of the home were photographed as the homeowner did not grant access to the backyard of the property.

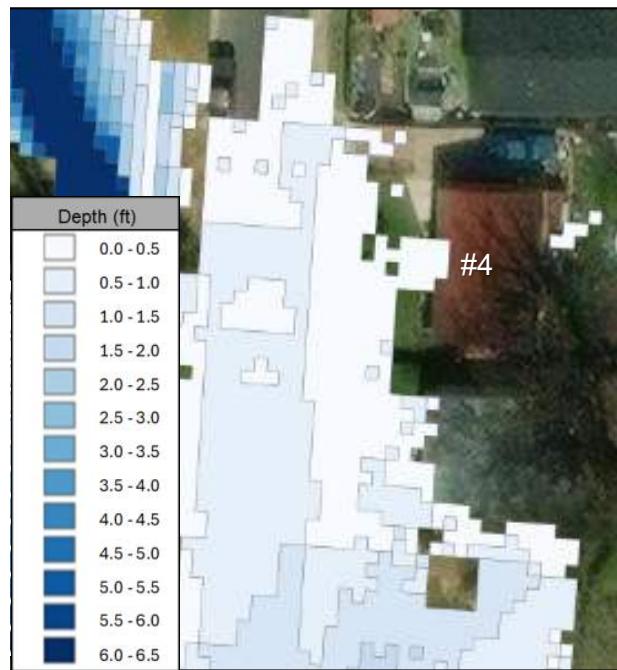
Figure 2.4.2.1 Property #4: 100-year flood depth above grade

Flood modeling indicates that the capacity of the Edmonston Channel culvert at Taussig Road will be exceeded in a 100-year event, as it will cause overland flow northward along 54<sup>th</sup> Street, with floodwater extending to the front (west) building wall of 4305 54<sup>th</sup> Street. See Figure 2.4.2.1. The 100-year flood level is approximately 3 feet below the first floor. Additionally, floodwater will be slightly below the lowest point of entry by 0.2 feet at the basement windowsill on the front (west) side of the building. Table 2.4.1 below lists the critical building elevations relative to the 100-year flood level. None of the basement wall penetrations are below the 100-year water surface elevation. Note that the objects adjacent to the exterior walls may have prevented the identification of other flood risks.

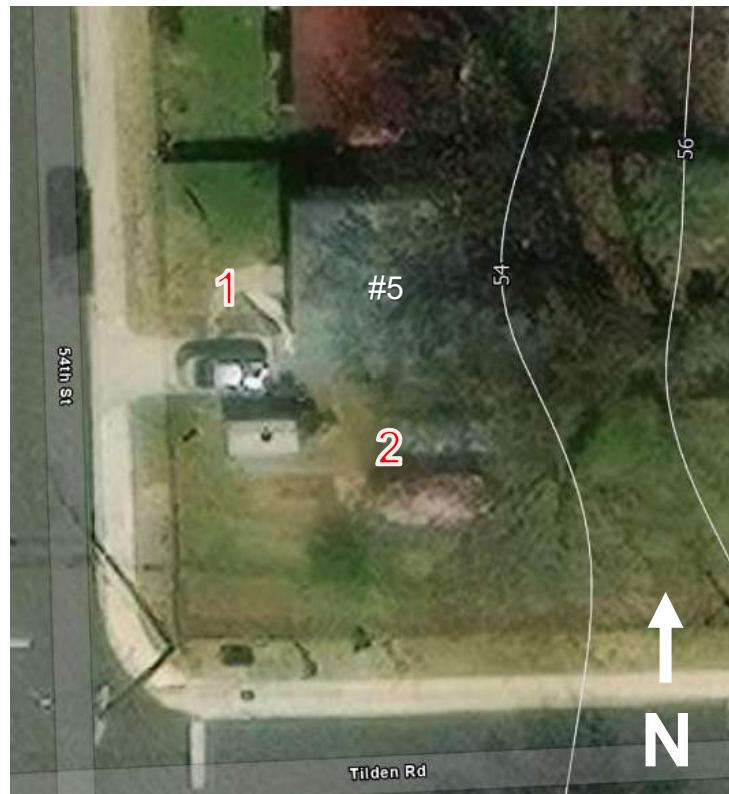
Figure 2.5.1.1 Property #5: Aerial view with elevation contours and photo numbering

The property at 4303 54<sup>th</sup> Street consists of a one-story building with a basement and sump pump. The building has a front door elevated at the top of a stair landing on the front (west) side, while a side door to the building is positioned near grade level on the south side. The building has two basement windows and a hose bib on the front (west) side. A dryer vent penetrates the basement wall approximately 6 inches above grade at the south side. The HVAC unit is located at grade at the southeast corner. Figure 2.5.1.1 below provides an aerial view of the home with topographic elevation contours and the property is further depicted in Figure 2.5.1.2 and Figure 2.5.1.3.

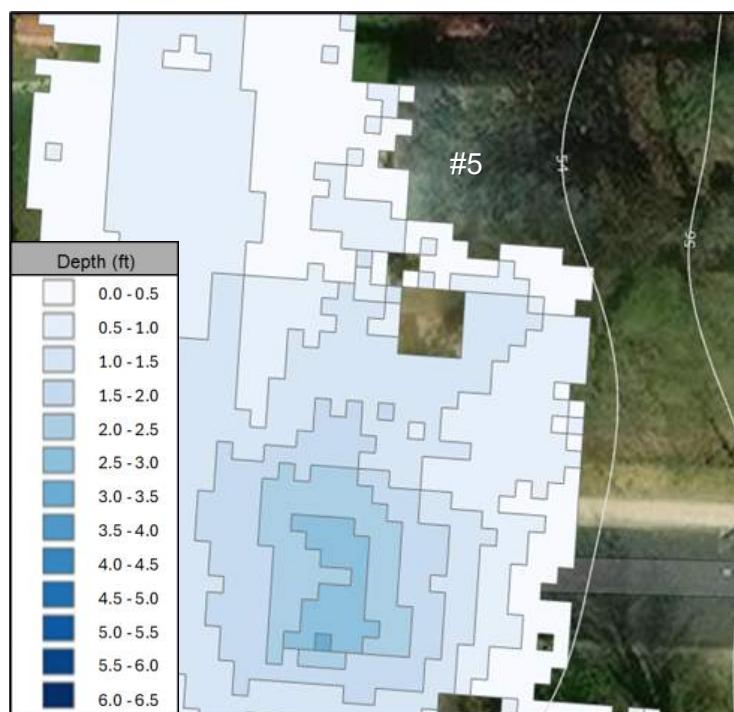
Figure 2.5.2.1 Property #5: 100-year flood depth above grade

Flood modeling indicates that the capacity of the Edmonston Channel culvert at Taussig Road will be exceeded in a 100-year event, as it will cause overland flow northward along 54<sup>th</sup> Street with floodwater extending to the front (west) and south side building walls of 4303 54<sup>th</sup> Street. See Figure 2.5.2.1. The 100-year flood level is 2.7 feet below the first floor. Floodwater could potentially enter the basement through the basement window at the front (west) side. Table 2.5.1 below lists the critical building elevations relative to the 100-year flood level. The lowest point of entry at the basement windowsill is at the 100-year water surface elevation. None of the basement wall penetrations are below the 100-year water surface elevation. Note that the restricted access to the backyard by the fence may have prevented the identification of other flood risks.

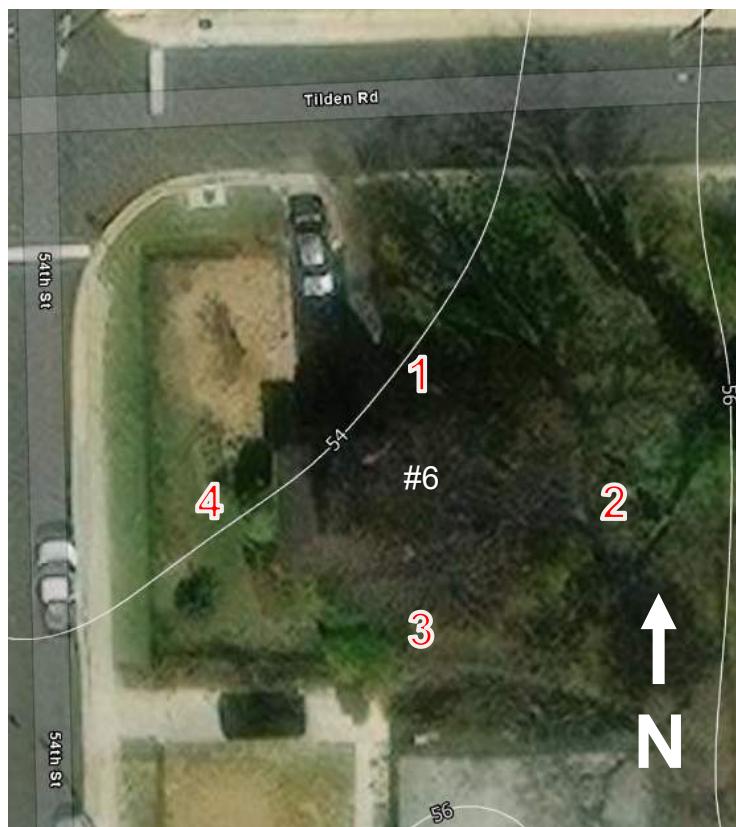
Figure 2.6.1.1 Property #6: Aerial view with elevation contours and photo numbering

The property at 5401 Tilden Road consists of a structural brick building with a garage and basement. Stairs at the front (north) of the house lead up to an elevated front entrance landing. The driveway slopes downward from the road to the garage door at the basement level. The garage door is more than a foot below the top of the driveway. There is a trench drain in front of the garage door. Basement windows are located near grade level at each side of the building. The building has several wall penetrations for cable penetrations, a hose bib, a dryer vent, and an electric meter. Each of these penetrations is more than 18 inches above grade. The HVAC unit is at grade along the back (south) side. Figure 2.6.1.1 below provides an aerial view of the home with topographic elevation contours, and the property is further depicted in Figure 2.6.1.2, Figure 2.6.1.3, Figure 2.6.1.4, and Figure 2.6.1.5.

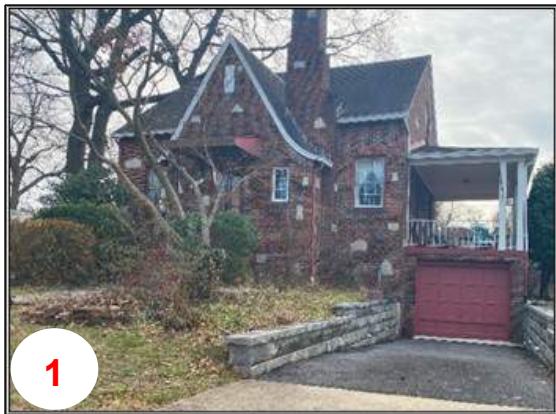
Figure 2.6.1.2 Property #6: Front side (north side)

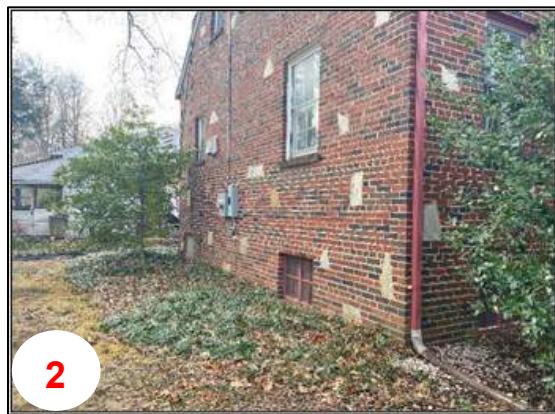
Figure 2.6.1.3 Property #6: Side (east side)

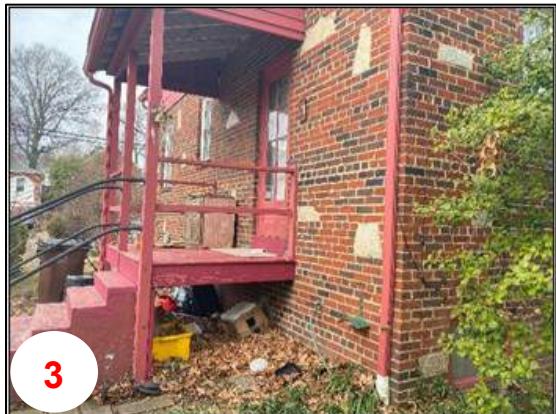
Figure 2.6.1.4 Property #6: Back side (south side)

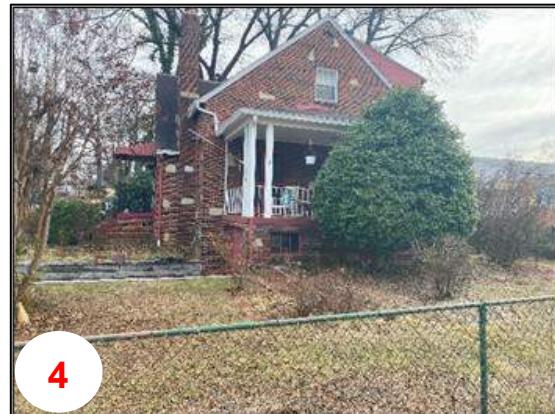
Figure 2.6.1.5 Property #6: Side (west side)
