# Bladensburg Flood Reduction Preliminary Design Report

## Flood Reduction Preliminary Design Report

Residents and property owners along Edmonston Channel and Quincy Run in the Town of Bladensburg, Maryland have experienced repetitive flooding on their properties during heavy rainfall events. Corvias Infrastructure Solutions (CIS), the managing partner for the Clean Water Partnership (CWP) with Prince George's County, Maryland, selected Stantec Consulting Services Inc. (Stantec) to evaluate the causes and severity of flooding and to develop alternatives to reduce flooding which is impacting properties along Edmonston Channel and Quincy Run.

Stantec previously conducted a comprehensive analysis and presented its findings and recommendations in the *Bladensburg Flood Reduction Alternatives Evaluation Report*, dated October 2024. This report advances the selected alternatives for Edmonston Channel (Figure ES-1) and Quincy Run (Figure ES-2) from the evaluation study into the preliminary design phase, incorporating surveyed topographic and subsurface utility data to further refine and optimize the designs.

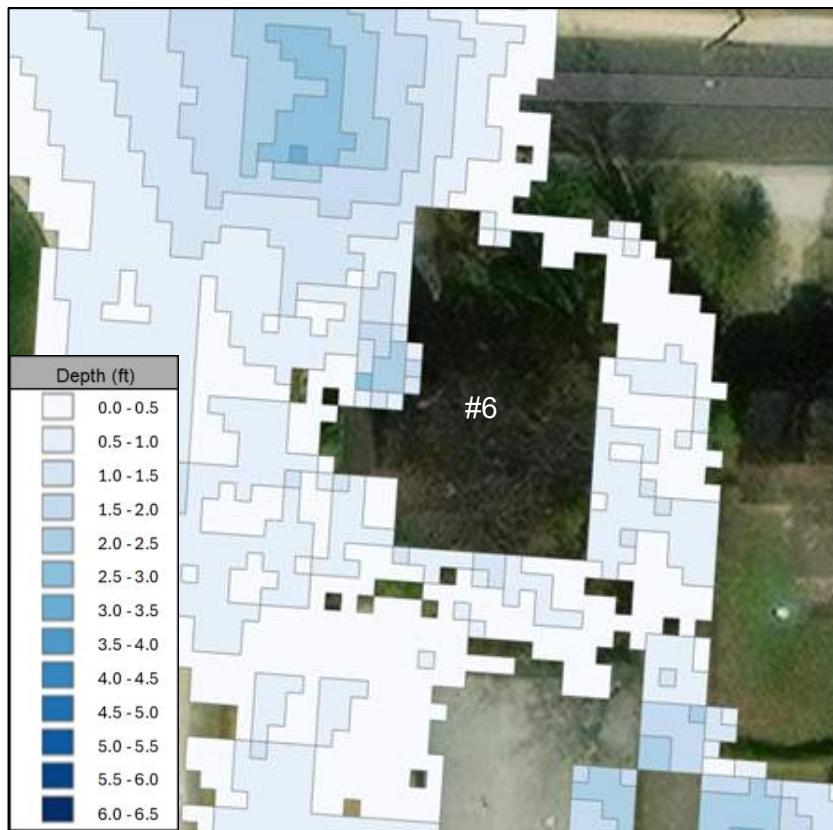
Figure 2.6.2.1 Property #6: 100-year flood depth above grade

Flood modeling indicates that the capacity of the Edmonston Channel culvert at Taussig Road will be exceeded in a 100-year event, as it will cause overland flow northward along 54<sup>th</sup> Street, with floodwater surrounding the building at 5401 Tilden Road. See Figure 2.6.2.1. The 100-year flood level is 2.8 feet below the first floor. However, the floodwater depth of 5.7 feet above the bottom of the garage door poses significant threat to the building. Floodwater would likely enter the basement through the garage at the front (north) side and basement windows on all four sides of the building. The basement windowsills are approximately 1 foot below the 100-year flood level. The HVAC unit at the back (south) side of the building is at risk to floodwater as well. Table 2.6.1 below lists the critical building elevations relative to the 100-year flood level. The lowest point of entry at the driveway would be the first location floodwater would exceed a critical elevation and begin to pose a flooding threat to the garage and basement. This location is approximately 4.7 feet below the 100-year water surface elevation. Also, a dryer vent with an elevation similar to the 100-year water surface elevation is at risk to floodwater. Note that the objects adjacent to the exterior walls may have prevented the identification of other flood risks.

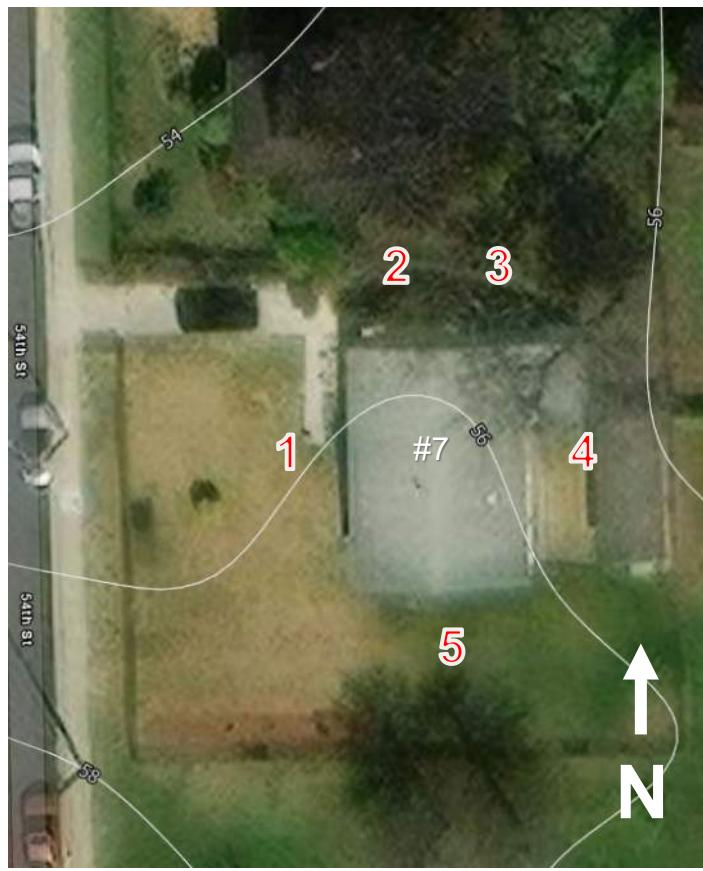
Figure 2.7.1.1 Property #7: Aerial view with elevation contours and photo numbering

The property at 4211 54<sup>th</sup> Street consists of a single-story brick veneer building with a basement door on the north side. A sump pump is located next to the basement door. Basement windows are located near grade level at each side of the building. Several of the basement windows are covered with boards on the back (east) side of the home. An addition to the home was added on the northeast end, which has an additional door at grade. The HVAC unit is located on the back (east) side at grade. There are exterior basement wall penetrations on the north, east, and south sides of the building for a plumbing pipe, electrical service, cable, hose bib, and a stairwell fixture. Figure 2.7.1.1 below provides an aerial view of the home with topographic elevation contours, and the property is further depicted in Figure 2.7.1.2, Figure 2.7.1.3, Figure 2.7.1.4, Figure 2.7.1.5 and Figure 2.7.1.6.

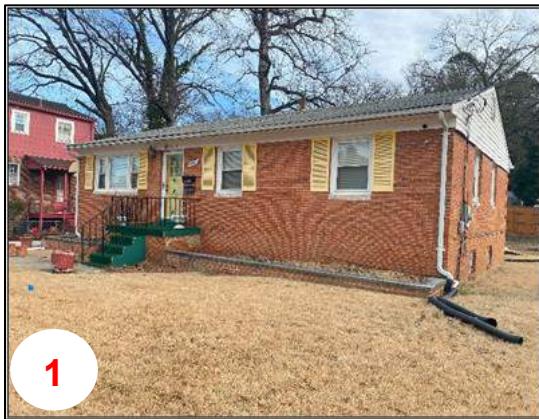
Figure 2.7.1.2 Property #7: Front side (west side)

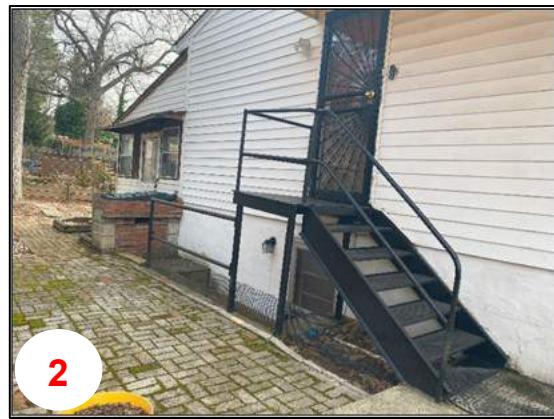
Figure 2.7.1.3 Property #7: Side (north side)

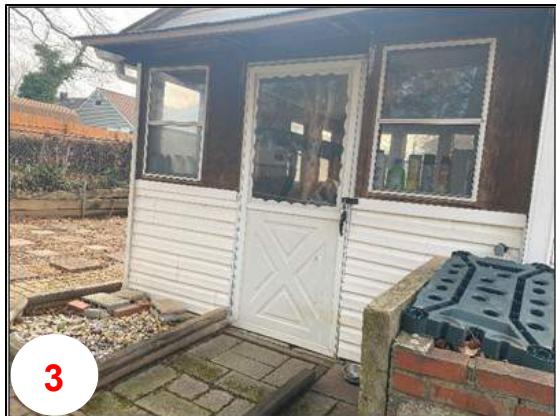
Figure 2.7.1.4 Property #7: Side addition (north)

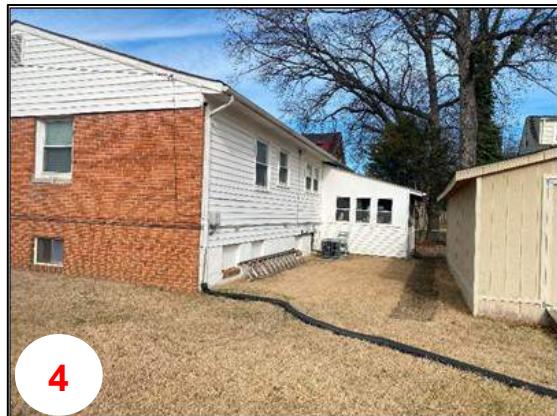
Figure 2.7.1.5 Property #7: Back (east side)

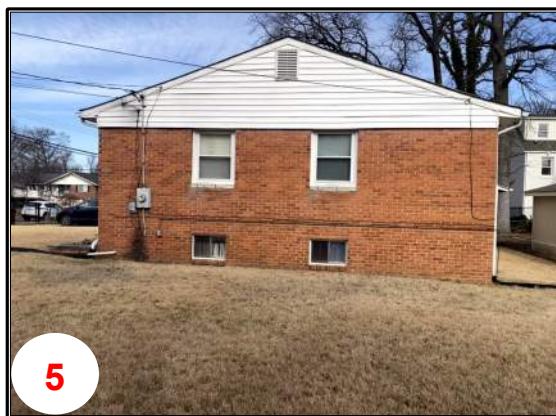
Figure 2.7.1.6 Property #7: Side (south)

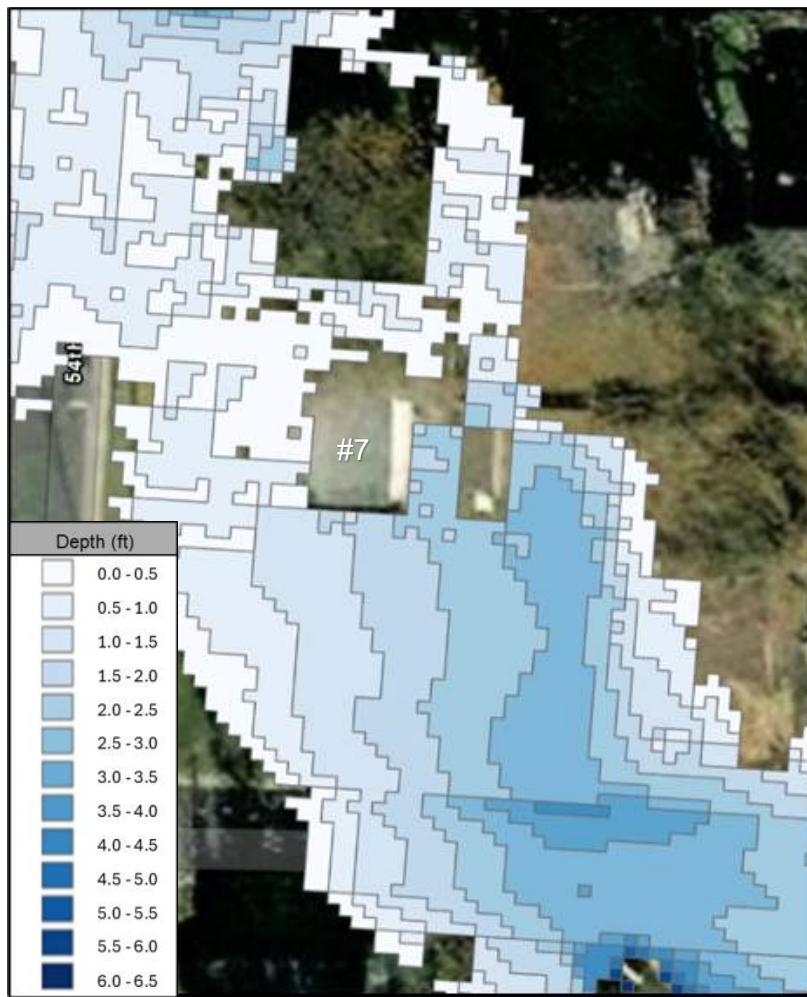
Figure 2.7.2.1 Property #7: 100-year flood depth above grade

Flood modeling indicates that the capacity of the Edmonston Channel culvert at Taussig Road will be exceeded in a 100-year event, as it will cause overland flow northward along 54<sup>th</sup> Street with floodwater surrounding the building at 4211 54<sup>th</sup> Street. See Figure 2.7.2.1. The 100-year flood level is approximately 1.5 feet below the first floor. Floodwater will likely enter the basement through the basement door at the north side and basement windows at the south and east sides of the building. The basement windows are approximately 1.6 feet below the 100-year flood level. The addition at the back (east) side is at risk to floodwater entering the building, with the exterior door approximately 1.3 feet below the 100-year flood level. The HVAC unit at the back (east) side of the building is approximately 2 feet below the 100-year flood level. Table 2.7.1 below lists the critical building elevations relative to the 100-year flood level. The lowest point of entry at the upper stair landing to the basement door would be the first location floodwater would exceed a critical elevation and begin to pose a flooding threat to the basement. This location is below the 100-year water surface elevation by 2.4 feet. The basement door is 7 feet below the 100-year water surface elevation. Also, a couple of the basement wall penetrations are below the 100-year water surface elevation, including the plumbing pipe and cable at the south side.

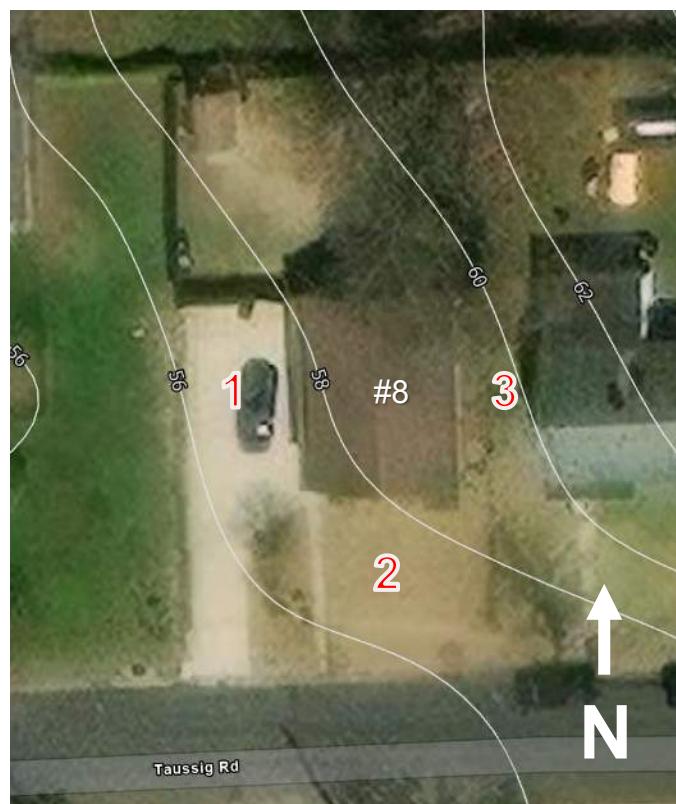
Figure 2.8.1.1 Property #8: Aerial view with elevation contours and photo numbering

The property at 5404 Taussig Road consists of a one-story building with a crawlspace. The front entrance has steps leading up to the front door along the front (west) side. Nearby there is a boarded opening to the crawlspace located a few inches above grade. The building has ventilation vents for the crawlspace just below the first floor that allow airflow in and out of the crawlspace. The east side of the building has a door and HVAC unit approximately 0.5 feet above grade. Figure 2.8.1.1 below provides an aerial view of the home with topographic elevation contours, and the property is further depicted in Figure 2.8.1.2, Figure 2.8.1.3 and Figure 2.8.1.4. Only three sides of the home were photographed as the homeowner did not grant access to the backyard of the property.

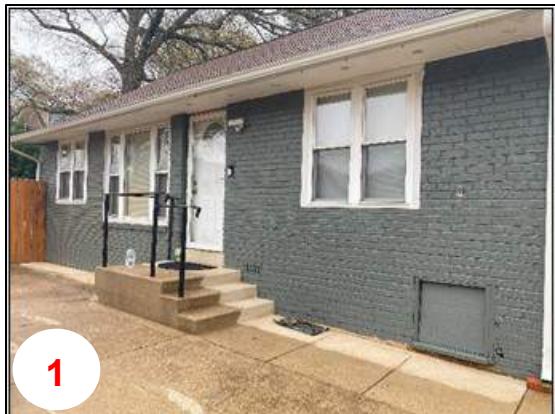
Figure 2.8.1.2 Property #8: Front side (west side)

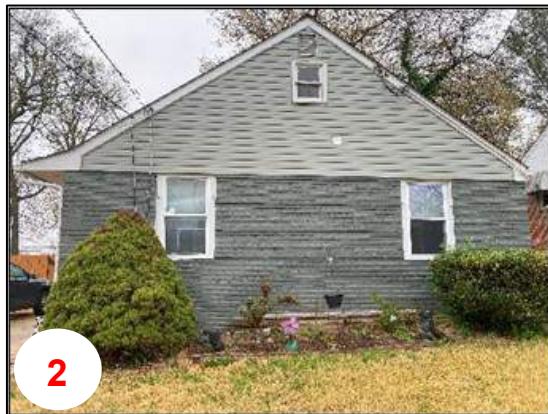
Figure 2.8.1.3 Property #8: Side (south side)

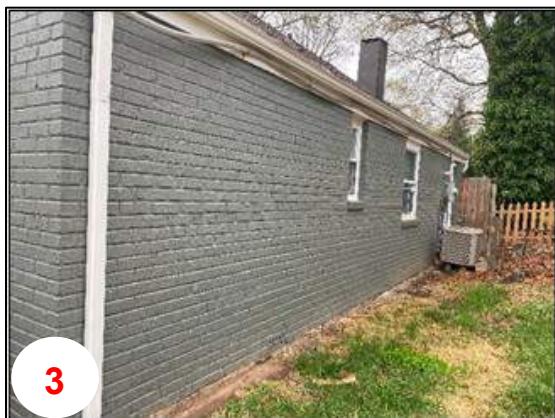
Figure 2.8.1.4 Property #8: Side (east side)

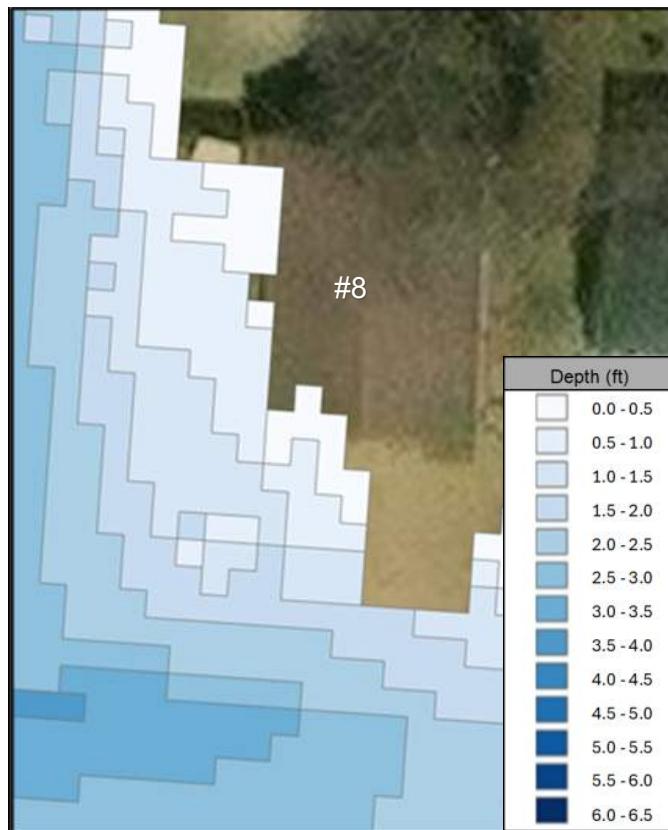
Figure 2.8.2.1 Property #8: 100-year flood depth above grade

Flood modeling indicates that the capacity of the Edmonston Channel culvert at Taussig Road will be exceeded in a 100-year event, as it will cause overland flow northward such that floodwater extends to the front (west) and south sides of the building at 5404 Taussig Road. The 100-year flood level is approximately 1.1 feet below the first floor. A 100-year event could inundate the crawlspace with approximately 1 foot of water as it potentially enters through the boarded opening on the front (west) side of the home.

Figure 2.8.2.1 shows the modeled 100-year flood depth near the building. Table 2.8.1 below lists the critical building elevations relative to the 100-year flood level. The lowest point of entry at the crawlspace door is approximately 0.8 feet below the 100-year water surface elevation. None of the wall penetrations are below the 100-year water surface elevation.

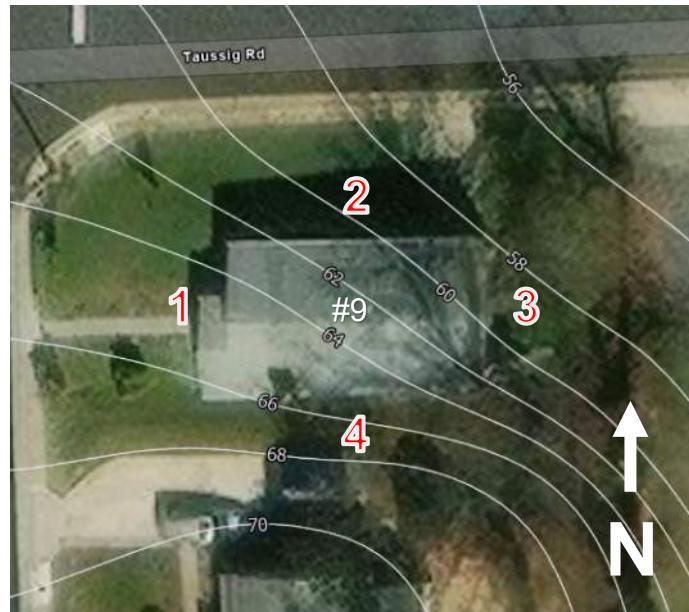
Figure 2.9.1.1 Property #9: Aerial view with elevation contours and photo numbering

The Property at 4209 54<sup>th</sup> Street consists of a one-story building with a basement. A garage door on the north side of the home is connected to the basement level and is at grade. There are two basement windows on the north side as well as several wall penetrations such as an electric meter, cable, dryer vent, and hose bib. Each of these penetrations is at least 2.5 feet above the basement floor. The HVAC unit is at grade on the south side. Figure 2.9.1.1 below provides an aerial view of the home with topographic elevation contours, and the property is further depicted in Figure 2.9.1.2, Figure 2.9.1.3, Figure 2.9.1.4, and Figure 2.9.1.5.

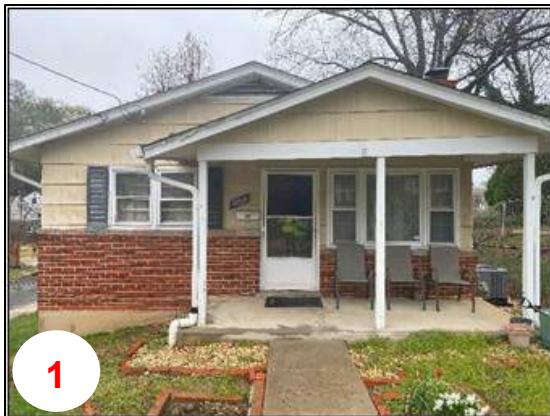
Figure 2.9.1.2 Property #9: Front side (west side)

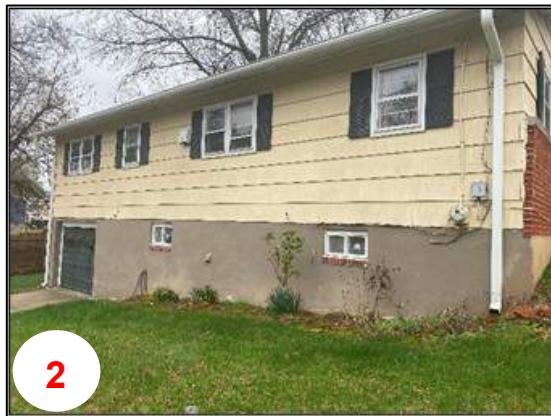
Figure 2.9.1.3 Property #9: Side (north side)

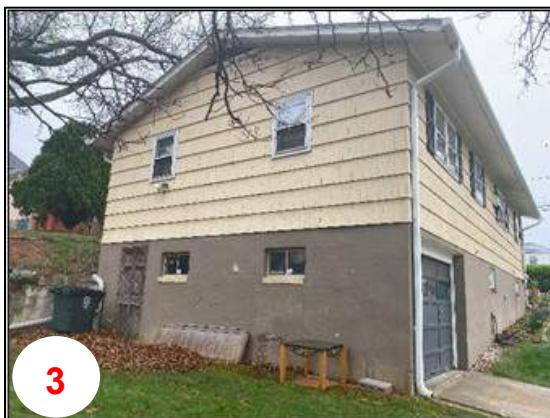
Figure 2.9.1.4 Property #9: Back side (east side)

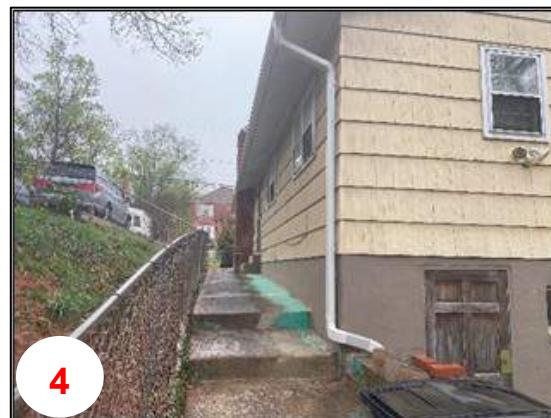
Figure 2.9.1.5 Property #9: Side (south side)

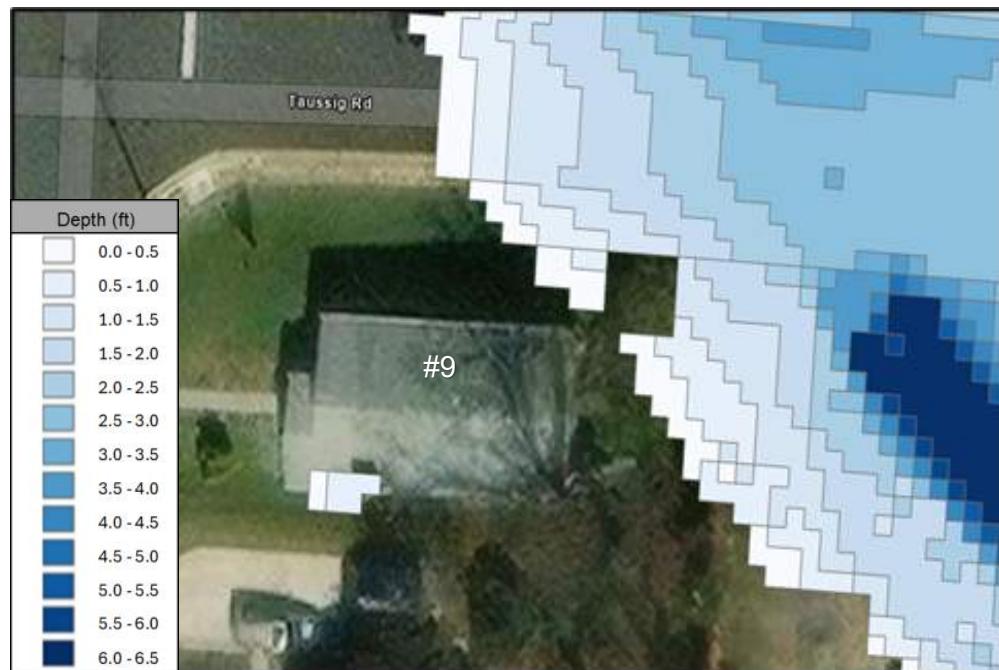
Figure 2.9.2.1 Property #9: 100-year flood depth above grade

The property at 4209 54<sup>th</sup> Street borders the Edmonston Channel on the back (east) side of the property near the Edmonston Channel culvert at Taussig Road where it transitions underground. Flood modeling indicates that the capacity of the Edmonston Channel culvert at Taussig Road will be exceeded in a 100-year event, as it will cause floodwater to encroach on the northeast corner of the building. The 100-year flood level is 8 feet below the first floor. However, floodwater could potentially enter the basement through the basement door at the back (east) side and the garage door at the north side. Figure 2.9.2.1 shows the modeled 100-year flood depth to be approximately 0.5 feet above the nearest adjacent grade to the building. Table 2.9.1 below lists the critical building elevations relative to the 100-year flood level. The lowest point of entry at the basement garage is approximately 0.4 feet below the 100-year water surface elevation. None of the basement wall penetrations are below the 100-year water surface elevation. According to the resident, there has been no flooding of the building.

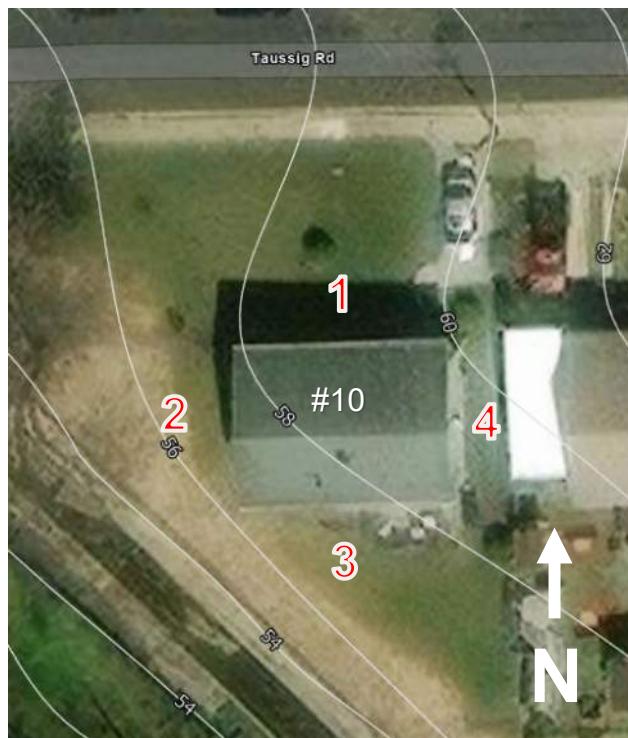
Figure 2.10.1.1 Property #10: Aerial view with elevation contours and photo numbering

The property at 5409 Taussig Road consists of a split-level building. There are ground floor windows at the front (north), east, and back (south) sides. The exterior wall at the back (south) side has penetrations for hose bibs, a dryer vent, and electrical service. At the back (south) side the basement door is below grade and accessed by way of an exterior step. Figure 2.10.1.1 below provides an aerial view of the home with topographic elevation contours, and the property is further depicted in Figure 2.10.1.2, Figure 2.10.1.3, Figure 2.10.1.4, and Figure 2.10.1.5.

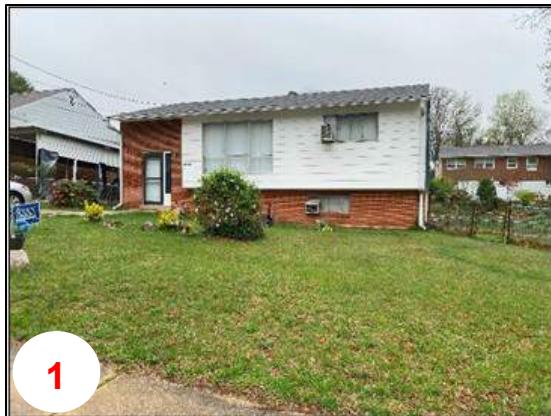
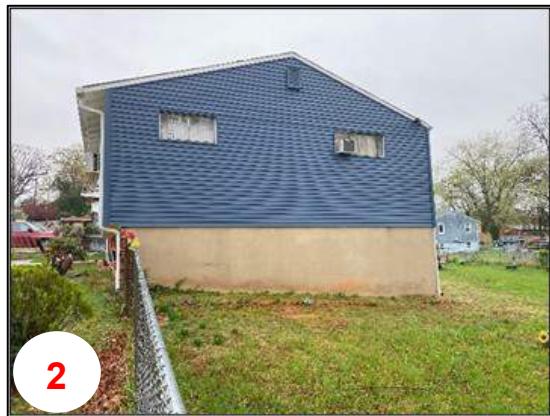
Figure 2.10.1.2 Property #10: Front side (north side) Figure 2.10.1.3 Property #10: Side (west side)

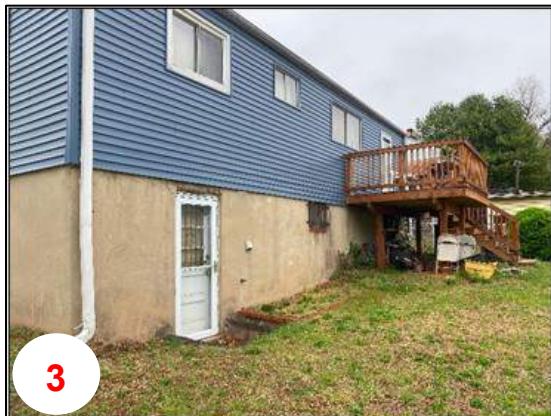
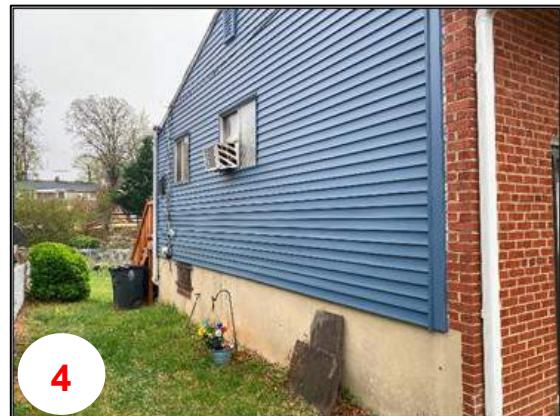
Figure 2.10.1.4 Property #10: Back side (south side) Figure 2.10.1.5 Property #10: Side (east side)

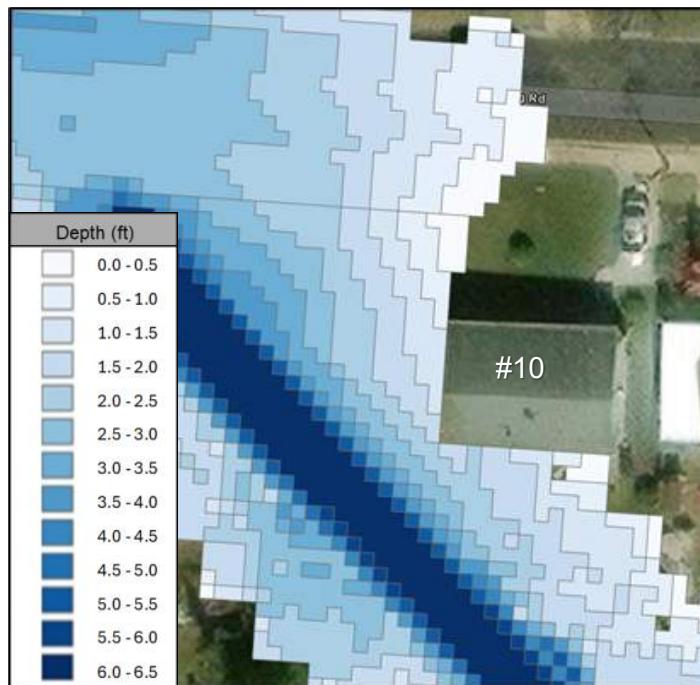
Figure 2.10.2.1 Property #10: 100-year flood depth above grade

The property at 5409 Taussig Road borders the Edmonston Channel on the west side of the property near the Edmonston Channel culvert at Taussig Road where it transitions underground. Flood modeling indicates that the capacity of the Edmonston Channel culvert at Taussig Road will be exceeded in a 100-year event, as it will cause floodwater to extend to the back (south) side and west side of the building. Flood modeling indicates that the 100-year flood level is more than 5 feet below the main floor. However, floodwater could potentially enter the ground floor (basement) through the lowest level back (south) door. Figure 2.10.2.1 shows the modeled 100-year flood depth to be approximately 2.5 feet above the nearest adjacent grade to the building. Table 2.10.1 below lists the critical building elevations relative to the 100-year flood level. The lowest point of entry at the top of basement door stairwell would be the first location floodwater would exceed a critical elevation and begin to pose a flooding threat to the basement. This location is below the 100-year water surface elevation by 2.4 feet. The basement door is 3.2 feet below the 100-year water surface elevation. A hose bib penetrating the basement wall near the door is below the 100-year water surface elevation.

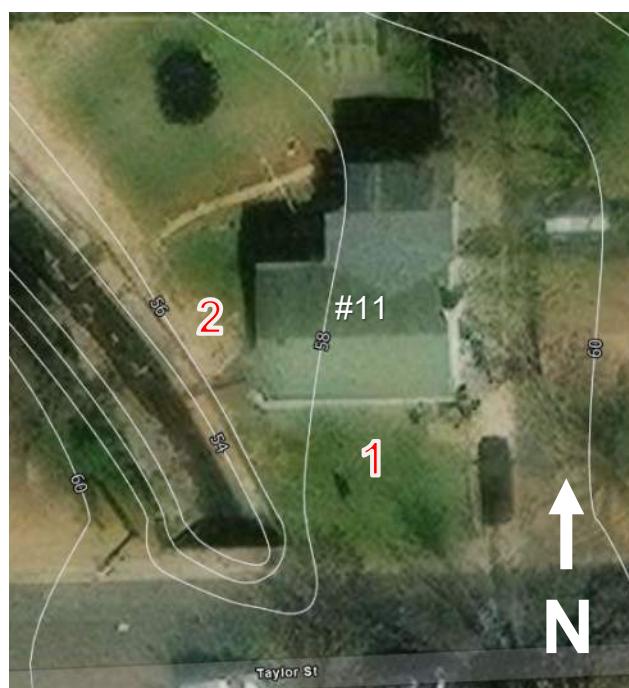
Figure 2.11.1.1 Property #11: Aerial view with elevation contours and photo numbering

The property at 5408 Taylor Street consists of a one-story building with a basement and a sump pump system. A few steps lead to the front (south) door at an elevated landing. The back door on the back (north) side of the building is a few inches above grade. There are two basement windows along the front (south) side and two along the west side of the building approximately 1 foot and 2 feet above grade, respectively. Multiple penetrations exist at the exterior wall for electrical components along the west side. Figure 2.11.1.1 below provides an aerial view of the home with topographic elevation contours, and the property is further depicted in Figure 2.11.1.2 and Figure 2.11.1.3. Only two sides of the home were able to be photographed as the homeowner did not grant access to the property.

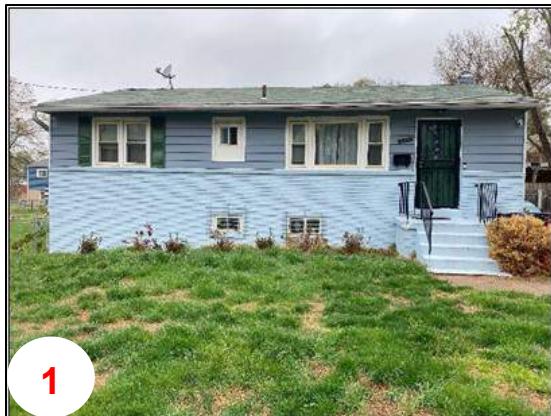
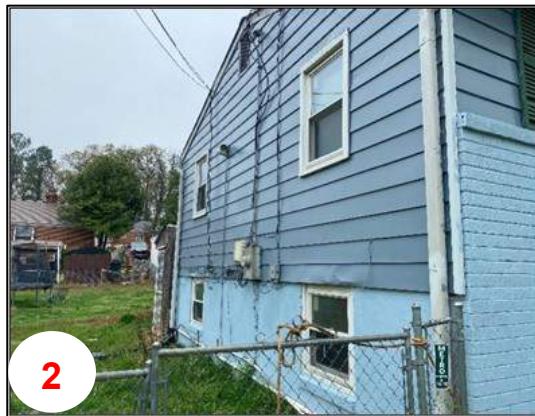
Figure 2.11.1.2 Property #11: Front side (south side) Figure 2.11.1.3 Property #11: Side (west side)

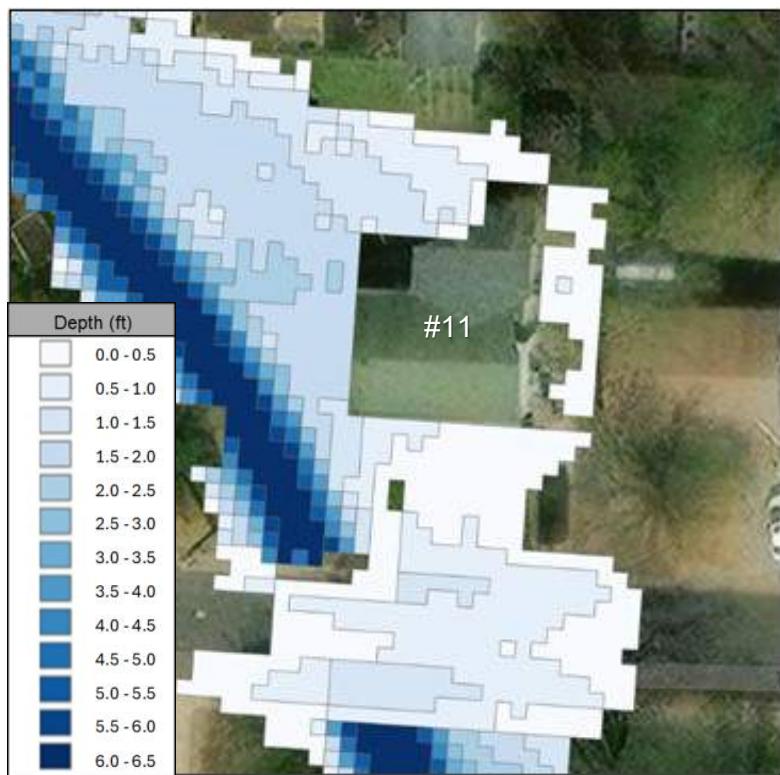
Figure 2.11.2.1 Property #11: 100-year flood depth above grade

The property at 5408 Taylor Street borders the Edmonston Channel on the west side of the property near the Taylor Street bridge. Flood modeling indicates that the capacity of the Taylor Street bridge will be exceeded in a 100-year event, as it will cause floodwater to overtop the bridge and stretch eastward until it surrounds the building. See Figure 2.11.2.1. The main floor is 3.7 feet above the 100-year flood. However, floodwater will likely enter the basement through the basement door at the back (north) side and through basement windows at the west side of the building. The basement windows are approximately 0.5 feet below the 100-year flood level. Table 2.11.1 below lists the critical building elevations relative to the 100-year flood level. Based upon the survey, the lowest point of entry at the bottom of the basement door is 2 feet below the 100-year water surface elevation. Note that the restricted access to the backyard by the fence may have prevented the identification of other flood risks.

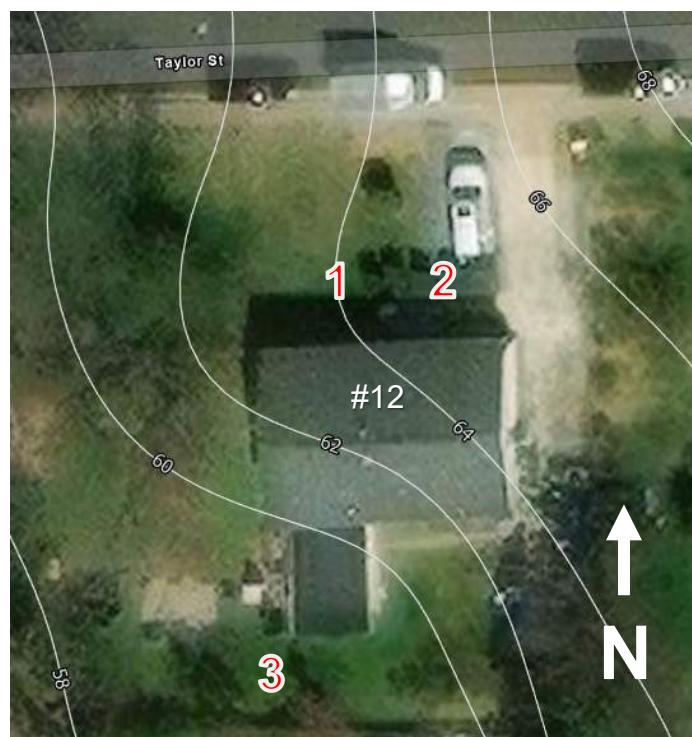
Figure 2.12.1.1 Property #12: Aerial view with elevation contours and photo numbering

The property at 5411 Taylor Street consists of a one-story building with a basement and sump pump system. There is an addition on the back (south) side at the same level as the basement. The homeowner did not grant permission for measurements and only permitted limited access for photography. As such there is limited data available and documented, apart from verbal descriptions provided by the homeowner. Figure 2.12.1.1 below provides an aerial view of the home with topographic elevation contours and the property is further depicted in Figure 2.12.1.2, Figure 2.12.1.3, and Figure 2.12.1.4.

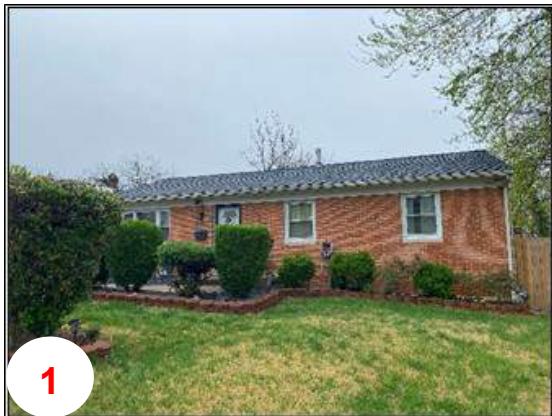
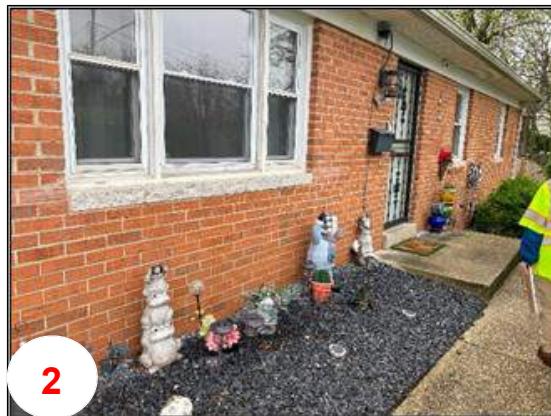
Figure 2.12.1.2 Property #12: Front side (north side) Figure 2.12.1.3 Property #12: Front side (north side)

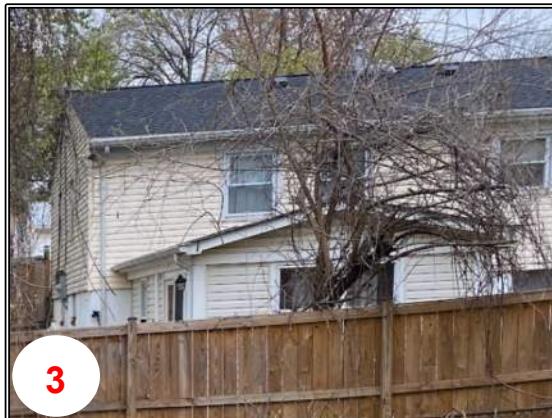
Figure 2.12.1.4 Property #12: Back side (south side)

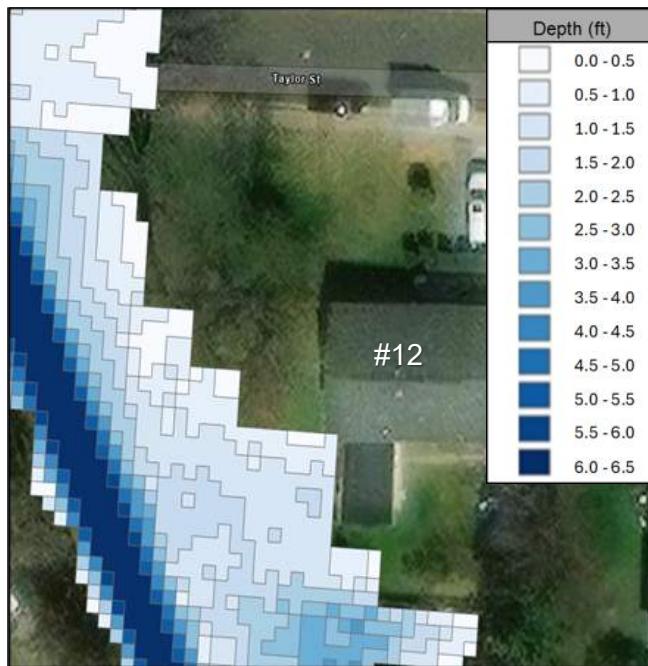
Figure 2.12.2.1 Property #12: 100-year flood depth above grade

The property at 5411 Taylor Street borders the Edmonston Channel on the west side of the property near the Taylor Street bridge. Flood modeling indicates that floodwater encroaches on the southwest corner of the building in a 100-year event. See Figure 2.12.2.1. The main floor is 6.8 feet above the 100-year flood. However, floodwater will likely enter the addition at the back (south) side through the door and from there floodwater may extend into the basement. Table 2.12.1 below lists the critical building elevations relative to the 100-year flood level. Based upon the survey, the lowest point of entry at the bottom of the door at the addition is 0.6 feet below the 100-year water surface elevation. Note that the restricted access to the backyard by the fence may have prevented the identification of other flood risks.

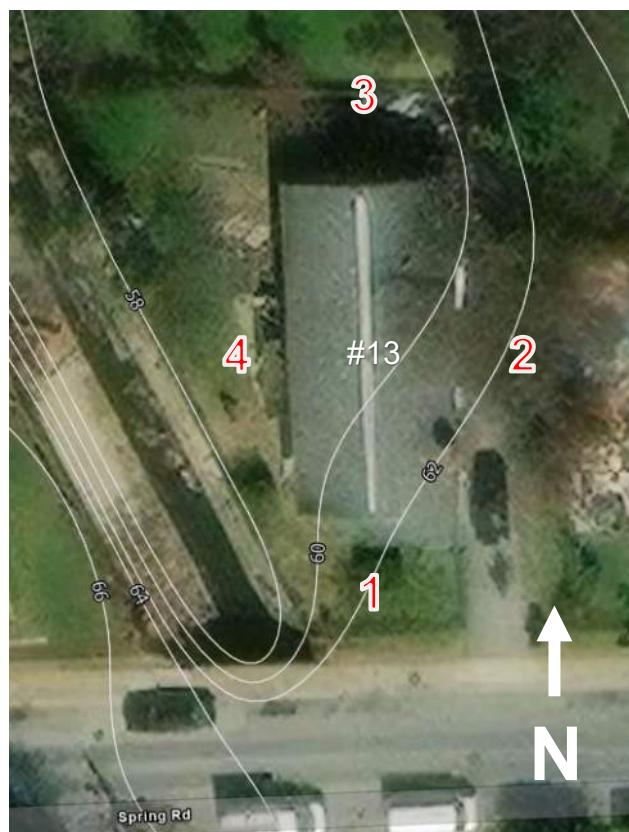
Figure 2.13.1.1 Property #13: Aerial view with elevation contours and photo numbering

The property at 5416 Spring Road consists of a one-story building with a basement. The grade is highest near the front (south) and tapers down to low points at the west side of the building. There are two basement doors at grade on the west side. Additionally, along the west side and a few steps up from the doors, the building has the HVAC unit and window at grade. The building has multiple penetrations through the exterior basement wall at the front (south), west, and back (north) sides for electrical conduits, a hose bib, dryer vents, electrical outlets, and a window A/C unit. The home has a sump pump in the backyard with a trench. Figure 2.13.1.1 below provides an aerial view of the home with topographic elevation contours, and the property is further depicted in Figure 2.13.1.2, Figure 2.13.1.3, Figure 2.13.1.4, and Figure 2.13.1.5.

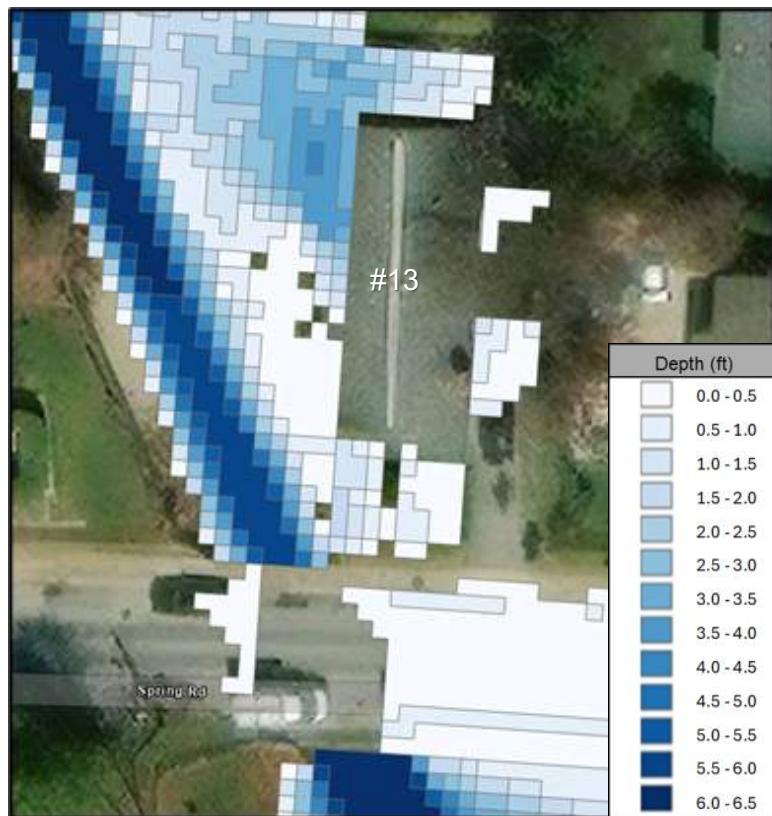
Figure 2.13.2.1 Property #13: 100-year flood depth above grade

The property at 5416 Spring Road borders the Edmonston Channel on the west side of the property near the Spring Road bridge. Flood modeling indicates that the capacity of the Spring Road bridge will be exceeded in a 100-year event, as it will cause floodwater to overtop the bridge and extend to the south, west, and north walls of the building. See Figure 2.13.2.1. The main floor is 4.4 feet above the 100-year flood level. However, floodwater will likely enter the basement at the west side through two basement doors. The backyard slopes down towards the building so that the bottom of the basement doors are roughly 2 feet below the top of the channel. The sump pump in the backyard will likely not help during a 100-year event because the outfall will be pumping to an area of the channel that is likely below the 100-year water surface elevation. Table 2.12.1 below lists the critical building elevations relative to the 100-year flood level. The lowest point of entry at the bottom of the southernmost basement door is 3.9 feet below the 100-year water surface elevation. The nearby basement door to the north is just a few inches above this low point. Several basement wall penetrations are below the 100-year water surface elevation, including a plumbing pipe, dryer vents, hose bib, and electrical outlet at the west side. Note that the lattice screen under the side deck may have prevented the identification of other flood risks.

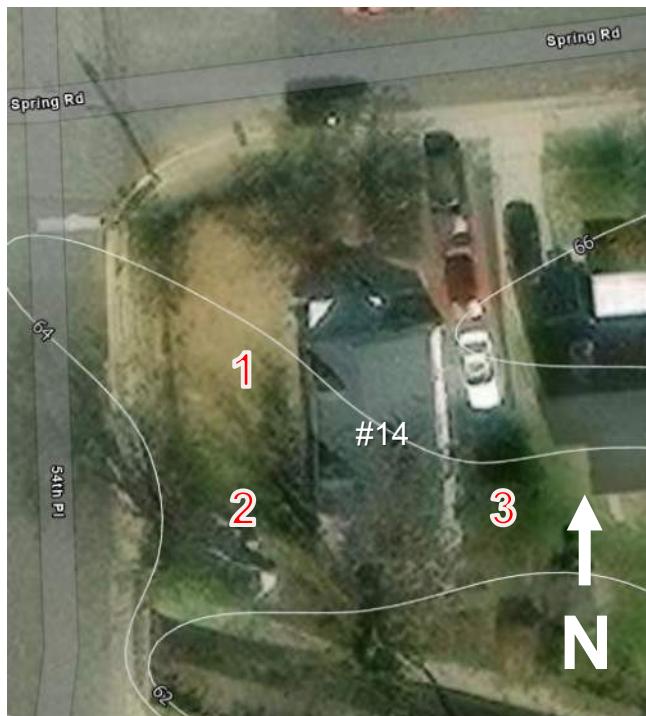
Figure 2.14.1.1 Property #14: Aerial view with elevation contours and photo numbering

The property at 5419 Spring Road consists of a one-and-a-half story building with dormers at the roof. There are steps leading up to the front (north) door at a covered porch. The building has a finished basement. Close to the front (north) and along the west side, a basement window is at grade. The grade slopes down from the front to the back (south) of the building. Towards the back of the building, a shortened door at grade along the west side provides access to the basement. Under the back deck, a former basement opening is covered with boards. The building has two sump pumps. The HVAC unit is located a few inches above grade at the east side. Nearby, the HVAC conduit penetrates the exterior wall. Other basement wall penetrations include an electrical conduit and piping. Figure 2.14.1.1 below provides an aerial view of the home with topographic elevation contours, and the property is further depicted in Figure 2.14.1.2, Figure 2.14.1.3 and Figure 2.14.1.4.

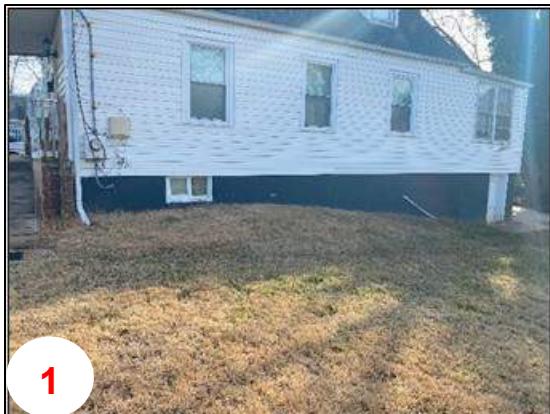
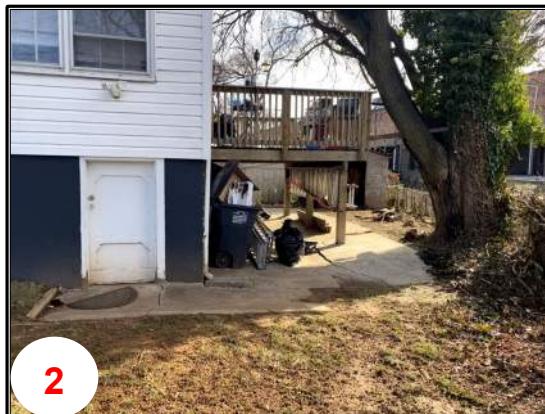
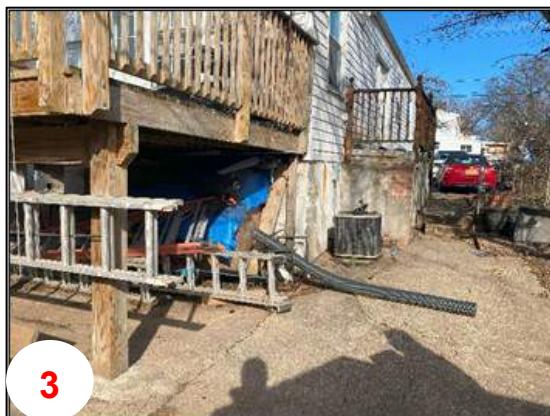
Figure 2.14.1.2 Property #14: Side (west side)

Figure 2.14.1.3 Property #14: Side (west side)

Figure 2.14.1.4 Property #14: Side (east side)

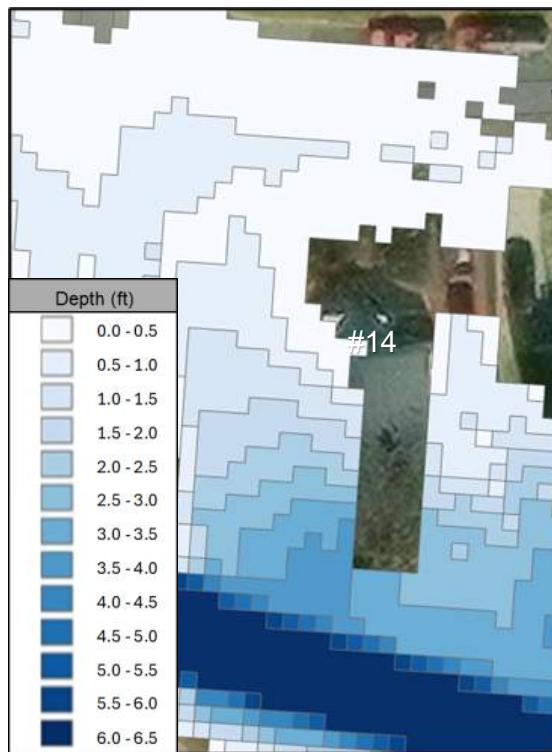
Figure 2.14.2.1 Property #14: 100-year flood depth above grade

The property at 5419 Spring Road borders the Edmonston Channel on the south side of the property near the 54<sup>th</sup> Place bridge. Flood modeling indicates that the capacity of the 54<sup>th</sup> Place bridge will be exceeded in a 100-year event, as it will cause floodwater to back up and extend to the east, south, and west walls of the building. See Figure 2.14.2.1. The main floor is 2.4 feet above the 100-year flood level. However, floodwater will likely enter the basement at the west side through a basement door as well as through boarded windows at the south side. Table 2.14.1 below lists the critical building elevations relative to the 100-year flood level. The lowest point of entry at the bottom of the basement door is 3.9 feet below the 100-year water surface elevation. A couple of basement wall penetrations are below the 100-year water surface elevation, including a plumbing pipe, and the HVAC conduit. Also, the HVAC unit at the east side of the building is more than a few feet below the 100-year water surface elevation. The homeowner stated no awareness of flooding to the building. Note that the objects adjacent to the exterior wall under the back (south) deck may have prevented the identification of other flood risks.

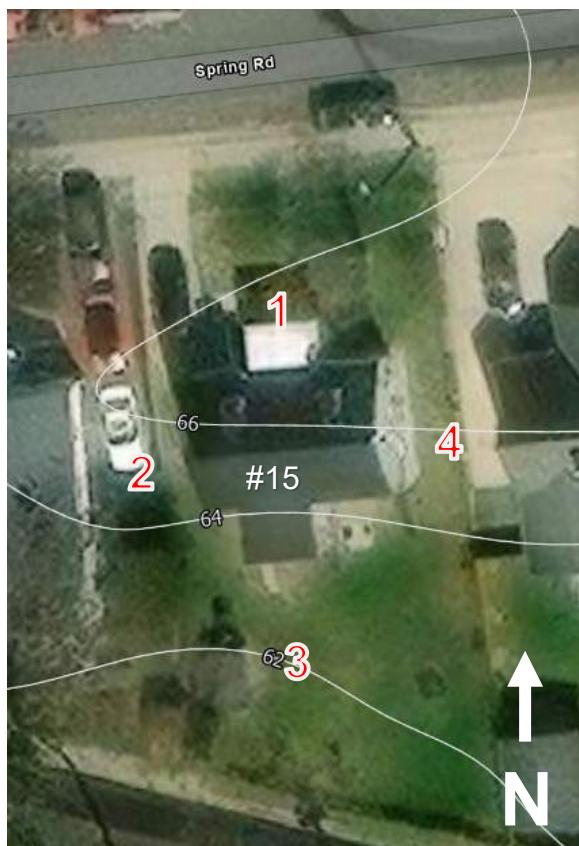
Figure 2.15.1.1 Property #15: Aerial view with elevation contours and photo numbering

The property at 5421 Spring Road consists of a one-and-a-half story building with dormers at the roof. The grade slopes down from the front to the back of the building. At the back (south) side of the building, exterior steps lead down from the adjacent grade to a basement door. The HVAC unit is at grade near the basement door. Basement windows exist on the east, south, and west sides of the building. The building also has a sump pump system. There are penetrations through the basement wall for a hose bib (west side), dryer vent (south side), and gas piping (east side). Figure 2.15.1.1 below provides an aerial view of the home with topographic elevation contours, and the property is further depicted in Figure 2.15.1.2, Figure 2.15.1.3, Figure 2.15.1.4, and Figure 2.15.1.5.

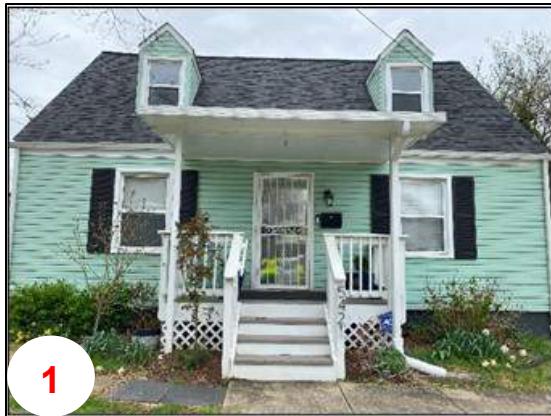
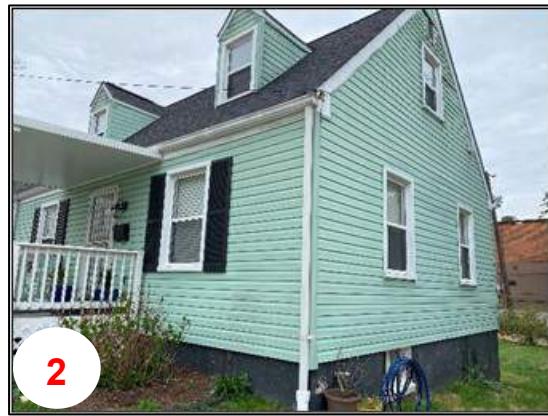
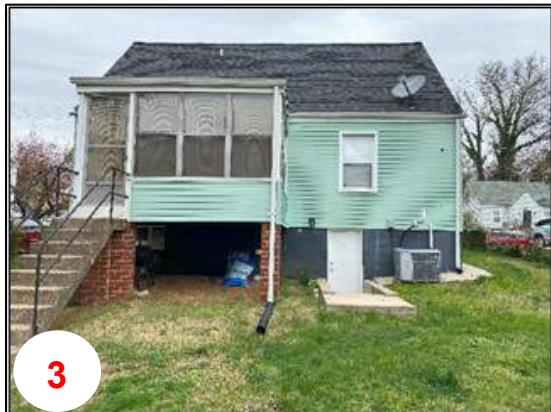
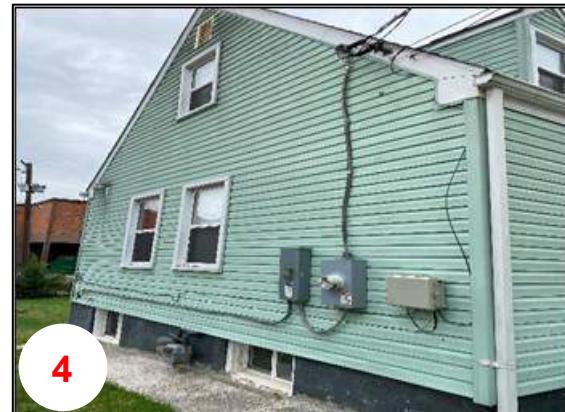
Figure 2.15.1.2 Property #15: Front side (north side) Figure 2.15.1.3 Property #15: Side (west side)

Figure 2.15.1.4 Property #15: Back side (south side) Figure 2.15.1.5 Property #15: Side (east side)
