# Bladensburg Flood Reduction Preliminary Design Report

## Flood Reduction Preliminary Design Report

Residents and property owners along Edmonston Channel and Quincy Run in the Town of Bladensburg, Maryland have experienced repetitive flooding on their properties during heavy rainfall events. Corvias Infrastructure Solutions (CIS), the managing partner for the Clean Water Partnership (CWP) with Prince George's County, Maryland, selected Stantec Consulting Services Inc. (Stantec) to evaluate the causes and severity of flooding and to develop alternatives to reduce flooding which is impacting properties along Edmonston Channel and Quincy Run.

Stantec previously conducted a comprehensive analysis and presented its findings and recommendations in the *Bladensburg Flood Reduction Alternatives Evaluation Report*, dated October 2024. This report advances the selected alternatives for Edmonston Channel (Figure ES-1) and Quincy Run (Figure ES-2) from the evaluation study into the preliminary design phase, incorporating surveyed topographic and subsurface utility data to further refine and optimize the designs.

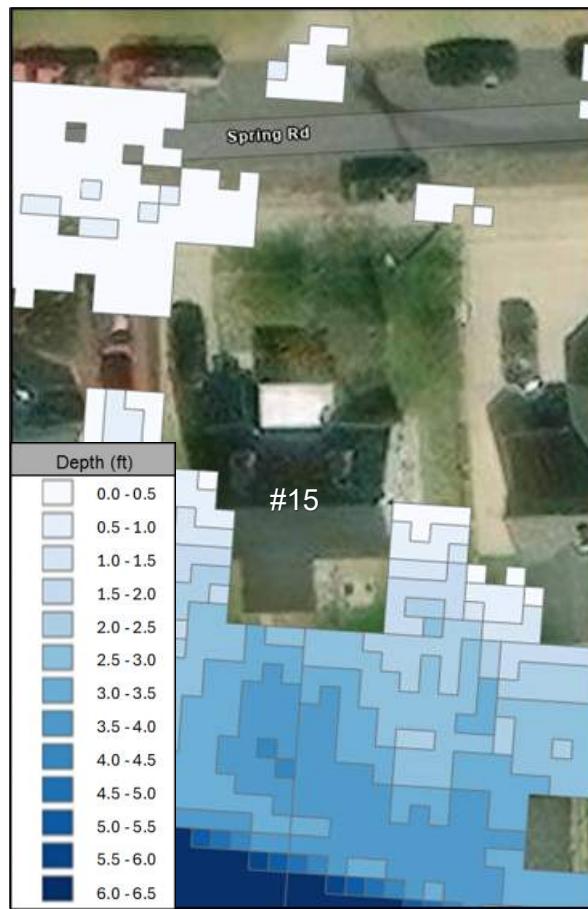
Figure 2.15.2.1 Property #15: 100-year flood depth above grade

The property at 5421 Spring Road borders the Edmonston Channel on the back (south) side of the property near the 54<sup>th</sup> Place bridge. Flood modeling indicates that the capacity of the 54<sup>th</sup> Place bridge will be exceeded in a 100-year event, as it will cause floodwater to back up and extend to the east, south, and west walls of the building. See Figure 2.15.2.1. The main floor is 2.8 feet above the 100-year flood. However, floodwater will likely enter the basement at the back (south) side through a basement door as well as through a basement window at the east side. Table 2.15.1 below lists the critical building elevations relative to the 100-year flood level. The lowest point of entry is at the upper stairwell landing to the basement door at 2.0 feet below the 100-year water surface elevation, where the basement door is 4.2 feet below. A dryer vent at the south penetrates the basement wall below the 100-year water surface elevation. Also, the HVAC unit at the south side of the building is approximately a few feet below the 100-year water surface elevation.

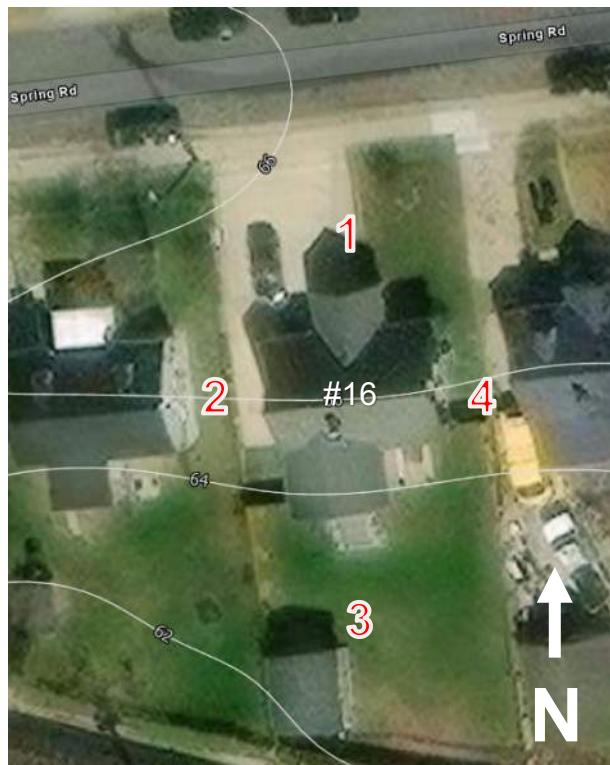
*Figure 2.16.1.1 Property #16: Aerial view with elevation contours and photo numbering*

The property at 5423 Spring Road consists of a one-and-a-half story building with dormers at the roof. There are steps leading up to the front (north) door at a covered porch. The grade slopes down from the front to the back of the building. At the back (south) side, exterior steps lead down from the adjacent grade to a basement door. A roof has been constructed over the exterior stairwell to the basement door (not pictured below). Basement windows exist on the east, south, and west sides of the building. Two of the basement windows have window wells with covers with one on the east side and one on the west side. The HVAC unit on the west side of the building is at grade. There are penetrations through the basement wall for an electrical conduit, gas piping, and HVAC conduit along the west side. Figure 2.16.1.1 below provides an aerial view of the home with topographic elevation contours, and the property is further depicted in Figure 2.16.1.2, Figure 2.16.1.3, Figure 2.16.1.4, and Figure 2.16.1.5.

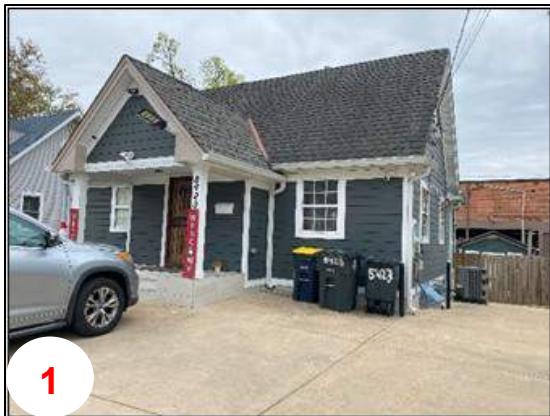
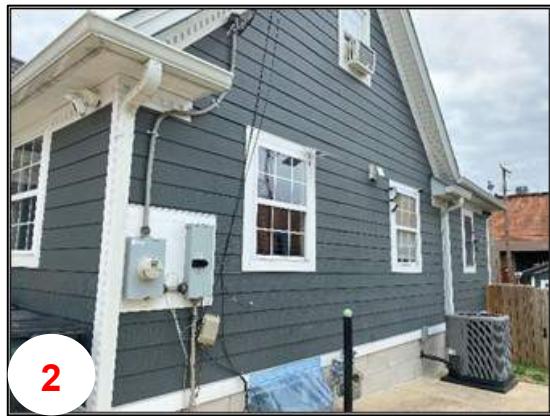
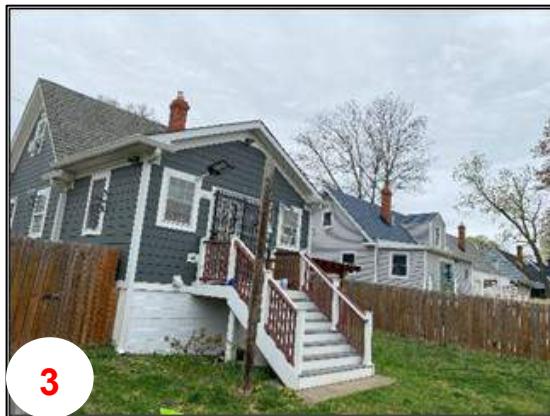
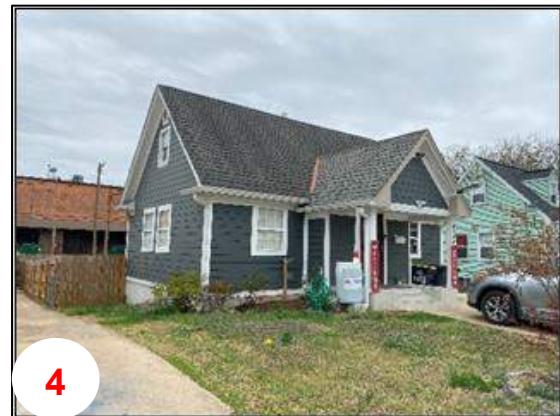
Figure 2.16.1.2 Property #16: Front side (north side) Figure 2.16.1.3 Property #16: Side (west side)

Figure 2.16.1.4 Property #16: Back side (south side) Figure 2.16.1.5 Property #16: Side (east side)

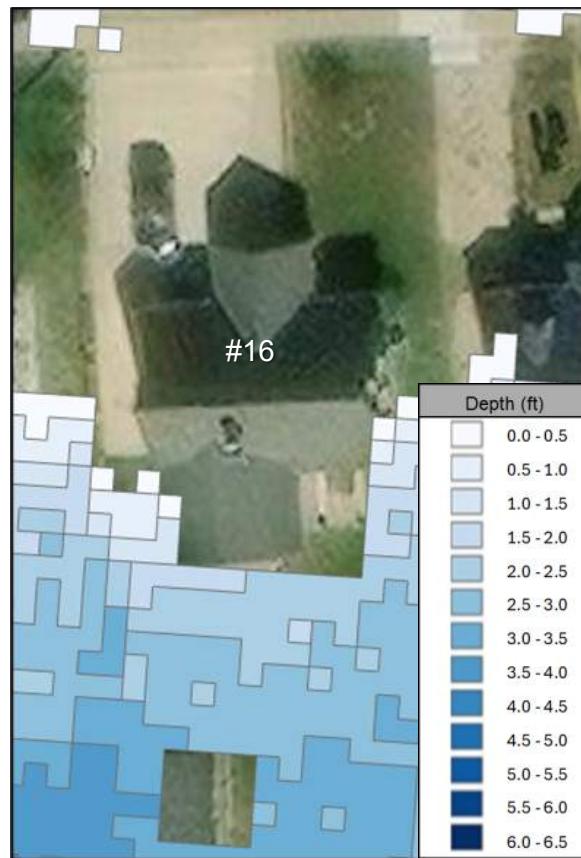
Figure 2.16.2.1 Property #16: 100-year flood depth above grade

The property at 5423 Spring Road borders the Edmonston Channel on the back (south) side of the property. Flood modeling indicates that floodwater from a 100-year event will extend to the east, south, and west walls of the building. See Figure 2.16.2.1. The main floor is 2.5 feet above the 100-year flood level. However, floodwater will likely enter the basement at the south side through a basement door and window, as well as through basement windows at the east and west sides. Table 2.16.1 below lists the critical building elevations relative to the 100-year flood level. The lowest point of entry is at the upper stairwell landing to the basement door at 3.0 feet below the 100-year water surface elevation, whereas the basement door is 5.3 feet below. Also, the HVAC unit at the west side of the building is a few inches below the 100-year water surface elevation.

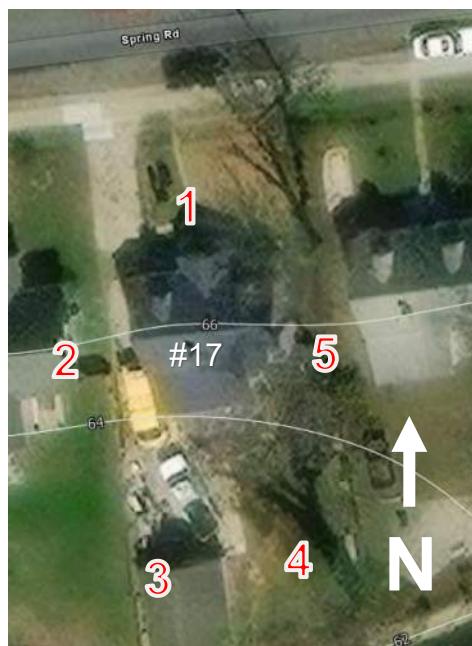
Figure 2.17.1.1 Property #17: Aerial view with elevation contours and photo numbering

The property at 5425 Spring Road consists of a one-and-a-half story building with dormers at the roof. The grade slopes down from the front to the back of the building. At the back (south) side of the building, exterior steps lead down from the adjacent grade to a basement door with a basement window at the stairwell. The HVAC unit is at grade near the basement door. Basement windows are located a few inches above grade on the east, south, and west sides of the building. There are penetrations through the basement wall for a hose bib, a plumbing pipe, electrical conduit, gas piping, and HVAC conduit. Figure 2.17.1.1 below provides an aerial view of the home with topographic elevation contours, and the property is further depicted in Figure 2.17.1.2, Figure 2.17.1.3, Figure 2.17.1.4, Figure 2.17.1.5 and Figure 2.17.1.6.

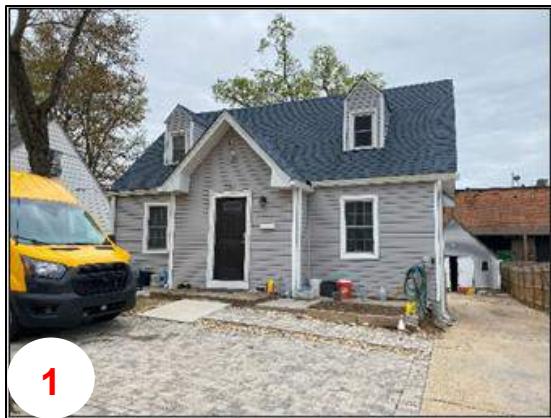
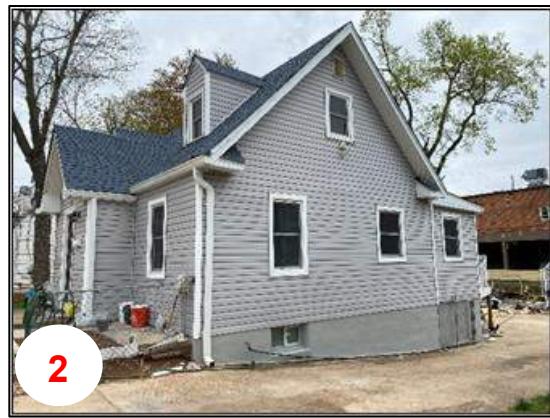
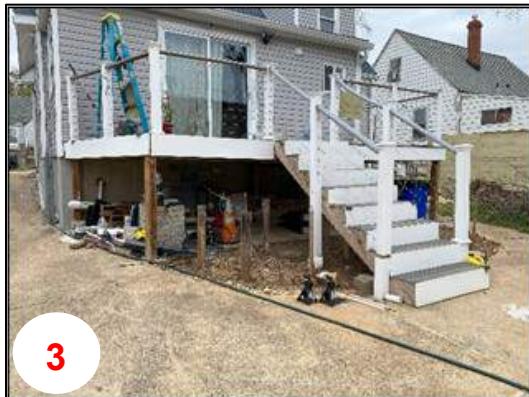
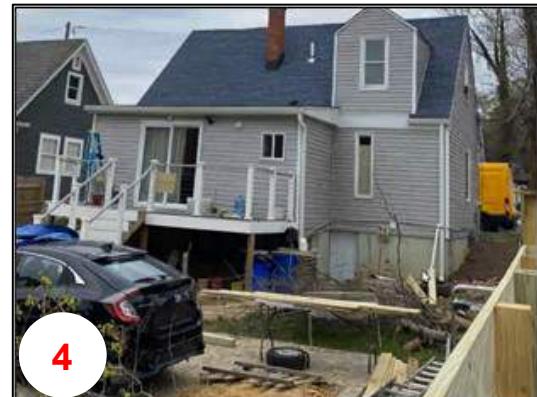
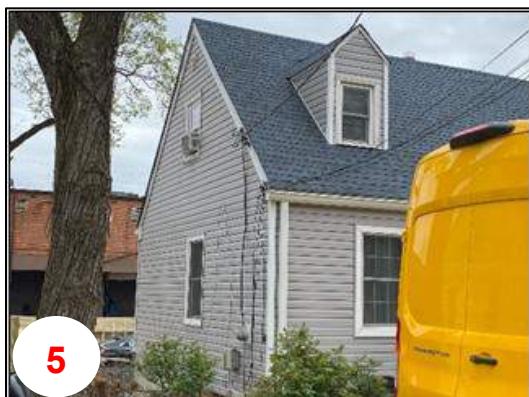
*Figure 2.17.1.2 Property #17: Front side (north side) Figure 2.17.1.3 Property #17: Side (west side)*

*Figure 2.17.1.4 Property #17: Back side (south side) Figure 2.17.1.5 Property #17: Basement door and steps (south side)*

*Figure 2.17.1.6 Property #17: Side (east side)*

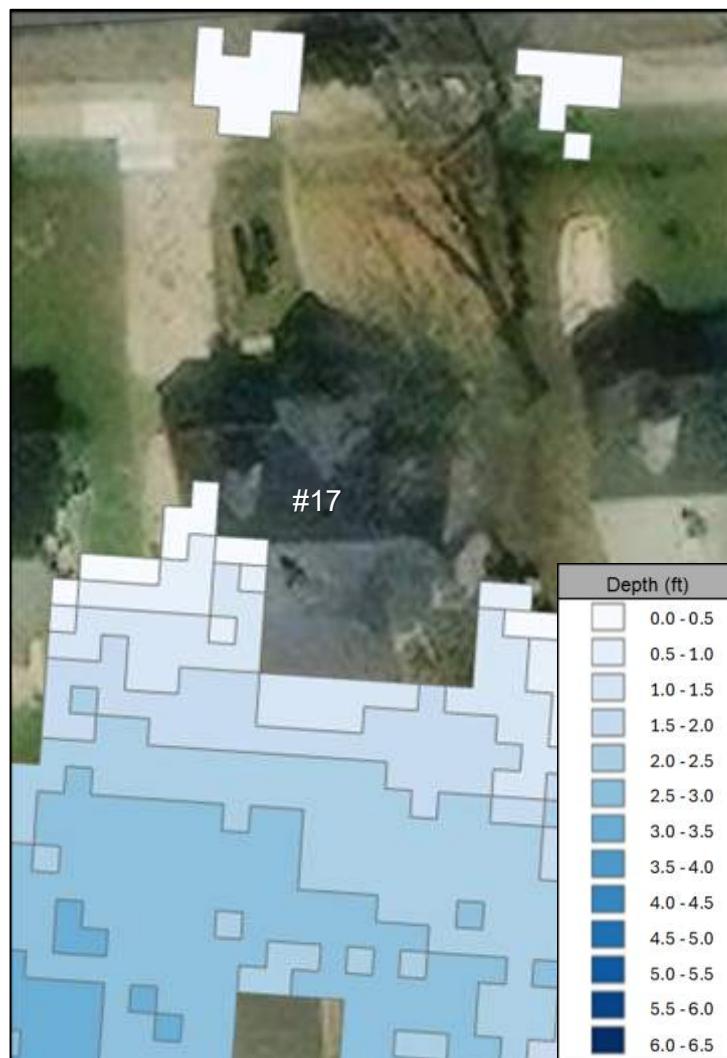
Figure 2.17.2.1 Property #17: 100-year flood depth above grade

The property at 5425 Spring Road borders the Edmonston Channel on the back (south) side of the property. Flood modeling indicates that floodwater from a 100-year event will extend to the east, south, and west walls of the building. See Figure 2.17.2.1. The main floor is 2.6 feet above the 100-year flood level. However, floodwater will likely enter the basement at the south side through a basement door and window. Table 2.17.1 below lists the critical building elevations relative to the 100-year flood level. The lowest point of entry is at the upper stairwell landing to the basement door at 2.0 feet below the 100-year water surface elevation, whereas the basement door is 4.8 feet below. Also, the HVAC unit at the south side of the building is more than 1 foot below the 100-year water surface elevation. The homeowner reported that they've experienced no flooding in the building for the past eight years. Note that the objects under and around the back (south) deck may have prevented the identification of other flood risks.

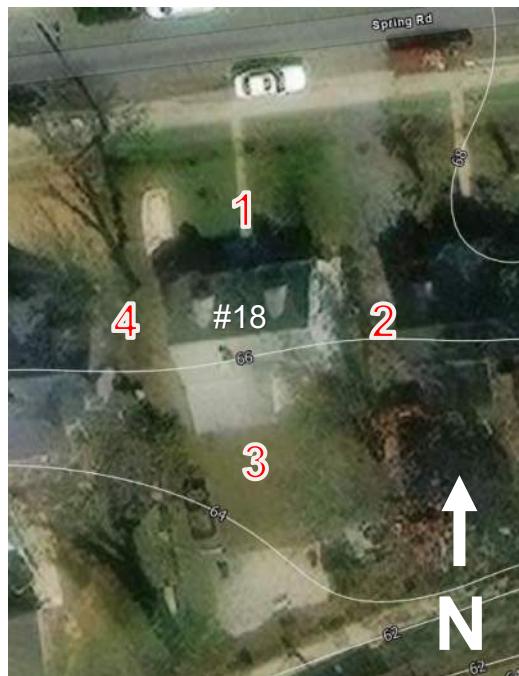
*Figure 2.18.1.1 Property #18: Aerial view with elevation contours and photo numbering*

The property at 5427 Spring Road consists of a one-and-a-half story building with dormers at the roof. The grade slopes down from the front to the back of the building. At the back (south) side of the building, exterior steps lead down from the adjacent grade to a basement door. The HVAC unit is at grade near the basement door. Basement windows are located a few inches above grade on the east and west sides of the building. There are penetrations through the basement wall for a vent, hose bib, plumbing pipes, and gas piping. The back of the building has a boarded-up area below the first-floor addition that could not be accessed. Figure 2.18.1.1 below provides an aerial view of the home with topographic elevation contours, and the property is further depicted in Figure 2.18.1.2, Figure 2.18.1.3, Figure 2.18.1.4, and Figure 2.18.1.5.

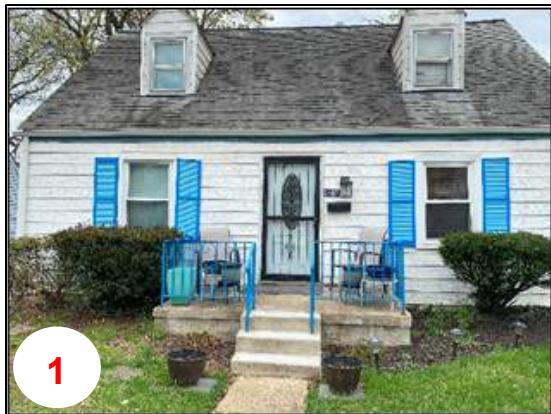
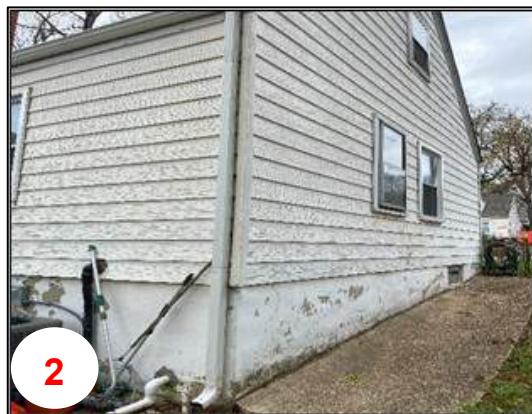
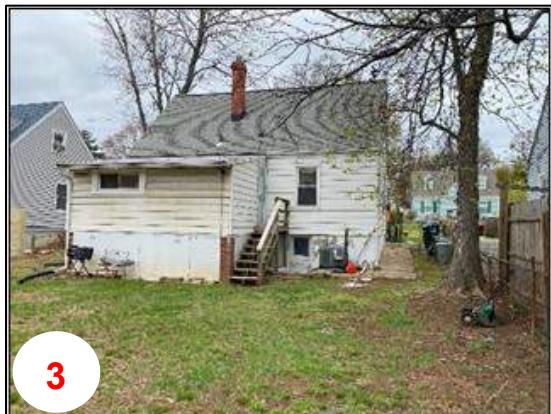
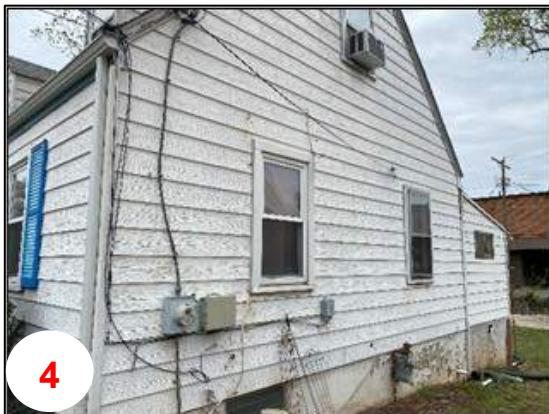
Figure 2.18.1.2 Property #18: Front side (north side) Figure 2.18.1.3 Property #18: Side (east side)

Figure 2.18.1.4 Property #18: Back side (south side) Figure 2.18.1.5 Property #18: Side (west side)

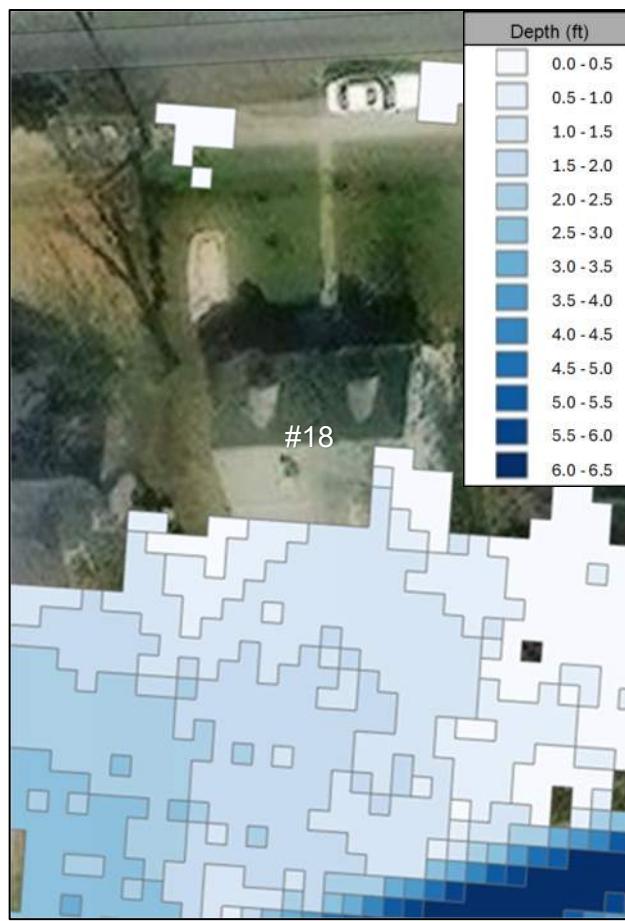
Figure 2.18.2.1 Property #18: 100-year flood depth above grade

The property at 5427 Spring Road borders the Edmonston Channel on the back (south) side of the property. Flood modeling indicates that floodwater from a 100-year event will extend to the east and south walls of the building. See Figure 2.18.2.1. The main floor is 2.7 feet above the 100-year flood level. However, floodwater will likely enter the basement at the south side through a basement door. Table 2.18.1 below lists the critical building elevations relative to the 100-year flood level. The lowest point of entry is at the upper stairwell landing to the basement door at 1.4 feet below the 100-year water surface elevation, whereas the basement door is 4.3 feet below. A couple holes and a plumbing pipe at the west side along with a plumbing pipe at the back (south) side penetrate the basement wall below the 100-year water surface elevation. Also, the HVAC unit at the south side of the building is more than 1 foot below the 100-year water surface elevation. According to the homeowner, the basement flooded a few years ago. Note that the boarded-up area under the back (south) addition may have prevented the identification of other flood risks.

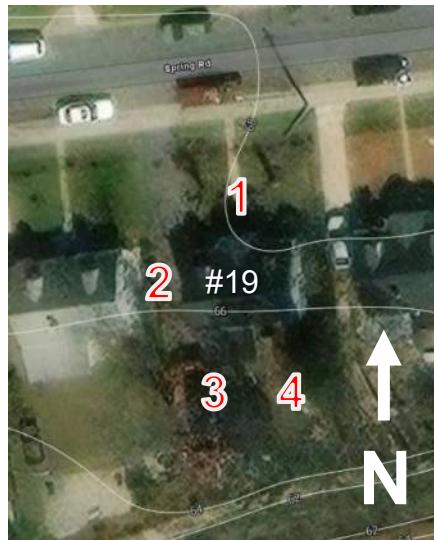
Figure 2.19.1.1 Property #19: Aerial view with elevation contours and photo numbering

The property at 5429 Spring Road consists of a one-and-a-half story building with dormers at the roof. The grade slopes down from the front to the back of the building. At the back (south) side of the building, exterior steps lead down from the adjacent grade to a basement door. The HVAC unit is at grade near the basement door. Basement windows are located a few inches above grade on the east and west sides of the building. The building has a sump pump with a battery backup. The back of the building has an area below the first-floor addition that has been closed in with lattice panels. There are penetrations through the basement wall for a hose bib, a plumbing pipe, and dryer vent. Figure 2.19.1.1 below provides an aerial view of the home with topographic elevation contours, and the property is further depicted in Figure 2.19.1.2, Figure 2.19.1.3, Figure 2.19.1.4, and Figure 2.19.1.5.

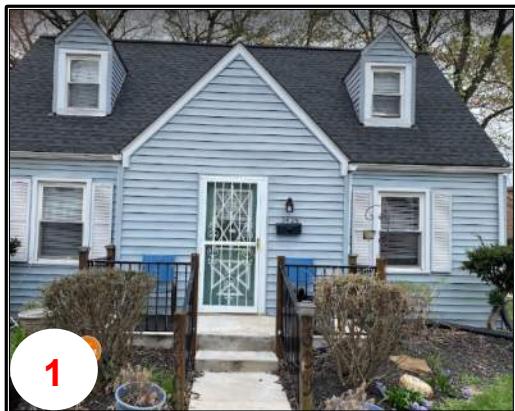
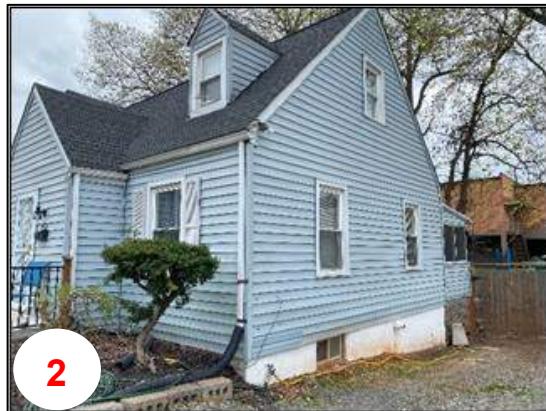
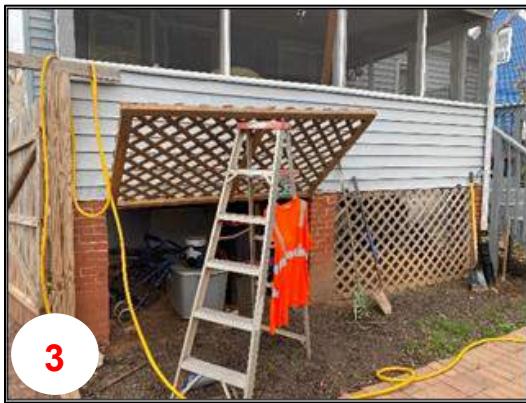
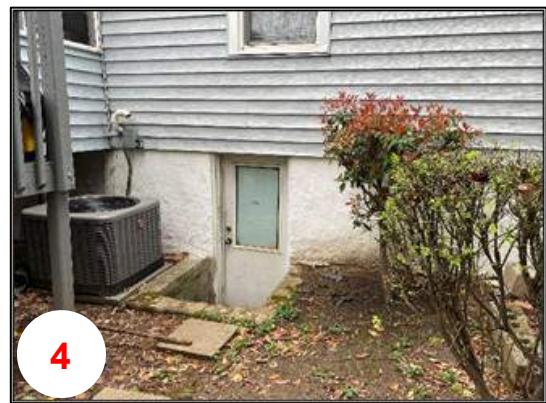
Figure 2.19.1.2 Property #19: Front side (north side) Figure 2.19.1.3 Property #19: Side (west side)

Figure 2.19.1.4 Property #19: Back side (south side) Figure 2.19.1.5 Property #19: Basement door and steps (south side)

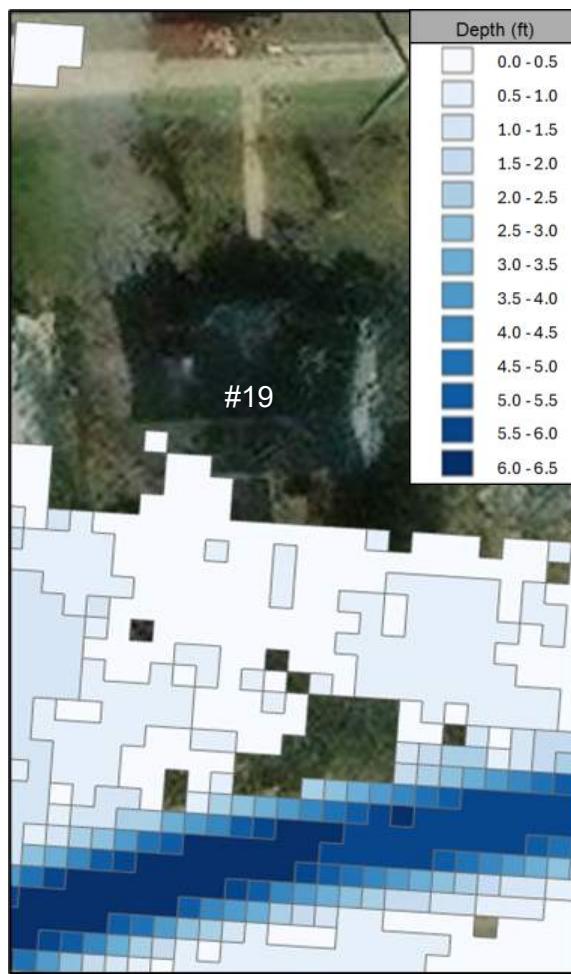
Figure 2.19.2.1 Property #19: 100-year flood depth above grade

The property at 5429 Spring Road borders the Edmonston Channel on the back (south) side of the property. Flood modeling indicates that floodwater from a 100-year event will extend to the east, south, and west walls of the building. See Figure 2.19.2.1. The main floor is 3.3 feet above the 100-year flood level. However, floodwater will likely enter the basement at the back (south) side through a basement door and through a basement window at the east side. Table 2.19.1 below lists the critical building elevations relative to the 100-year flood level. The lowest point of entry is at the upper stairwell landing to the basement door at 0.9 feet below the 100-year water surface elevation, whereas the basement door is 3.9 feet below. Also, the HVAC unit at the south side of the building is approximately 1 foot below the 100-year water surface elevation. The homeowner reported that minimal floodwater has been seen in the backyard. Note that the lattice screen under the back (south) addition may have prevented the identification of other flood risks.

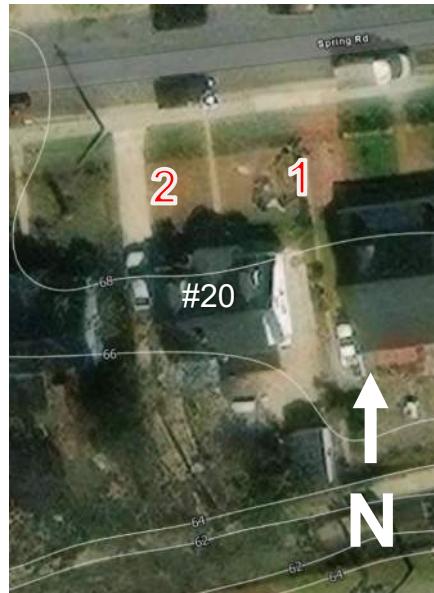
Figure 2.20.1.1 Property #20: Aerial view with elevation contours and photo numbering

The property at 5431 Spring Road consists of a one-and-a-half story building with dormers at the roof. The grade slopes down from the front to the back of the building. At the back (south) side of the building, exterior steps lead down from the adjacent grade to a basement door. A dog and “beware of dog” sign was present in the yard that prevented full data collection. Figure 2.20.1.1 below provides an aerial view of the home with topographic elevation, and the property is further depicted in Figure 2.20.1.2 and Figure 2.20.1.3.

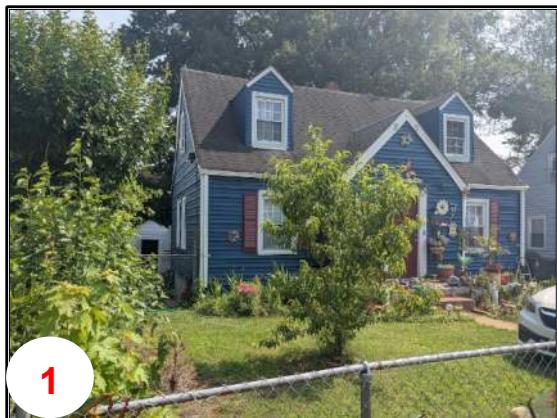
*Figure 2.20.1.2 Property #20: Front side  
(northeast side)*

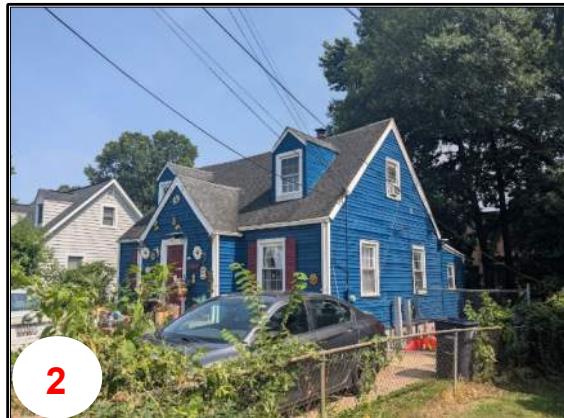
*Figure 2.20.1.3 Property #20: Front side  
(northwest side)*

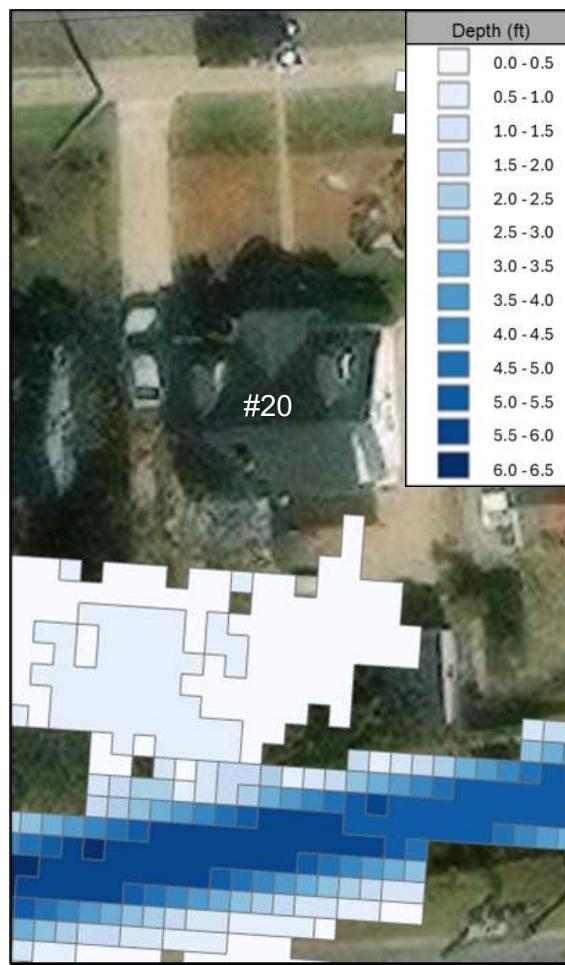
Figure 2.20.2.1 Property #20: 100-year flood depth above grade

The property at 5431 Spring Road borders the Edmonston Channel on the back (south) side of the property. Flood modeling indicates that floodwater from a 100-year event will extend to the south wall of the building. See Figure 2.20.2.1. The main floor is 3.8 feet above the 100-year flood level. However, floodwater will likely enter the basement at the back (south) side through a basement door. Table 2.20.1 below lists the critical building elevations relative to the 100-year flood level collected during the survey. Based upon the survey, the lowest point of entry is at the upper stairwell landing to the basement door at 0.4 feet below the 100-year water surface elevation, whereas the basement door is 3.4 feet below. Note that the restricted access to the backyard may have prevented the identification of other flood risks.

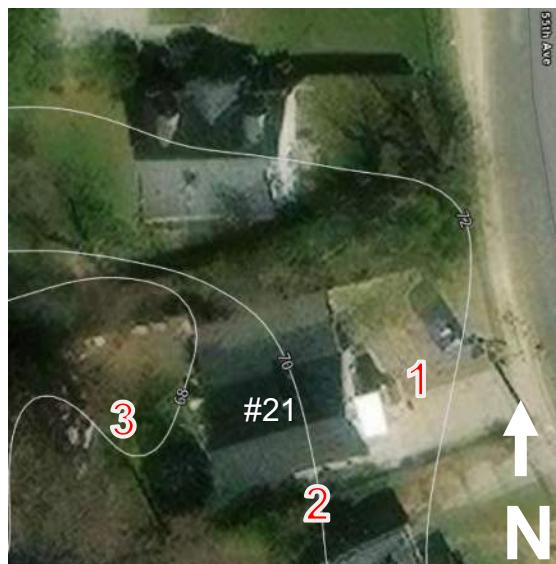
Figure 2.21.1.1 Property #21: Aerial view with elevation contours and photo numbering

The property at 4106 55<sup>th</sup> Avenue consists of a one-and-a-half story building. The grade slopes down from the front to the back of the building. A lower level area below the first-floor addition at the north side has been closed in with boards. There are three doors at the back (west) side of the building which are at grade. The HVAC unit nearby is approximately 11 inches above grade. The south side of the building has two basement windows more than a couple feet above grade. There are penetrations through the basement wall for an electrical conduit, a plumbing pipe, and a hose bib. Figure 2.21.1.1 below provides an aerial view of the home with topographic elevation contours, and the property is further depicted in Figure 2.21.1.2, Figure 2.21.1.3 and Figure 2.21.1.4.

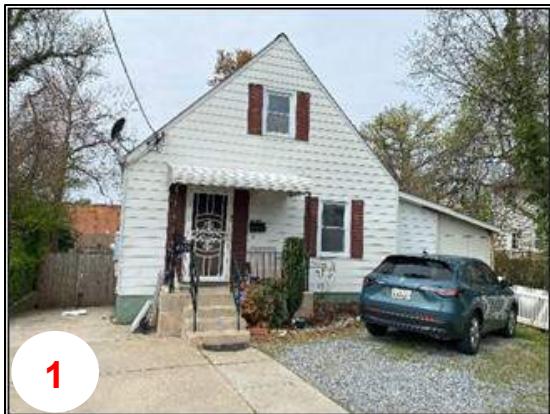
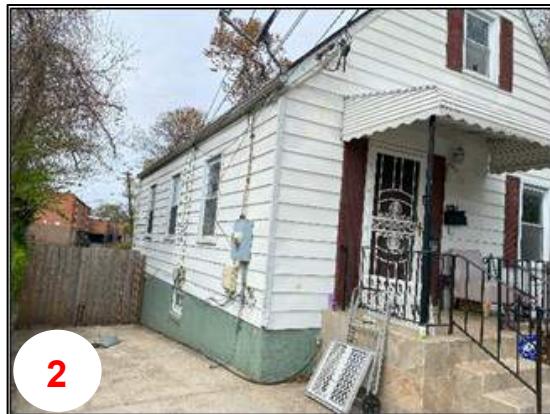
Figure 2.21.1.2 Property #21: Front side (east side)   Figure 2.21.1.3 Property #21: Side (south side)

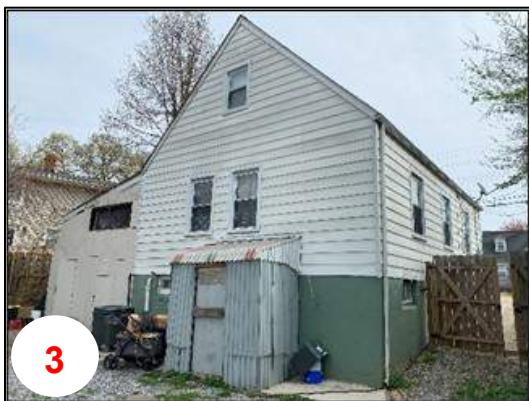
Figure 2.21.1.4 Property #21: Back side (west side)

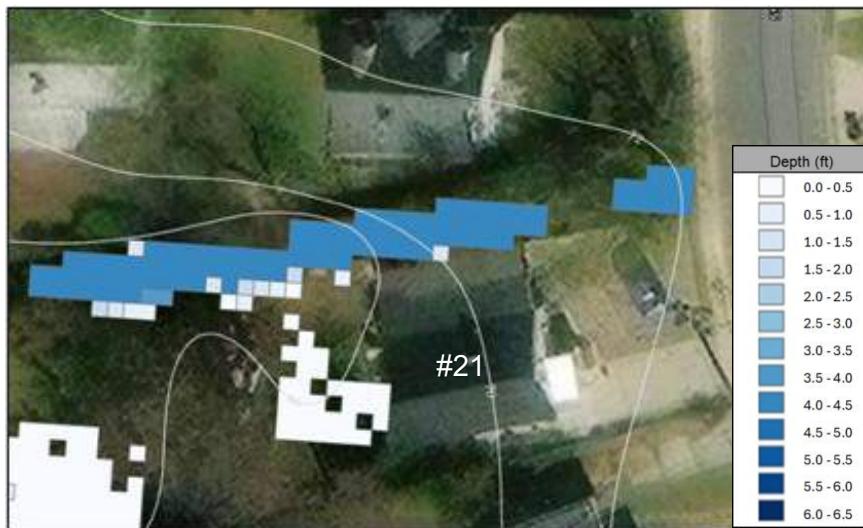
Figure 2.21.2.1 Property #21: 100-year flood depth above grade

The property at 4106 55<sup>th</sup> Avenue abuts the Edmonston Channel on the north side of the property. Flood modeling indicates that floodwater from a 100-year event will extend to the back (west) wall of the building. See Figure 2.21.2.1. The main floor is 6.1 feet above the 100-year flood level. However, floodwater will potentially enter the basement at the back (west) side through a lower level door at the addition. Table 2.21.1 below lists the critical building elevations relative to the 100-year flood level. The lowest point of entry is the lower level door at 0.2 feet below the 100-year water surface elevation. None of the basement wall penetrations observed or HVAC unit are below the 100-year water surface elevation. Note that the boarded-up area under the addition at the north side and the area within the metal enclosure at the back (west) side may have prevented the identification of other flood risks.

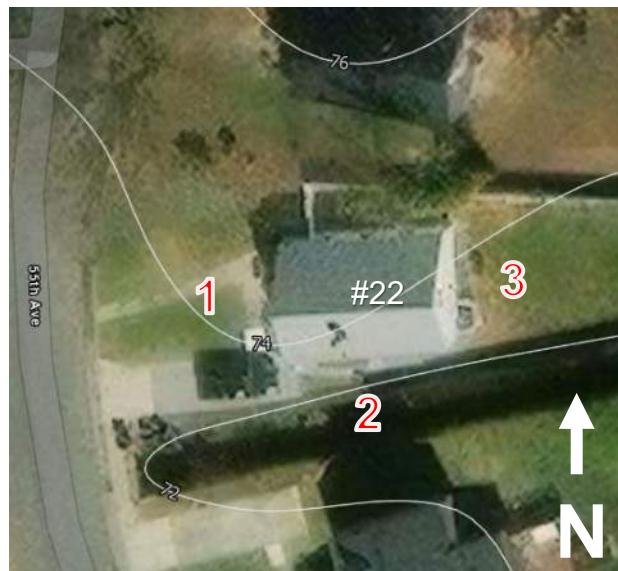
Figure 2.22.1.1 Property #22: Aerial view with elevation contours and photo numbering

The property at 4105 55<sup>th</sup> Avenue consists of a one-and-a-half story building with a south side deck and basement door at the bottom of an exterior stairwell. The back (east) side of the building has a basement window a couple feet above grade and the HVAC unit at grade. Additional penetrations could not be identified due to limited access to the property. Figure 2.22.1.1 below provides an aerial view of the home with topographic elevation contours, and the property is further depicted in Figure 2.22.1.2, Figure 2.22.1.3 and Figure 2.22.1.4.

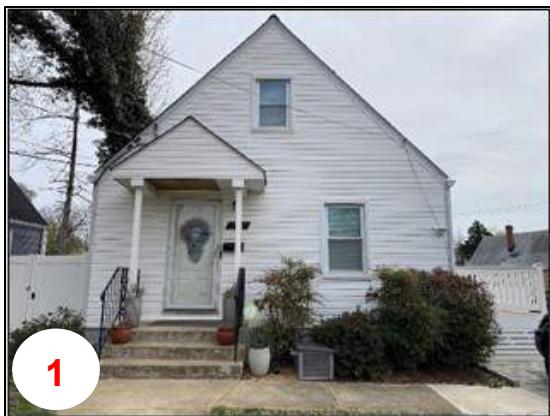
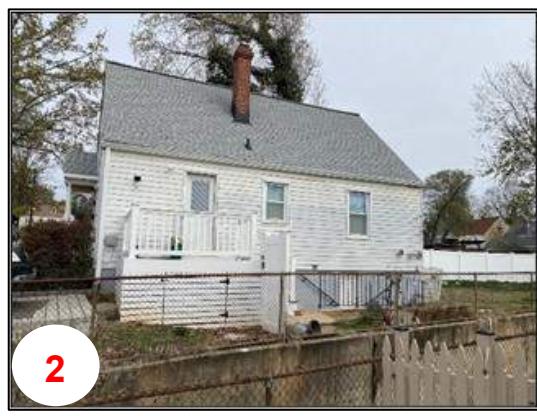
Figure 2.22.1.2 Property #22: Front side (west side)   Figure 2.22.1.3 Property #22: Side (south side)

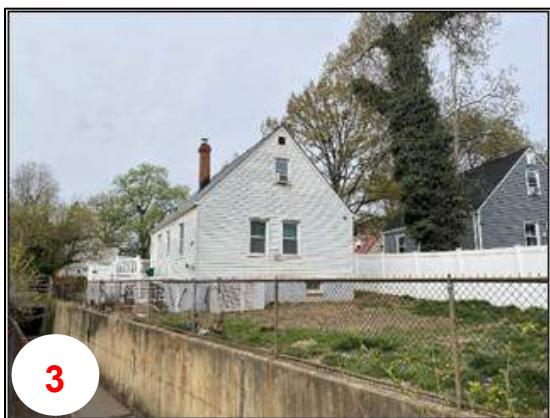
Figure 2.22.1.4 Property #22: Back side (east side)

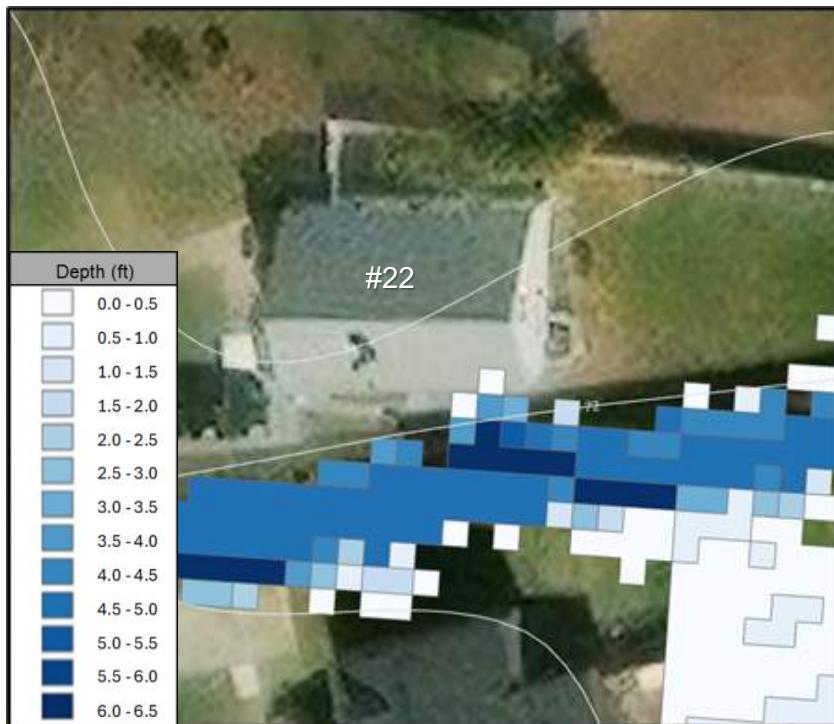
Figure 2.22.2.1 Property #22 100-year flood depth above grade

The property at 4105 55<sup>th</sup> Avenue borders the Edmonston Channel on the south side of the property. Flood modeling indicates that floodwater from a 100-year event will overtop the channel and extend to the south wall of the building. See Figure 2.22.2.1. The main floor is 4.4 feet above the 100-year flood level. However, floodwater will likely enter the basement at the south side through a basement door. Table 2.22.1 below lists the critical building elevations relative to the 100-year flood level. Based upon the survey, the lowest point of entry is at the upper stairwell landing to the basement door at 0.2 feet below the 100-year water surface elevation, whereas the basement door is 2.6 feet below. Also, the HVAC unit at the back (east) side of the building may be at the 100-year water surface elevation, but could not be confirmed because of limited access to the site during the site visit. Note that the boarded-up area under the deck on the south side may have prevented the identification of other flood risks.

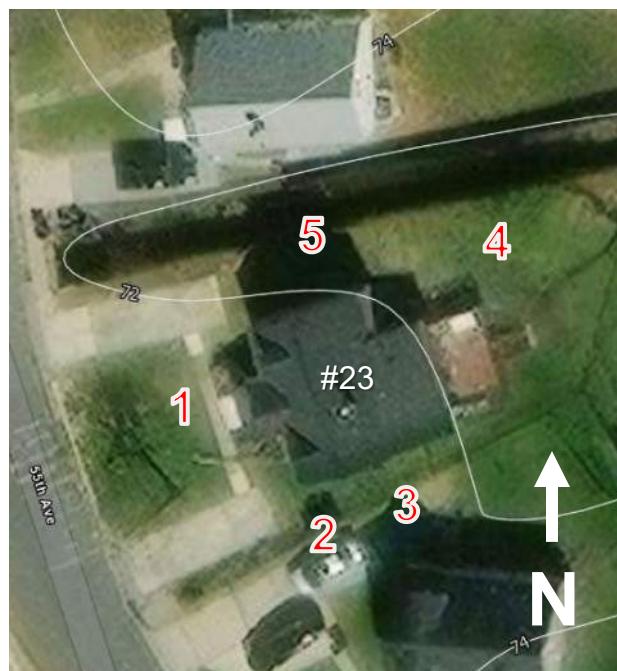
Figure 2.23.1.1 Property #23: Aerial view with elevation contours and photo numbering

The property at 5429 Spring Road consists of a one-and-a-half story building with dormers at the roof. At the back (east) side of the building, exterior steps lead down from the adjacent grade to a basement door next to the backyard deck. The building has a sump pump system. There is a window on the north and south sides of the building. The window on the south side is slightly below grade and has a window well which is constructed of corrugated metal. Nearby the HVAC unit sits at grade. The basement window on the north side is a few inches above grade. There are penetrations through the basement wall for a hose bib, a plumbing pipe, electrical conduit, and HVAC conduit. Figure 2.23.1.1 below provides an aerial view of the home with topographic elevation contours, and the property is further depicted in Figure 2.23.1.2, Figure 2.23.1.3, Figure 2.23.1.4, Figure 2.23.1.5 and Figure 2.23.1.6.

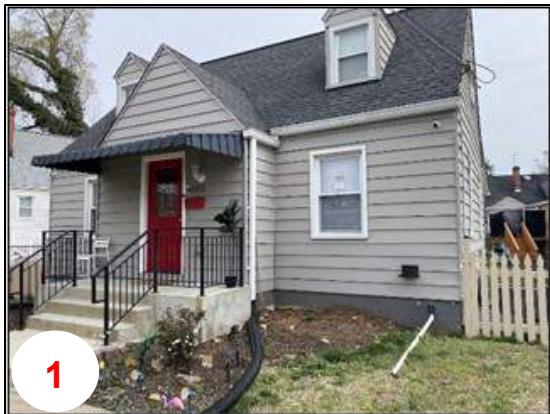
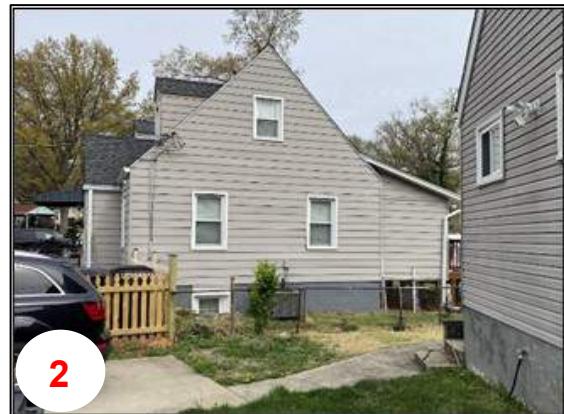
*Figure 2.23.1.2 Property #23: Front side (west side)   Figure 2.23.1.3 Property #23: Side (south side)*

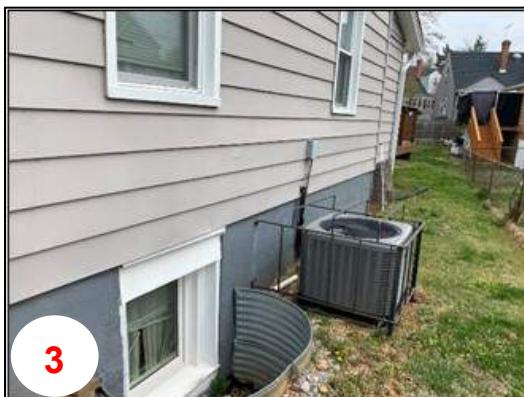
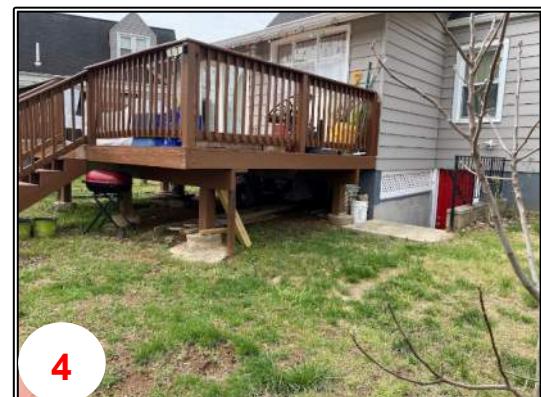
*Figure 2.23.1.4 Property #23: Side (south side)*

*Figure 2.23.1.5 Property #23: Back side (east side)*

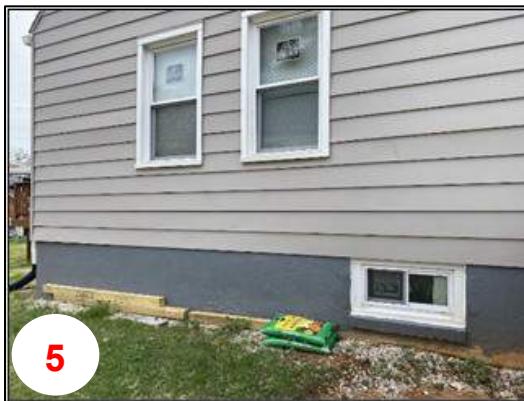
*Figure 2.23.1.6 Property #23: Side (north side)*

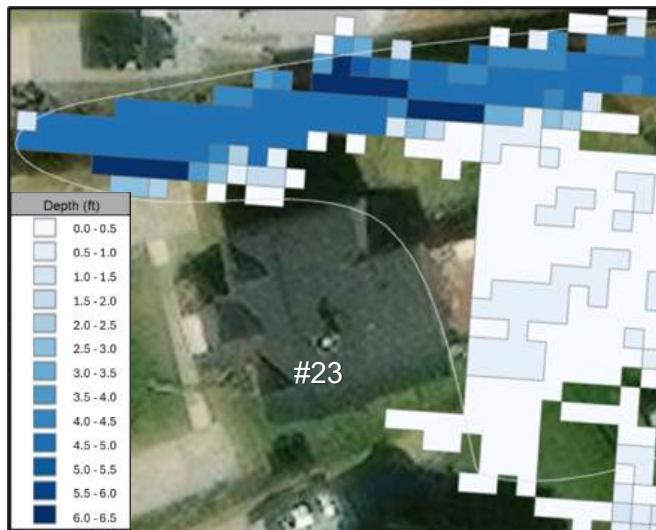
Figure 2.23.2.1 Property #23: 100-year flood depth above grade

The property at 4103 55<sup>th</sup> Avenue borders the Edmonston Channel on the north side of the property. Flood modeling indicates that floodwater from a 100-year event will overtop the channel and extend to the north, east, and south walls of the building. See Figure 2.23.2.1. The main floor is 3.5 feet above the 100-year flood level. However, floodwater will likely enter the basement at the back (east) side through a basement door and may enter through the south side basement window. Table 2.23.1 below lists the critical building elevations relative to the 100-year flood level. The lowest point of entry is at the upper stairwell landing to the basement door at 0.5 feet below the 100-year water surface elevation, whereas the basement door is 4.0 feet below. Also, the HVAC unit at the south side of the building is approximately 0.5 feet below the 100-year water surface elevation. None of the basement wall penetrations are below the 100-year water surface elevation. Note that the objects under the back (east) side deck may have prevented the identification of other flood risks.

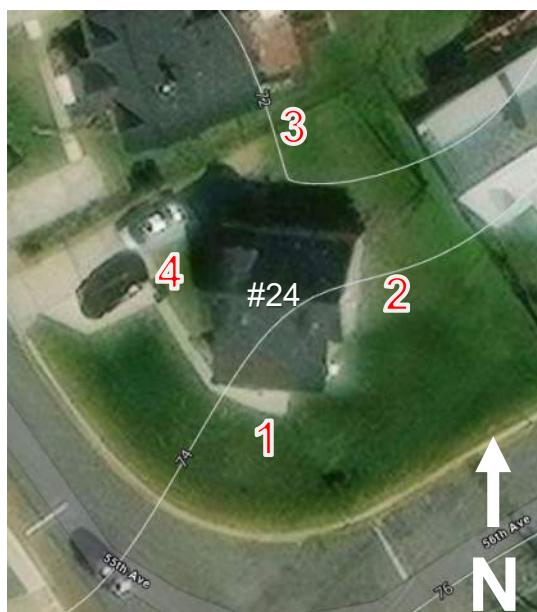
Figure 2.24.1.1 Property #24: Aerial view with elevation contours and photo numbering

The property at 4101 55<sup>th</sup> Avenue consists of a one-and-a-half story building with dormers at the roof. The grade slopes down from the front to the back of the building. At the back (north) side of the building, exterior steps lead down from the adjacent grade to a basement door. Along the same side, the HVAC unit is at grade. Basement windows are located between a couple inches to a couple feet above grade on the east, north, and west sides of the building. There are penetrations through the basement wall for plumbing pipes, vents, hose bibs, electrical conduit, gas piping, and cable conduit. Figure 2.24.1.1 below provides an aerial view of the home with topographic elevation contours, and the property is further depicted in Figure 2.24.1.2, Figure 2.24.1.3, Figure 2.24.1.4 and Figure 2.24.1.5.

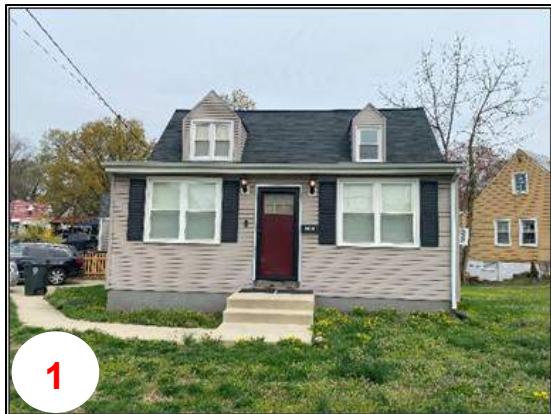
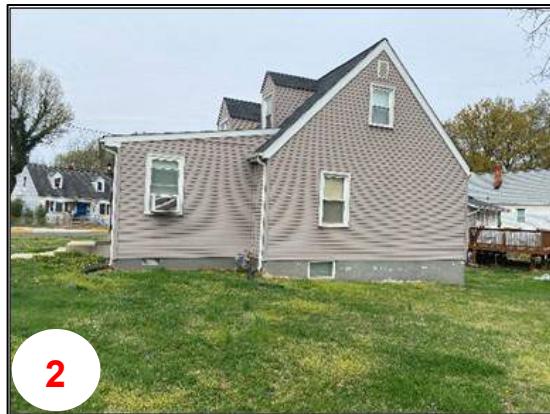
Figure 2.24.1.2 Property #24: Front side (south side) Figure 2.24.1.3 Property #24: Side (east side)

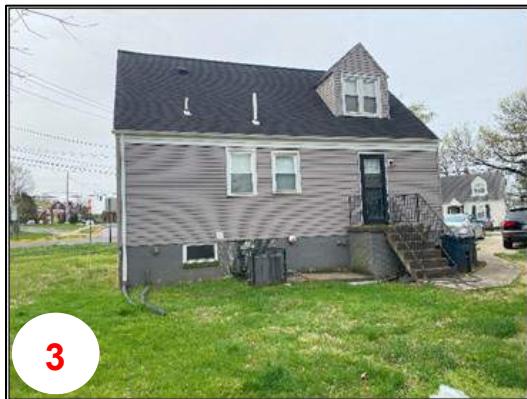
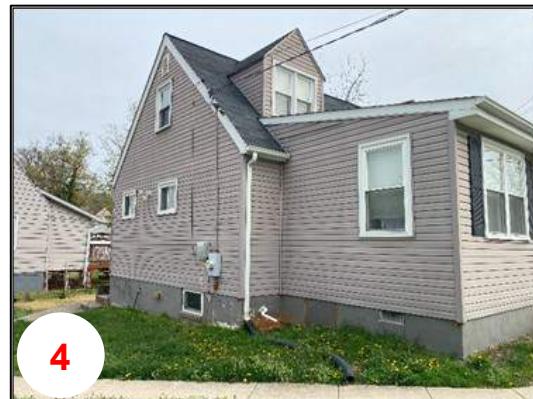
Figure 2.24.1.4 Property #24: Back side (north side) Figure 2.24.1.5 Property #24: Side (west side)

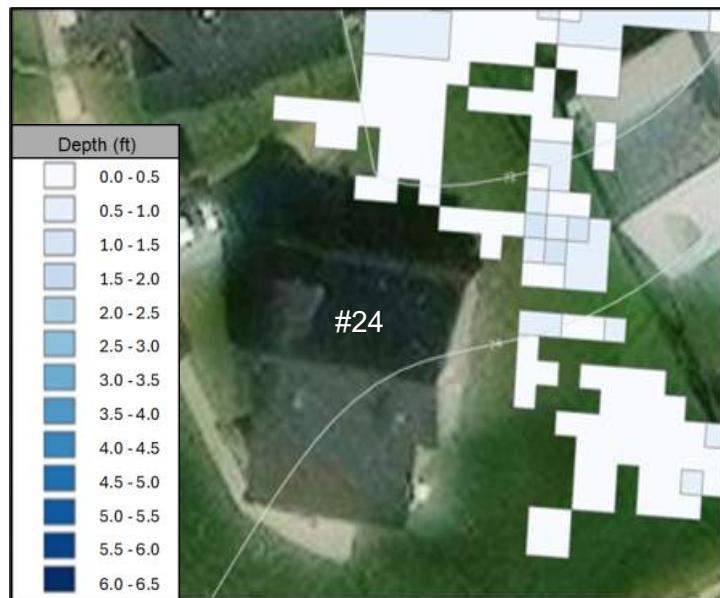
Figure 2.24.2.1 Property #24: 100-year flood depth above grade

The property at 4101 55<sup>th</sup> Avenue is located south of the Edmonston Channel. Flood modeling indicates that floodwater from a 100-year event will overtop the channel and extend to the back (north) wall of the building. See Figure 2.24.2.1. The main floor is 3.8 feet above the 100-year flood level. However, floodwater could potentially enter the basement at the back (north) side through a basement door. Table 2.24.1 below lists the critical building elevations relative to the 100-year flood level. The lowest point of entry is at the upper stairwell landing to the basement door at 0.5 feet above the 100-year water surface elevation, whereas the basement door is 6.1 feet below. Also, the HVAC unit at the back (north) side of the building is approximately 0.3 feet below the 100-year water surface elevation. None of the basement wall penetrations are below the 100-year water surface elevation.

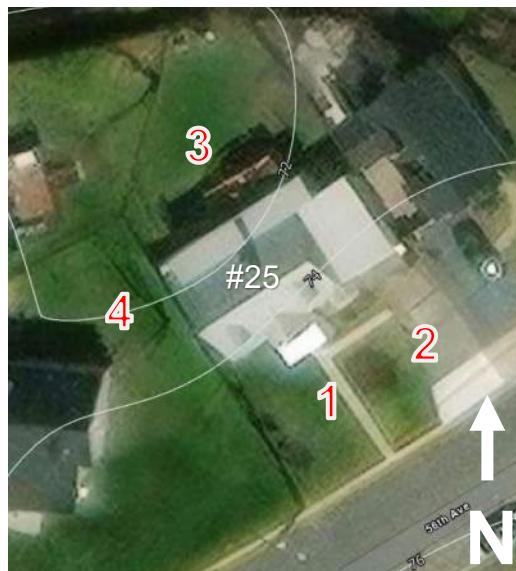
Figure 2.25.1.1 Property #25: Aerial view with elevation contours and photo numbering

The property at 4100 56<sup>th</sup> Avenue consists of a one-and-a-half story building with dormers at the roof. The grade slopes down from the front to the back of the building. There is an open sump pump at the back of the house that drains to the channel and an additional sump pump inside the building at the basement level. The basement door and HVAC unit are located at the back (north) side of the building at grade. Basement wall openings are covered with boards on the east, north, and west sides of the building. There are penetrations through the basement wall for a dryer vent, and electrical conduit. Figure 2.25.1.1 below provides an aerial view of the home with topographic elevation contours, and the property is further depicted in Figure 2.25.1.2, Figure 2.25.1.3, Figure 2.25.1.4, and Figure 2.25.1.5.
