# Bladensburg Flood Reduction Preliminary Design Report

## Flood Reduction Preliminary Design Report

Residents and property owners along Edmonston Channel and Quincy Run in the Town of Bladensburg, Maryland have experienced repetitive flooding on their properties during heavy rainfall events. Corvias Infrastructure Solutions (CIS), the managing partner for the Clean Water Partnership (CWP) with Prince George's County, Maryland, selected Stantec Consulting Services Inc. (Stantec) to evaluate the causes and severity of flooding and to develop alternatives to reduce flooding which is impacting properties along Edmonston Channel and Quincy Run.

Stantec previously conducted a comprehensive analysis and presented its findings and recommendations in the *Bladensburg Flood Reduction Alternatives Evaluation Report*, dated October 2024. This report advances the selected alternatives for Edmonston Channel (Figure ES-1) and Quincy Run (Figure ES-2) from the evaluation study into the preliminary design phase, incorporating surveyed topographic and subsurface utility data to further refine and optimize the designs.

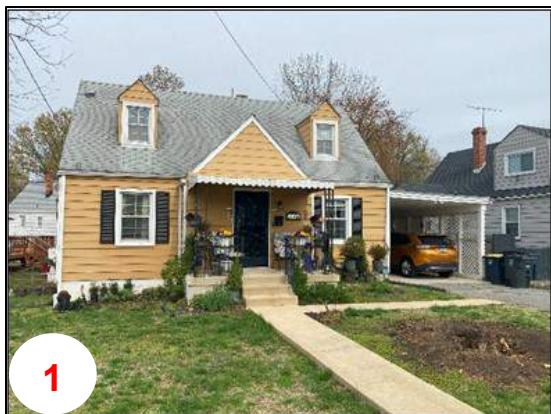
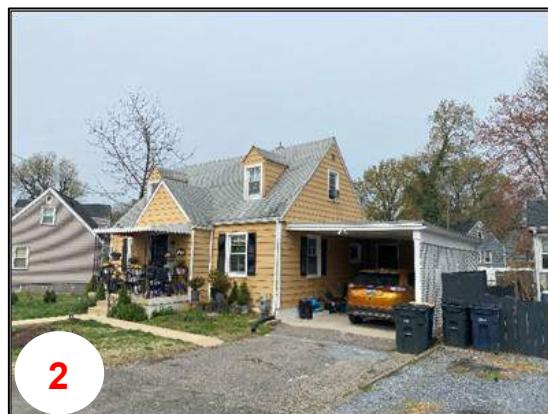
Figure 2.25.1.2 Property #25: Front side (south side) Figure 2.25.1.3 Property #25: Side (east side)

The property at 4100 56<sup>th</sup> Avenue consists of a one-and-a-half story building with dormers at the roof. The grade slopes down from the front to the back of the building. There is an open sump pump at the back of the house that drains to the channel and an additional sump pump inside the building at the basement level. The basement door and HVAC unit are located at the back (north) side of the building at grade. Basement wall openings are covered with boards on the east, north, and west sides of the building. There are penetrations through the basement wall for a dryer vent, and electrical conduit. Figure 2.25.1.1 below provides an aerial view of the home with topographic elevation contours, and the property is further depicted in Figure 2.25.1.2, Figure 2.25.1.3, Figure 2.25.1.4, and Figure 2.25.1.5.

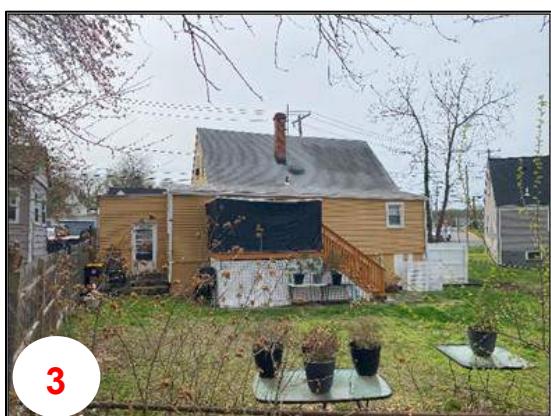
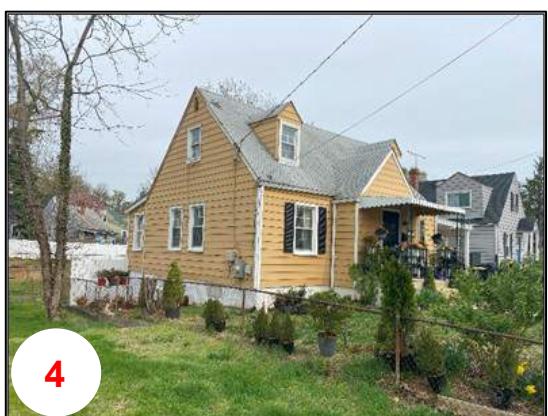
Figure 2.25.1.4 Property #25: Back side (north side) Figure 2.25.1.5 Property #25: Side (west side)

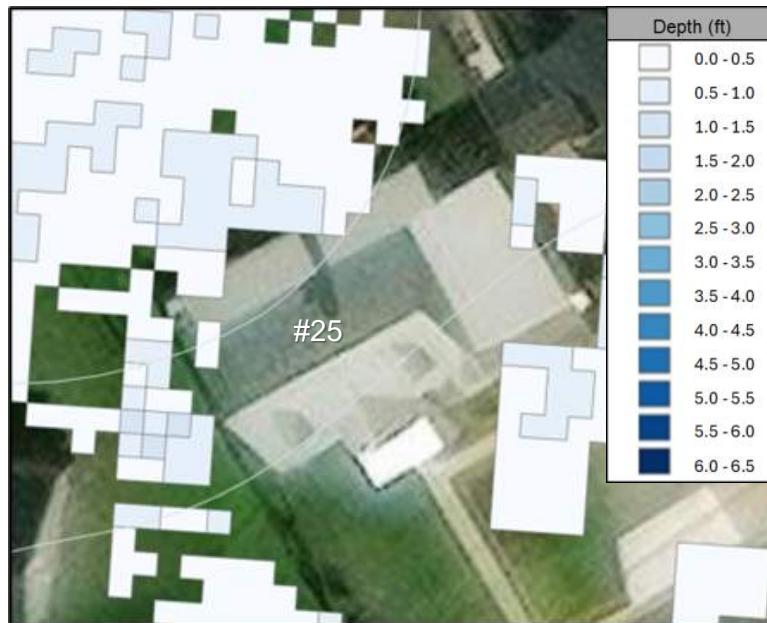
Figure 2.25.2.1 Property #25 100-year flood depth above grade

The property at 4100 56<sup>th</sup> Avenue is located south of the Edmonston Channel. Flood modeling indicates that floodwater from a 100-year event will extend to all four sides of the building. See Figure 2.25.2.1. The main floor is 4.4 feet above the 100-year flood level. However, floodwater will likely enter the basement through a basement door and may enter through a few other boarded openings at the back (north) side. Table 2.25.1 below lists the critical building elevations relative to the 100-year flood level. The lowest point of entry is at the basement door at 2.0 feet below the 100-year water surface elevation. Also, the HVAC unit nearby is more than 1.0 feet below the 100-year water surface elevation. None of the basement wall penetrations are below the 100-year water surface elevation. The homeowner reported that floodwater has previously penetrated the home. Note that the objects adjacent to the exterior wall at the carport may have prevented the identification of other flood risks.

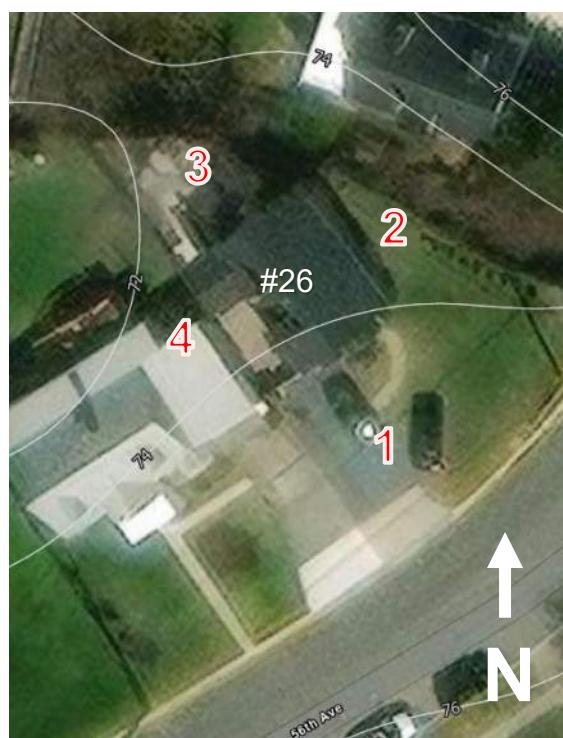
Figure 2.26.1.1 Property #26: Aerial view with elevation contours and photo numbering

The property at 4102 56<sup>th</sup> Ave consists of a one-and-a-half story building with a dormer at the roof. The grade slopes down from the front to the back of the building. At the back (north) side of the building, exterior steps lead down from the adjacent grade to a basement door. There are walls at each side that support a small roof at the exterior stairs. The HVAC unit is at grade near the basement door. Basement windows are at or below grade on the east, north, and west sides of the building. The window at the west side has a window well which is constructed of metal. There are penetrations through the basement wall for a plumbing pipe, dryer vent, hose bib, and electrical conduit. Figure 2.26.1.1 below provides an aerial view of the home with topographic elevation contours, and the property is further depicted in Figure 2.26.1.2, Figure 2.26.1.3, Figure 2.26.1.4 and Figure 2.26.1.5.

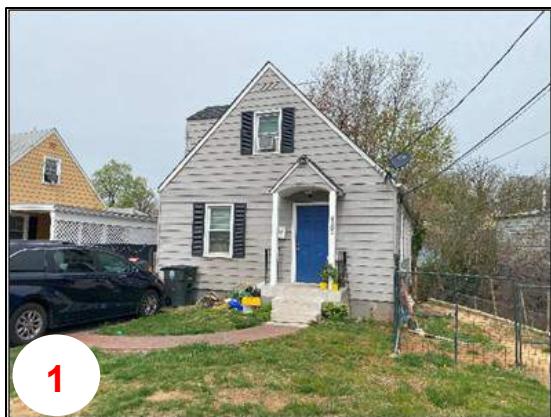
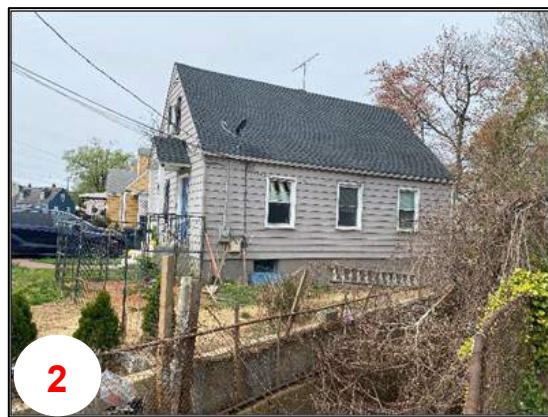
Figure 2.26.1.2 Property #26: Front side (south side) Figure 2.26.1.3 Property #26: Side (east side)

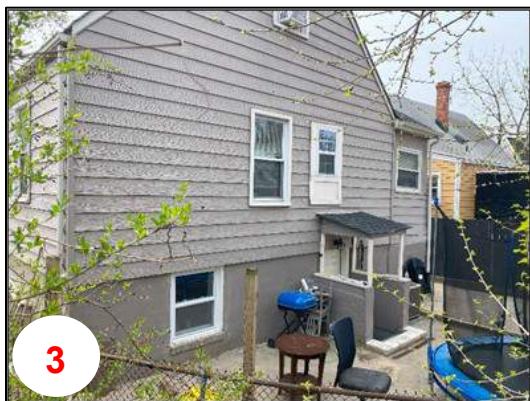
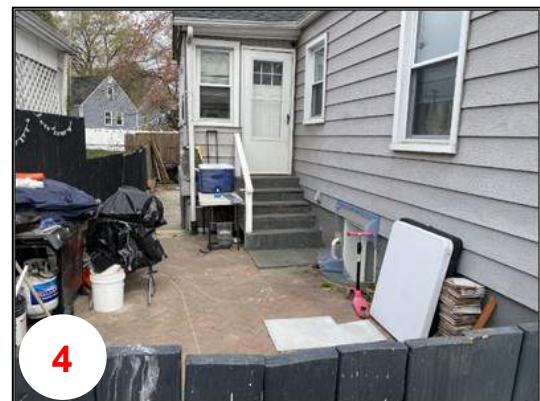
Figure 2.26.1.4 Property #26: Back side (north side) Figure 2.26.1.5 Property #26: Side (west side)

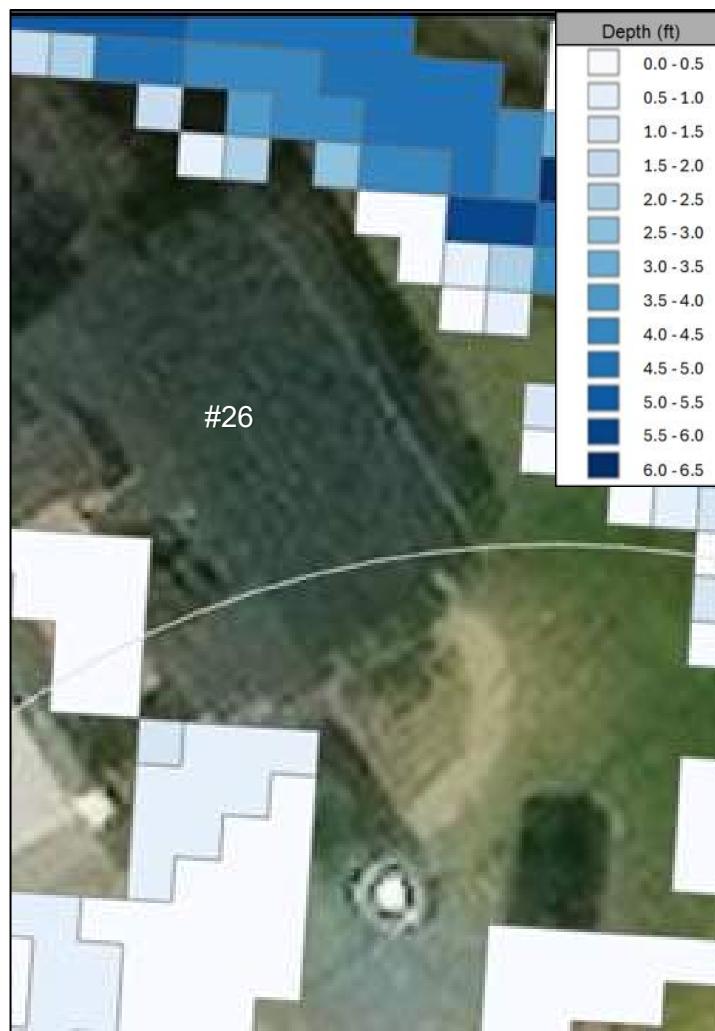
Figure 2.26.2.1 Property #26: 100-year flood depth above grade

The property at 4102 56<sup>th</sup> Avenue abuts the Edmonston Channel at the east side of the property. Flood modeling indicates that floodwater from a 100-year event will overtop the channel and extend to the back (north) wall of the building. See Figure 2.26.2.1. The main floor is 3.8 feet above the 100-year flood level. However, floodwater could potentially enter the basement at the back (north) side through a basement door as well as through basement windows at the east, north, and west sides of the building. Table 2.26.1 below lists the critical building elevations relative to the 100-year flood level. The lowest point of entry is at the upper stairwell landing to the basement door at 0.9 feet below the 100-year water surface elevation, whereas the basement door is 3.2 feet below. Also, the HVAC unit at the back (north) side of the building is approximately 1.5 feet below the 100-year water surface elevation. A few of the basement wall penetrations are at or may be below the 100-year water surface elevation including a hose bib, electrical conduit, and plumbing pipe. Note that the objects adjacent to the exterior walls may have prevented the identification of other flood risks.

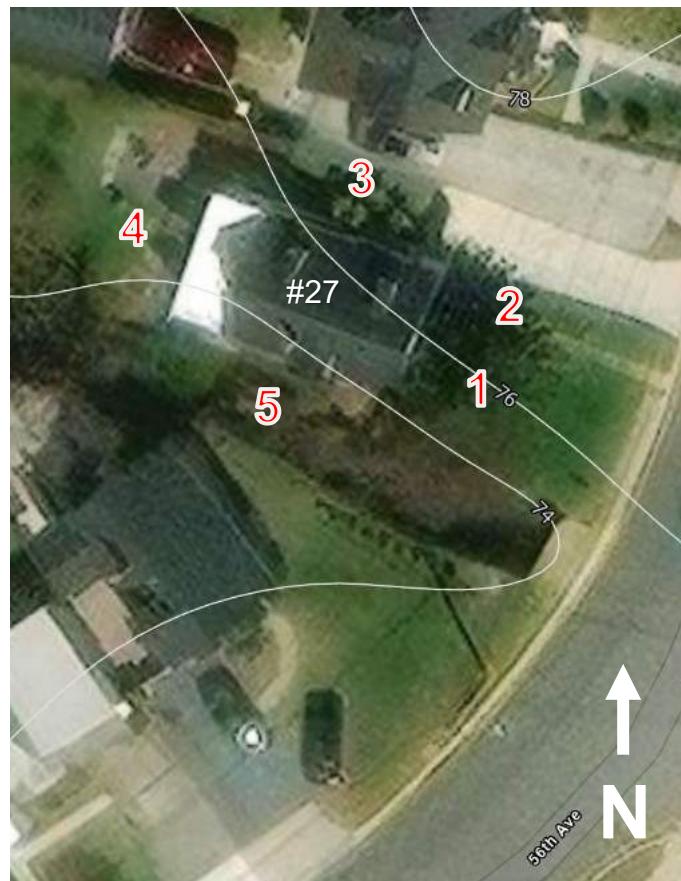
*Figure 2.27.1.1 Property #27: Aerial view with elevation contours and photo numbering*

The property at 4104 56<sup>th</sup> Avenue consists of a one-and-a-half story building with dormers at the roof. The grade slopes down from the front to the back of the building. At the back (west) side of the building, exterior steps lead down from the adjacent grade to a basement door. There is a small roof over the exterior steps. The HVAC unit is at grade at the south side of the building. Basement windows are located below or above grade on the north, west and south sides of the building. The window on the north side has a window well which is constructed of metal with a cover. There are penetrations through the basement wall for a hose bib, dryer vent, plumbing pipe, electrical conduit, and HVAC conduit. Figure 2.27.1.1 below provides an aerial view of the home with topographic elevation contours, and the property is further depicted in Figure 2.27.1.2, Figure 2.27.1.3, Figure 2.27.1.4, and Figure 2.27.1.5 and Figure 2.27.1.6.

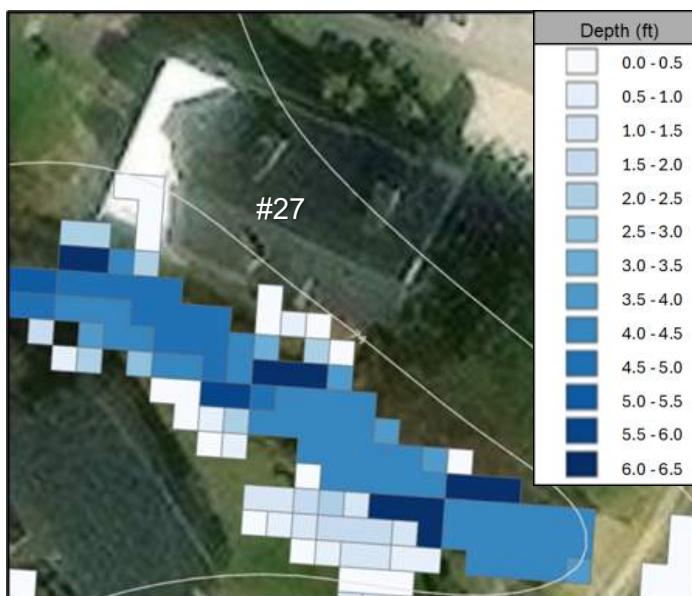
Figure 2.27.2.1 Property #27: 100-year flood depth above grade

The property at 4104 56<sup>th</sup> Avenue abuts the Edmonston Channel at the south side of the property. Flood modeling indicates that floodwater from a 100-year event will overtop the channel and extend to the back (west) wall and south wall of the building. See Figure 2.27.2.1. The main floor is 4.7 feet above the 100-year flood level. However, floodwater could potentially enter the basement at the back (west) side through a basement door. Table 2.27.1 below lists the critical building elevations relative to the 100-year flood level. The lowest point of entry is at the upper stairwell landing to the basement door at 0.1 feet below the 100-year water surface elevation, whereas the basement door is 2.1 feet below. Also, the HVAC unit at the south side of the building is approximately a few inches below the 100-year water surface elevation. None of the basement wall penetrations are below the 100-year water surface elevation. The homeowner reported they have seen water on the floor of the basement at the west side of the building. Note that the objects under the back (west) side landing may have prevented the identification of other flood risks.

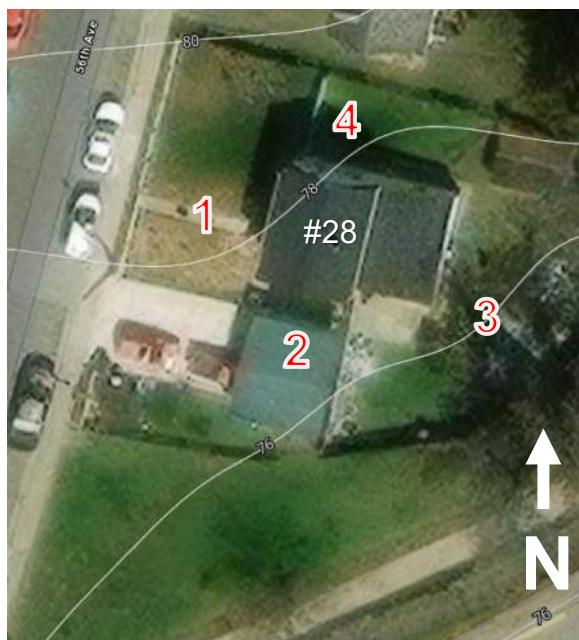
Figure 2.28.1.1 Property #28: Aerial view with elevation contours and photo numbering

The property at 4111 56<sup>th</sup> Avenue consists of a two-story home with a basement. There is an at-grade addition at the back (east) side of the building. Two basement windows are located a few inches above grade on the north and south sides of the building. The HVAC unit is at grade along the north side. There are penetrations through the basement wall for a dryer vent, hose bib, electrical conduit, and HVAC conduit. Figure 2.28.1.1 below provides an aerial view of the home with topographic elevation contours, and the property is further depicted in Figure 2.28.1.2, Figure 2.28.1.3, Figure 2.28.1.4, and Figure 2.28.1.5.

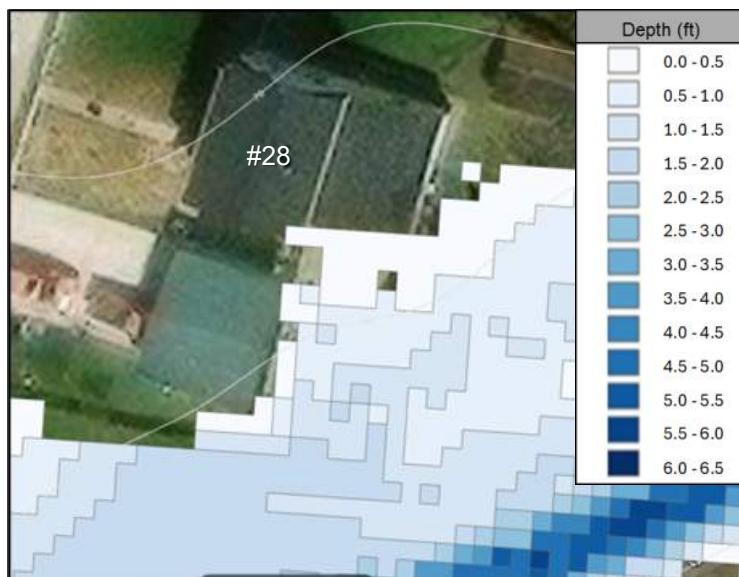
Figure 2.28.2.1 Property #28: 100-year flood depth above grade

The property at 4111 56<sup>th</sup> Avenue is located north of the Edmonston Channel. Flood modeling indicates that floodwater from a 100-year event will overtop the channel and extend to the south wall and back (east) wall of the building. See Figure 2.28.2.1. The main floor is 3.5 feet above the 100-year flood level. However, floodwater could potentially enter the addition at the back (east) side through a side door. Table 2.28.1 below lists the critical building elevations relative to the 100-year flood level. The lowest point of entry is at the side door at 0.4 feet above the 100-year water surface elevation. None of the basement wall penetrations are below the 100-year water surface elevation. Note that the objects adjacent to the exterior walls may have prevented the identification of other flood risks.

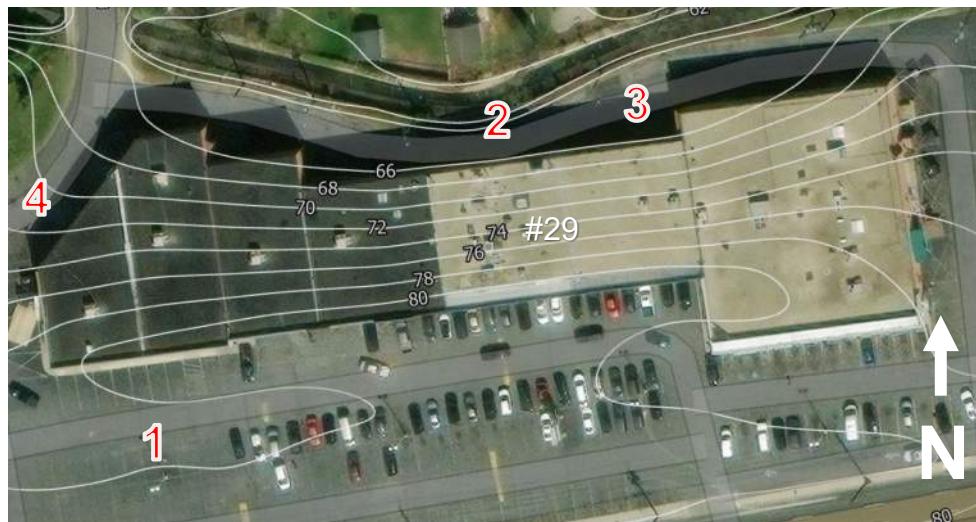
Figure 2.29.1.1 Property #29: Aerial view with elevation contours and photo numbering

The property at 5416 Annapolis Road consists of a large one-story shopping center complex located adjacent to the Edmonston Channel. The basement level is constructed with concrete masonry units (CMU). The grade slopes down from the front to the back of the building. At the back (north) side there are several doors at grade and several loading docks approximately 3.5 feet above grade that service the basement. Wall penetrations for electrical are located approximately 1.5 feet above grade at the back (north) side. Figure 2.29.1.1 below provides an aerial view of the complex with topographic elevation contours, and the property is further depicted in Figure 2.29.1.2, Figure 2.29.1.3, Figure 2.29.1.4, and Figure 2.29.1.5.

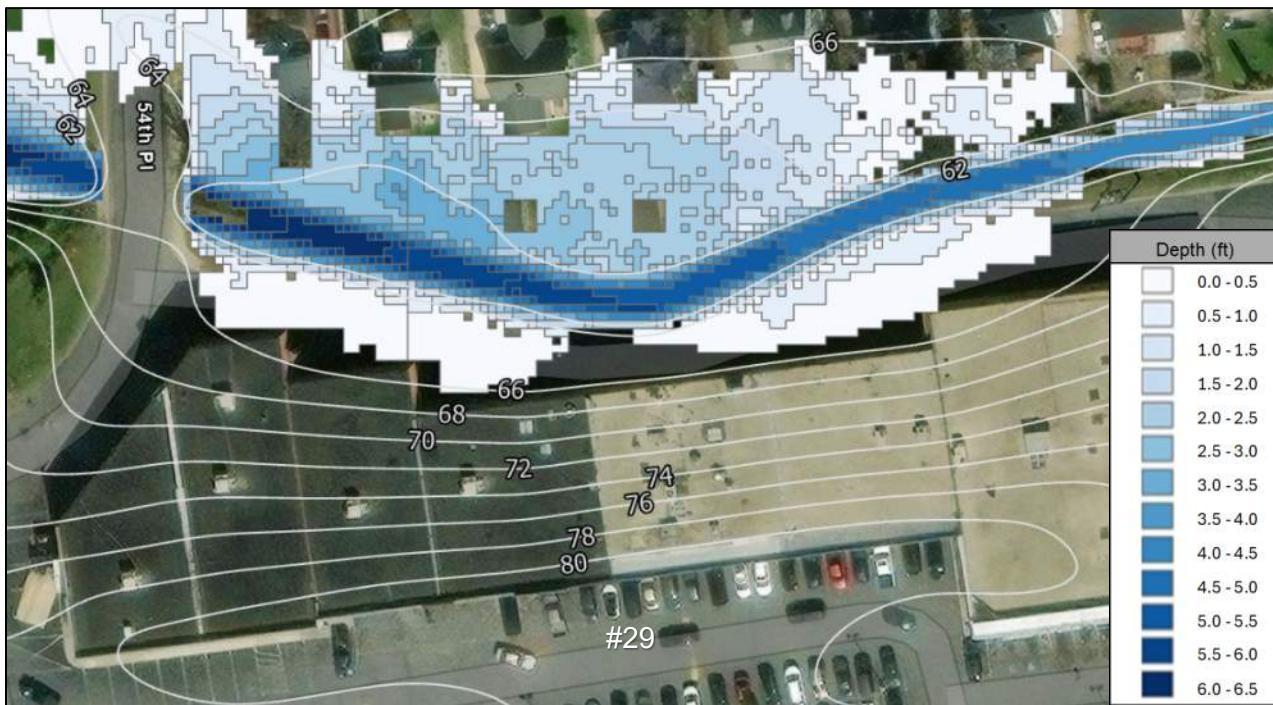
Figure 2.29.2.1 Property #29: 100-year flood depth above grade

The property at 5416 Annapolis Road is located south of the Edmonston Channel. Flood modeling indicates that floodwater from a 100-year event will overtop the channel and extend to the back (north) wall of the building. See Figure 2.29.2.1. The lower floor level is 2.6 feet above the 100-year flood level. However, floodwater could enter the exterior access doors that likely lead to a stairwell for entry to the lower floor level at the back (north) side. This is not expected to impact the lowest floor level, but may affect contents behind these access doors which may include mechanical, electrical, and plumbing systems that were not accessible for observation during the site visit. Table 2.29.1 below lists the critical building elevations relative to the 100-year flood level. The lowest point of entry to the lowest floor level is at the back (north) loading dock doors at 2.6 feet above the 100-year water surface elevation. A transformer at the same side is below the 100-year water surface elevation as well. Note that the restricted access through the exterior access doors may have prevented the identification of other flood risks.

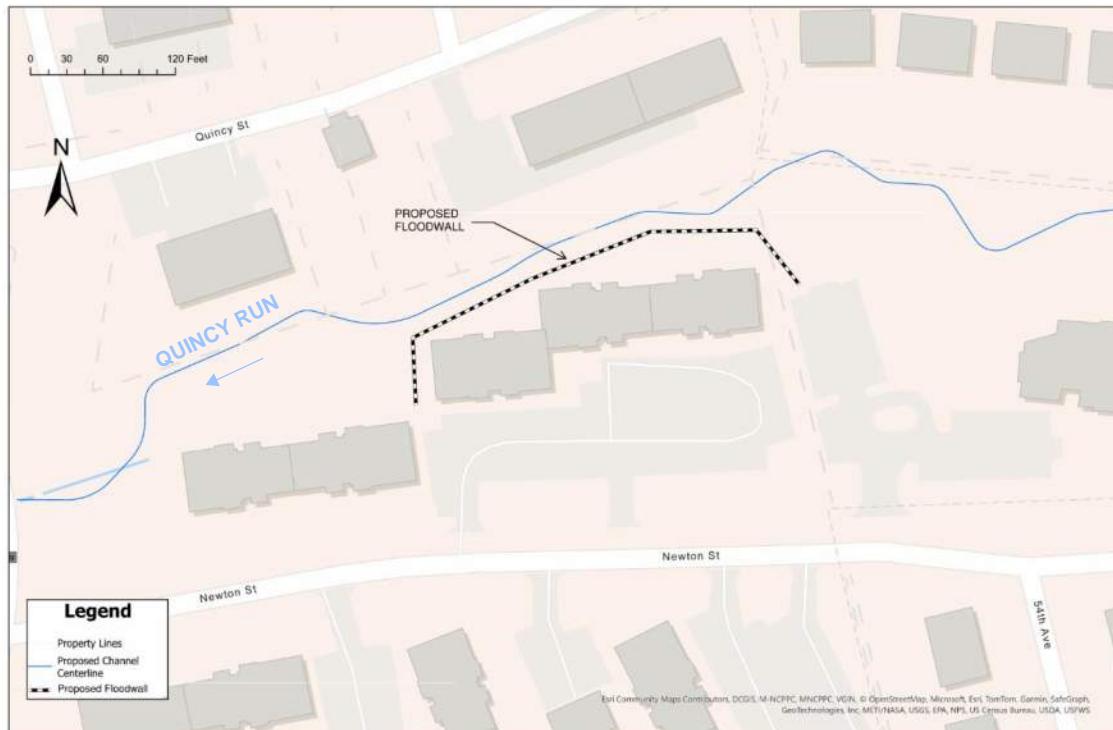
**Figure 2: Proposed Floodwall Location**

The proposed location and alignment of the floodwall are shown in Figure 1 and Figure 2. Stormwater runoff from the building's parking lot will no longer be able to discharge to the stream and will instead pond behind the proposed floodwall. Therefore, pumps were designed to drain the interior floodwater. For this analysis, only the 100-year return event was evaluated for the pump design. However, the pump station will be used to evacuate water during other frequent events, as needed.

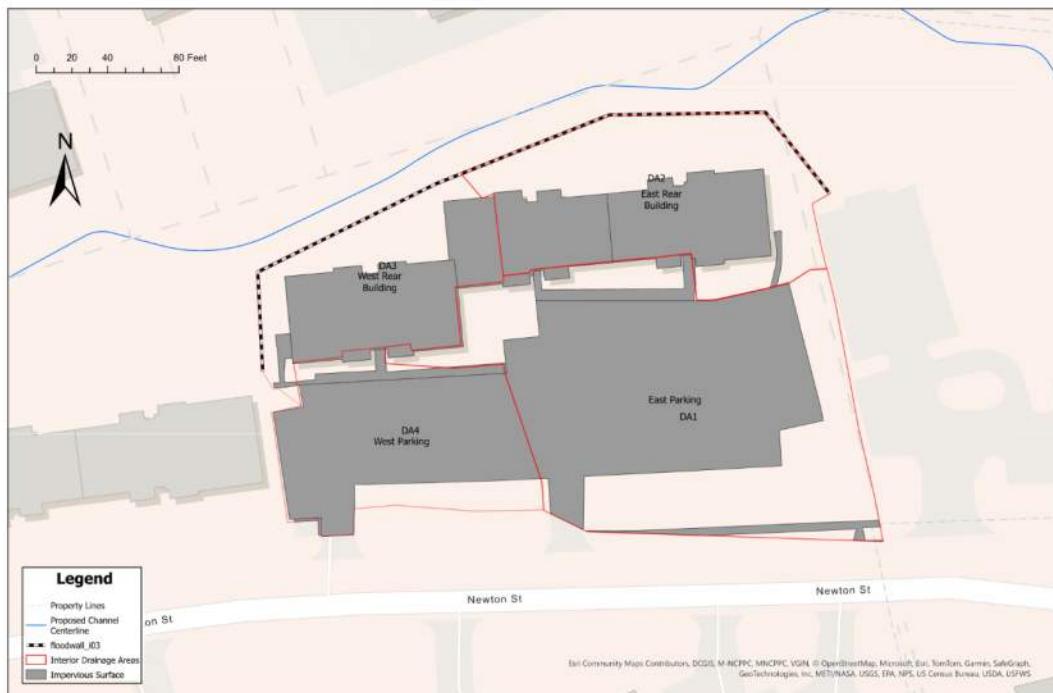
**Figure 3: Impervious Area**

The only two land covers for the site are impervious (buildings and paved areas) and grass/lawn. The impervious areas are depicted in Figure 3. The impervious surfaces dataset is from Prince George's County Planning Department. A conservative assumption that the slopes were greater than 7% was used for the grass/lawn.

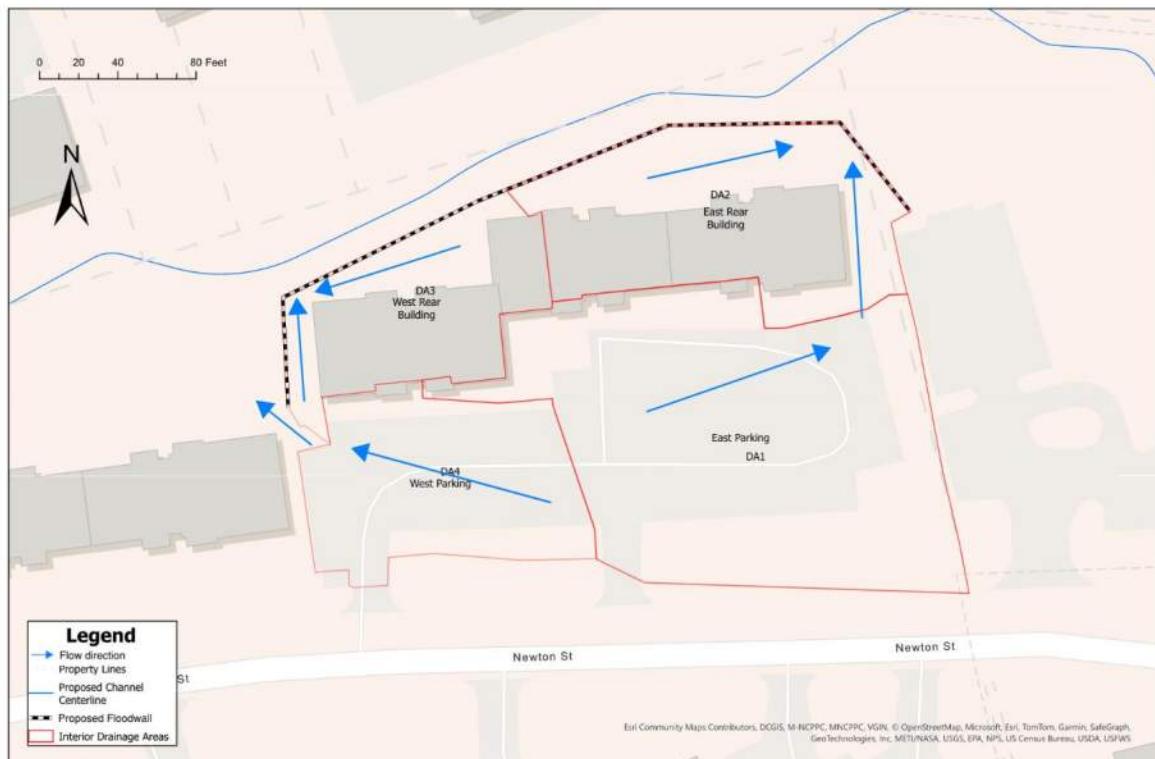
**Figure 4: Interior Drainage Areas**

Four drainage areas were delineated using site specific survey data supplemented with publicly available Digital Elevation Model data for Prince Georges County, MD (Figure 4). The total, impervious and pervious areas from the GIS were used to calculate the weighted runoff coefficients and the flows.

The east parking lot (DA1) conveys runoff to a curb cut and swale before discharging to Quincy Run. The east rear building (DA2) includes runoff from behind the building and part of the roof. The west rear building (DA3) includes the runoff from behind the building and part of the roof. DA2 and DA3 are separated by a short wall that divides the flow. A storm inlet conveys runoff from the west parking lot (DA4) through the existing storm sewer system and discharges directly to Quincy Run. If overflow at this inlet occurs, the runoff will be conveyed overland and outside of the floodwall.

Flows were determined for each of the drainage areas separately, in addition to the Total East DA (DA1 and DA2) and the Total West DA (DA3 and DA4) flows. Total East DA assumes that the entire flow from the east parking lot and the east rear building will contribute to the interior flooding. Total West DA assumes that the entire flow from the west parking lot and the west rear building will contribute to the interior flooding behind the floodwall. As noted herein, the flows from the east and west sides of the building remain separate due to a wall behind the building, and therefore it is assumed that two pumps will be needed, one for each side.

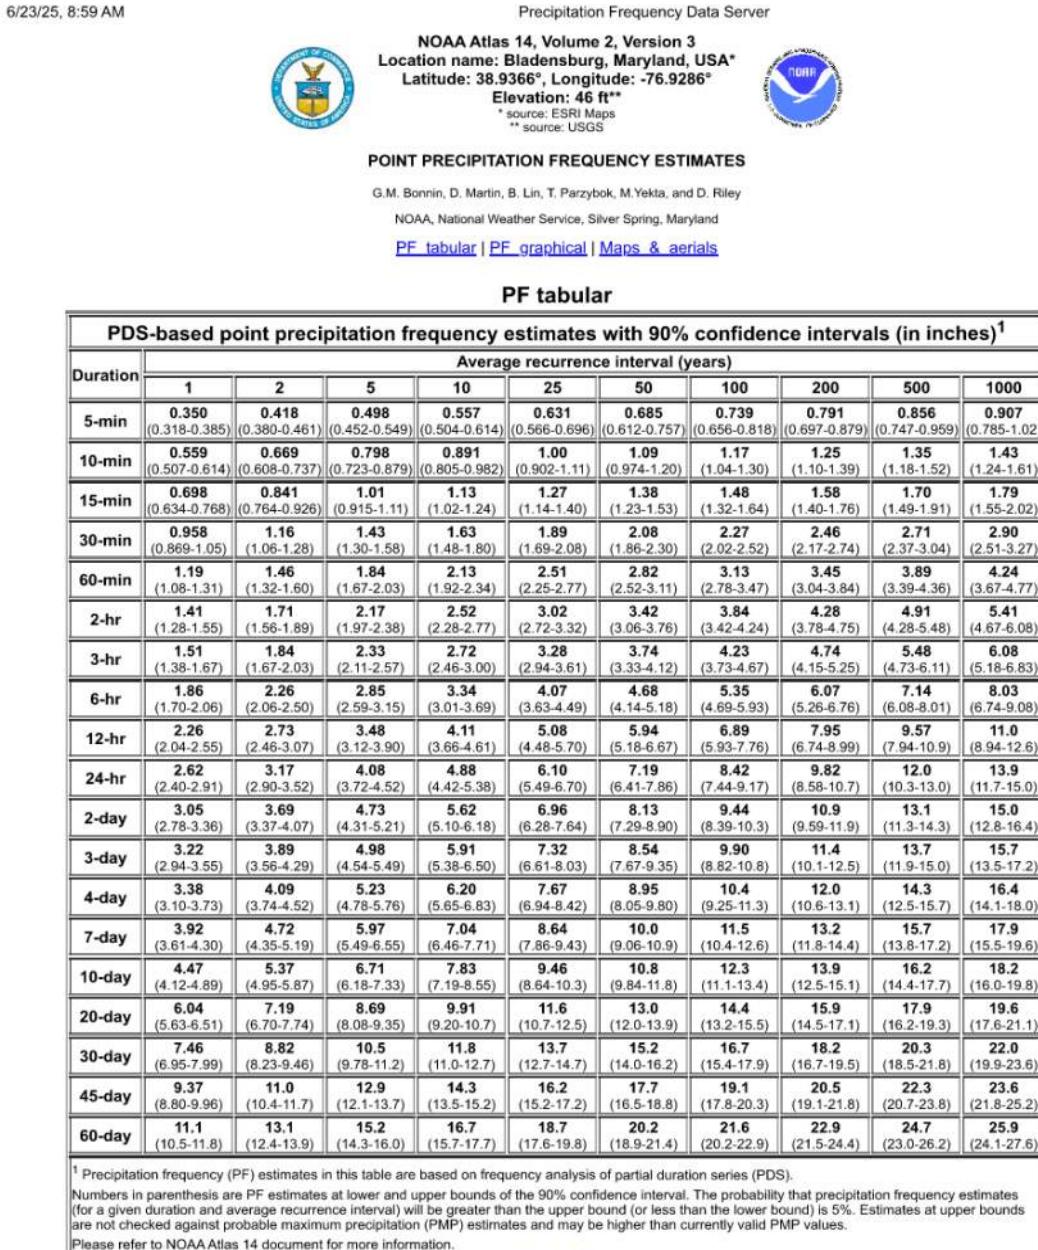
Figure 5: NOAA Atlas 14 for Bladensburg, MD. Accessed June 23, 2025.

Rainfall intensity for the Rational Method was based on rainfall intensity curves from NOAA Atlas 14 (Figure 5). The intensity curves were developed for Times of Concentration (Tc) of 5-minutes to 1-hour storm frequencies for the 1-, 2-, 5-, 10-, 50-, and 100-yr return events. Since our site is less than 2 acres, Section 8.2.2.1 of the Design Manual states that commercial, industrial, apartments, or similar should use a Tc of 5 minutes. The NOAA Atlas 14 gives the 100-yr, 5-minute rainfall as 0.739 which translates to an intensity of 8.88 in/hr.

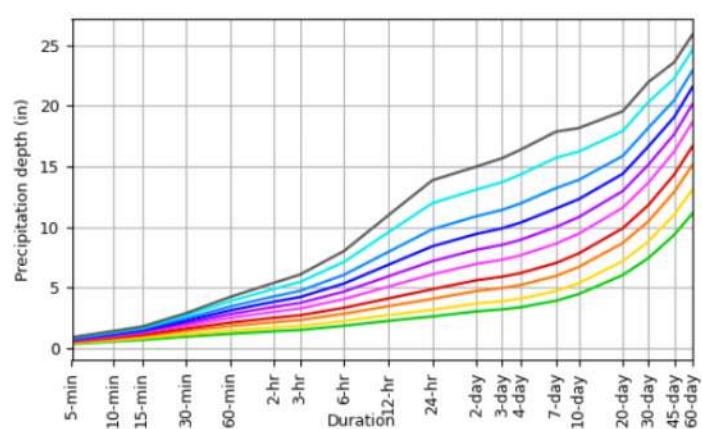
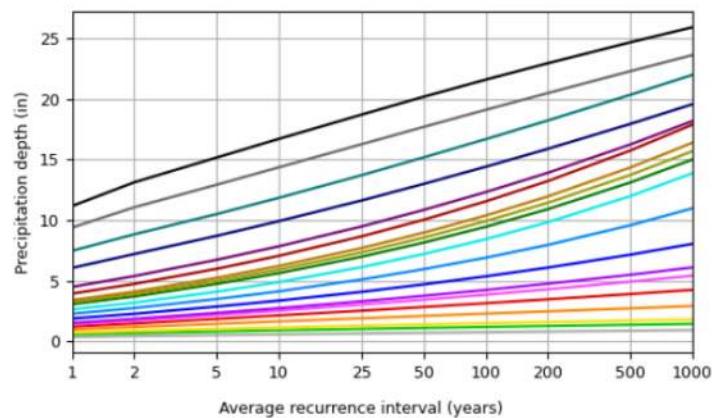
PDS-based depth-duration-frequency (DDF) curves  
Latitude: 38.9366°, Longitude: -76.9286°

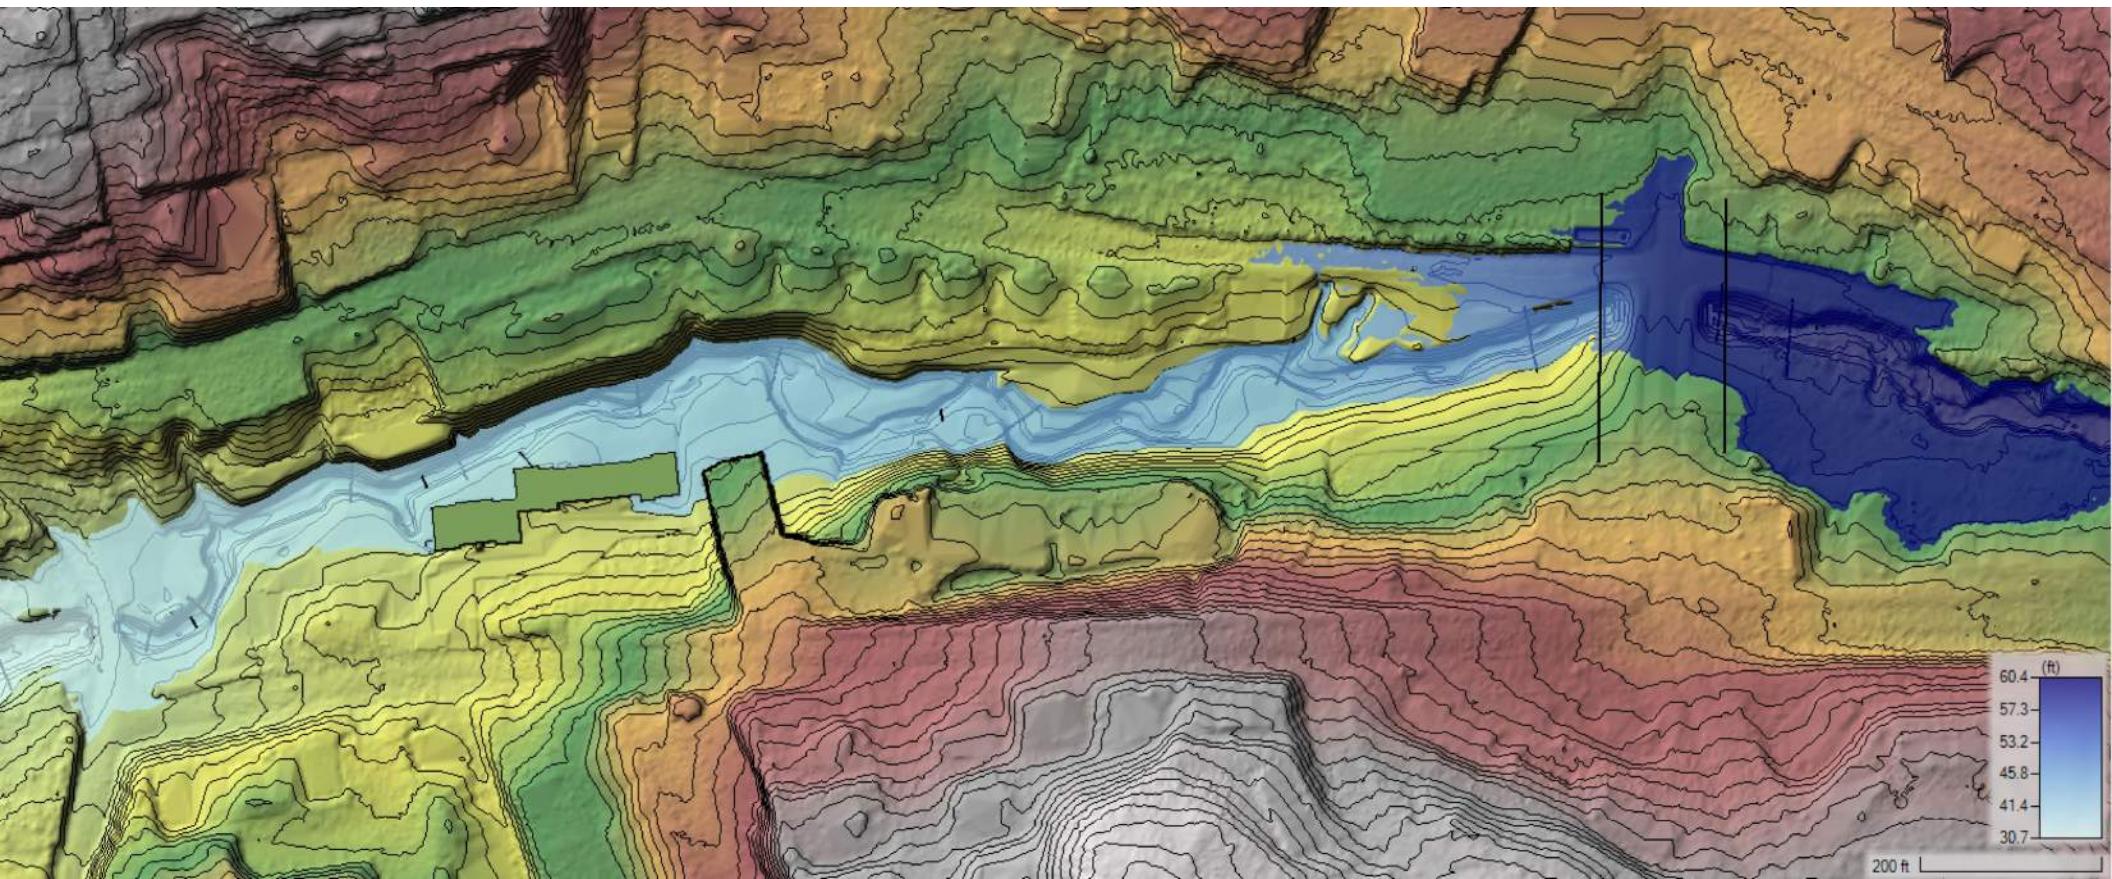
Existing Conditions

100-YR Water Surface Elevation

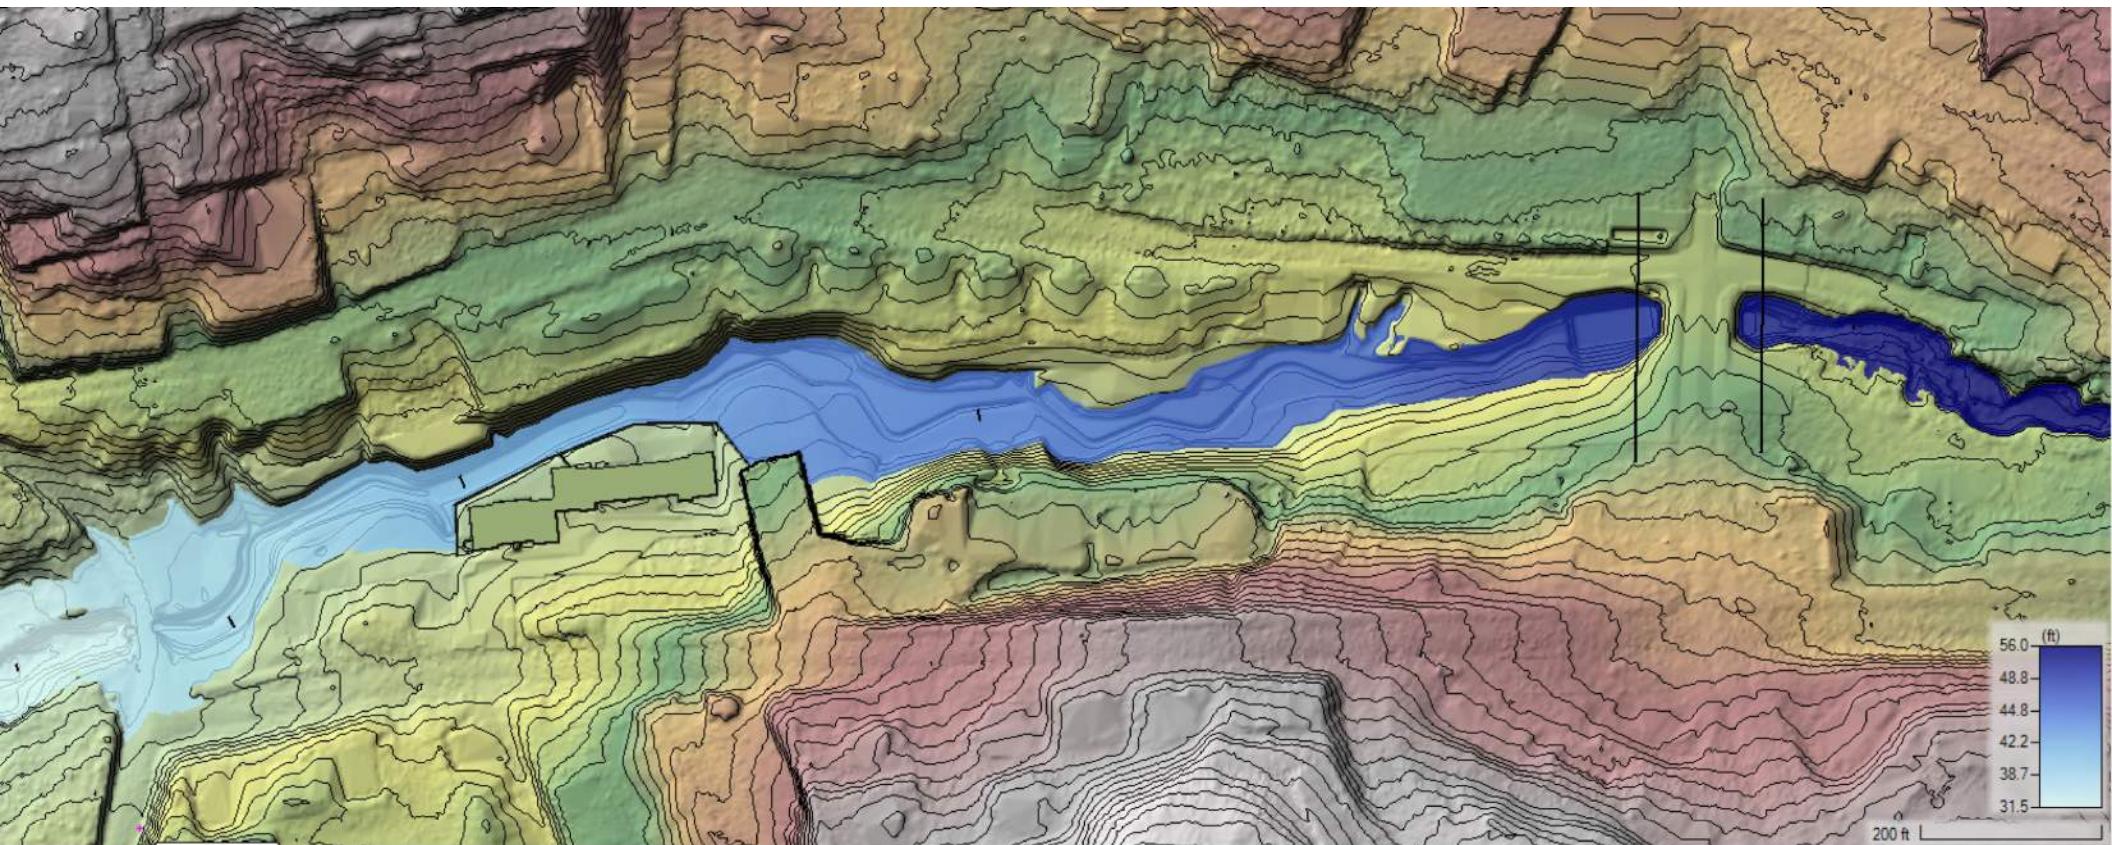
Proposed Conditions

100-YR Water Surface Elevation
