THE CITY OF
BURLESON
TEXAS

Water and Wastewater Leak Detection Update

City Council
March 2, 2026

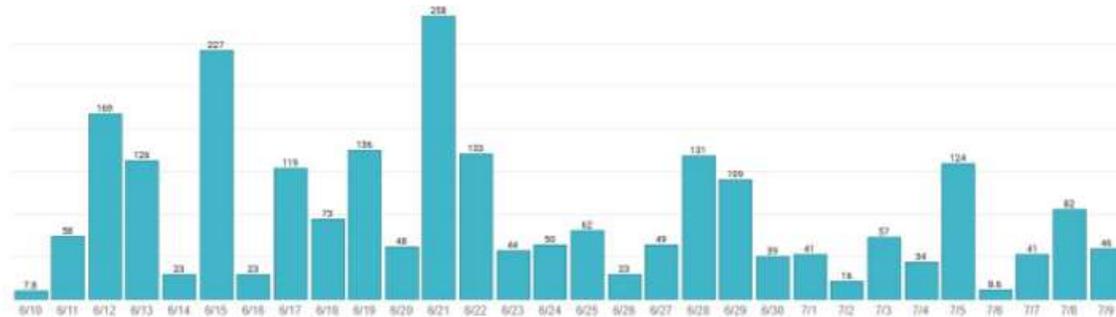
Normal Usage over 30 days

Example of Normal vs. Continuous Consumption

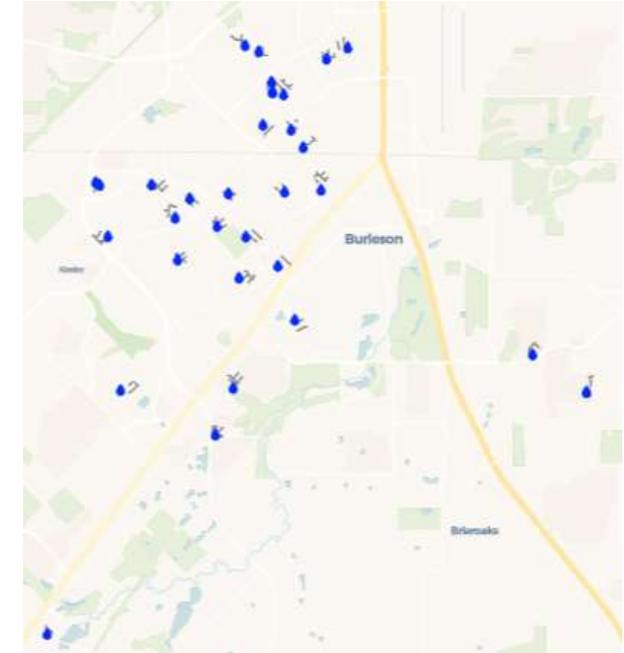
Satellite Water Leak Detection: Utility-side

Utility Leak Categories	Number of Leaks	Corrected
Service Pipe	7	Y
Service Connection	6	Y
Valve (shut off)	1	Y
Fire Hydrant	5	Y
Water Meter	7	Y
Water Meter Curb Stop	7	Y
Total	33

Service Pipe: connection from the distribution main to the building’s plumbing system

Service Connection: assembly (pipes, valves, fittings) that links the water main to the customer’s service line or meter

Valve: mechanical device installed that controls, shuts off, or regulates water flow

Water Meter Curb Stop: valve—located underground near the curb—that enables utilities (and sometimes customers) to shut off water flow before the meter

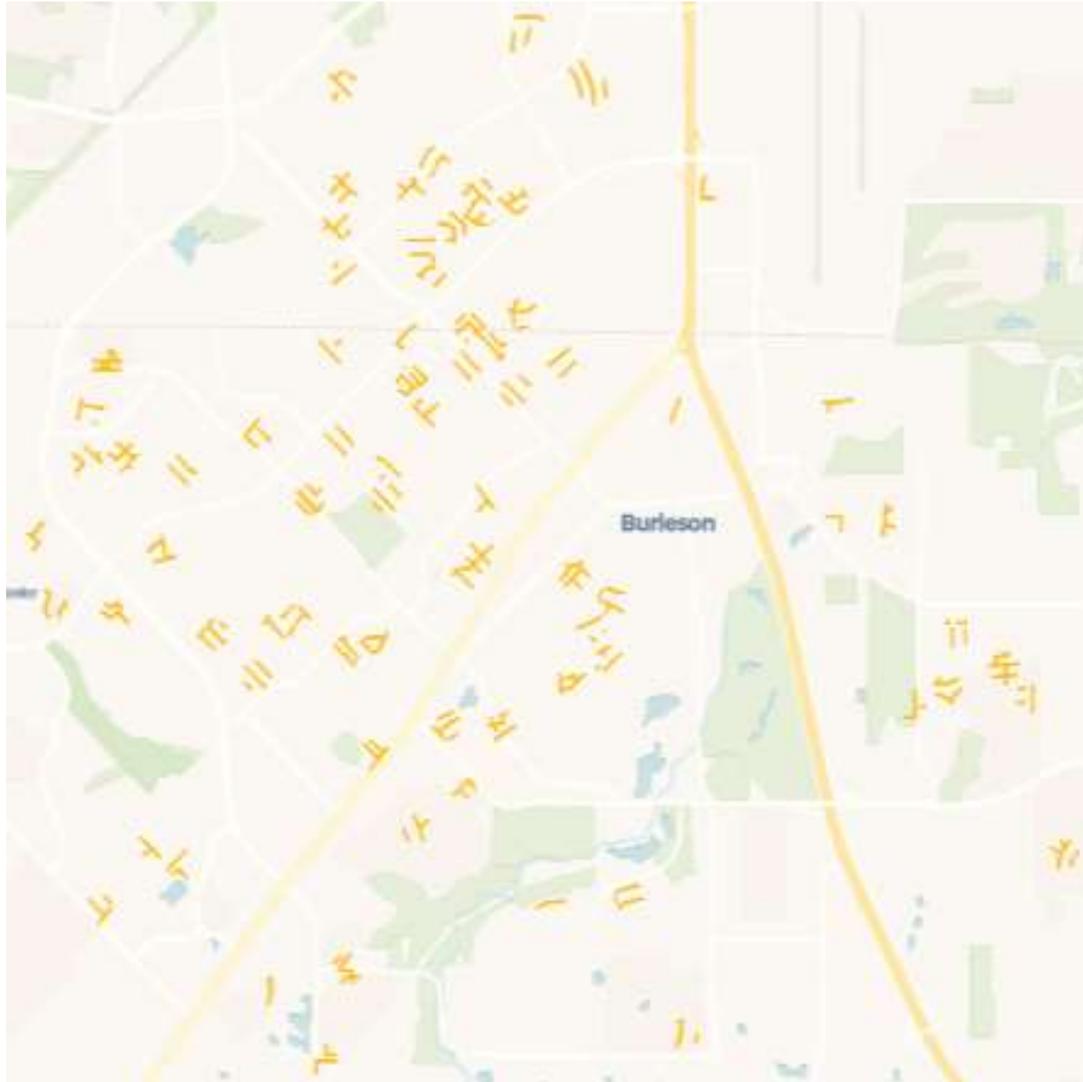
Satellite Wastewater Leak Detection

- CCTV inspection completed for approximately **nine of 21** miles identified
- Smoke testing completed for **six of 21** miles identified
- Corrective actions resulting from activities above:
 - Five manholes rehabilitated to address structural issues and infiltration
 - 100 manhole rain guards installed
 - 35 broken/missing sewer cleanout caps replaced

- 21 miles of sewer mains identified for inspection (100 segments or Areas of Interest (AOIs) identified by satellite scans and analysis)
- Field validation through a combination of smoke testing, CCTV, and visual checks
- Field investigations found no evidence of sanitary sewer overflows
- Acoustic detection is much less effective for gravity flow wastewater mains (much more effective for water mains)
