# CJ DENS EAST SUBDIVISION

## PRELIMINARY SUBDIVISION PLANS

COVER SHEET  
CJ DENS SUBDIVISION  
CJ DENS LACAMAS II LLC  
CAMAS, WASHINGTON

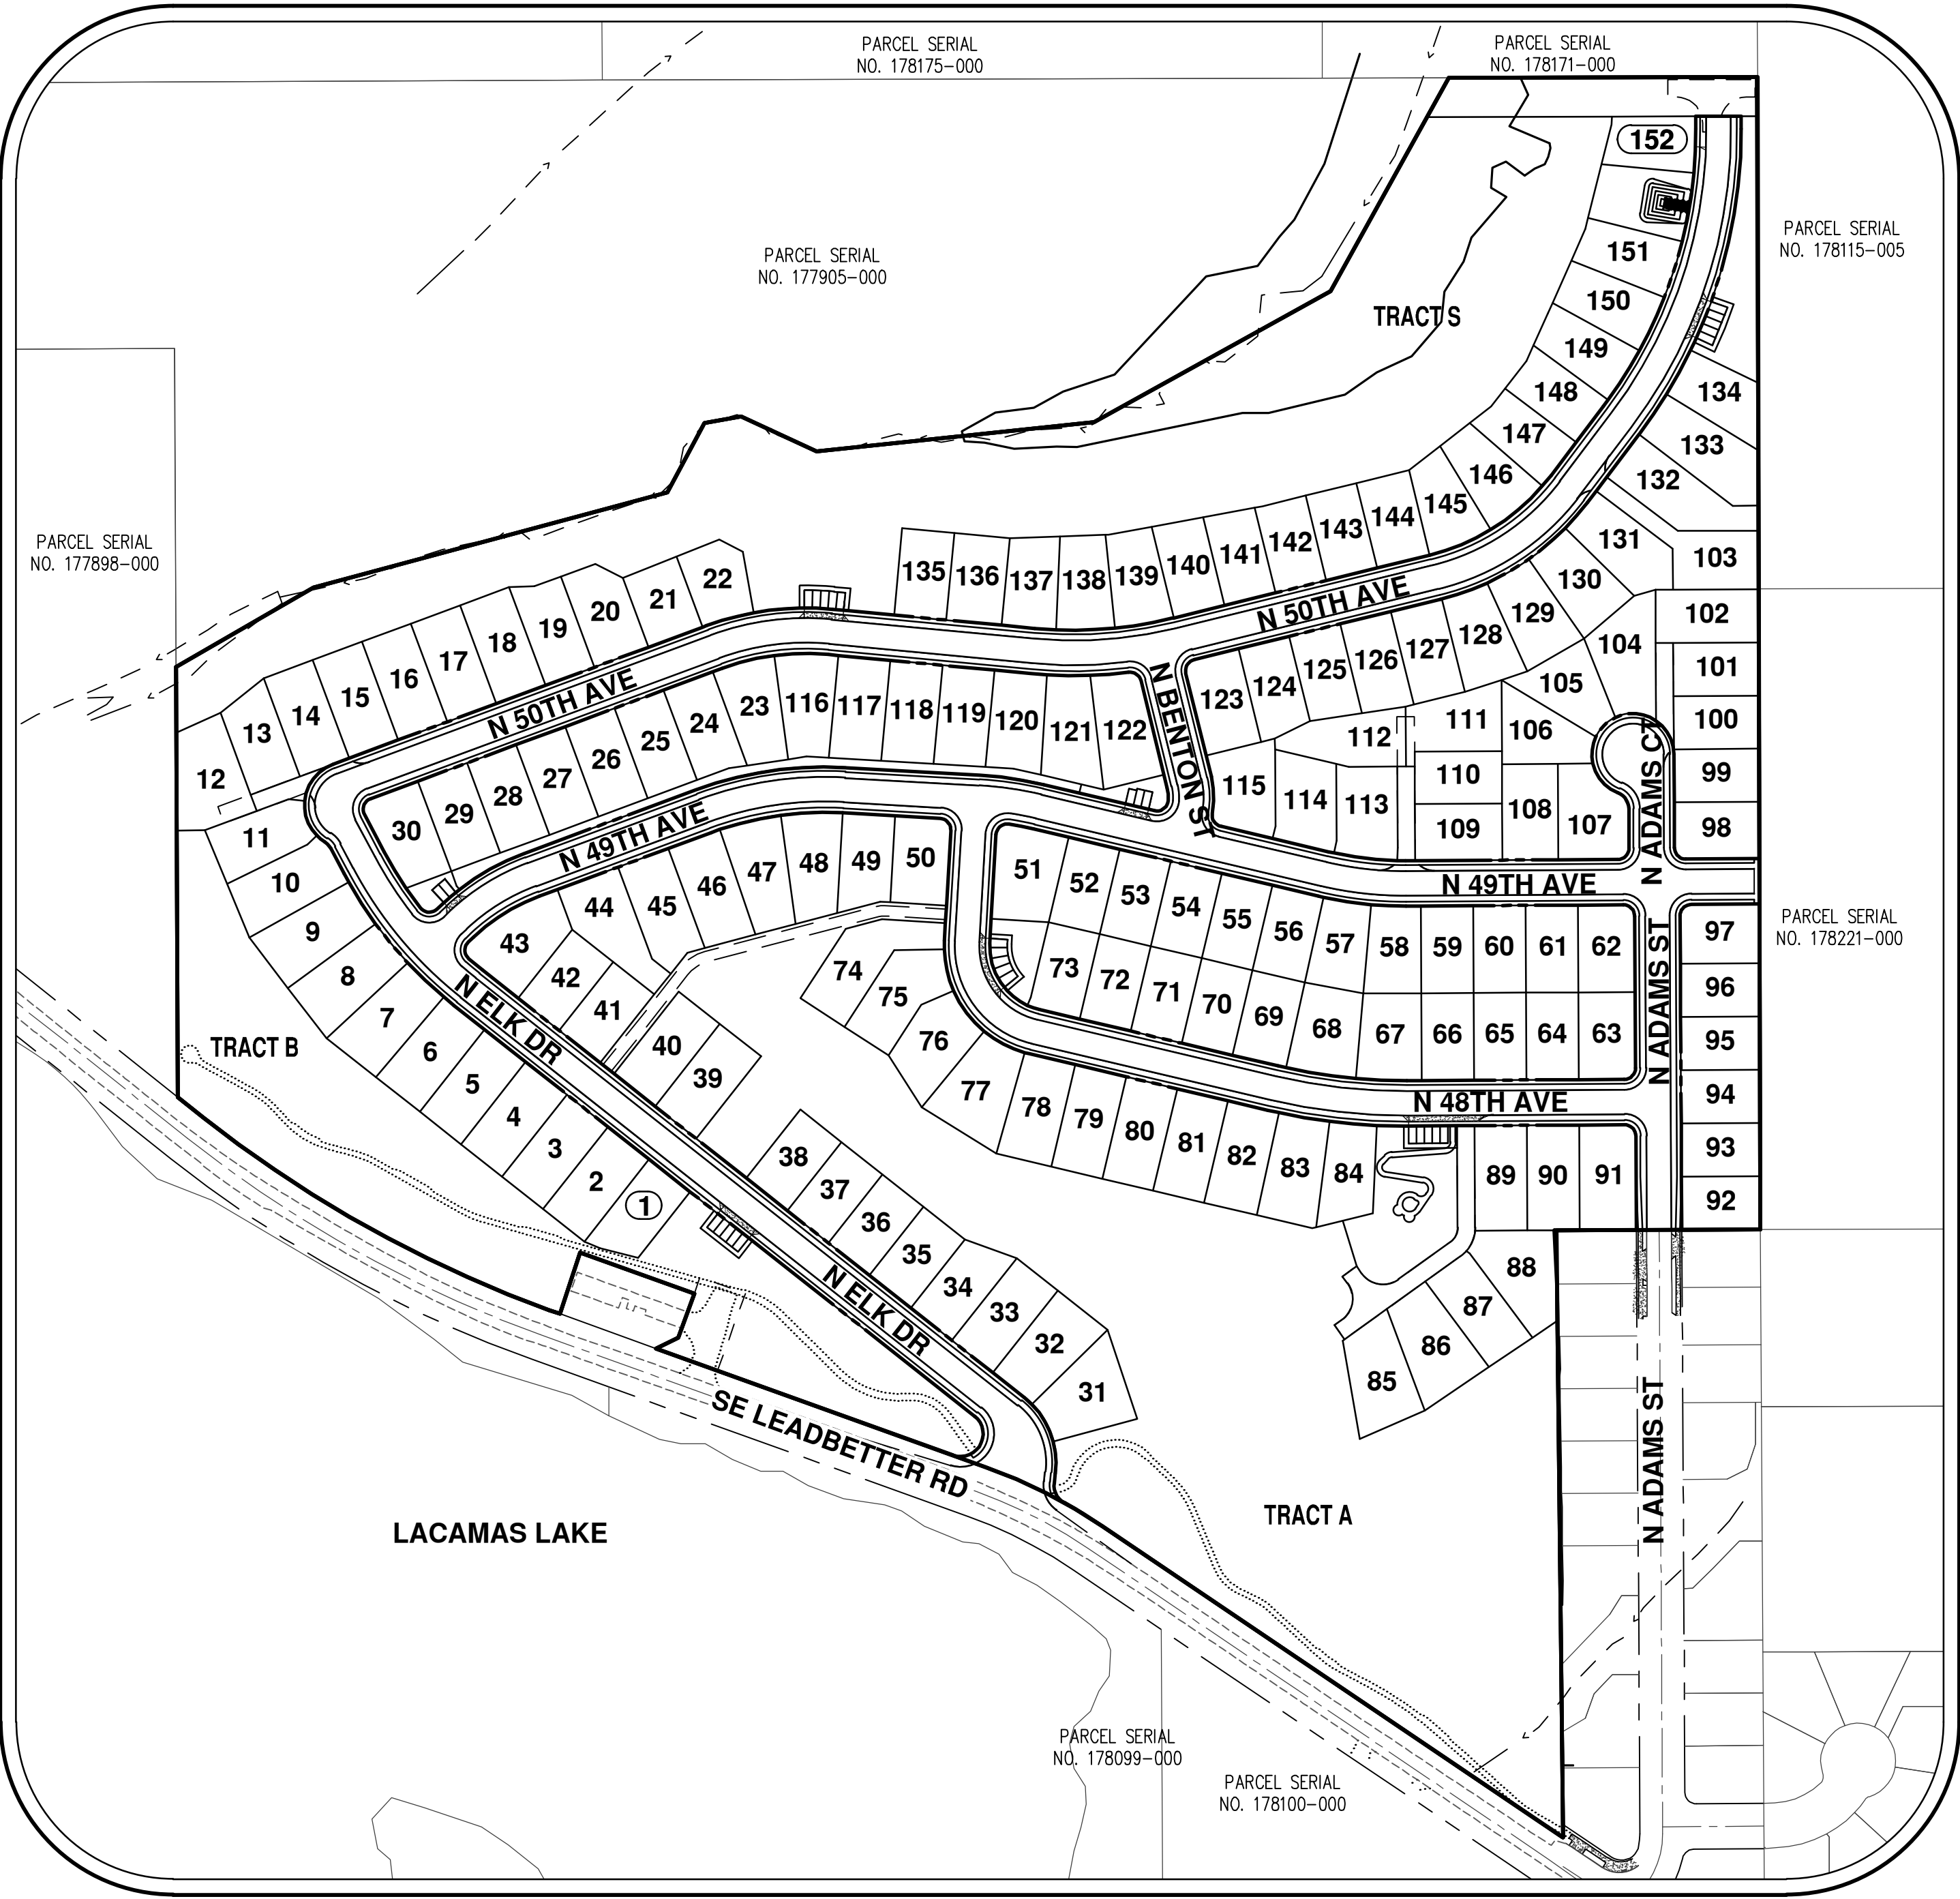
SITE MAP

1"=150'

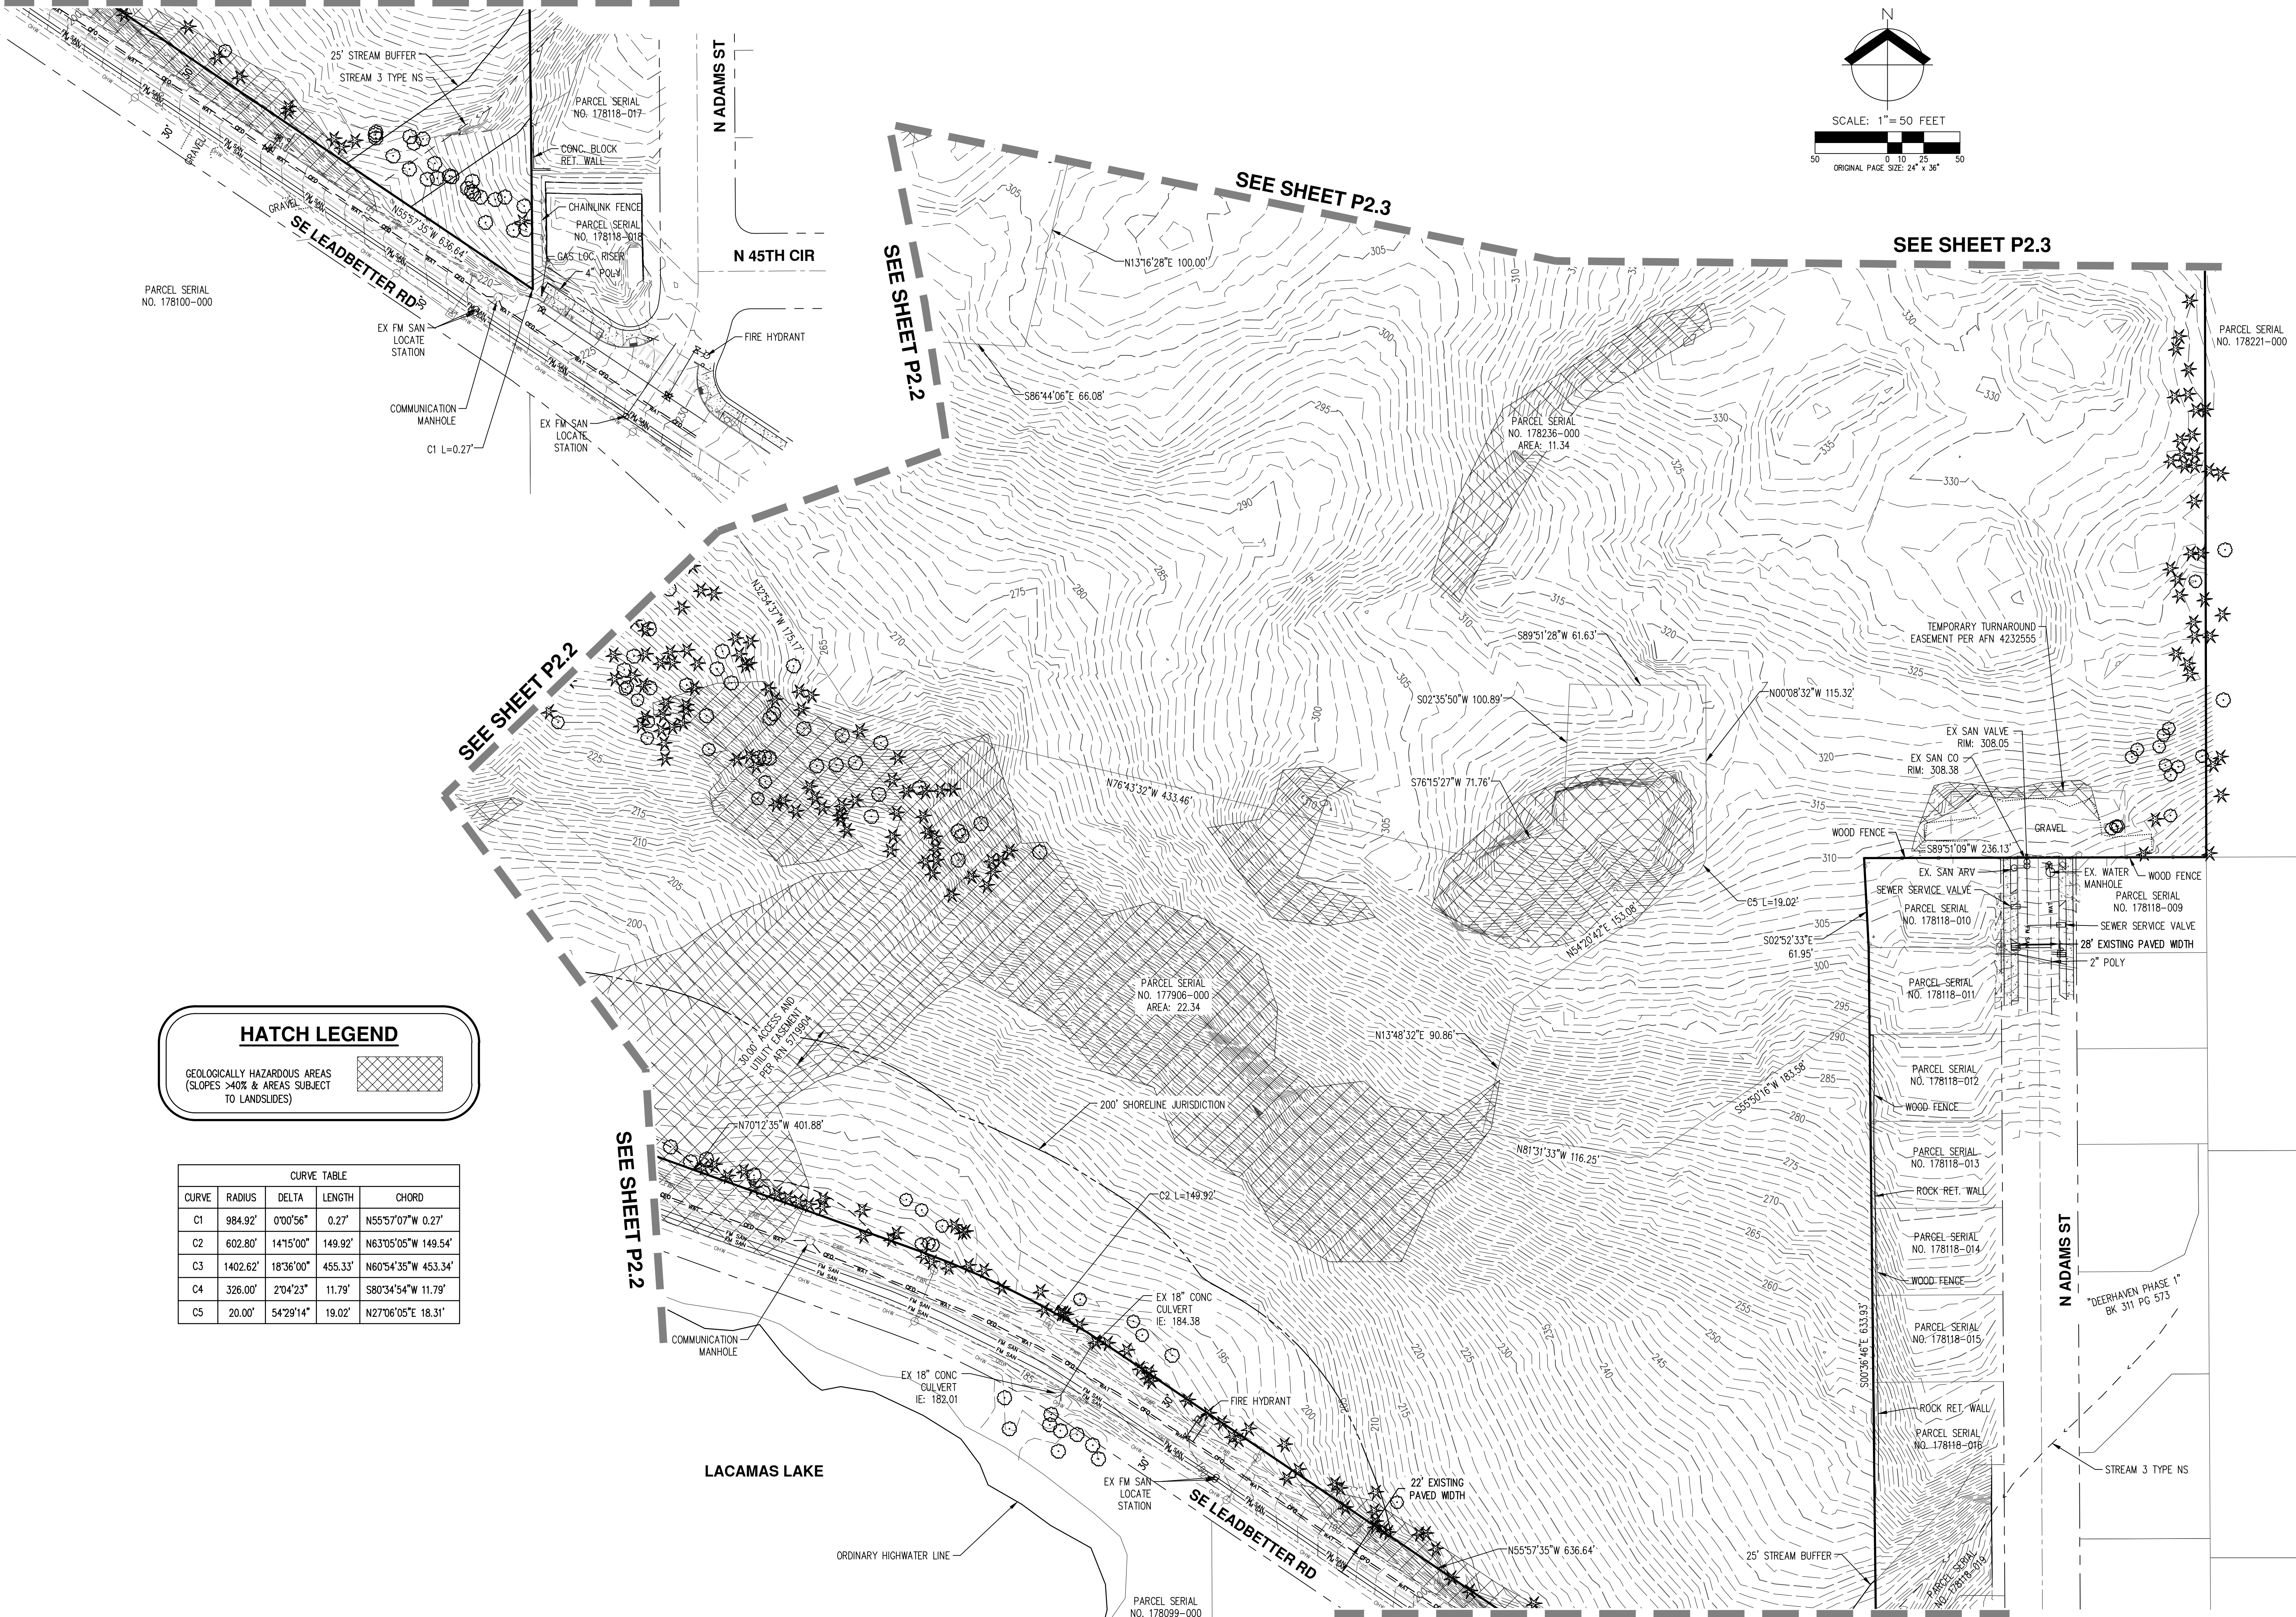
EXISTING CONDITIONS (SOUTH)  
CJ DENS SUBDIVISION  
CJ DENS LACAMAS II LLC  
CAMAS, WASHINGTON

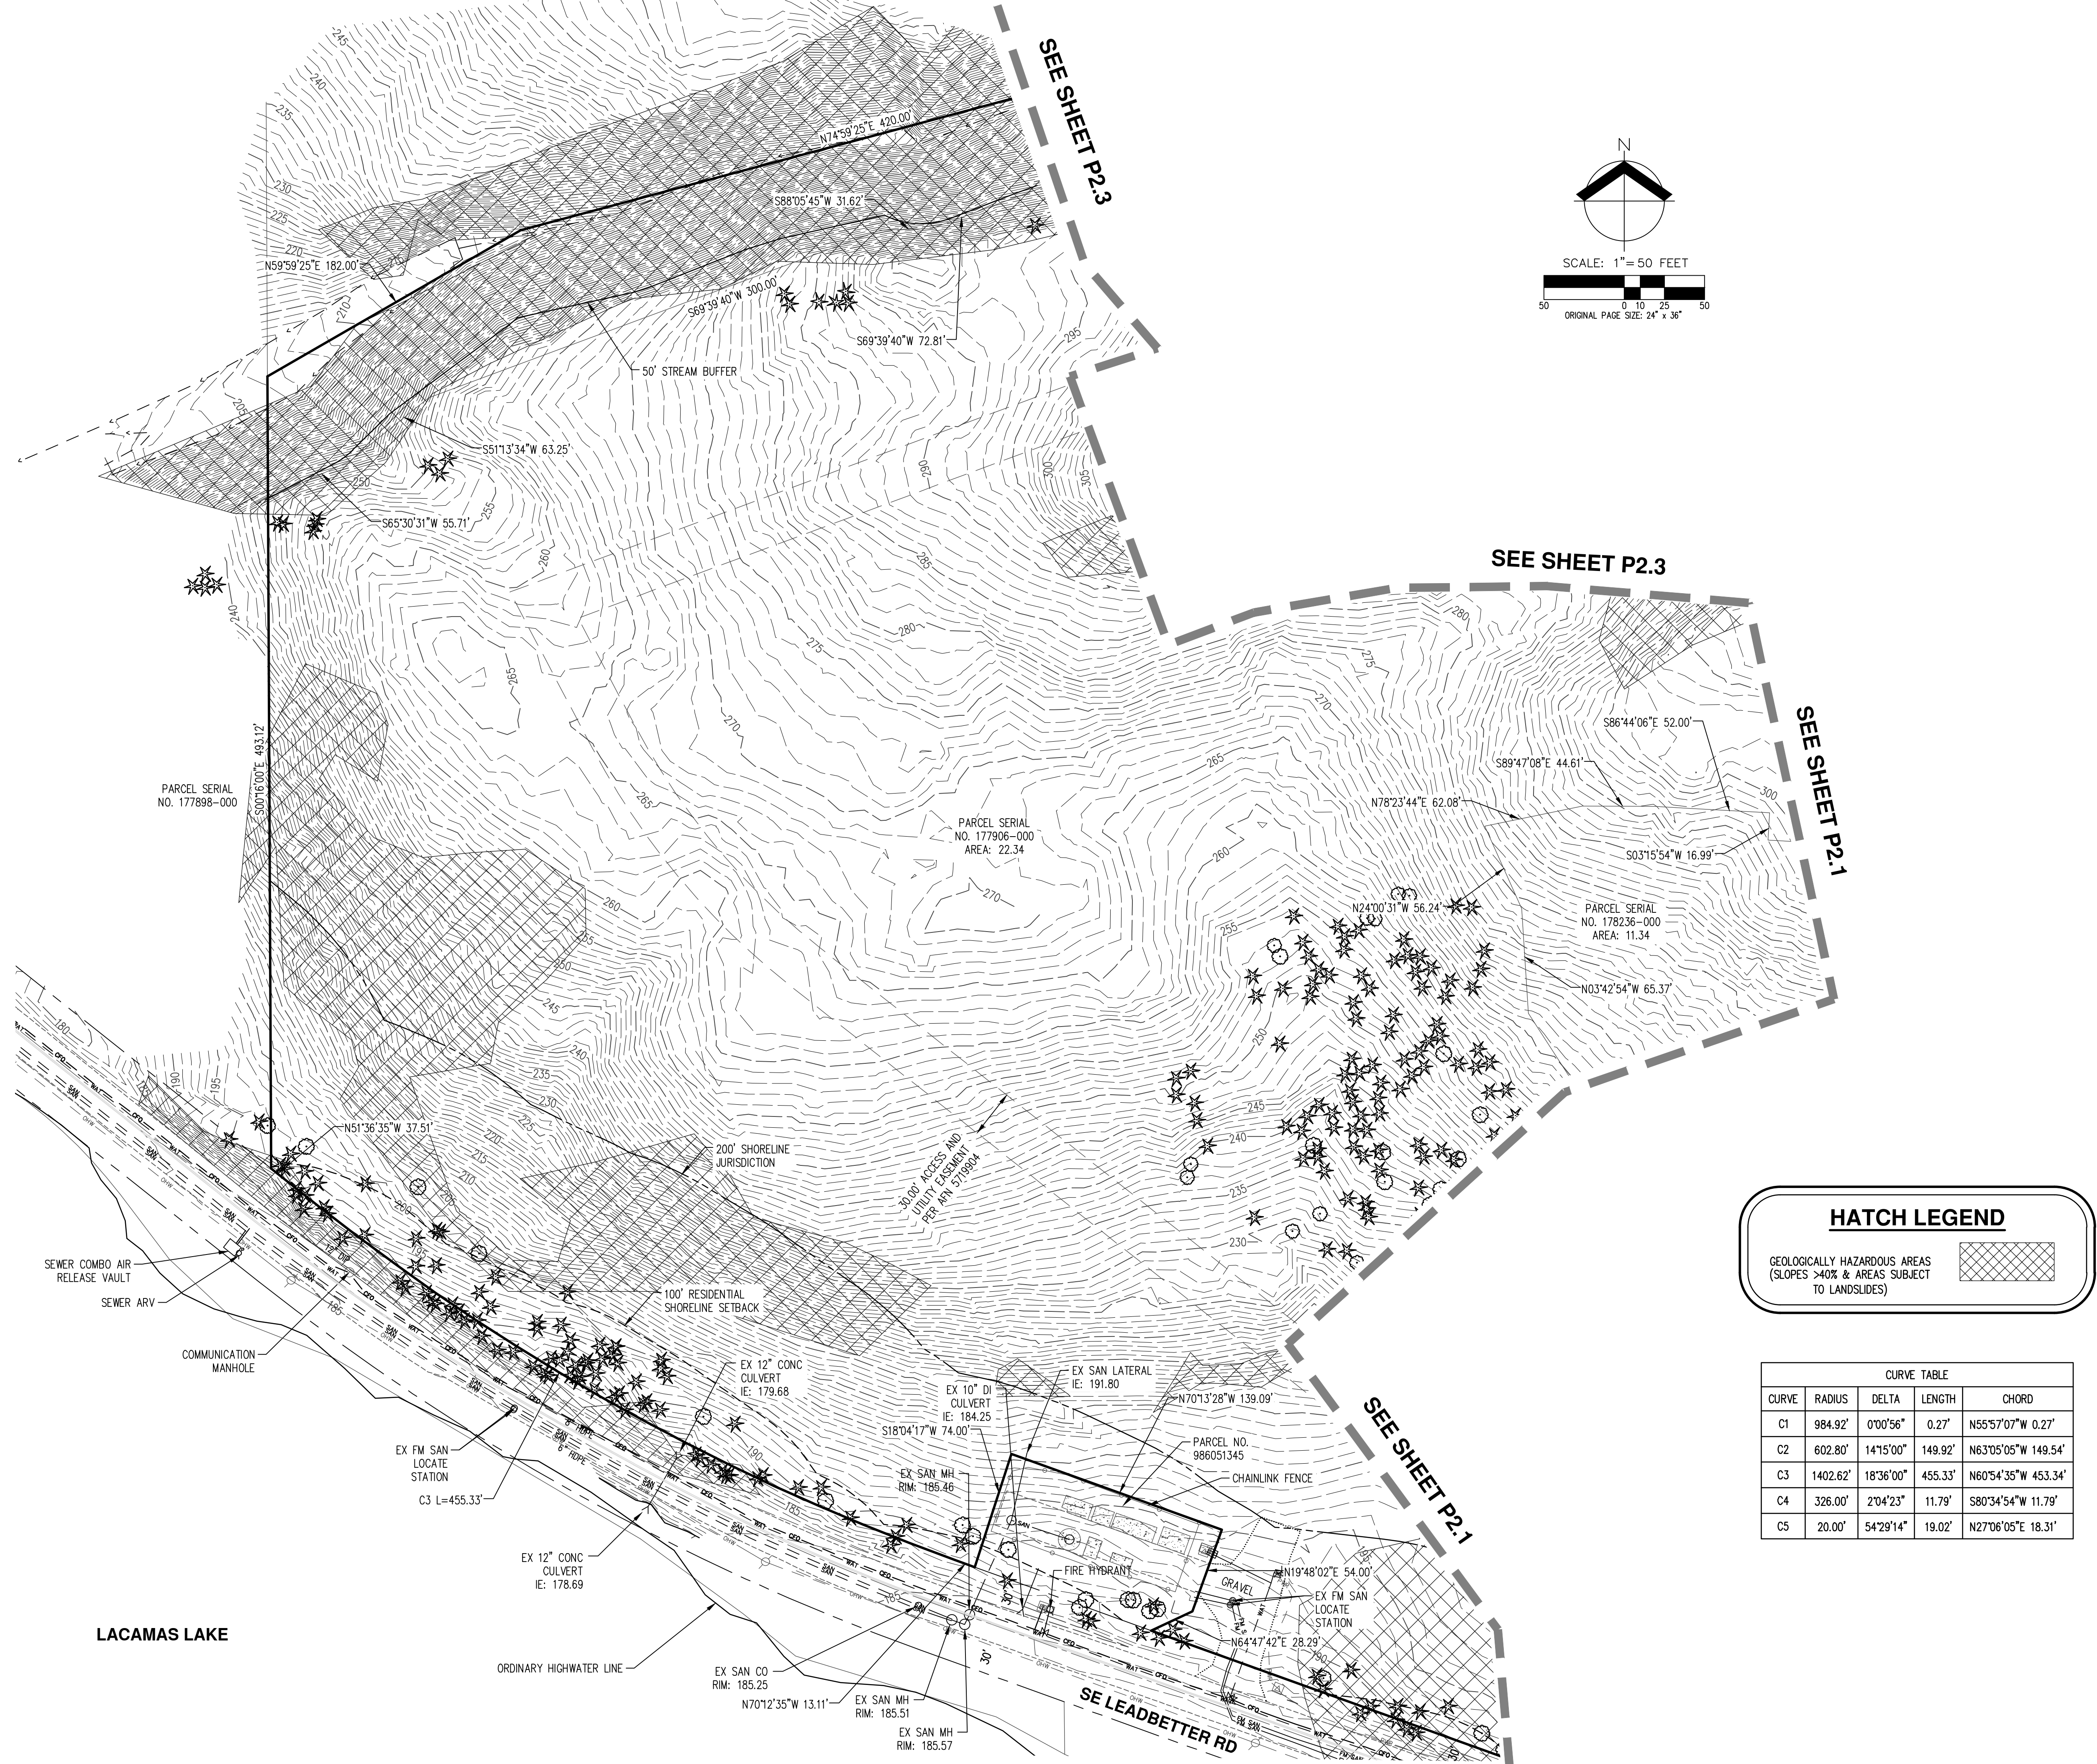
EXISTING CONDITIONS (WEST)  
CJ DENS SUBDIVISION  
CJ DENS LACAMAS II LLC  
CAMAS, WASHINGTON

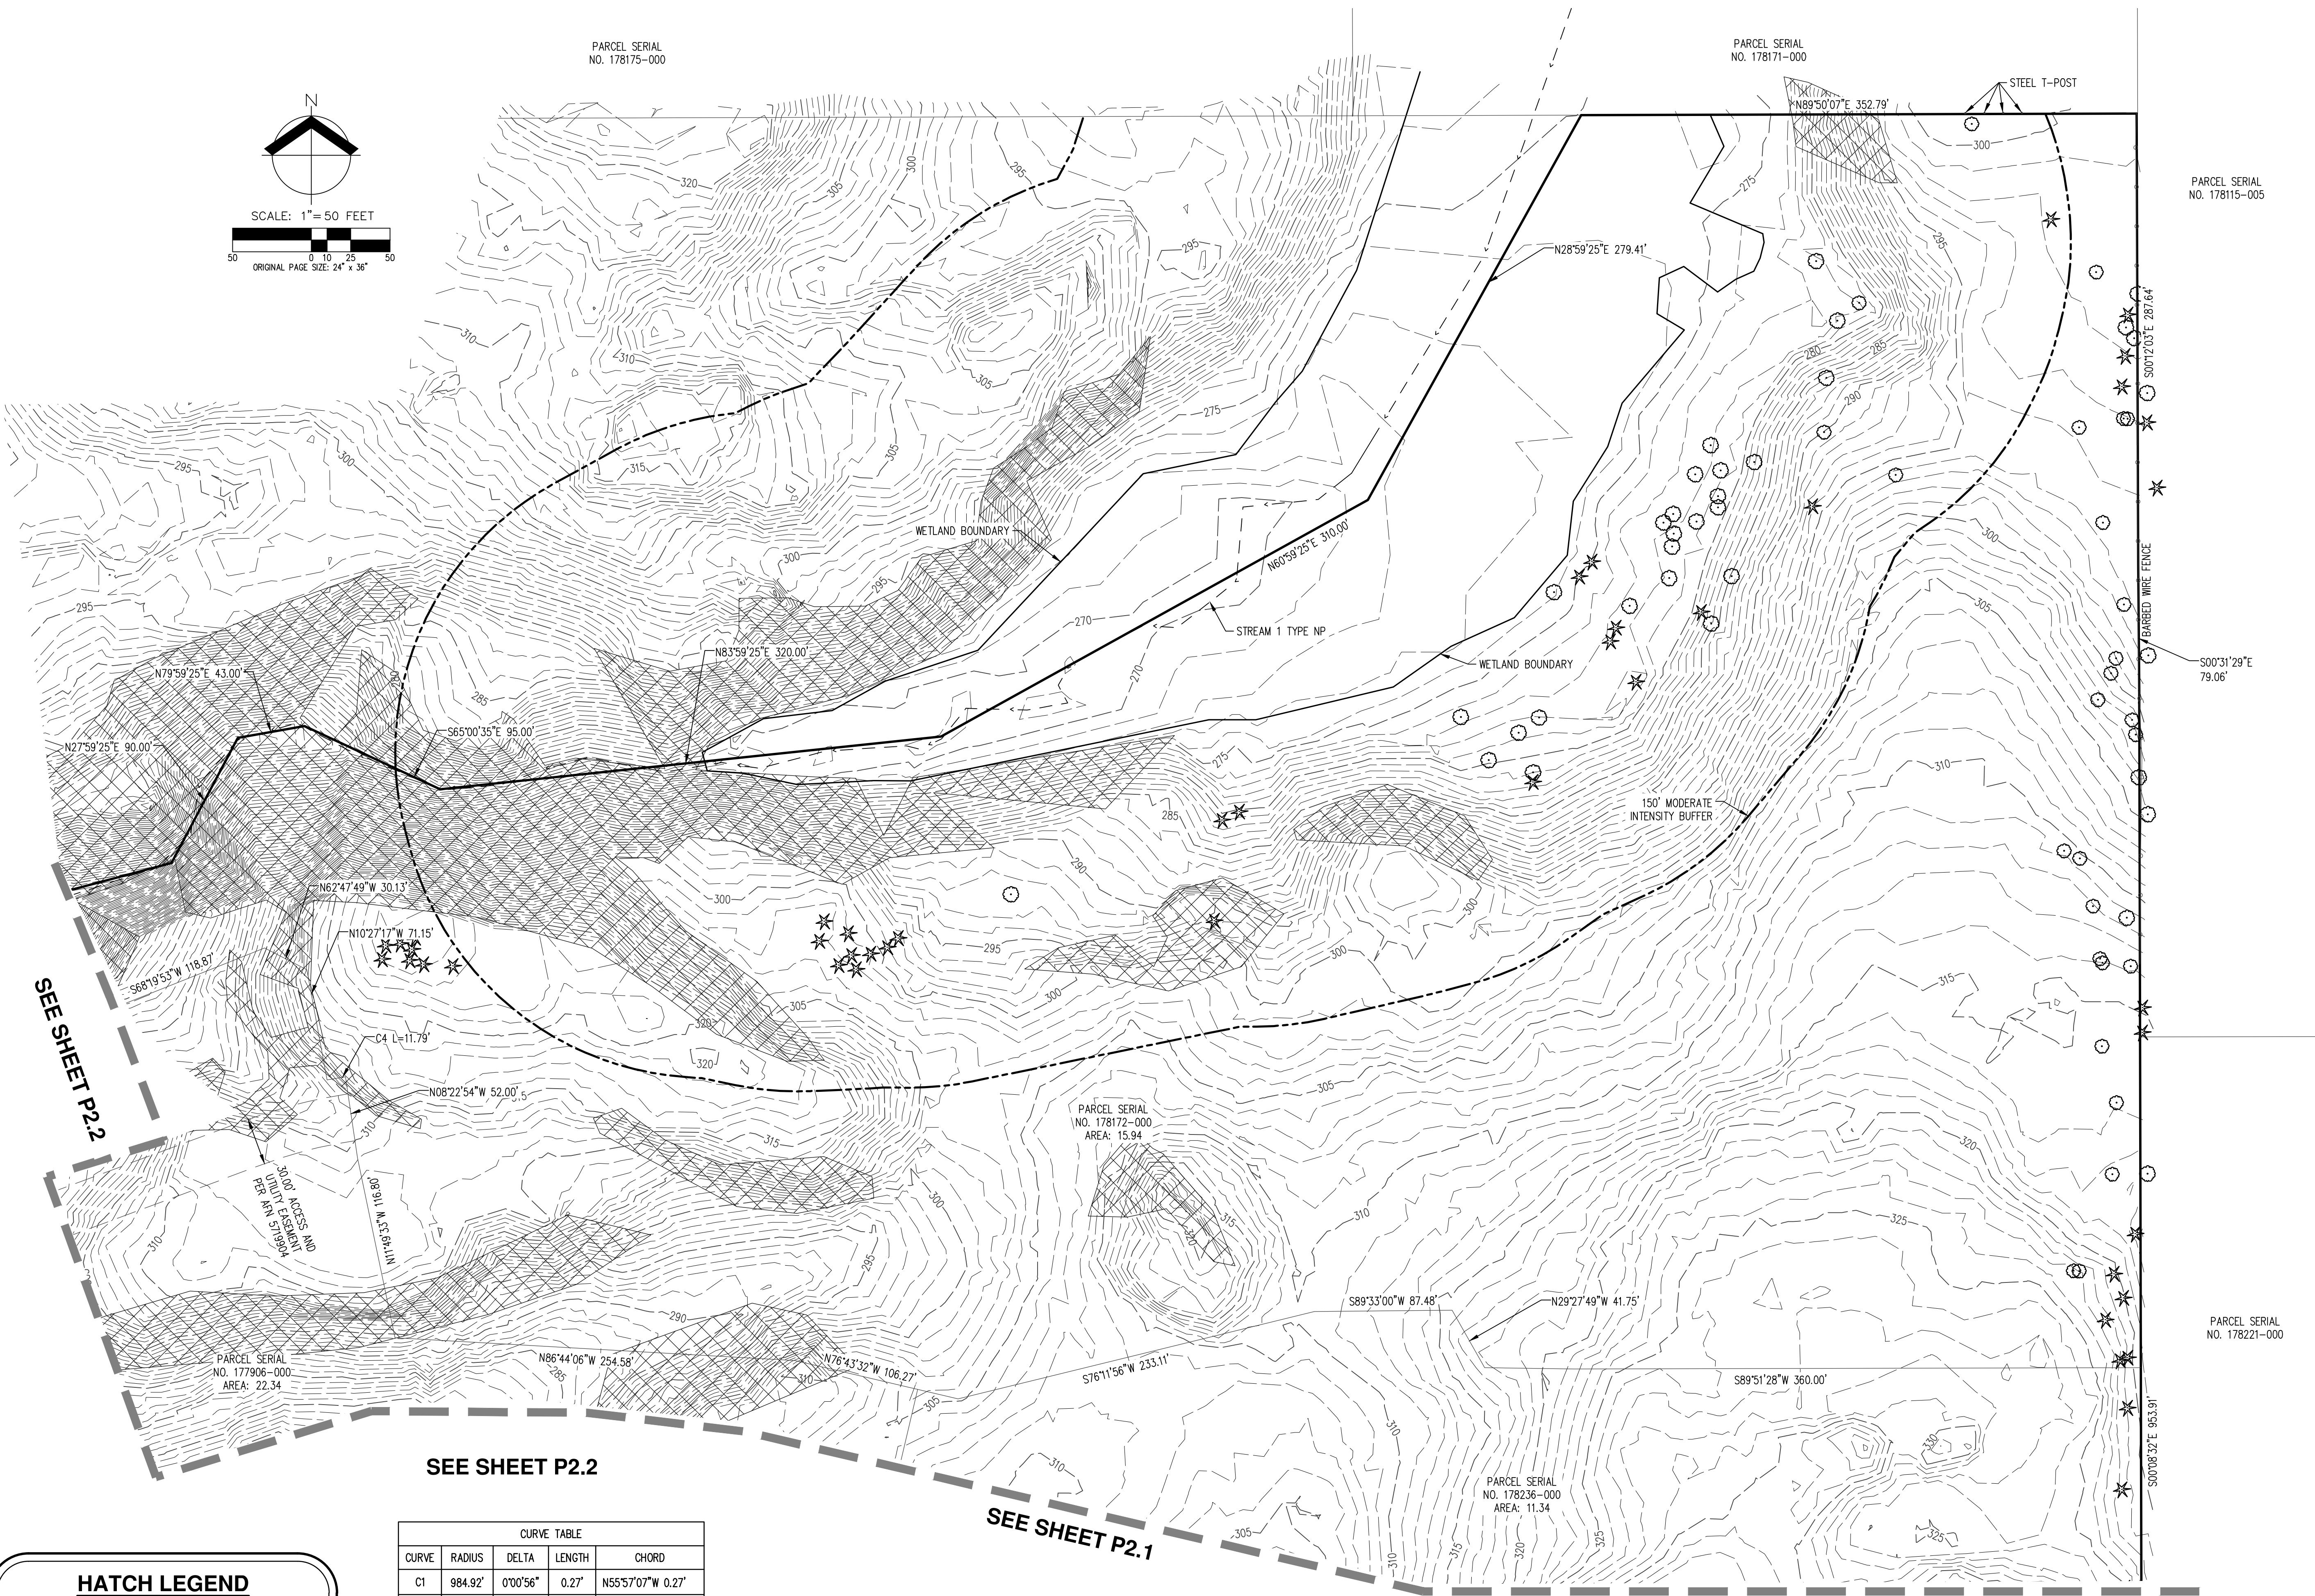
EXISTING CONDITIONS (NORTH)  
CJ DENS SUBDIVISION  
CJ DENS LACAMAS II LLC  
CAMAS, WASHINGTON

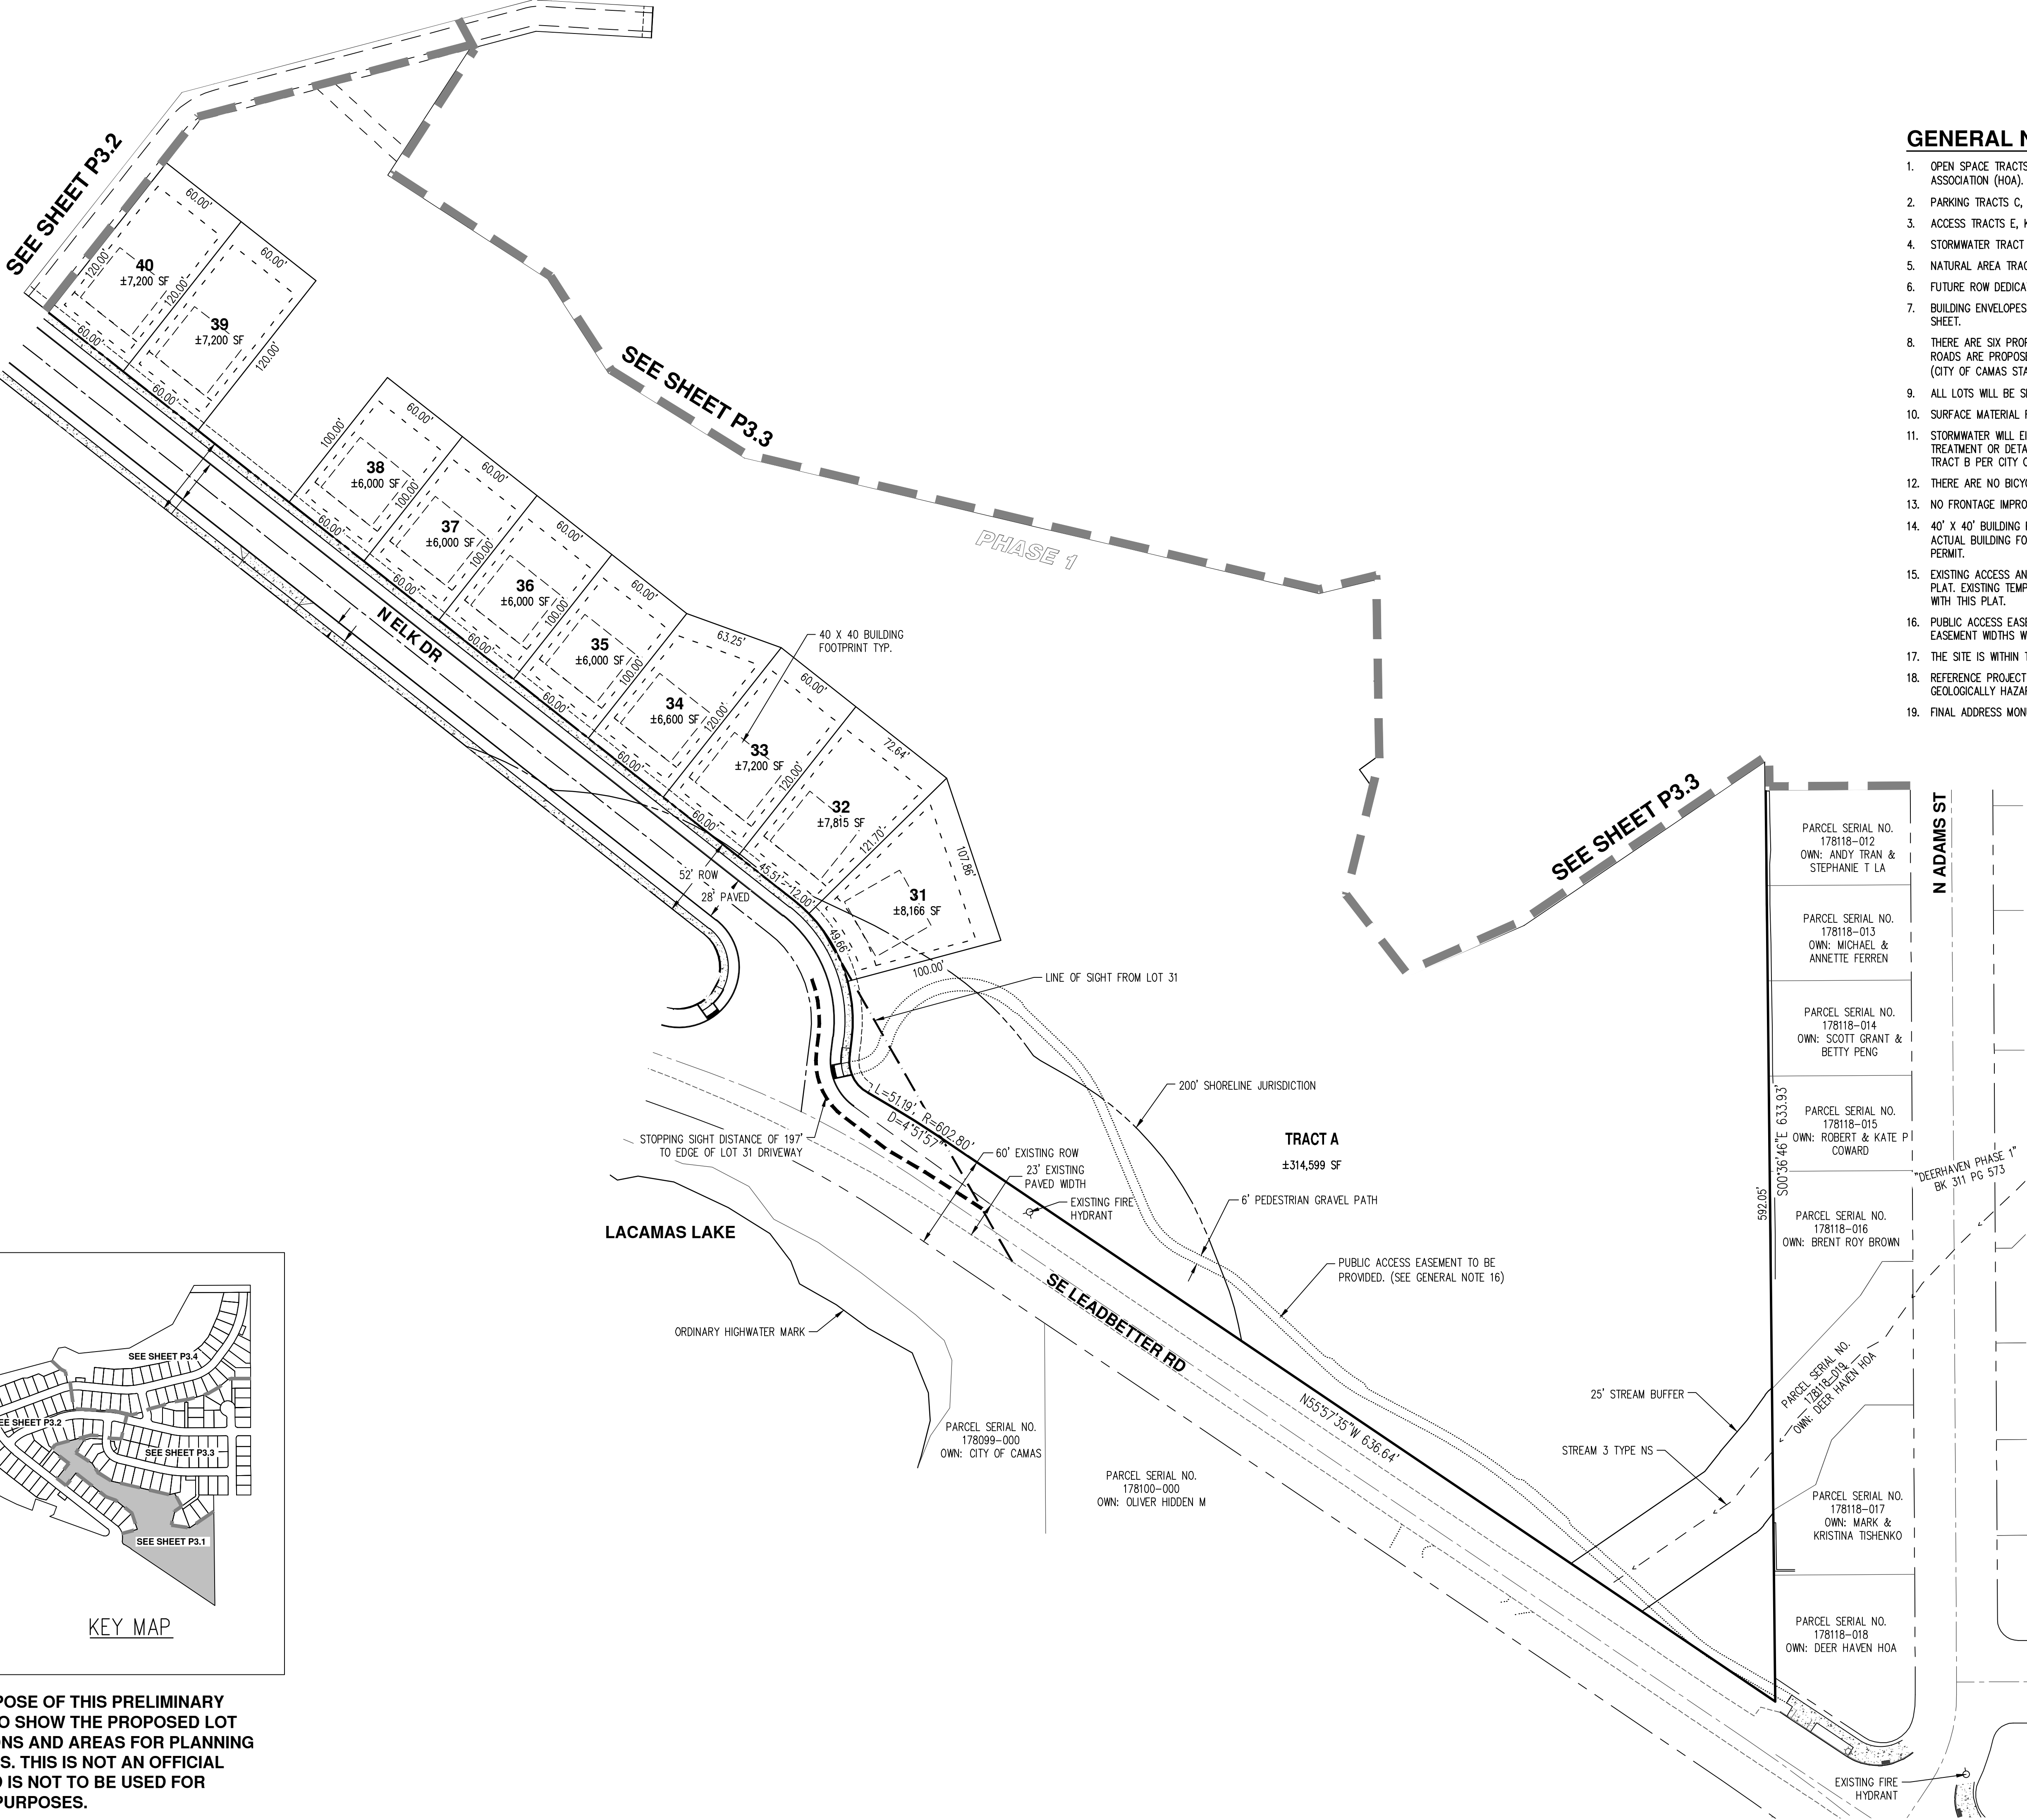
P3.1

PRELIMINARY PLAT  
CJ DENS SUBDIVISION  
CJ DENS LACAMAS II LLC  
CAMAS, WASHINGTON

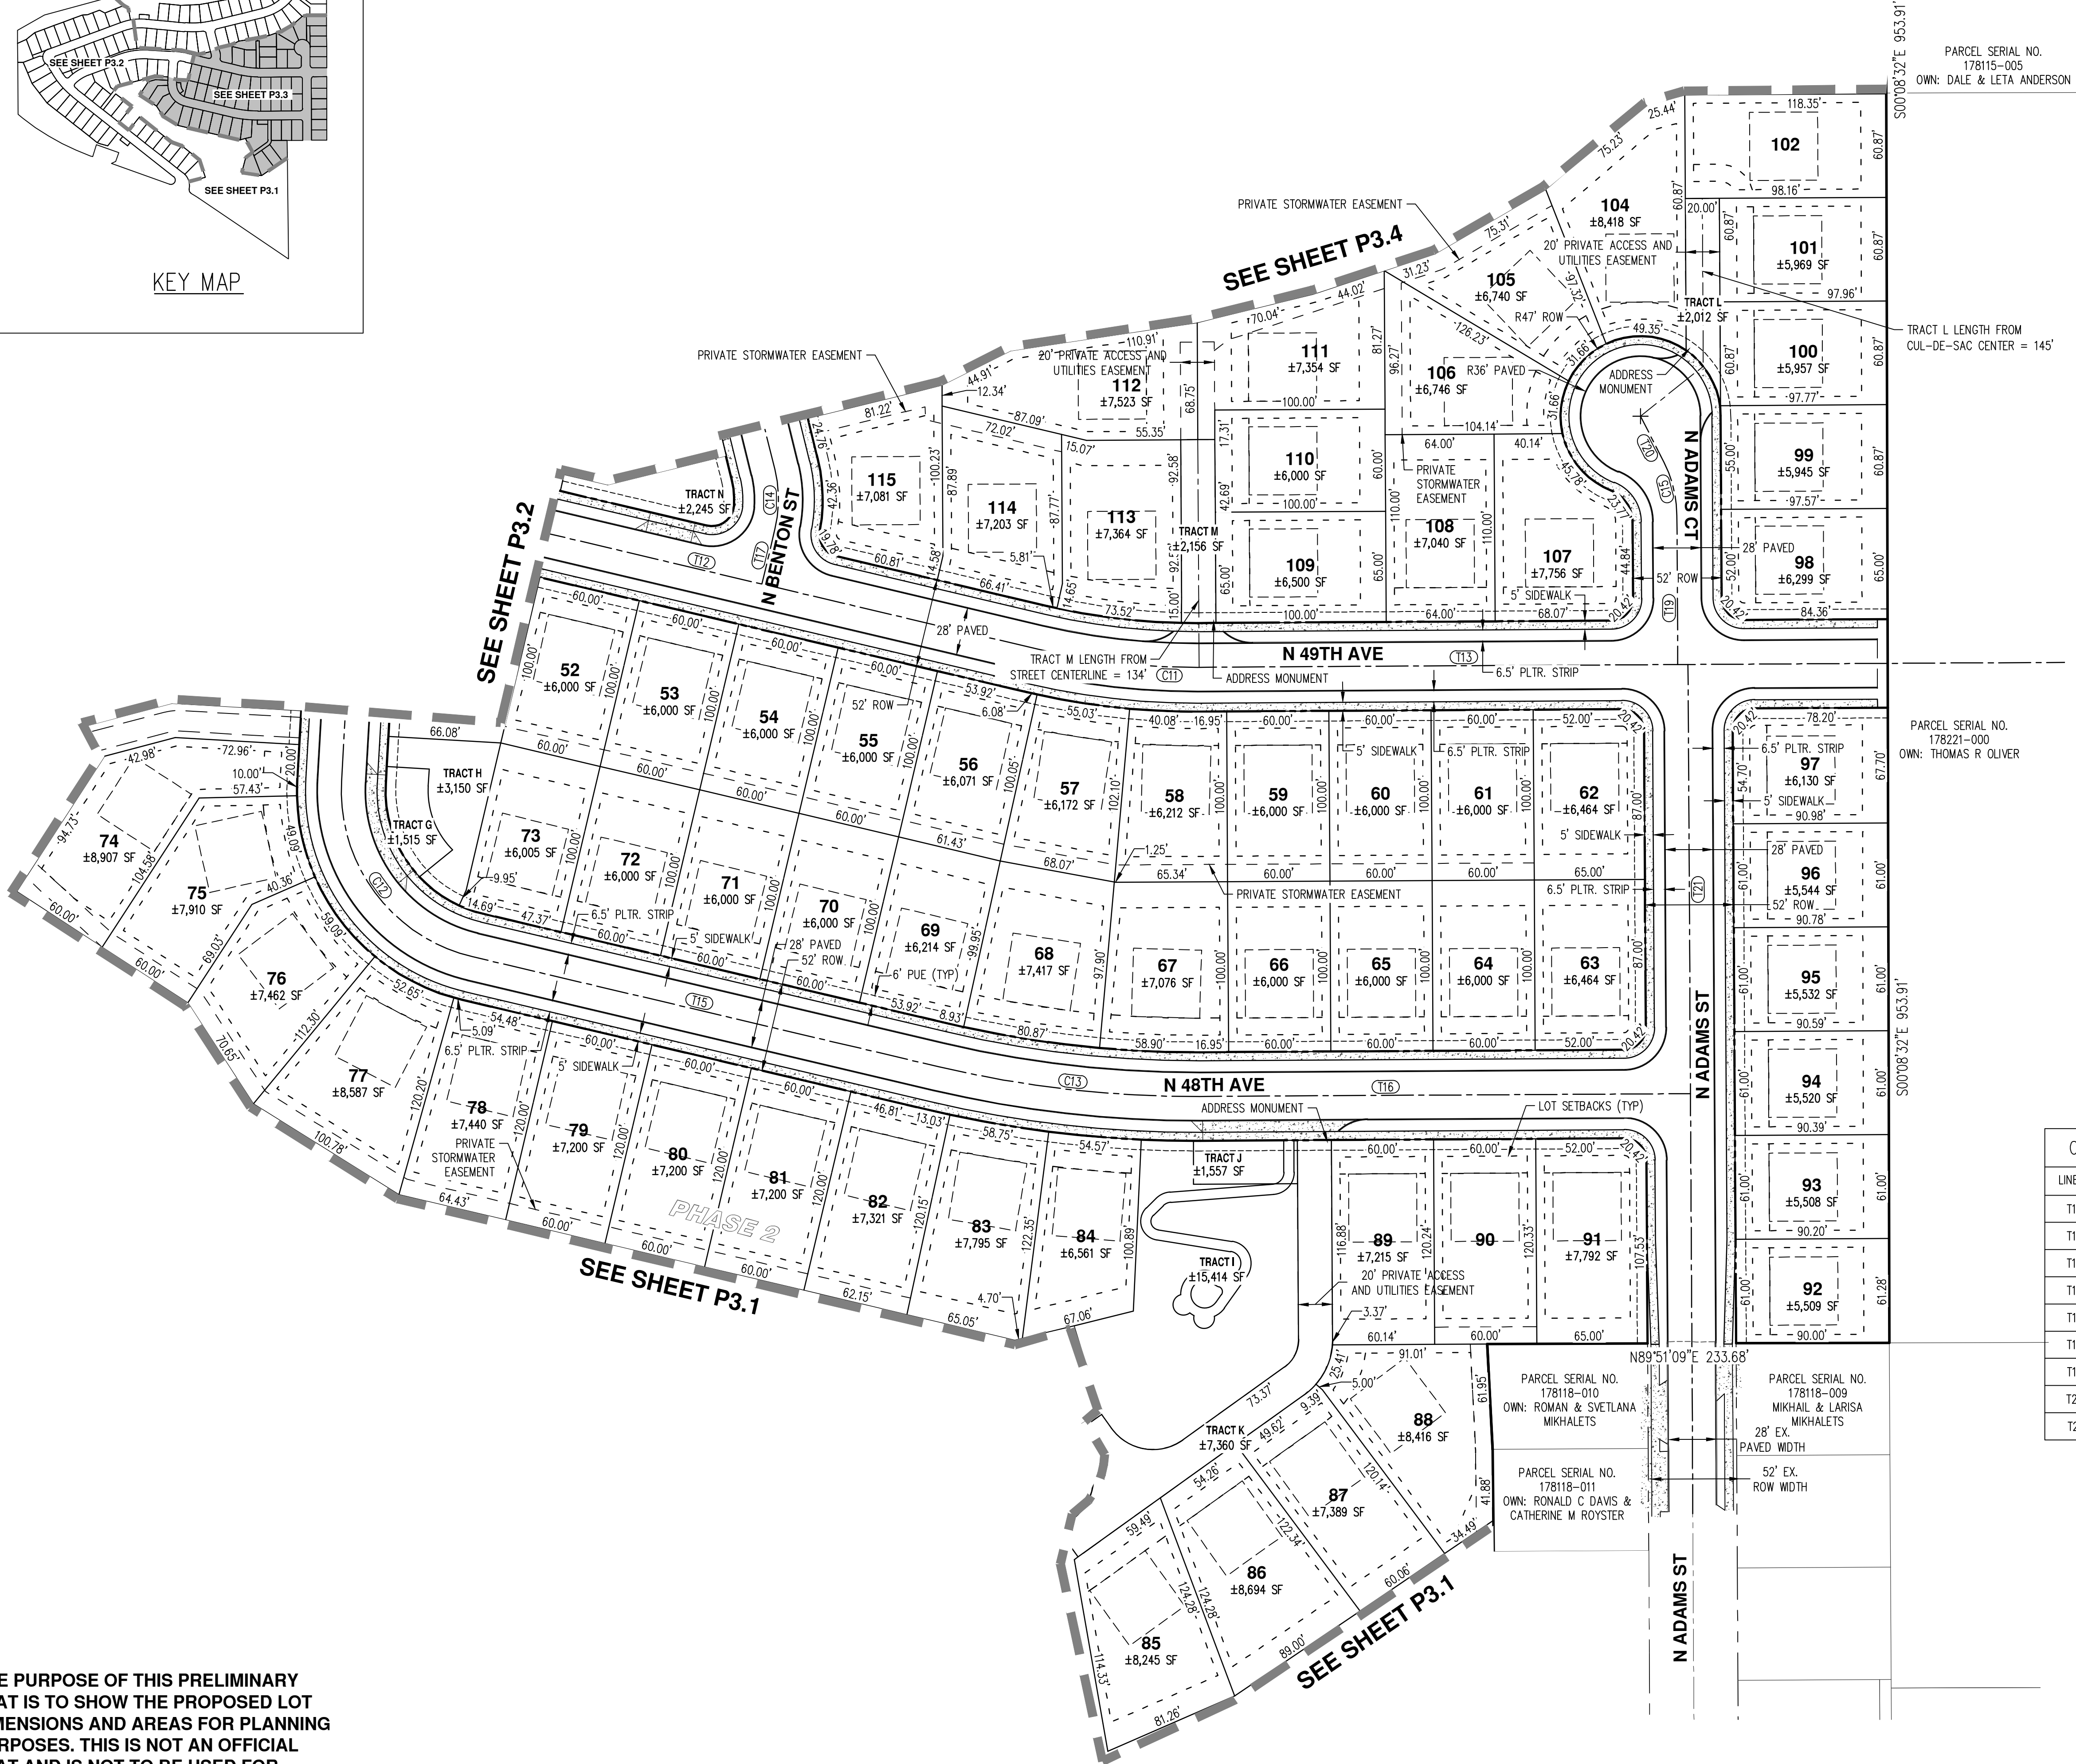
PRELIMINARY PLAT  
CJ DENS SUBDIVISION  
CJ DENS LACAMAS II LLC  
CAMAS, WASHINGTON
