# CJ DENS EAST SUBDIVISION

## PRELIMINARY SUBDIVISION PLANS

COVER SHEET  
CJ DENS SUBDIVISION  
CJ DENS LACAMAS II LLC  
CAMAS, WASHINGTON

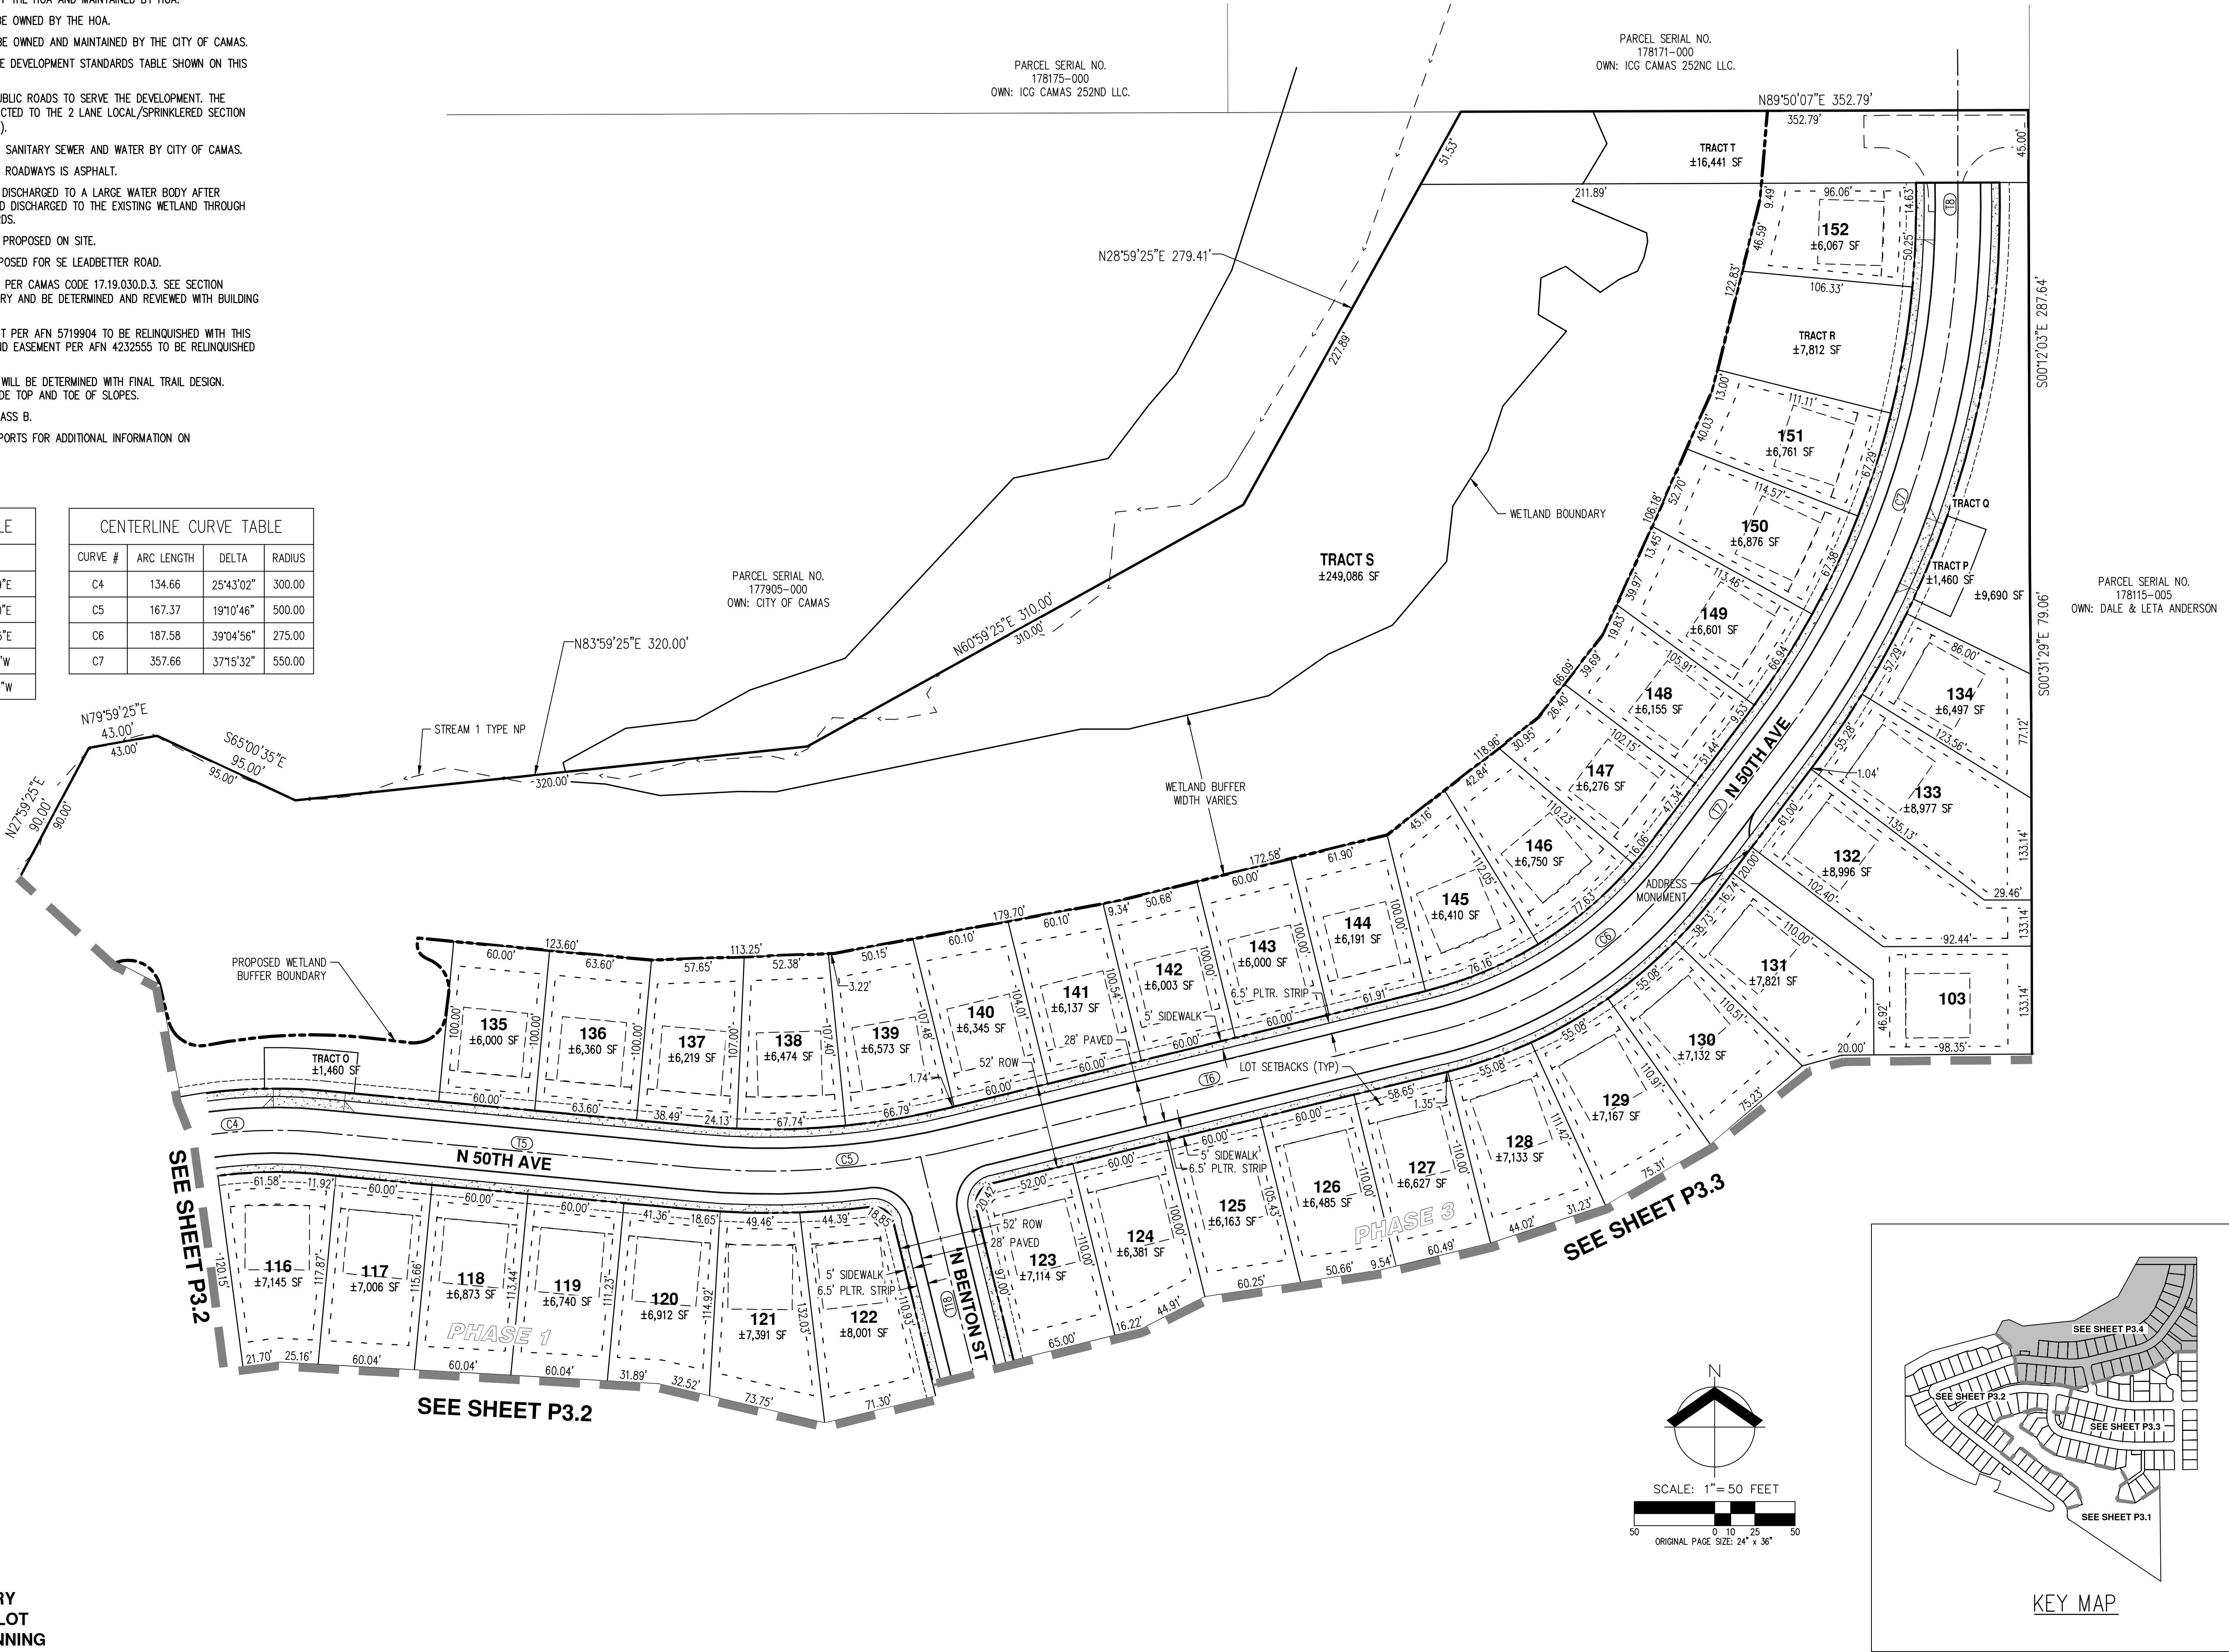
P3.4

PRELIMINARY PLAT  
CJ DENS SUBDIVISION  
CJ DENS LACAMAS II LLC  
CAMAS, WASHINGTON

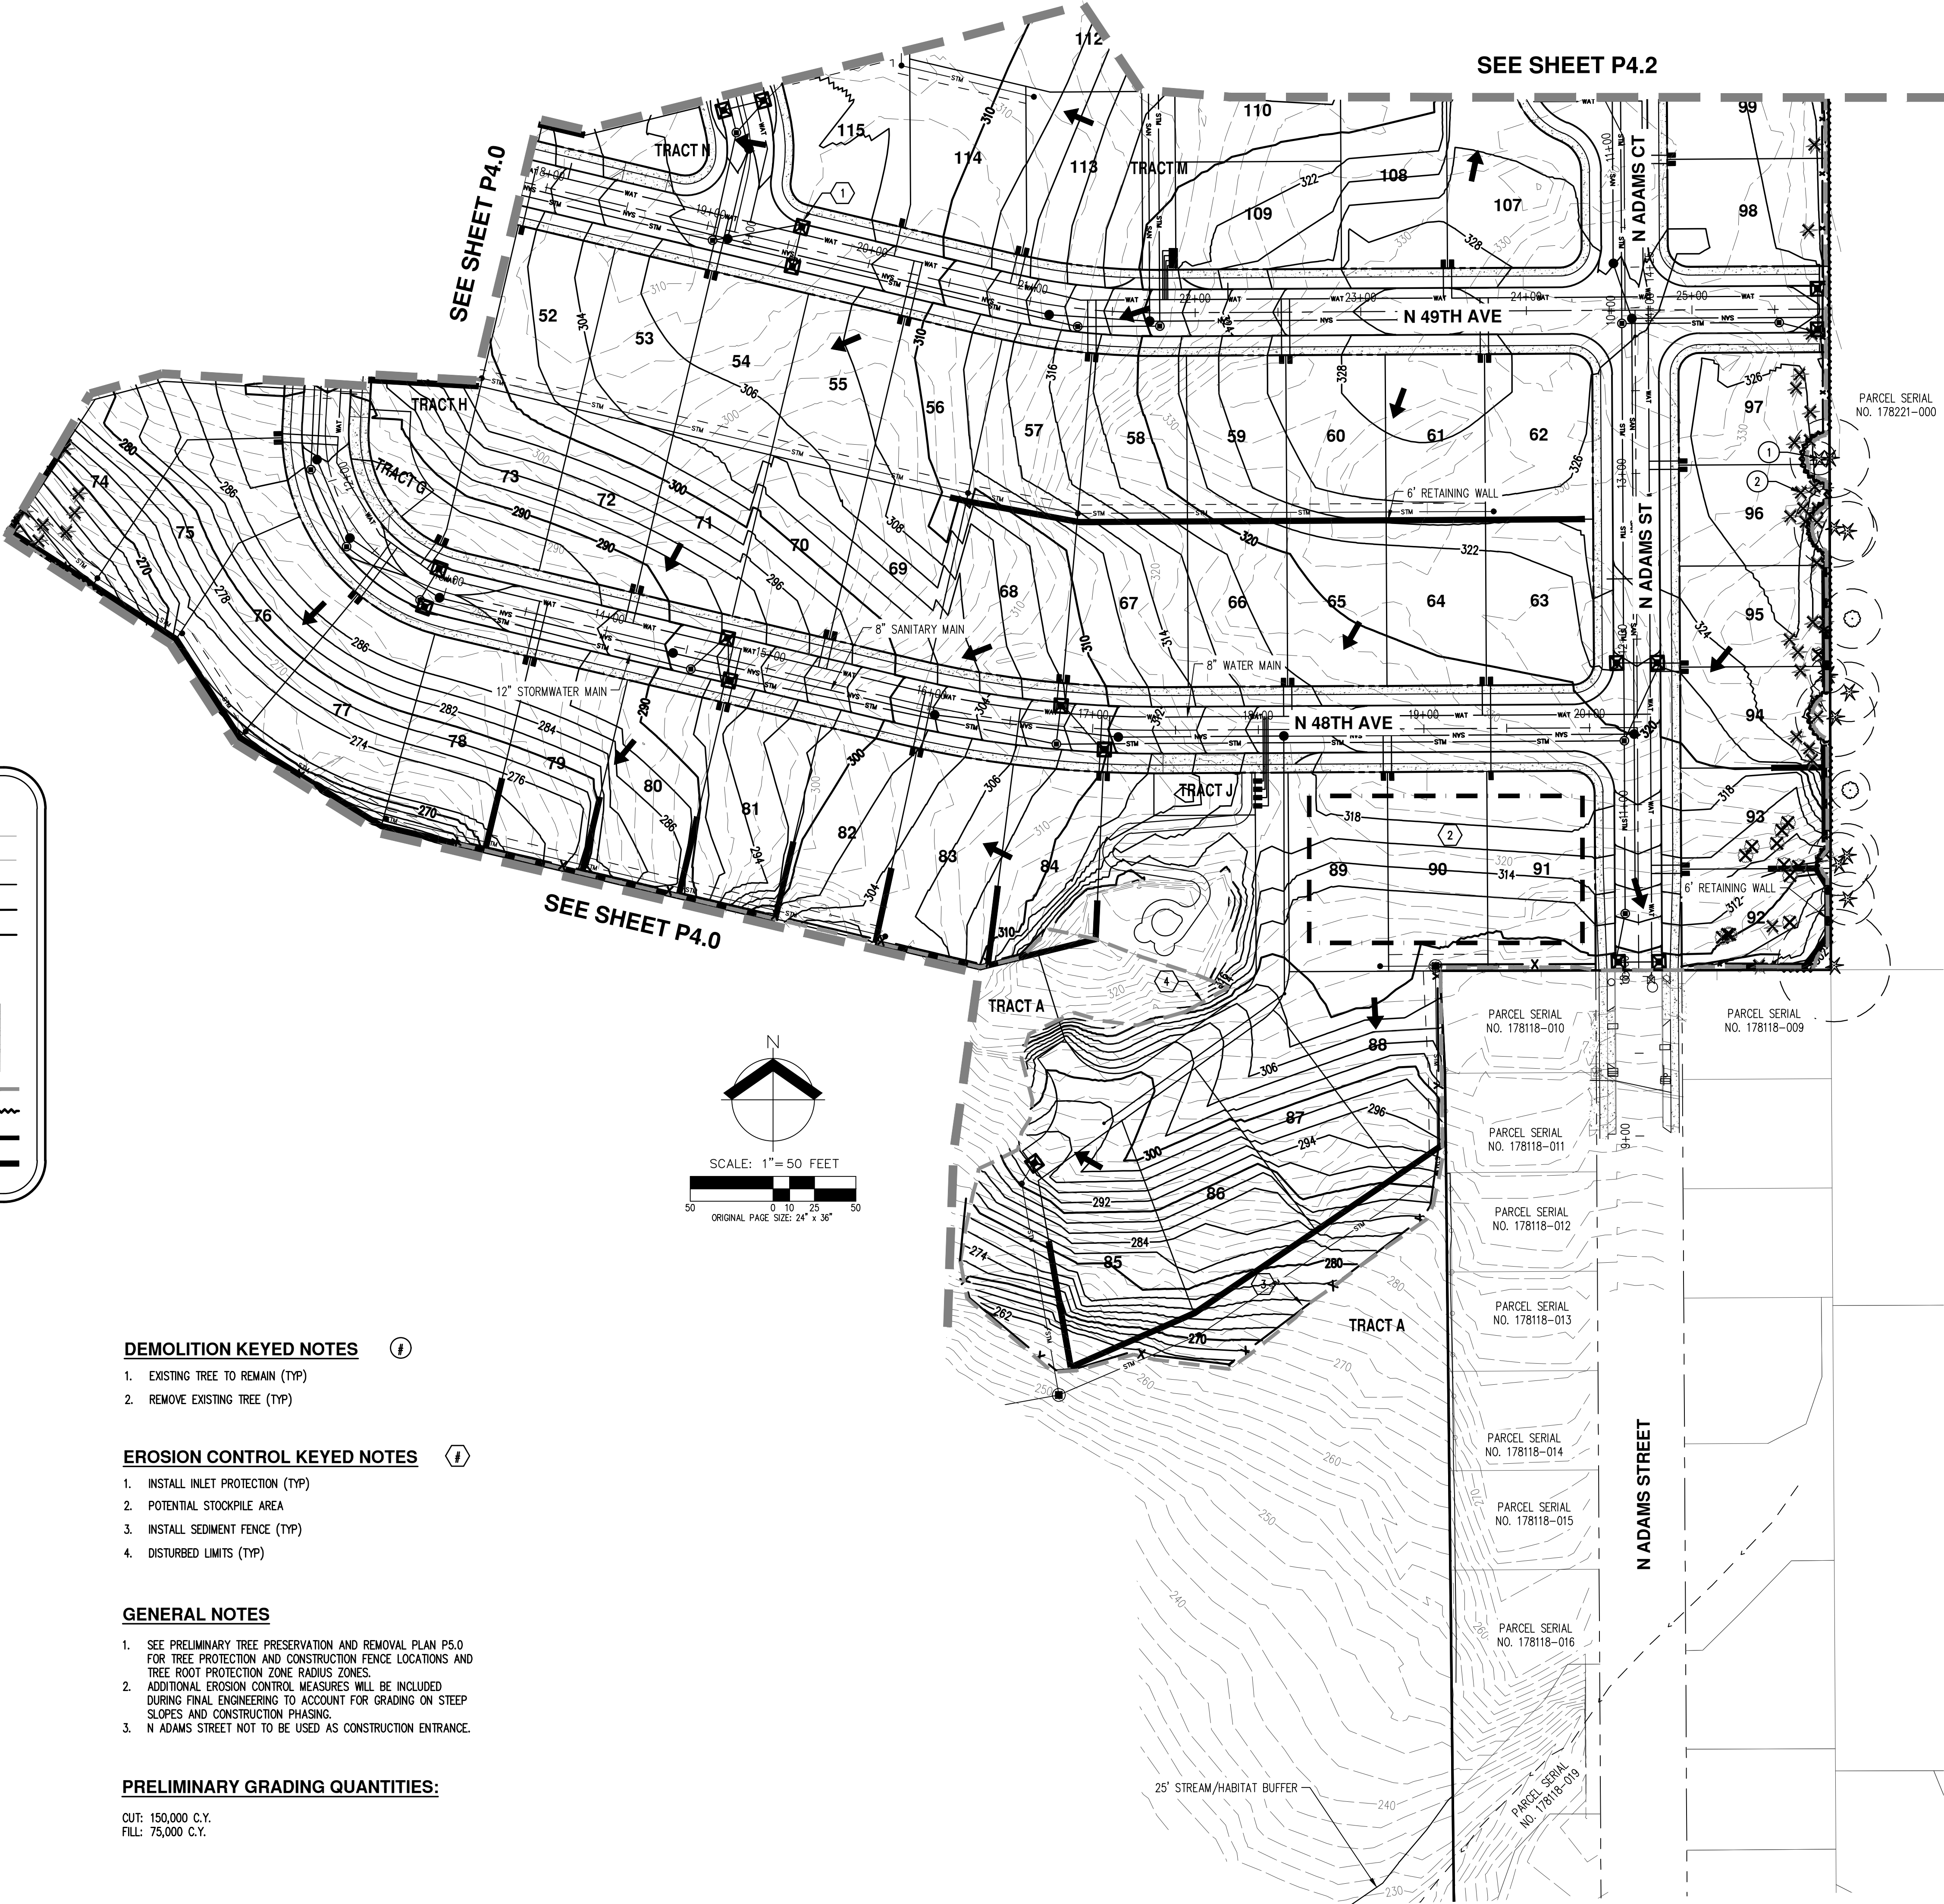
P4.1

PRELIMINARY GRADING AND ESC PLAN  
CJ DENS SUBDIVISION  
CJ DENS LACAMAS II LLC  
CAMAS, WASHINGTON

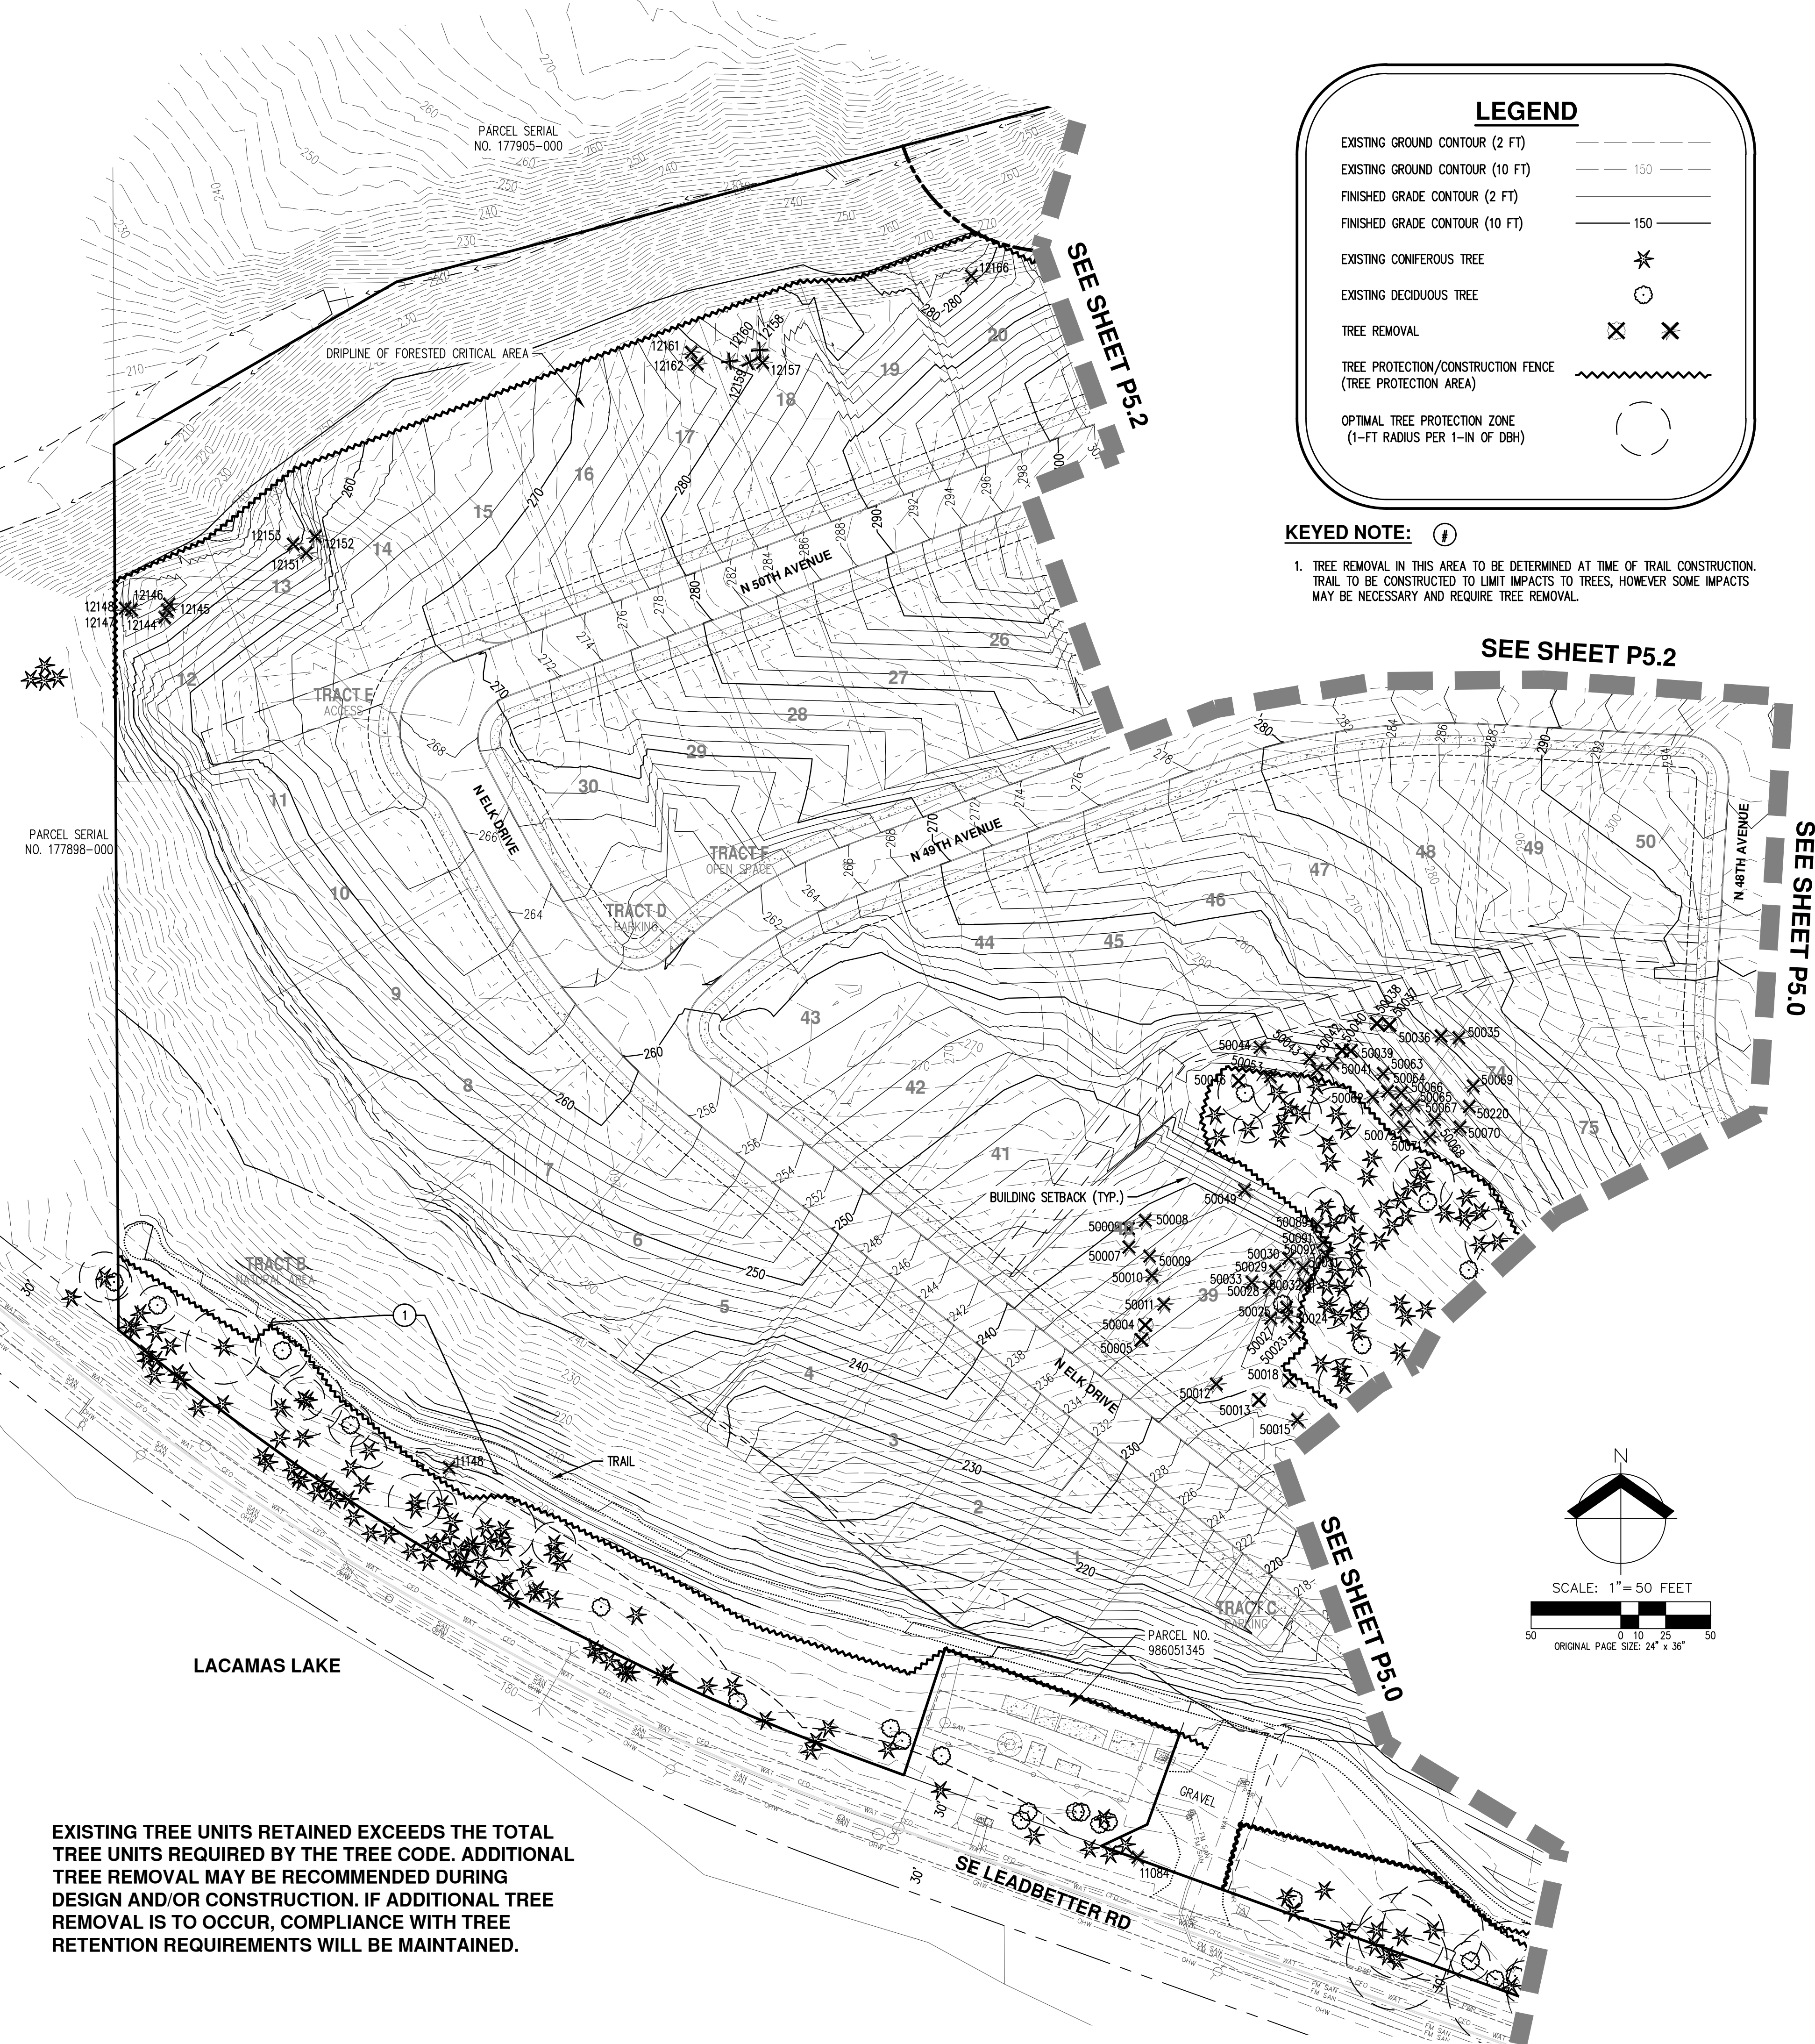
P5.2

1. TREE REMOVAL IN THIS AREA TO BE DETERMINED AT TIME OF TRAIL CONSTRUCTION. TRAIL TO BE CONSTRUCTED TO LIMIT IMPACTS TO TREES, HOWEVER SOME IMPACTS MAY BE NECESSARY AND REQUIRE TREE REMOVAL.

EXISTING TREE UNITS RETAINED EXCEEDS THE TOTAL TREE UNITS REQUIRED BY THE TREE CODE. ADDITIONAL TREE REMOVAL MAY BE RECOMMENDED DURING DESIGN AND/OR CONSTRUCTION. IF ADDITIONAL TREE REMOVAL IS TO OCCUR, COMPLIANCE WITH TREE RETENTION REQUIREMENTS WILL BE MAINTAINED.

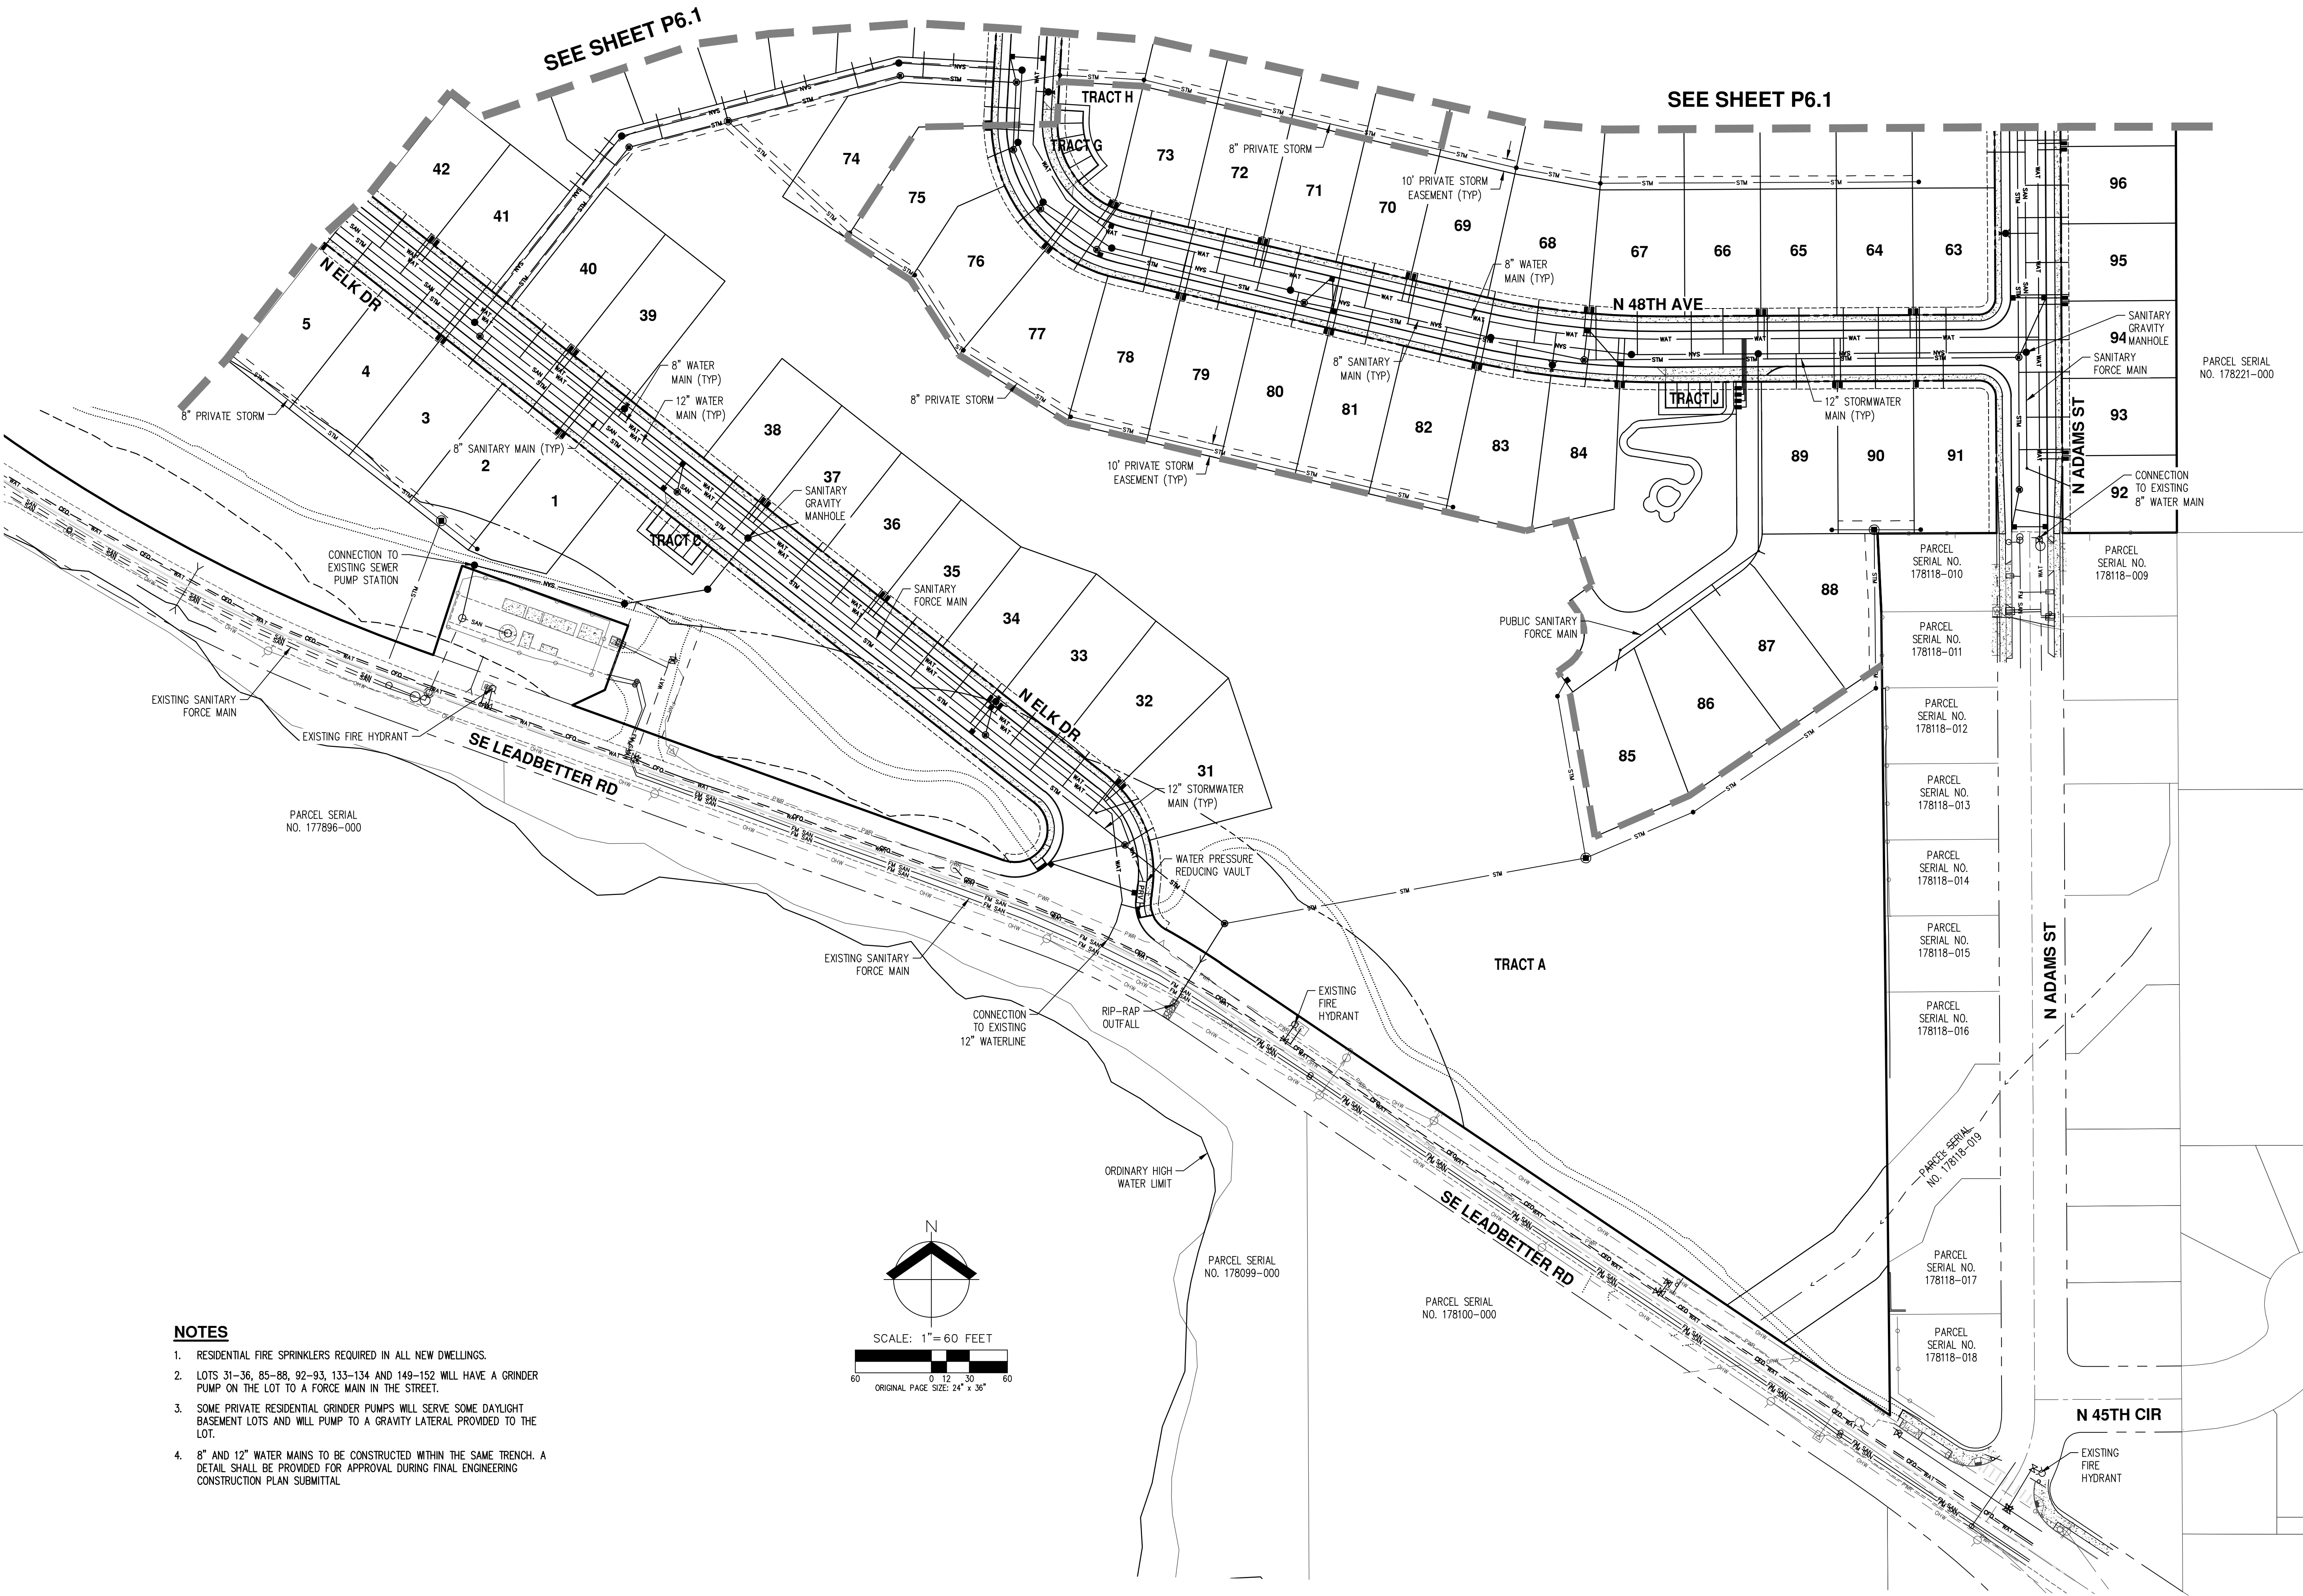
PRELIMINARY COMPOSITE UTILITY PLAN (SOUTH)

- 1. RESIDENTIAL FIRE SPRINKLERS REQUIRED IN ALL NEW DWELLINGS.
- 2. LOTS 31-36, 85-88, 92-93, 133-134 AND 149-152 WILL HAVE A GRINDER PUMP ON THE LOT TO A FORCE MAIN IN THE STREET.
- 3. SOME PRIVATE RESIDENTIAL GRINDER PUMPS WILL SERVE SOME DAYLIGHT BASEMENT LOTS AND WILL PUMP TO A GRAVITY LATERAL PROVIDED TO THE LOT.
- 4. 8" AND 12" WATER MAINS TO BE CONSTRUCTED WITHIN THE SAME TRENCH. A DETAIL SHALL BE PROVIDED FOR APPROVAL DURING FINAL ENGINEERING CONSTRUCTION PLAN SUBMITTAL.

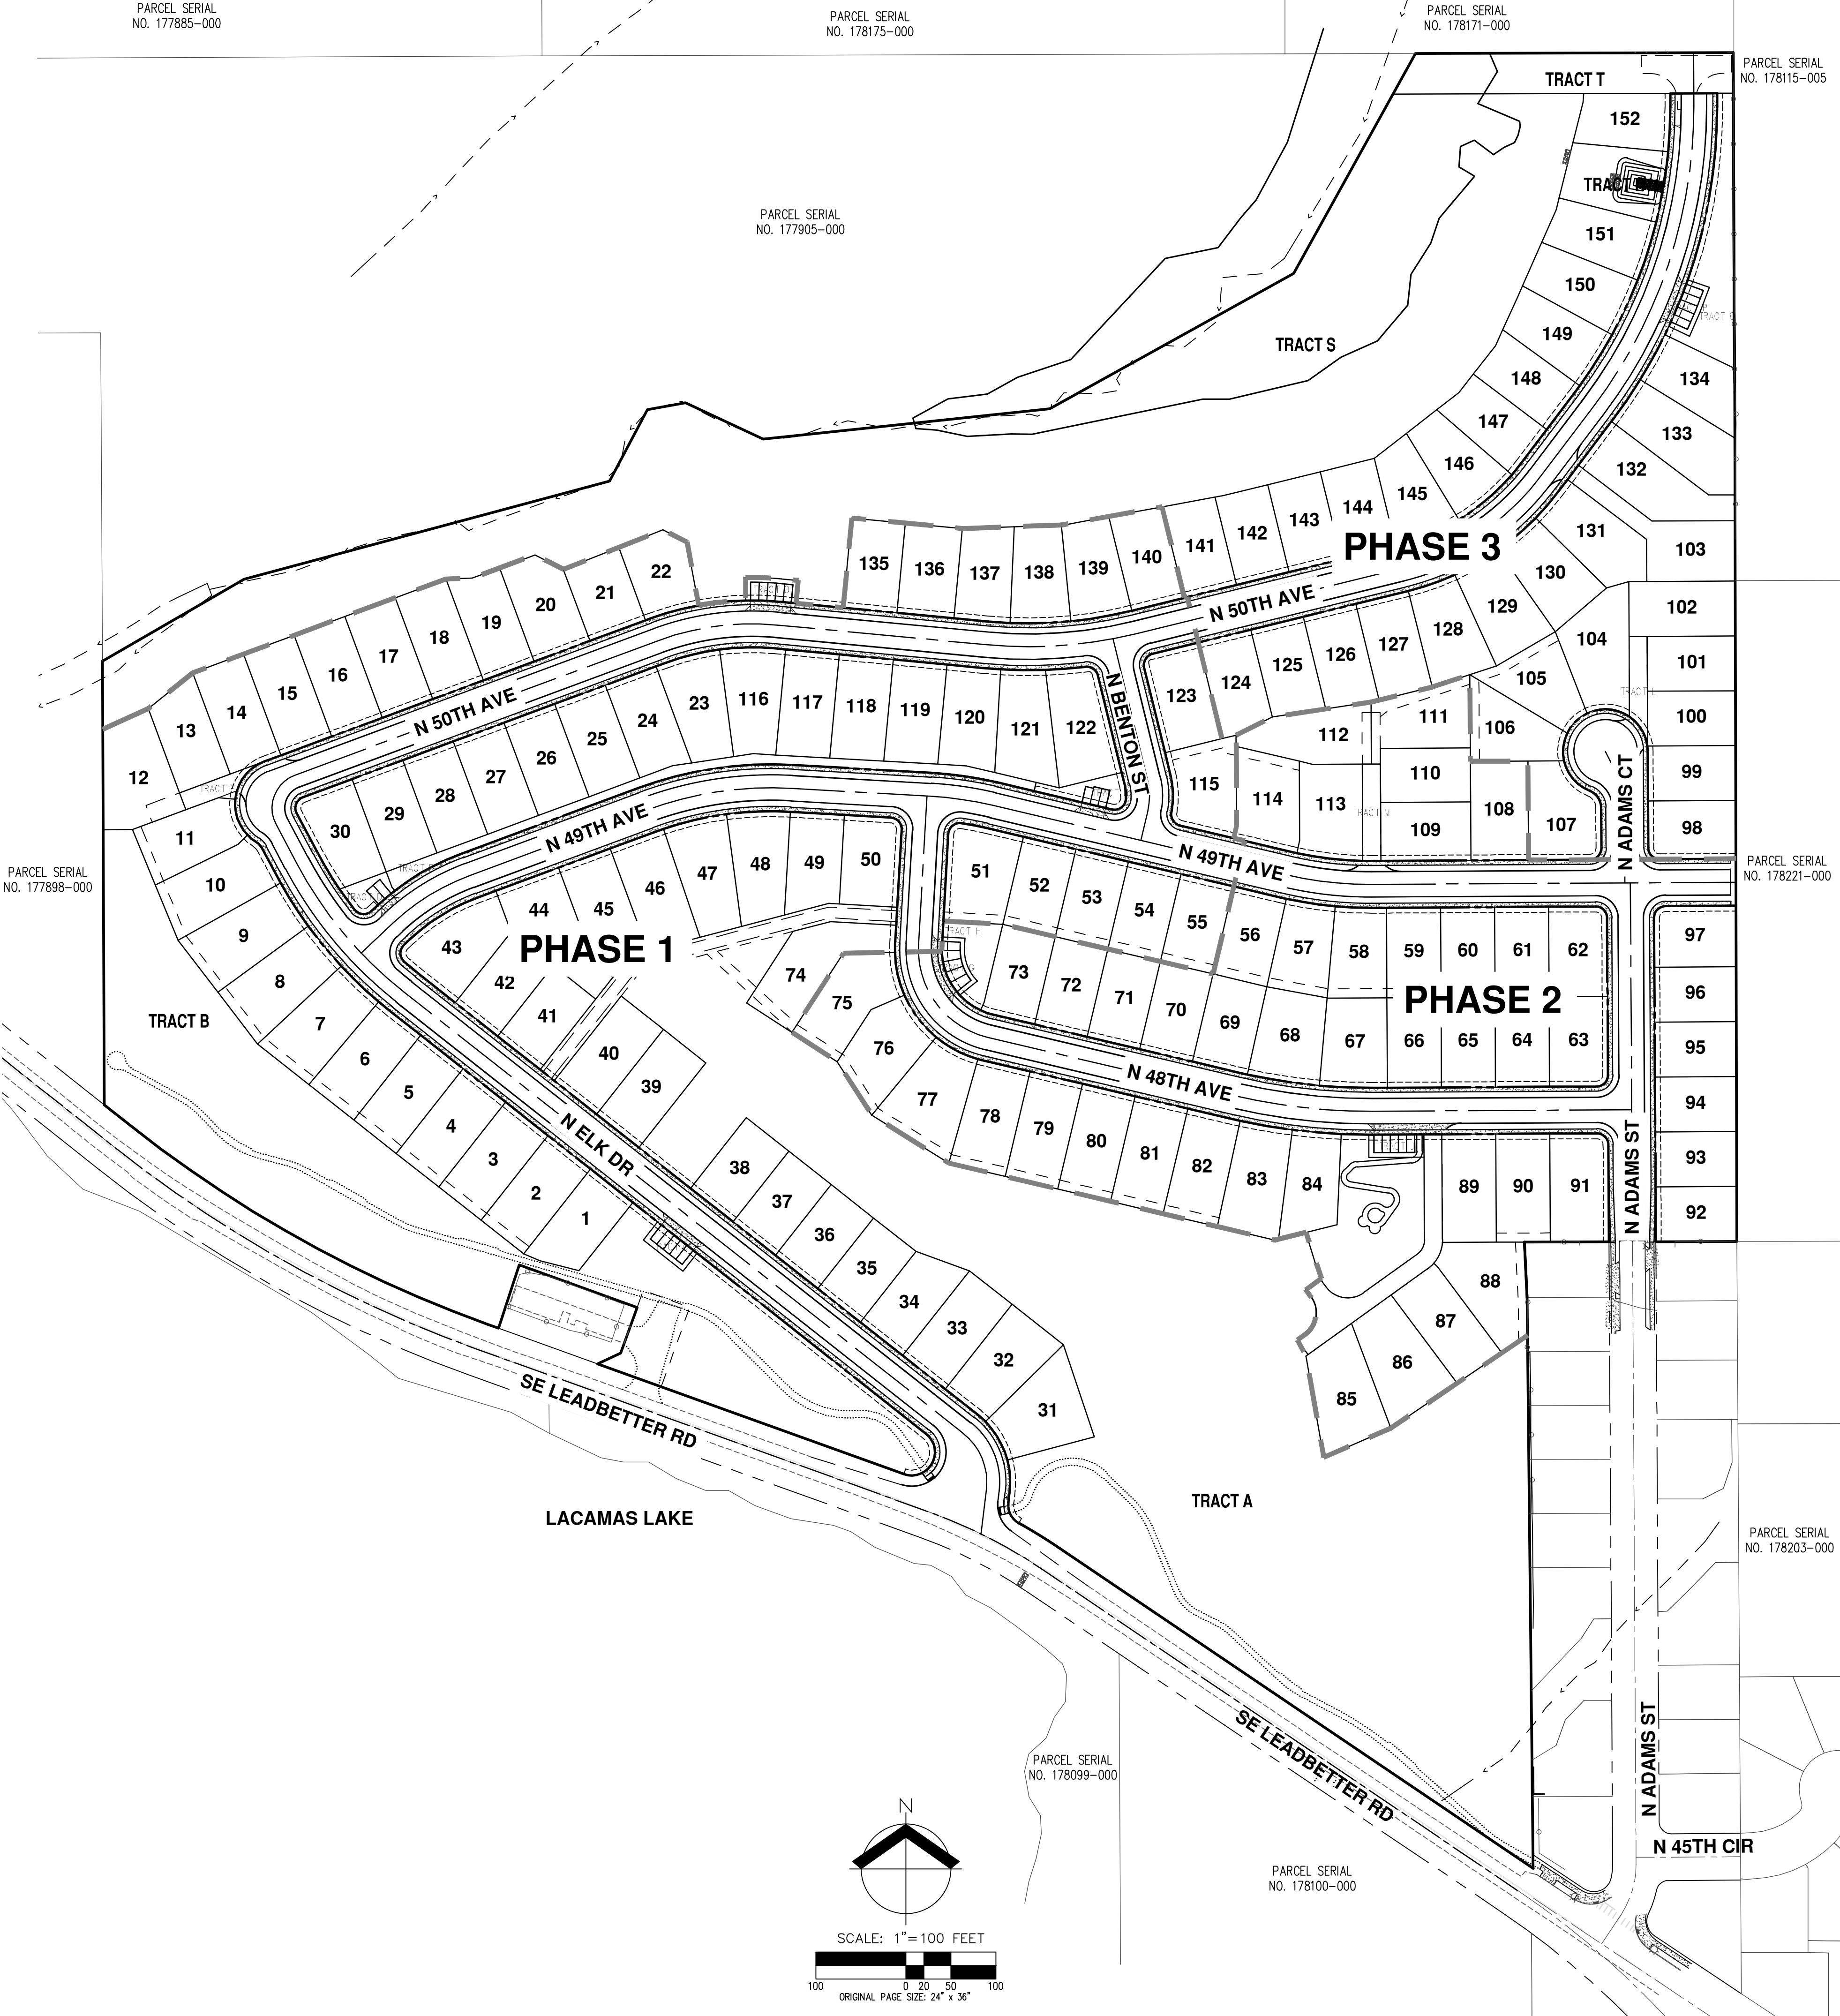
**PRELIMINARY STORMWATER PLAN**  
**CJ DENS SUBDIVISION**  
**CJ DENS LACAMAS II LLC**  
**CAMAS, WASHINGTON**

REAR YARD RUNOFF FOR LOTS 92-103 WILL BE COLLECTED AND DISPERSED INTO THE NEIGHBORING PROPERTY. ROOFS WILL DRAIN TO A STORMWATER LATERAL. SEE PRELIMINARY TIR FOR BASIN MAP DESCRIBING EXISTING ON-SITE FLOWS.

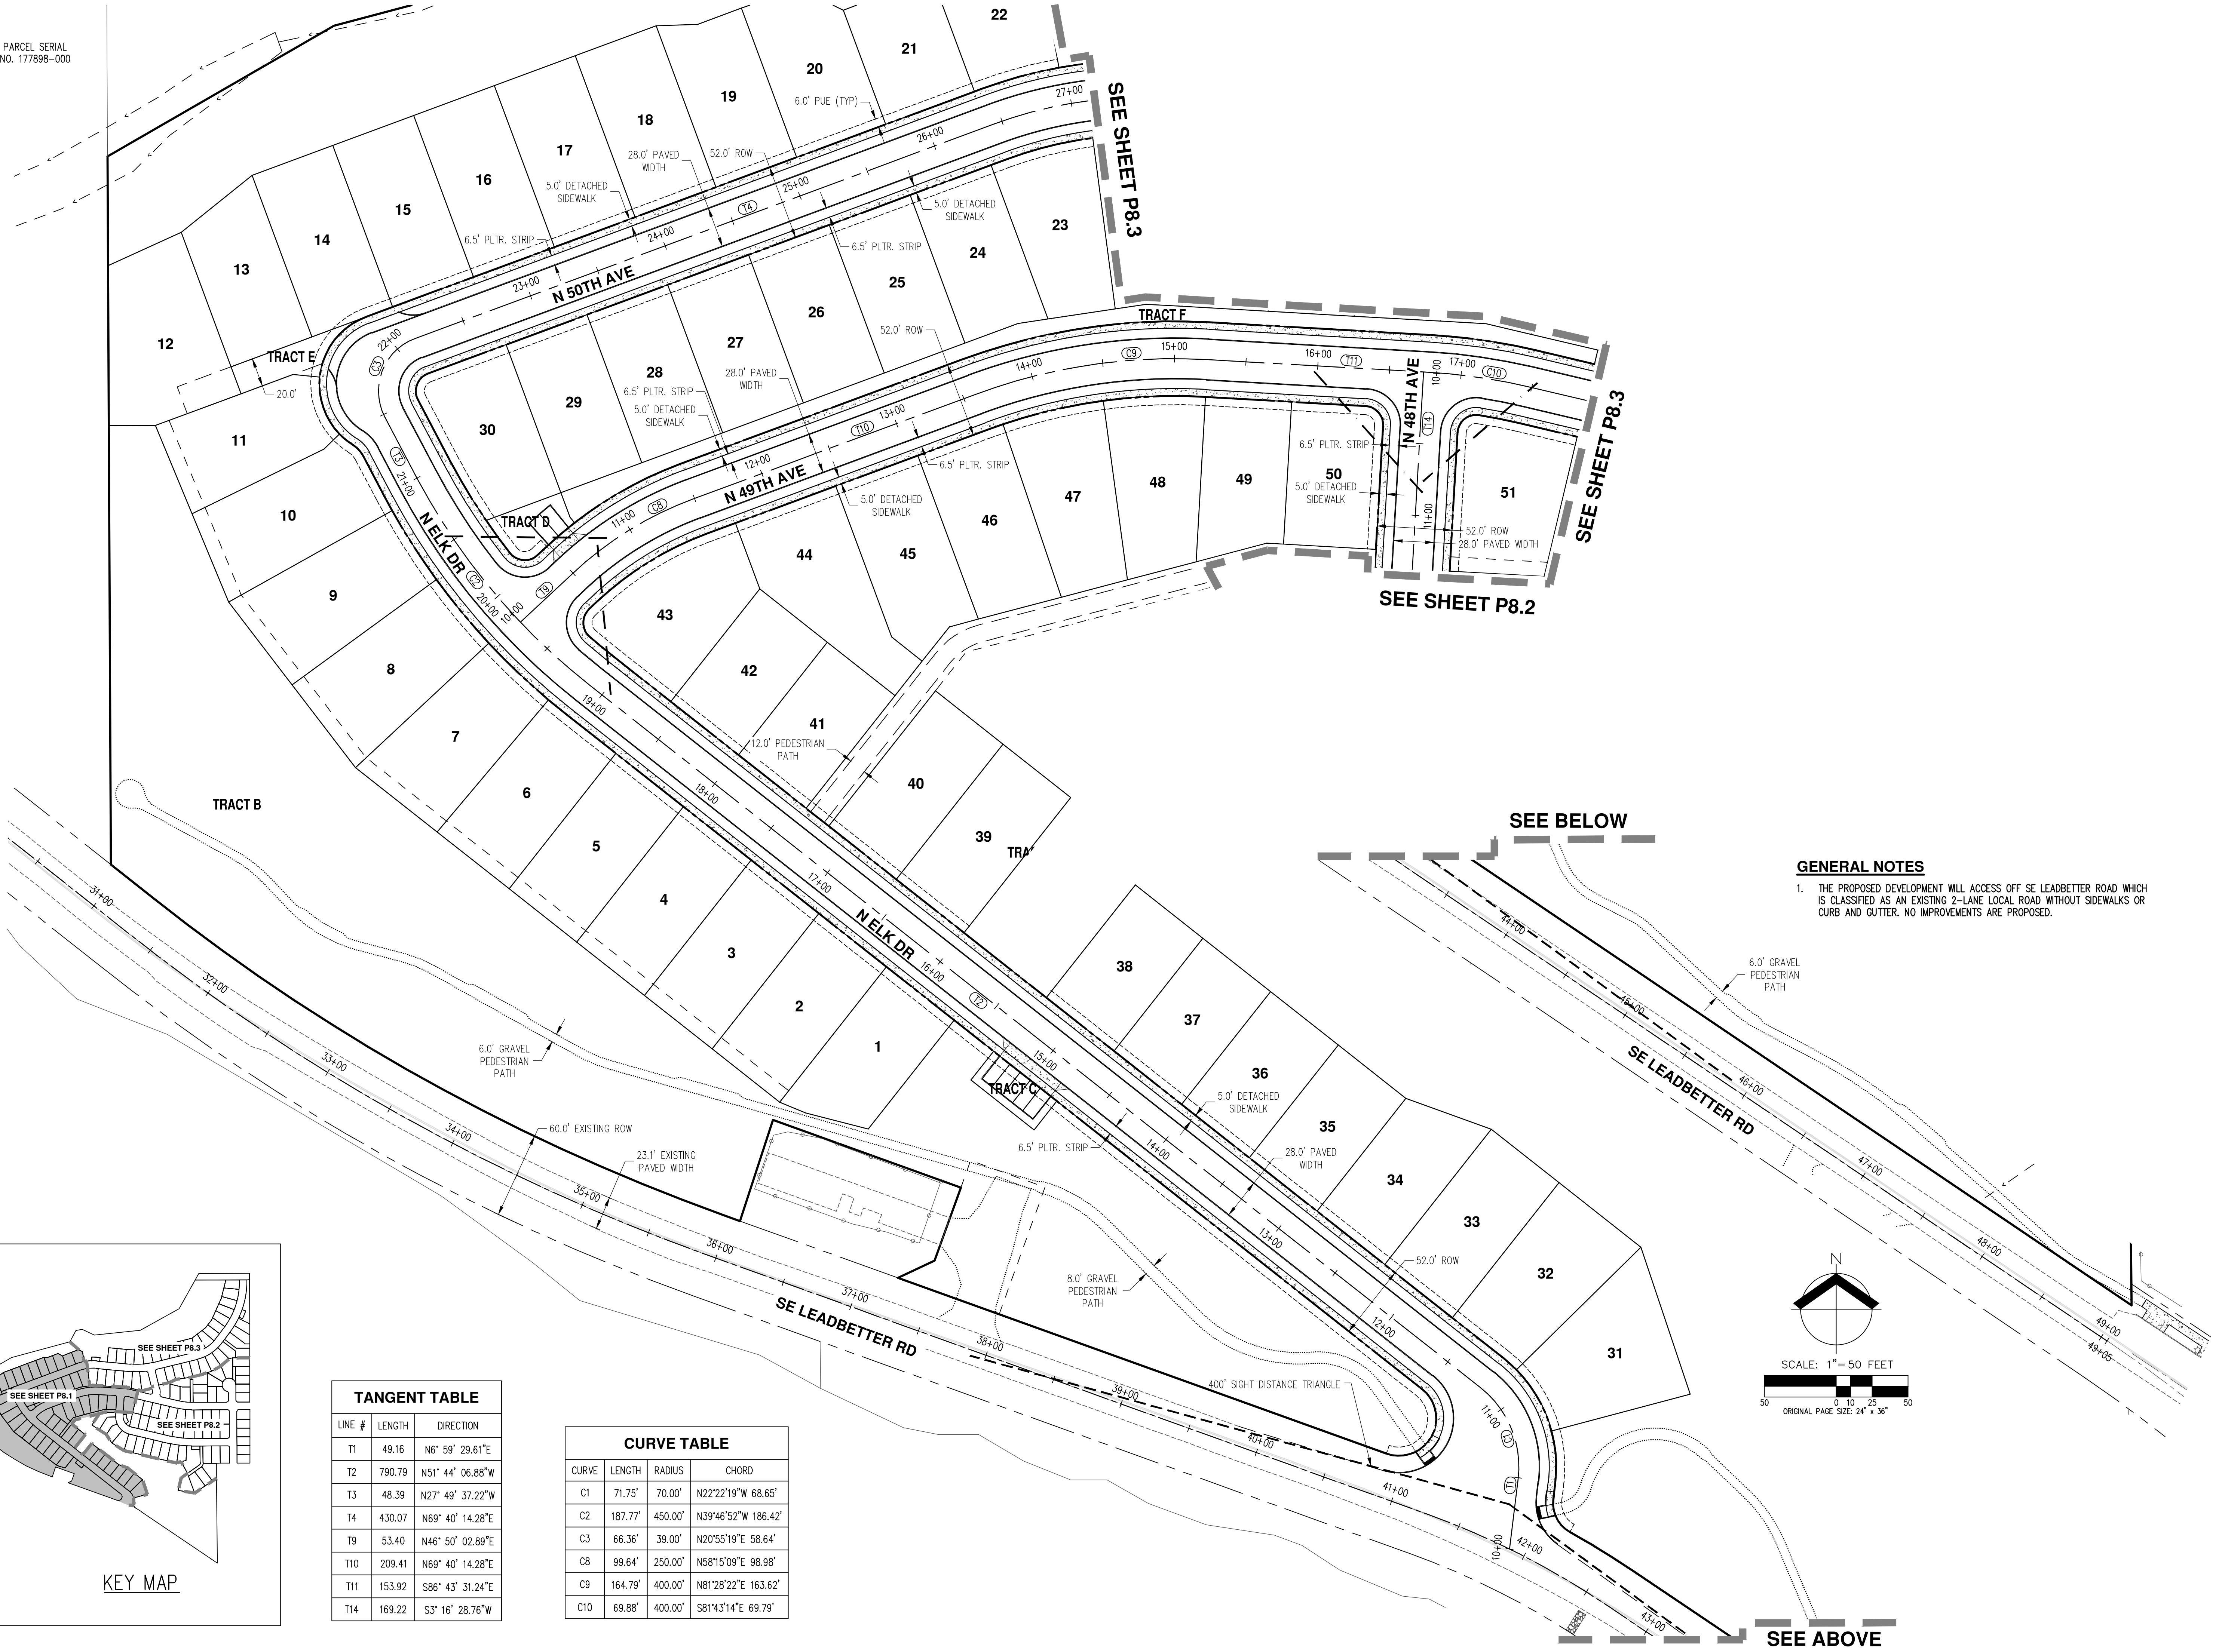
PRELIMINARY STREET PLAN  
CJ DENS SUBDIVISION  
CJ DENS LACAMAS II LLC  
CAMAS, WASHINGTON

- GENERAL NOTES**
1. THE PROPOSED DEVELOPMENT WILL ACCESS OFF SE LEADBETTER ROAD WHICH IS CLASSIFIED AS AN EXISTING 2-LANE LOCAL ROAD WITHOUT SIDEWALKS OR CURB AND GUTTER. NO IMPROVEMENTS ARE PROPOSED.
